# Flow Quality Surveys in the Settling Chamber of the NASA Glenn Icing Research Tunnel (2011 Tests)

In 2011, the heat exchanger and refrigeration plant for NASA Glenn Research Center's Icing Research Tunnel (IRT) were upgraded. Flow quality surveys were performed in the settling chamber of the IRT in order to understand the effect that the new heat exchanger had on the flow quality upstream of the spray bars. Measurements were made of the total pressure, static pressure, total temperature, airspeed, and flow angle (pitch and yaw). These measurements were directly compared to measurements taken in 2000, after the previous heat exchanger was installed. In general, the flow quality appears to have improved with the new heat exchanger.

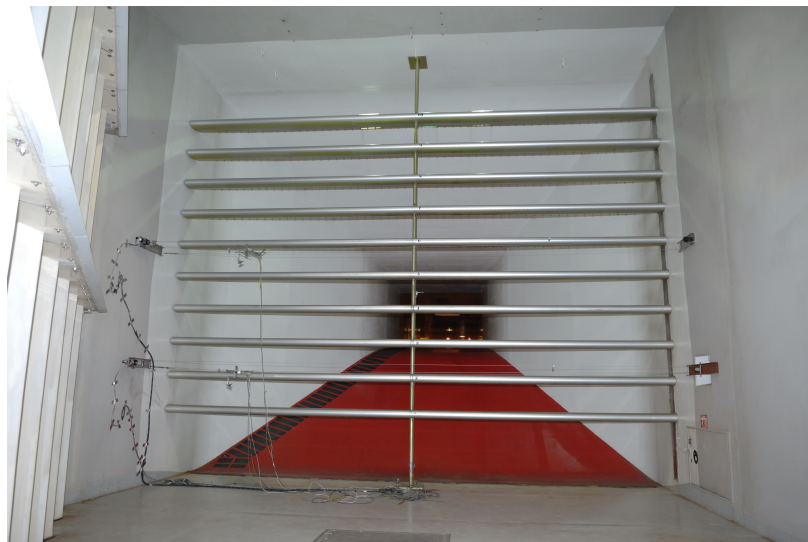
Figure 5: Two traversing platforms mounted for horizontal survey, with spray bars and test section behind.
