## **GLASS BUBBLES INSULATION FOR LIQUID HYDROGEN STORAGE TANKS**

J. P. Sass<sup>1</sup>, W. W. St.Cyr<sup>2</sup>, T. M. Barrett<sup>3</sup>, R. G. Baumgartner<sup>4</sup>, J. W. Lott<sup>2</sup>, and J. E. Fesmire<sup>1</sup>

A full-scale field application of glass bubbles insulation has been demonstrated in a 218,000 L liquid hydrogen storage tank. This work is the evolution of extensive materials testing, laboratory scale testing, and system studies leading to the use of glass bubbles insulation as a cost efficient and high performance alternative in cryogenic storage tanks of any size. The tank utilized is part of a rocket propulsion test complex at the NASA Stennis Space Center and is a 1960's vintage spherical double wall tank with an evacuated annulus. The original perlite that was removed from the annulus was in pristine condition and showed no signs of deterioration or compaction. Test results show a significant reduction in liquid hydrogen boiloff when compared to recent baseline data prior to removal of the perlite insulation. The data also validates the previous laboratory scale testing (1000 L) and full-scale numerical modeling (3,200,000 L) of boiloff in spherical

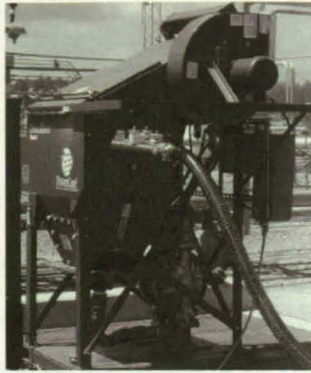
**FIGURE 4.** The portable dust collection system designed for offloading bubbles in remote locations.

A portable dust collection system (see FIGURE 4) was designed specifically for this new application to enable offloading of a pressure differential trailer in a remote location. It was designed to collect and contain airborne glass bubbles that are conveyed during the loading and venting process. The dust collector continuously monitors the loading of its filter, and automatically releases a burst of reverse pneumatic flow to clear the filter. The bubbles liberated from the filter are collected in an integrated hopper to be recycled into the process later. This equipment performed efficiently, collecting airborne glass bubbles with no release to the surrounding environment.
