Impact Testing of Aluminum 2024 and Titanium 6Al-4V for Material Model Development

*J. Michael Pereira, Duane M. Revilock, Bradley A. Lerch and Charles R. Ruggeri
Glenn Research Center, Cleveland, Ohio*

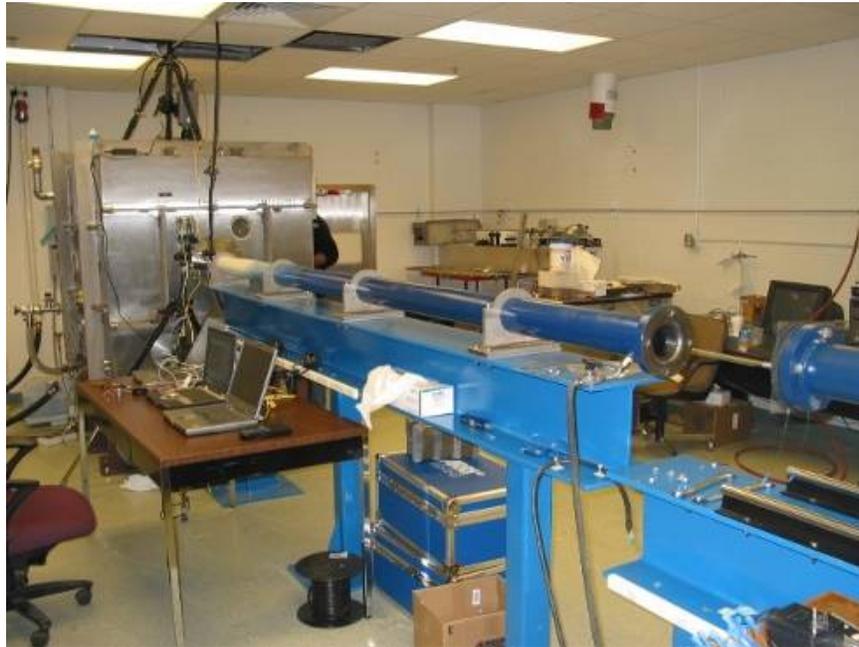
Figure 4.—Large Vacuum Gas Gun (shown with 3 in. diameter gun barrel).

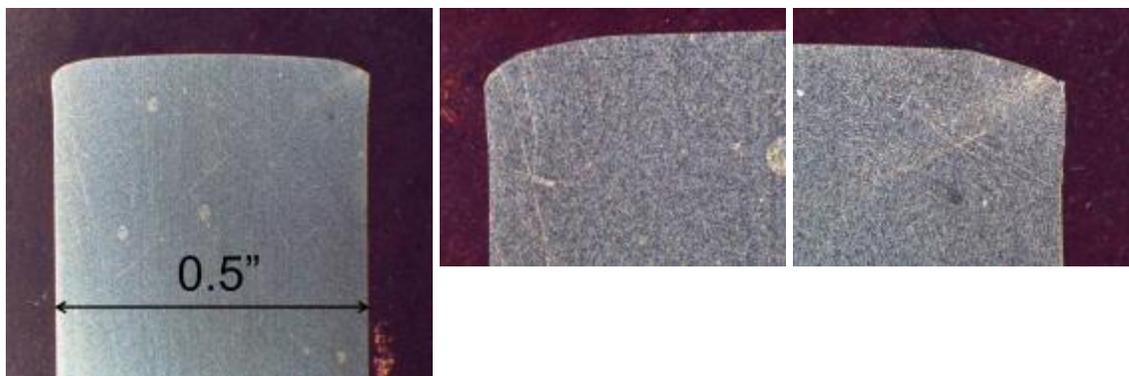
Figure 29.—Evidence of extensive plastic deformation in Ti-6Al-4V projectile.

An additional set of tests was conducted on the 0.14 in. thick Ti-6Al-4V plates using a hardened steel projectile of the same mass as the Ti-6Al-4V projectile (see Table 7, row 6). As shown in the table, there was a considerable reduction (15%) in the penetration speed. Simple elastic-plastic LS-DYNA analyses confirmed a significant increase in plastic strains in the panel with a projectile having a higher yield strength, and therefore hardness, and it can be speculated that the higher impedance of the harder projectile induces higher particle velocities and resulting higher strains. It has been observed elsewhere in Anderson et al. (Ref. 1) that the ballistic limit velocity decreases significantly when the hardness of the projectile exceeds that of the target. In thick targets, it has been shown by Forrestal and Piekutowski (Ref. 2) that penetration depth increases and projectile deformation decreases as the hardness of the projectile increases. Hardness is an indicator of material yield strength.

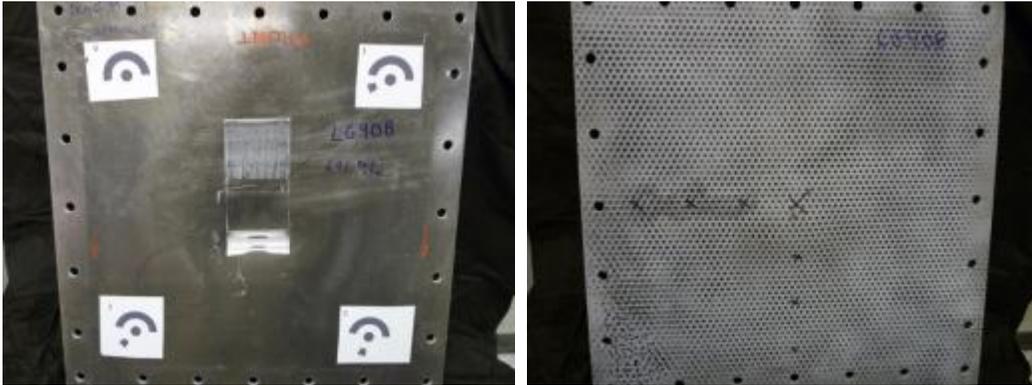
Figure 32.—Large Al-2024 Test Panel, front and back, side test LG908.

Four impact tests on each of the large Al-2024 and Ti-6Al-4V panels described in Section 2.2, using the NGFBF blade fragment simulating projectile. Results of these tests are shown in Table 8 and Table 9. Photos from the impact tests are shown in Figure 32 to Figure 39. It can be seen from the test photographs that failure initiation and the majority of the damage occurs when the heavier root section of the blade impacts the panel. This is consistent with what occurs in an actual jet engine fan blade out incident.

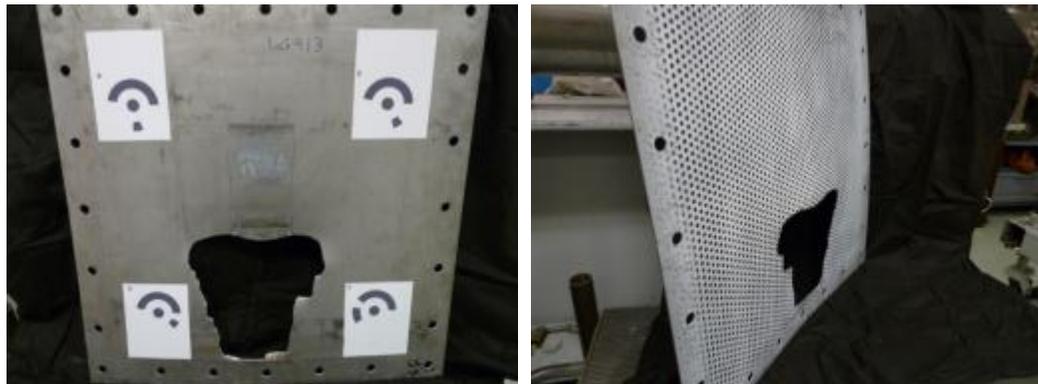
Figure 37.—Large Ti-6Al-4V Test Panel, front and back side, test LG913.
