SAFELY CONDUCTING AIRPORT SURFACE TRAJECTORY-BASED OPERATIONS

Denise R. Jones, Lawrence J. Prinzel, III, Randall E. Bailey, and Jarvis J. Arthur, III

National Aeronautics and Space Administration, Hampton, VA

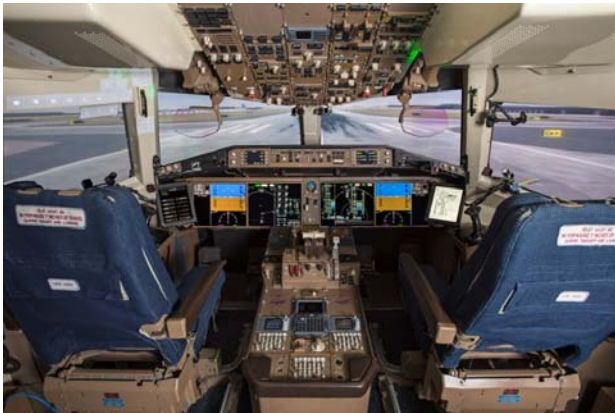
Figure 1. RFD Flight Deck

As shown in Figure 1, the simulator had four large main instrument panel displays referred to as: (left to right) pilot's Primary Flight Display (PFD),

pilot's Navigation Display (ND), co-pilot's ND, and co-pilot's PFD. Each display panel had 13.25 inch x 10.5 inch viewable area at 1280 x 1024 resolution.

This research was conducted in the Research Flight Deck (RFD) simulator at NASA Langley Research Center (LaRC) (Figure 1) which is a high-fidelity, six degrees-of-freedom motion-based large commercial aircraft simulator with full-mission capability and advanced glass flight deck displays. Operations were conducted at the Memphis International (KMEM) airport. The out-the-window (OTW) scene included realistic taxiways and runways with appropriate markings, airport lighting, and other aircraft in simulated visibility conditions and provided approximately 20/40 visual acuity with a collimated 200° horizontal by 40° vertical field of view at 26 pixels per degree resolution.

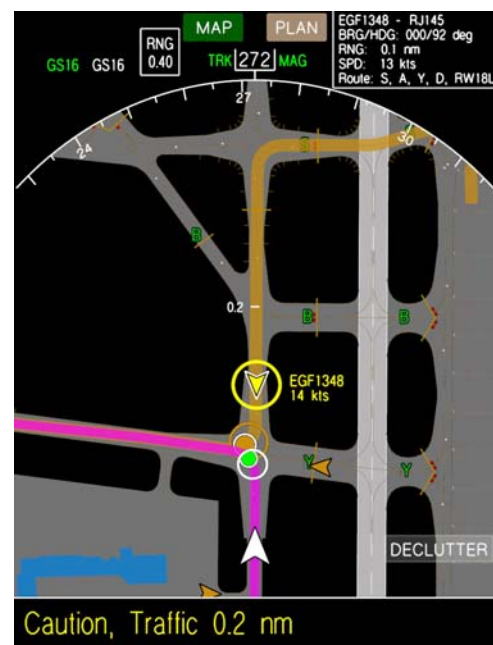
Figure 2. AMM Showing Caution Alert

Caution alerts were generated for conditions that required immediate flight crew awareness and subsequent flight crew response. A caution alert was displayed on the AMM as an enlarged yellow traffic symbol surrounded by a yellow circle for the relevant traffic, an identification tag and ground speed in knots, and a yellow line around the relevant runway, if applicable. An alert message (“Caution, Traffic”) was displayed at the bottom of the AMM in yellow text along with the estimated distance to the traffic. An audible annunciation was also made (“Caution, Traffic, Caution, Traffic”) (Figure 2).

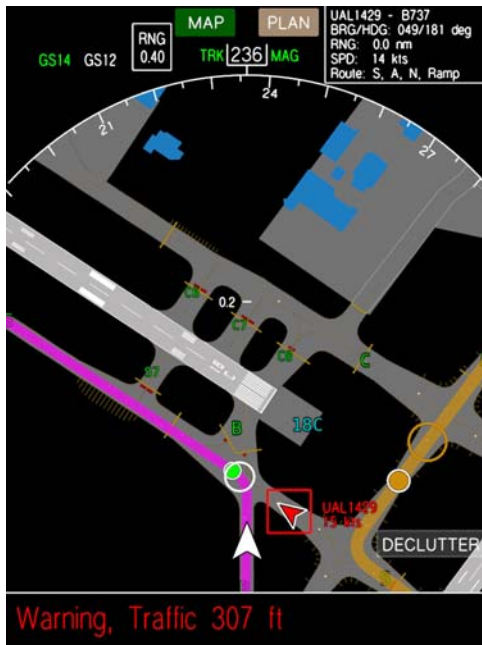
Figure 3. AMM Showing Warning Alert

Warning alerts were issued for conditions that required immediate flight crew awareness and immediate flight crew response. Warning alerts could occur without preceding caution alerts. A warning alert was displayed in the same manner on the AMM as a caution alert, except the warning was associated with the color red, a square was used to surround the traffic symbol, and the alert message was “Warning, Traffic” (Figure 3).

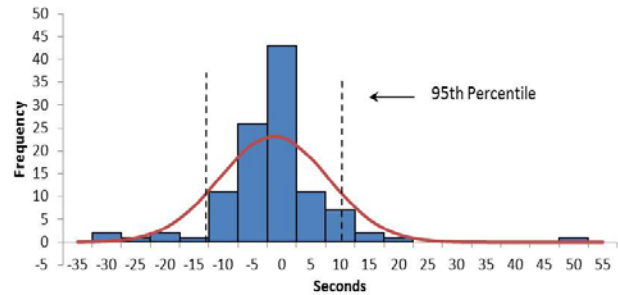
In general, the flight crews were able to conform well to the STBO guidance during the straight taxi segments (Figure 8). The crews were able to maintain +/- 10 seconds of the guidance at the straight segment mid-point location 86.1% (93 of 108) of the time and +/- 15 seconds for 92.6% (100 of 108) of the time.

There was a significant main effect found for HUD condition. Pilots had significantly better STBO guidance conformance, on the straight route segments, using a HUD (mean, μ , = 1.1 sec, standard deviation, σ , = 11.3 sec) than without using a HUD (μ = -2.6 sec, σ = 7.9 sec).

Figure 8. STBO Straight Segment Location Conformance

In the straight-segments, crews were able to adjust their speed to meet their RTA. When viewed as conformance along the route, the data shows

relatively good performance (92.6% compliance) but with some very significant tails in the data (i.e., one ~50 seconds early and several ~30 seconds late). Along route conformance was suboptimal in these cases since the crews were only asked to meet the end-of-route RTA performance. Intermediate/waypoint RTAs were not used.
