# Development of the RANCOR Rotary-Percussive Coring System for Mars Sample Return

Gale Paulsen\*, Stephen Indyk\* and Kris Zacny\*

Proceedings of the 42<sup>nd</sup> Aerospace Mechanisms Symposium, NASA Goddard Space Flight Center, May 14-16, 2014

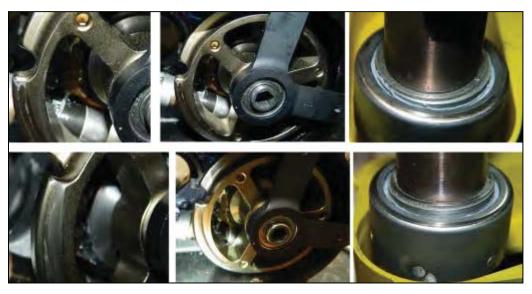
Another advantage to the canted follower design is an increased life of the CAM / follower mechanism. Two RANCOR units were assembled and tested; a Honeybee and a JPL unit. After over 50,000 percussive cycles with the Honeybee RANCOR unit and over 30,000 percussive cycles with the JPL RANCOR unit, there is little wear on the mechanism (Figure 13). The only obvious wear location is the end of the ramp on the CAM where the follower is released. The follower also had a lubricious coating (Magnaplate Nedox FM-5) that has been worn off on the contact area which was anticipated. At the end of the CAM ramp the Magnaplate Nedox SF-2 plating has been worn off entirely. In designs where the follower is not canted (Figure 12) this plating is removed over essentially the entire contact area of the CAM after only a few thousand cycles.

Figure 13. Images of wear in CAM and Follower for Honeybee unit after 50,000+ cycles (top 3 images) and the JPL unit after 30,000+ cycles (bottom 3 images)

- 6. Using a canted or sloped follower for the hammer mechanism (i.e. follower is tilted to match the slope of the cam) is an ideal solution for the percussive mechanism. This type of solution has now been implemented on its third Honeybee drilling system and has performed efficiently on all systems. When compared to a more traditional follower design where the follower is perpendicular to its axis of travel, the canted follower is about twice as efficient and the wear in the mechanism is significantly reduced.
