Meteoroid-Induced Anomalies on Spacecraft

Bill Cooke

Meteoroid Environment Office, NASA Marshall Space Flight Center

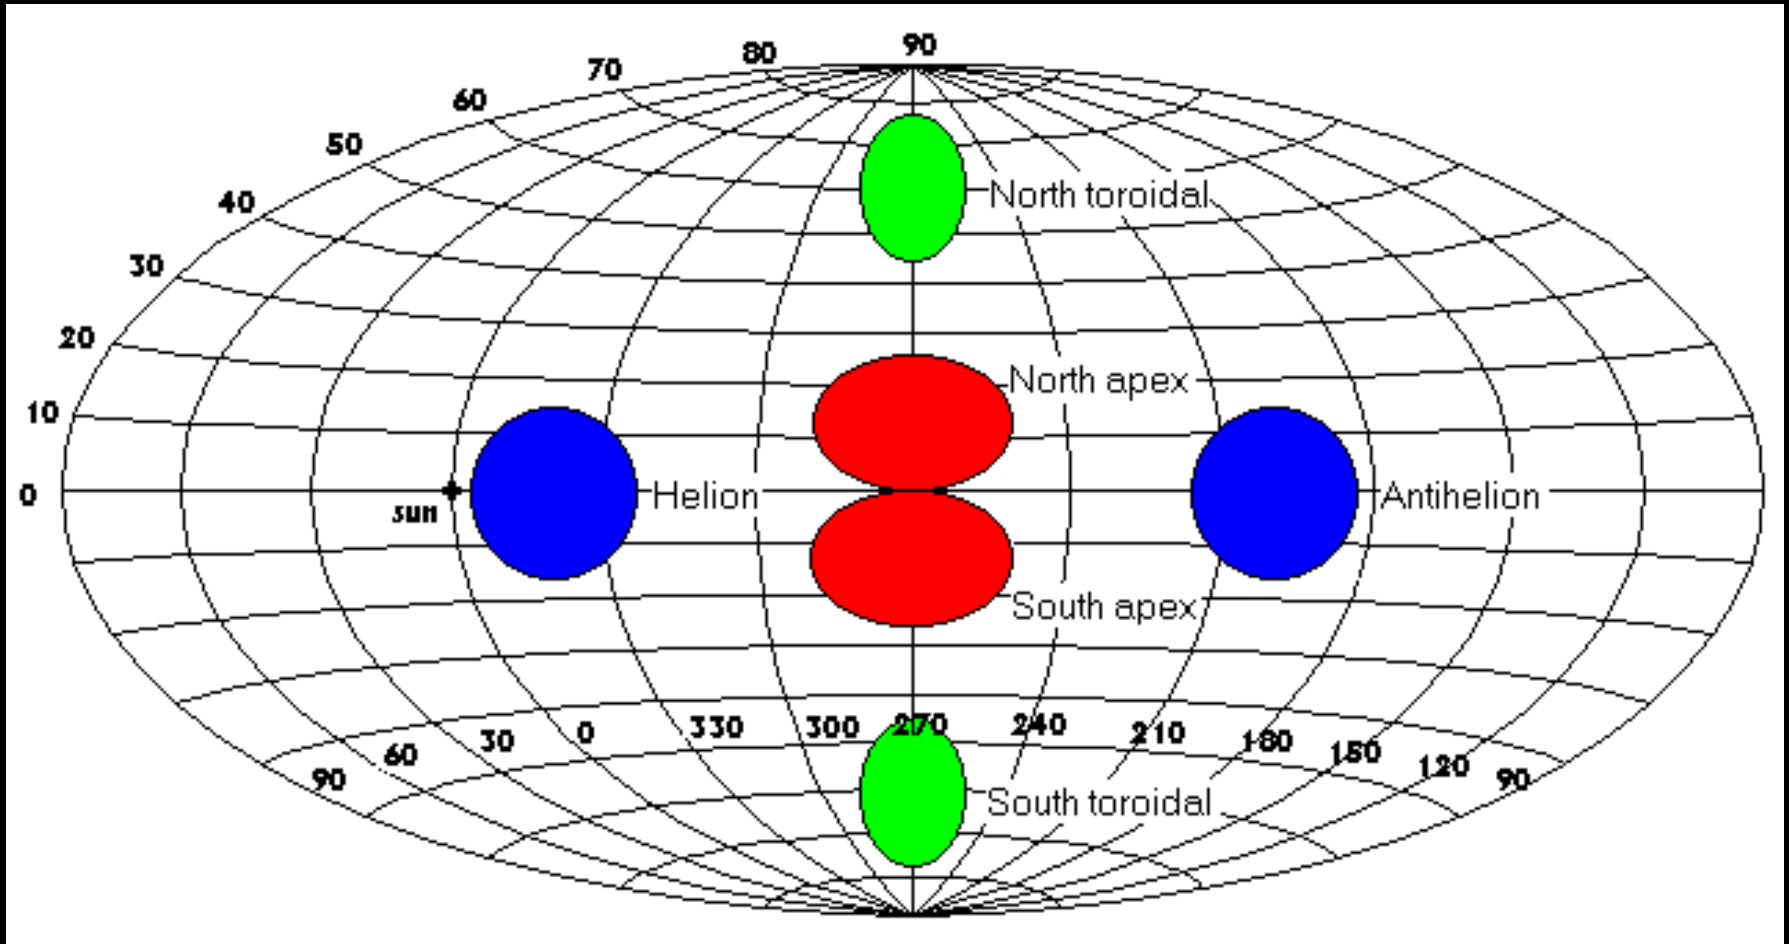
Sporadic Directionality

- Sporadic meteoroid background is directional (not isotropic) and accounts for 90% of the meteoroid risk to a typical spacecraft.
- Meteor showers get all the press, but account for only ~10% of spacecraft risk.
 - Bias towards assigning meteoroid cause to anomalies during meteor showers.
- Vast majority of meteoroids come from comets and have a bulk density of $\sim 1 \text{ g cm}^{-3}$ (ice).
- High speed meteoroids ($\sim 50 \text{ km s}^{-1}$) can induce electrical anomalies in spacecraft through discharging of charged surfaces (also EMP?).

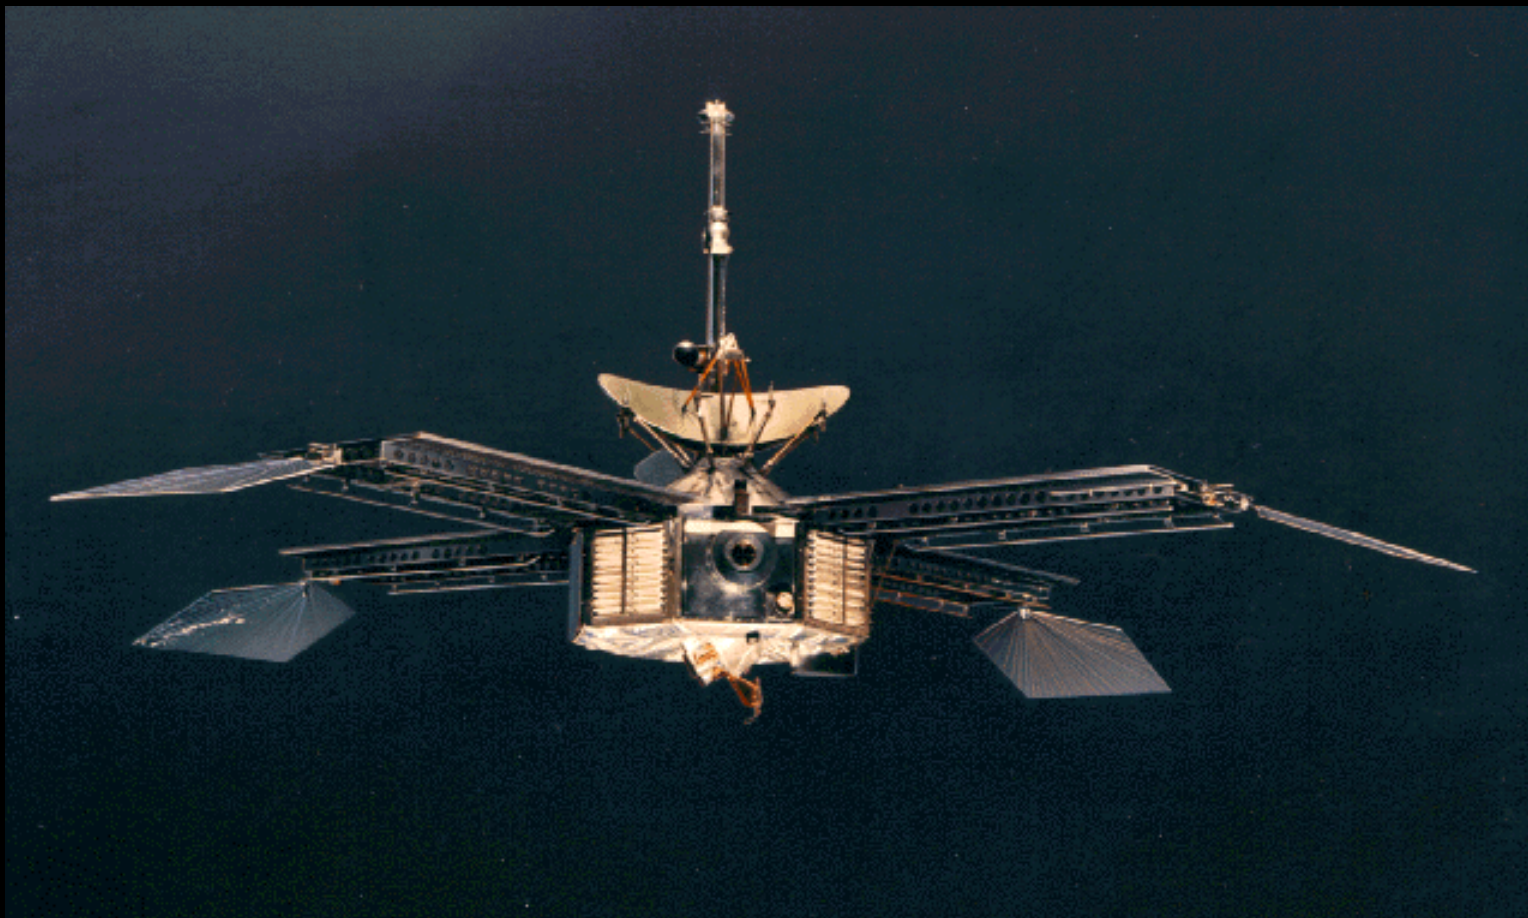
- Launched 28 November 1964; flew by Mars on 14-15 July 1965.
- From *Astronautics and Aeronautics*, 1967, pg. 270-271, September 15 entry:

“Mariner IV, launched Nov. 28, 1964, survived apparent micrometeoroid shower. Spacecraft’s cosmic dust detector registered 17 hits within 15 min, while Mariner IV traveled between orbits of earth and Mars. Spacecraft was 29.6 million miles from earth and had traveled about 1.4 billion miles in its 1,020 days of flight. Micrometeoroid shower had caused temporary change in spacecraft’s attitude but no loss of power. Scientists concluded, from one-degree temperature drop inside spacecraft, that only the thermal shield was damaged. Within about a week, spacecraft was operating normally without any apparent effect from incident...”

- Position of spacecraft at encounter:
 - Heliocentric distance: 1.273 AU
 - Ecliptic Longitude: 343.6 degrees
 - Ecliptic Latitude: 2.25 degrees N.
- Spacecraft torqued about roll axis; thermal insulation ripped away.
- Report estimates that the spacecraft was struck by 2 or 3 orders of magnitude more particles than the 17 recorded by the dust instrument (Mariner IV is only U.S. spacecraft sent to Mars with meteoroid detector).
- Impact rates this high have only been measured near comet nuclei (Halley).

Number of hits during shower was 1500x higher than mission average, and only 60x lower than Giotto's hit rate at closest approach to Halley.

Impacts suffered by M4 may have resulted from a passage through a cometary meteoroid stream or the debris of or perhaps even the "coma" of an undetected dead or nearly-dead comet.

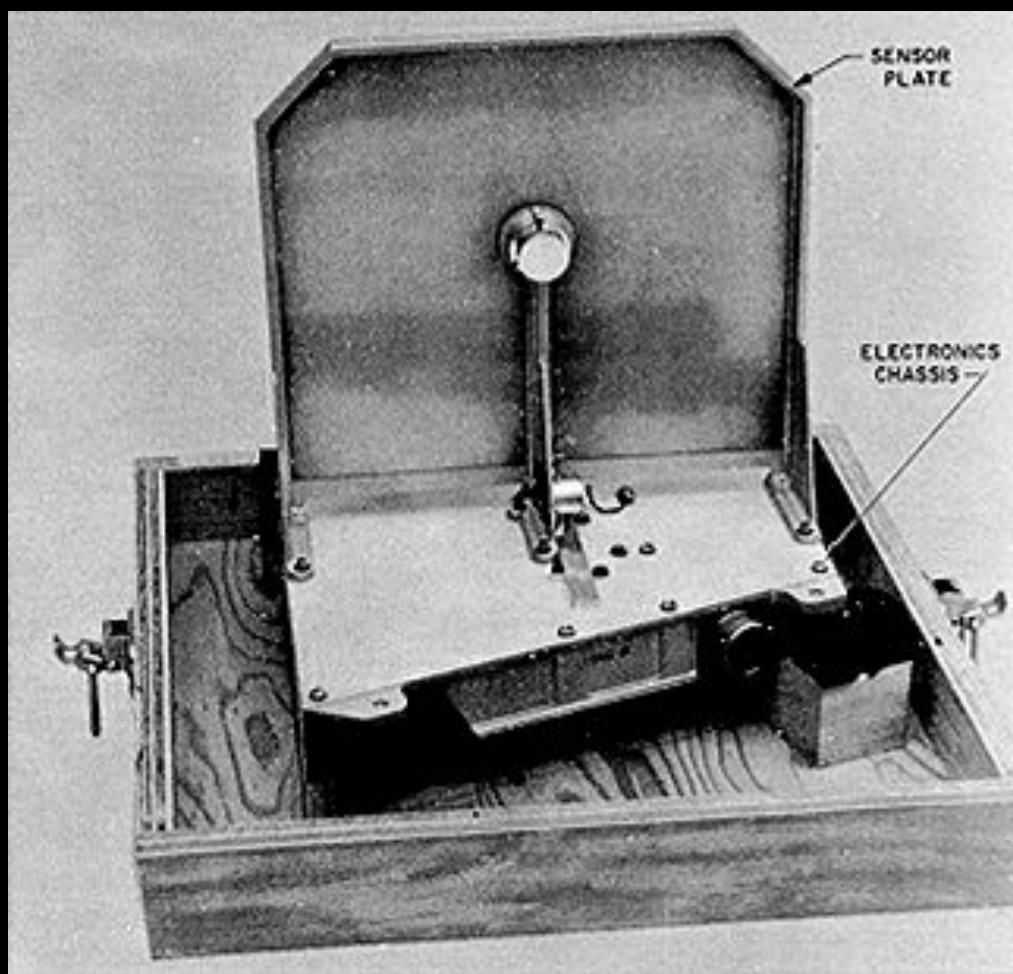
Mariner IV Cosmic Dust Detector
22.1cm on a side, 0.8 mm thick

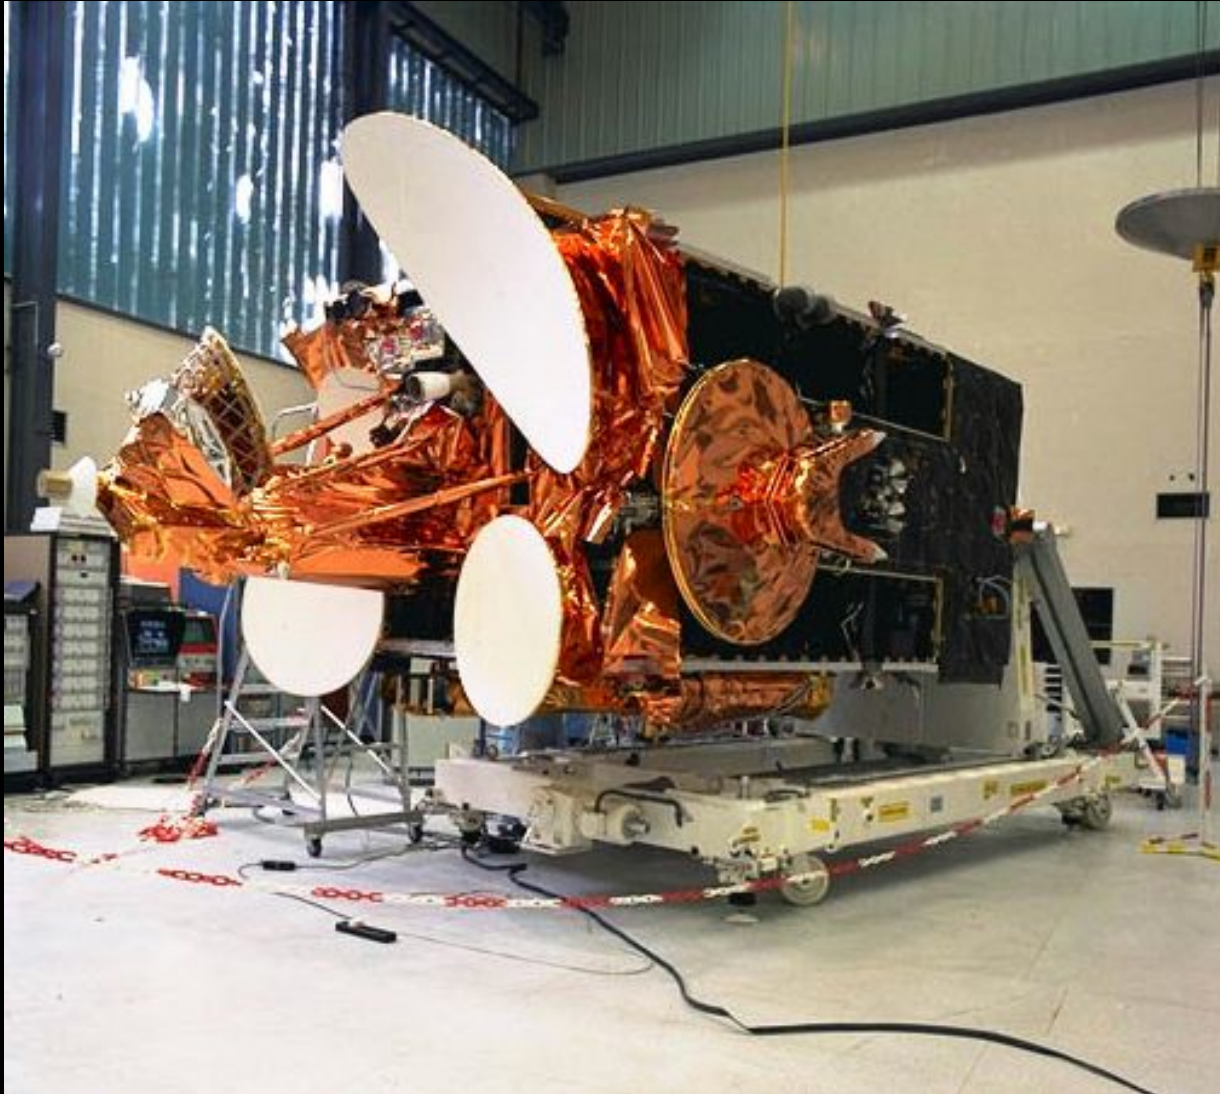
- Technology demonstration satellite - launched 12 July 1989; largest civilian comm satellite built up to that time.
- South solar panel stopped tracking the Sun in January 1991 (particle impact?).
- 19 June 1991– attitude control issue; incorrect commands uplinked from ground resulted in tumbling and drift off station. Vehicle recovered and put back into service at 19W on 7 August 1992.

- Olympus roll gyro stops at 23:32 UTC August 11. Spacecraft enters ESA mode and fails to acquire the Sun.

- Attempts to recover spacecraft exhausted most of remaining fuel, making it impossible to return the vehicle to service. Mission was terminated August 12, and the spacecraft was moved into a disposal orbit 200 km below GEO.
- ESA anomaly investigation attributed the failure to a Perseid strike on the south solar array.
 - South array had 8.5 m^2 of area exposed to the stream.
 - There was a possible conducting path to the gyro through the spacecraft umbilical.
 - Ground hypervelocity tests showed plasma generated by a meteoroid strike to be proportional to $v^{3.5}$.

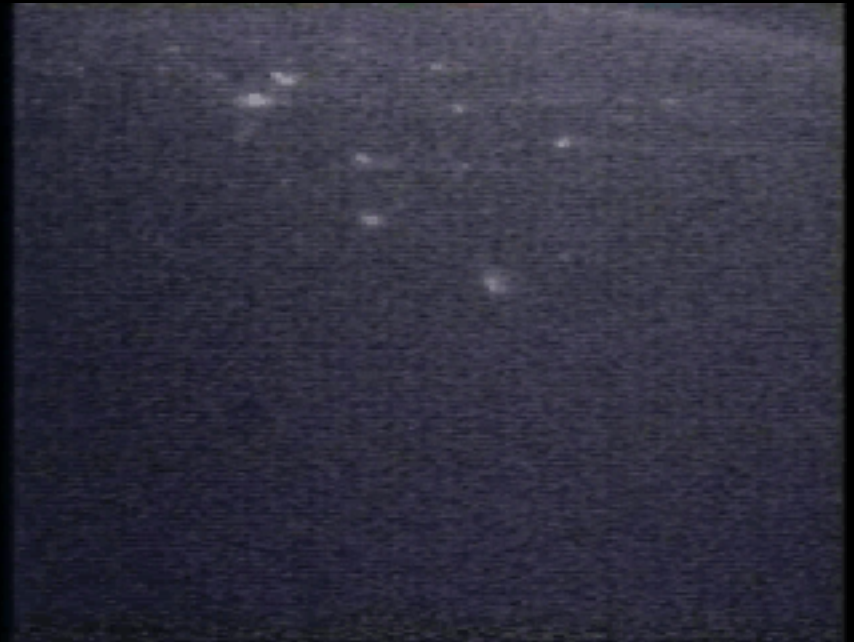
The 1993 Perseids

- Before modern shower forecasting techniques – no one knew what to expect.
- Parent comet (Swift-Tuttle) had just passed perihelion in December of 1992, so there were many “predictions” of a major outburst.
- Launch of STS-51 (Discovery) delayed until after shower peak – only Shuttle launch ever delayed because of a meteor shower.
- An outburst did occur, with meteor rates exceeding 250 per hour around 3:30 UTC on August 12.

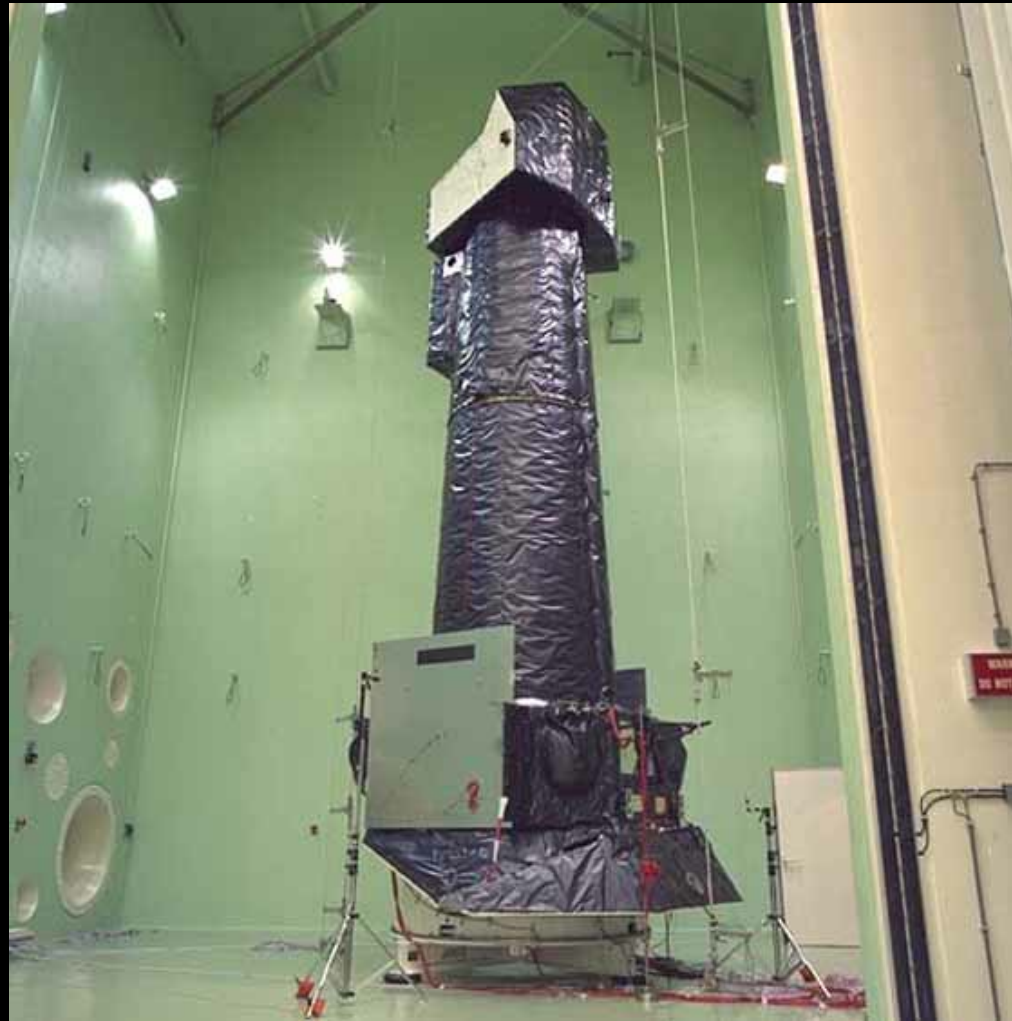
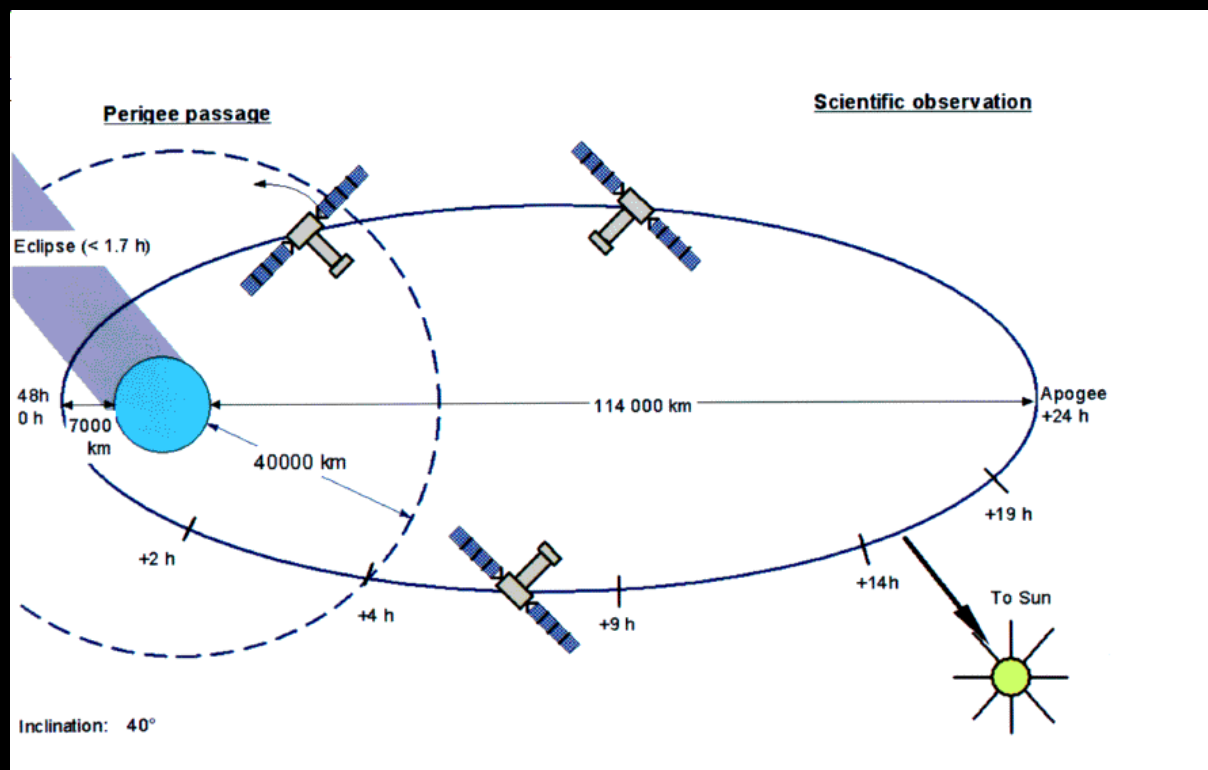
- ESA X-ray observatory
- Launched on 10 December 1999; still operational

- On 17 September 2001 at 23:31 UTC, a diffuse light was observed in a single frame taken by the MOS1 camera.
- Immediately after the event, 27 new bad pixels were noted.
 - Anomaly investigation concluded meteoroid impact.
 - Camera was observing an X-ray object located in the same direction as the south Toroidal sporadic source.
- XMM-Newton has taken other hits: 15 October 2000, 12 August 2002, and 9 March 2005.
- The 2005 hit destroyed the CCD6 segment of the MOS1 camera.
- XMM-Newton's multiple cameras have an estimated 22% per annum impact probability for the ensemble.

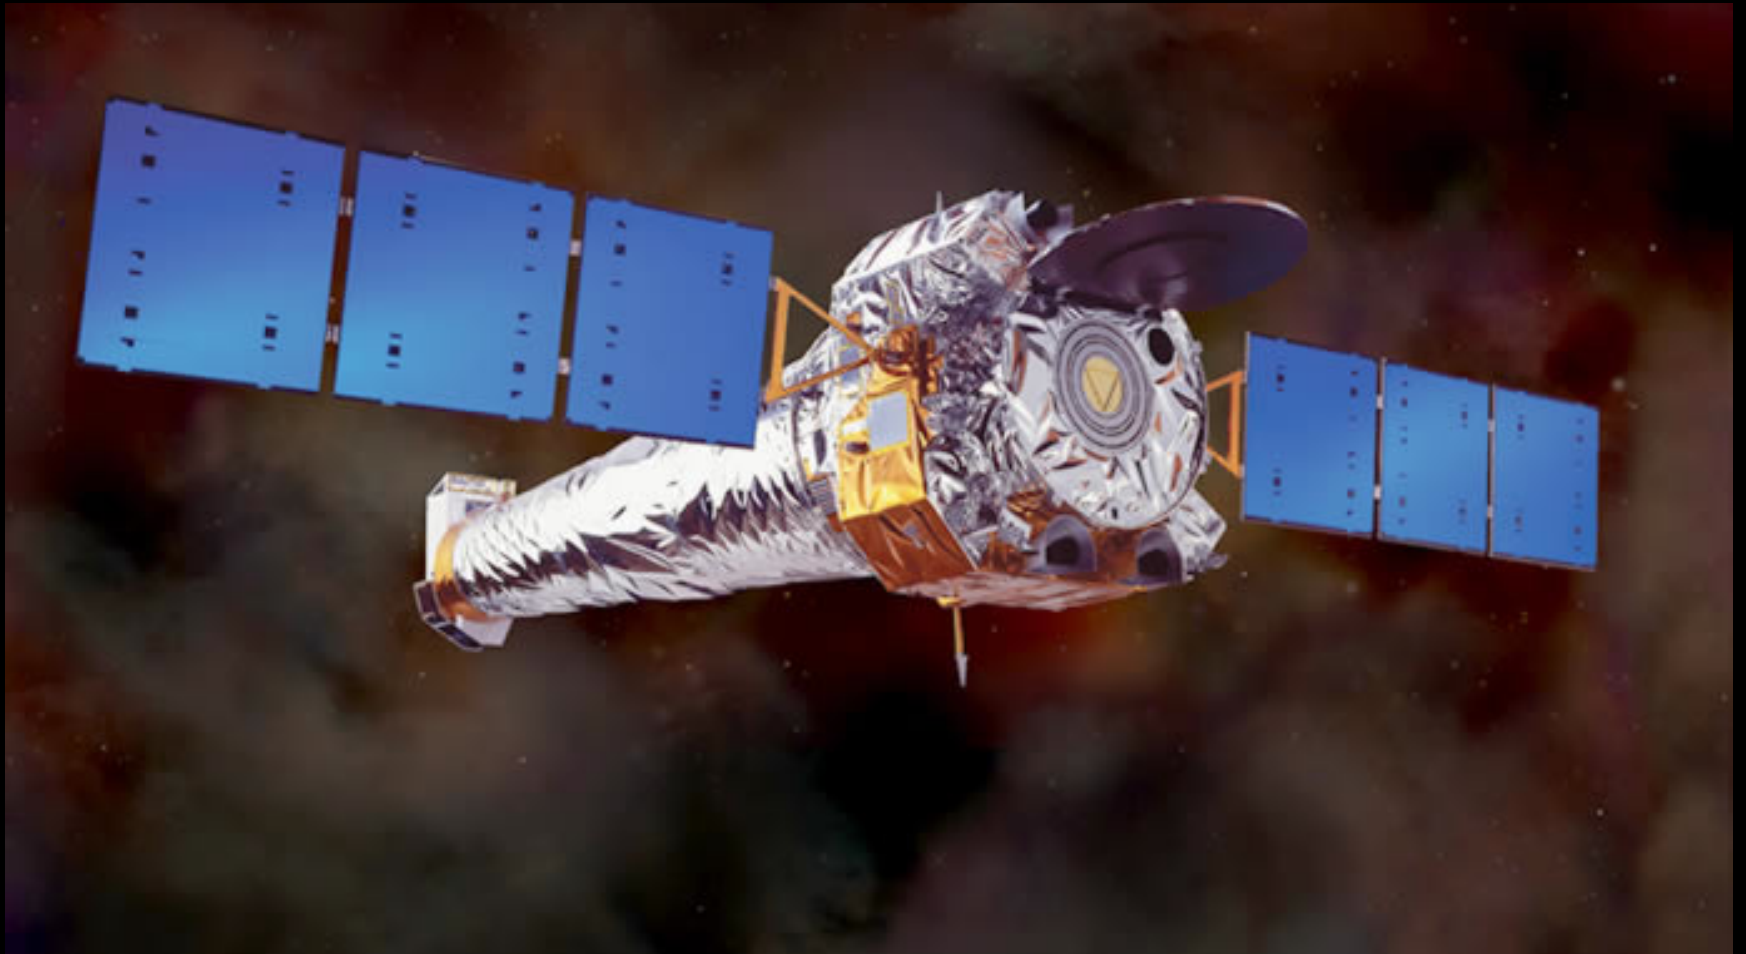
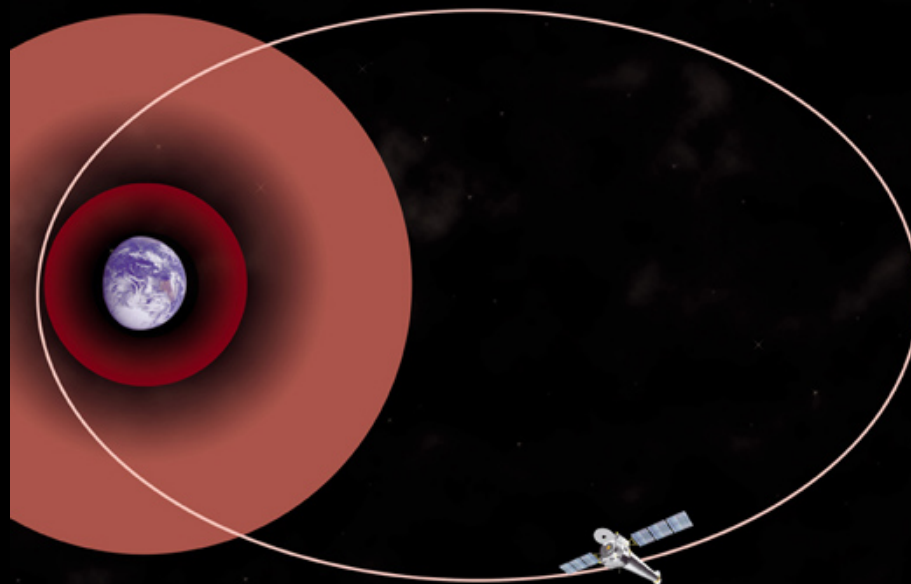
Chandra

- NASA X-ray observatory.
- Launched 23 July 1999; still operational.
- Perigee: 16,000 km Apogee: 133,000 km

- Disturbance in pointing stability just before 4:00 UTC on 15 November 2003.

- Program computed that an impact by a 1 mm Leonid could account for observed displacement – other causes ruled out.
 - Impact out near apogee.
- However, there was no Leonid storm in 2003, and the impact occurred well away from the observed shower maxima. At time of impact, meteor rates were <20 per hour.
- Measurements of the sporadic flux shows that it was 2 orders of magnitude larger than the Leonid flux at the event time.
 - Leonid radiant is located within the north Apex sporadic source, which has an average speed of 55 km s^{-1} .
 - Fluxes would indicate that an impact by a north Apex sporadic is 5 times more likely than that from a Leonid.

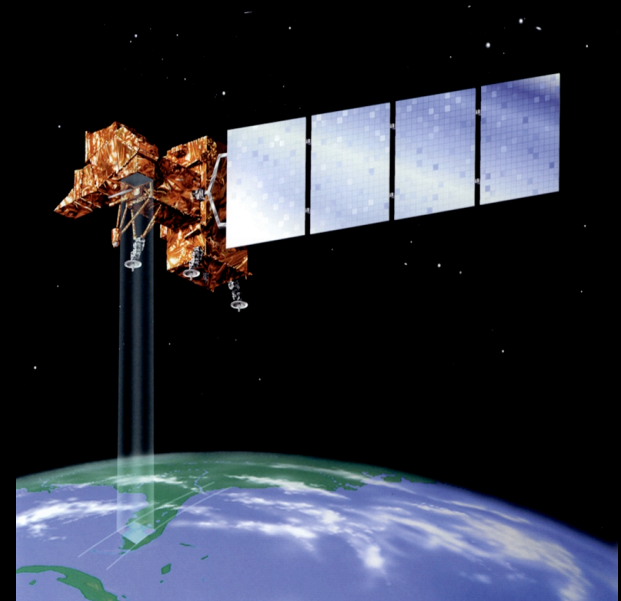
Landsat 5

- What: Remote sensing satellite.
- Event: Struck by a Perseid near the time of the shower peak on August 13 2009.
- Consequences:
 - Gyro temporarily failed; spacecraft began tumbling.
- Outcome: Normal operations restored by August 17.

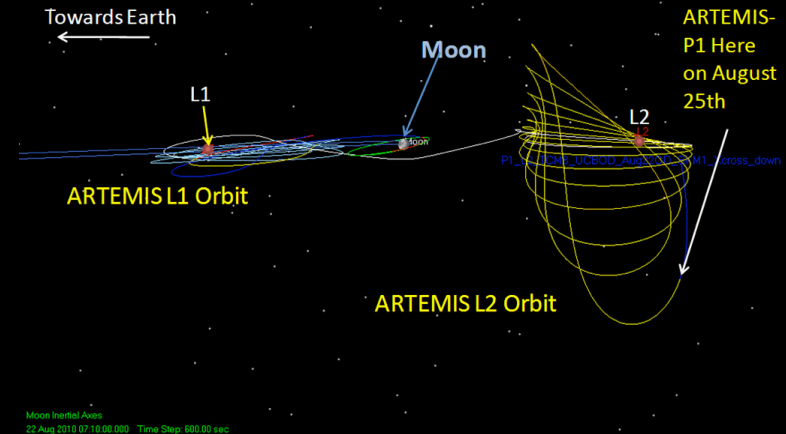
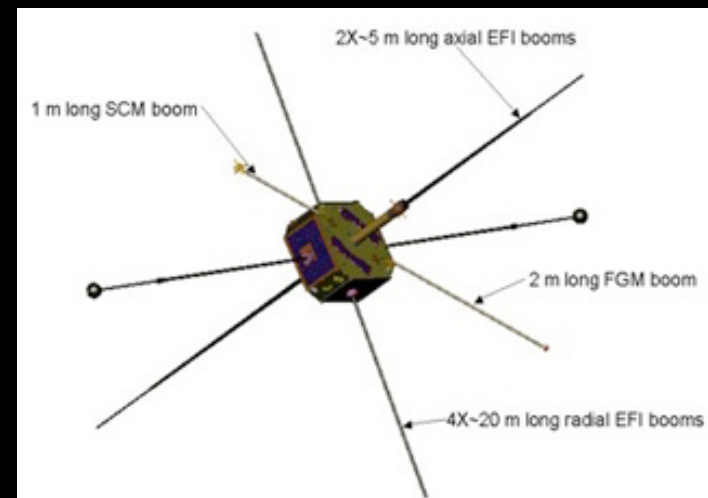
ARTEMIS-P1 Spacecraft's Orbit – Side View

- What: NASA Science satellite.
- Event: Struck by a meteoroid on 14 Oct 2010.
- Consequences:
 - Sphere 2 cut away
- Outcome: Normal operations restored almost immediately.

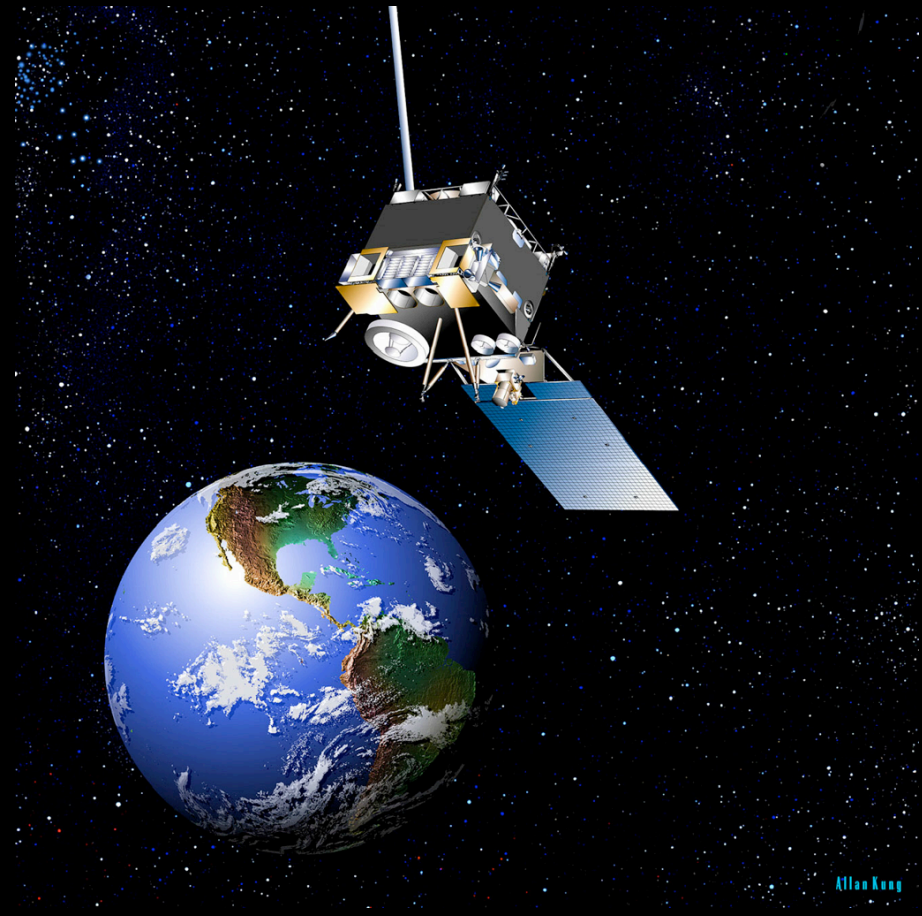
GOES 13

- What: USG weather satellite.
- Event: Struck by a Helion meteoroid on 22 May 2013.
- Consequences:
 - Attitude drift of 2° per hour from nadir
 - Spacecraft entered safe mode
- Outcome: Normal operations restored 7 days later.
