**Title: Failure Predictions of Out-of-Autoclave Sandwich Joints  
with Delaminations under Flexure Loads**

## ABSTRACT

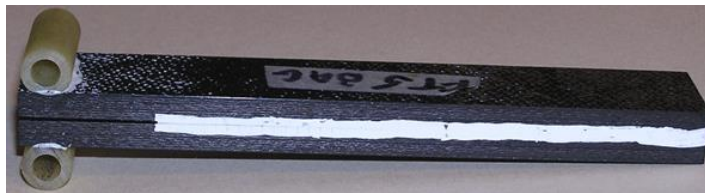
Figure 1. DCB test specimen with 2.5-inch flaw.

IM7/977-3 substrate using vacuum bag pressure only, per manufacturer's recommendation. Three coupons were tested with a 2.5-inch long flaw (Figure 1) and three coupons with a 3.5 inch long flaw. A displacement gauge was used for accurate measurement of crack opening displacement. Keyence digital microscope images were taken every 15 seconds for instantaneous crack length measurements. The Mode I average energy release rate ( $G_{IC}$ ) was measured as 1.3 lbf/inch, as shown in Figure 2, and it was consistent between the panels with initial flaws of 2.5 and 3.5 inches. The load-displacement response from the finite element simulations using cohesive elements, shown in Figure 3, was in good agreement with experimental response, shown in Figure 4. The response was relatively insensitive to mesh density.

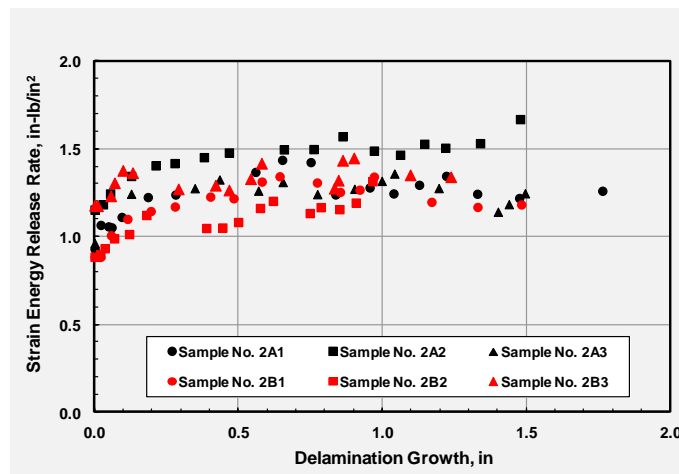
Figure 2. Strain energy release rate as a function of delamination growth.

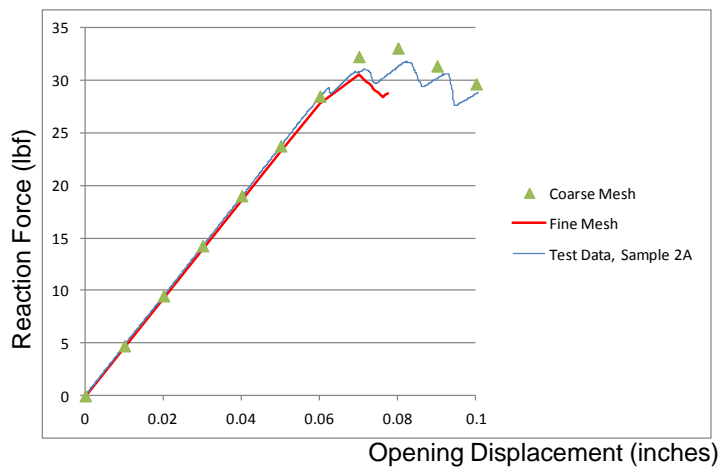
Figure 4. Structural response of DCB for test and model.

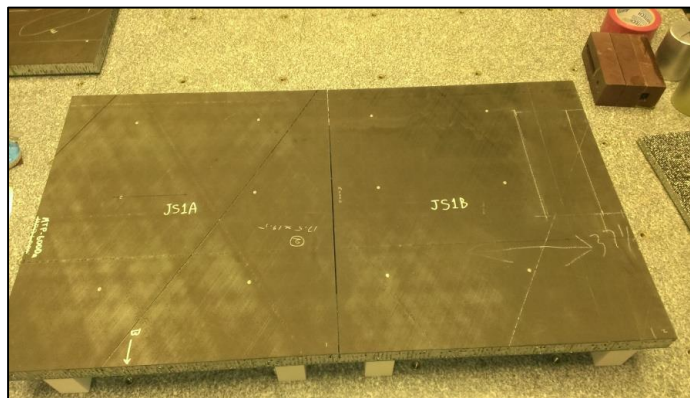
Figure 5. Joint Segment (JS1).

For this study, panel segments with a radius of curvature of 198 inches, manufactured by the NASA Light Spacecraft Structures and Materials program, were used. The panel segments, Figure 5, were processed IA. The segments were joined with splice adhesive, Figure 6 and 7. Teflon® inserts, 1.6-inch in diameter, were placed (Figure 8) and doublers were bonded to join the panel segments, Figure 9 and 10. Individual 4PB coupons were excised from the fabricated composite joint.

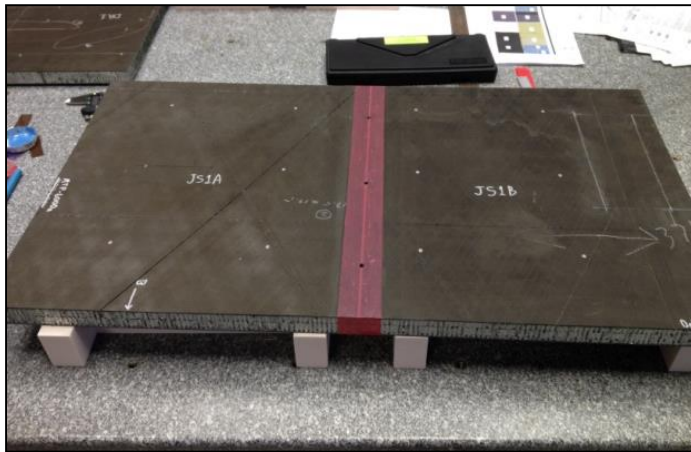
Figure 6. Panel position for injection of adhesive.

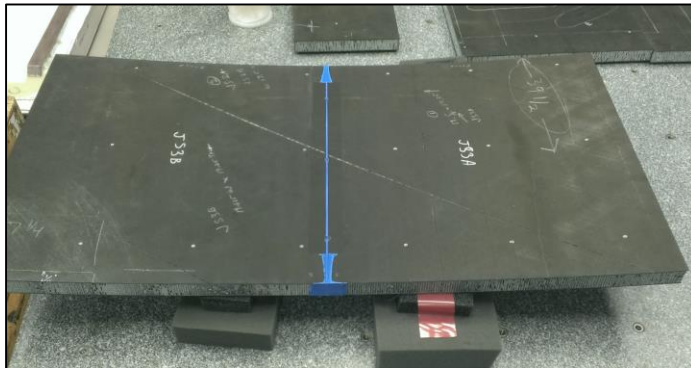
Figure 7. Injection completed.

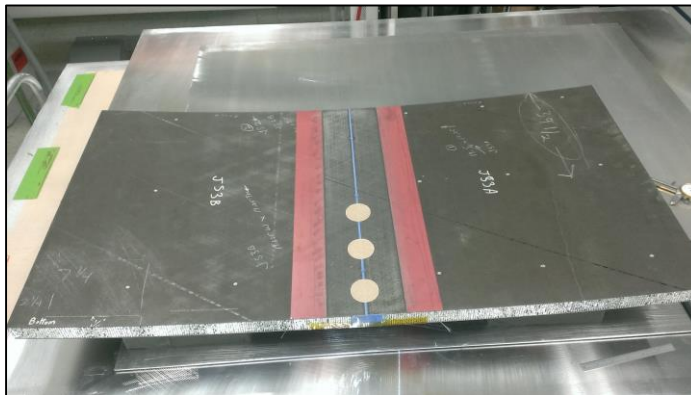
Figure 8. Joint area hand abraded, flaws placed.

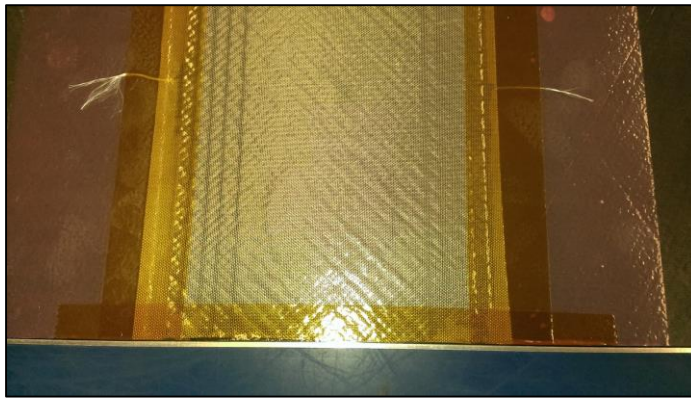
Figure 9. Joint doubler layup.

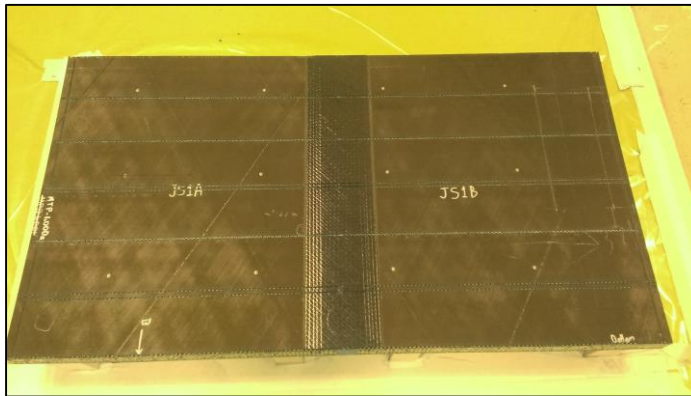
Figure 10. Finished joint panels.

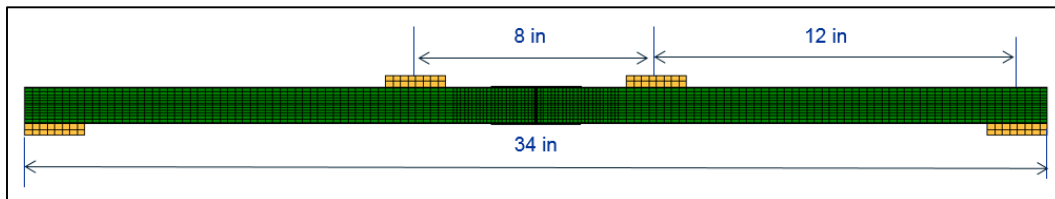
Figure 11. 34-inch long 4PB specimen cut along zero degree ply.

Two different 4PB configurations were tested: 34-inch long specimens along the zero degree ply (and core ribbon direction), and 38-inch long specimens transverse to the zero degree ply (and cross-ribbon orientation). The full panels were manufactured and then cut into separate samples. Schematics of the general test configurations for these two specimens can be seen in Figure 11 and Figure 12 (curvature is not shown).

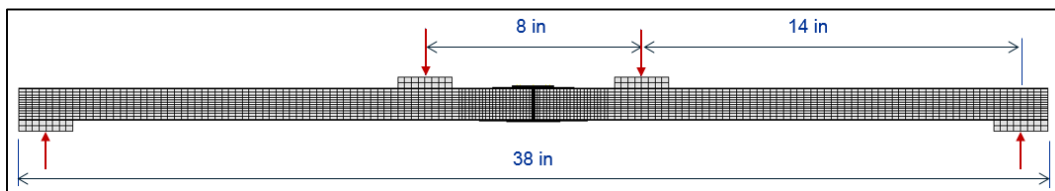
Figure 12. 38-inch long 4PB specimen cut transverse to zero degree ply.

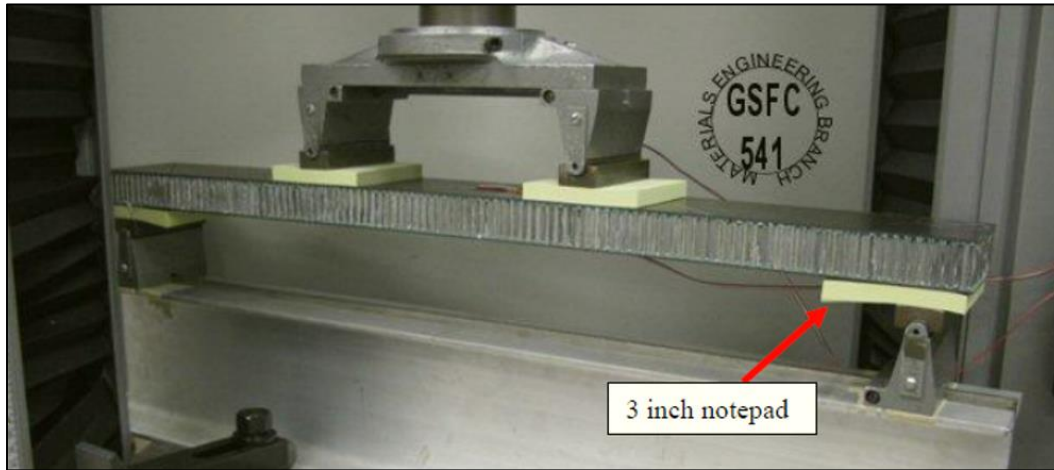
Figure 13. Four-Point-Bend Test.

For the actual test, notepads were used at the supports and load point to prevent local stresses from failing the composite core before the joint in the constant shear region could be properly loaded. The 4PB test setup can be seen in Figure 13.

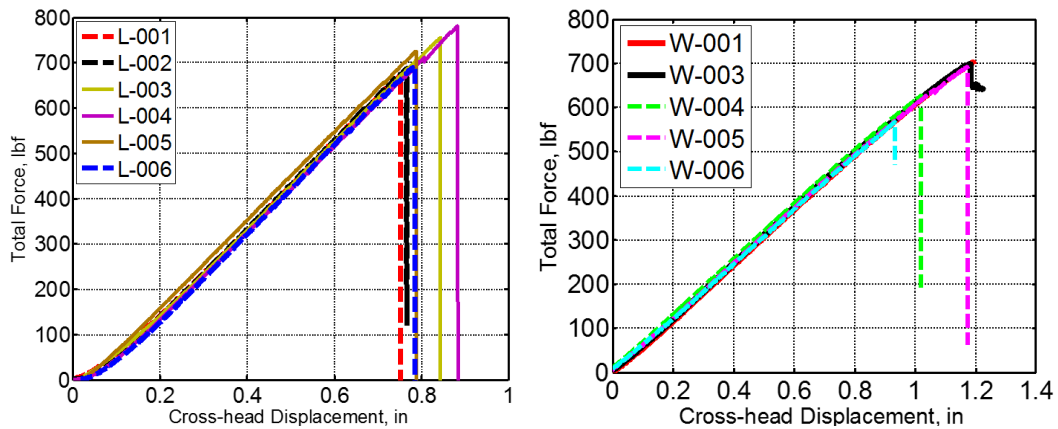
Figure 14. Load vs. deflection of 4PB samples for 34-inch specimens (left) and 38-inch specimens (right).

Six specimens of each configuration, 34-inch and 38-inch, were tested in 4PB. For each configuration, only half of the specimens included 1.6-inch diameter Teflon® debond inserts. The defect flaw size was selected based on analyses of the 4PB coupon, to ensure failure in the jointed region. Table I summarizes the test results for the 34-inch (L) and 38-inch (W) 4PB specimens. Maximum deflections were measured at the centerline midspans of the coupons using Digital Image Correlation (DIC), which follows features on the surface from frame to frame using image-based cross-correlation tracking. Load versus deflection curves of the 34-inch (L) and 38-inch (W) specimens are shown in Figure 14. It should be noted that regardless of initial failure mode (e.g., core shear failure or joint failure), the damage propagates relatively abruptly at the joint. The strength reduction from the pristine coupons to coupons with flaws was 9 to 10 percent.

\*\*Problem with Instron® crosshead data acquisition. Max load and displacement reported from DIC. No plot possible for W-4PB-002 in Figure 14.

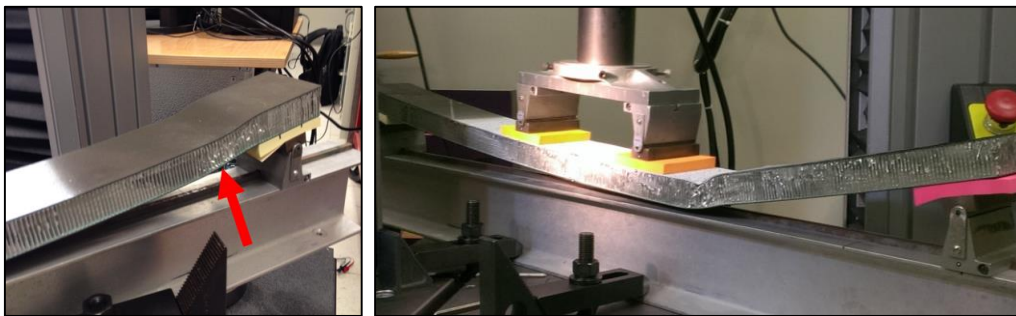
Figure 15. Core shear failure for 38-inch unflawed specimen.

\*Max displacement does not apply. Core shear failure occurred. Max displacement not relevant (see Figure 15).

Several different failure modes were observed in test, depending on whether or not flaw inserts were included in the doubler joint. Core shear was one failure mode observed, specifically for unflawed specimens. This failure mode can be seen in Figure 15 for a 38-inch W specimen. For flawed specimens and all 34-inch specimens, delamination growth at the joint was the most likely mode encountered, as seen in Figure 16.

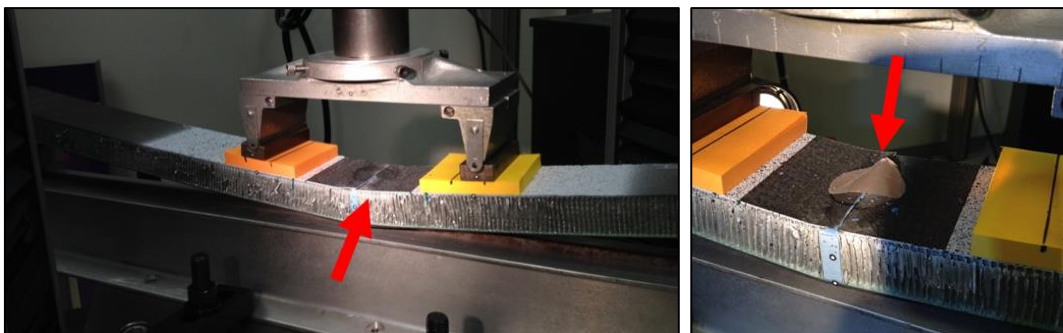
Figure 16. Joint failure for flawed specimen (left); Joint failure for flawed specimen with top doubler debonding and coming off (right).

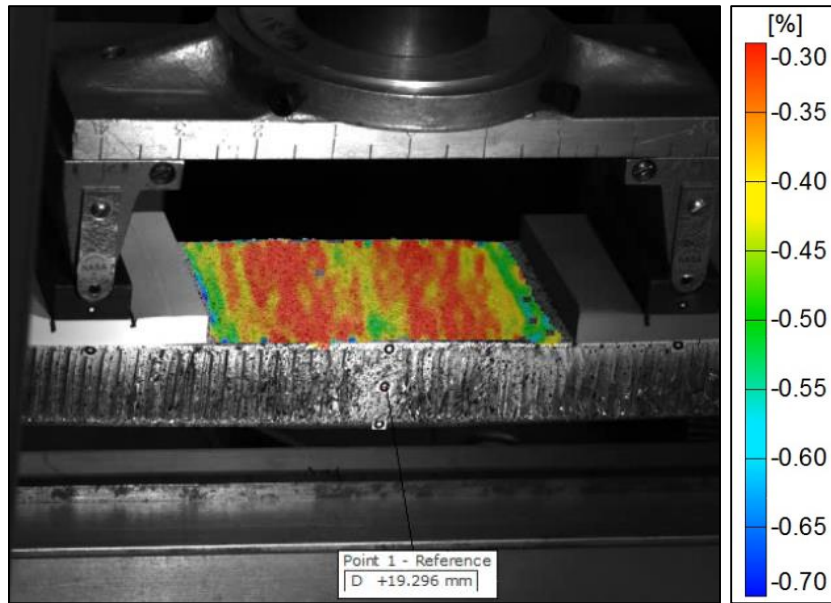
Figure 17. Axial strain of joint for 34-inch specimen with flaw.

In addition to measuring maximum centerline deflection and reaction load, surface strains were measured in the joint region using DIC as shown in Figure 17. A stochastic pattern was applied to the surface of the materials using black and white spray paint to provide tracking points for the full-field strain measurement. Figure 18 compares 34-inch 4PB specimens with and without a flaw. The location of the flaw is shown in the figure with a circle. Axial strain fields were captured digitally at the last frame before failure. Strain limits were set identically from  $-3000 \mu\epsilon$  to  $-7000 \mu\epsilon$ . It can be observed that the influence of the Teflon® insert increases the strain field on the joint seam.

The last metric for comparison between the performed tests and the analyses is that of surface strains at the joint. Figure 17 and Figure 18 showed test results for axial surface strains by DIC. Shown below in Figure 30 and Figure 31 are axial surface strains just before joint failure for test and analysis of 34-inch and 38-inch specimens, respectively. For the 34-inch specimens, strain in the circular debond region are 5 to 10 percent higher in analysis than in test, which corresponds to the roughly 11 percent higher peak load that the analysis predicted over the tests. For the 38-inch specimens, strains in the joint region match very well to the tests (approximately within 1 percent). The influence of the Teflon® inserts on the strain fields is noted in the figures.

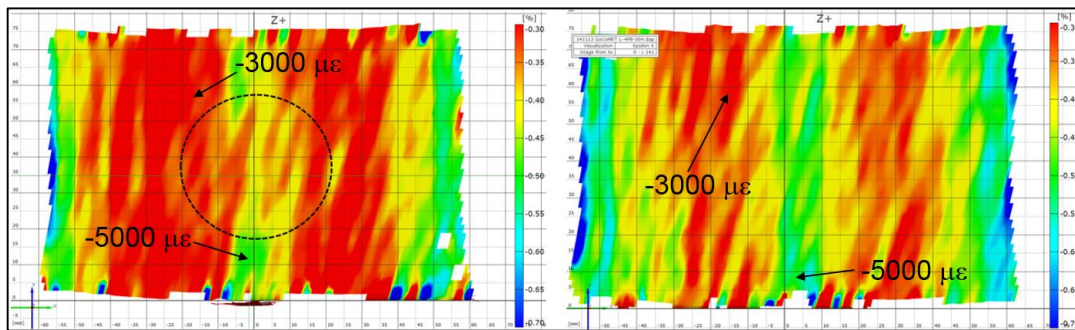
Figure 18. Axial strain of joint surface for 34-inch specimen with flaw (left) and without flaw (right).

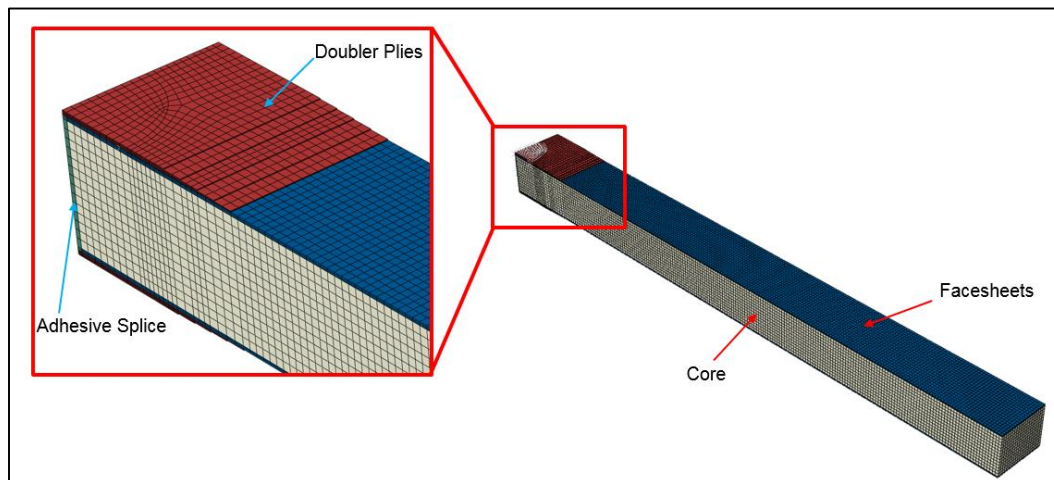
Figure 19. Isometric view of 34-inch 4PB specimen FEM.

To reduce analysis time, two-way symmetry was utilized for all 4PB models discussed here. In order to improve convergence of the solution, all models are displacement-controlled. Figure 19 illustrates the general model setup and mesh of the 34-inch specimen, and Figure 20 shows the same model with dimensions and boundary conditions (BCs) labeled. Note that the symmetric boundary conditions for X-symmetry and Z-symmetry are labeled as  $U_x = 0$  and  $U_z = 0$ , respectively.

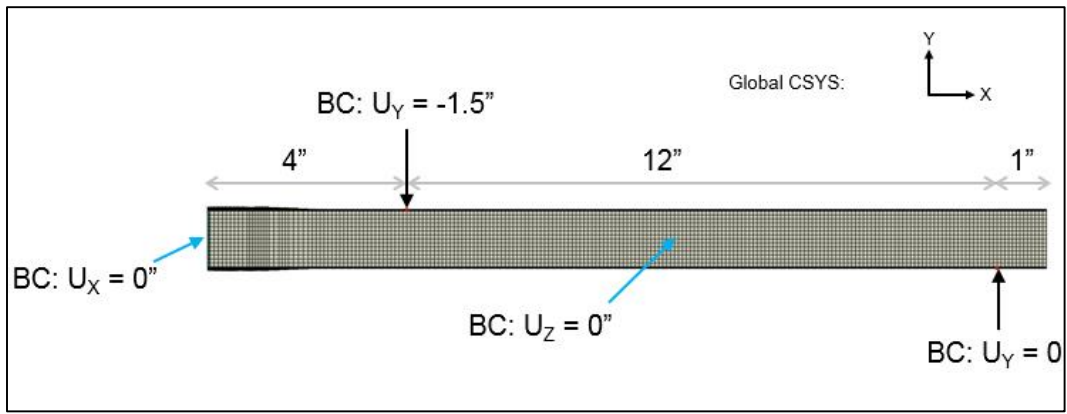
Figure 20. Side view of 34-inch 4PB specimen FEM with BCs and dimensions.

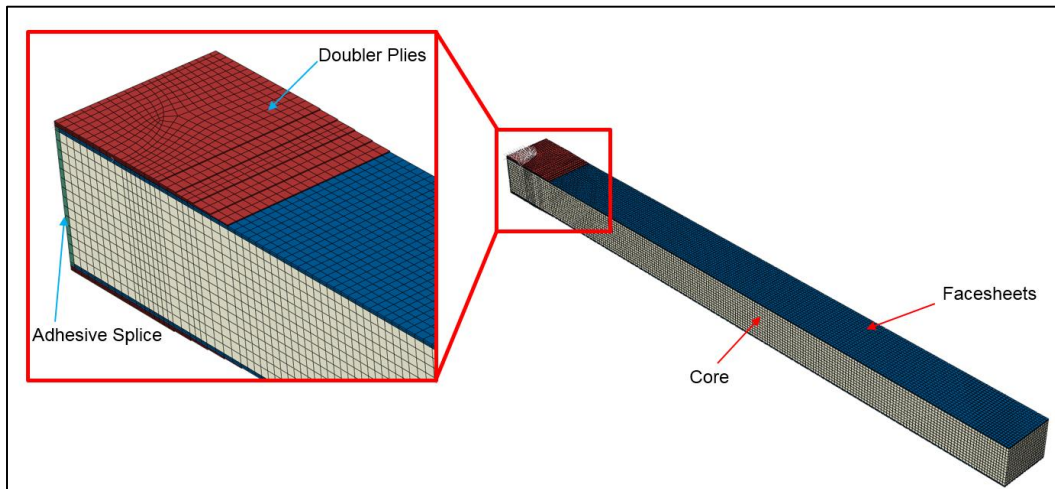
Figure 21. Isometric view of 38-inch 4PB specimen FEM.

Figure 21 illustrates the general model setup and mesh of the 38-inch specimen, and Figure 22 shows the same model with dimensions and BCs labeled. For the 38-inch specimen, note that the global coordinate system (CSYS) remains the same, but a new local coordinate system was defined for the material orientation since those specimens were cut transverse to zero degrees.

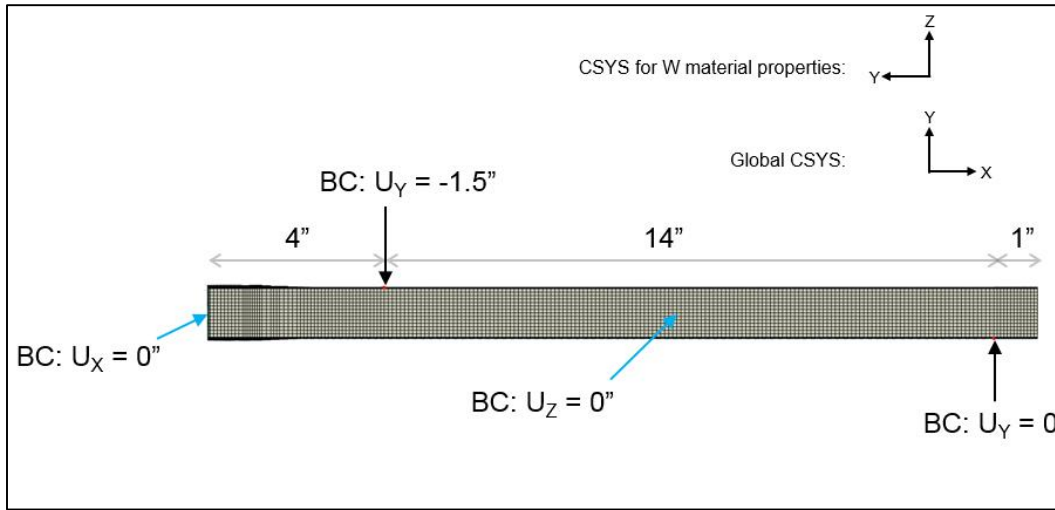
Figure 22. Side view of 38-inch 4PB specimen FEM with BCs and dimensions.

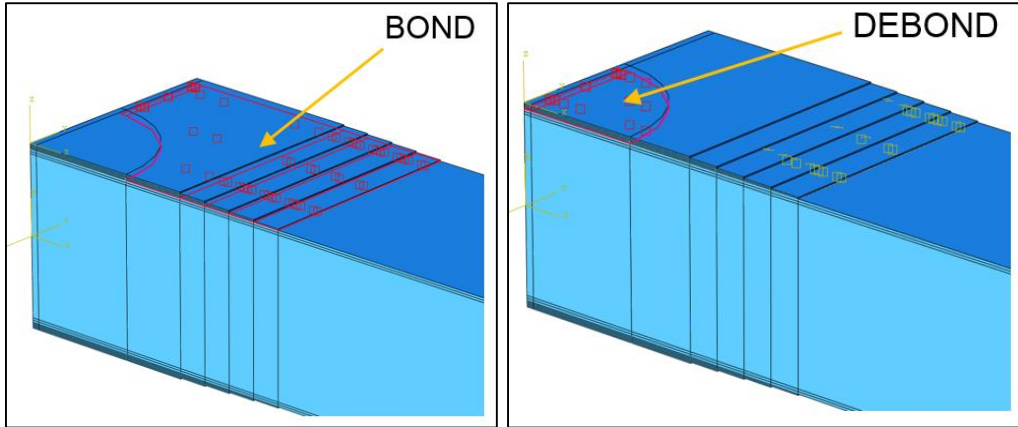
Figure 23. FEM schematics showing locations of bond (left) and debond (right).

The evolution of damage occurs when the mixed-mode energy release failure criterion reaches one. Figure 23 shows the bond and debond regions in the models. Table II summarizes the cohesive bond and debond properties.

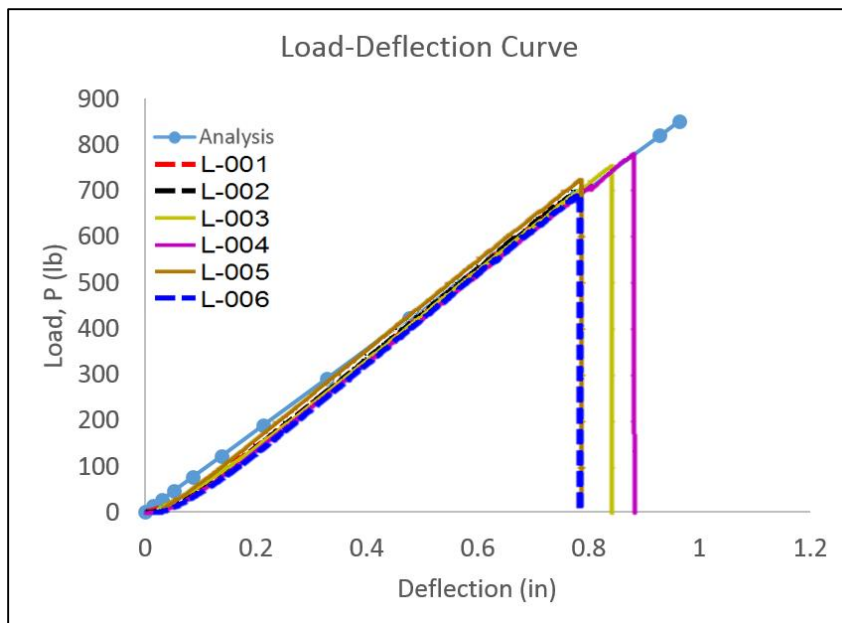
Figure 25. Test vs. analysis load-deflection results for undamaged 34-inch 4PB specimen.

Finite element results for 34-inch and 38-inch specimens without a flaw (i.e., undamaged) were first compared to test data. A graphical representation of this data is shown in Figure 25 and Figure 26, respectively. For the 34-inch specimen, only L-003, L-004, and L-005 were the undamaged samples. For the 38-inch specimen, only W-001 and W-003 were the undamaged samples.

The 34-inch analysis predicted joint failure would occur at a peak load of 852 lbf while the maximum load seen in test for that specimen was 781 lbf, so the model prediction was within 10 percent. The 38-inch analysis predicted that core shear failure would occur at a peak load of 724 lbf, while the maximum load seen in test for that specimen was 702 lbf, so the model prediction was within 3 percent. This could indicate that the core strength properties were lower than the strength used in the analysis.

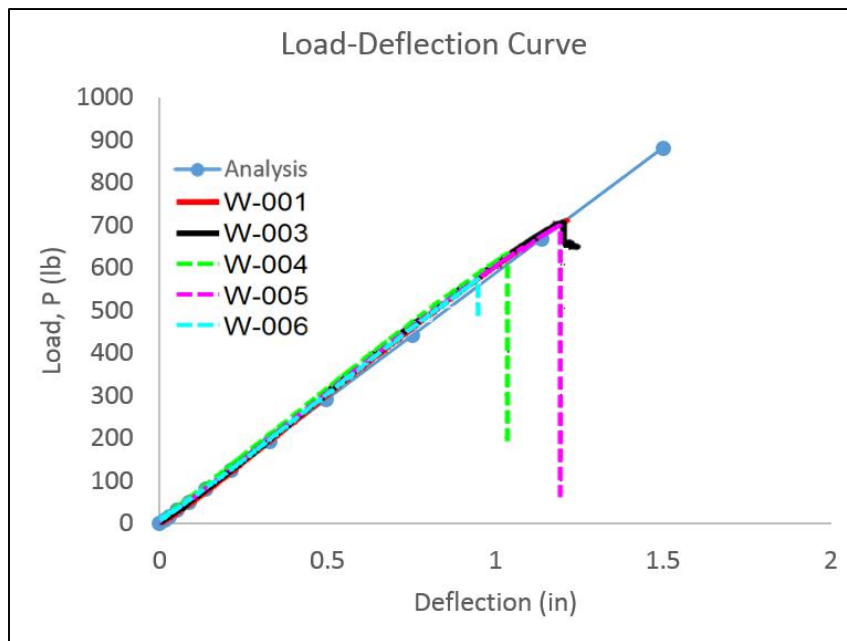
Figure 26. Test vs. analysis load-deflection results for undamaged 38-inch 4PB specimen.

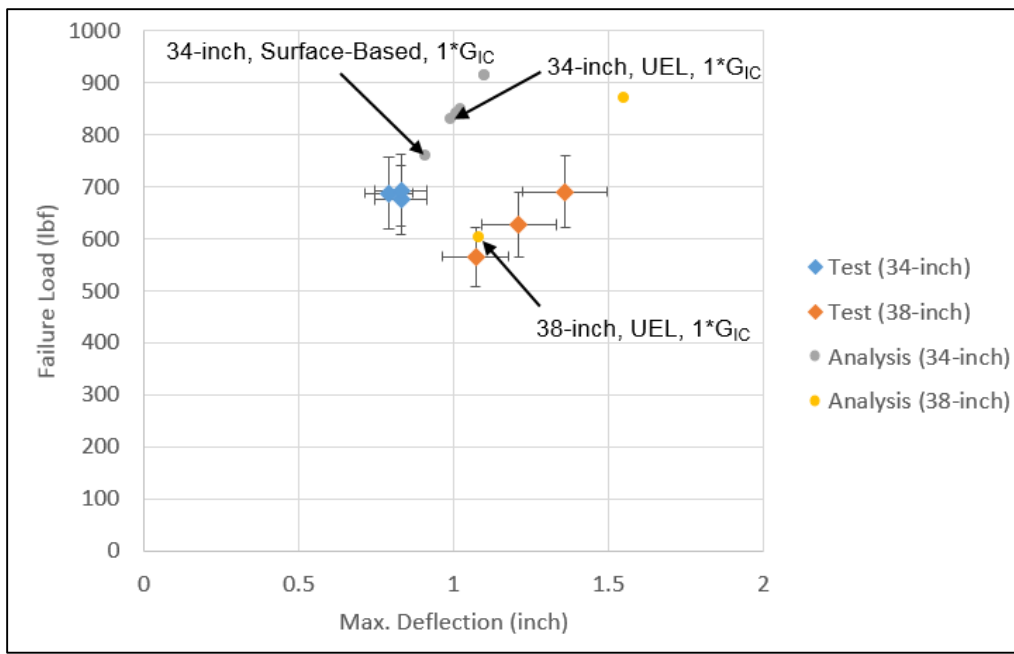
Figure 27. Failure load vs. max deflection of flawed 4PB tests and analyses.

A summary of the analysis results for 34-inch and 38-inch flawed specimens is shown in Table IV. For comparison, a new summary of the test results as originally seen in Table I is shown below in Table V with only the flawed specimens shown. For the 34-inch specimens, the best match to tests is the surface-based cohesive elements with a  $G_{IIC}$  value equal to  $1 \cdot G_{IC}$ . For the 34-inch specimens, the peak load of 759 lbf is within 11 percent of the average test peak load. For the 38-inch specimens, the peak load of 604 lbf is within 4 percent of the average test peak load. The failure load versus maximum deflection of all the tests and analyses summarized in Tables IV and V is shown graphically in Figure 27, with +/-10 percent error bars on the test data. It was found through the analyses that the UEL bond methodology had a better rate of convergence, but the surface-based cohesive methodology typically was closer to test results when it converged.  $G_{IIC}$  is typically two or three times that of  $G_{IC}$ , but since  $G_{IIC}$  was not measured, this assumption could not be validated. A  $G_{IIC}$  value of  $1 \cdot G_{IC}$  was closer to tests in all analyses.

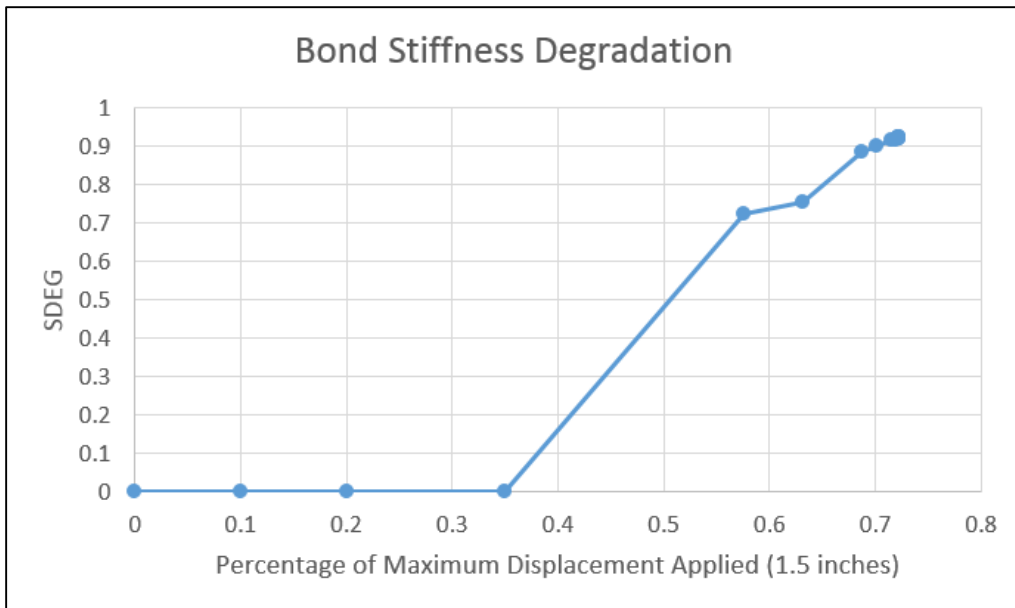
Figure 28. Scalar stiffness degradation as a function of maximum displacement applied for 38-inch specimen analysis (UEL) with flaw.

The analysis that proved closest to tests was the 38-inch W specimen, with UEL flaw and  $G_{IIc} = 1 \cdot G_{IC}$ , and was inspected for damage propagation at the joint doubler interface to the panels. The scalar stiffness degradation (SDEG) variable, a measure of an element's residual stiffness, was monitored at the interface through the analyses. The SDEG has a value from zero to one where a value of one corresponds to a fully damaged bond element. A plot of this variable through the analysis step is shown in Figure 28 for the element where bond failure is first initiated. From Figure 28 it can be concluded that bond failure initiates at approximately 35 percent of the maximum displacement applied, which corresponds to a load of 308 lbf. Ultimate failure is predicted to occur at close to 72 percent of the maximum displacement applied. Figure 29 shows a contour plot of SDEG in the region of the specimen where bond failure is occurring.

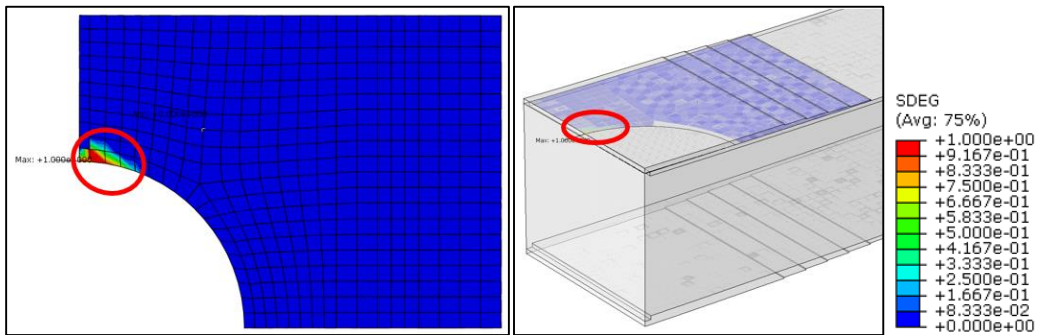
Figure 29. Scalar stiffness degradation at failure of 38-inch specimen analysis (UEL) with flaw.

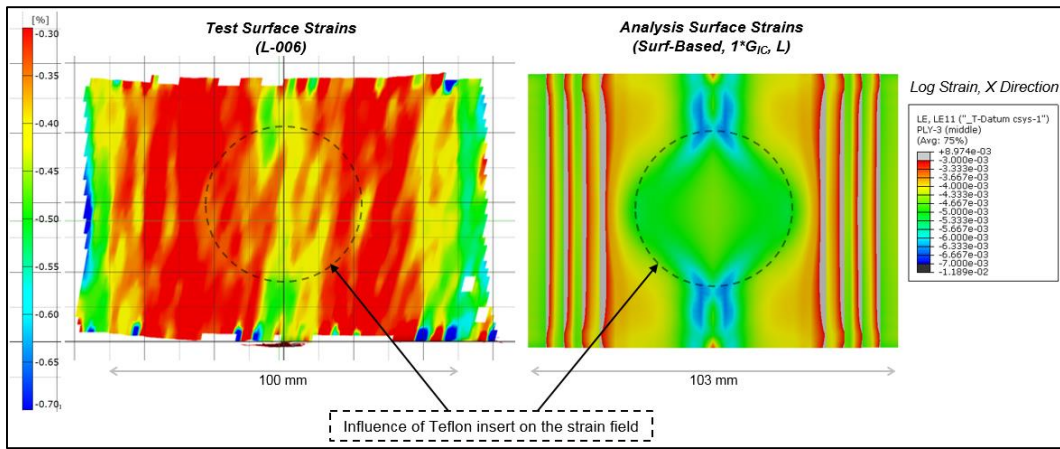
Figure 30. Axial surface strains observed during test with DIC (left) and FEM analysis (right) of 34-inch flawed specimens.

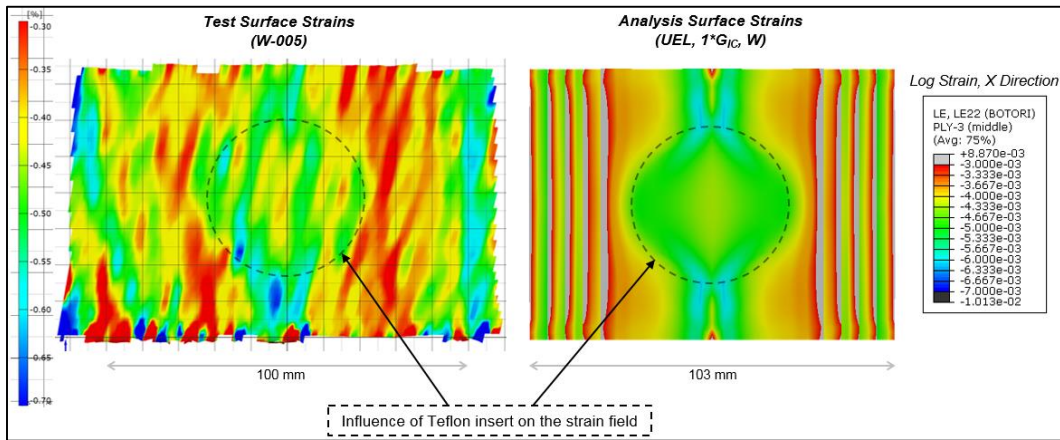
Figure 31. Axial surface strains observed during test with DIC (left) and FEM analysis (right) of 38-inch flawed specimens.
