REPORT NO. 30-8

## WELDED TITANIUM CASE FOR SPACE-PROBE ROCKET MOTOR

JET PROPULSION LABORATORY  
CALIFORNIA INSTITUTE OF TECHNOLOGY  
PASADENA, CALIFORNIA  
SEPTEMBER 3, 1959

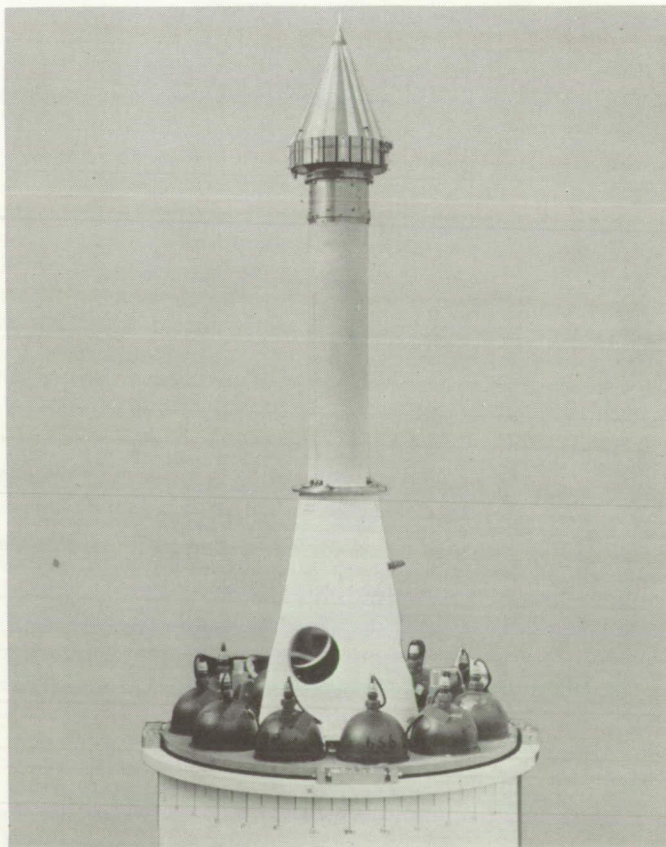
**Fig. 1. Moon-Probe Vehicle Showing Pioneer IV Mounted on Titanium-Cased Fourth-Stage Rocket Motor**

The titanium-cased fourth stage of *Juno II* is shown with the payload and on the missile in Fig. 1; the stainless-steel motor cases used in the *Jupiter-C* vehicle are shown in Fig. 2. The fourth-stage motor case has a diameter of 6-in., a length of approximately 38-in., and a nominal cylindrical wall thickness of 0.025-in. As shown in Fig. 1, the case serves as the structural support of the payload and is aligned to the upper stage assembly through an alignment ring. The nozzle is threaded into the end of the motor case, and is of the ceramic-coated steel design.

As shown in Fig. 1, the *Pioneer IV* payload was attached to the forward skirt of the fourth-stage motor. To conserve weight, nut plates were used to make this attachment. These nut plates were bonded to the titanium alloy with an epoxy adhesive, since soldering is not a simple procedure on titanium alloys.

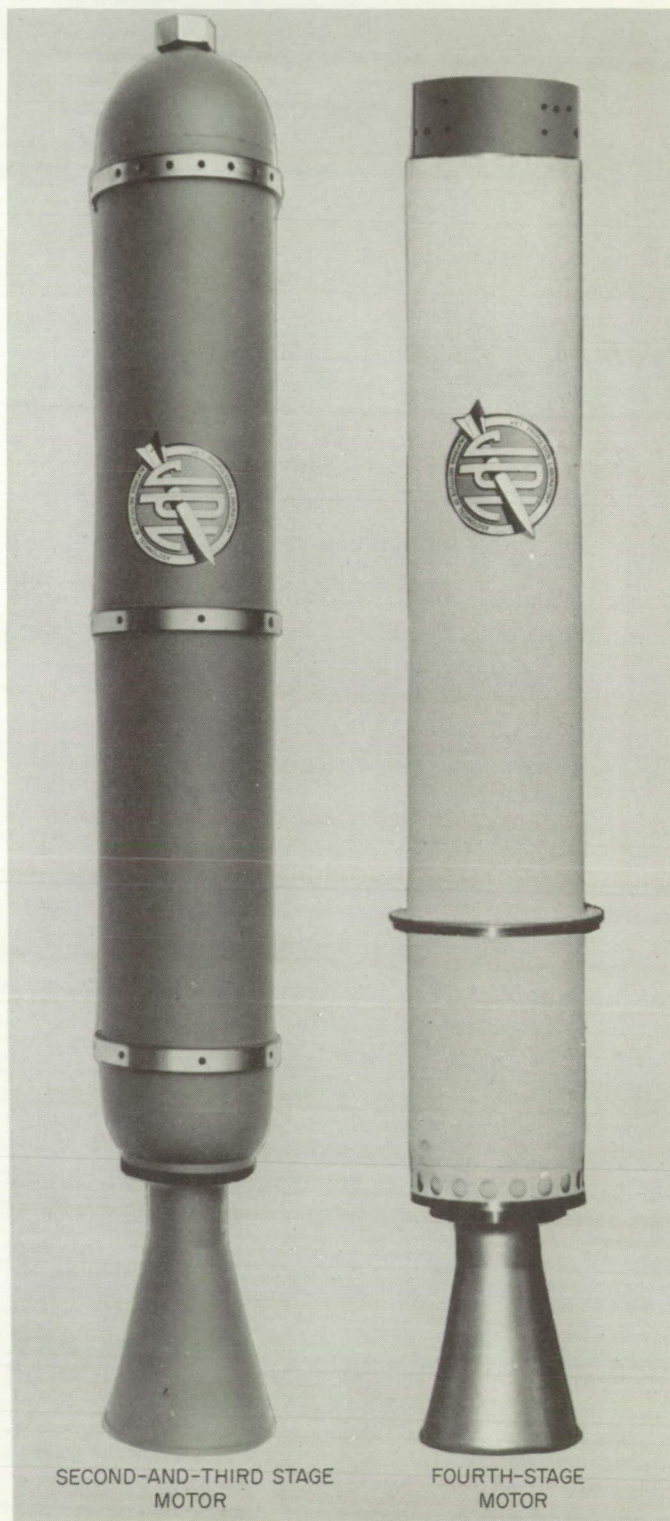
**Fig. 2. Stainless-Steel Jupiter-C Upper Stage Motor Cases**

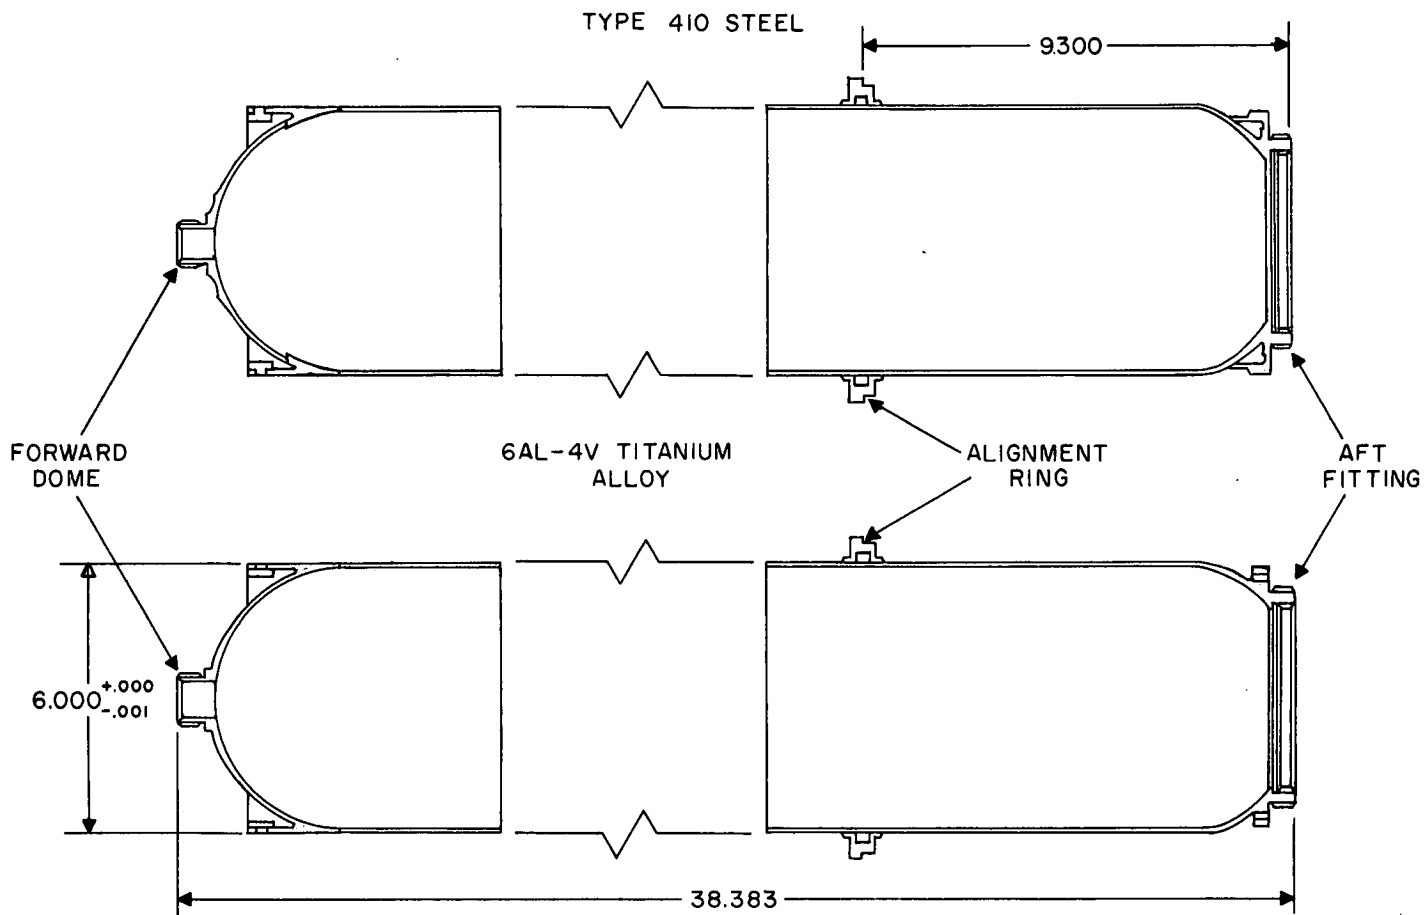
FORWARD DOME AND AFT FITTING OF TYPE 410 STEEL CASE CONSTRUCTED OF THREE PIECES WELDED TOGETHER. CORRESPONDING COMPONENTS OF 6AL-4V TITANIUM ALLOY CASE WERE MACHINED FROM 6.5 INCH DIAMETER BILLET.

**Fig. 3. Comparison of 6Al-4V Titanium-Alloy and Type 410 Stainless-Steel Fourth-Stage Motor Cases**

Figure 3 shows a comparison of the components used to make the stainless steel and the 6Al-4V titanium alloy cases. The forward dome and aft fitting for the stainless steel assembly were fabricated from a combination of forged, spun and machined parts. In order to facilitate the fabrication of the titanium alloy motor, these components were machined from a large-diameter billet.

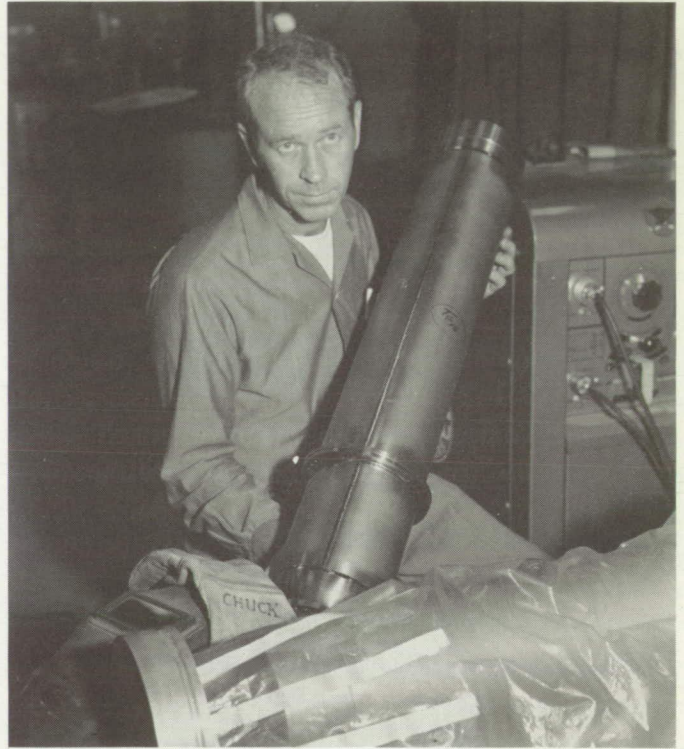
**Fig. 4. Completed Weldment of Titanium-Alloy Motor Case**

A completed fourth-stage rocket motor case fabricated from the titanium alloy is shown in Fig. 4. The details of the various fabrication operations are depicted in Figs. 5 through 11. Table 1 describes the welding procedures used.

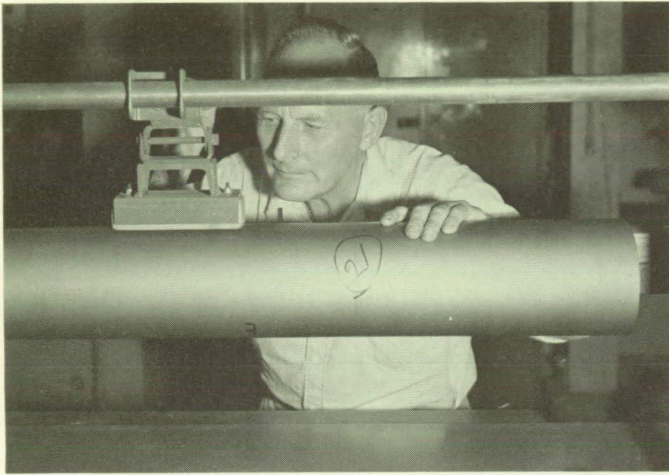
**Fig. 5. Final Sizing of Titanium-Alloy Shell**

Figure 5 shows a sizing jig being used to finish the 6-in.-diam. rolled shell. Because of its high annealed yield strength and considerable "spring-back" the titanium alloy could not be hand formed at room temperature as was the stainless steel, but required use of the jig. By maintaining good joint fit, a high degree of cleanliness, and adequate gas shielding, the longitudinal weld could be done without an enclosure, as shown in Fig. 6.

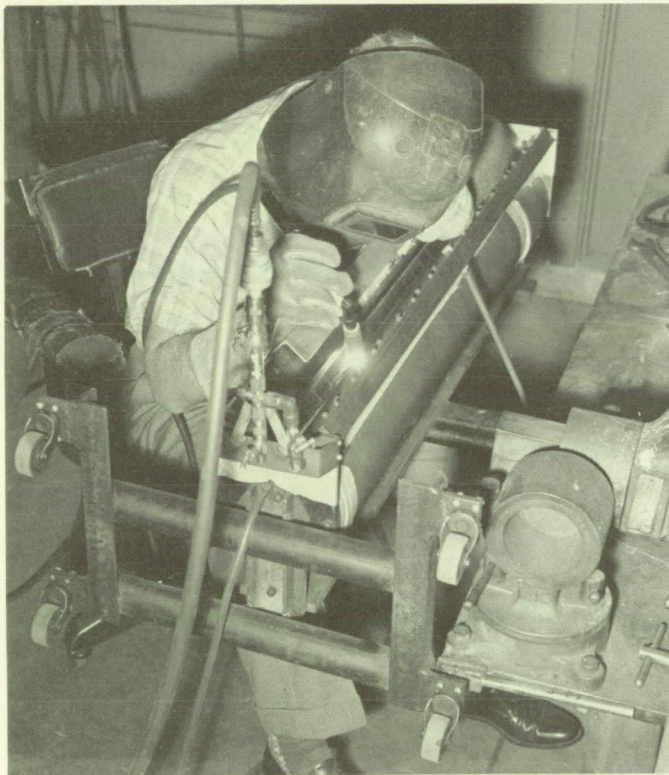
**Fig. 6. Seam-Welding Titanium-Alloy Shell**

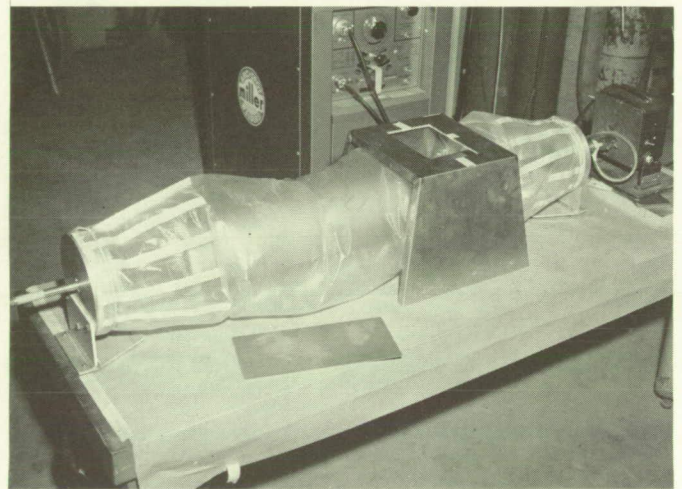
**Fig. 7. Plastic Enclosure Used to Weld Titanium Motor Case**

During the initial phases of the fabrication program it was determined that if extreme care was used, all circumferential welds could be made in an open-topped trough which was purged with argon prior to and during welding. However, as the fabrication became more extensive it was decided that a system requiring less care and time would have to be developed. Such a system is shown in Fig. 7. It utilizes a long plastic bag reinforced at the seams with glass-fabric tape and supported at the weld site with a sheet-metal bridge. This system was simple to construct, easily purged and capable of providing a satisfactory atmosphere. The 5-by-7-in. opening in the bridge allowed the welder convenient access to the three joints to be welded in each motor case. A suitable protective shield was obtained by means of a slightly positive gas flow.

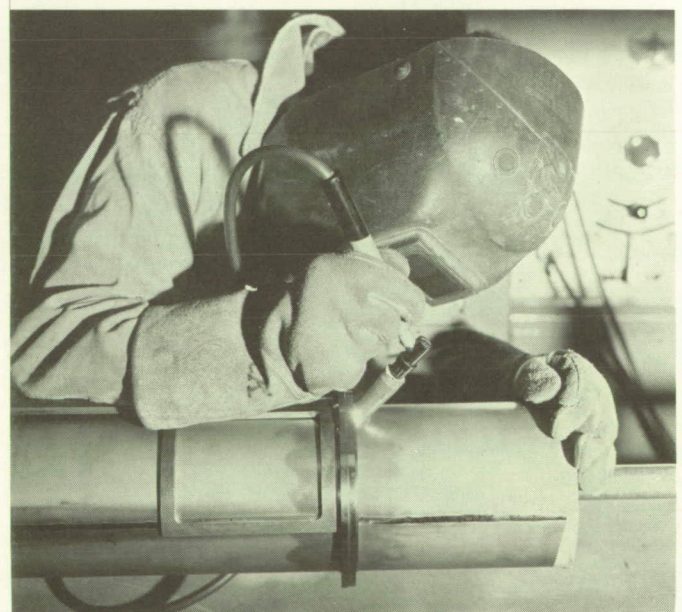
**Fig. 8. Tack-Welding Alignment Ring to Shell**

Figures 8 and 9 illustrate tacking and welding of the alignment ring. This weld required no filler metal, since a flange was provided on each edge of the ring for fusing to the shell. Although the final welding was carried out

in the plastic chamber, the tacking was performed without an enclosure. Improper fit-up between the ring and the shell resulted in low cooling rates and shrinkage distortion, both of which caused weld contamination. To keep this contamination at a minimum, short segments of the ring were welded 180 deg apart and along opposite edges until the entire weld was complete.

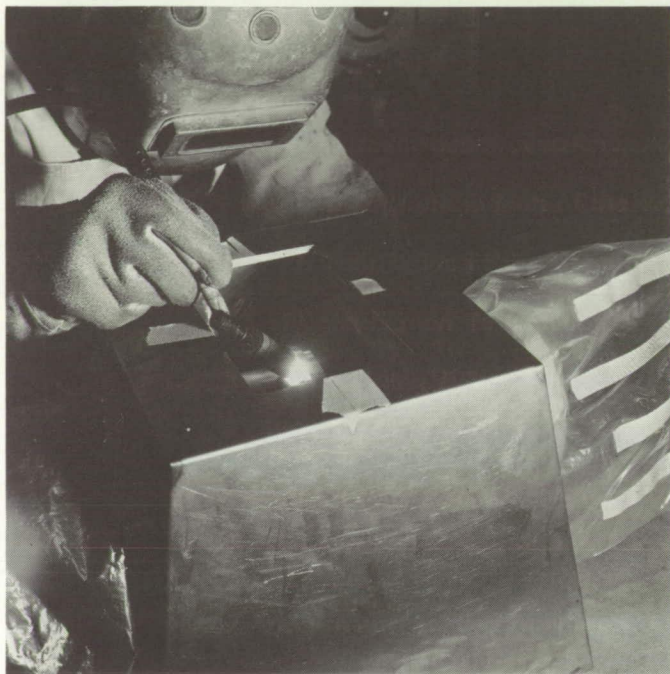
**Fig. 9. Welding Alignment Ring to Shell**

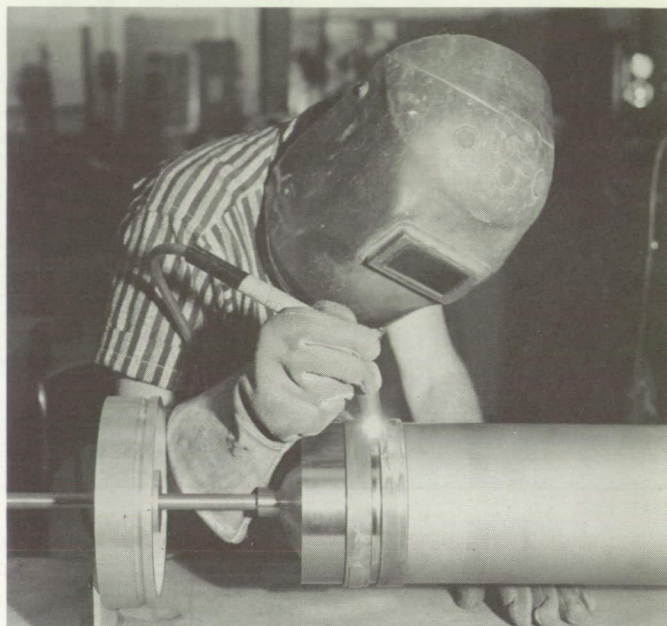
**Fig. 10. Tack-Welding Forward Dome to Shell**

A circumferential weld typical of the forward and aft dome welds is illustrated in Fig. 10. This figure shows the forward dome being tack-welded to the shell sub-assembly. This weld was actually performed in the plastic chamber but for the purpose of clarity is shown being performed in air. An expanding copper back-up mandrel and copper chill rings were used to control the cooling rate of the weld. The cooling rate was very important; if it was too rapid, there was a greater incidence of porosity; if it was too slow, the weld metal discolored, indicating possible contamination.

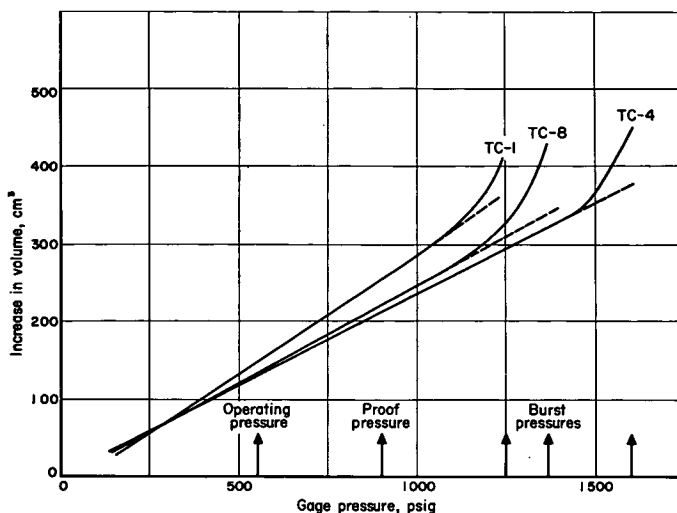
Fig. 11. Increase in Volume during Hydrostatic-Pressure Test of Titanium-Alloy Motor Case

In addition to hydrostatic and static-firing proof tests, five cases were hydrostatically tested to rupture. These test results are shown in Fig. 11 and Table 2. The curves of Fig. 11 show the increase in volume as a function of pressure for three of five motor cases tested to rupture. These measurements were obtained by pressurizing the

tanks with water taken from a calibrated standpipe. The deviation from linearity of the volume-pressure curve is interpreted as bulk yielding and represents high ductility of the motor case in the presence of biaxial loading. The variation in pressure at which fracture occurred resulted from different sheet thickness and strength properties which are shown in Table 2. This table compares all of the cases which have been hydrostatically tested to rupture and shows the nominal calculated hoop stress based on the fracture pressure, the ultimate strength of material from locations near the area from which the case material was taken, and the ratio of these two values. Since the hoop-stress calculation is based on an elastic stress relationship, it is not directly applicable in the plastic regime.
