NASA/TM—2016–218977

Design and Use of a Guided Weight Impactor to Impart Barely Visible Impact Damage

Abstract

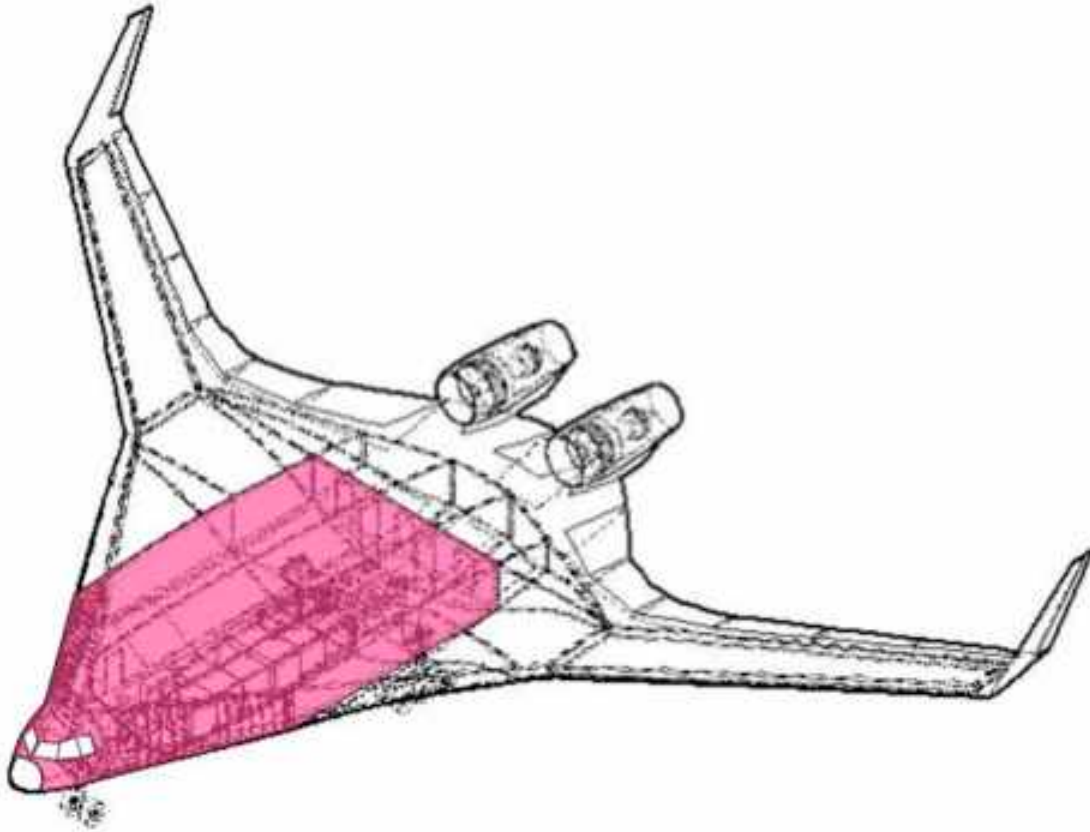
Figure 1. Typical pressurized portion of a HWB aircraft concept, indicated by red shaded area.

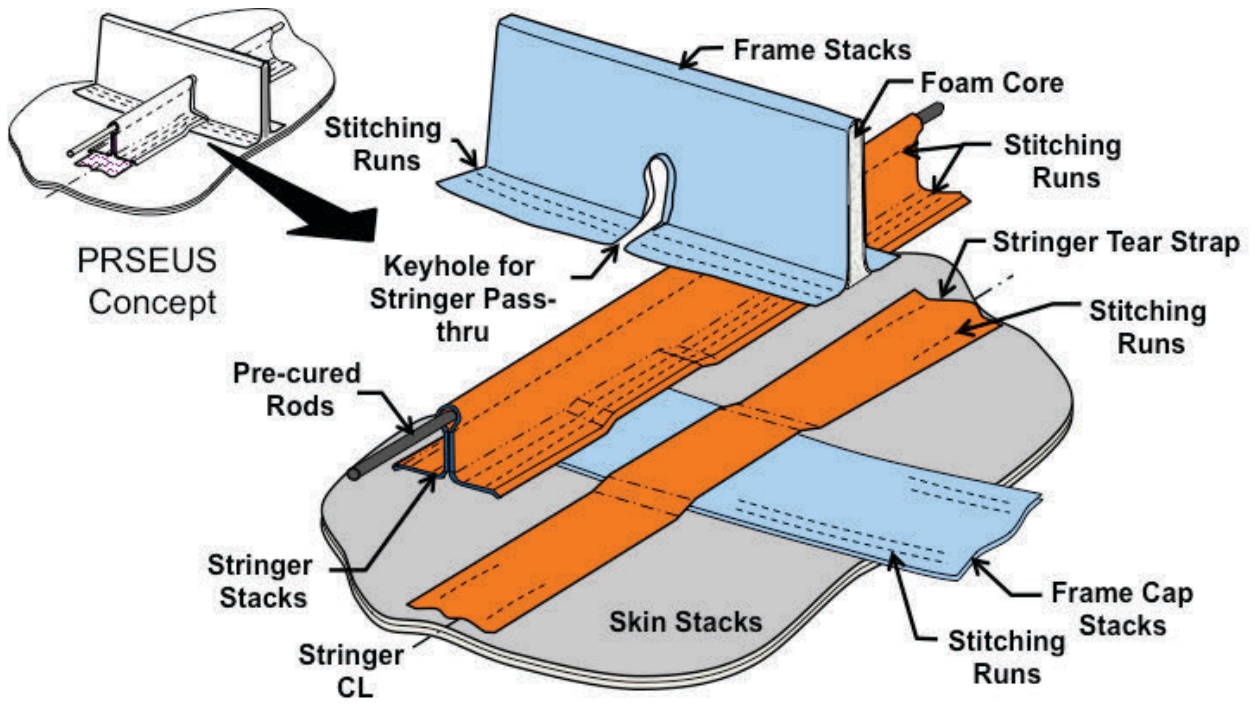
Figure 2. Typical PRSEUS concept.

The Pultruded Rod Stitched Efficient Unitized Structure (PRSEUS)¹ is a concept that has been developed by The Boeing Company (Boeing) to address the complex structural design aspects associated with a pressurized hybrid wing body (HWB) aircraft configuration as shown in Figure 1. The HWB has been a focus of the NASA Environmentally Responsible Aviation (ERA) Project, with structural development primarily addressing the pressurized, non-circular fuselage portion of the HWB. PRSEUS is an integral structural concept whereby skins, frames, stringers, and tear straps are all stitched together, then infused and cured in an out-of-autoclave process. The PRSEUS concept, as it has been applied to pressurized HWB fuselage structure, is shown in Figure 2. The concept has evolved from stitching technology development activities in several NASA-Boeing and Air Force Research Lab (AFRL)-Boeing programs beginning in the 1990's.²⁻⁵ The key to the PRSEUS concept is the pre-cured, pultruded rod that is contained within the stringer wrap plies and which passes through the frames, providing an uninterrupted load path through the acreage in the stringer direction. At the same time, the full height frame stiffener is also continuous, except for the keyhole through which the stringer passes, providing an uninterrupted load path in the direction perpendicular to the stringer. These efficient structural stiffening members provide the majority of the panel stiffness, permitting the use of minimum skin thickness for many applications. For example, typical PRSEUS stringer and frame cross-sections examined for HWB fuselage-type structure are shown in Figure 3, where the skin is minimum gage and the stringer and frame are the main load carrying components.^{6,7} Minimum gage is a stack of 9 layers of carbon/epoxy material that is 0.052 inches thick. Typical stringers in the HWB design use only a single stack for the stringer, which creates a two-stack web and single-stack wrap around the rod at the top of the stiffener.

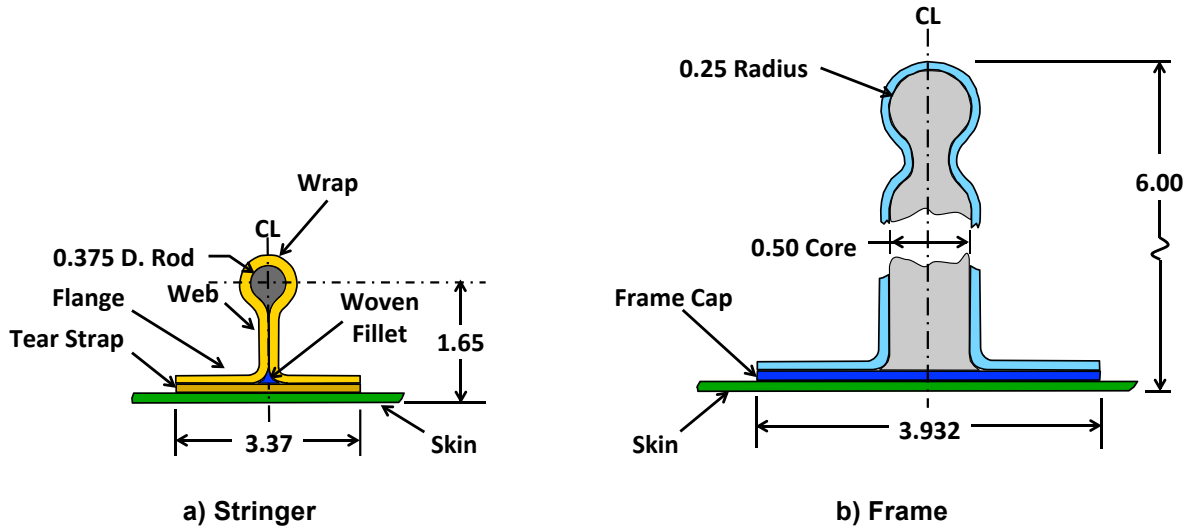
Figure 3. Typical pressurized HWB fuselage frame and stringer cross-sections. Dimensions are in inches, and typical stack values are shown for stringer.

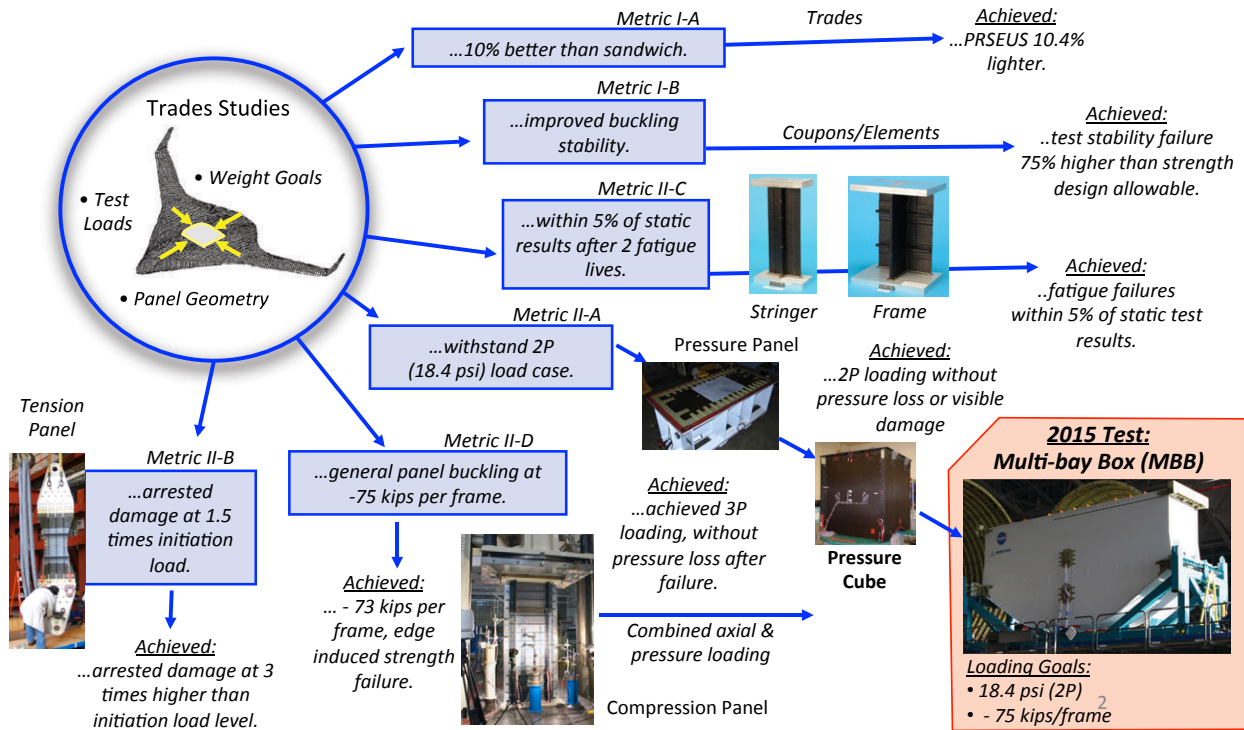
Figure 4. HWB structural development building-block approach.

Throughout ERA, the building block approach has been used to design, analyze, build, and test HWB PRSEUS structural components leading to an 80%-scale center portion of the HWB as shown in Figure 4 and identified in the lower right portion of the figure by the shaded region. Testing of the 80%-scale Multi-bay Box (MBB) in the Combined Loads Test System (COLTS) Facility at NASA Langley Research Center (LaRC)^{8,9} began in April 2015. The MBB was subjected to a series of load cases with testing being concluded in May after the infliction of discrete source damage to the top of the test article. A photograph of the test article between the platens in the COLTS Facility and a graphical representation of the COLTS arrangement are shown in Figure 5. Actuators connected to the platens are used to apply mechanical loads to the test article. Pressure loading was applied using a high-pressure feed line that was connected to the MBB. Five loading condition combinations were applied to the pristine MBB in a series of experiments, first up to design limit load (DLL) and then up to design ultimate load (DUL) levels for each condition. These loading conditions were 1) an internal pressure load alone; 2) a load simulating a 2.5-g wing up-bending condition which subjects the crown panel to compressive loads; 3) a -1-g wing down-bending condition which subjects the crown panel to tensile loads; 4) a combination of pressure and -1-g wing down-bending; and 5) a combination of pressure and 2.5-g wing up-bending. Details of the testing, load conditions, and results are presented in Refs. 10-12. Included within the testing was a repeated set of the five load conditions after barely visible impact damage (BVID) was introduced. BVID was introduced to satisfy conditions representative of the requirements in the Federal Aviation Regulations (FAR) requirements, PART 25-Airworthiness Standards: Transport Category Airplanes,¹³ which is summarized in Ref. 14. The requirement is that composite structures with Category 1 damage, including BVID, shall demonstrate a reliable service life while retaining ultimate load capability. How BVID was imparted to the MBB and the development of a guided drop weight impactor that was used to impart BVID to the exterior of the MBB is described in the current report.

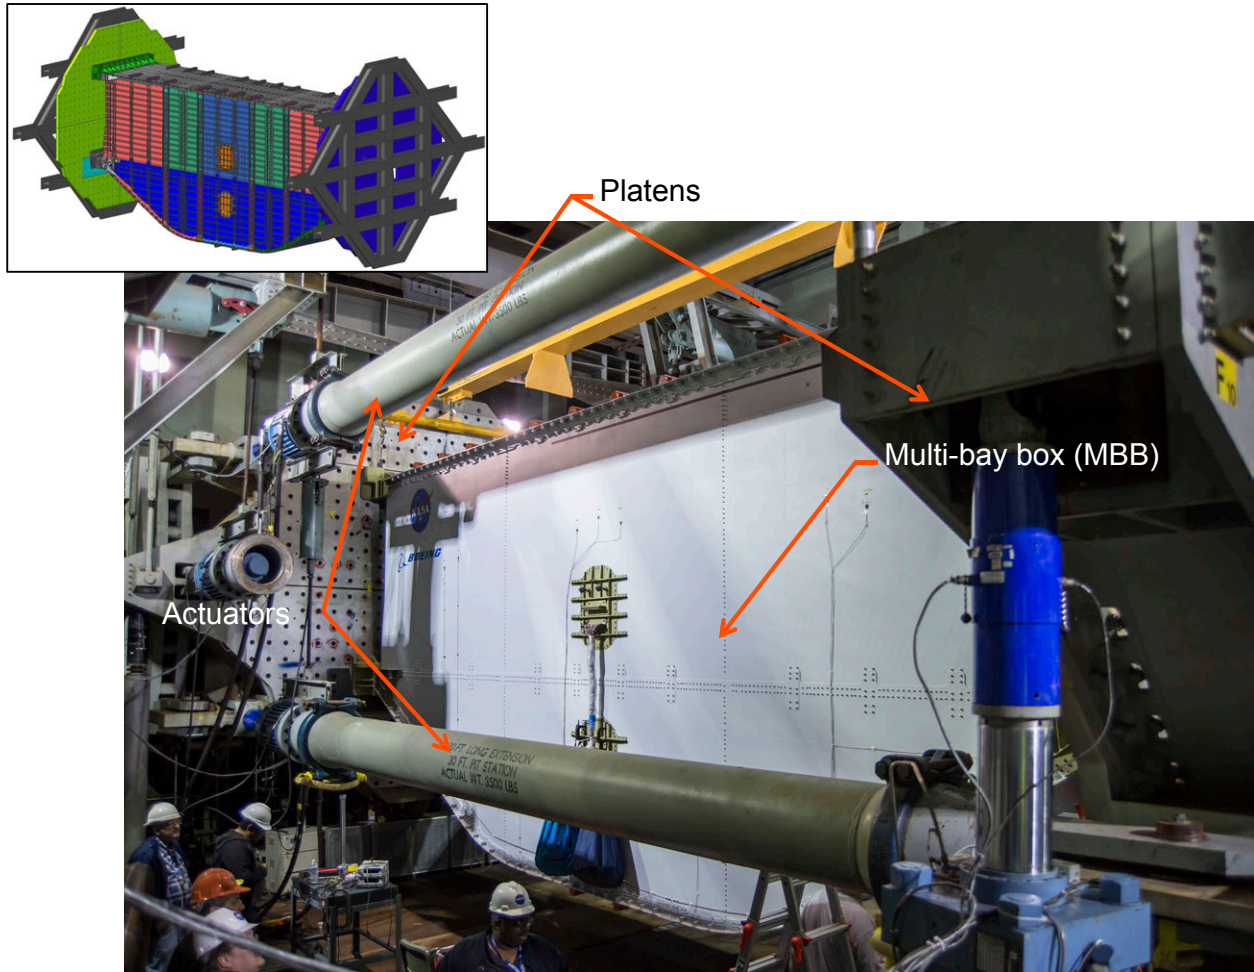
Figure 5. Photograph of MBB in COLTS test chamber and graphical representation (inset).

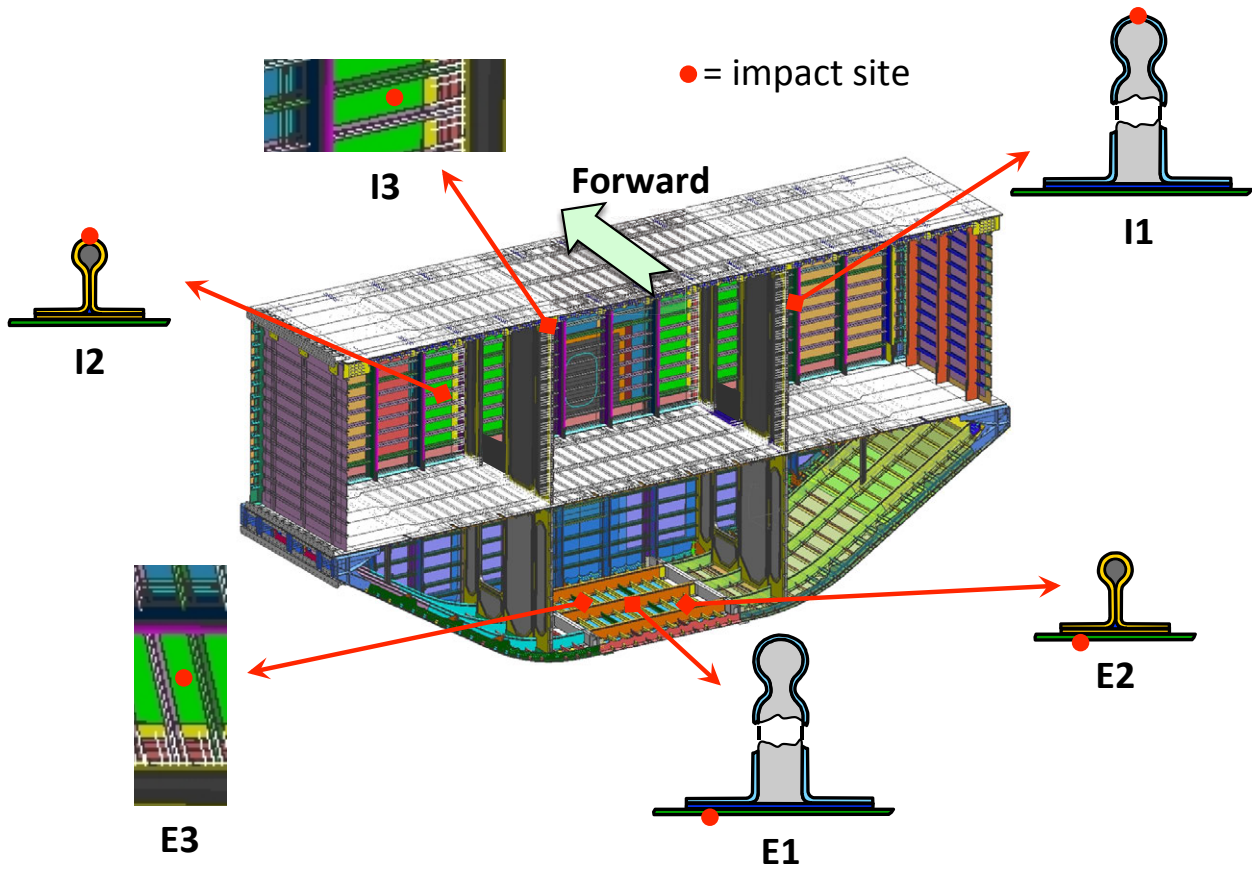
Figure 6. MBB impact locations (aft bulkhead removed for clarity).

Interior - Upper Forward Bulkhead				
ID	Description	Energy (ft-lb)	Weight (lb)	Velocity (ft/s)
I1	Frame Top	20	3.708	18.63
I2	Stringer Top	20	3.708	18.63
I3	Center Skin Bay	15	3.708	16.14
Exterior - Keel				
ID	Description	Energy (ft-lb)	Weight (lb)	Velocity (ft/s)
E1	Frame Flange	60	15	16.04
E2	Stringer Flange	50	15	14.65
E3	Center Skin Bay	15	5	13.89

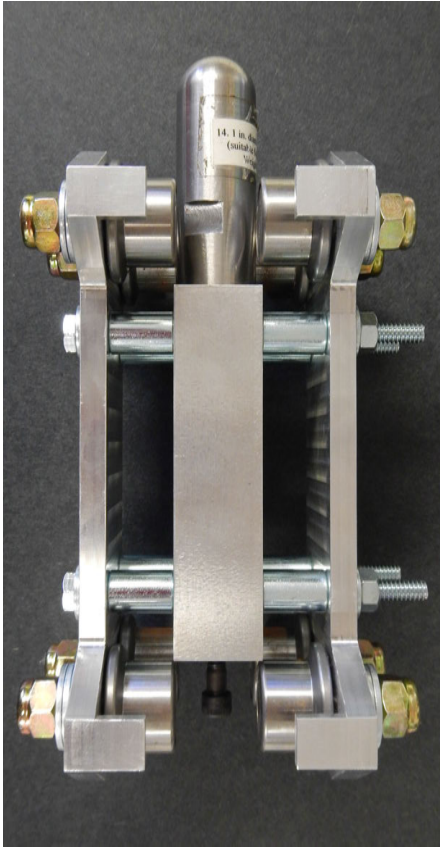
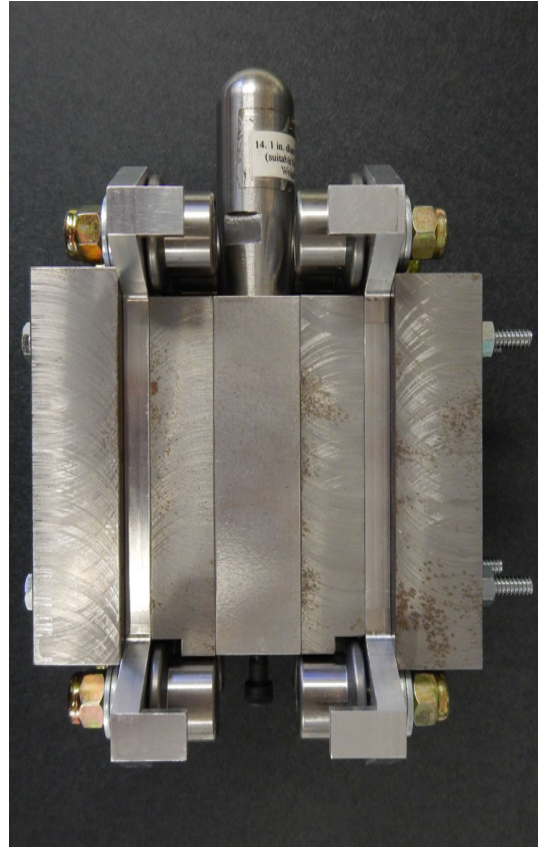
a) 5-lb

b) 15-lb

Figure 7. Pictures of the two configurations of the impact weight used to impact the MBB.

As designed, the guided drop weight impactor consists of two main components, namely the guided impact weight and the guide track. This configuration is similar to a roller coaster, whereby gravity provides the driving force on the coaster, whose motion is controlled by the configuration of the track. The impact weight runs along the track and is constrained at impact to be moving in the required direction, which for the MBB was vertically. To satisfy the two required impact weight values, design of the impact weight resulted in a baseline 5-lb impact weight that is configurable to 15-lb by adding weight blocks. The two configurations used to impact the MBB are shown in Figure 7. An expanded view of the 5-lb impact weight with components labeled is shown in Figure 8, with a listing of components provided in Table 2. An expanded view of the 15-lb impact weight with components labeled is shown in Figure 9, with a listing of components provided in Table 3. The impact tup is attached to the base weight using a threaded stud, so that if desired, the shape of the impact tup can be changed to a different geometry. Two sets of 4 wheels are attached to each of the wheel brackets to guide the weight on the track. Flanged load runners were used as the wheels to help keep the weight centered on the track while it was rolling. The wheel brackets are attached to the base weight using four bolts and spacers (which in the 15-lb configuration are replaced by two of the added weights) that position the wheels at the proper width for the track. Tabs on the wheel brackets, adjacent to each of the wheels, ensure that at no time can the weight be ejected off the track, enabling the weight to only exit the track at the ends. In order to ensure that the baseline impact weight was 5 lbs, the remainder of the components were designed and chosen such that their total weight was just under 5 lbs. A weight adjustment screw was added on the aft end of the base weight, opposite the impact tup, by which washers or other small weights could be added to tune the total weight to the required 5 lbs. The 15-lb version of the impact weight was similarly tuned to the required weight. In fact, the configurable design actually enables the impact weight to be configured to any value of 5 pounds or greater, provided that the added weights don't interfere with the track or other components. Drawings for the manufactured parts of the guided weight are provided in Appendix A.

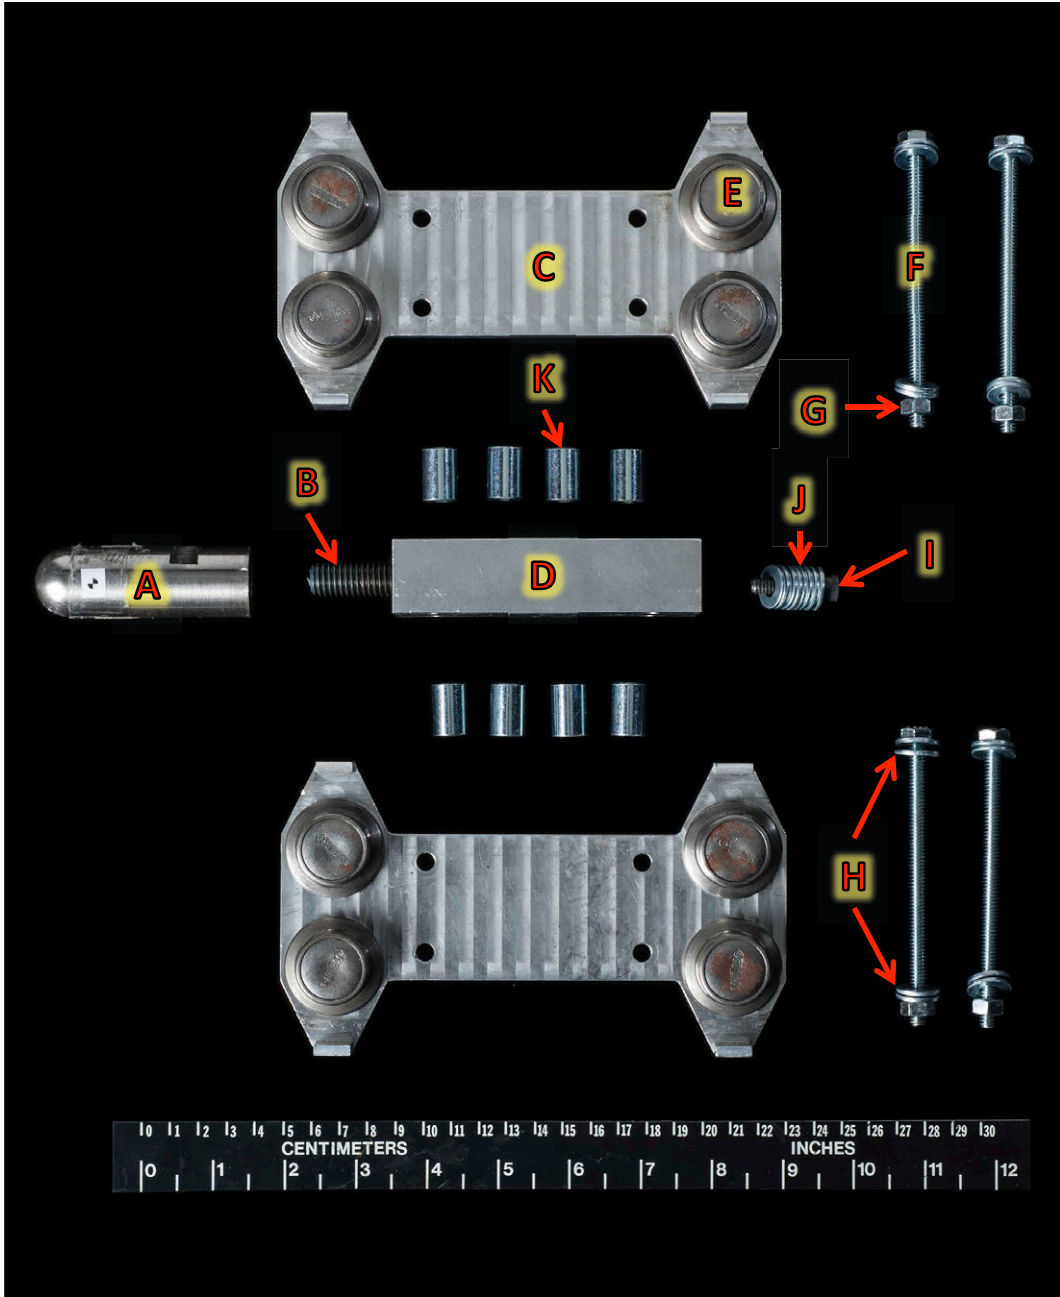
Figure 8. Expanded view of the 5-lb impact weight components.

ID	Part	Drawing #	Material	Quantity
A	Impact Tup	N/A	Steel	1
C	Central Block	RCI0007	Aluminum	1
D	Car Wheel Bracket	RCI0008	Aluminum	2

ID	Part	Quantity
B	Threaded Stud, 1/2"-13, 2.25" length	1
E	Load Runner with Flange (Osborn Part# FLR-1 W/H)	8
F	Bolt, 1/4"-20, 4.0" length	4
G	Nut, 1/4"-20	4
H	Washer, 1/4" ID	16
I	Socket Cap Screw, 1/4"-20, 1.0" length	1
J	Washer, 1/4" ID (weight tuning)	As needed
K	Unthreaded Zinc-coated Steel Spacer	8

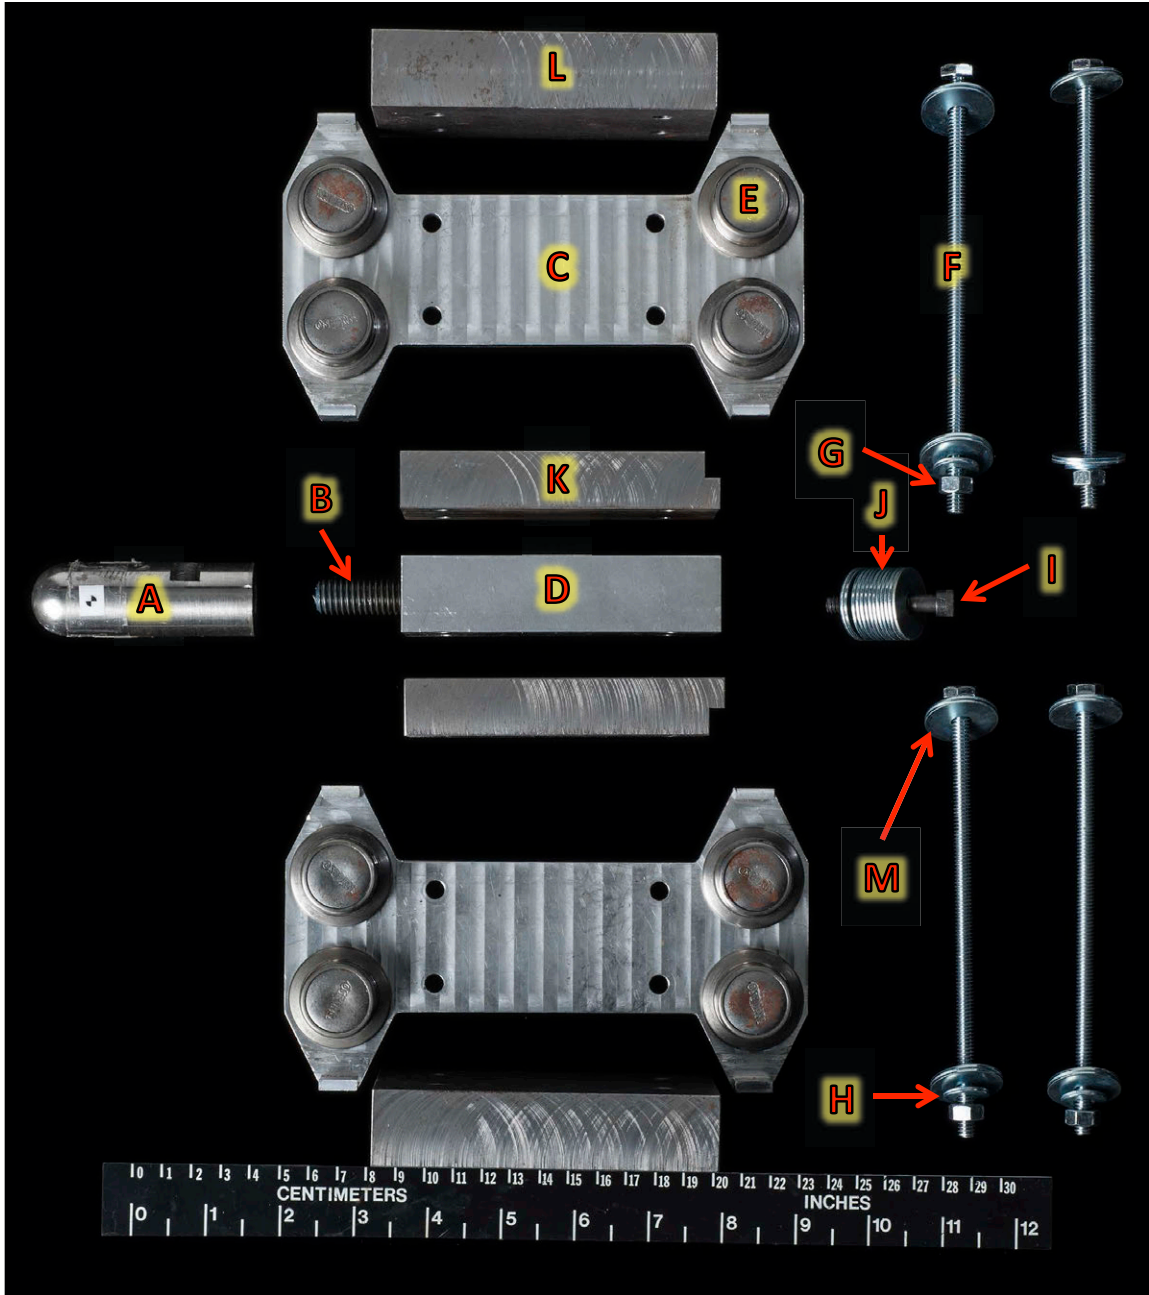
Figure 9. Expanded view of the 15-lb impact weight components.

ID	Part	Drawing #	Material	Quantity
A	Impact Tup	N/A	Steel	1
C	Central Block	RCI0007	Aluminum	1
D	Car Wheel Bracket	RCI0008	Aluminum	2
K	Weight Block #1	RCI0009	Steel	2
L	Weight Block #2	RCI0010	Steel	2

ID	Part	Quantity
B	Threaded Stud, 1/2"-13, 2.25" length	1
E	Load Runner with Flange (Osborn Part# FLR-1 W/H)	8
F	Bolt, 1/4"-20, 6.0" length	4
G	Nut, 1/4"-20	4
H	Washer, 1/4" ID	8
I	Socket Cap Screw, 1/4"-20, 1.5" length	1
J	Fender Washer, 1/4" ID, 1.0" OD (weight tuning)	As needed
H	Fender Washer, 1/4" ID, 1.0" OD	16

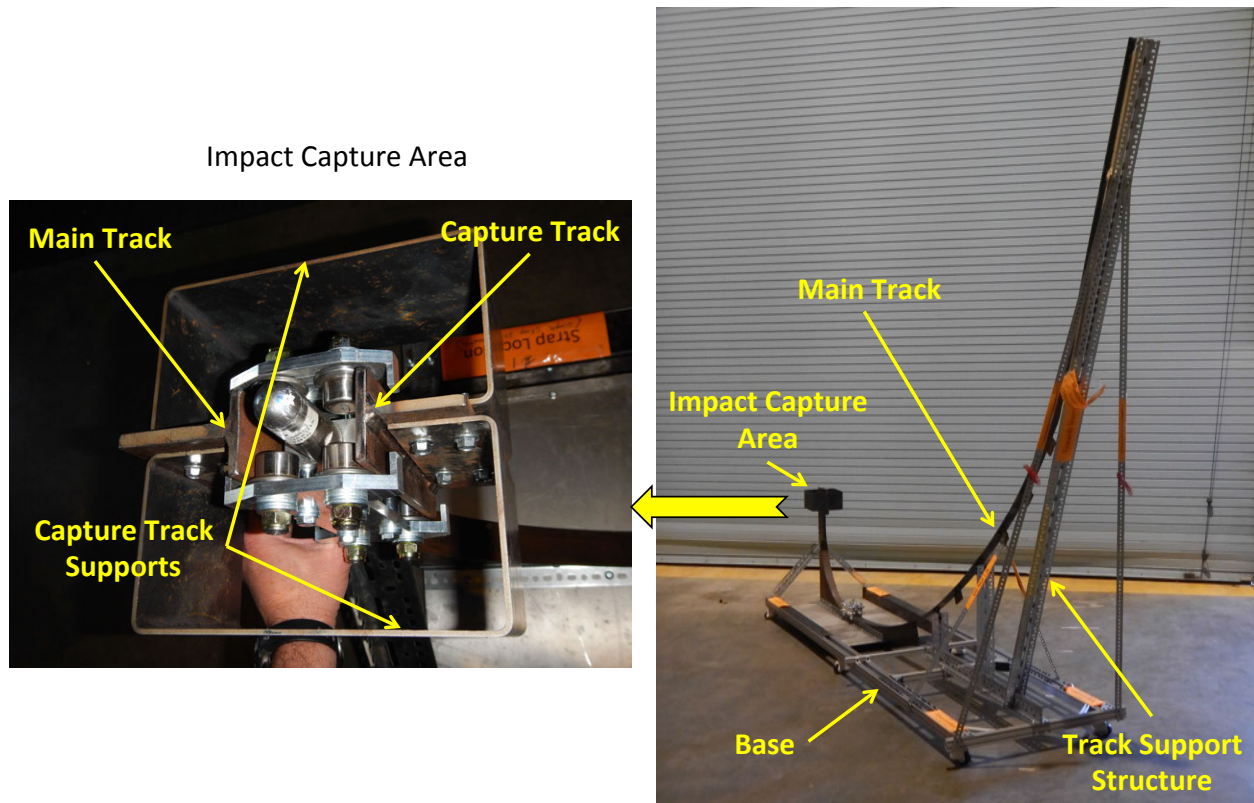
Figure 10. Guided weight impactor track.

The track, shown in Figure 10, consists of two portions, namely the main track and the capture track, and is approximately 12-ft long, 3-ft wide, and 10-ft tall. The main track provides the height required to impart the necessary energy level. However, a portion of the main track works with the capture track to constrain the motion of the weight at the end of the track during impact. The capture track restrains the weight at impact by holding the weight against the main track, to guide the weight to the correct location at impact. As utilized on the MBB, the track was configured to have the impact weight traveling vertically upward at impact, however, the track could be configured to have impact imparted at nearly any angle away from vertically downward. For example, the track could be configured to impact normal to a circular fuselage at the 45-degree location, as measured from the keel of the fuselage towards the side. Depending on the impact energy and the structural response to the impact, it may be necessary to capture the weight (or insert a protective element such as a paddle) after initial impact to avoid a secondary impact event. As the angle moves away from vertically upward, the need to capture the weight after applying the required impact increases in order to eliminate the chance for double impact. The track is mounted to a base, and is supported in the area of the capture track and the areas of high force, such as where the weight is changing direction along the curved portion of the track adjacent to the base, by a plate to provide a more rigid track. Six off-the-shelf casters with rubber wheels are mounted on the base to allow for ease of movement of the track. The casters also have rubber supports/levelers that can be lowered in order to raise the wheels off the ground, to level the track base, and to help prevent movement of the track assembly while the impacts are being applied. The track base was assembled from off-the-shelf extruded aluminum bars, and the support braces were steel angles and straps. Drawings for key manufactured parts of the track are provided in Appendix B.

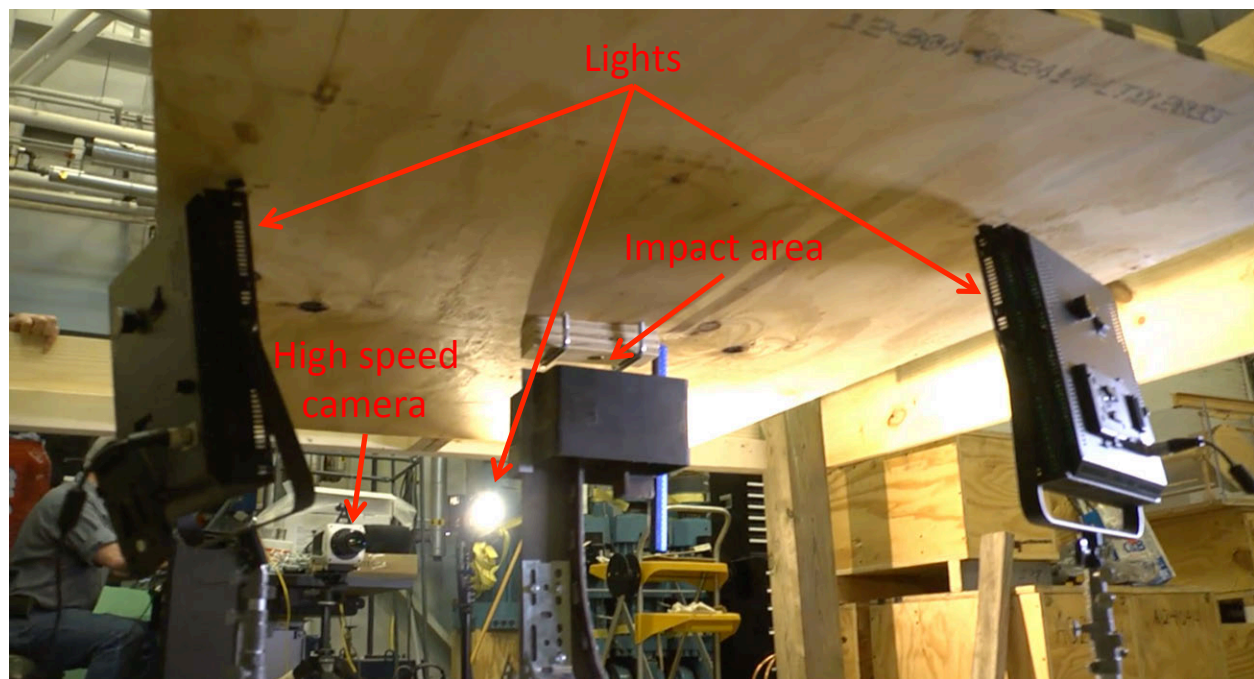
Figure 11. Setup for guided-weight impactor calibration.

Calibration of the guided drop weight impactor was performed by impacting a wooden mock-up of the keel from various heights for each of the two weight configurations, and by measuring the velocity at impact using high-speed cameras. The setup is shown in Figure 11, where the impact area is seen in the center of the image. The impact area consists of two removable pieces of plywood that can be replaced as needed when they become damaged, and which were held in place on the mock-up using u-bolts. Phantom high speed cameras from Vision Research were located on both sides of the impact area (only one camera visible in the Figure 11), and the associated software provided with the cameras was used to calculate the velocity at impact.¹⁹ An example screen capture from one of the calibration trials for the 5-lb weight is shown in Figure 12. To ensure consistency in the velocity measurement process, bowtie markers were added to both sides of the impact tip, and scales were added to the capture track support, as identified in the figure. The bowtie marker was used to provide a consistent point to measure, and the scale was attached to the capture track support in a plane that was perpendicular to the camera axis, and which contained both the scale and the bowtie marker. The removable wood impact sample was used to provide a fresh surface for the impacts, which also enabled development of the alignment process by examining the location of each impact compared to the target location that had been drawn onto the wood. An example of the wood after an impact is shown in Figure 13, where it can be seen that the impactor could be aligned to impact the proper location with very good accuracy, within about a sixteenth of an inch. After calibration for each impact energy, the track was marked to indicate the weight release location for performing the impacts to the MBB.

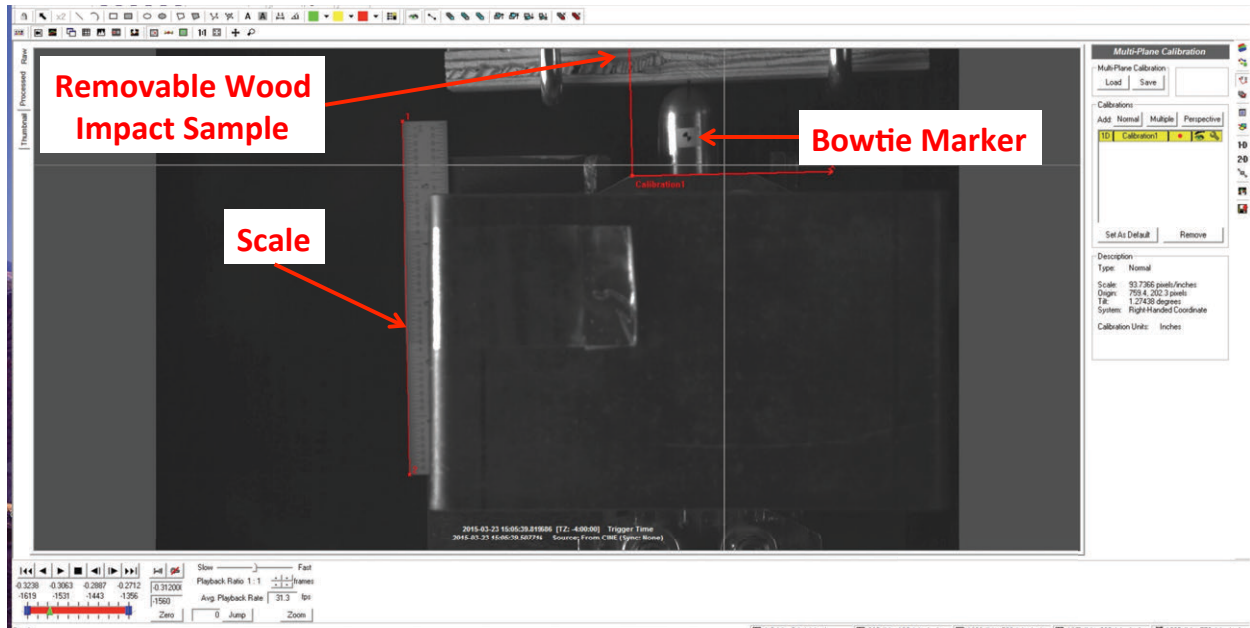
Figure 12. Example velocity measurement screen capture.

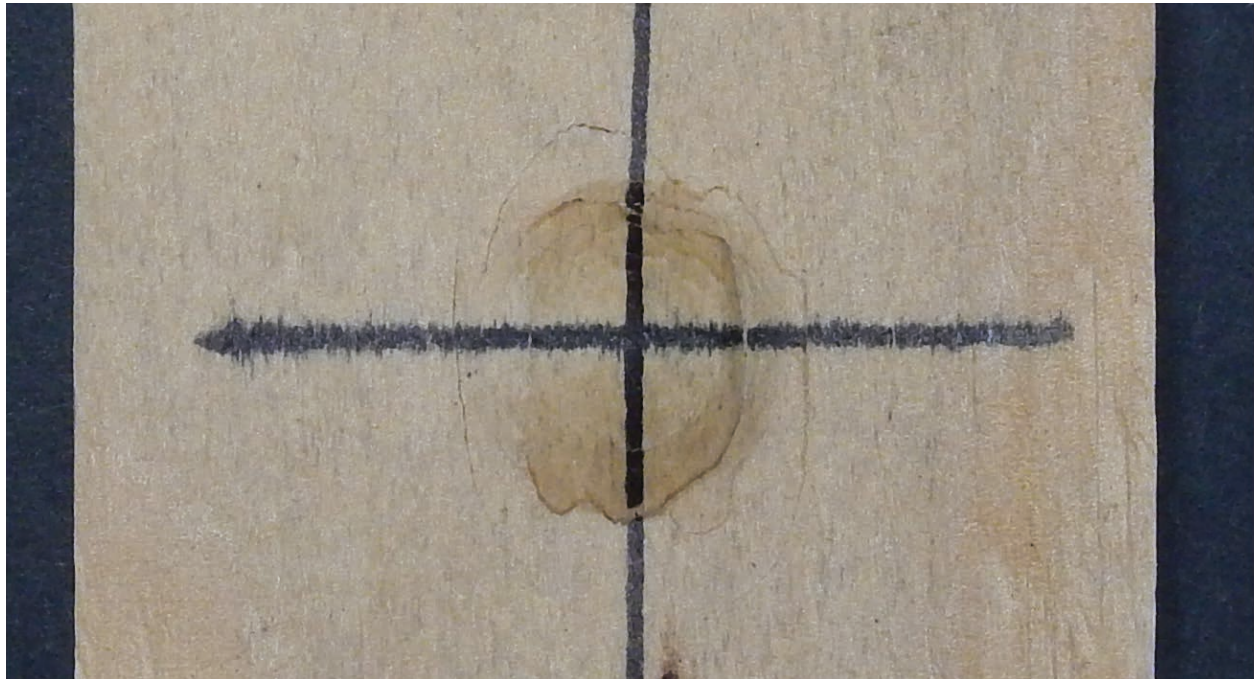
Figure 13. Wood impact sample from 5-lb weight impact test.

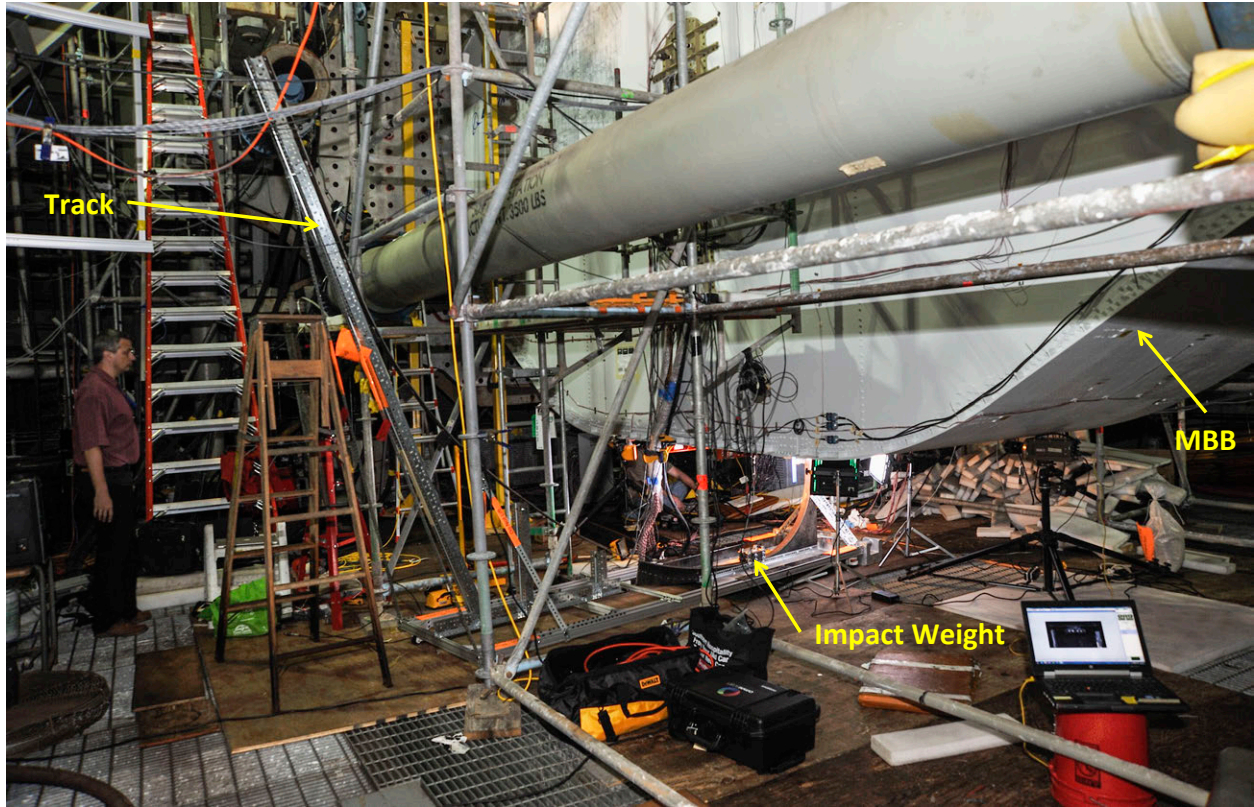
Figure 14. Impactor in COLTS in location to impart exterior skin BVID to MBB keel.

The impactor was used to impact the MBB while it was installed in the COLTS Facility, as shown in Figure 14 for the skin impact. Alignment of the impactor for applying the exterior skin impact is shown in Figure 15. Alignment was performed by locating the track with the weight held in position in near contact with the surface so that the nose of the tup could be matched up with a cross mark that indicated the desired location of the impact. It is possible to replace the tup with a part that holds a laser that would point at the surface to make alignment even more accurate, but that extra effort was not employed for the MBB. The impactor was leveled using a level on the track base, and the position was achieved using the leveling pads built into the wheels. In Figure 15, weights can be seen on the floor at the capture end of the impactor. These weights were placed tight against the end of the impactor while the impact was being imparted to provide reactive support in order to prevent the impactor from moving when the weight was making the tight turn prior to impact. The weights were necessary because during the calibration tests, it was found that the friction on the six rubber supports was not sufficient to prevent movement of the track during impacts.

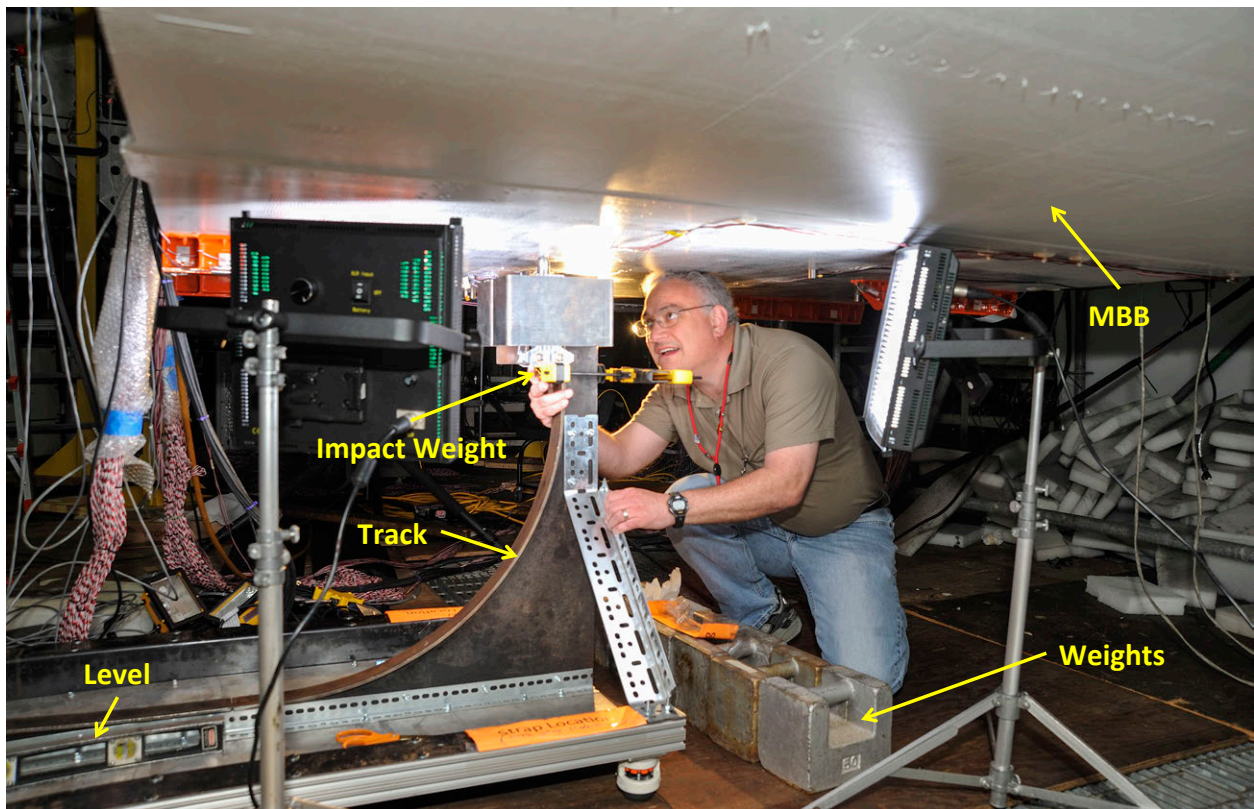
Figure 15. Alignment of impactor for exterior skin impact.

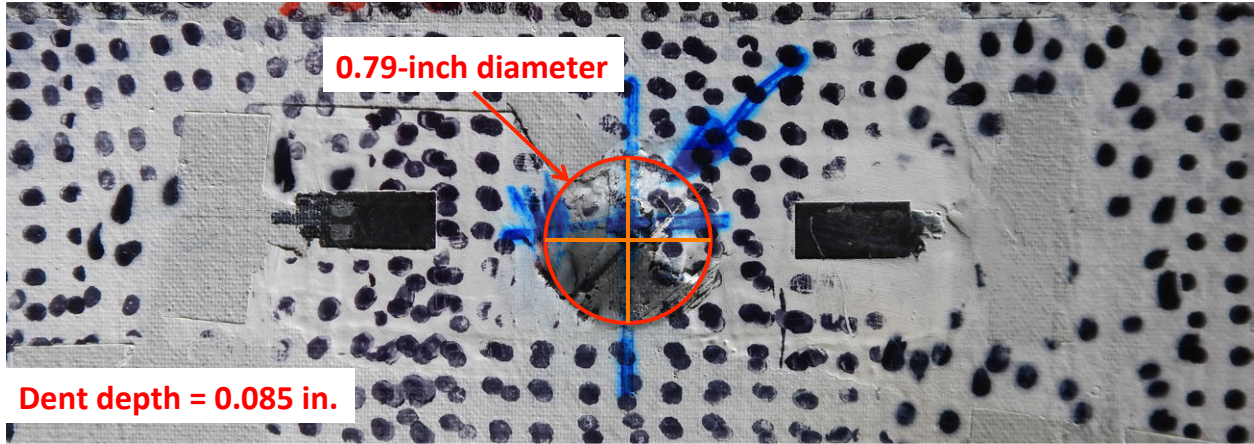
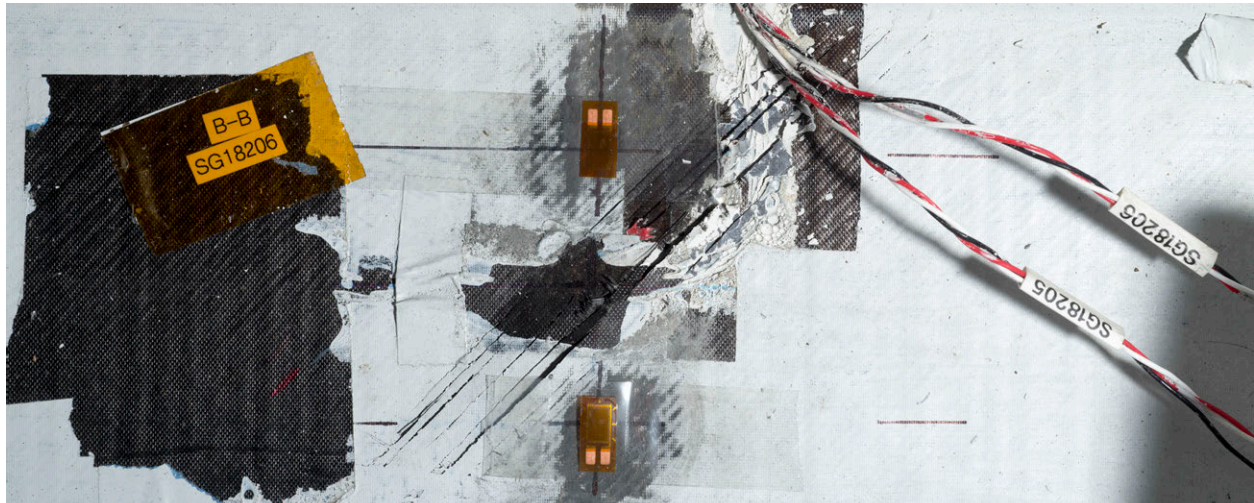
a) Exterior surface, where the blue and orange crosses indicate the target and actual impact locations, respectively

b) Interior surface

Figure 16. Center keel after exterior skin impact.

The skin impact on the center keel, impact (E3), is shown in Figure 16, where the dent depth was 0.085-inches deep and approximately 0.79 inches in diameter. The impact was within about a sixteenth of an inch of the desired location, and the impact velocity was 14.17 ft/s compared to the target of 13.89 ft/s, for error of about 2.02%. The combination of the dent development and the structural deflection resulted in the tup traveling a distance of approximately 15/32 of an inch (0.469 inches) after initial tup contact. Superimposed images at impact and maximum deflection are shown in Figure 17. Also shown in the figure is the total deflection as indicated by a red line superimposed upon the scale at the right-hand side of the image. Therefore, the structure had an elastic deformation of approximately 0.384 inches as a result of the 15 ft-lb impact on the skin.

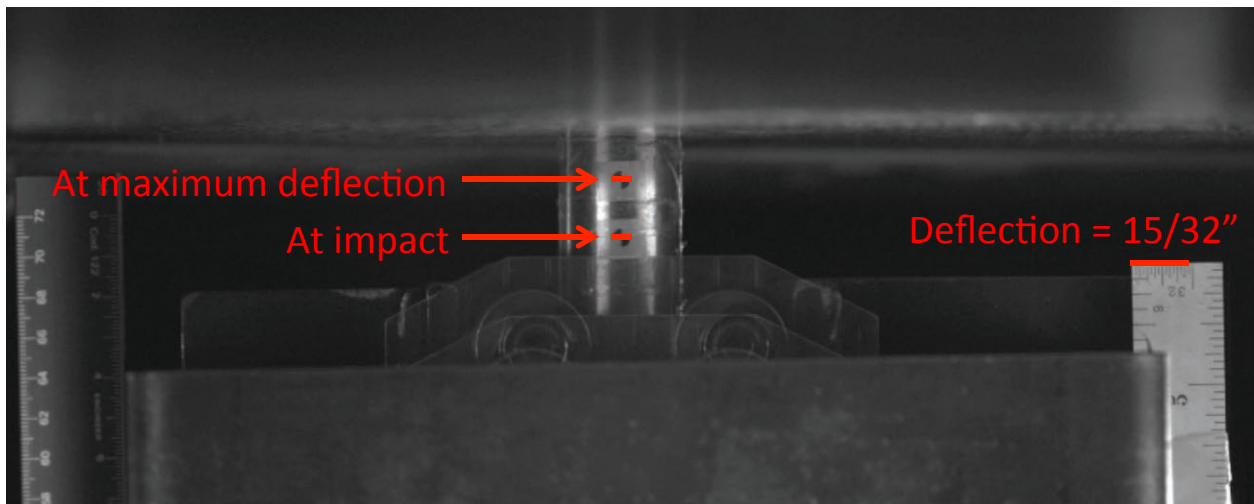
Figure 17. Position of impact tup during exterior skin impact.

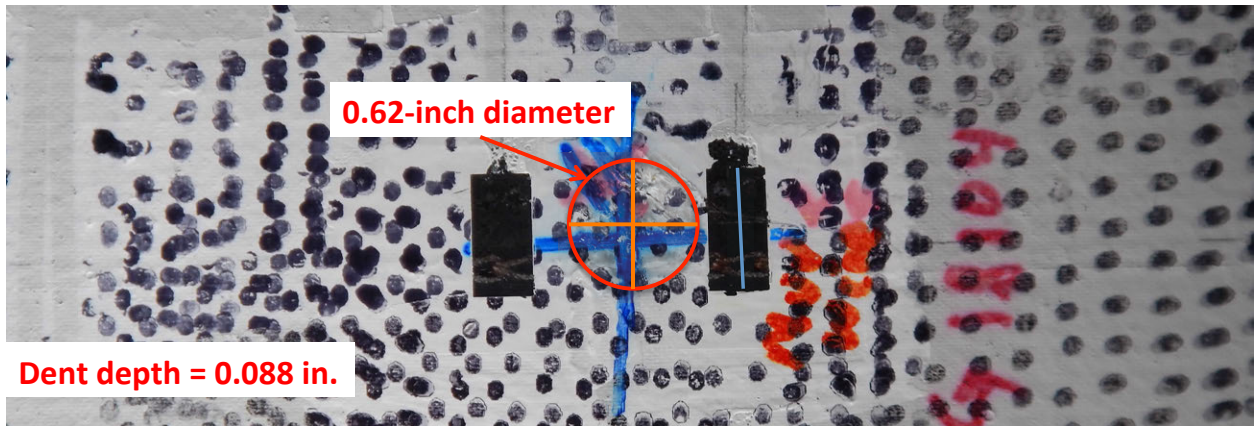
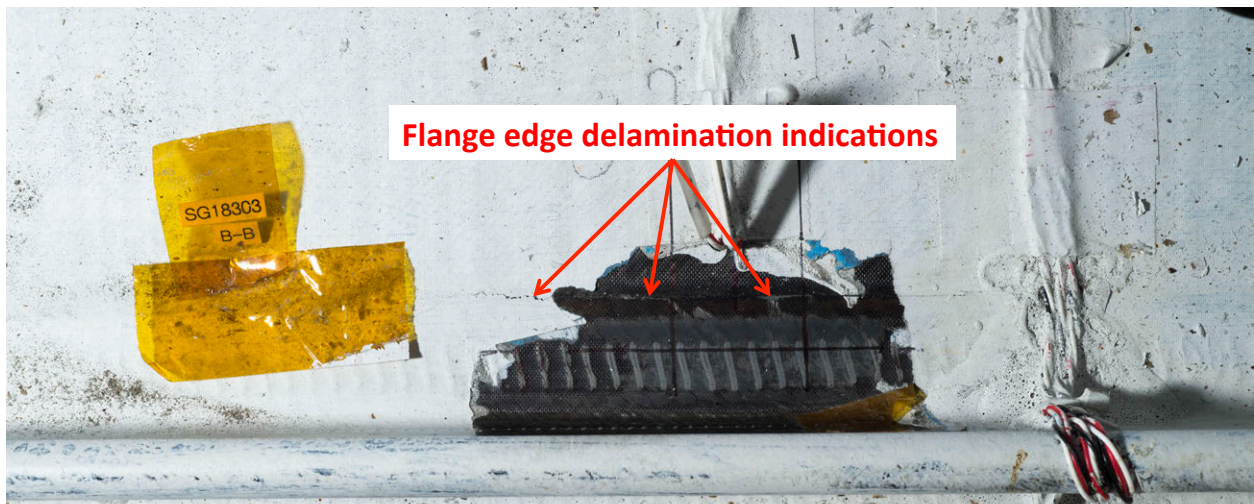
a) Exterior surface, where the blue and orange crosses indicate the target and actual impact locations, respectively

b) Interior surface

Figure 18. Center keel after exterior stringer flange impact.

The stringer flange impact (E2) is shown in Figure 18, where the dent depth was 0.088-inches deep and approximately 0.62 inches in diameter. The impact was within about a sixteenth of an inch of the desired location, and the impact velocity was 14.61 ft/s compared to the target of 14.65 ft/s, for an error of -0.27%. The combination of the dent development and the structural deflection resulted in the tup traveling a distance of approximately 11/32 of an inch (0.344 inches) after initial tup contact. Superimposed images at impact and maximum deflection are shown in Figure 19. Also shown in the figure is the total deflection as indicated by a red line superimposed upon the scale at the right-hand side of the image. Therefore, the structure had an elastic deformation of approximately 0.256 inches as a result of the 15 ft-lb impact on the skin.

stitch line than that for the stringer flange impact (E2) in Figure 18. Additionally, it appears that, by comparing the interior images in Figure 18 for E2 and Figure 20 for E1, there is more substantial flange on the skin side of the stringer flange stitch line, which provided additional material to absorb the impact at the E2 location. The shift of the entire track was the result of the weights and sand bags being insufficient to keep the track from moving during the impact due to the bearing force that was being applied to the tup. Additional track restraint (weight or other means) might have prevented track movement and may have lessened the penetration of the tup. Lastly, due to the combination of tup penetration and elastic deformation of the test article, the wheels of the impact weight became disengaged from the track, which permitted additional shift in tup location as the tup was bearing at the flange stitch line. If the track end was closer to the test article, then this additional shift and resulting penetration may have been lessened. The resulting damage was much more severe than BVID, but testing demonstrated that this severe damage did not result in any growth.¹¹
