NASA/TM—2016–218977

Design and Use of a Guided Weight Impactor to Impart Barely Visible Impact Damage

Abstract

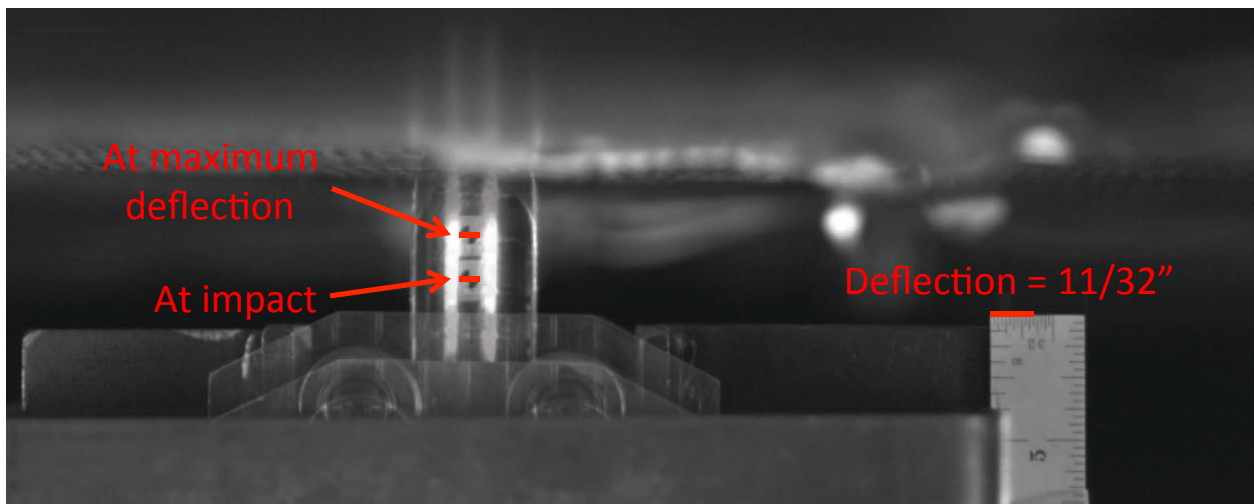
Figure 19. Position of impact tup during exterior stringer flange impact.

The stringer flange impact (E2) is shown in Figure 18, where the dent depth was 0.088-inches deep and approximately 0.62 inches in diameter. The impact was within about a sixteenth of an inch of the desired location, and the impact velocity was 14.61 ft/s compared to the target of 14.65 ft/s, for an error of -0.27%. The combination of the dent development and the structural deflection resulted in the tup traveling a distance of approximately 11/32 of an inch (0.344 inches) after initial tup contact. Superimposed images at impact and maximum deflection are shown in Figure 19. Also shown in the figure is the total deflection as indicated by a red line superimposed upon the scale at the right-hand side of the image. Therefore, the structure had an elastic deformation of approximately 0.256 inches as a result of the 15 ft-lb impact on the skin.

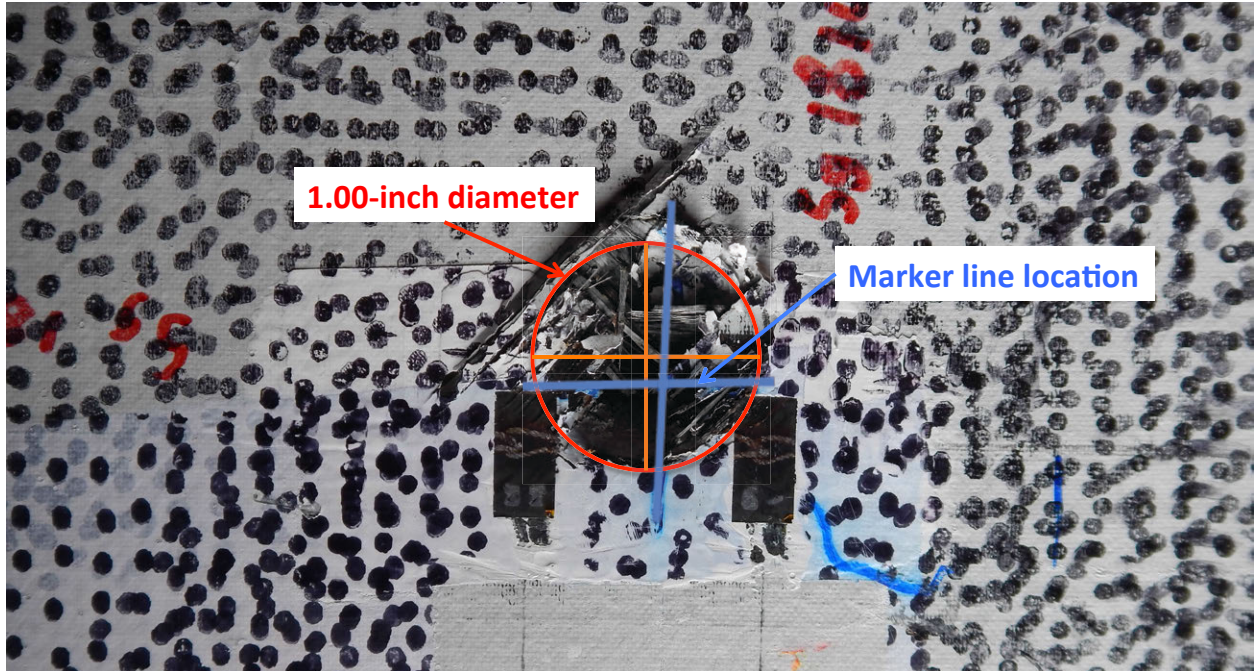
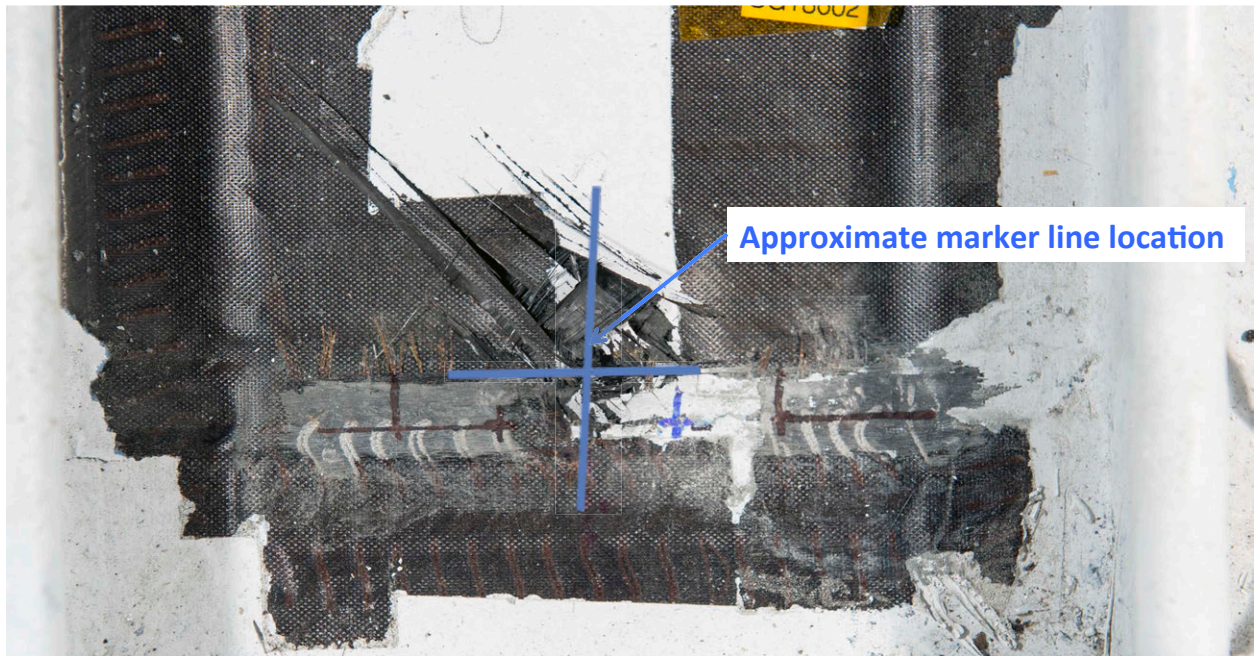
a) Exterior surface, where the blue and orange crosses indicate the target and actual impact locations, respectively

b) Interior surface

Figure 20. Center keel after exterior frame flange impact.

The frame flange impact (E1) is shown in Figure 20. Unfortunately, the impact weight tup fully penetrated the test article, with the wheel brackets coming to rest against the surface of the test article as shown in Figure 21. During this penetration process the impact weight shifted, as shown in Figure 22. This shift resulted from a combination of shift in the entire track due to the resulting force on the tup while penetration was occurring, and shift of the impact weight once the forward wheels of the weight exited the end of the track and were no longer constrained. In Figure 22, it is seen that each of these shifts is equal, approximately 3/32 of an inch, as shown by the yellow and orange lines superimposed on the scale at the right-hand side of the image. The total shift resulting from these shift component values is 3/16 of an inch, depicted by the red line superimposed on the scale in the image of Figure 22. Accounting for this shift, the approximate initial impact location is indicated in Figure 23 by the yellow cross. This initial impact location was within a sixteenth of an inch of the desired location, and the impact velocity was 15.75 ft/s compared to the target of 16.04 ft/s, for an error of about -1.81%. Several factors were potential contributors to the penetration at the frame flange impact location (E1). First, the blue target mark shown in Figure 20 was not at the desired location, and is farther from the

stitch line than that for the stringer flange impact (E2) in Figure 18. Additionally, it appears that, by comparing the interior images in Figure 18 for E2 and Figure 20 for E1, there is more substantial flange on the skin side of the stringer flange stitch line, which provided additional material to absorb the impact at the E2 location. The shift of the entire track was the result of the weights and sand bags being insufficient to keep the track from moving during the impact due to the bearing force that was being applied to the tup. Additional track restraint (weight or other means) might have prevented track movement and may have lessened the penetration of the tup. Lastly, due to the combination of tup penetration and elastic deformation of the test article, the wheels of the impact weight became disengaged from the track, which permitted additional shift in tup location as the tup was bearing at the flange stitch line. If the track end was closer to the test article, then this additional shift and resulting penetration may have been lessened. The resulting damage was much more severe than BVID, but testing demonstrated that this severe damage did not result in any growth.¹¹

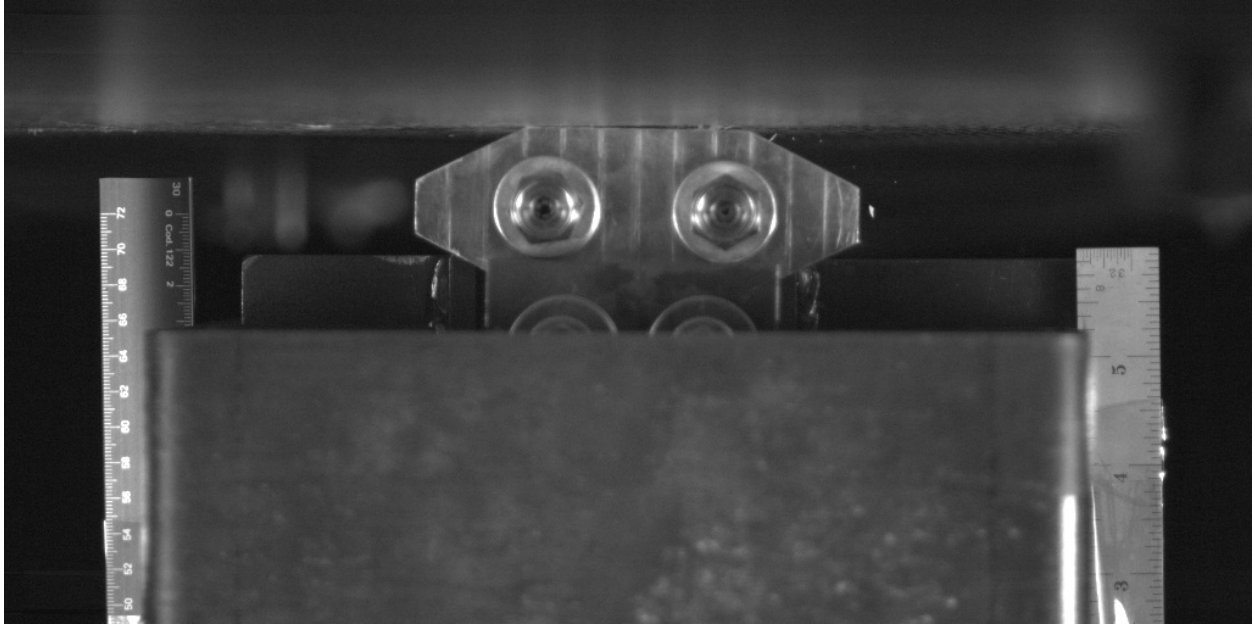
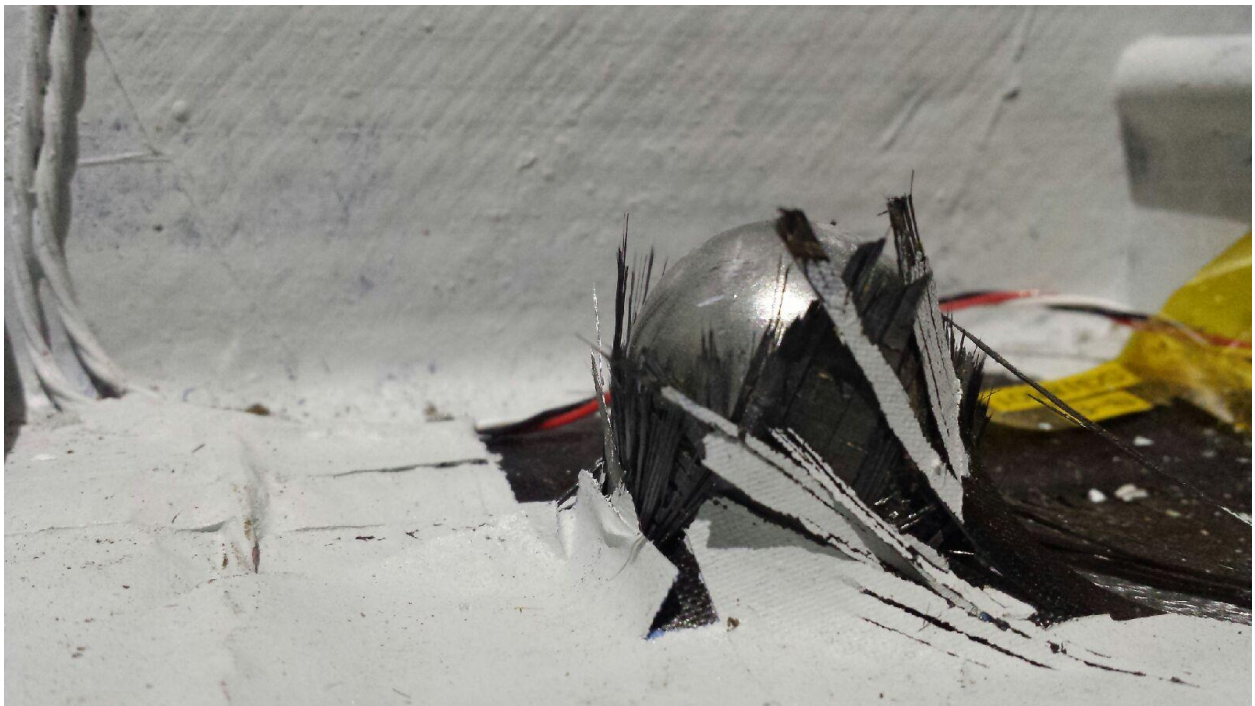
Figure 21. Impact tup penetrating MBB after exterior frame flange impact.

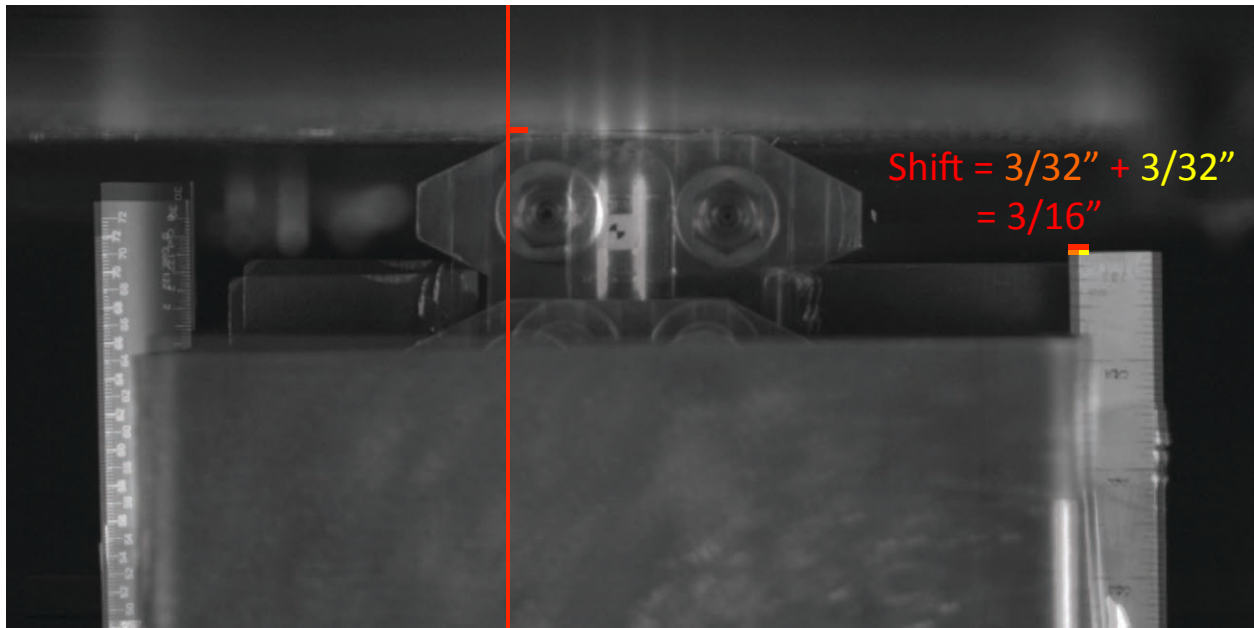
Figure 22. Position shift during exterior frame flange impact.

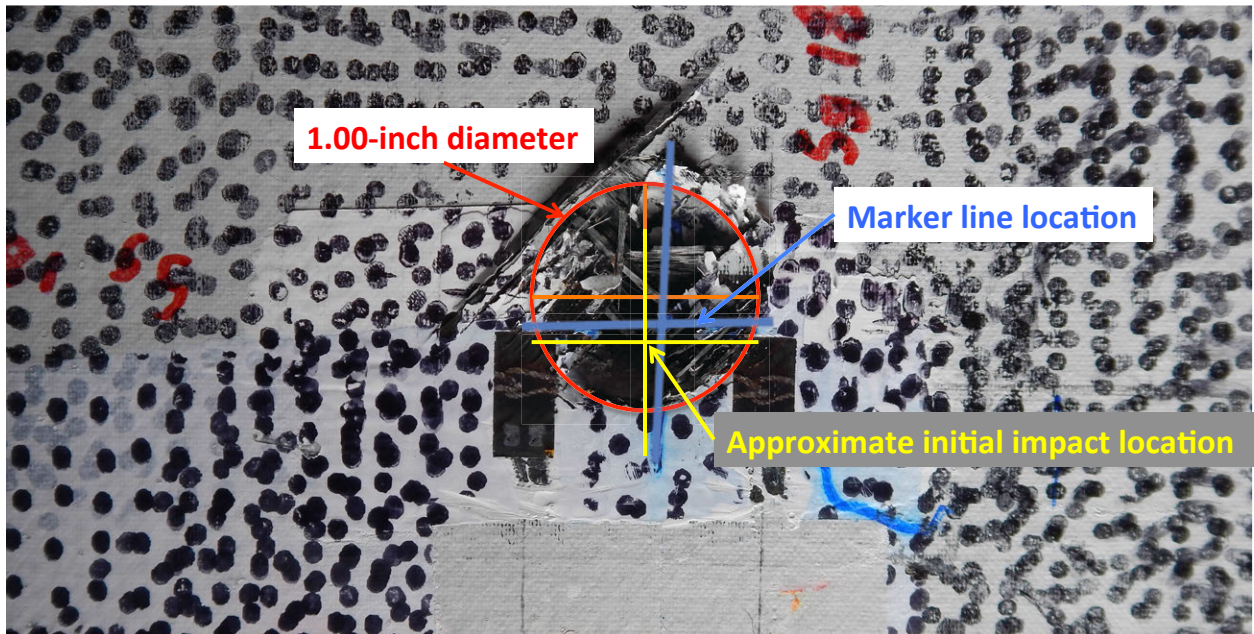
Figure 23. Initial position of impact tup during exterior stringer flange impact.

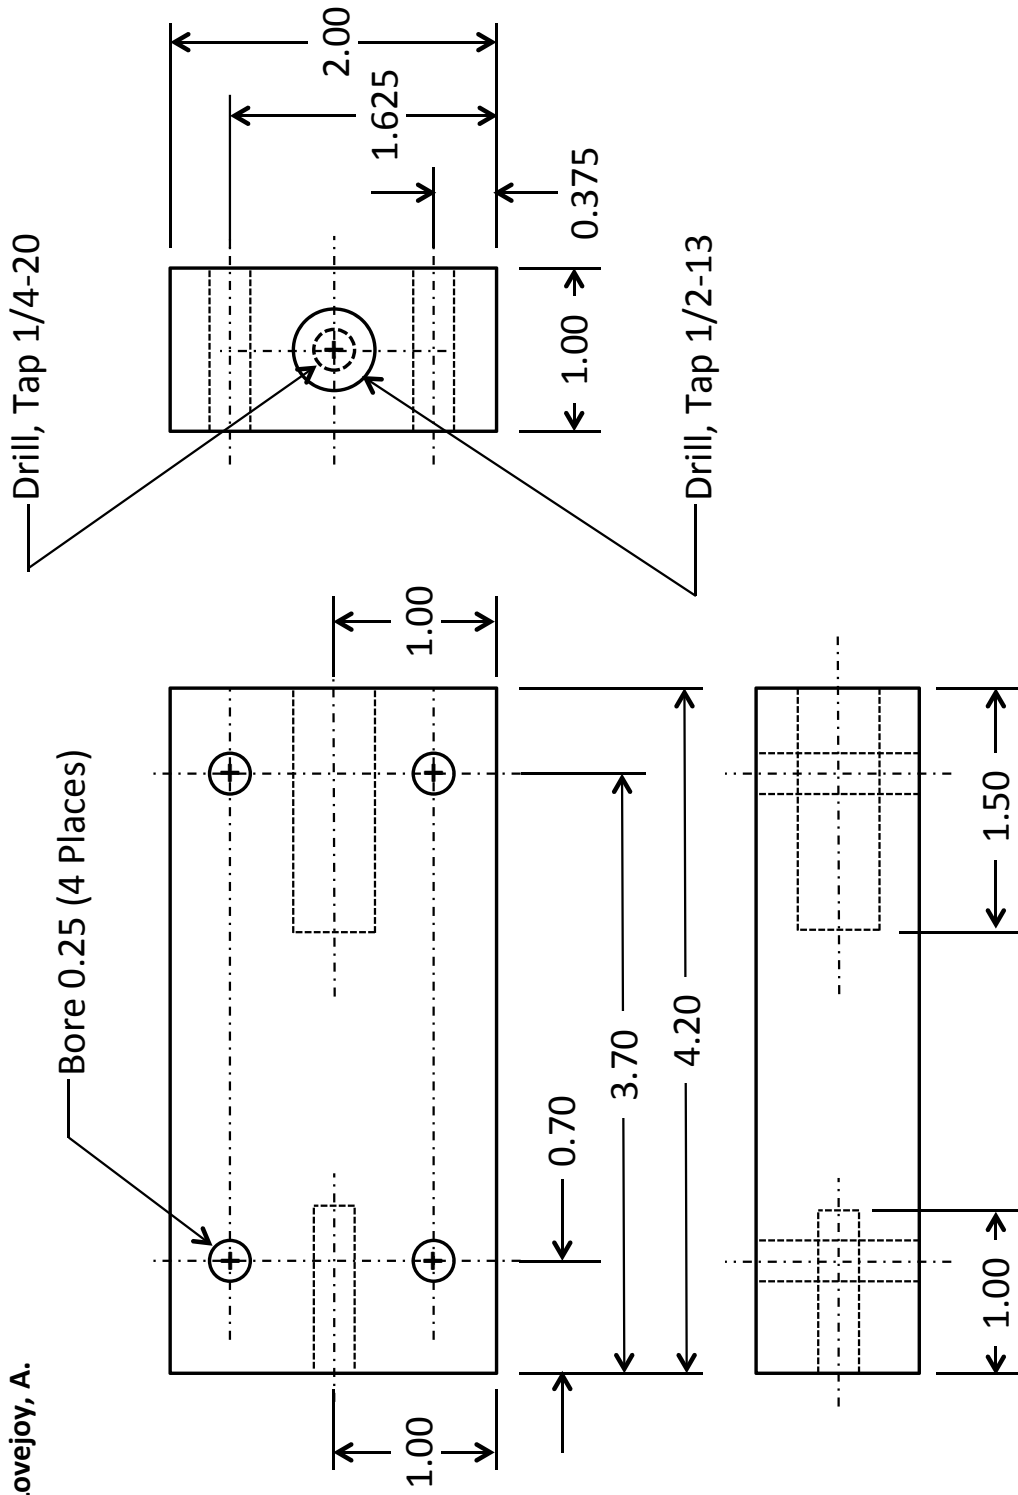
Drawing #RCI0009 – (rev. 1)

Notes:

- 1) Fabricated from aluminum plate stock.
- 2) Bore tolerance +0.005, -0.000.

Part: Weight Block #1

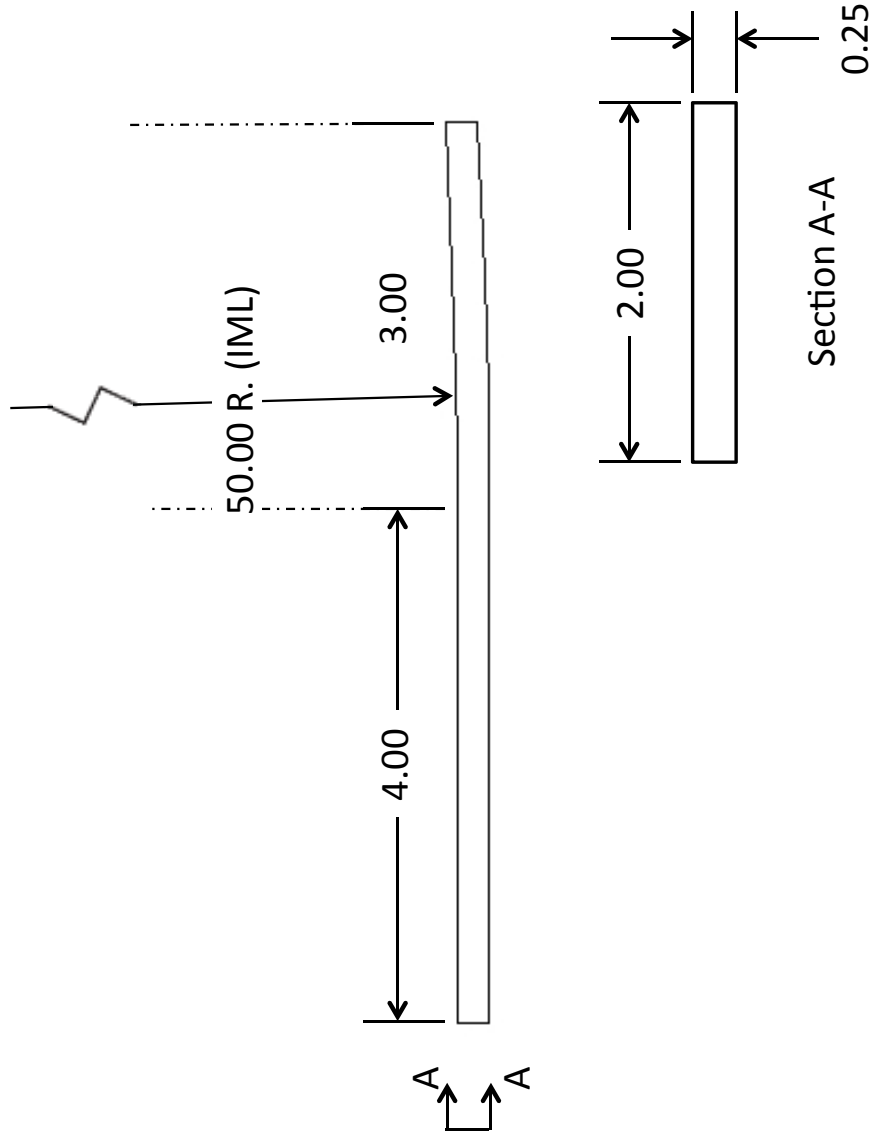
Drawing #RCI0004 (rev. 1)

- Notes:
- 1) Fabricated from steel bar stock.
 - 2) End region straight.
 - 3) Dimensions in inches.
 - 4) Dimensions are IML for track length.

Part: Track #1 Web

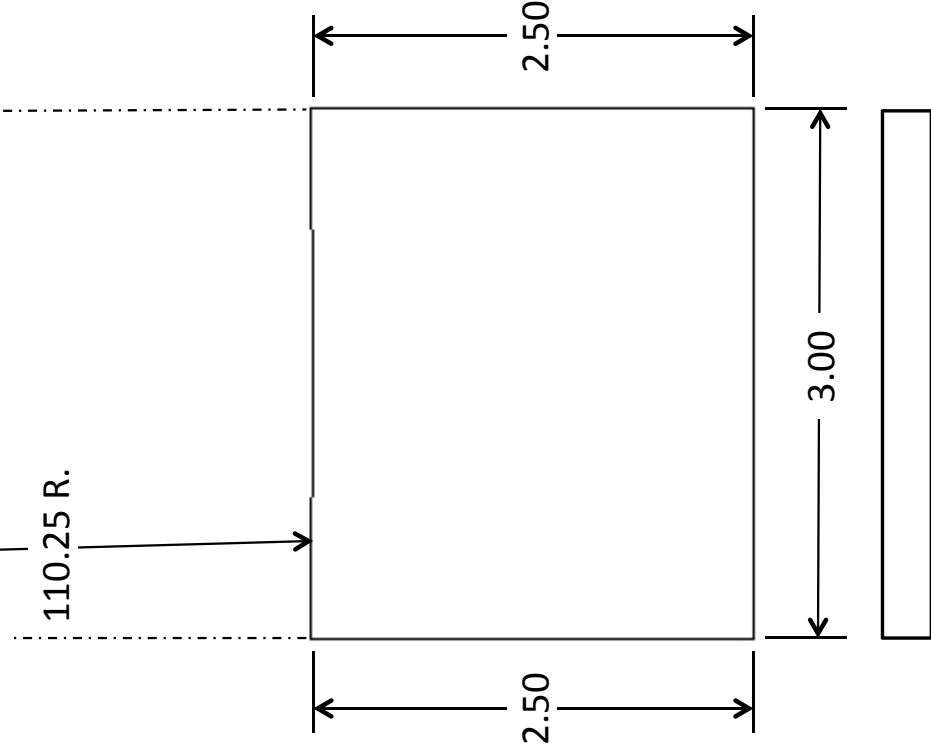
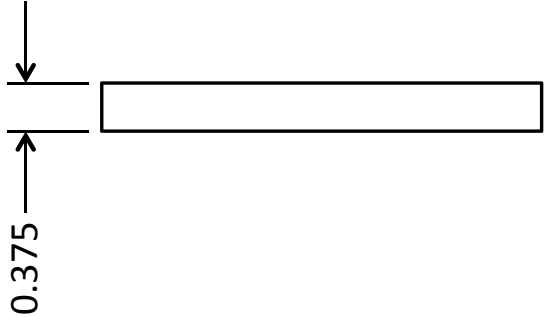
Drawing #RCI0006 (rev. 1)
Part: Track #2 Tabs
Lovejoy, A.

- Notes:
- 1) Fabricated from steel sheet stock.
 - 2) Tolerance on radius +0.00, -0.01.
 - 3) Fabricate 10 pieces.

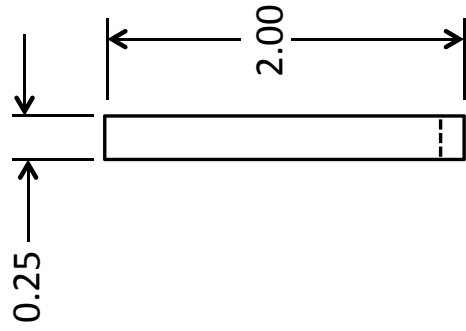
Drawing #RCI0011 (rev. 1)

Part: Track #3 Web

- Notes:
- 1) Fabricated from steel bar stock.
 - 2) End region straight.
 - 3) Dimensions in inches.
 - 4) Length dimensions are OML.

Section A-A

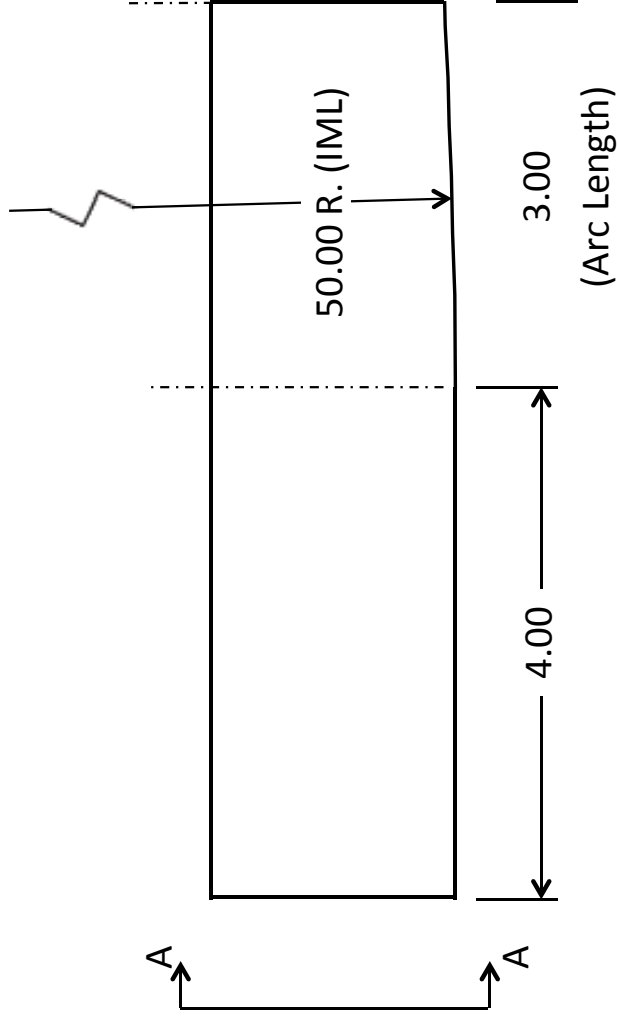
Drawing #RCI0012, Sheet 1 (rev. 1)

Part: Track #3 Brace
