Filter Efficiency and Pressure Testing of Returned ISS Bacterial Filter Elements

Robert D. Green¹ and Juan H. Agui²
NASA Glenn Research Center, Cleveland, Ohio 44135, USA

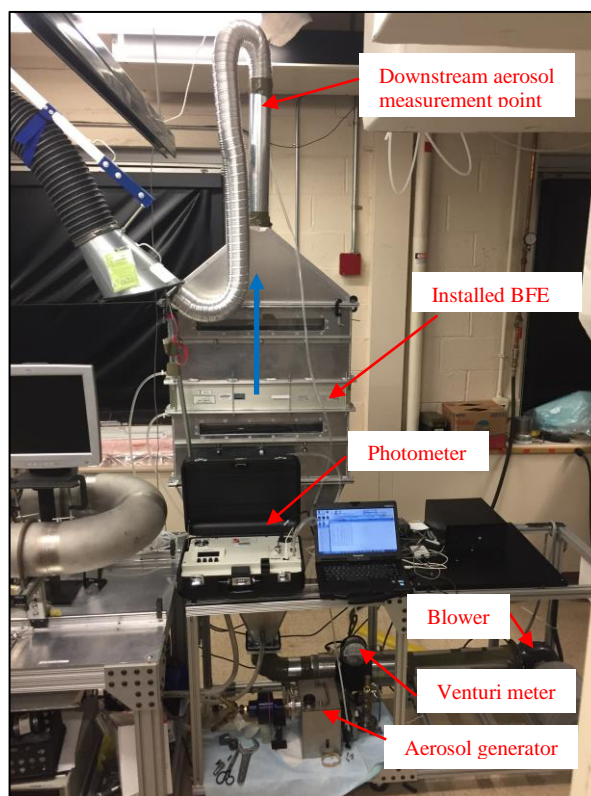
Figure 1. Filter element testing setup. Modified test rig for efficiency testing — blue arrow indicates direction of air flow.

An upright test duct system with an aerosol generator was designed and used for leak testing of the ISS filters; the details were discussed in Ref. 7. This same test duct system was modified to perform overall efficiency tests on the ISS filters reported in our 2016 work.⁴ These modifications included a venturi meter to measure volumetric flow, an impactor attachment for the aerosol generator, and a conical exit hood, added downstream of the test filter. Slight modifications to this test duct were made for this work, namely a longer length duct and flow straightener were installed between the blower and venturi meter to reduce turbulence and lower the noise in the differential pressure measurements across the venturi, improving flow rate measurement. Figure 1 is a photo of the present test setup showing these upgrades and improvements.

Air flow through the test duct is from bottom to top as shown by the blue arrows in Figure 1. The flow expands through the lower tapered section to accommodate the cross-section of the ISS BFE test article; the challenge aerosol is introduced near the bottom of this tapered section to allow for uniform mixing prior to reaching the inlet of the BFE test article. A reverse tapered test section, collects the air flow exiting the filter and directs it to a 7.6 cm (3 inches) diameter exit tube. The downstream samples are measured from a port ~6 tube diameters downstream of the entrance to this exit tube to ensure that airflow will be fully mixed.

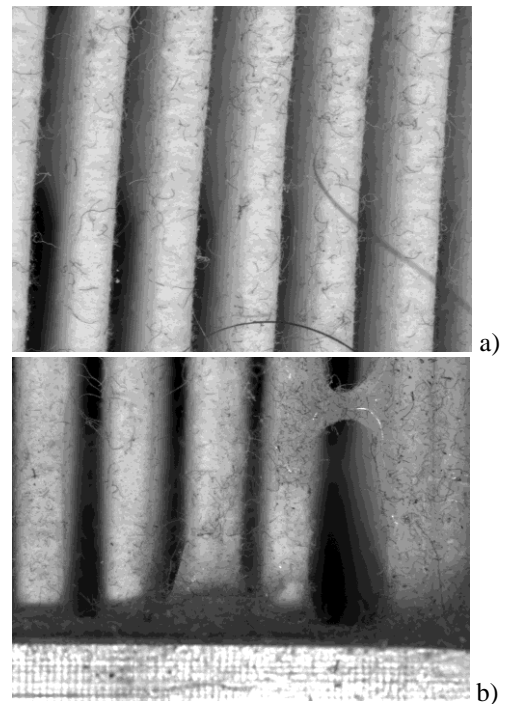
The inlet surface of each ISS BFE was scanned and imaged using a video camera with a 1:1 macrolens, on a scanning platform. Figure 2 shows two images of the pleated media surface. These close-up images of the media surface showed sparse embedded particulates in the pleat edges visible to the naked eye, primarily what appear to be cloth fibers and hairs. The interior of pleats appear to contain larger accumulations of particulate matter, but would require destructive means to provide a more thorough examination. A slight fraying of the HEPA media fibers was observed in some areas but visible protrusions or compromised areas were not evident. Inspecting the filter in whole with the naked eye, the fraying appears to be more pronounced near the center of the short length cross-section, which would be indicative of wear due to vacuuming of the surface caused by pressing the Nomex[®] screen (without support in the center) against the pleat edges causing more abrasion, compared to pleat edges near the frame. There appeared to be concentrated accumulations of debris at edges of the inlet surface, possibly due to “tackiness” of the adhesive used to bond the media to the frame.

Figure 2. Images of the BFE S/N 0009 HEPA media. The images cover an 18.4 mm × 12 mm area. a) Inlet pleat edges near middle of cross-section; b) Edge of inlet surface including aluminum frame and adhesive.

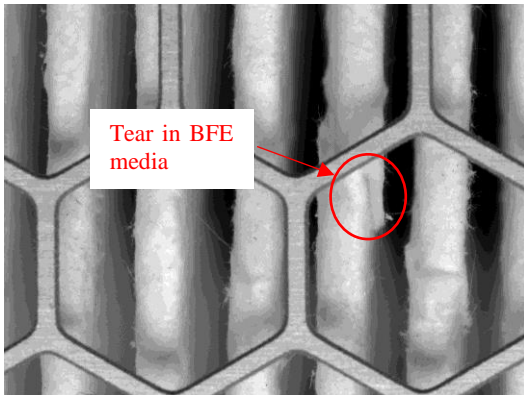
Figure 4. Image of the BFE S/N 0010 outlet side with tear in HEPA filter media. The image cover an 18.4 mm × 12 mm area. Post-leak testing with photometer, visual inspection revealed a small tear in media (circled in red). Location is ~12 cm from one end of long edge and ~4.5 cm in from short edge of BFE. Rigid aluminum screen mentioned in text is also visible.

stage test, and in fact, the penetration efficiency actually slightly increased at the lower flow rate. Because S/N 0010 failed this first stage test, a manual scanning leak test was performed on it using the method described in Ref. 6. The entire exit cross-section of the back face of the filter was scanned by slowly sweeping (at ~1-2 cm/s) the handheld photometer probe down the long dimension of the filter, covering approximately one half the cross section, then sweeping the remainder of the cross-section in the reverse direction, looking for an area of the cross-section where a significantly higher reading is observed. During the scanning, we typically observed penetration readings in the 0.5-2% range. We observed readings in the 1-5% range in one area approximately 12 cm (4.7 inches) from one end of the frame. This measurement spike was repeatable with the photometer. After performing this scanning leak test, the BFE inlet and outlet surfaces were visually inspected. On the outlet side of the BFE, a small (1-2 mm) tear was visible in the same general location of the measurement spike (see Fig. 4). No visible compromise or blemish of the filter media was observed on the inlet side. This result is surprising, as the inlet side of the BFE is more susceptible to the ISS housekeeping activities mentioned earlier, and the outlet side of the BFE is protected by a more rigid, non-removable aluminum screen, as

0.0605%, significantly above the initial unused measured value of 0.03%. Despite this increase in penetration efficiency, the overall filtration efficiency, $E_T = 1 - P$, of 99.94% the returned S/N 0010 unit still meets the ISS design specification of 99.9% minimum.⁹ But since the penetration efficiency did increase for this particular unit, it is a potential indication of a leak in the filter media and was subject to leak testing, discussed in the next section.
