SPACE LAUNCH SYSTEM

# Fundamentals of Launch Vehicle Ablative Thermal Protection System (TPS) Materials

TFAWS2017

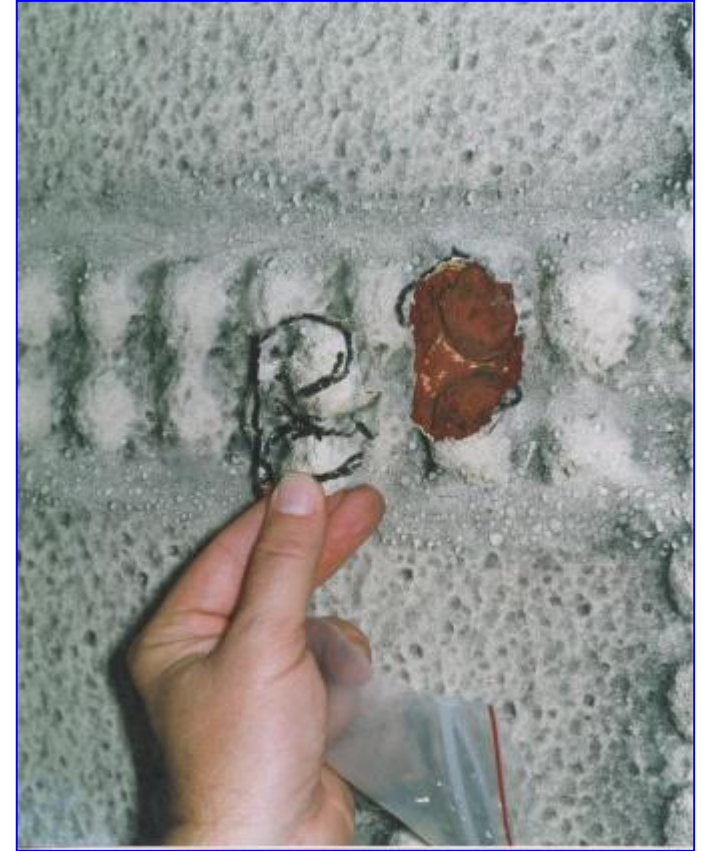
MSA pop-off

- First flight of Marshall Convergent Coating (MCC-1) was in 1996.
  - Prior to that, SRB used Marshall Sprayable Ablator (MSA)
  - MSA had low tensile strength
  - MSA had wasteful batch process
  - Surface imperfections required frequent repair
  - Lot of “pop-offs” that would damage orbiter tiles
- Developed CST technology to remove issues
  - Able to choose durable epoxy
  - No batch issues
  - Easily monitor flow rates

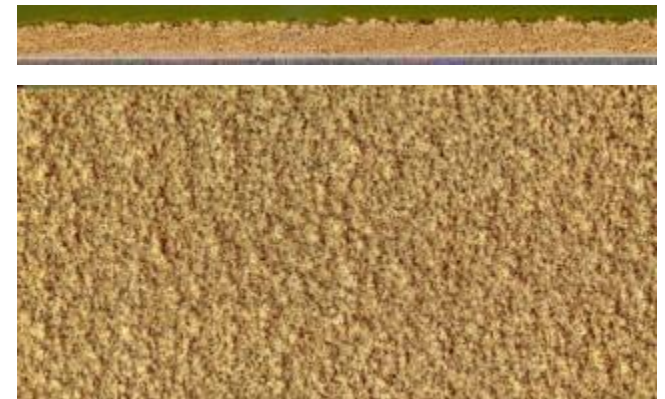
**MCC-1 Cross-Section and Surface**

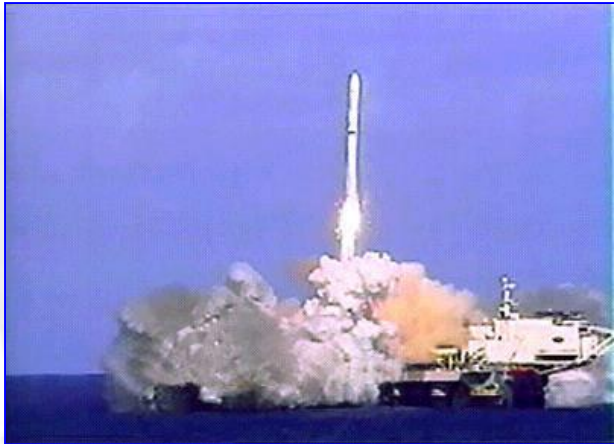
SeaLaunch  
Payload Fairings

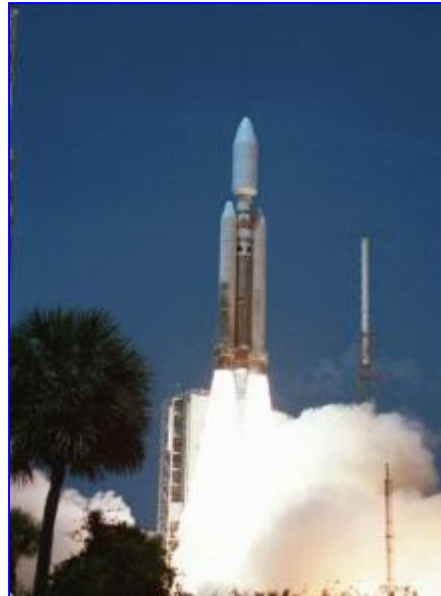
Titan IV  
Payload Fairings

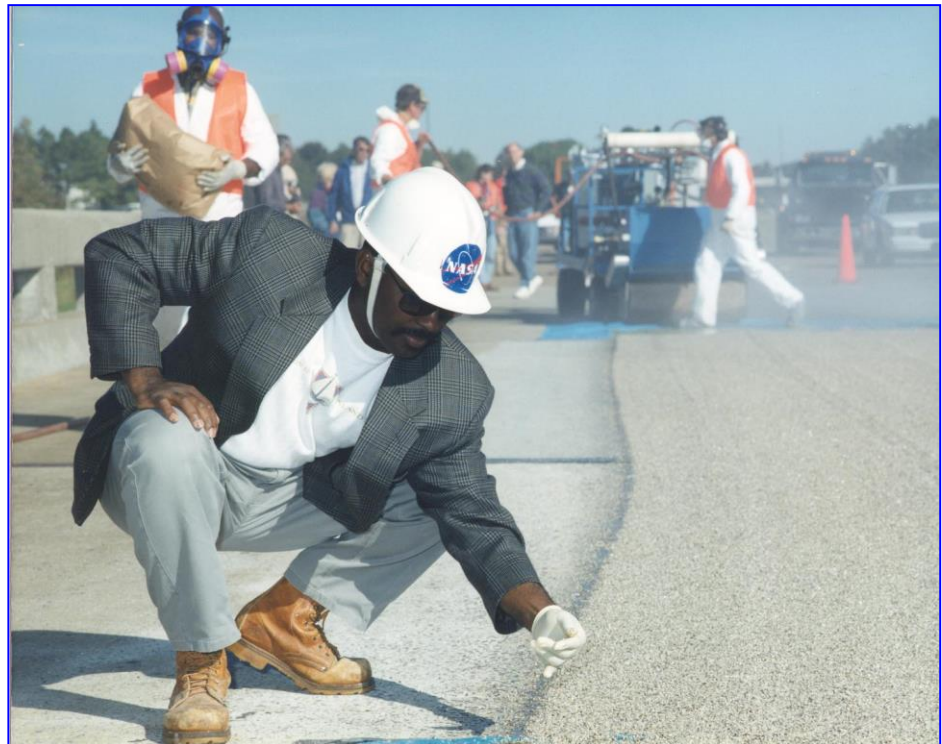
- Technology Transfer
  - Convergent Spray Technology is used in non-space applications
  - Epoxy filled with abrasive flint tested on road surfaces
- Skid Resistant
- Durable
- EPA Compliant

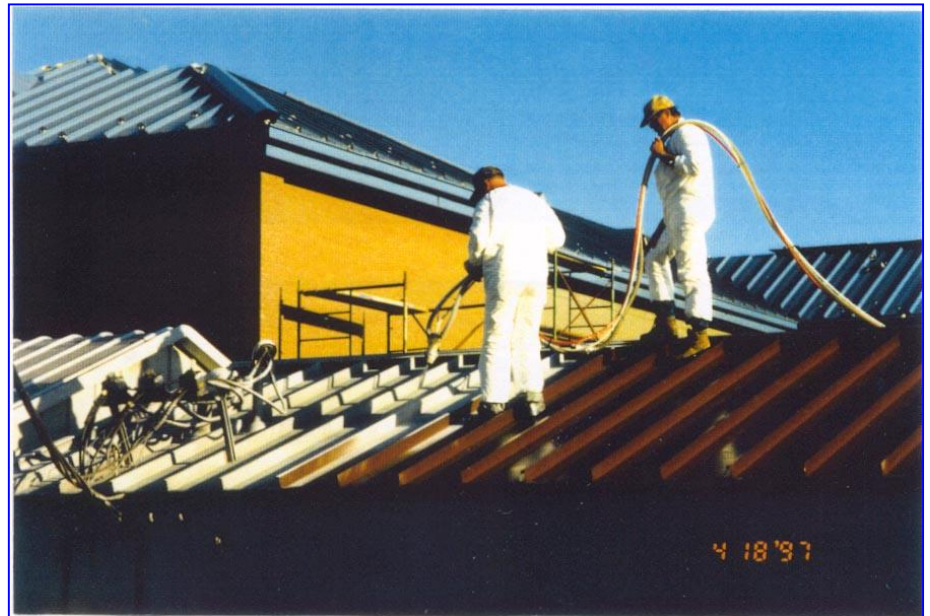
- Technology Transfer
  - Acrylic filled with recycled rubber tested on two MSFC building roofs
  - Weathers well
  - EPA Compliant
  - Uses recycled automobile tires

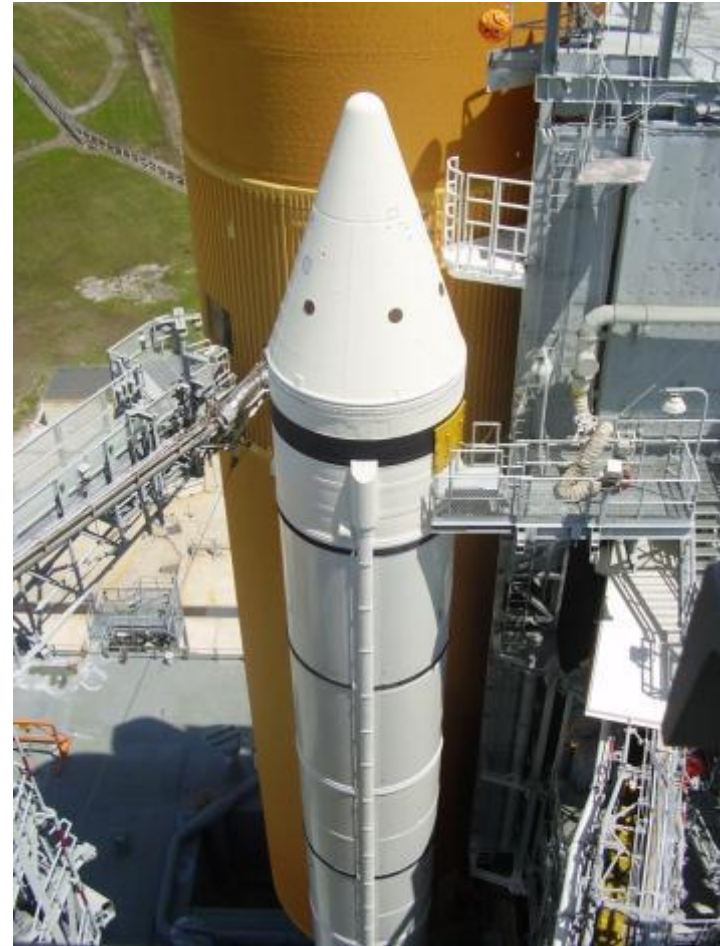
- MCC-1 is the main acreage TPS for the Space Shuttle Solid Rocket Booster (SRB)

- Nosecap
- Frustum
- Forward Skirt
- Aft Skirt
- Systems Tunnel

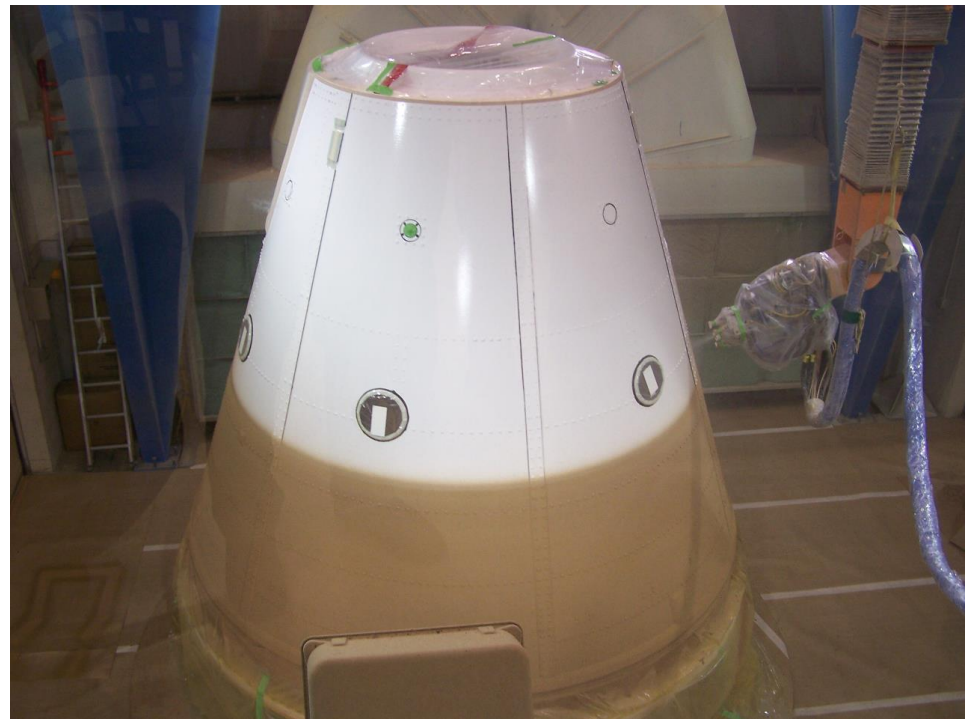
- MCC-1 application to Frustum
  - Spray parameters are controlled by computer software programs developed for each component.
- Table rotation speed
- Stand-off distance
- Vertical movement of arm
- Constituent flow velocity

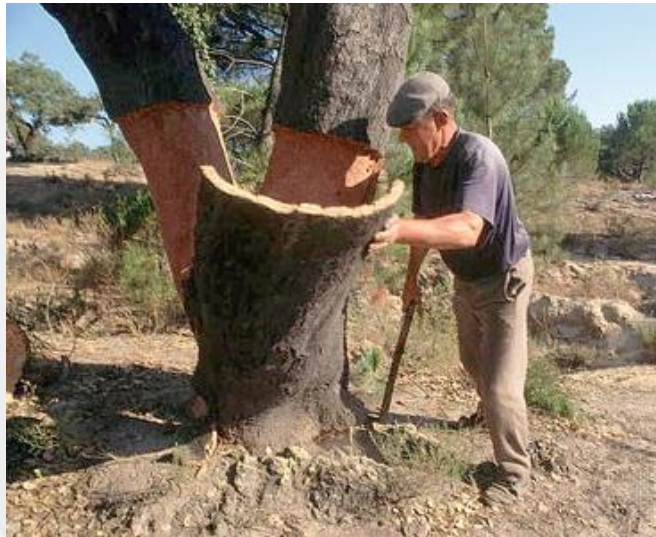
- Insulative properties of cork have been known since ancient times
  - Cork is the bark of the Cork Oak tree
  - Grown mainly in Spain and Portugal
- Cork cells are small irregular pentagonal or hexagonal prisms.
  - 50% of cork is gas enclosed in cells
  - Low Conductivity
  - No convection between cell structure
  - Low radiation between cells.

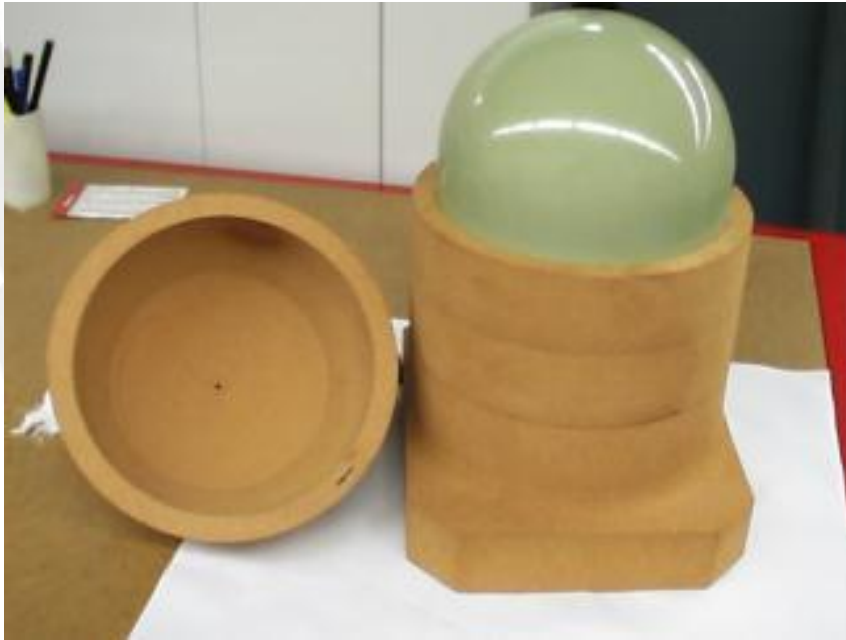
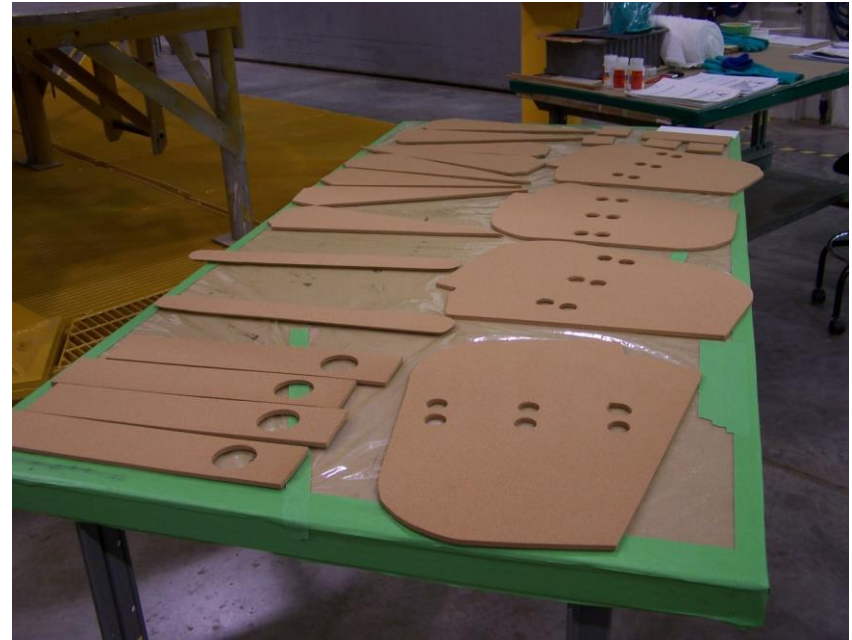
- Cork has been used as a TPS from the beginning of space flight
  - P50 cork is a composite of ground cork and phenolic binders
  - Sheets of cork are purchased in relatively small sheets in specific thicknesses.
  - Sheet cork is used in areas that are hard to spray
  - It is easy to cut and machine

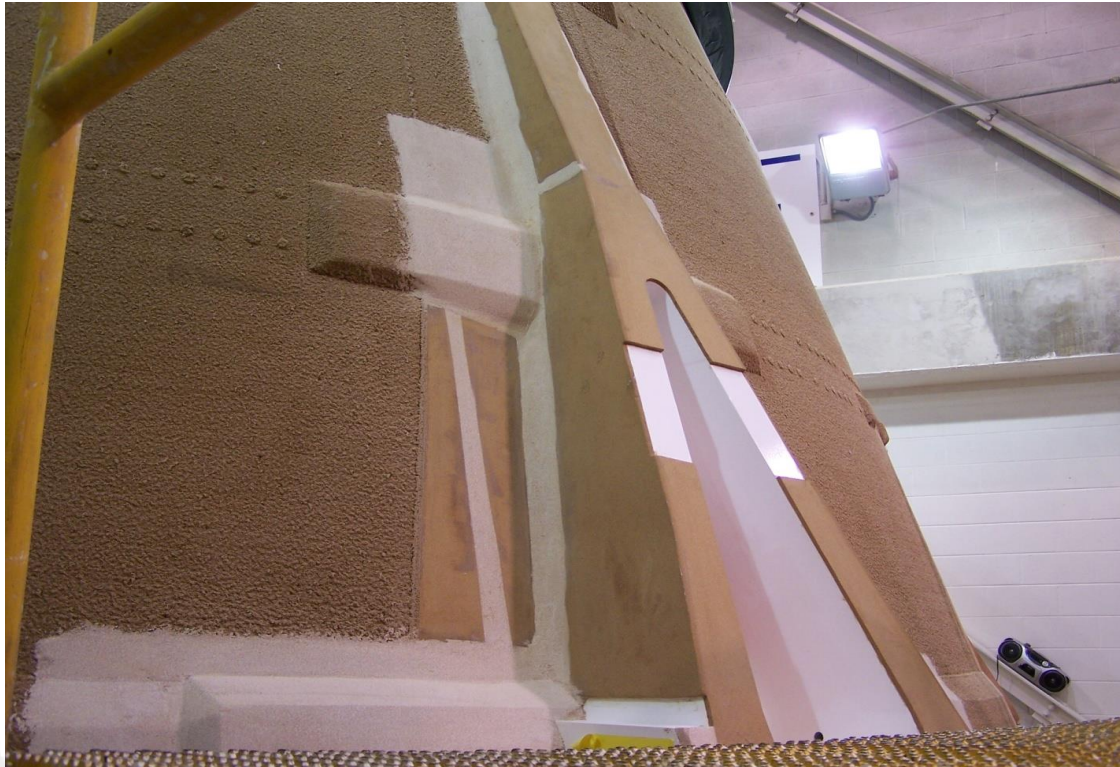
- Because of this labor intensive process and the small stock size, sheet cork is not recommended for large areas

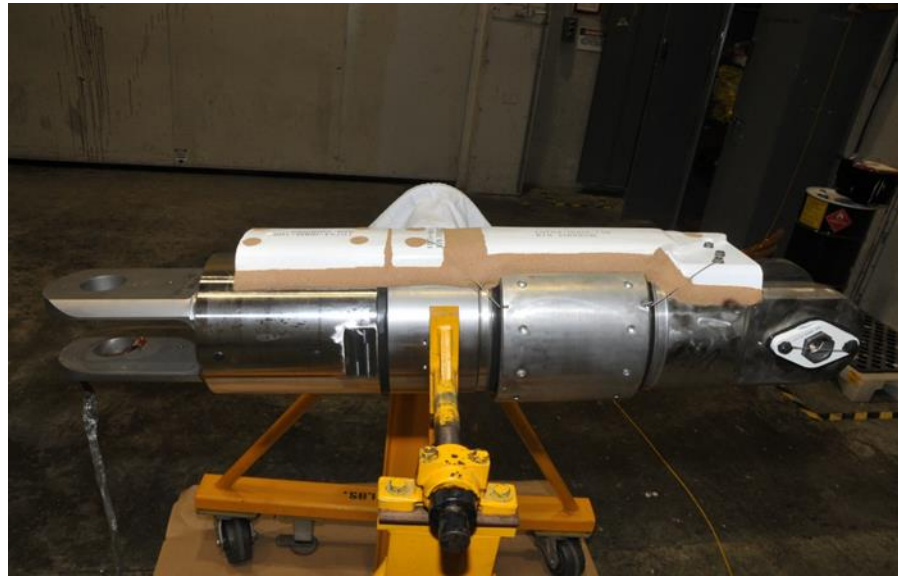
RT-455 closeout on the Diagonal Strut

- Close out materials are hand applied and are used in areas where applying cork is not convenient, in final assembly operations, and for repairs.
- For shuttle operations there were two close out materials used:
  - BTA (Booster Trowellable Ablator)
  - Thermal Ablative Compound (RT-455)
- For SLS operations, only RT-455 is used.

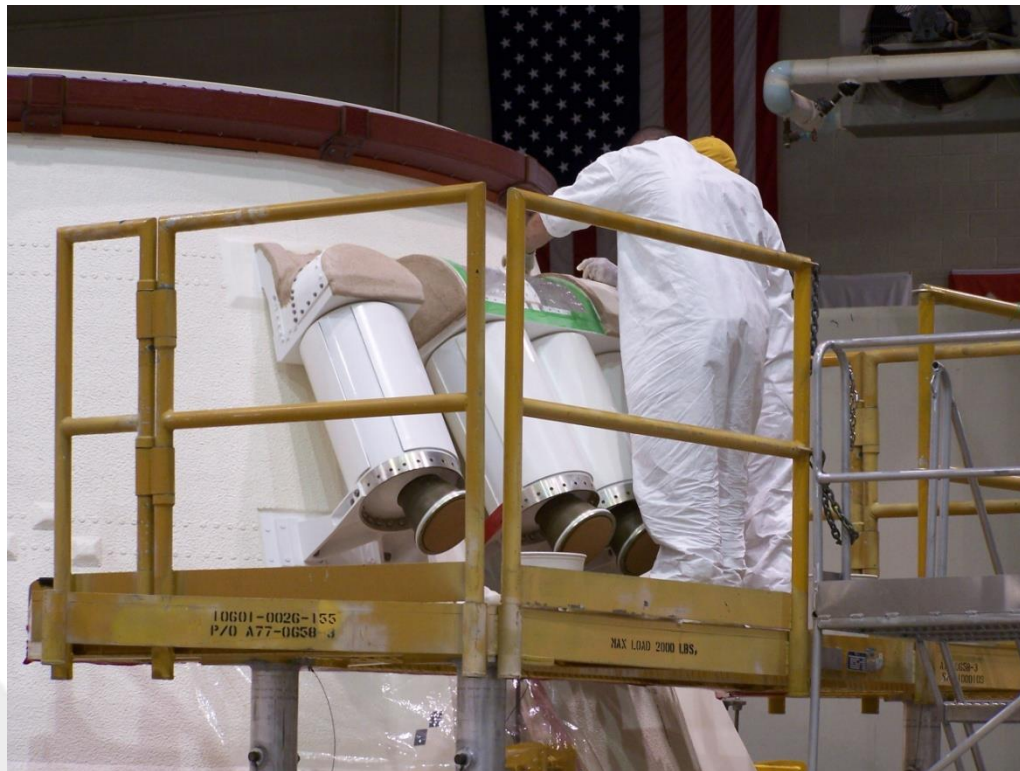
BTA closeout on BSM Housing

- Booster Trowelable Ablator (BTA) is a mix of Epoxy, Glass Ecospheres and ground cork.
  - A vacuum mixer is required for processing.
- RT-455 is a mix of Polyamide Resin, Epoxy Resin, and ground cork
  - RT-455 can be mixed by hand or by a mechanical mixer

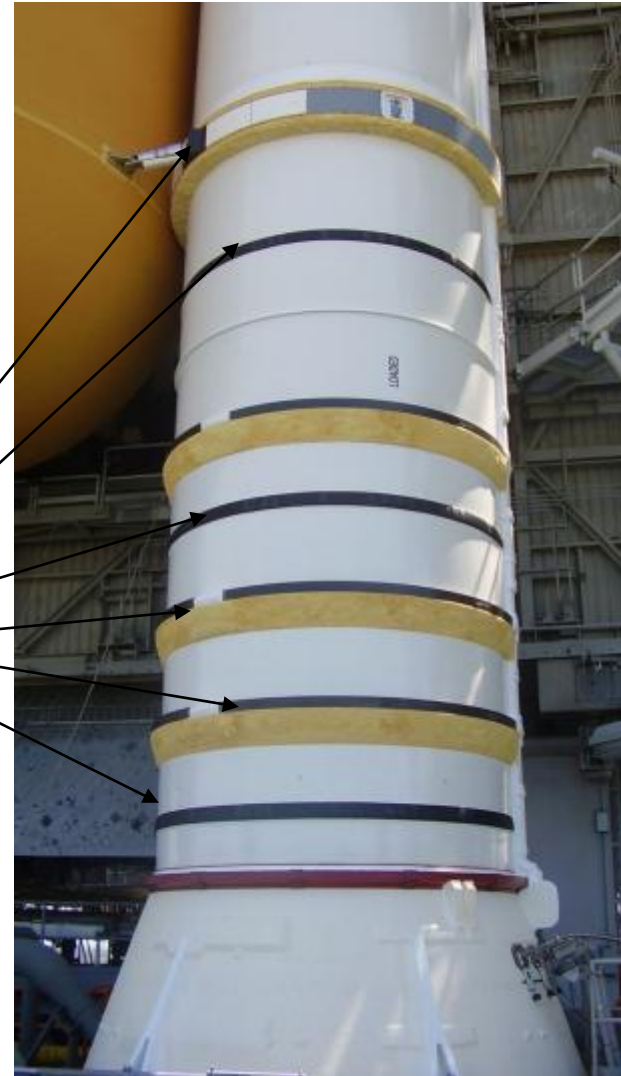
SF-EPDM

- Silica Filled Ethylene Propylene Diene Monomer
- High Temperature Rubber
- Used in High Heat / High Shear areas
  - For shuttle: Protuberances during re-entry
- Also used as a weatherseal on Factory Joints

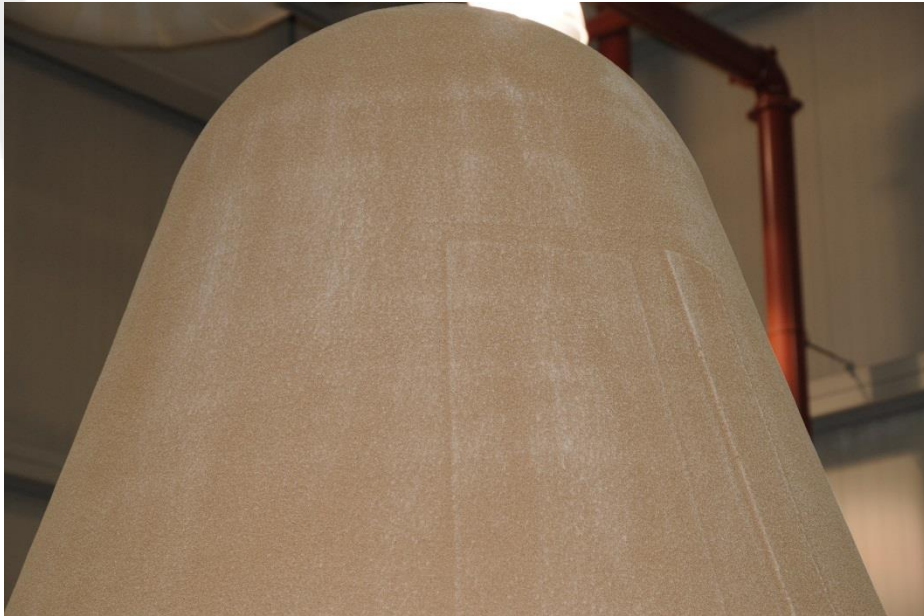
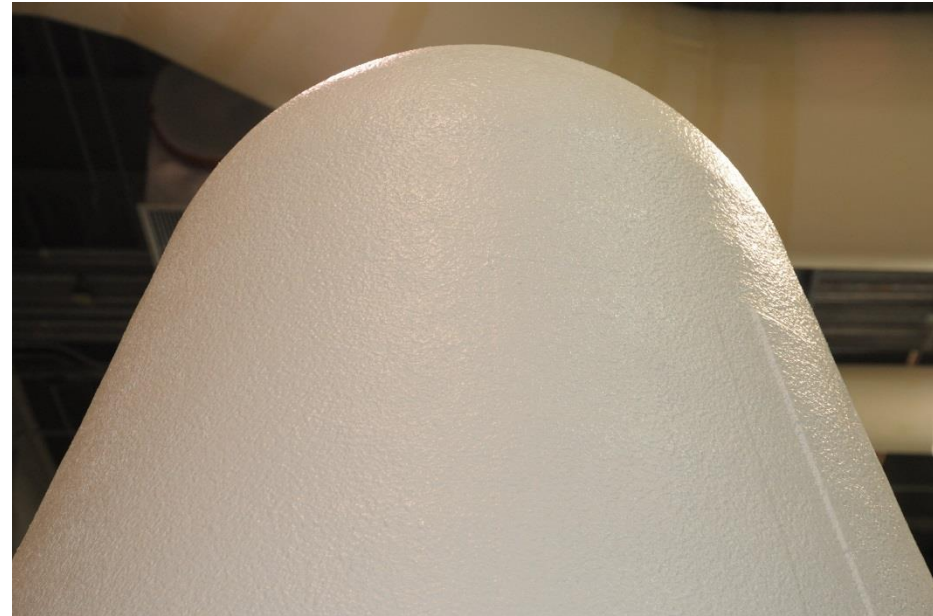
- Why are the TPS materials white on the Booster?
  - Ablative TPS materials are covered with a moisture barrier topcoat.
  - Prevent fungus growth and moisture absorption from the ambient environment

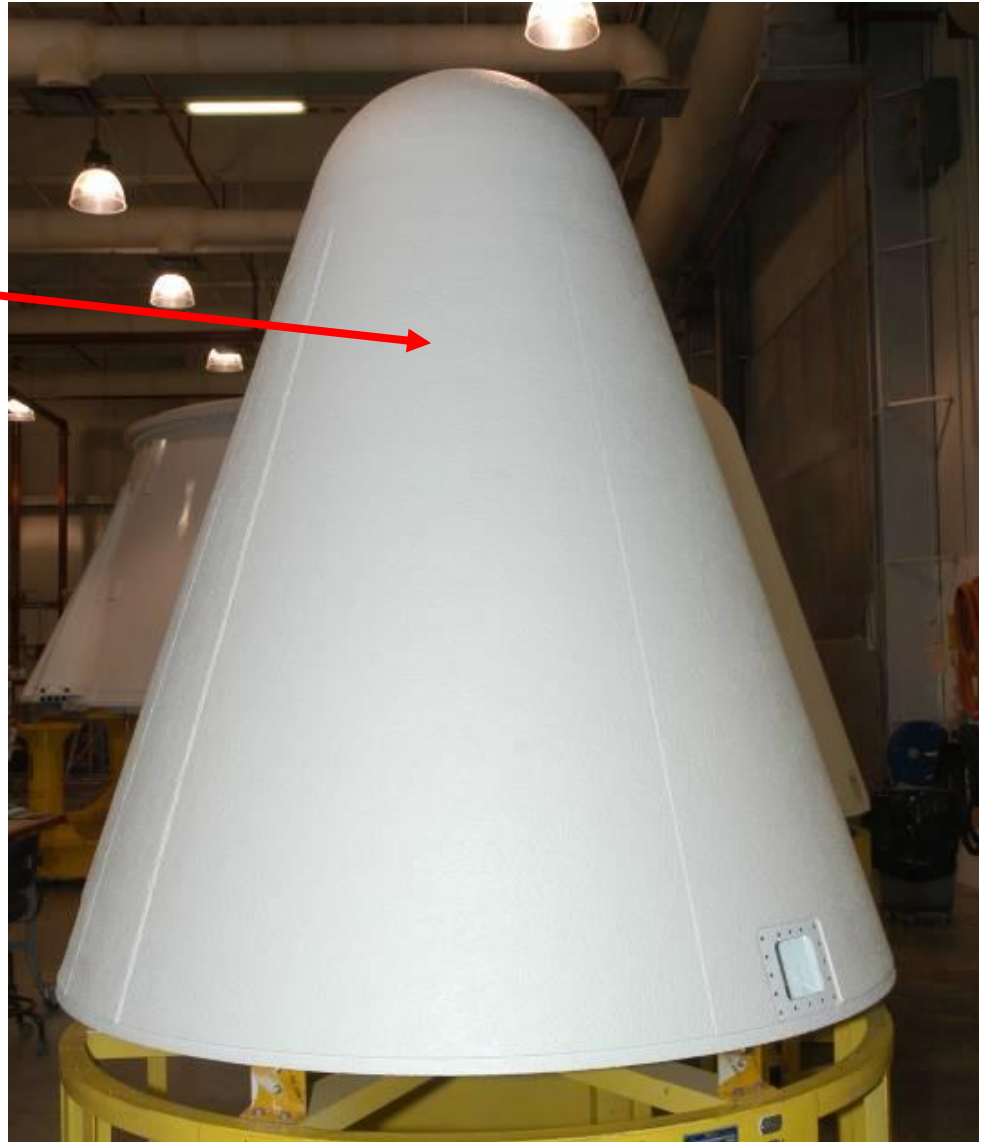
# SRB Nosecap

Acreage:  
MCC-1

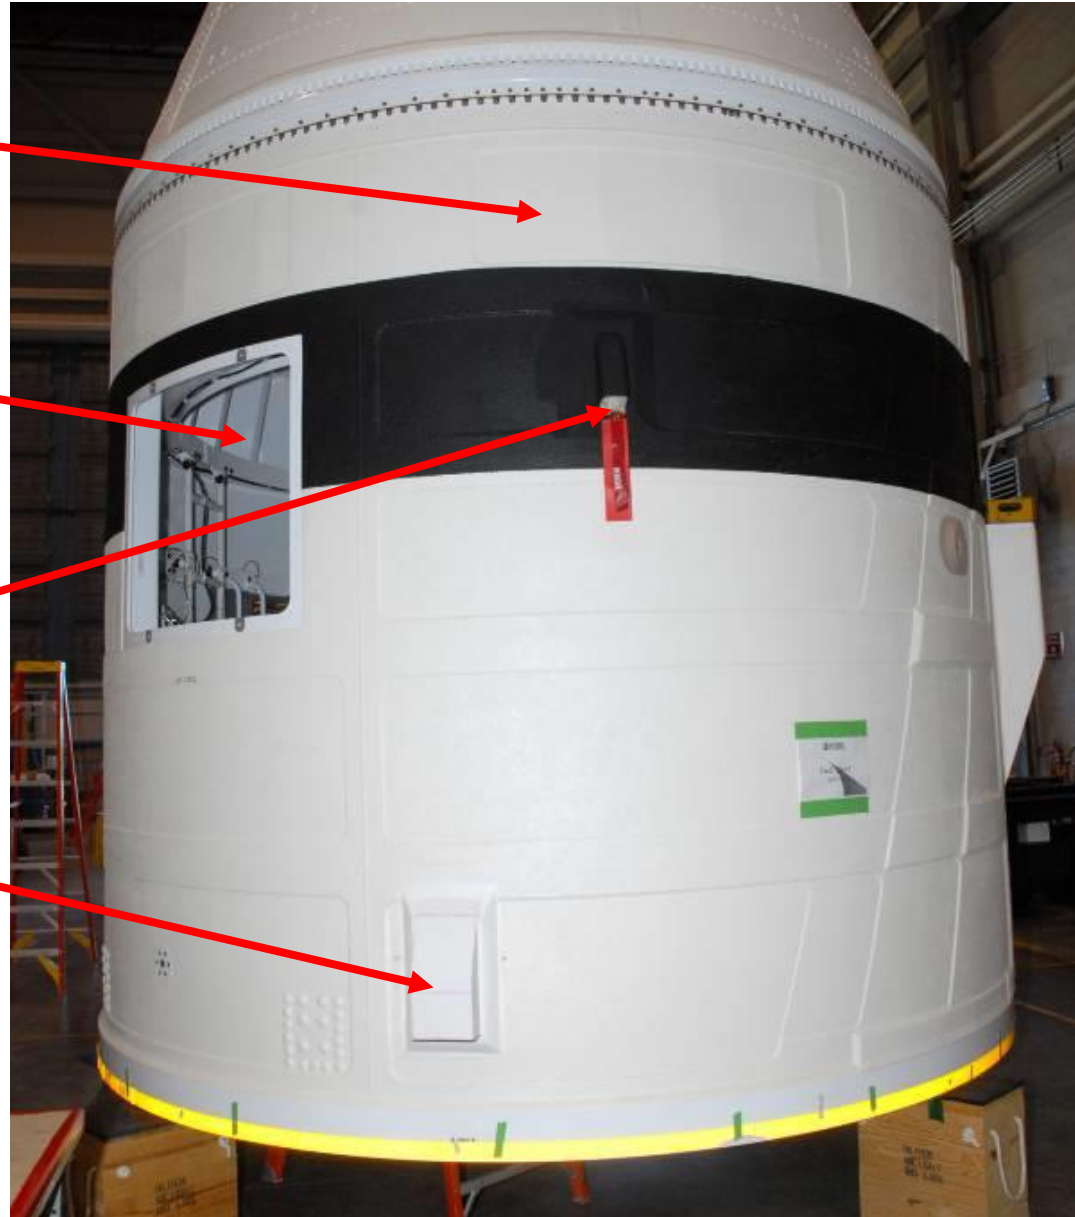
# SRB Forward Skirt

Acreage:  
MCC-1

Access Door:  
Bare

Forward Skirt Camera:  
Cover: Machined Cork  
Aft Face: BTA

Range Safety System Antenna:  
SLA-220

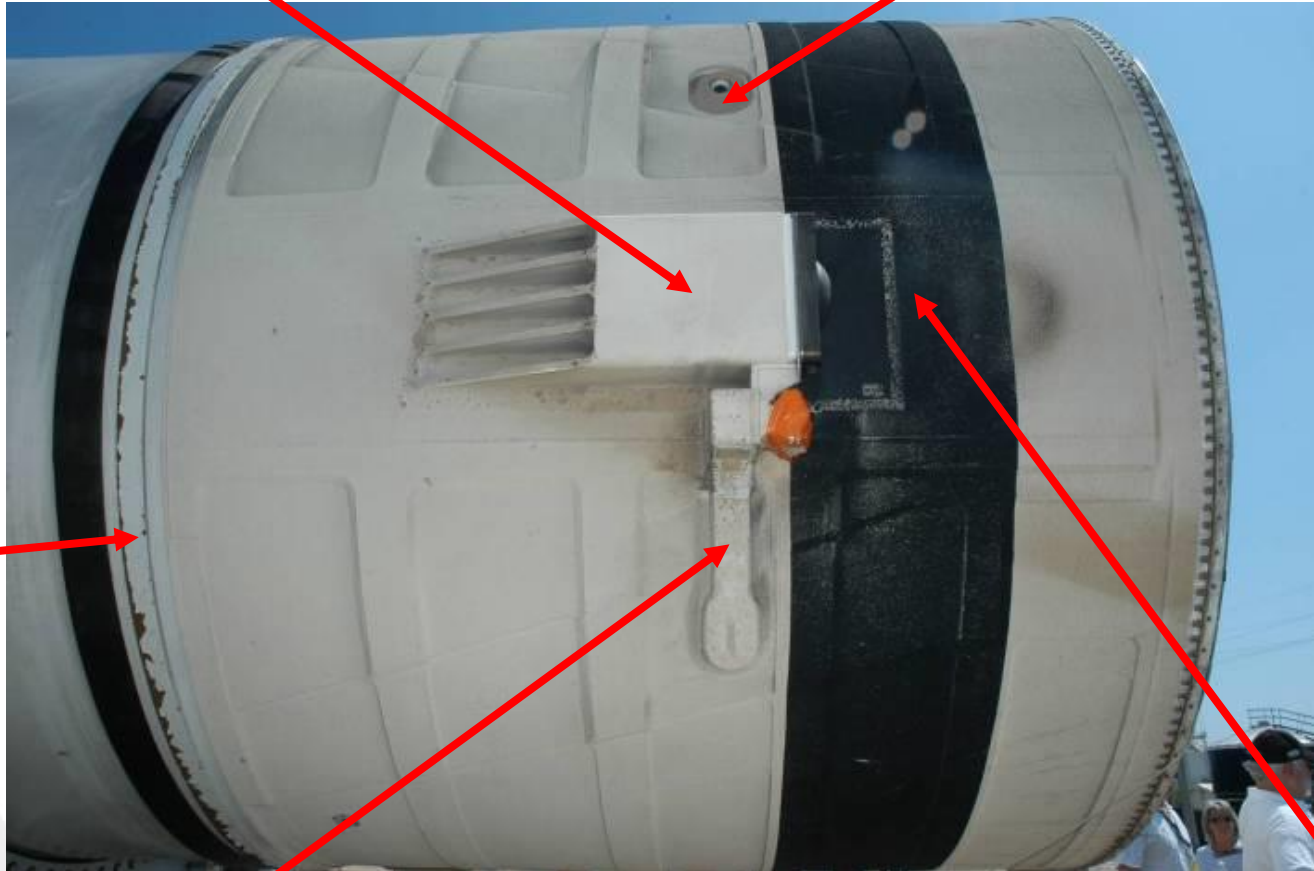
# SRB Forward Skirt

Forward Attach Fitting  
(Thrust Post):  
Cork

ET Observation Camera  
BTA

Forward Skirt  
Joint TPS:  
Cork

Range Safety Crossover:  
Cork  
BTA and RT455

Boltcatcher  
(Remains with ET):  
Machined Cork

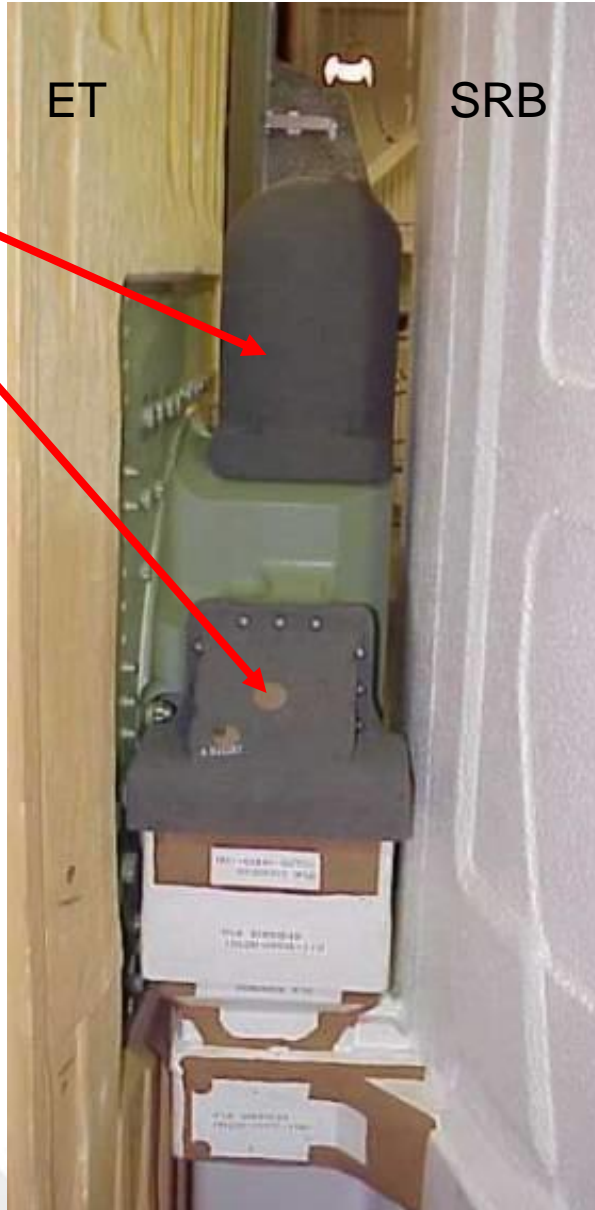
Silicone based  
with cork filler

Used prior to  
Columbia accident

Machined cork used  
after Columbia

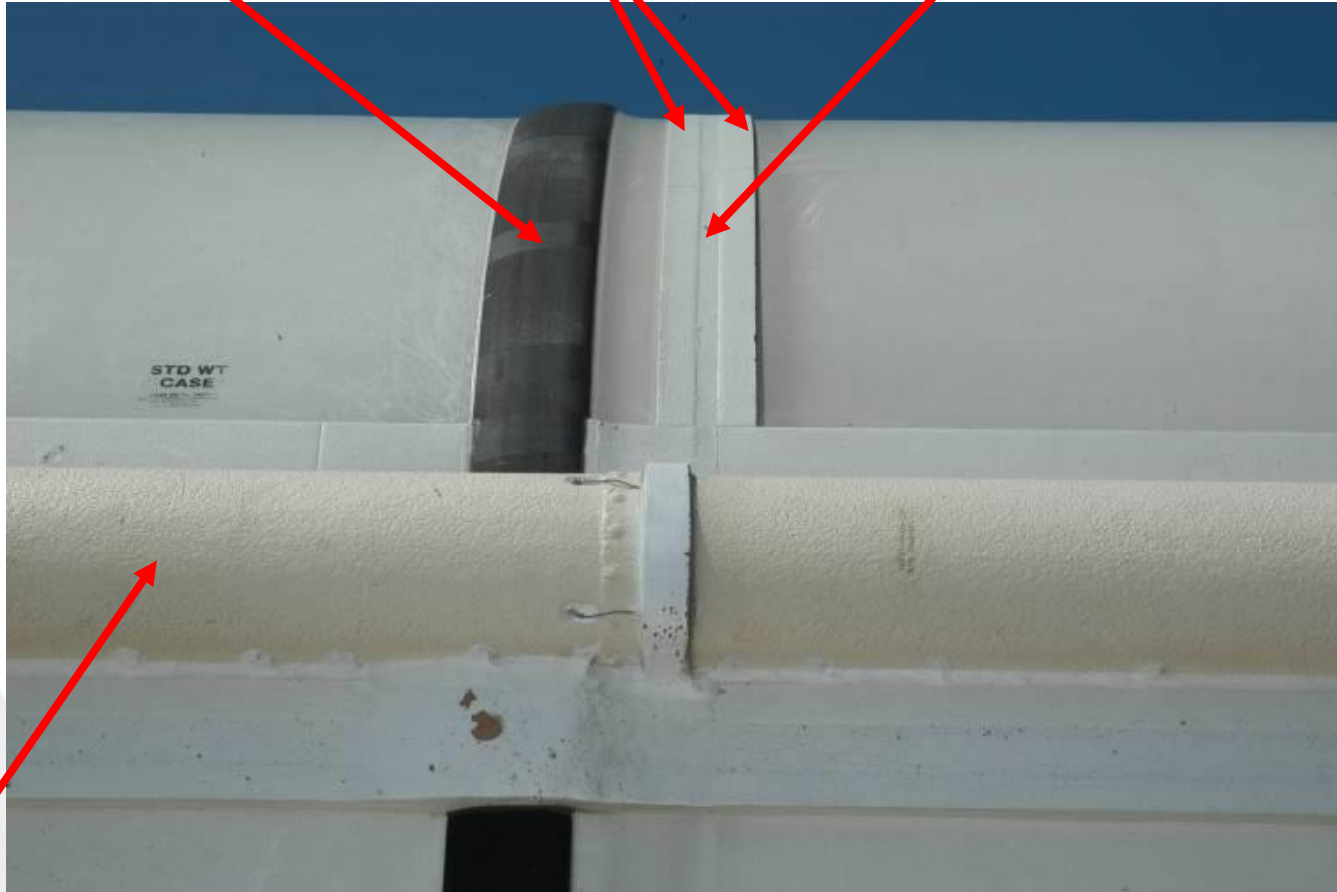
# RSRM Motor Case

Factory Joint:  
EPDM

GEI Run  
Cork

GEI Run  
RT455

Systems Tunnel Cover:  
MCC-1

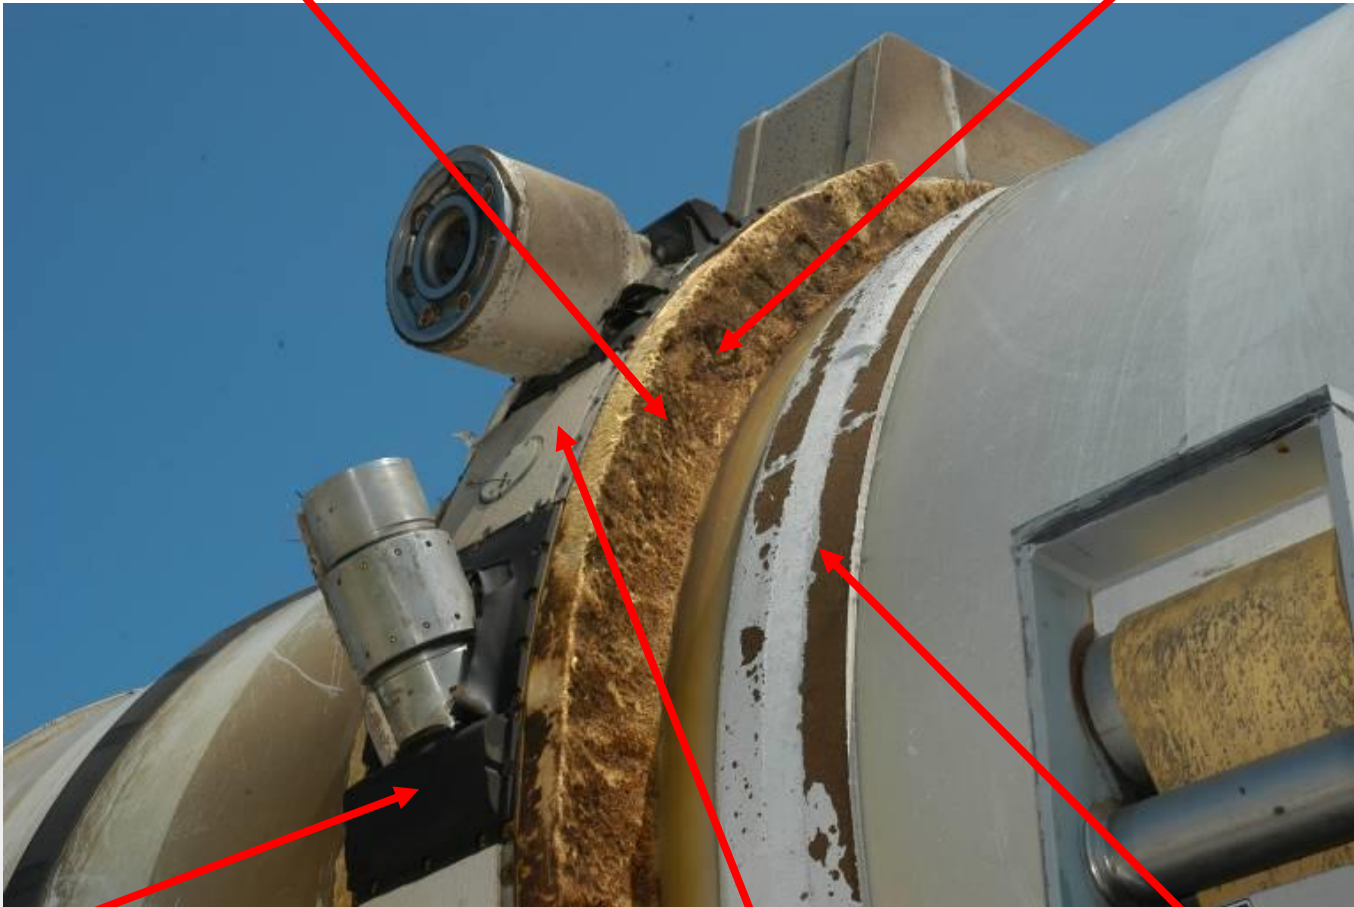
# Attach Ring and Aft Strut

ETAR Forward Web:  
Froth Pak Foam  
Over Cork

Porta-Pull Repair:  
PDL

Strut Cover:  
EPDM

Outboard Cover:  
Cork

Field Joint  
Cork and RT-455

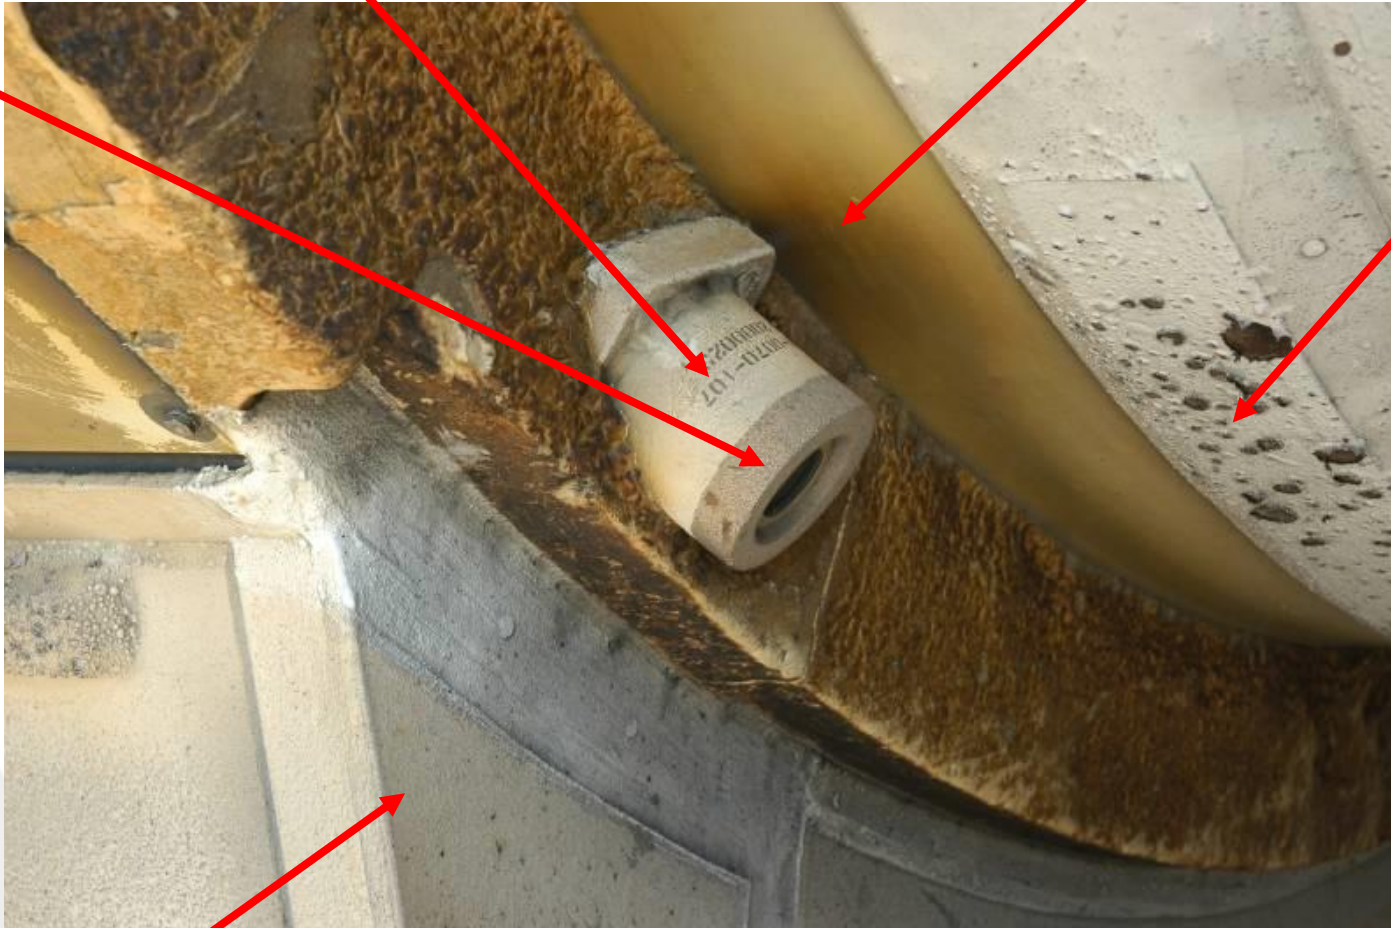
# Attach Ring Camera

Camera Body:  
Machined Cork

Note: Off gassing of foam  
constituents

Close Out:  
BTA

Field  
Joint

IEA Box:  
Cork with RT455 Closeout

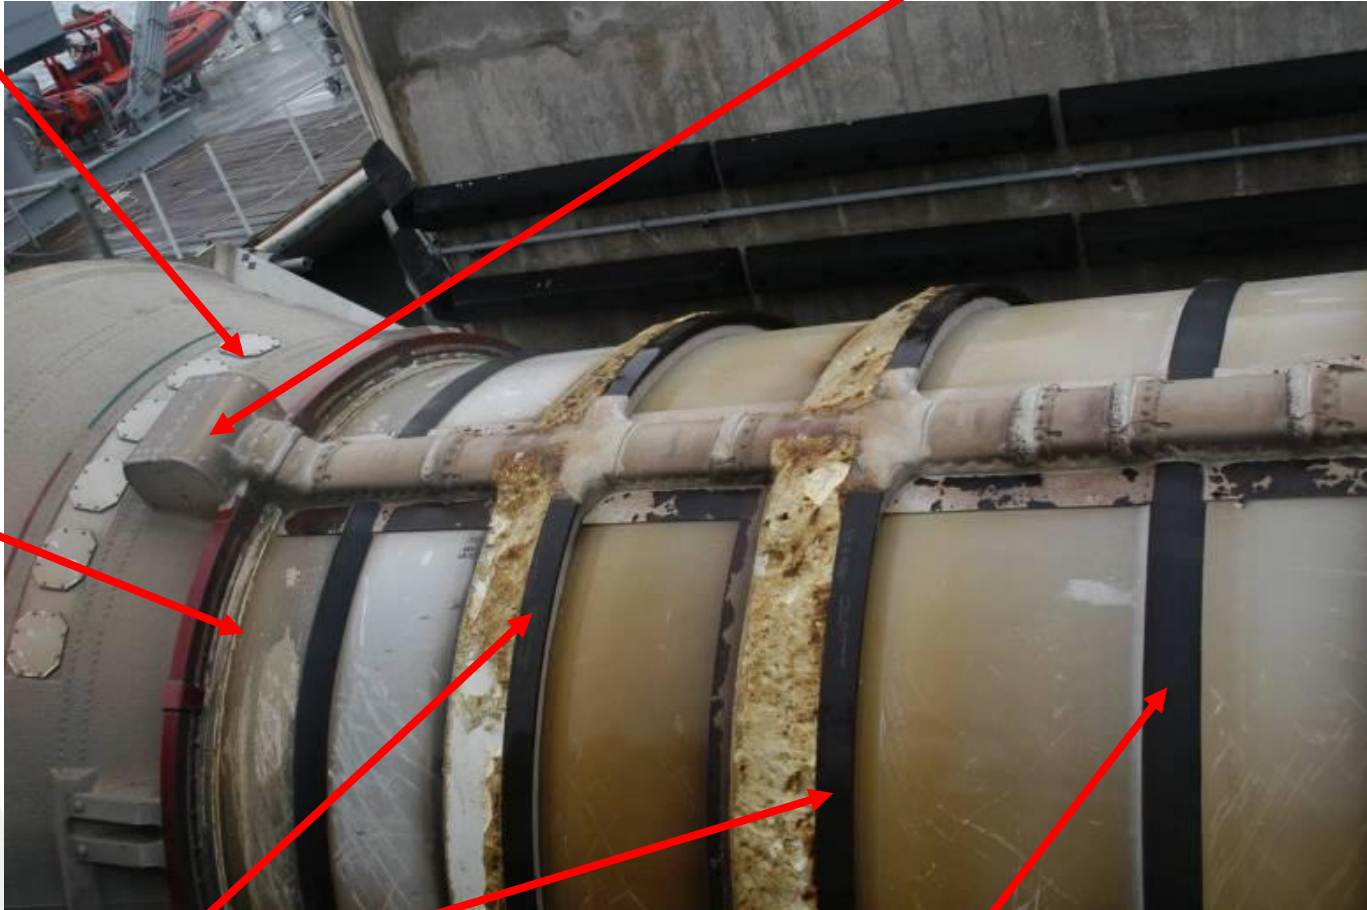
# RSRM Motor Case – Aft Segment

TVC Access Doors  
Bare Aluminum

Aft Crossover Housing  
MCC-1

Aft Skirt  
Joint TPS:  
Cork

Stiffener Rings:  
EPDM  
Foam applied for water impact protection

Active Stiffener Stubs:  
EPDM

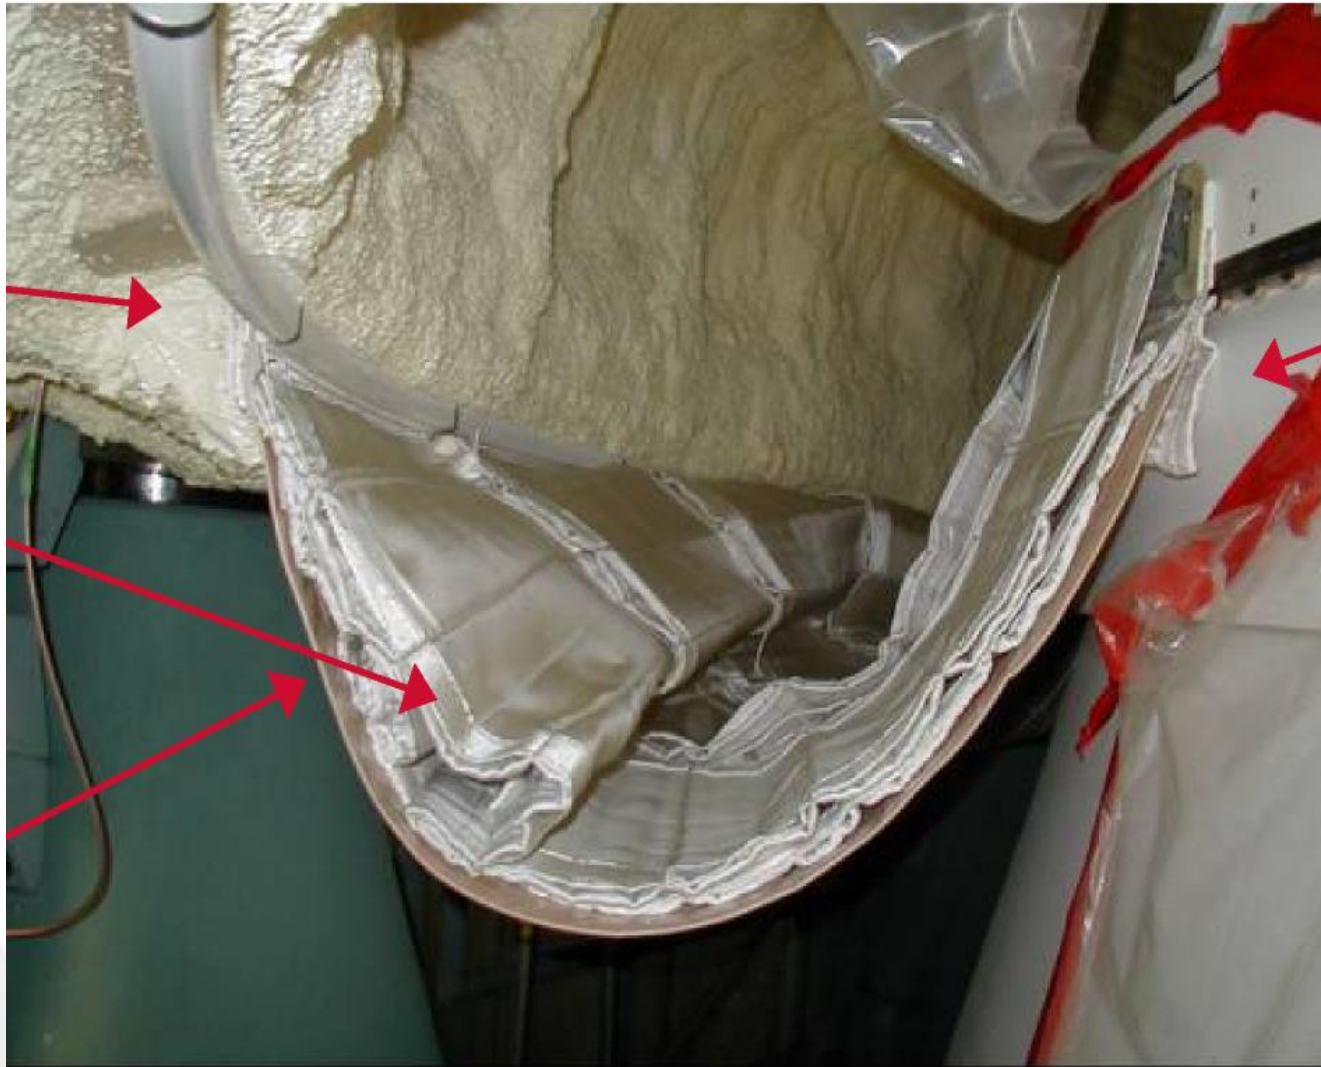
# SRB Thermal Curtain

Aft Skirt

RSRM Nozzle

Inner and Outer  
Blanket  
Astroquartz  
Fiberglass

Viton-Coated  
Nylon

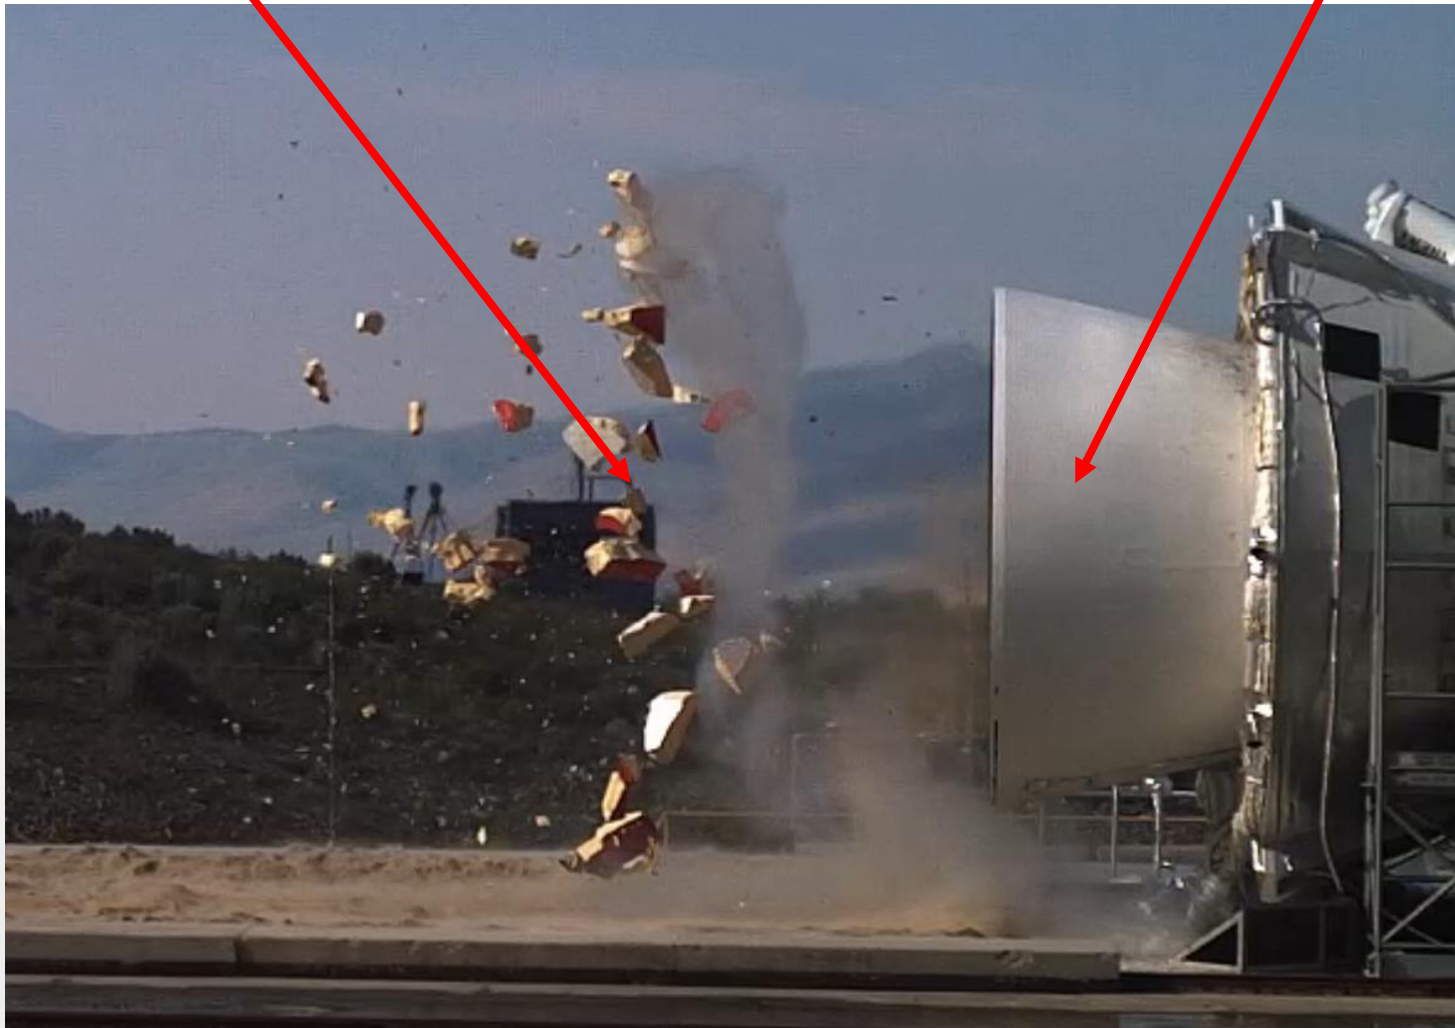
# RSRM Nozzle

Nozzle Plug  
Cork

Nozzle Exit Cone  
Cork
