SPACE LAUNCH SYSTEM

# Fundamentals of Launch Vehicle Ablative Thermal Protection System (TPS) Materials

TFAWS2017

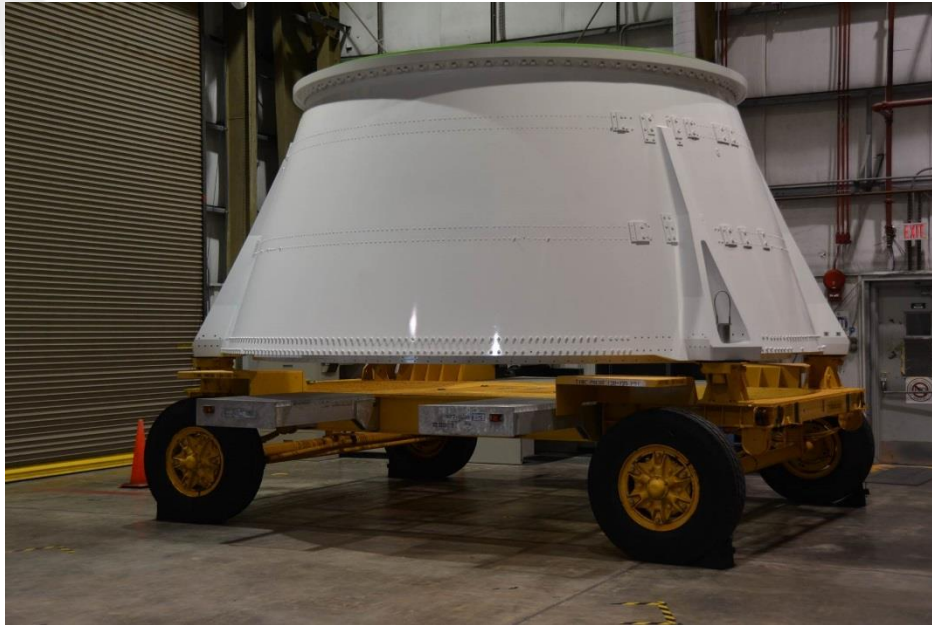
SRB components have the TPS removed, are refurbished, and are kept at KSC.

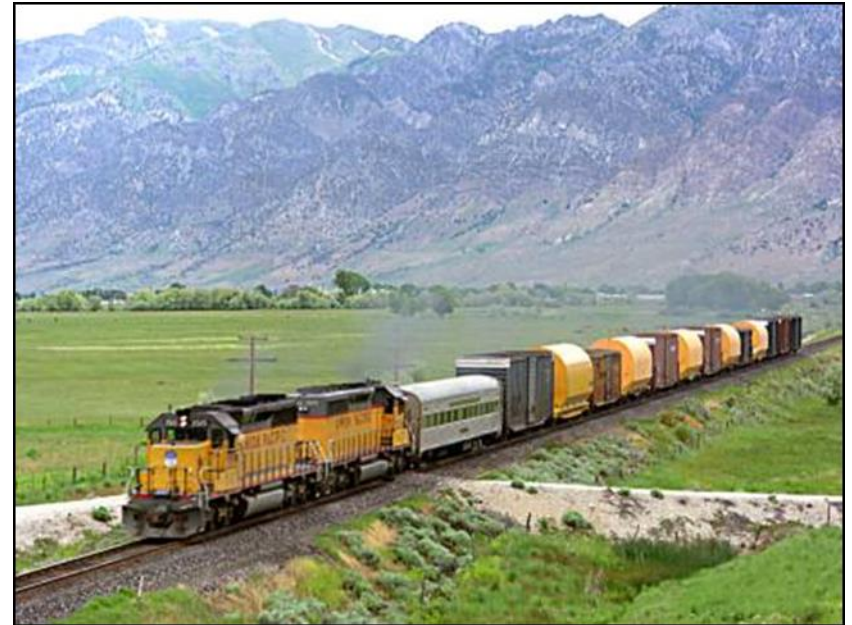
RSRM components are shipped back to Utah via train for inspection and refurbishment. The cases will be loaded with propellant and shipped back to KSC.

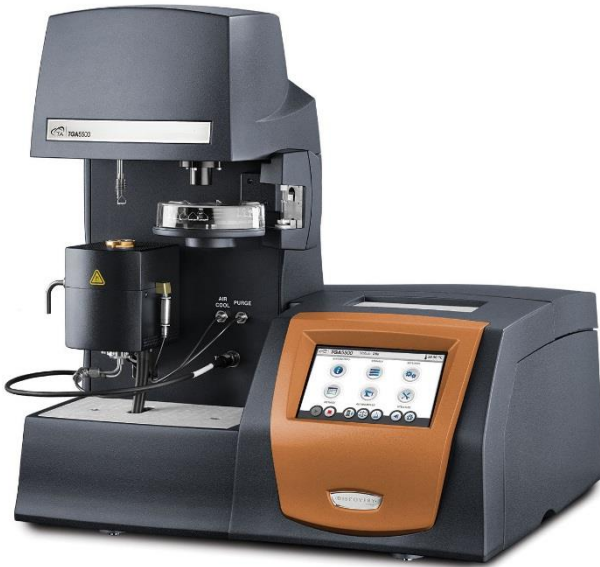
- A ground sample of the material is placed in the crucible.
- The crucible is heated by small furnace, typically in an inert environment.
- A balance weighs the sample as various components offgas.
- Is used to generate an ablation temperature.
  - Different criteria have been used to define ablation temperature.

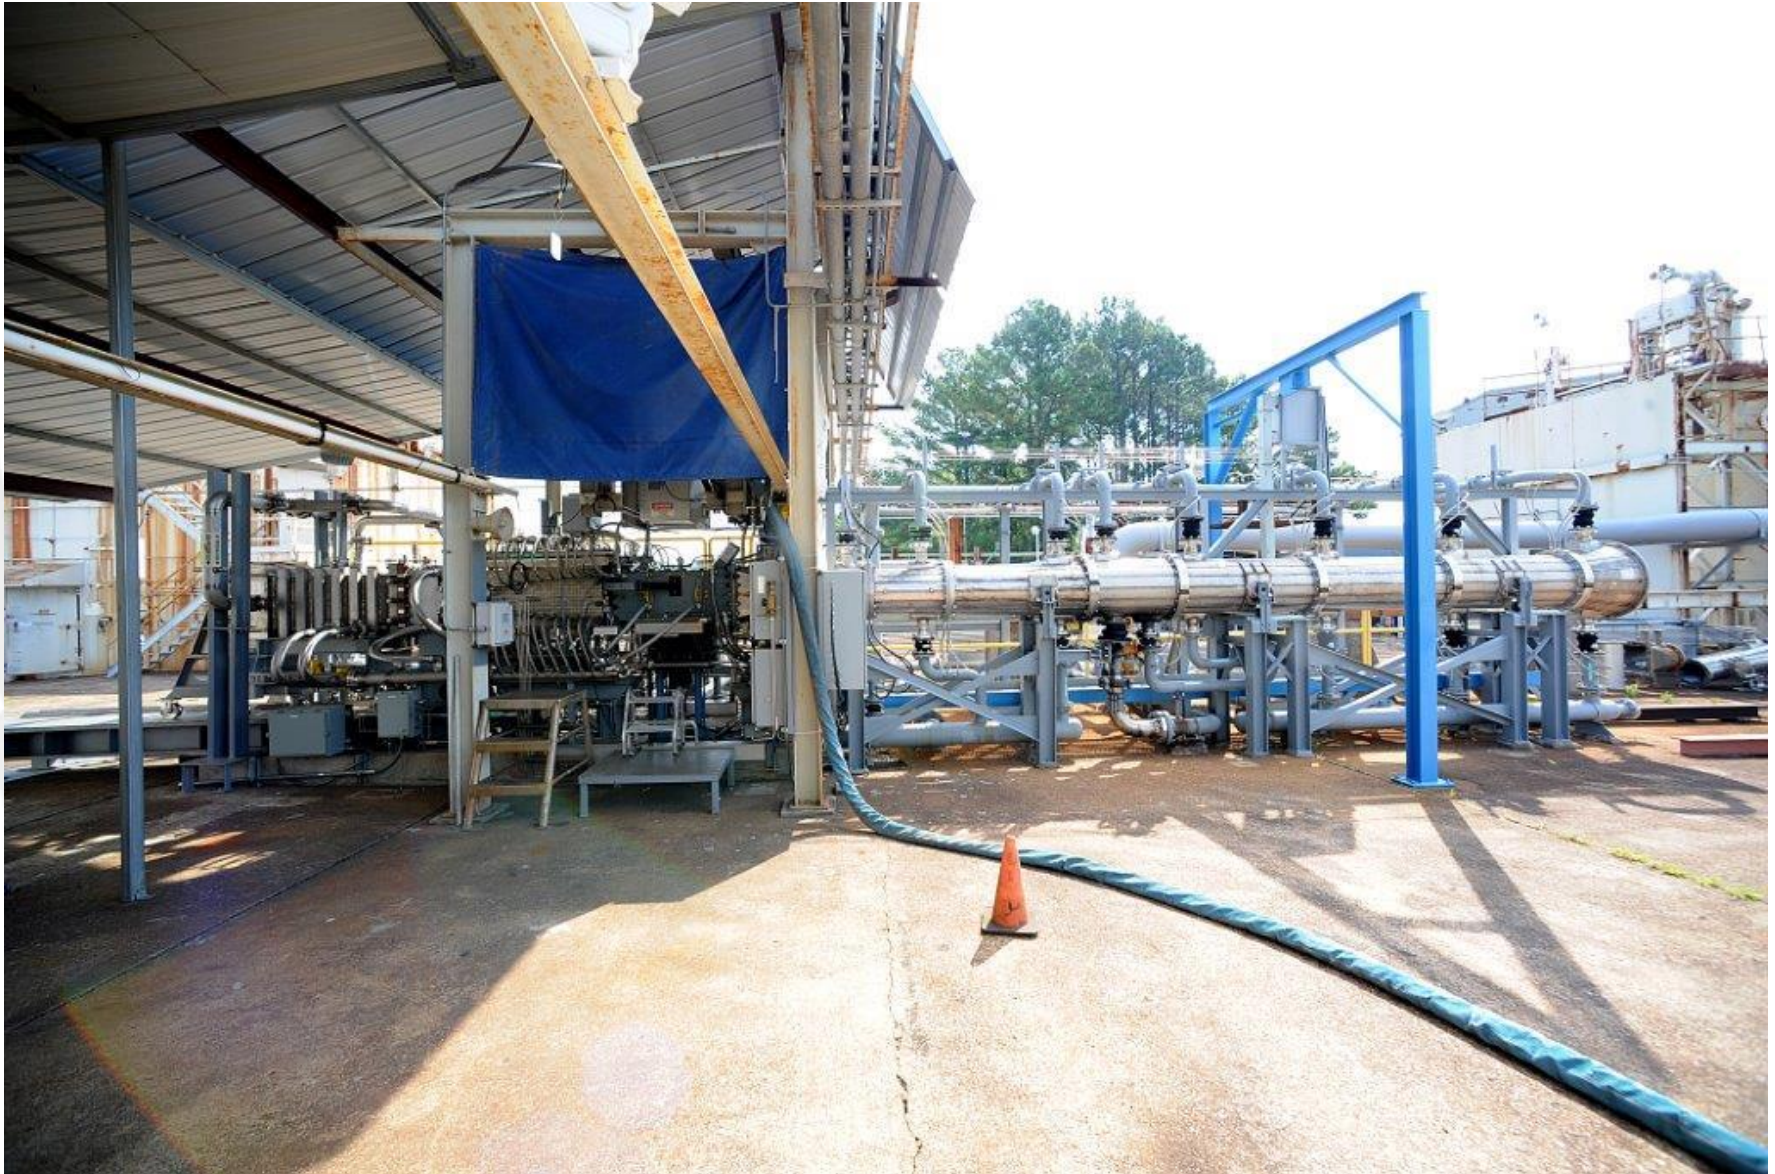
- Mach 4 Aerothermodynamic testing facility for Thermal Protection System materials.
- Combustion driven – lean mixture of gaseous Hydrogen ( $\text{GH}_2$ ) and missile grade air.
- Capable of temperatures of 1440 – 2400 °F and total pressures of 100 – 220 psia.
- 300kW radiant lamp system provides plume environment simulation. The only Mach 4 convective facility that can provide radiant environment.
- Shutter system in test section allows flow to become stable before insertion of test panel.
- Infrared (IR) thermal imaging/video capabilities allow for real-time surface temperature measurements.
- The HGF is reasonably small, inexpensive in operation, very flexible and efficient, and is operated with a small, highly experienced crew.

- Heritage facility dates to the 1970's.
- Current facility was constructed in the 1980's
- Many updates since then.
  - Improvements to the combustor to provide more uniform flow – 1990's
  - Panel insertion system – 1994
  - 300kW radiant lamp – 1995
  - Water cooled test section – 2013
  - New combustor – 2017
  - Enlarged throat downstream of test section - 2017

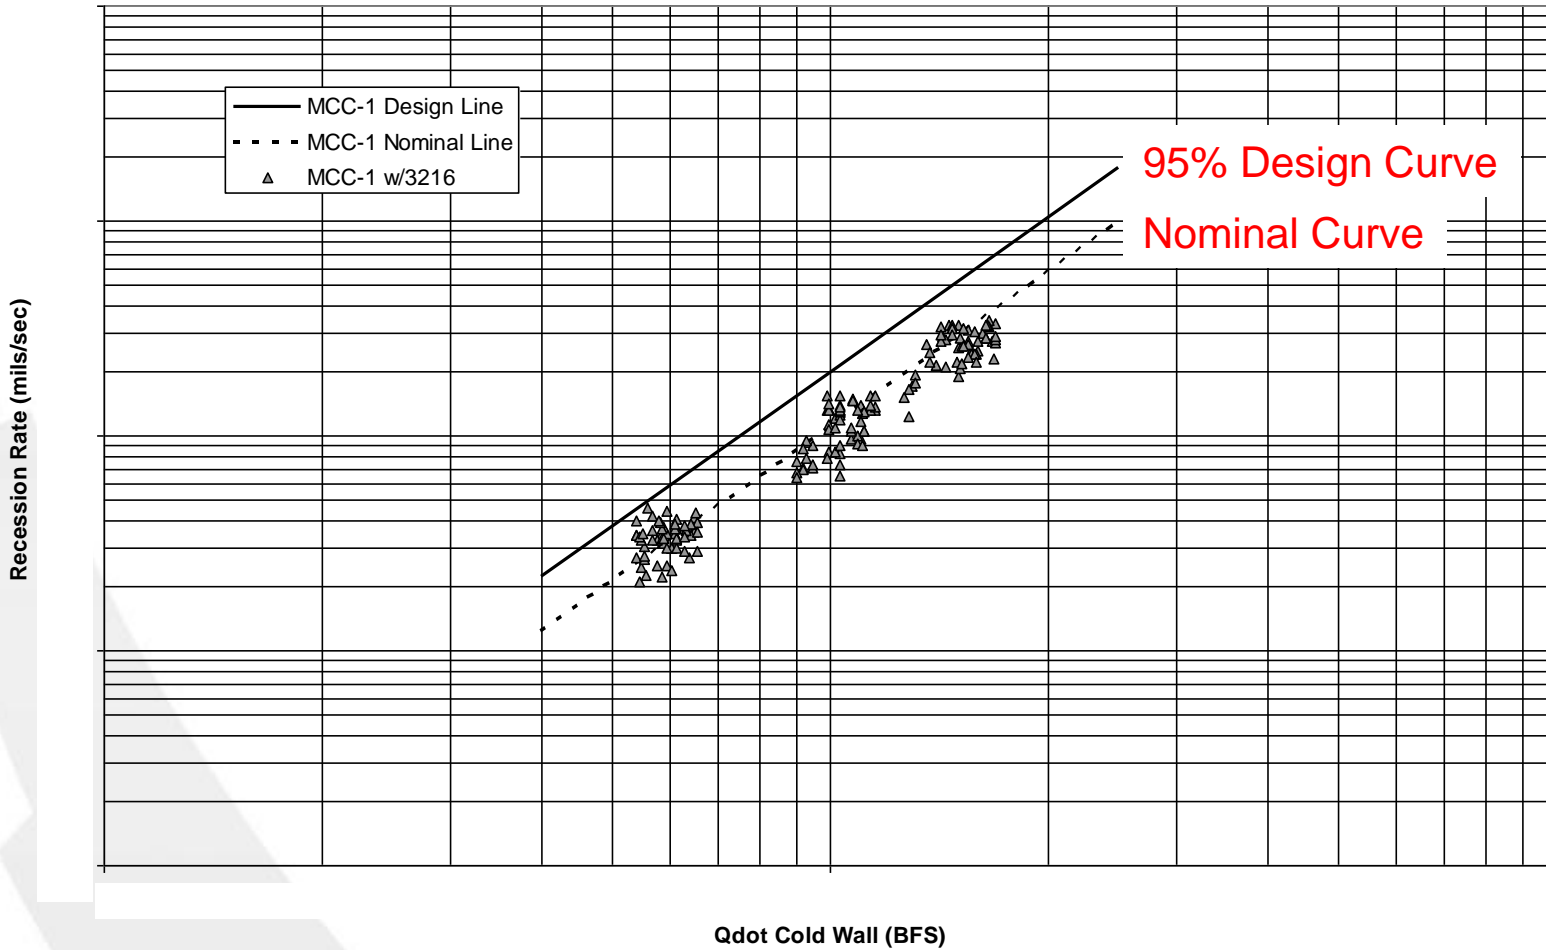
# Recession Rate Curve

$$R_{dot} = a * q_{cw}^b$$

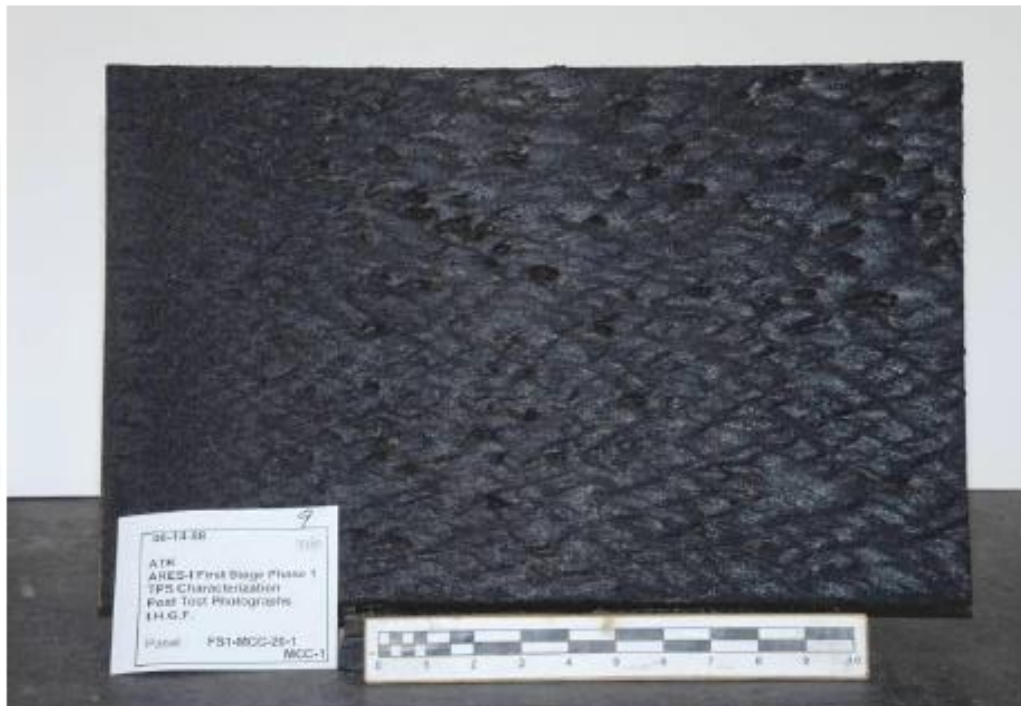
We look like this in testing

1. Continuous Mach 4 shear environment in test facility
2. Removing char before post-test measurements
3. The RHGF1 generates enthalpy levels higher than flight. Testing has shown that a higher enthalpy at the same heat rate will generate more recession
4. These parameters generate a conservative recession. We then generate a 95% design equation for analysis
5. And use a 99.7% Aeroheating flight environment for analysis
6. Analysis assumes total loss of material at ablation temperature.  
Does not account for insulative properties of remaining char
7. Recession rate does not account for effects of paint. Nor are the thermophysical properties of paint used in analysis.

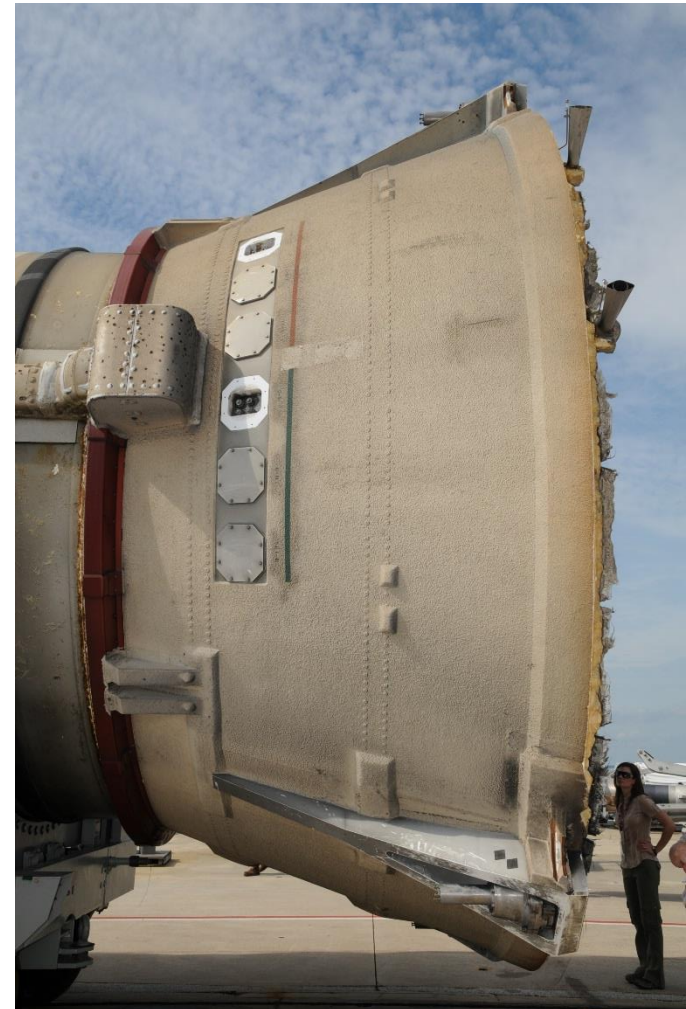
And this in post-flight

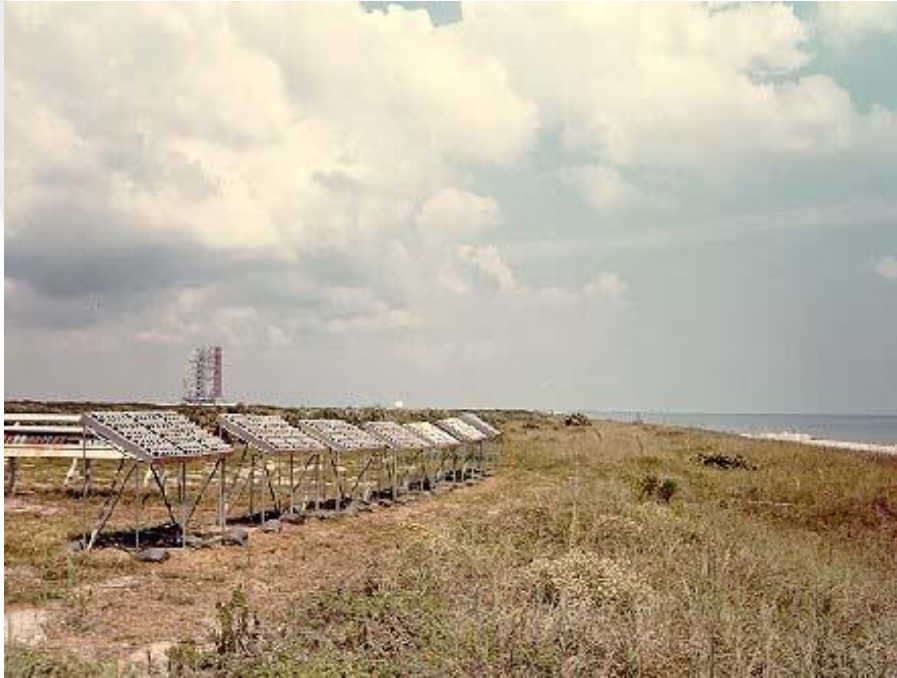
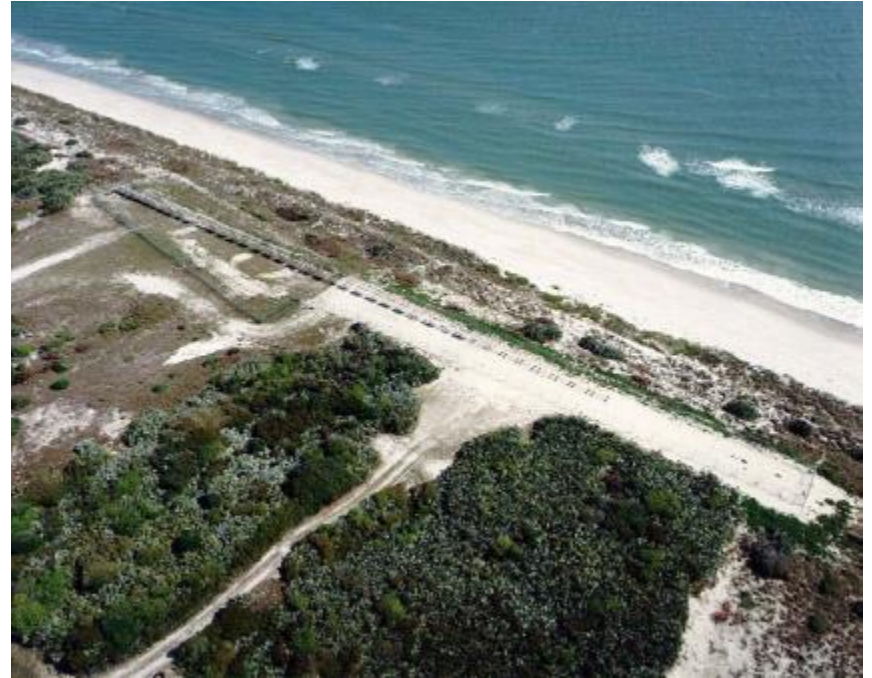
# Beach Exposure Testing

- Painted qualification test panels are placed on stands near the beach
  - Typically for 180 days
  - Panels are monitored occasionally to document degradation
  - Panels are brought to RHGF1 for testing
  - Pass/Fail requirement is no increase in recession or debris generation

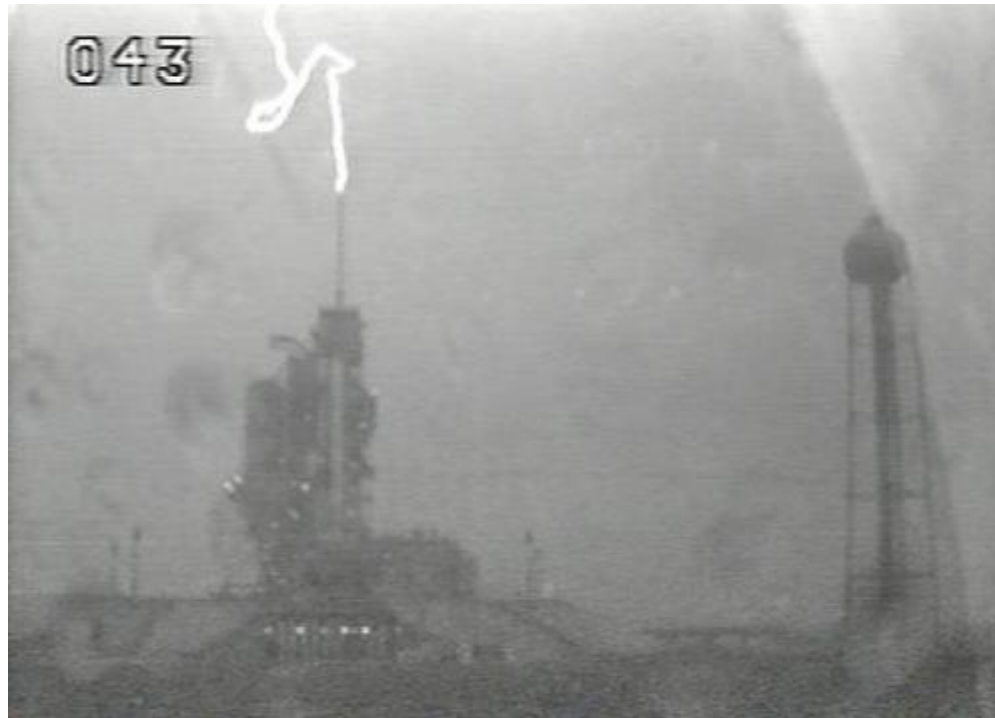
# Lightning Strike Testing

- Ensure effects of impact does not generate secondary debris
- Ensure substrate temperature limit is not violated

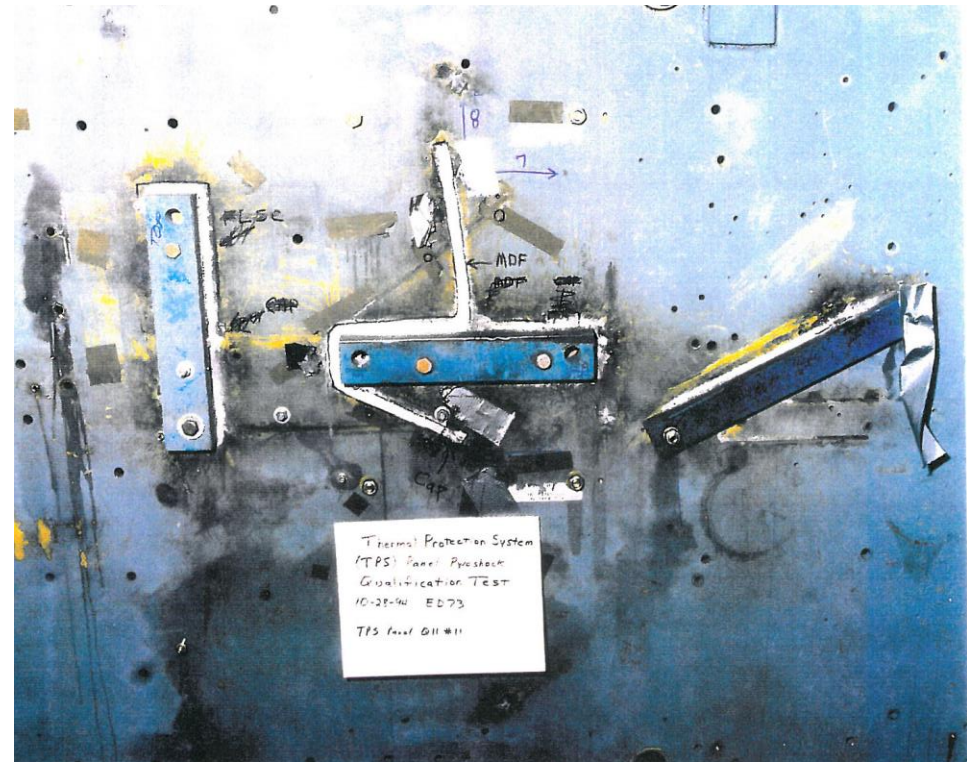
Pyro charges are placed on the back of a steel plate with a RHGF1 panel bolted to it.

TPS panel will be taken to RHGF1 and tested to ensure no hidden TPS cracks or debonds from the substrate.

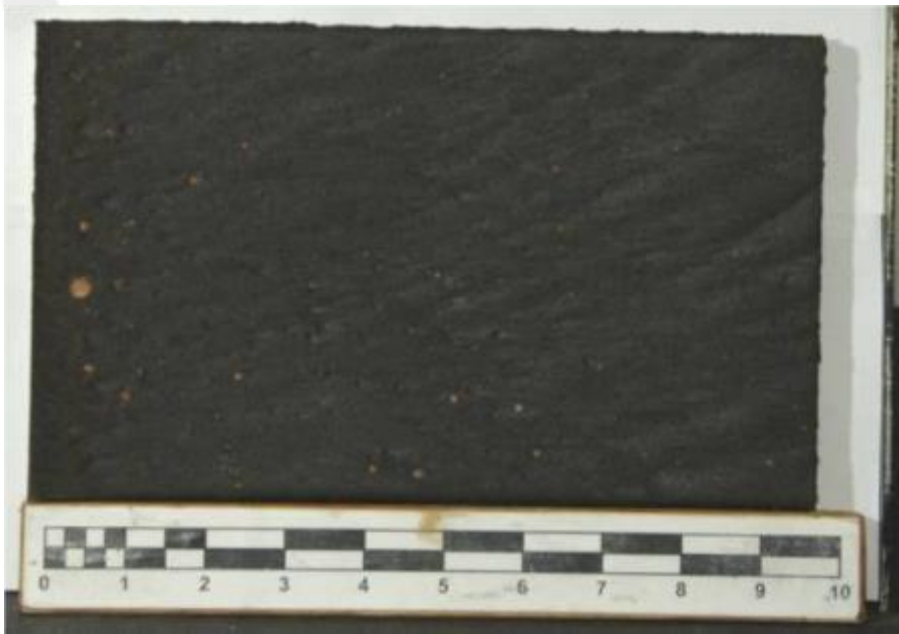
# Debris Generation Testing

- RHGF1 can be used to determine the likelihood of debris generation
  - Typically the facility is not conservative for debris generation
  - Debris is generated by increasing pressure in a void
  - Must have time for pressure to build before void is exposed
  - Low heat rate, long duration testing is more conservative for debris generation
  - Because of high shear environment, voids tend to vent before enough pressure can build up

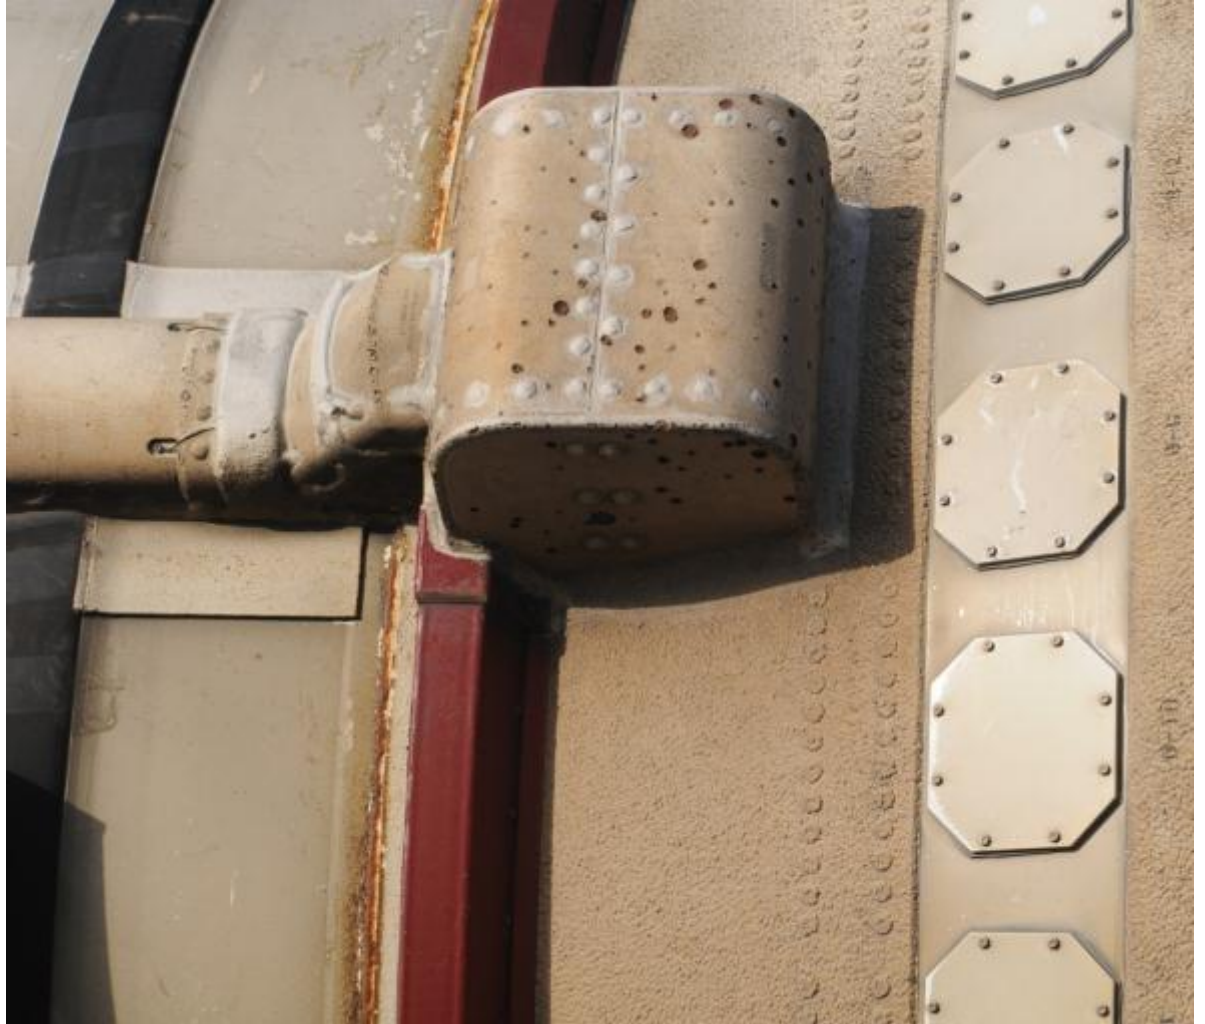
Post-Flight  
observation of  
cork “spalling”

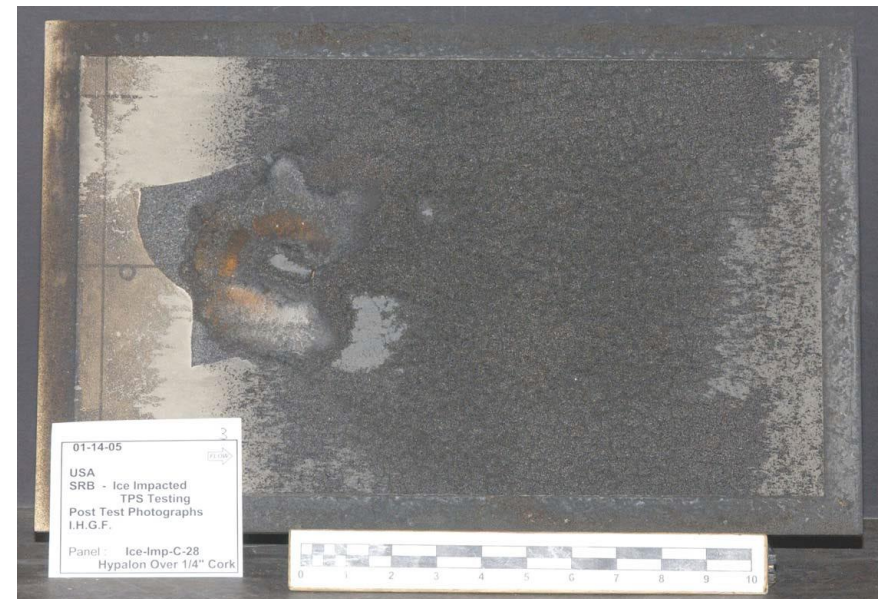
# Debris Impact Testing

- After the Columbia accident, all TPS materials were tested for debris impact effects
- Photos of cork after ice impact testing.
  - Ensure impact doesn't generate secondary debris
  - Ensure substrate temperature limit is not violated

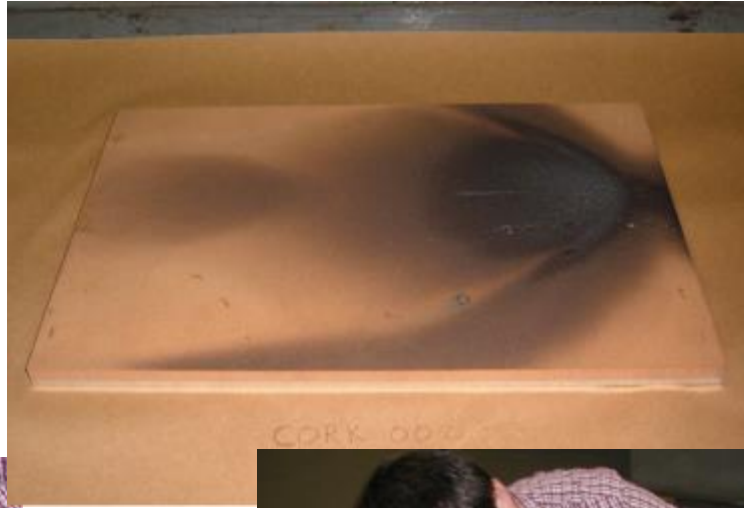
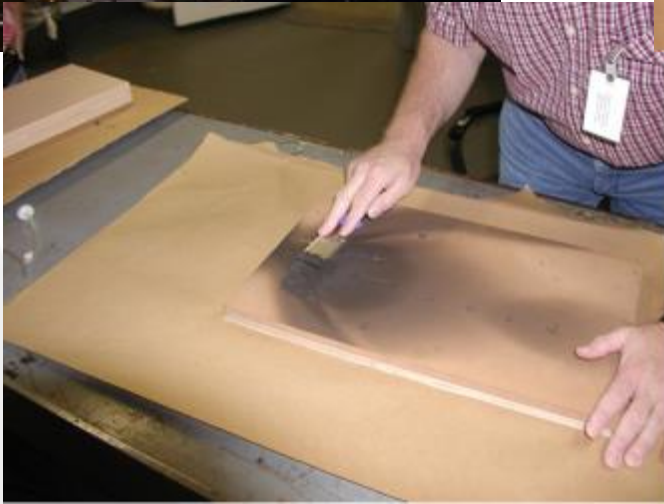
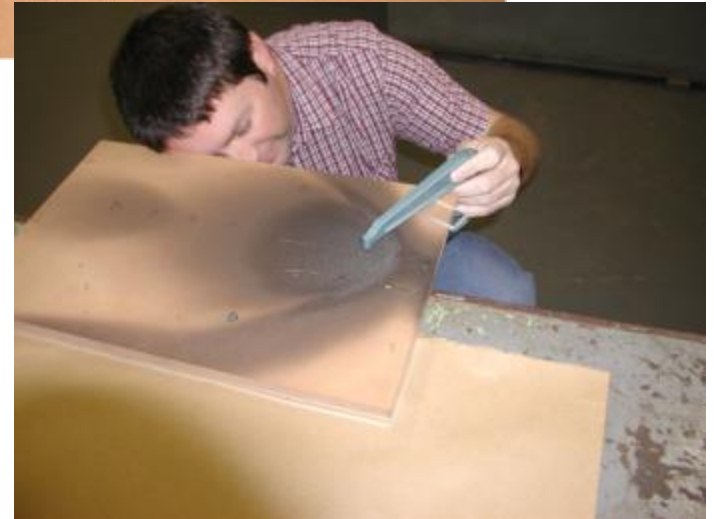
Same process as RHGF1: Calibration, Test, Measure, Scrape, Measure

- Cork ablation was less than historical database
- NCFI 24-124 was similar to historical database
  - Surface roughness makes measurement difficult. With small recession thickness, measurement errors are magnified.
- Overall, analytical uses of existing recession rates are conservative.

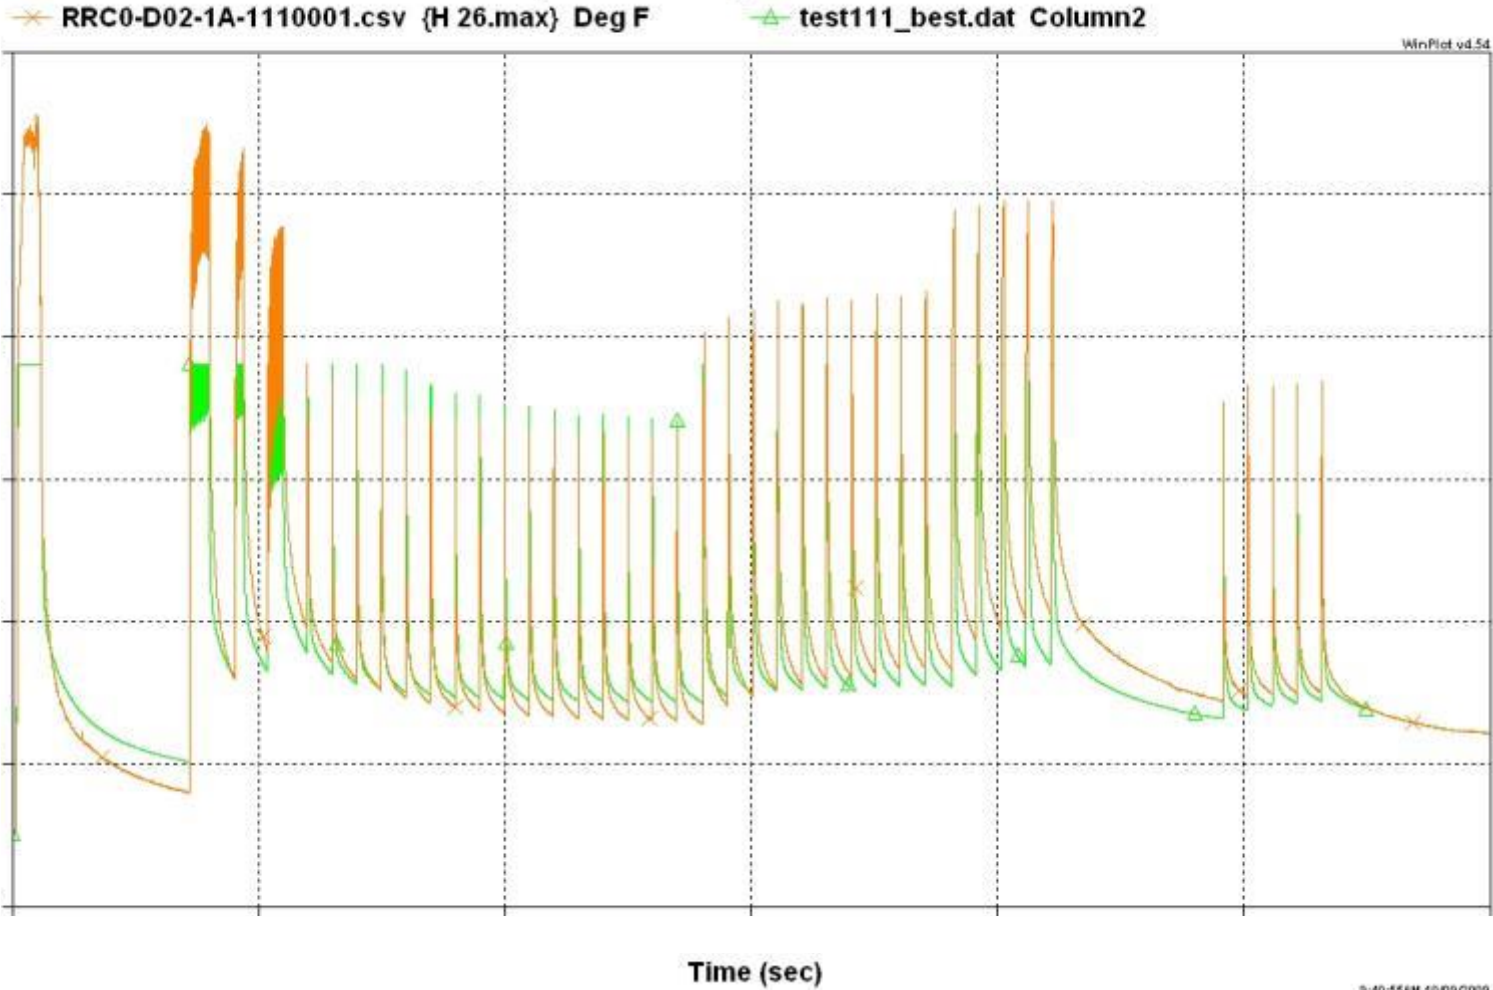
Surface Temperature Comparison For Test -111

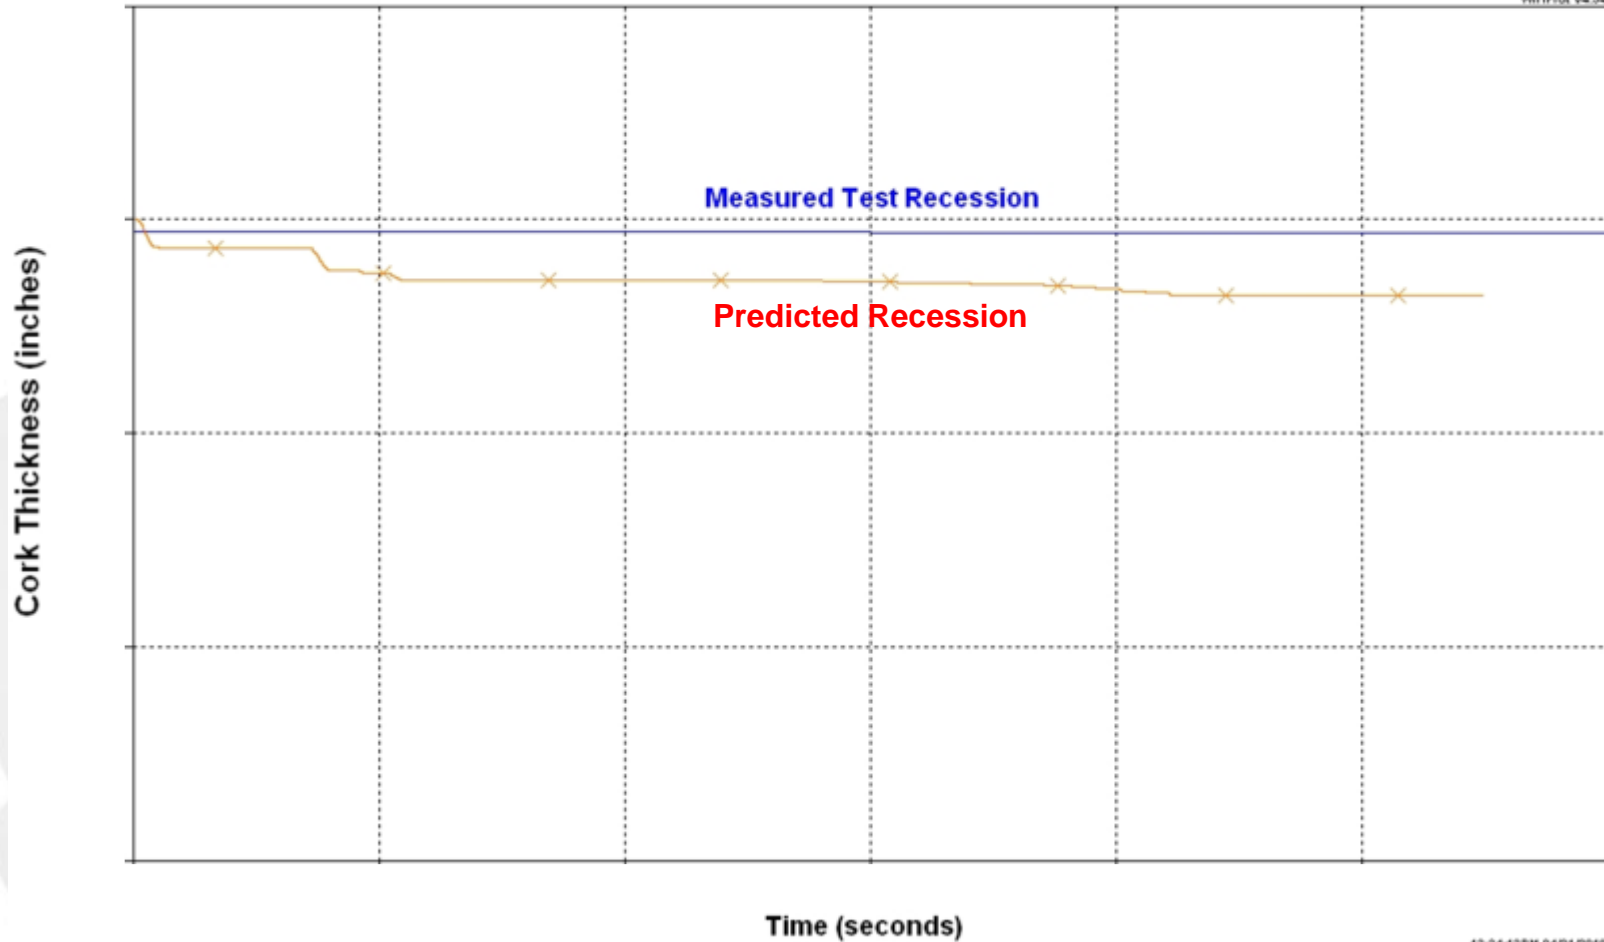
Comparison of Analytical and Measured Recession for Test -111

✕ Analytical Surface Recession

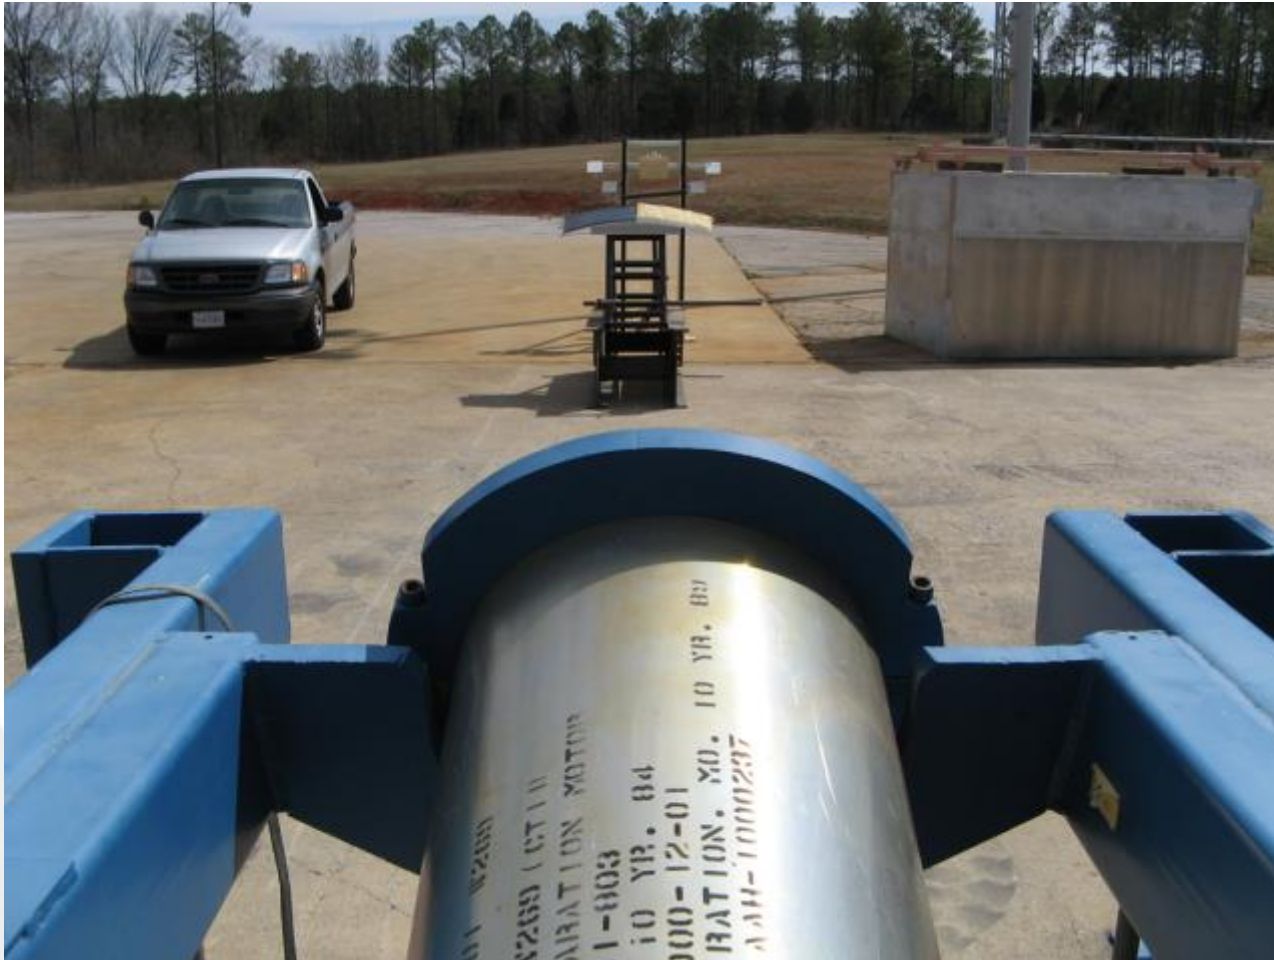
- The first test was performed at MSFC's East Test Area

- The test was instrumented, but the main objective was to see if the foam would survive.
- As you can see in the second picture, the plume wrapped around the backside and burned most of our instrumentation leads.
- The foam did survive.
- A lot of times, the most important thing you learn in a test is what NOT to do next time!

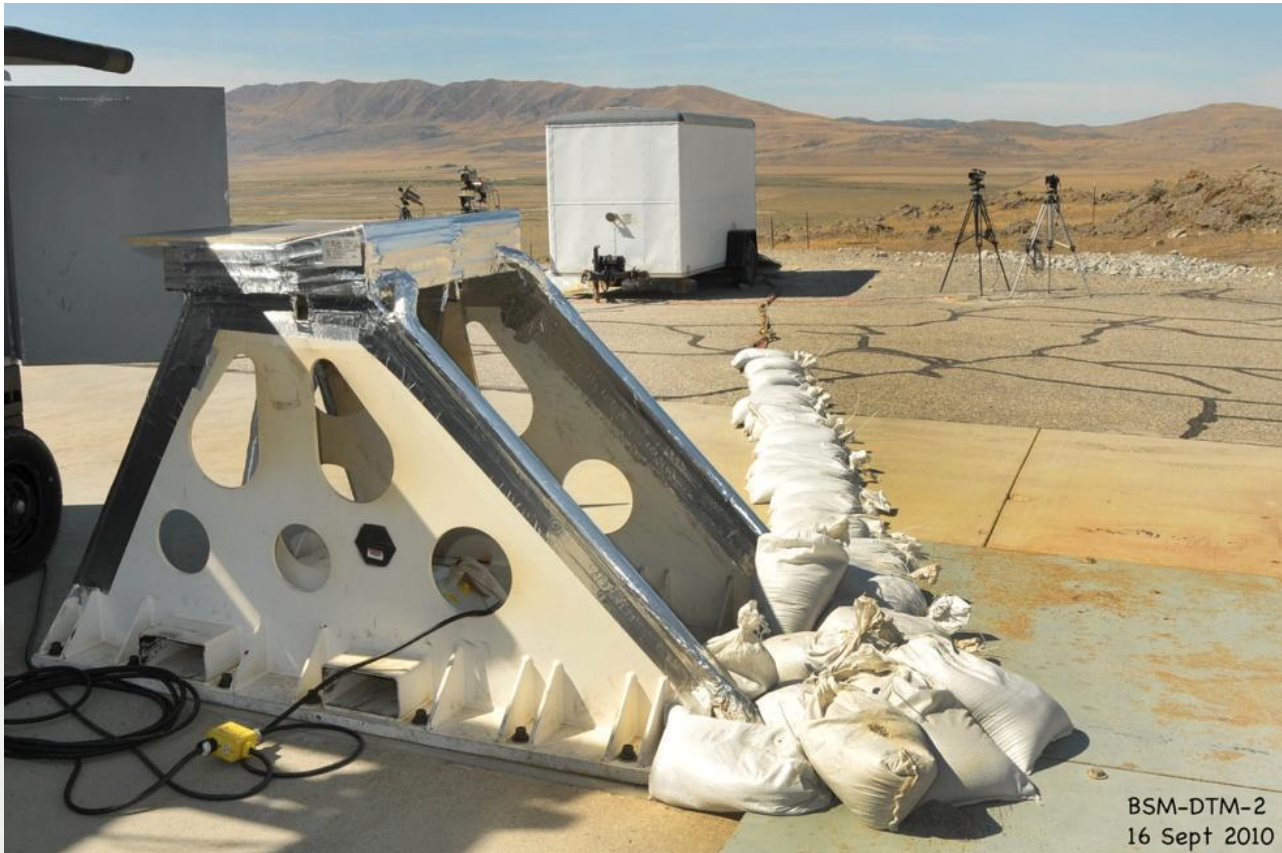
- The next tests were at ATK in Utah.
  - You can see the improvements from the previous test

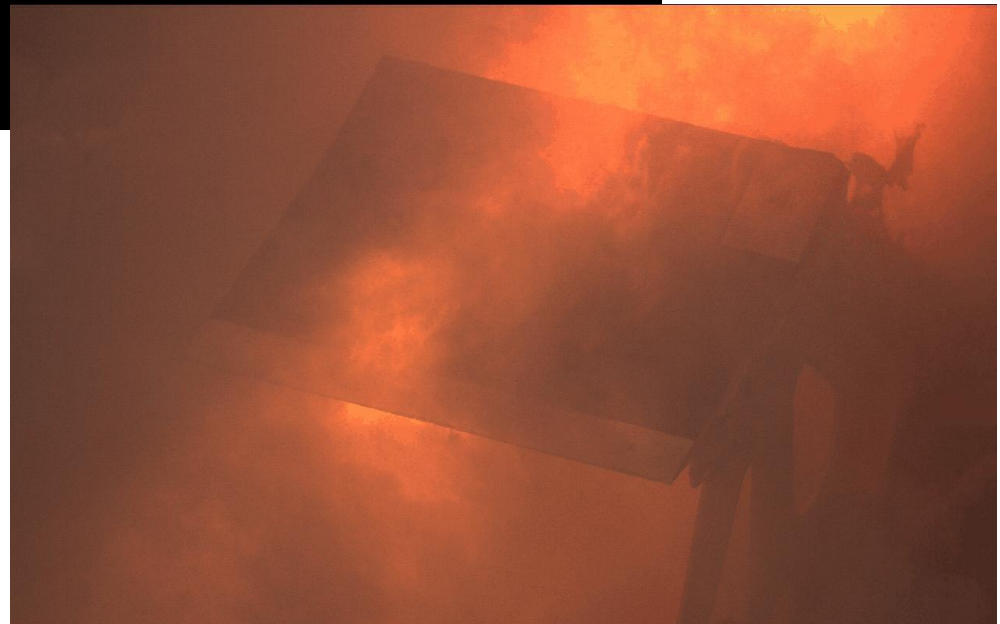
Motor fires for 0.8 – 1.0 seconds

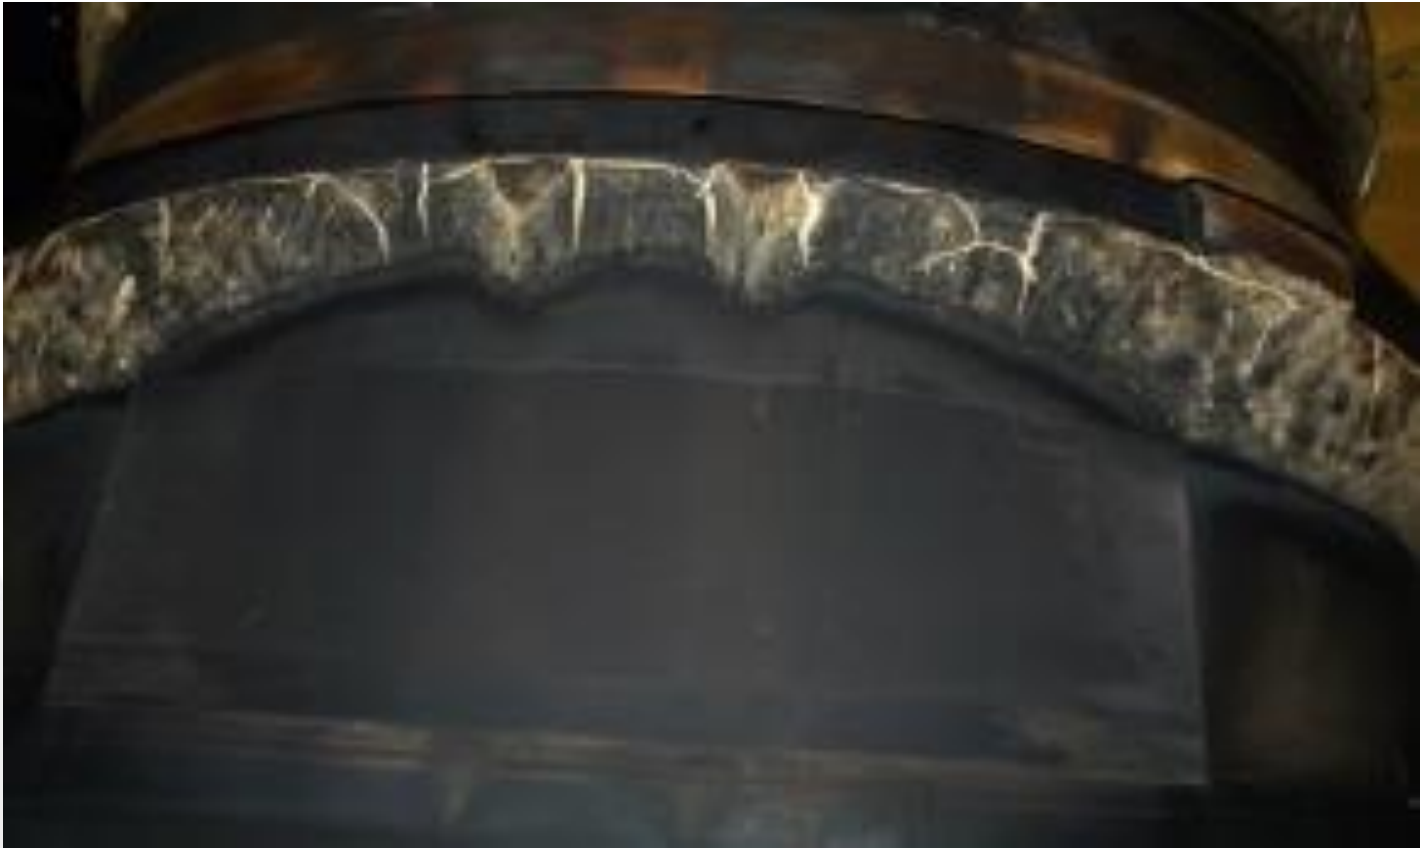
Ares 1-X post-flight showing the effects of the BDM plume on foam used for water impact mitigation

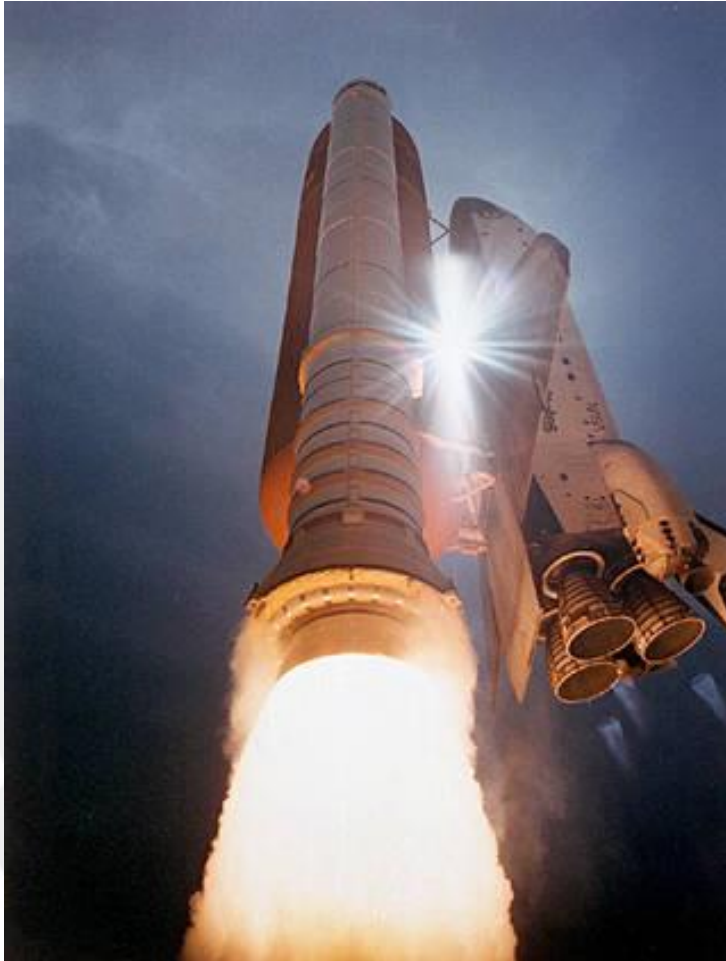
Thermal Curtain pre-ignition environments for SLS increased over heritage Shuttle

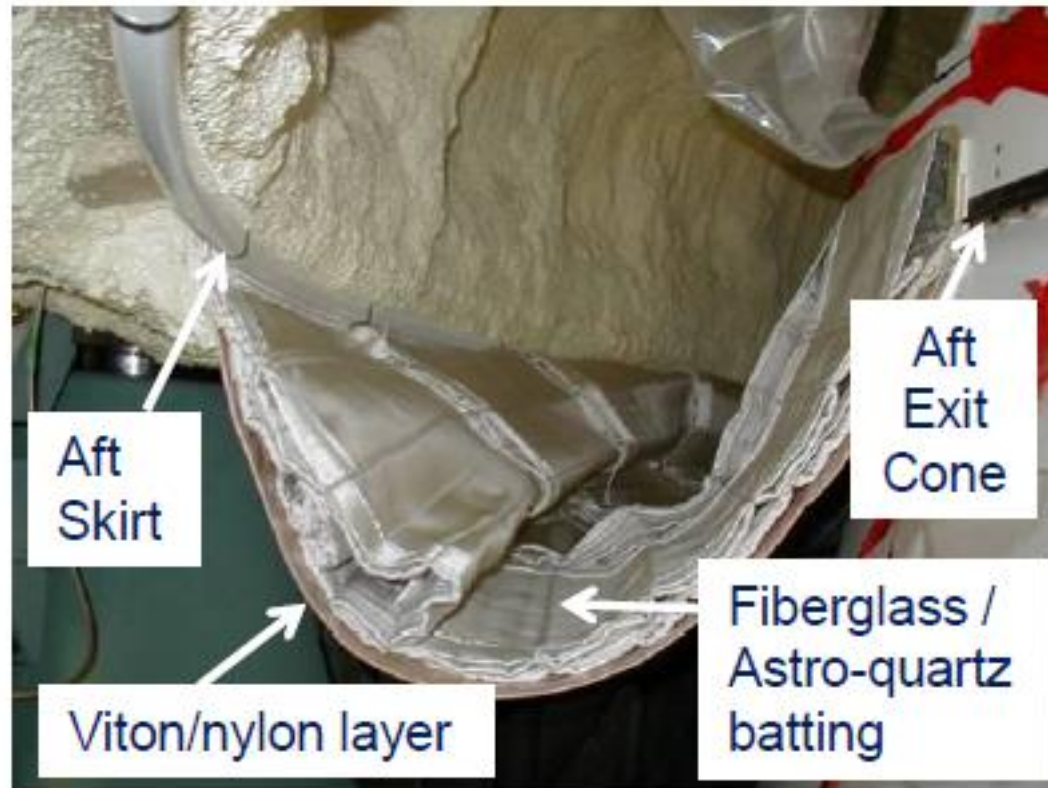
- Viton/nylon layer is necessary for structural integrity during ignition overpressure
- Pre-launch SLS radiation environments increased
- SLS ascent environments were enveloped by Shuttle heritage
- Need design to protect 7 second Main Engine firing
