SPACE LAUNCH SYSTEM

# Fundamentals of Launch Vehicle Ablative Thermal Protection System (TPS) Materials

TFAWS2017

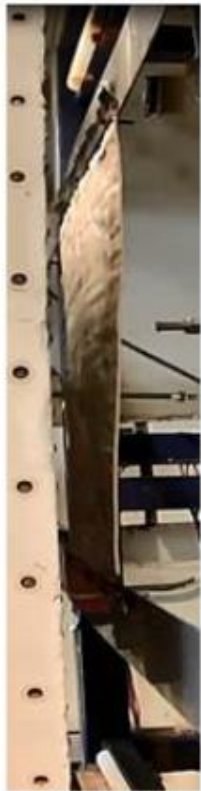
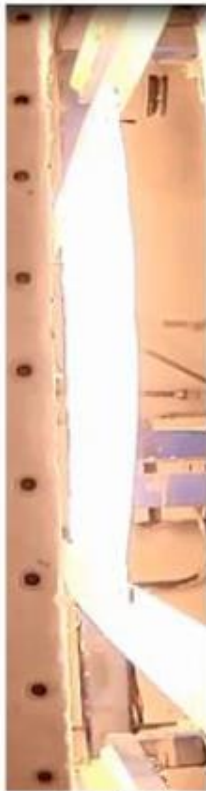
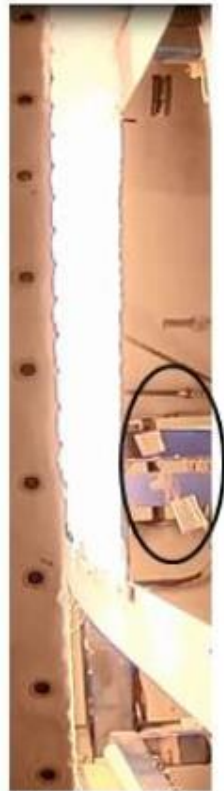
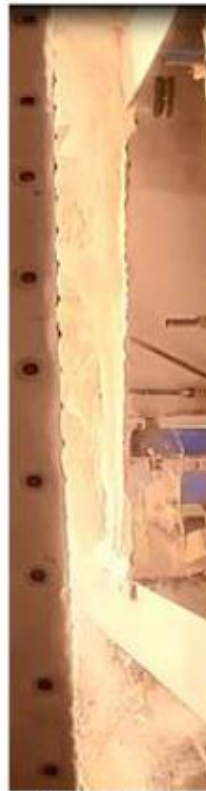
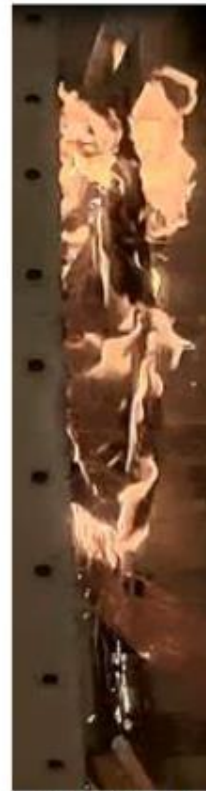
- The pre-ignition environment is purely a radiant environment.
- Tested at MSFC's Test Stand 300's radiant lamp bank.
- Viton/Nylon sample tested at a heat rate lower than design.
- Results showed the necessity of a design change.

Pre-test

End of  
Warm up

Thermocouple  
Loss / Flash  
Point

Simulated  
t-0

Post-test

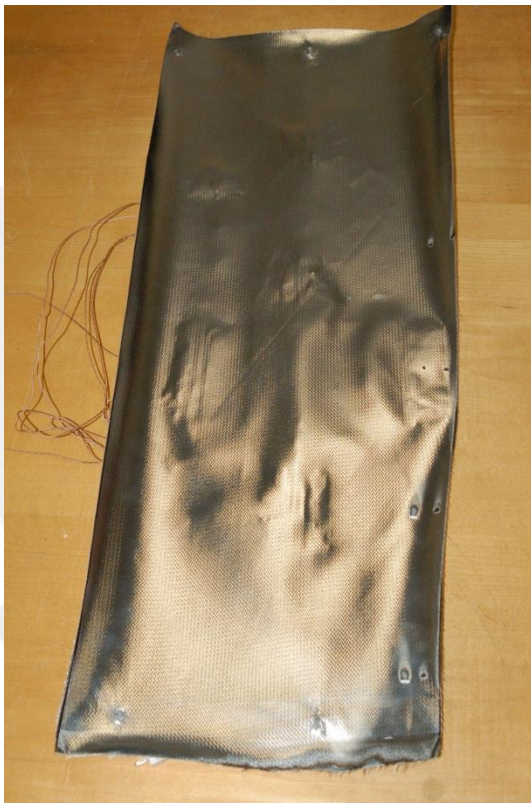
After first test

- The Gentex layer is only required to survive one exposure.
- Since it performed so well, it was tested two more times to simulate potential launch scrubs after Main Engine start.

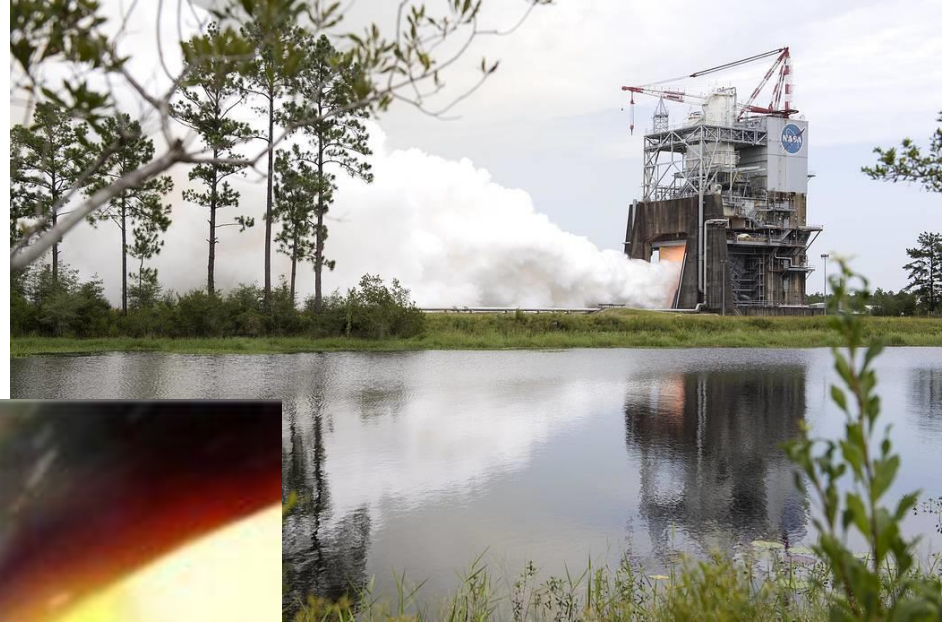
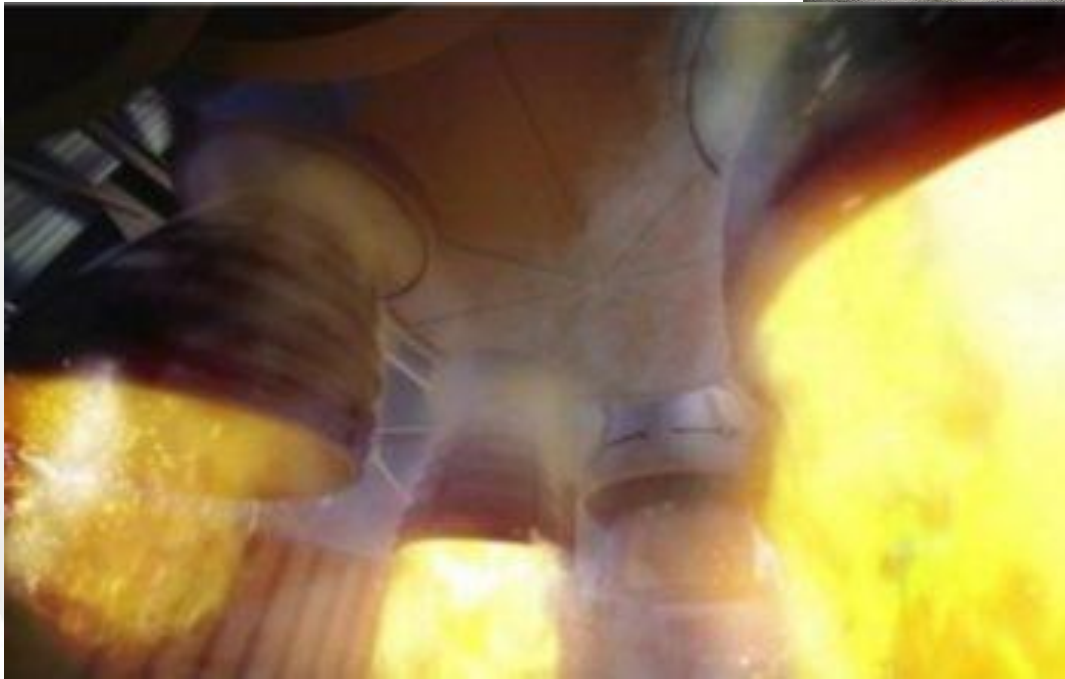
Core Stage plans a 500 second Green Run on an actual flight Core Stage to verify the Main Propulsion System.

Testing will be at the Stennis Space Center

Base Heat Shield is protected by P50 cork and is sized for flight.

- Base Heat Shield is protected by P50 cork and is sized for flight.
- Need additional TPS to protect for 500 second Green Run.
- However, we know our sizing methodology is conservative – there won't be as much ablation as we predict.
- So, there will be a lot of added cork still left on the flight vehicle.
  - More weight to carry – Core Stage is a 1:1 ratio
- Removing additional cork is time consuming and labor intensive
  - Produces dust that can damage surrounding hardware
  - May have to reapply Hypalon topcoat with an unqualified method
- Additional P50 is not a reasonable solution.
- Cannot attach any design solutions to test stand.
- Flight P50 cork cannot exceed 300 degrees F to maintain virgin properties
- Mitigating solution cannot cause slip in schedule to install, or remove.

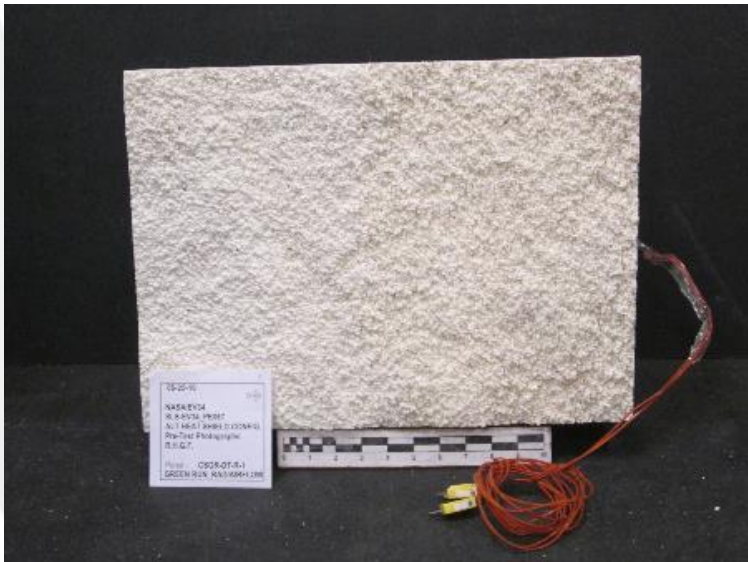
Pre-Test

- First test was to verify the need for reflective film.

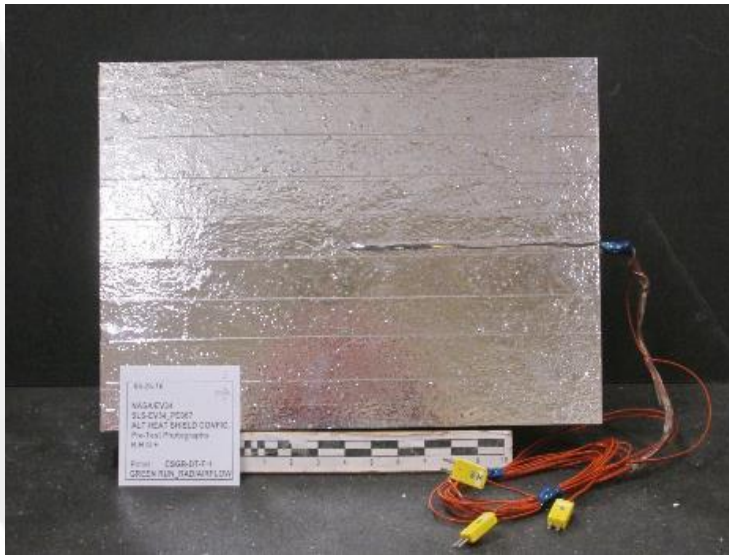
Pre-Test

- Next test was to verify the advantage of reflective film.

- Results of the test were so successful that future testing will remove the S-180 and test the foil directly over the flight cork.
- Thermocouples will monitor surface temperature of cork.
- If this design is selected, it's possible that the foil may be left on for flight.
  - Not as a thermal design requirement, but to reduce processing time.
