Space Launch System

Use of Shuttle Heritage Hardware in Space Launch System (SLS) Application – Structural Assessment

James N. Booker
Pravin Aggarwal

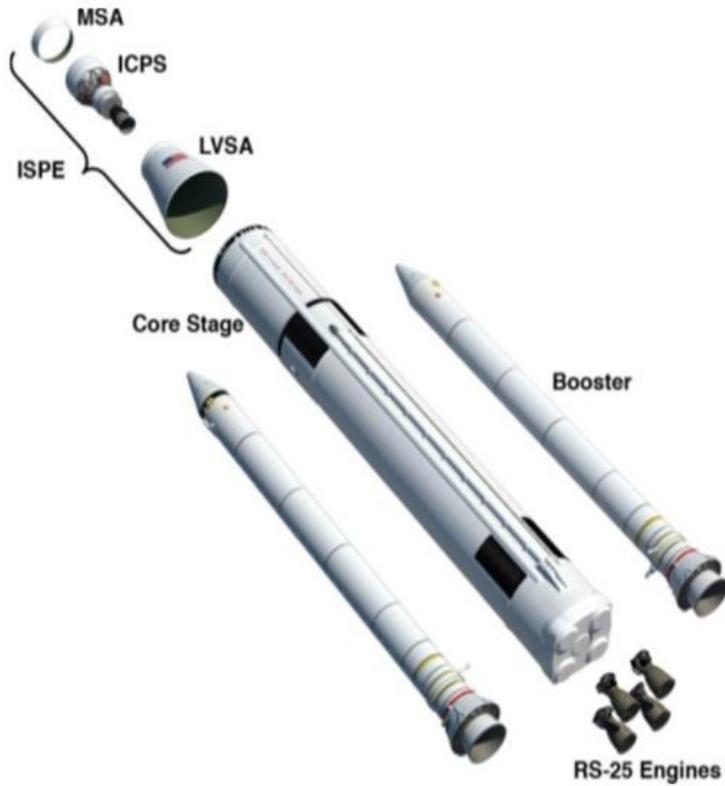
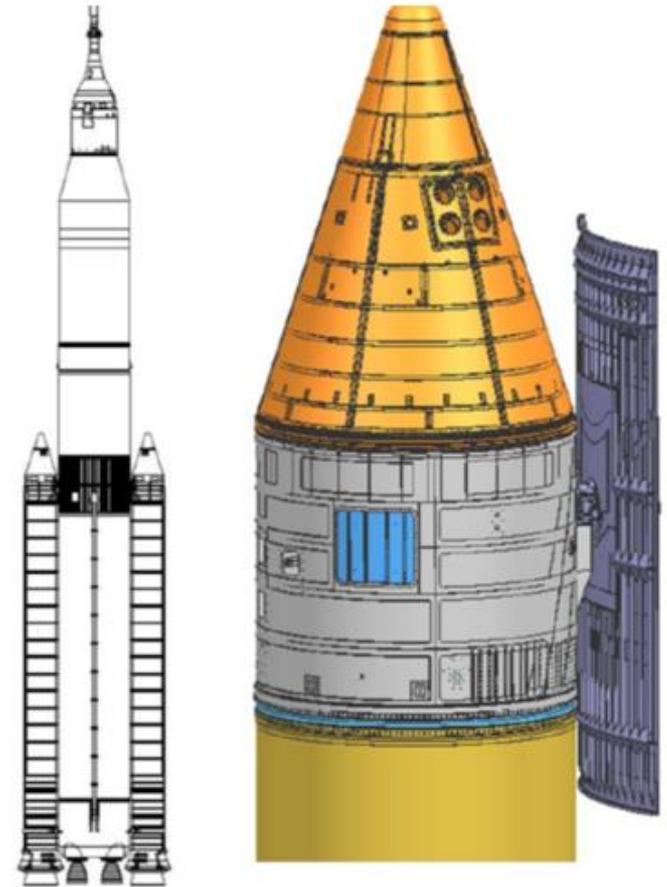
- ◆ **The Space Launch System (SLS) is a heavy-lift launch vehicle currently being designed to meet these goals**
 - SLS Block 1 architecture is the configuration for the first flight: EM-1
 - Block 1 includes Heritage: Solid Rocket Boosters and RS-25 Engines, New: Core Stage, Integrated Spacecraft and Payload Element (ISPE), Launch Vehicle Stage Adapter (LVSA), Separation System, MPCV Stage Adapter (MSA) Cryogenic Propulsion Stage

- ◆ **Heritage Boosters, left over from the Shuttle Program, will be used to provide the major ascent thrust to the Vehicle**
 - Qualification of heritage hardware to all structural and functional requirements of the SLS program provided significant challenges ~ ensuring **SAFETY**

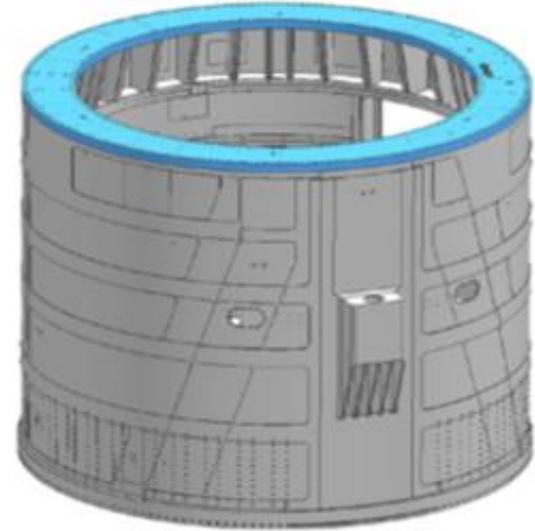
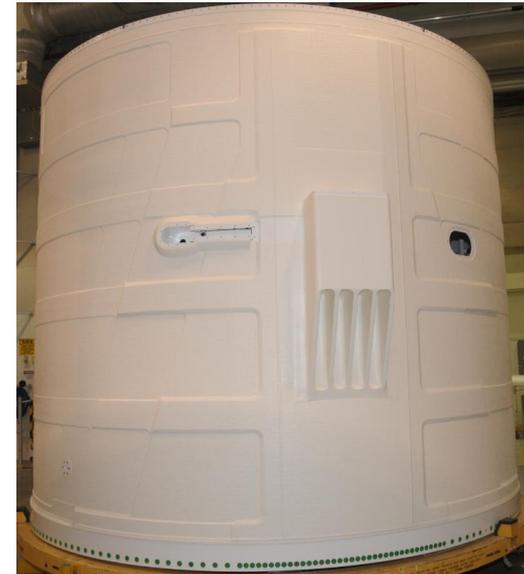
- ◆ **The SRB forward skirt structural assembly is an all welded, ring stiffened monocoque cylindrical shell, primarily manufactured from 2200 series Al alloy by McDonald Douglas between 1975 and 1984**
- ◆ **Located between the Nose Cap and Frustum**
- ◆ **The skin is machined to various thicknesses around the circumference of the shell with the forward ring, thrust post fitting and attach rings machined from special forgings.**
- ◆ **Primary purpose is to support the core vehicle prior to launch and act as the axial thrust take out point from booster to the core vehicle during flight**
- ◆ **Some structural modifications for SLS but majority is same as Shuttle configuration**

◆ **Forward Skirt Thrust Post carries axial and lateral loads at Solid Rocket Booster to Core interface**

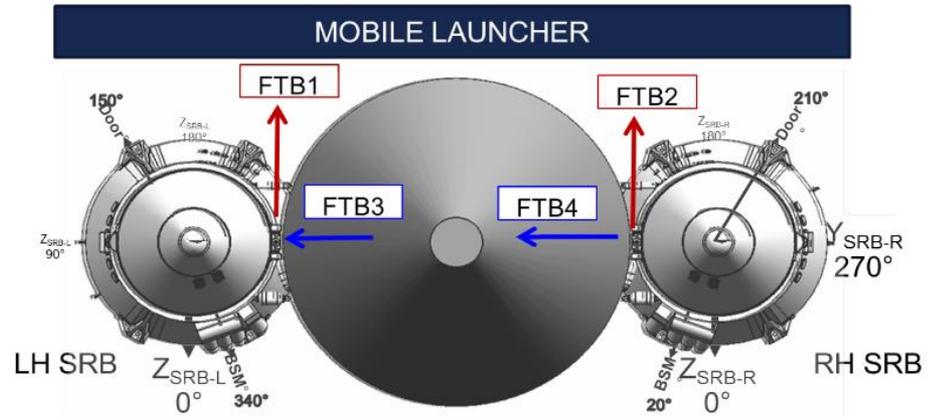
Booster	Indicator	Direction	Description
Left	FTB1	Transverse	Toward the fwd skirt door is positive (+)
	FTB3	Radial	Radial inward is positive (+)
	FTB5	Axial	Compression is negative (-)
Right	FTB2	Transverse	Toward the fwd skirt door is positive (+)
	FTB4	Radial	Radial outward is positive (+)
	FTB6	Axial	Compression is negative (-)

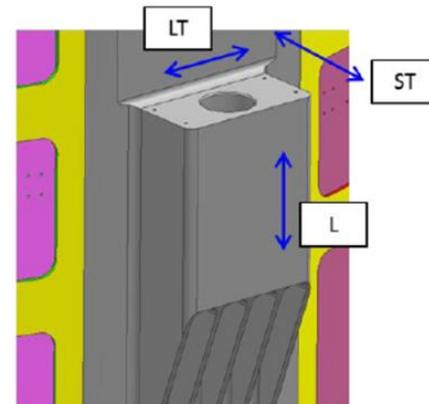
◆ **Structural testing of the heritage forward skirt was performed for the SLS program in 2014.**

- Two skirts randomly selected from inventory
- Tested all critical loading conditions to 1.4 x limit loads
- Tested both skirts to failure

◆ **Extensive instrumentation was used to monitor the structural status of the hardware and determine failure location and time**

- Strain gauges
- ARAMIS digital photogrammetry system
- String potentiometers
- Acoustic emission detectors
- Instrumented pins

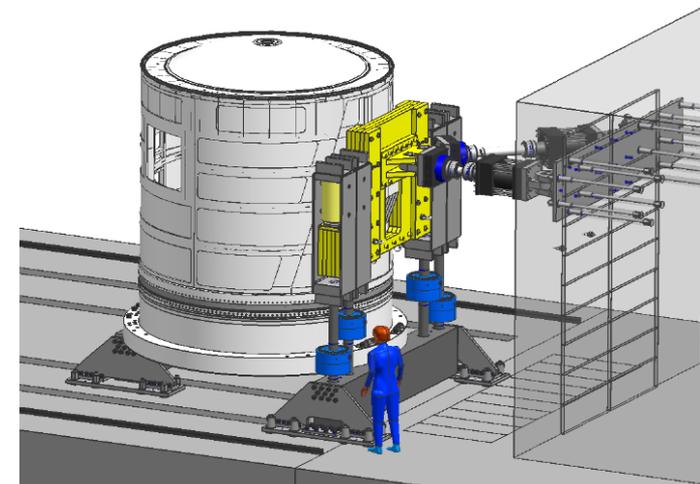
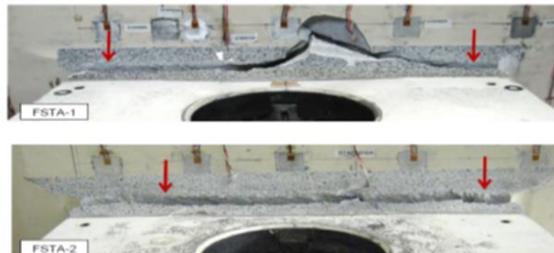
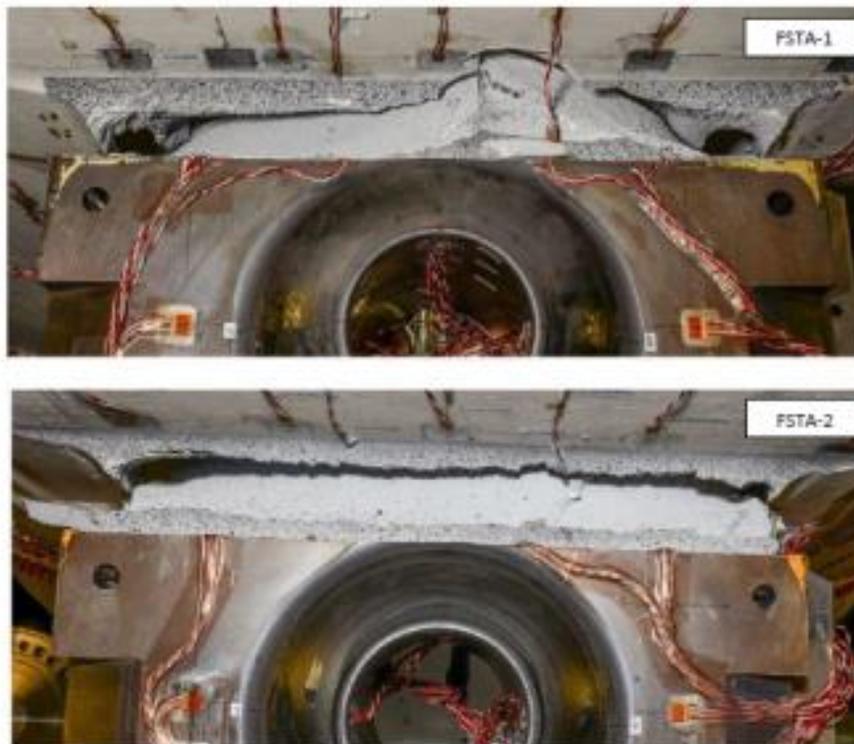
◆ **Both test articles failed well above the max predicted limit loads for SLS and pre-test analytical predictions due to crack initiation and growth across the fillet radius of the fitting**

◆ **Failure occurred in the primary load path**

- Initiated in fillet region
- Thrust Post gussets subsequently buckled

◆ **Strain gauges and ARAMIS located in region of failure**

- Compared well with each other
- Used to help Finite Element Model predictions

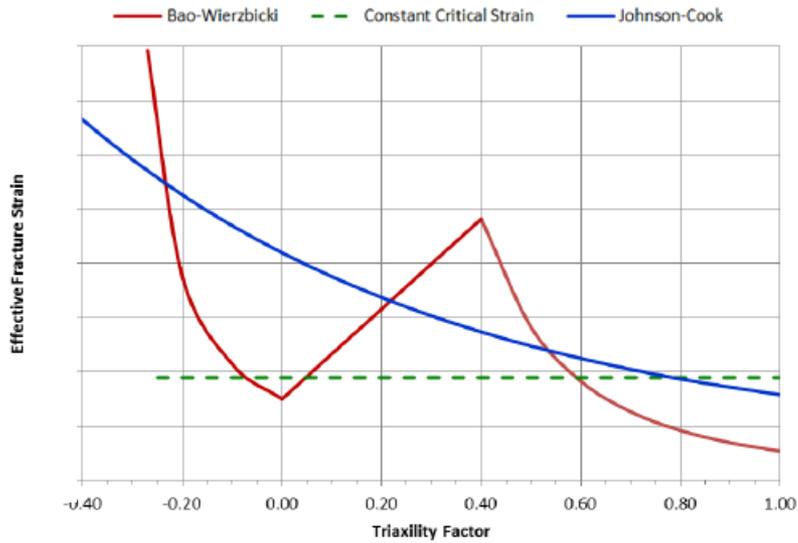
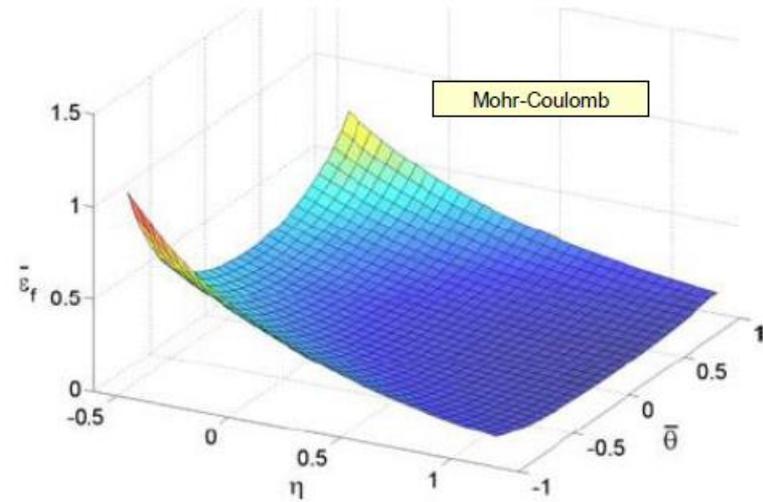
- ◆ **Failure Curves developed by plotting effective fracture strain vs Triaxiality factor**

References for plots included in accompanying paper

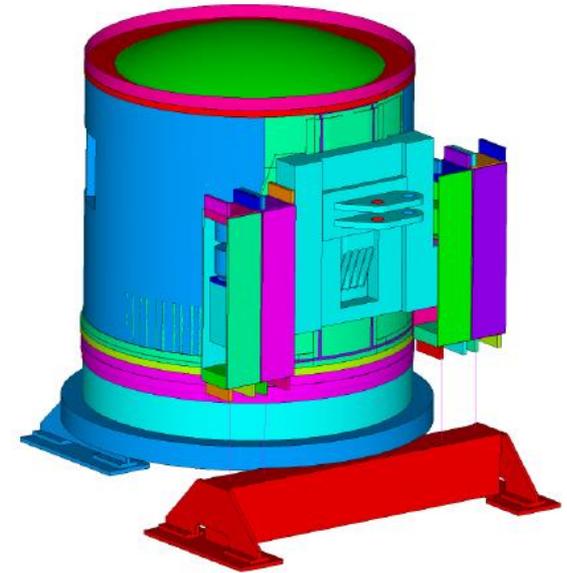
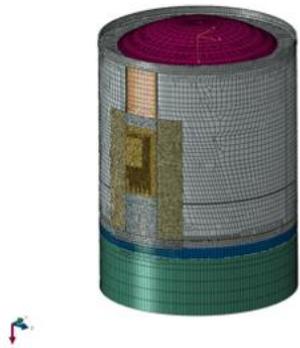
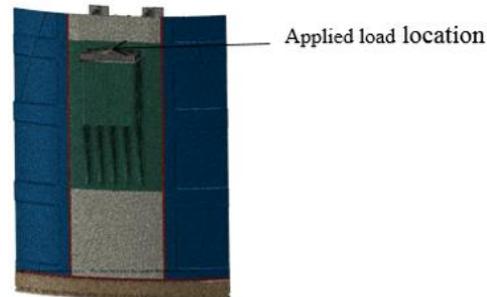
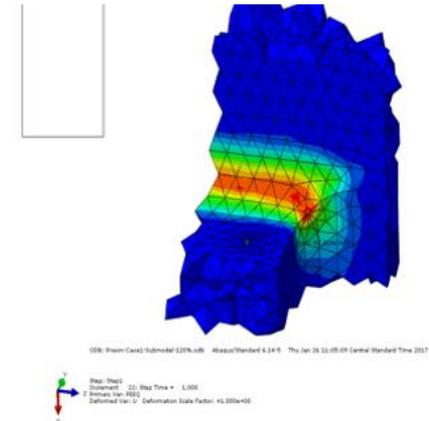
- ◆ **Two independent models were developed at MSFC**
 - Utilized commercial codes ANSYS and ABAQUS
- ◆ **First step was to build model representing test setup**
 - Modeled test equipment and load sequencing
 - Used material data from post-test cut samples
 - Overall structure response was characterized and correlated with model
 - Detailed sub-models created to characterized failure
- ◆ **Develop Bao-Wierznicki failure curve for tested structures using material test data and analysis results**
- ◆ **Rerun analysis for flight conditions**

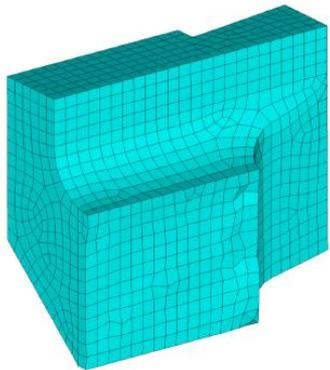
Isolate failure location

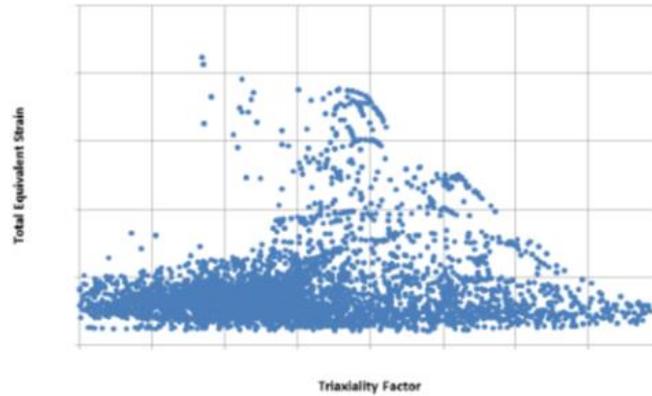
Plot Eqv. Strain vs TF at test failure load

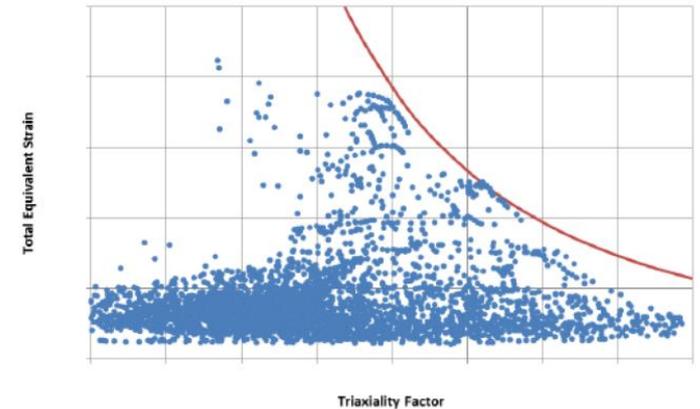
**Adjust B-W curve until just touching
This is failure curve**

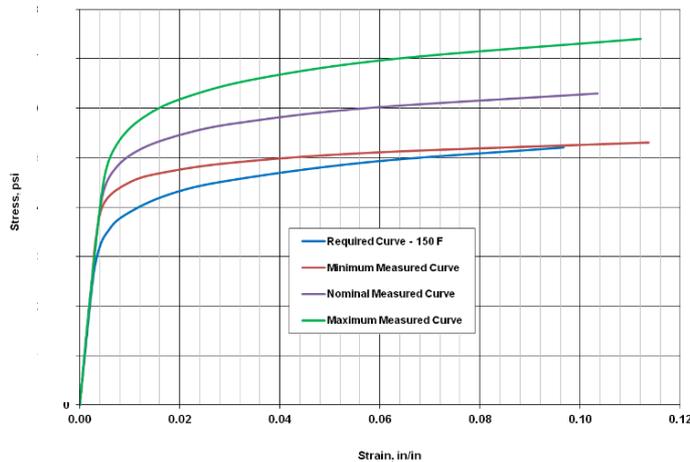
Apply flight loads, adjust model for minimum conditions and tolerances

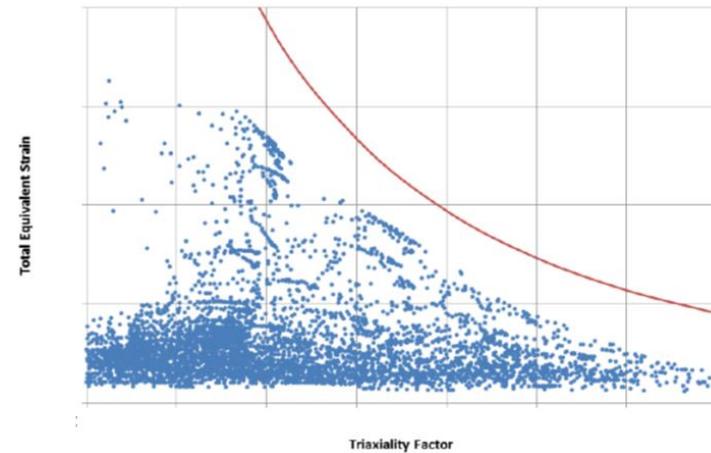
**Plot Eqv. Strain vs TF at flight limit load
Incrementally adjust until just touching failure curve
Difference is Factor of Safety**

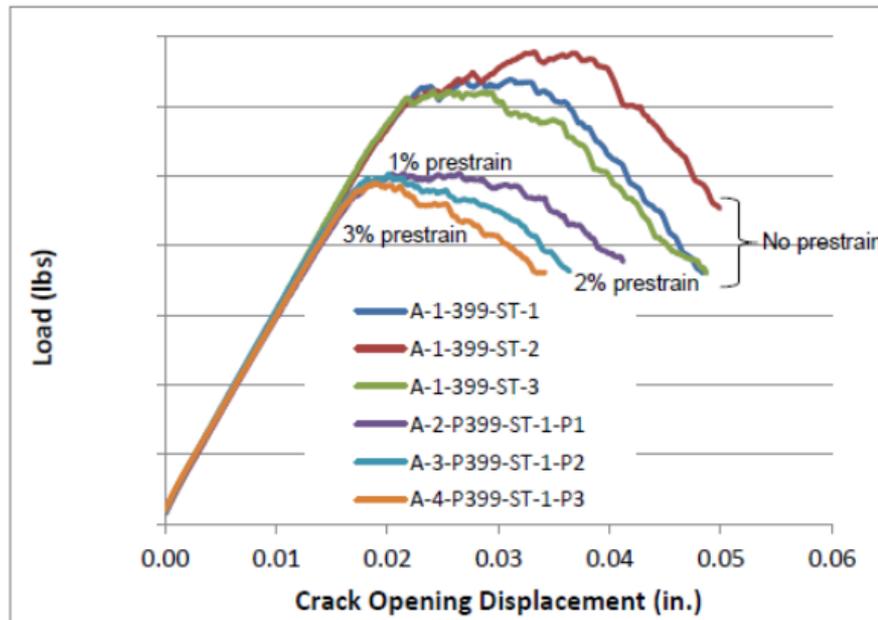
◆ **Traditional fracture assessment performed as well**

- Material samples taken from thrust post radius region to develop the fracture toughness properties
- Area experiences yielding very early in load sequence
- Samples pre-strained to different values and tested to determine worst-case fracture toughness
