Analysis of Performance Degradation of Silica Gels after Extended Use Onboard the ISS

The disassembly of two flight desiccant beds from the Carbon Dioxide Removal Assembly (CDRA) revealed significant discoloration of the silica gel near the bed inlet as well as a coincidental performance loss. This material was analyzed for the presence of chemical contaminants, physical porosity changes, and adsorption performance. The material characteristics are compared against the location in the bed from which they were sampled in order to develop profiles through the bed. Additional testing of the beds prior to disassembly provided more data points. Possible mechanisms for the loss of capacity are provided though no root cause has been confirmed. Extrapolation of the performance loss is used to estimate the required oversizing of the silica gel layer for long-term operation.

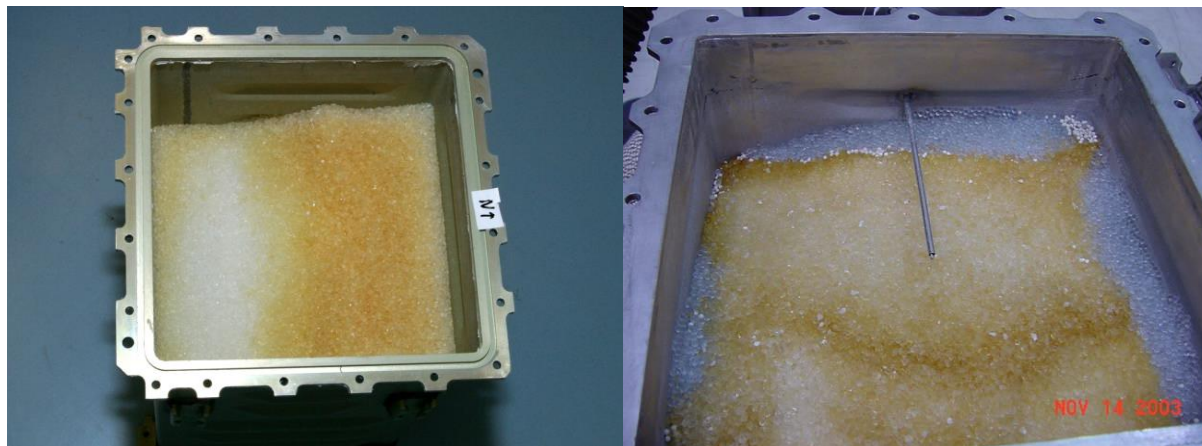
Figure 1: Photos of desiccant bed disassembly for flight (left) and POIST (right) showing discoloration of silica gel. Samples are removed layer-by-layer with a vacuum transfer line enabling sample collection at specific depths.

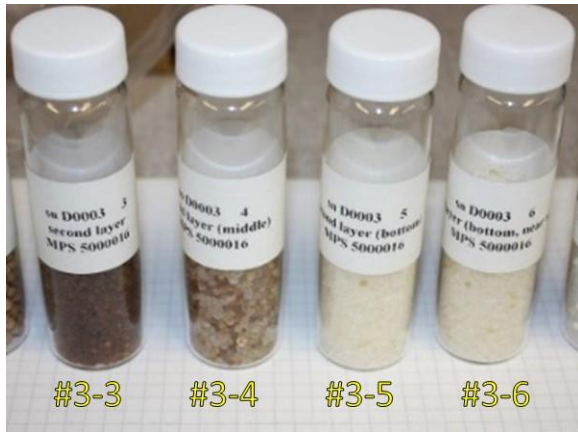
Figure 2: Photo of silica gel samples from CDRA-4 flight desiccant bed D0003. Sample -3 is from the end nearest the cabin air inlet and -6 is from the end adjacent the 13X layer.

challenged with a 10°C dew point air stream for an extended period of time. After this test, the unit was dried and returned for disassembly. Disassembly was conducted via layer-by-layer removal of material with a vacuum hose. At specified depths (0", 2", 4", 5.5"), the removed material was recovered for testing. The silica gel samples from D0003 are shown in Figure 2.

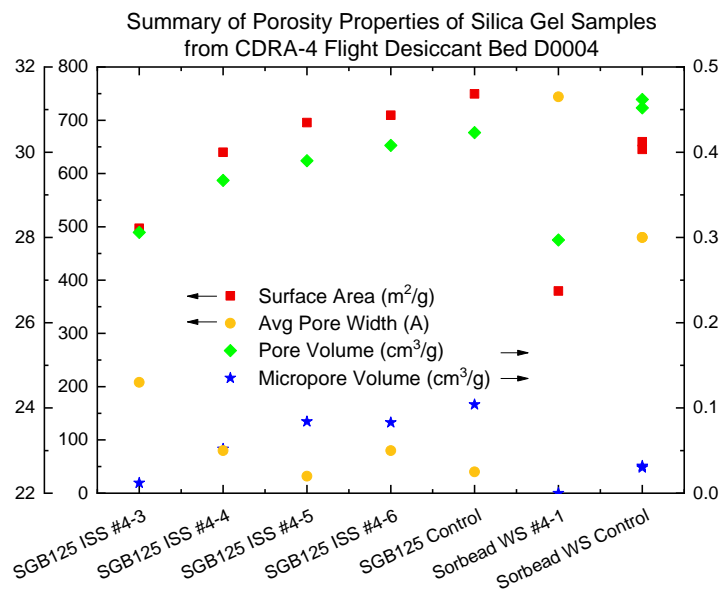
Figure 3: Summary of porosity properties for a series of control samples and samples from desiccant bed D0004 used in CDRA-4.

Surface area and pore volume analysis via the BET method showed a consistent trend across sample depth. The BET method utilizes N₂ adsorption at 77K and enables study of the surface area, micropore volume, total pore volume, pore size distribution, and a number of other porosity properties. Figure 3 shows a summary of the properties for samples from D0004 compared with control samples. Surface area losses of up to 35%

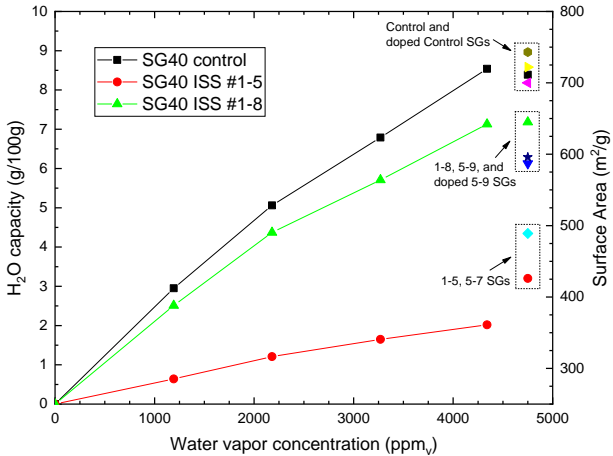
Figure 4: Results of testing on samples of control and the remaining flight SG40 as well as all available past surface area analyses of the various samples.

In Figure 4, the first iteration of testing on the two remaining flight SG40 samples was compared with unused SG40 and SGB125 from drums kept in storage on the ground. Measured surface areas are included to aid visibility of the correlation. The results in the previous report² indicated a severe degradation of material performance and showed a correlation to both presence of contaminants and reduction in surface area. Initial results shown in this study support those correlations. A definitive conclusion could not be reached with the limited test material remaining from the CDRA-3 flight beds D0001 and D0005.

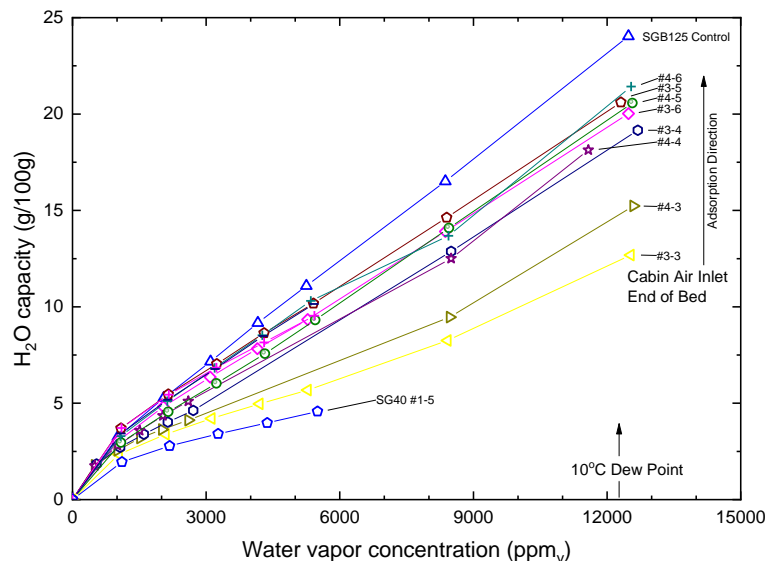
Figure 5: Water vapor isotherms obtained for control and flight silica gel samples at 25°C. For reference, the adsorbing flow direction of CDRA vs sample depth is shown for correlation to sample capacity.

To affirm the working theory that the cause of performance loss is loss of surface area, a study of the materials at water vapor levels equivalent to 10°C dew point at 25°C sample temperature was conducted. At the time of these measurements, neither lower sample temperatures nor higher dew points could be obtained. The normalized capacity values are shown in Figure 7 along with corresponding surface areas as reference. The additional isotherm points are shown in Figure 5

and are connected with the previously obtained isotherms. A nearly linear extrapolation from lower water vapor concentration results is observed. The samples from the front of the bed is severely degraded by almost 50% from the control sample while the remainder of the bed shows a 15% to 25% reduction in capacity. This performance loss may be significant to system operation as the front of the bed adsorbs a large fraction of water during each cycle.

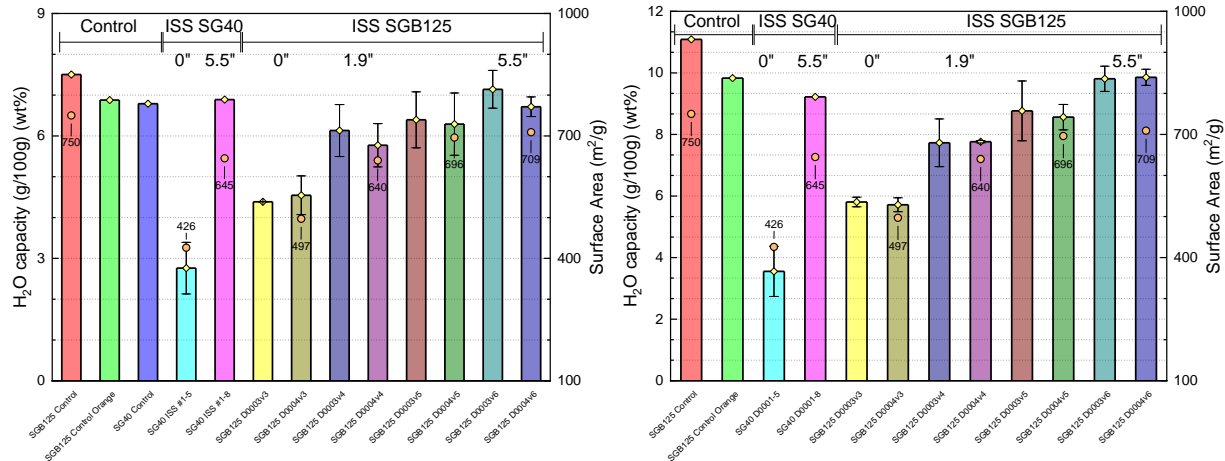
Figure 6: Results of water vapor adsorption test at low concentrations. Adsorption was conducted at 25°C and interpolated at 3250 [left] and 5250 [right] ppmv water vapor.

The water vapor isotherms shown previously are reduced to two particular water vapor concentrations for easier comparison in the form of a column chart. Since the data points were not collected at exactly the same concentrations, values were normalized to 3250 and 5250 ppm by assuming a linear relationship between concentration and capacity. The shape of the isotherms justify this method. Since each sample was tested at least twice, the results are reduced to mean and span values for each sample. Finally, sampling depths from bed disassembly notes and surface area data are included to generate the plots shown in Figure 6. Four orange-tinted beads were observed near the surface in the source drum of SGB125. These were individually extracted and tested with the results identified as “control orange.”

The trends are more readily visible in this format. Surface area correlates strongly with capacity. The samples taken from the end of the desiccant bed closest to the cabin air inlet show the greatest loss of performance, while samples taken from positions that correspond to drier sections of the bed which also see hotter temperatures are more similar to control samples. All flight samples show at least a slight reduction in performance versus control samples.

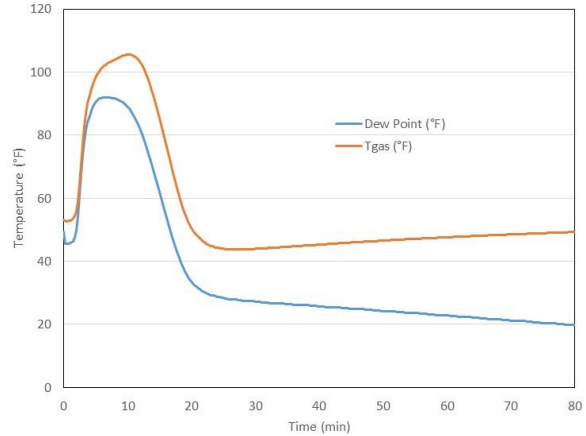
Figure 8: COMSOL simulation of the 4BMS system in operation showing the air temperature and dew point at the inlet of the silica gel layer of the desiccant bed during a desorption cycle. The two traces overlap indicating a condition of 100% RH.

There may be a point where the cool, water-laden wave leads to a condition of 100% relative humidity. Contact of silica gel with liquid water is known to cause the silica gel to fracture. The computer simulation does indicate a condition of 100% RH within the silica gel layer near the cabin air inlet end as shown in Figure 8. This 100% RH condition occurs within the first third of the bed as bounded by sample depths that showed the most degradation (D3-3 to D3-4 and D4-3 to D4-4). Perhaps this unique condition is a contributor to the silica gel degradation.

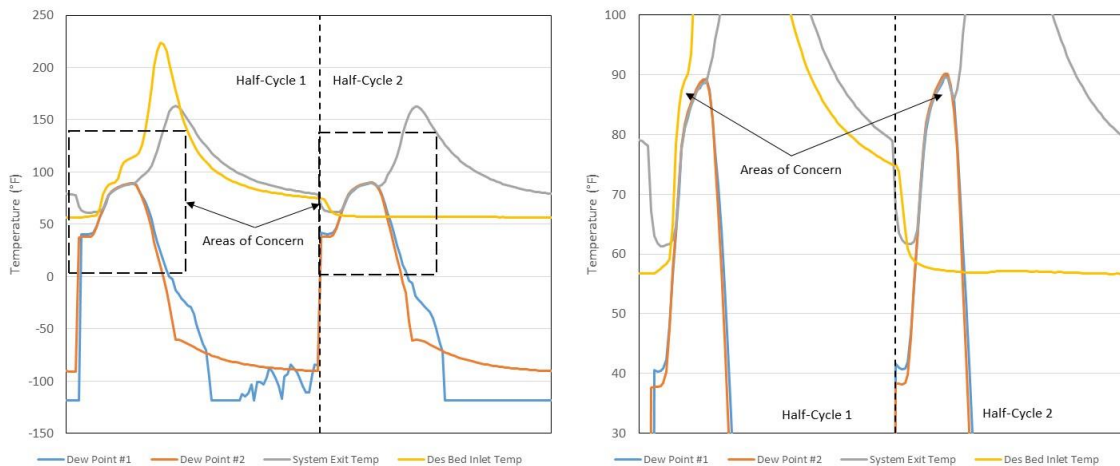
Figure 9: 4BMS-X test data (4Xr3-61) showing the temperature at the inlet of one desiccant bed and the system outlet along with two independent dew point measurements of the system outlet. Of particular note is the overlap of temperature and dew point curves at the early parts of a desorption cycle.

many occasions during operation of this system. The data gathered during desorption of a number of test series show the exit dew point nearly parallel with a temperature probe (labelled desiccant bed inlet) embedded at a point that would be equivalent to a bed depth between flight samples 3 and 4.

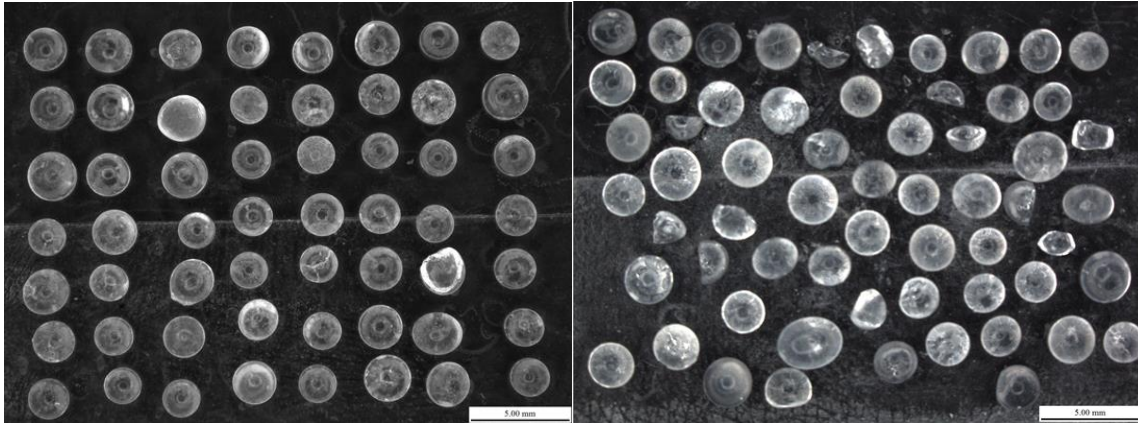
Figure 10: Photos of SGB125 from misting test report. Before [left] and after [right] misting.

Based on manufacturer notes, SGB125 and SG40 particles break when exposed to liquid water. This is a well-known behavior of silica gel across industry and is the reason for the protective Sorbead WS layer. An internal test to quantify misting-induced degradation was conducted and reported in 2015 by an ECLSS summer intern. Silica gel samples were conditioned with water vapor at 10°C dew point at ambient temperature then sprayed with a fine mist of liquid water. The results of that work was that silica gel beads fracture and show a slight loss of capacity (~2%). Figure 10 shows the broken SGB125 samples from this test. Since the test was conducted only once per sample, perhaps the effects on internal structure become measurable only after repeated exposure and cycling.

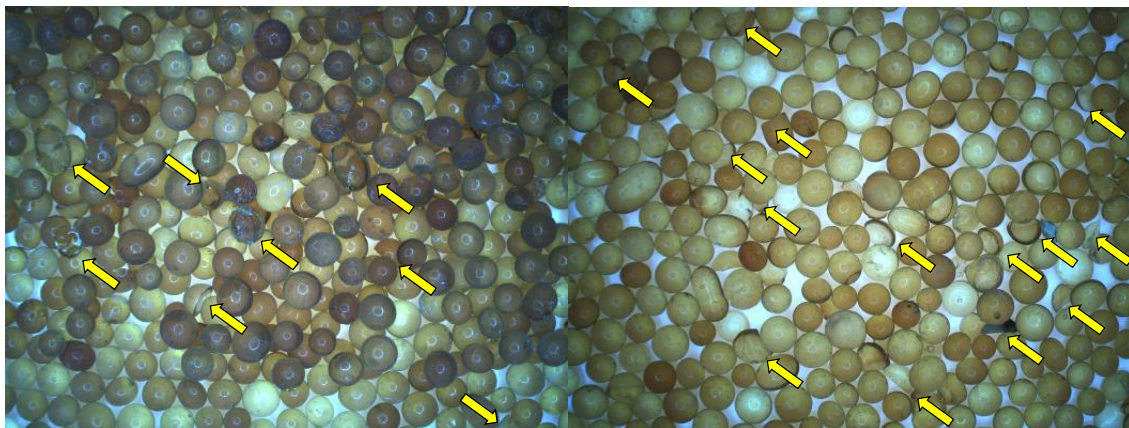
Figure 11: Photos of SGB125 sampled from the inlet of both CDRA-4 desiccant beds with arrows indicating some of the broken silica gel particles intermixed with the bulk.

No broken silica gel beads were mentioned in flight bed disassembly notes, perhaps due to the difficulty in observing them. A small number of broken silica gel beads were found in the D3v3 and D4v3 vials but were only observed due to the small sample vials. Pictures of these broken beads are shown in Figure 11 and the pattern of breakage is similar to the misting test with the major exception of orange discoloration. One hypothesis that can be

made is that the concentration wave poses a significant stress on the silica gel particles during each desorption cycle, sometimes to an extent similar to misting, and may be a cause of performance loss.

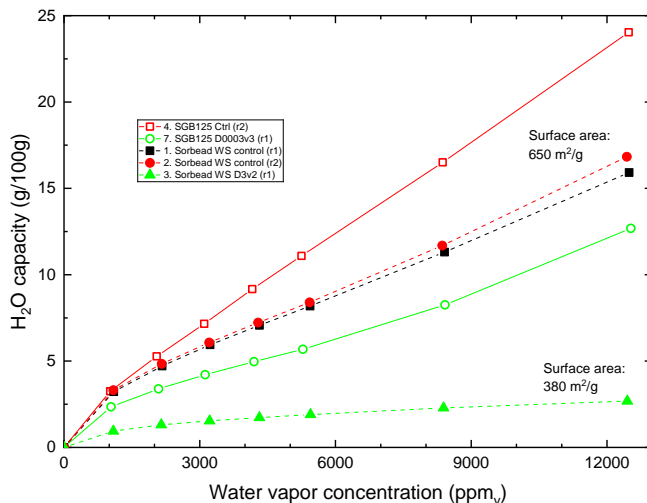
Figure 12: Water adsorption isotherm on two silica gels, SGB125 (solid lines) and Sorbead WS (dashed lines). Control and flight samples are shown along with the surface area measurements for the respective samples of Sorbead WS.

Both water vapor adsorption tests were conducted on the vials of desiccant that was sampled from the guard layer. The guard layer is 1” deep and composed of BASF Sorbead WS, a misting-stable silica gel with high robustness but reduced desiccation performance. The guard layer is the first sorbent layer exposed to incoming air and thus is expected to be most severely affected by possible contaminants. If misting occurs from upstream systems, the Sorbead WS will capture the liquid droplets and guard the bulk desiccant. The BET surface area for control samples is 650m²/g but only 380m²/g for flight sample #4-1. The same water vapor isotherms were measured on these samples. The results in Figure 12 clearly show an extensive loss in performance (~85%). This is extremely surprising considering the primary criterion for this material’s selection was robustness. This observation indicates the mechanism which imparts particle robustness is different from the mechanism for pore stability.

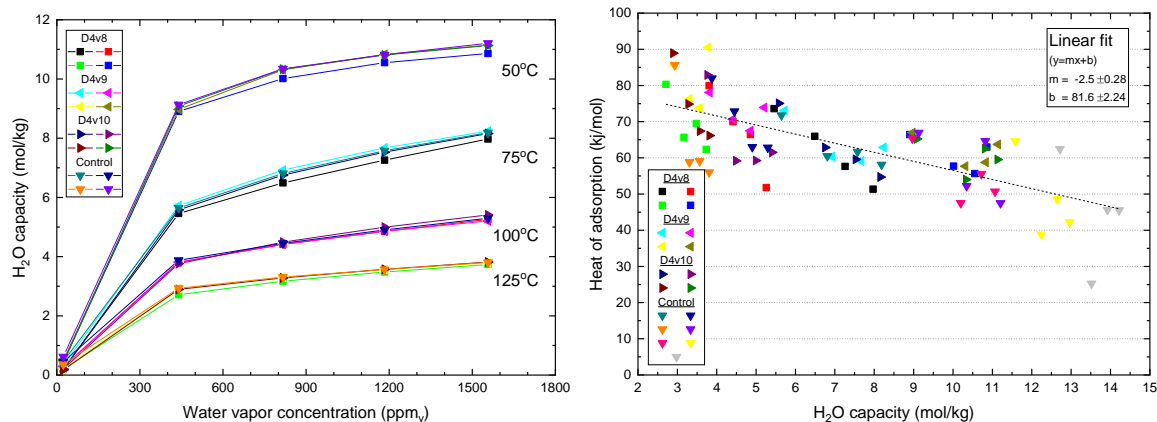
Figure 13: Water adsorption isotherms [left] and heat of adsorption [right] measurements on control and D0004 flight samples of zeolite 13X showing the seemingly imperturbable performance of the material.

Another water vapor isotherm measurement procedure was developed to study the performance of the 13X zeolite used in the flight desiccant beds. This material is commercially available as MS544 from Grace-Davison. At the MSFC test facility there are a number of lots of material available for testing, though not the same as the flight lot. The results in Figure 13 show that the material sampled from flight bed D0004 is indistinguishable from available control samples across a wide range of adsorption temperatures. New capabilities enabled simultaneous DSC operation in the *Sensys Evo* TGA which provides the data to calculate heat of adsorption. This new data is shown as well and correlates with widely published heats of adsorption for 13X in the range of 70-80 kJ/mol. The spread of the data points can be attributed to the derived nature of these values.

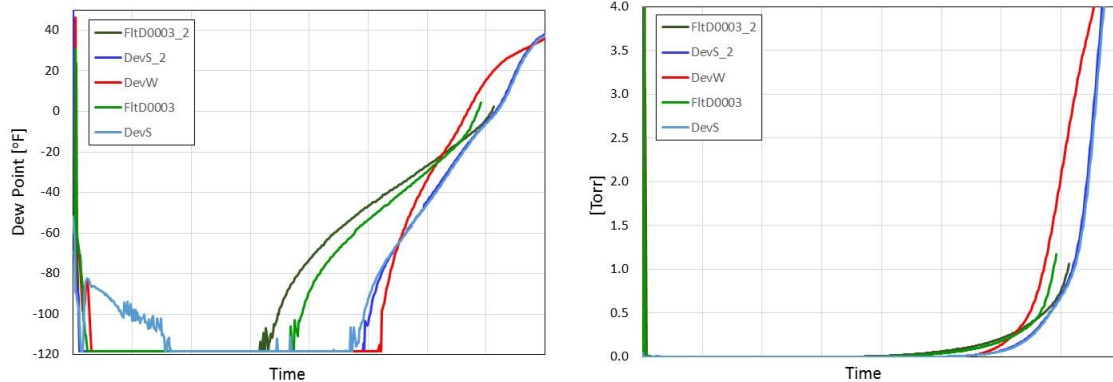
Figure 14: Results from the flight and development bed breakthrough tests. Dew point [left] is highly non-linear enhancing the visibility of trace breakthrough while the identical plot in partial pressure [right] shows the similarity of total capacity. The early trace breakthrough of flight bed D0003 is clearly visible in the left plot.

The first estimate is based on the reduced initial breakthrough time of CDRA-4 D0003 versus the CDRA-4EU beds DevW and DevS.⁵ This data is sourced from an internal report on the testing of these three beds after return-from-flight but before disassembly. The data in this report indicated that desiccation performance loss from use in flight had occurred and the breakthrough curves are shown in Figure 14.

Two aspects can be considered, the total capacity and the trace breakthrough time. All beds were challenged with the same inlet condition, therefore breakthrough time is roughly equivalent to performance. The overall capacity for each test is nearly equal as shown in Table 1. On the other hand, the first detectable breakthrough occurs at 64% of the time of the ground-based units. These fractions can be used to estimate a bed size for a 3-year mission. Since these beds must maintain extremely dry gas streams for the CO₂ sorbent and downstream systems, the time when trace water is detected is more critical. What needs to be calculated is the performance loss of the materials that can still ensure complete desiccation for entire half-cycle times after years of use.
