# Automated Fiber Placement Manufactured Composites for Science Applications

Ken Segal Composite Application Engineer NASA – Goddard Space Flight Center / Code 543

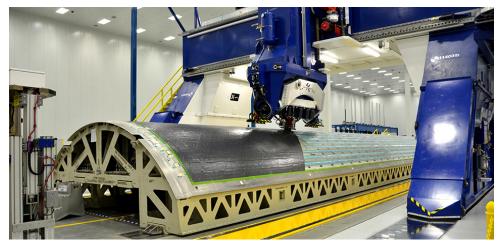
Composite Automated Processing Center (Ref: Electroimpact)

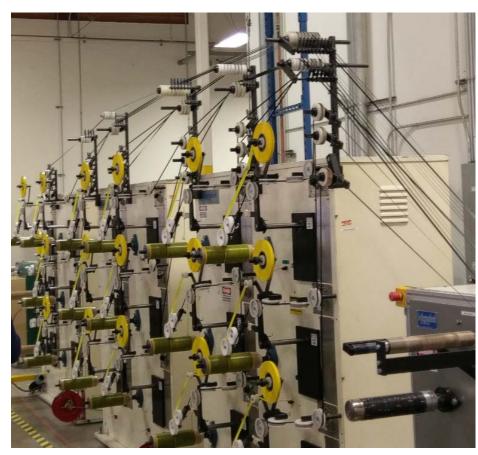
Tape slitting: extra steps to take 305mm (12") wide material to 6mm (1/4") wide

- Stiff fibers do not form as well as less stiff fibers
- Materials used for automation goes through more processing steps
- Automation steps apply forces not seen in handlayup

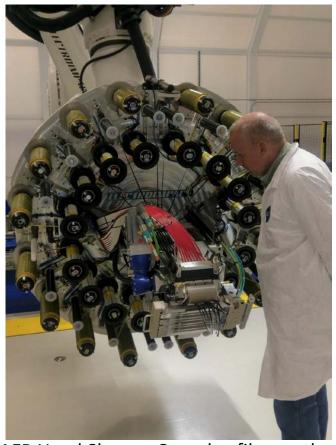
AFP Head Shown: Complex fiber path, Pneumatic forces, high process speeds

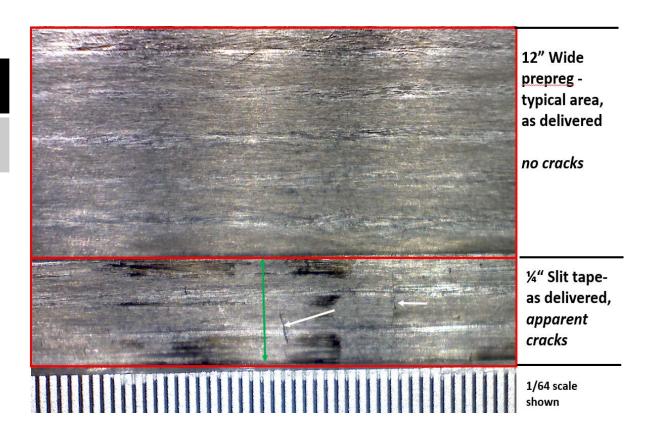
- 1<sup>st</sup> material batch incoming inspection showed the 'appearance' of cracks
- Tencate slit a second batch of material using a slightly higher processing temperature, and used a less stiff backing material
  - The feature observed in the first batch was not observed on the second batch of material

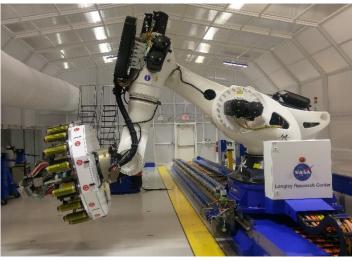
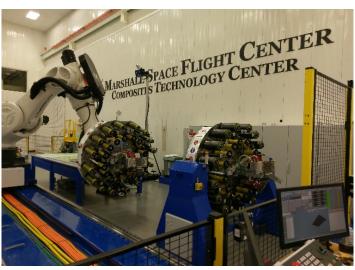
- All processing performed at NASA
  - Langley Research Center (LaRC)
    - Hand layup and AFP
  - Marshal Space Flight Center (MSFC)
    - AFP
- Identical Processing
  - Identical machine settings
  - Identical cures
- Ultrasonic NDE performed, no defects reported

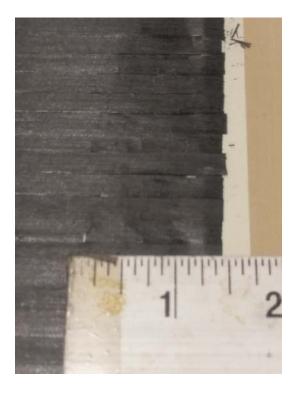
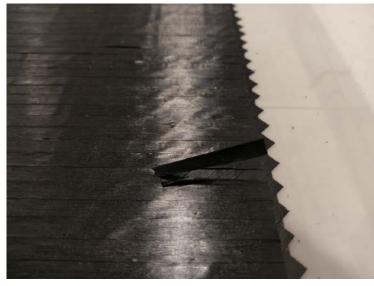
- Observed tow fractures during AFP
  - Most occurred within 50 mm from the end of layups.
  - local to where the pneumatics that drive the clamps and the cutters are located
- Higher AFP processing temperatures mitigated this effect

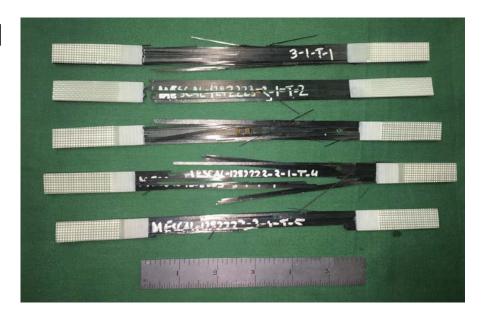
- Tension testing was performed both at GSFC and LaRC
- 1<sup>st</sup> one failed in grips due to excessive grip pressure
  - data not used
- All others failed explosively as would be expected in a [0] ply coupon

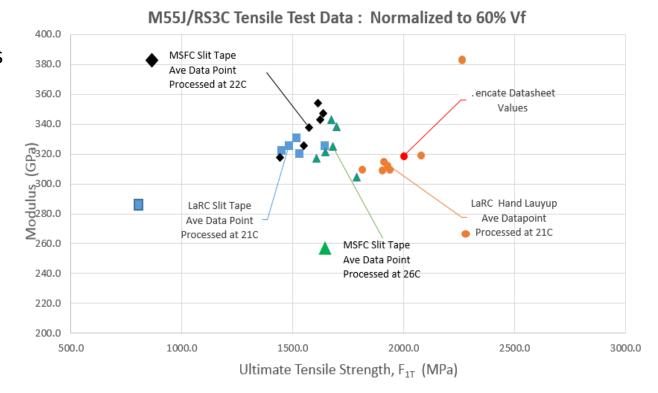
- Hand lay up tension modulus and strength meets baseline data within 3%
- All AFP Moduli are within 6% of baseline data
- AFP tensile strength does vary
  - AFP at RT / Slitting at RT
    - Strength 29.7% lower than baseline
  - AFP at RT / Slitting at Elevated Temp
    - Strength 23.9% lower than baseline
      - 5.8% recovery
  - AFP at Elevated Temp / Slitting at Elevated Temp
    - Strength 17.3% lower than baseline
      - 12.4% recovery
- AFP studies\* on other materials show effects on properties are around 5%

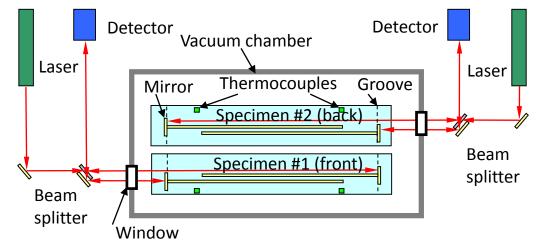
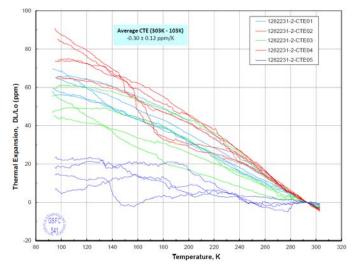
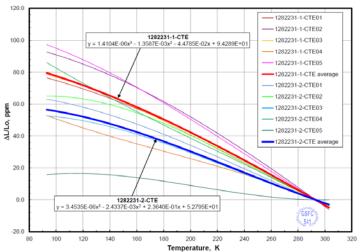
- CTE measured with a Michelson interferometer (per ASTM E289-17)
- Minimum of 3 coupons from each panel type
- No coupon preconditioning
- Measured from 323 to 98 K (50 to -175 °C)
- Each measurement cycle repeated at least 3 times
- Best fit applied to averaged thermal expansion data to get a 3<sup>rd</sup> order polynomial
  - Derivative of the polynomial reported as CTE measurement

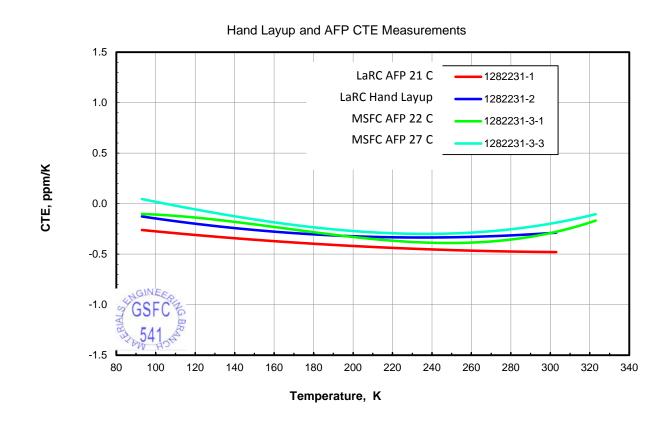
- Hand Layup CTE
  - -0.3 ppm/K
- LaRC AFP processed at 22 °C
  - CTE -0.4 ppm/K
- MSFC AFP processed at 22 °C
  - CTE -0.2 ppm/K
- LaRC AFP Processed at 27 °C
  - CTE -0.3 ppm/K
- Error +/- 0.1 ppm/K (based on standard deviations)

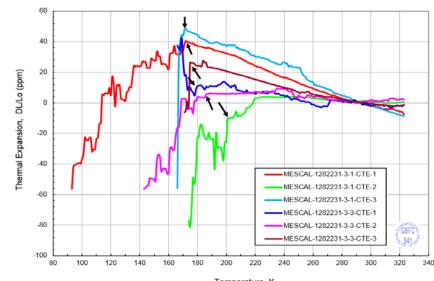
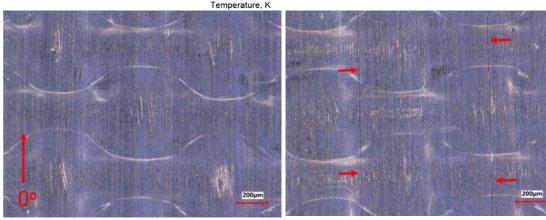
- Upon 1<sup>st</sup> cool down all 6 coupons had a sudden change in thermal expansion
  - Occurs between 200 and 170 K
    - Thermal expansion data not valid after that because mirrors moved
- Surface inspections indicated cracking
  - This is seen parallel to the fiber direction

Before Thermal Cycle

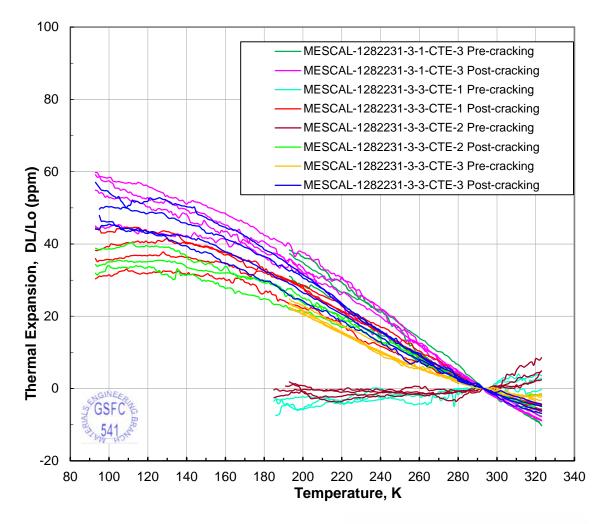
- Coupons 1282231-3-3-CTE-1 and CTE-2
  - Two coupons from same panel
  - the pre-cracking thermal expansion is lower than the post-cracking thermal expansion.
  - Little difference between the pre- and post- cracking thermal expansion for the other 4 coupons.
  - Post Cracking behavior is the basis for CTE results, and those are still low
- Coupons 1282231-3-1 CTE-3 and 1282231-3-3 CTE-3
  - Two coupons from different panels
  - AFP processed at 21 and 27 °C
  - Little difference in pre- and postcracking behavior
