GT2019-90002

ANALYSIS OF THE HONEYWELL UNCERTIFIED RESEARCH ENGINE (HURE) WITH ICE CRYSTAL CLOUD INGESTION AT SIMULATED ALTITUDES

Joseph P. Veres, Philip C.E. Jorgenson, Samaun Nili, Shashwath R. Bommireddy, Kenneth L. Suder
National Aeronautics and Space Administration, Glenn Research Center
Cleveland, Ohio, USA

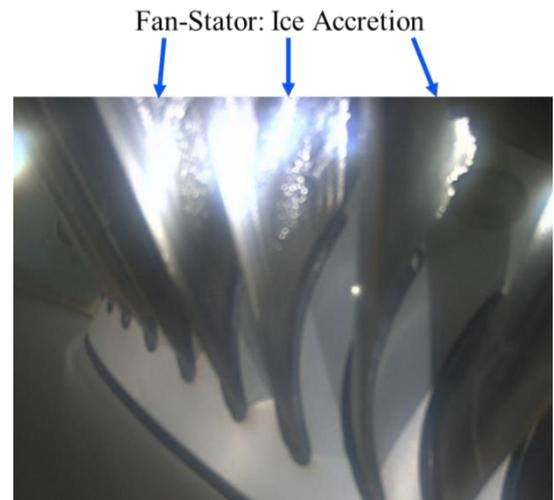
Figure 9. Video camera view of the fan-stator showing that ice accretion occurred there during Escort data 121.

Figure 9 shows the view of the fan-stator from the video camera mounted on the engine shroud facing radially inward towards the hub. The image shows a typical case (Escort 121) where the ice accretion was observed on the fan-stator through the video cameras.

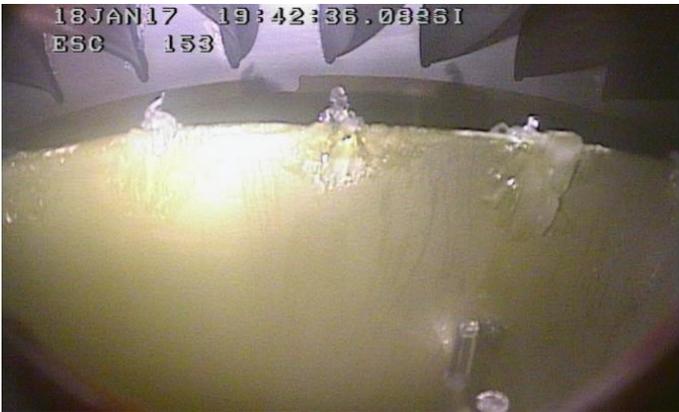
Figure 12. Escort 153. Ice accretion with ice horns on the splitter-lip at discrete circumferential locations.

Escort data point 153 and 156 are examples of the two distinct types of ice accretion in the splitter-shroud region in which ice accreted with horns on the splitter-lip (Escort 153, Figure 12), and without ice horns on the splitter but ice on the shroud (Escort 156, Figure 13). The ice accreted at discrete circumferential locations. For Escort data point 156, the compressor flow model was executed to determine the static wet bulb temperature distribution through the full fan, the fan-core and the four stage axial compressor, as well as the particle melt ratio over a range of particle size for 3 – 10 microns, and is illustrated in Figure 14. The flow model indicated that the splitter-lip-shroud surface wet bulb temperature was 24R below the Icing Wedge minimum threshold of 492R. The flow model for Escort data point 153 (ice horns on the splitter-lip) indicated that surface wet bulb temperature at that location was 19R below the Icing Wedge minimum threshold.

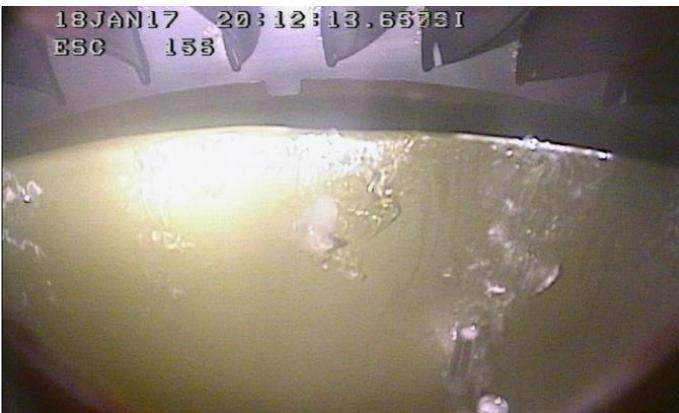
Figure 13. For Escort 156, there was ice accretion on the shroud, without horns on the splitter-lip.

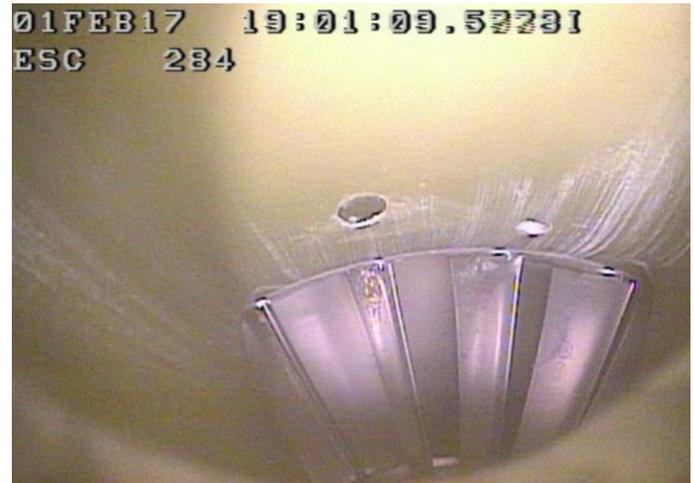
Figure 17. Ice accretion on the IGV surface near the tip (Escort 284 at 36K ft altitude).

Figure 17 shows the video image of ice accretion on the IGV for Escort data point 284. The ice accreted near the tip region.
