The Demonstration of a Light Extinction Tomography System at the NASA Glenn Research Center's Icing Research Tunnel

A prototype light extinction tomography system has been developed for acquiring real-time in-situ icing cloud uniformity and density measurements in the NASA Glenn Research Center's Icing Research Tunnel (IRT). These measurements are currently obtained manually during periodic cloud calibrations of the IRT. These manual measurements are time consuming and assume that cloud uniformity and density does not greatly vary between the periodic calibrations. It is envisioned that the new light extinction tomography system will provide the means to make these measurements in-situ in real-time and minimize the need for these manual measurements. This new system uses the principle of light extinction tomography to measure the spray density and distribution in the test section. The prototype system was installed and successfully demonstrated in the IRT in early 2018. Data sets were acquired for several typical spray and simulated fault conditions to assess system capability and sensitivity. This paper will describe the prototype light extinction system, the theory behind it, an

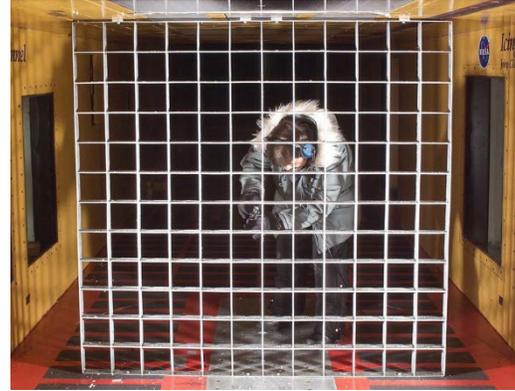
Figure 2.—Technician measuring the thickness of ice accreted on the Grid.

Periodic calibrations are conducted to characterize the icing cloud conditions and assure uniformity. Cloud uniformity is measured using a 6 by 6 ft grid in the test section. This grid extends floor to ceiling, and covers the central 6 ft of the 9 ft span. The grid mesh is 6 by 6 in. Mesh elements are 2 in. deep with a flat 1/8 in. face for ice accretion. During these calibrations, digital calipers are used to measure the ice thickness accreted at the center mesh points of the vertical elements. An image of a technician measuring ice on the grid during a typical calibration is shown in Figure 2. This manual method is time consuming and assumes that cloud uniformity and density does not greatly vary between the periodic calibrations.

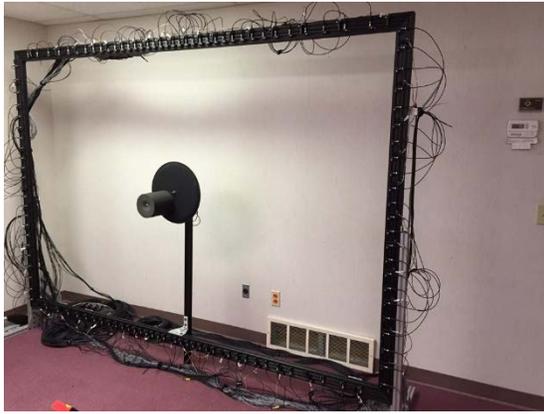
Figure 4. – Prototype IRT Light Extinction Tomography System. (a) Lab setup (b) Laser diodes and light detectors.

The prototype light extinction tomography system demonstrated in the Icing Research Tunnel consisted of sixty (60) laser diodes with sheet generating optics spaced every six degrees around the periphery of a 6 ft by 9 ft frame structure. In addition, one hundred twenty (120) fiber optically coupled detection elements were mounted every three degrees around this same structure. The conceptual layout of the system is shown in Figure 3 and the actual system set up in the lab for development work is shown in Figure 4a. A close up of the laser diodes and associated light detection elements is shown in Figure 4b.

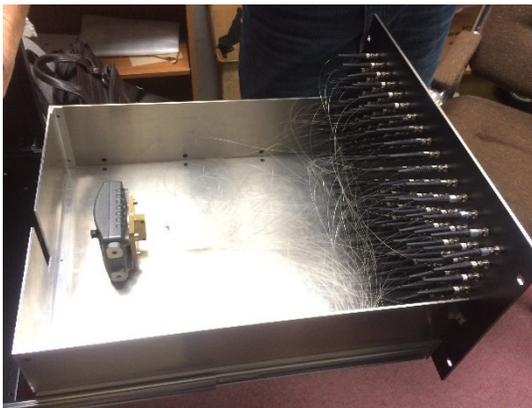
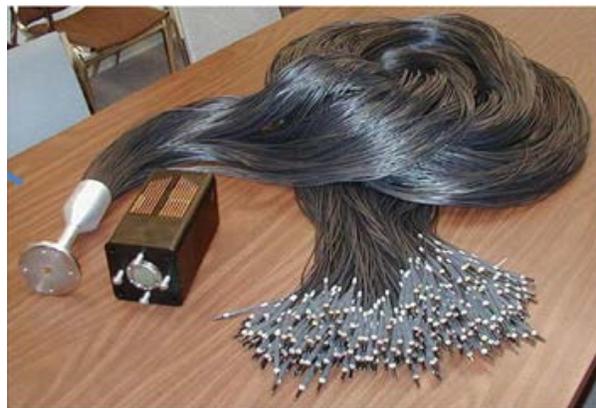
Figure 5. – Camera Configurations. (a) Line scan camera to fiber interface (b) Area scan camera to fiber interface.

Each detector utilized a flashed opal input diffuser at the fiber entrance which is coupled to the CCD camera for simultaneous sampling of all 120 light detector channels. The diffuser allows coupling of the laser light into the fibers at a very wide input angle of approximately ± 85 degrees with respect to the fiber face. The diffusers greatly increase the acceptance angle of the fibers at the cost of allowing only a small amount of the incident light to be coupled into the fiber. The laser diode sources (658nm wavelength) are pulsed sequentially while the detectors acquire line-of-sight extinction data for each laser pulse. A custom timing/trigging circuit was built in-house and used to pulse the laser diodes and control the data acquisition. The optical fibers are directly coupled to the CCD camera through a fiber optic faceplate. The fibers are directly butted up to the CCD to give a simultaneous snap shot of what the detectors are seeing for a given laser pulse. Two different CCD camera configurations were investigated for the purposes of reading the detector data for this prototype system. The first was a line scan camera with 12 bit depth (Fig. 5a). The second was a traditional area scan camera with 16 bit depth (Fig. 5b). Computed tomography algorithms were then used to reconstruct the data acquired from the detectors to provide a two dimensional image of the uniformity of the cloud flow through the test section. It was envisioned that the line scan camera would decrease the read time and result in faster response time. However, during the demonstration testing in the facility it was found that the area scan camera with its 16 bit depth provided the best overall results and will be used for future implementations of the system. More on this will be discussed in the following sections of this paper.

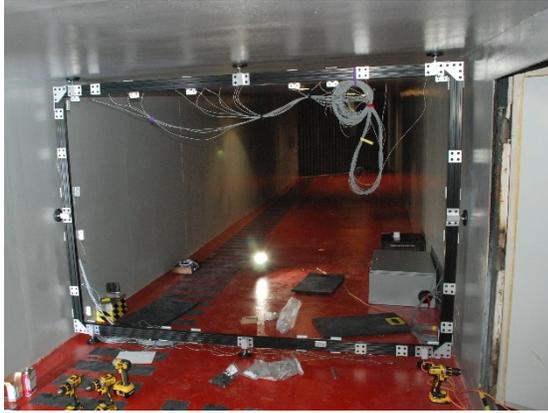
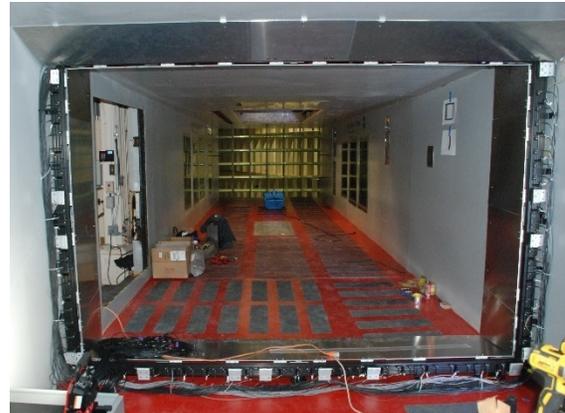
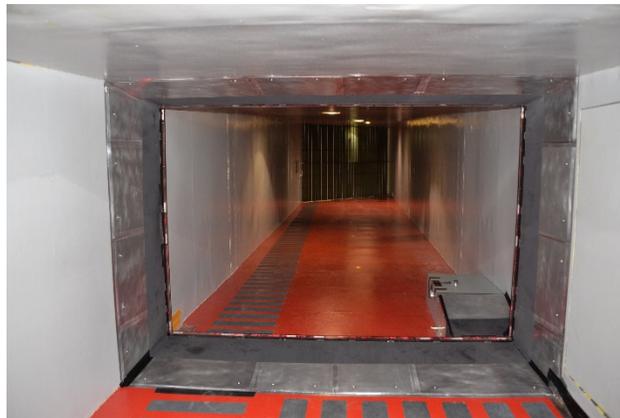
Figure 7. – Light extinction tomography system installation. (a) Frame being mounted in facility diffuser, looking downstream (b) Forward fairings installed, routing of laser and fiber optic cables on aft side in process, looking upstream (c) Installation complete, system ready for test operations, looking downstream.

The prototype system was installed in the facility diffuser, ~91 in. downstream from the end of the test section as this was found to be the location that would accommodate the prototype hardware's outside width and height while still being close to the test section. The conceptual layout of the prototype system is shown in Figure 6. The frame was bolted to the tunnel walls through the leveling feet that were installed to properly position the structure. Custom fabricated aluminum fairing panels were installed on both the upstream and downstream side of the tomography system's frame to guide the flow over and through the system along with providing protection to the optics and cabling. To prevent ice from building up on the optics and to further minimize flow disturbances, acrylic panels were installed along the periphery of the rig in the measurement plane where the optical access slots were located. Pictures showing the system during various steps of the installation are shown in Figures 7a and 7b. The system fully installed and ready for test operations is shown in Figure 7c.

In viewing the pictures of Figure 7, one can see that there were many compromises made in the installation for this initial proof-of-concept test. First, the off-the-shelf lab hardware did not have the low flow profile that will be needed in the final permanent version. This not only drove the location where it could be located in the facility, but it also created the need for the aluminum fairings on both the upstream and downstream side of the system to minimize flow disturbances and guide the flow over the hardware. This created a convergent-divergent area at the system that would not be present in the permanent version. Second, the lab hardware had limited lengths of cables for the lasers and fiber optic light detectors. This caused the controller for the laser and the camera for the light detectors to be located in a metal cabinet that was installed downstream of the system in the diffuser. This is shown on the lower right-hand corner of the system in Figure 7c. This had the potential to create a localized flow disturbance in this corner which would not be normally present in the facility's flow. For the permanent installation these components will be located outside of the test section with sufficient lengths of cabling and penetrations required to route the cabling through the test section walls, minimizing the amount of hardware in the flow path. In the end, even with these compromises, the ultimate goal of assessing the system's performance for this initial proof-of-concept test was achieved. It was felt by the authors' that it was better to validate the system's performance before pursuing a more costly installation that would eliminate all of these issues. These items will be addressed in the final system design for the permanent installation of this system into the IRT.
