NASA/TM—2019–220133

# **Stress Corrosion Evaluation of Elgiloy Alloy for the ISS ECLSS—Universal Waste Management System**

*Pablo D. Torres  
Marshall Space Flight Center, Huntsville, Alabama*

**May 2019**

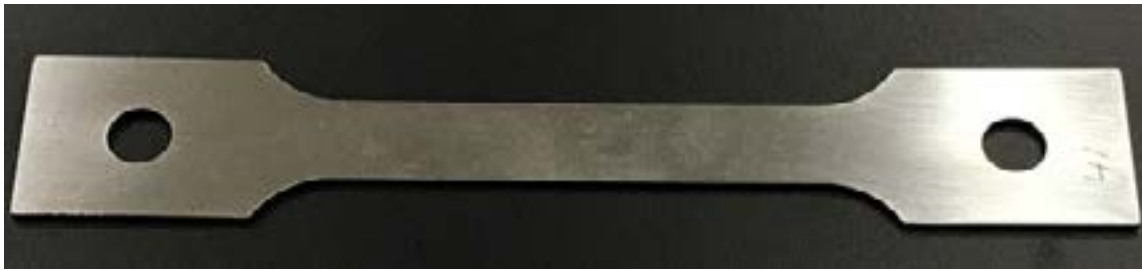
Figure 2. View of representative Elgiloy stress corrosion specimen as received.

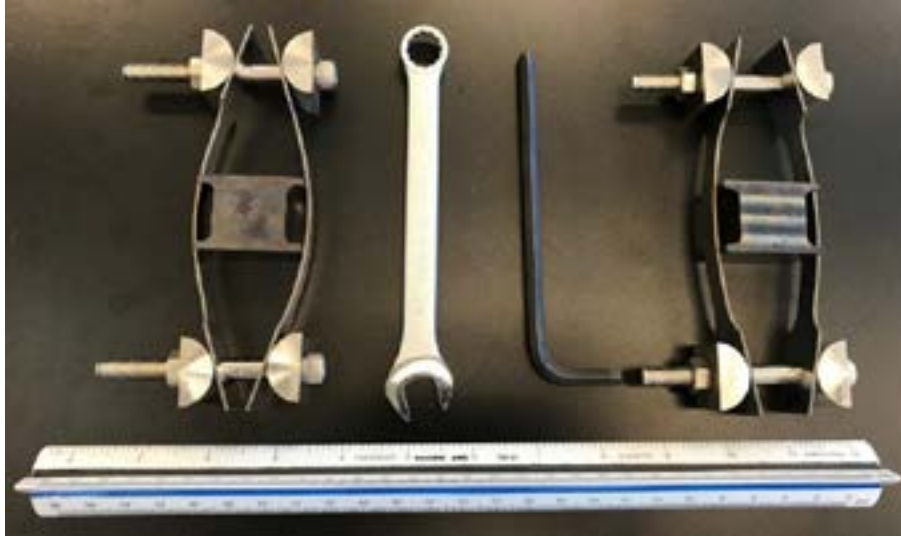
Figure 7. Tools to load beam specimens and representative assembled samples.

Figures 5 and 6 show the H-fixture and rocker, respectively, which are components of the stressing assembly, and were fabricated from PH 13-8 Mo stainless steel material. CRES 18-8 bolts with 5/16-18 threads were used as part of the assembly. Figure 7 shows the tools used for loading the samples as well as two fully assembled samples. The appearance of the samples loaded to different percentages of the yield strength and corresponding deflection values are shown in figure 8 for one of the three sets tested. Figure 9 shows close views of representative samples loaded to 90% of the YS.

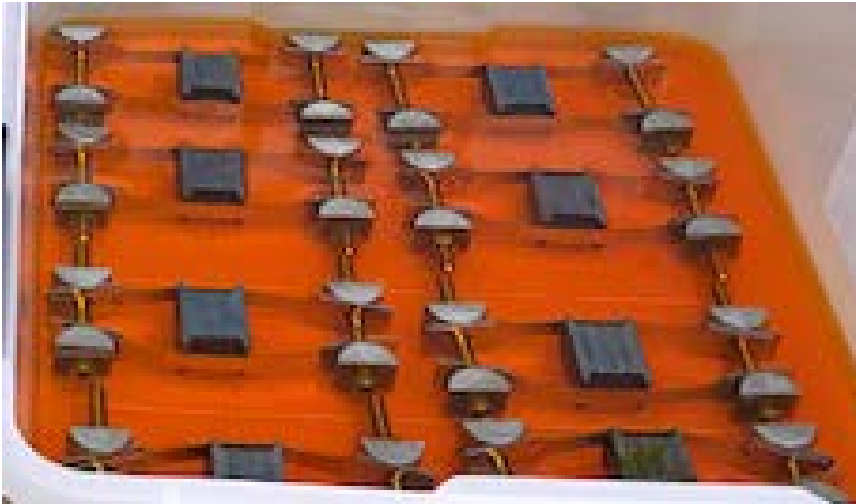
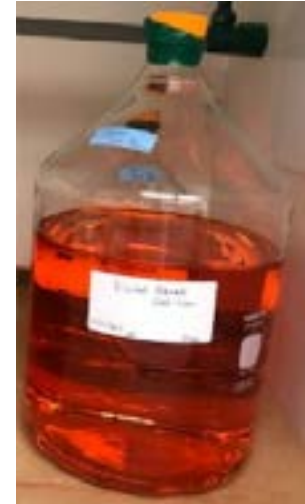
Figure 10. Samples being tested by complete immersion in the diluted ECLSS solution.

After the samples were loaded, they were exposed to concentrated alternate pretreatment (pretreat) stabilizer, diluted pretreat stabilizer, and to 3.5% sodium chloride (NaCl) alternate immersion per reference 8 in replicates of four. Table 3 describes how these solutions were prepared. Exposure in the pretreat solutions was by complete immersion. In the alternate immersion test, for each hour, the samples were exposed to two cycles, an immersion cycle of 10 min, and a drying cycle of 50 min. Those cycles were repeated for the entire length of the test. The pH of the solution during alternate immersion testing was in the range of 6.4 to 7.2. The humidity and temperature conditions in the room were  $45 \pm 10\%$  relative and  $80 \pm 2$  °F, respectively. Figures 10–12 show the specimens in test. Test duration in all environments was 1 yr (365 days).

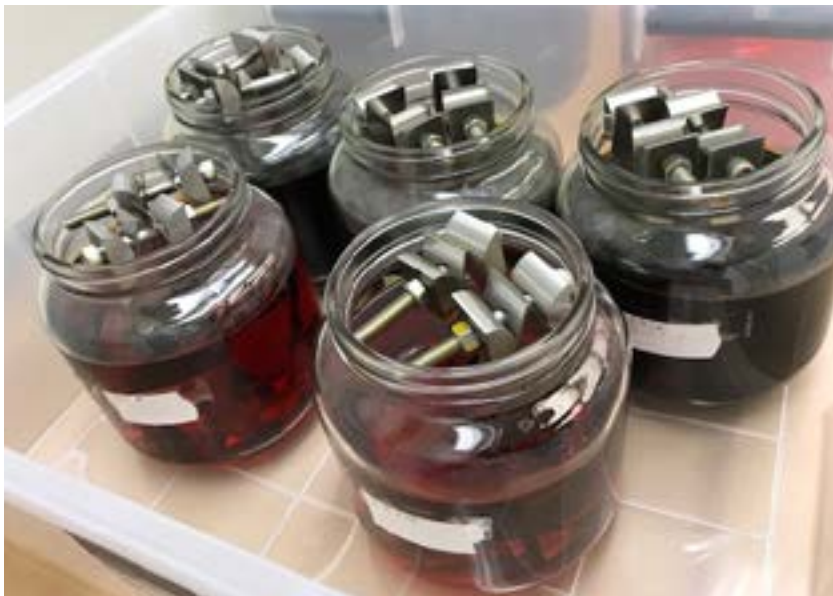
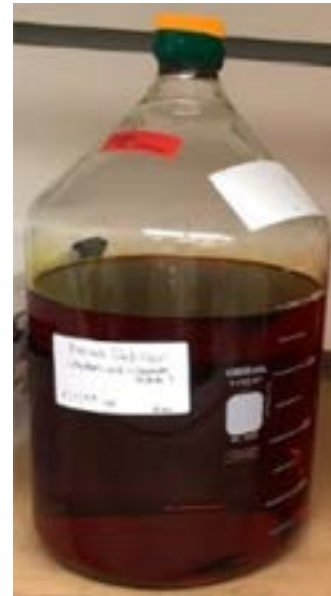
Figure 11. Samples being tested by complete immersion in the concentrated ECLSS solution.

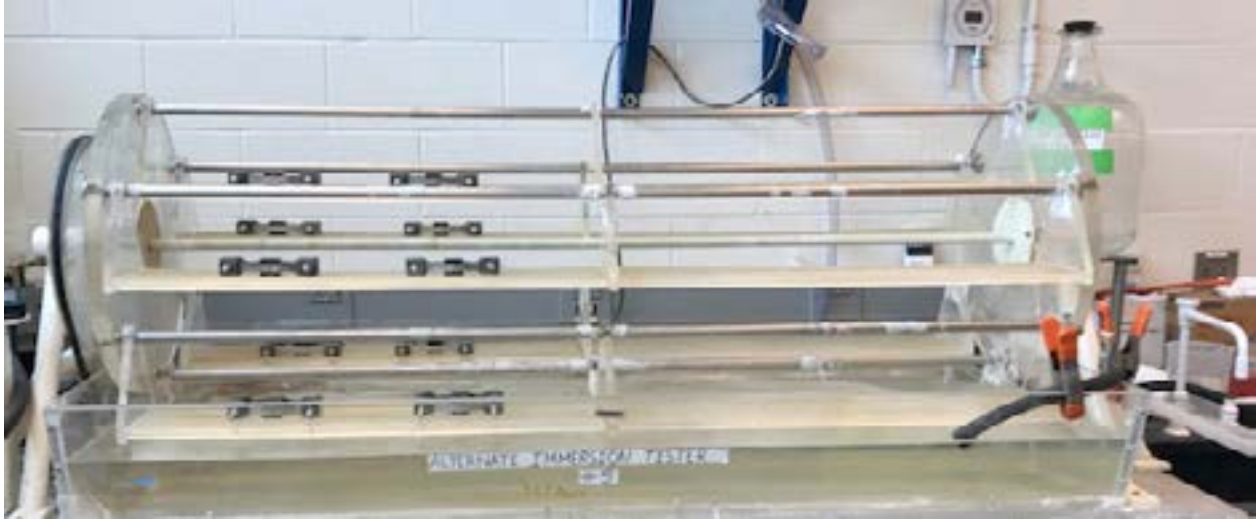
Figure 12. Samples being tested by alternate immersion in 3.5% NaCl solution.

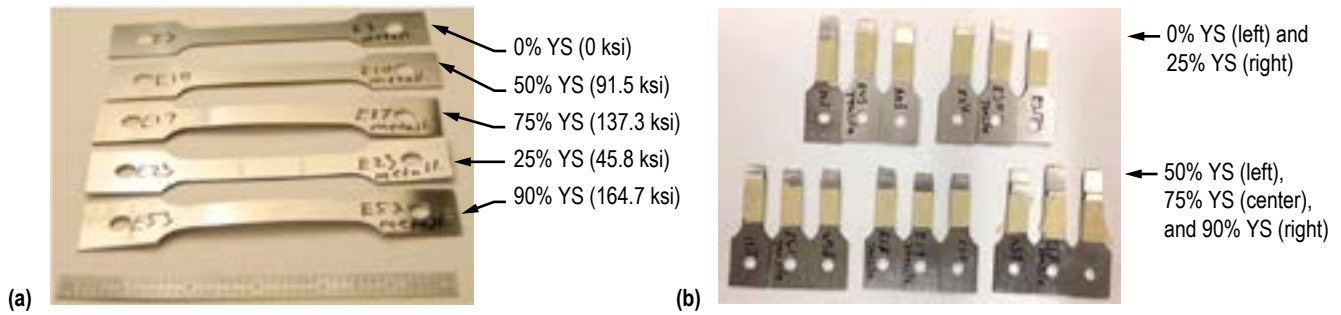
Figure 14. Samples exposed to diluted alternate pretreat stabilizer for 365 days and subjected to post-test evaluations: (a) Used for metallographic analysis and (b) tensile tested.

None of the specimens failed in this test after a year-long exposure, as shown in table 4. After the exposure was completed, the specimens were removed from the environments, washed with water, and disassembled. The specimens subjected to the highest stress levels suffered the most permanent deformation, especially those stressed to 90% YS. For each set of four specimens at the same condition, one was subjected to metallography, and three were tensile tested to determine reduction in tensile strength. The total number of specimens subjected to metallography and tensile testing at the end of the exposure were 15 and 45, respectively. The specimens are shown in figures 13–15.

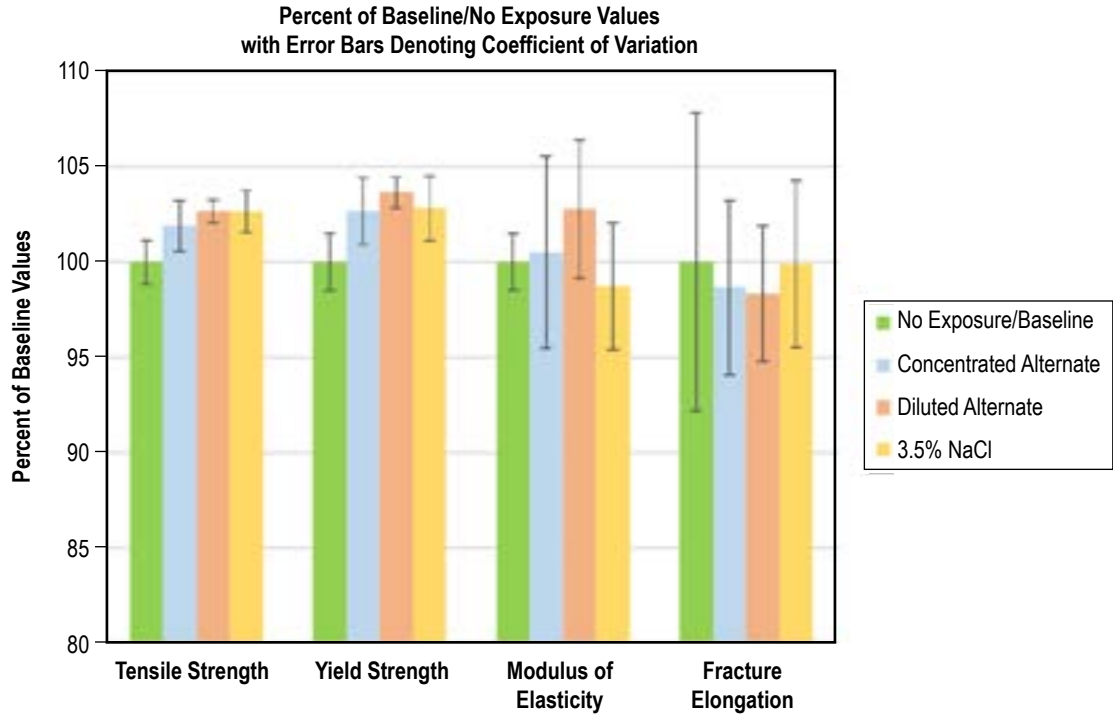
Figure 16. Graphical representation comparing baseline and post-exposure tensile data values.

Tables 5–7 show the tensile tests results after exposure. These tests had the purpose of determining if there was any reduction in tensile strength on the material resulting from exposure. As seen in those tables, no reduction in tensile strength occurred. The prevalent tendency was for the UTS values to be higher than the initial baseline values obtained before the test with non-exposed specimens. A graphical representation comparing baseline and final values for UTS, YS, modulus of elasticity, and elongation is presented in figure 16. Figure 17 shows stress-strain curves for normalized values for nonexposed and exposed specimens, and figure 18 illustrates the averages of these normalized values. All tensile data values used to generate these illustrations are presented in appendix C. Metallographic evaluations were performed and no stress corrosion was observed in any of the samples. Metallographic views are presented in figures 19–33.

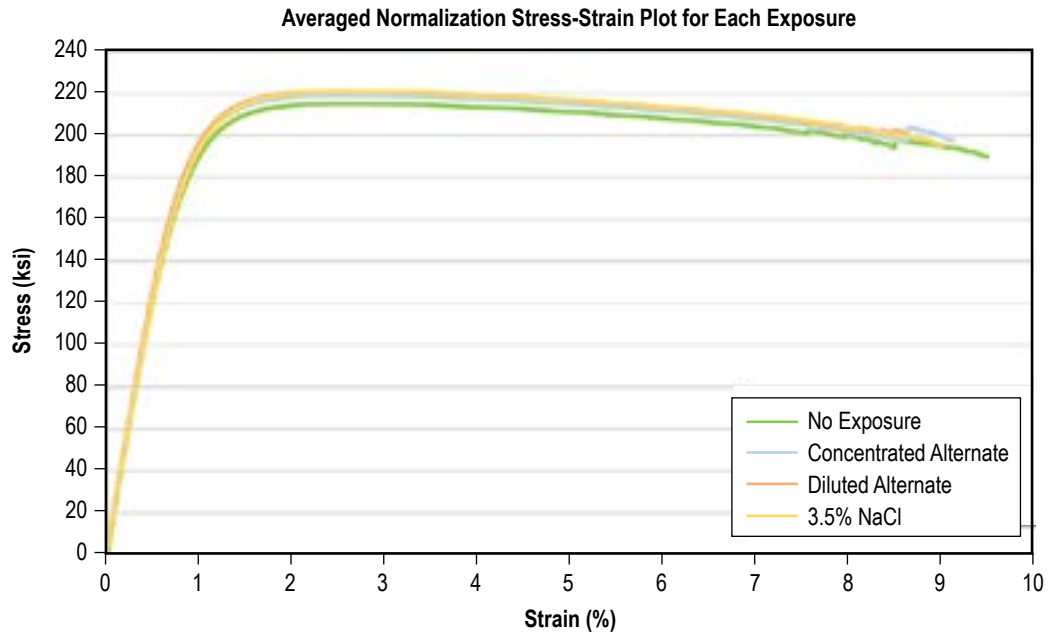
Figure 18. Stress-strain curves for averages of normalized values.
