# Mechanical Tensile Testing of Hiperco 50A at Cryogenic Temperature

Cryogenics and Fluids Branch

NASA Goddard Space Flight Center

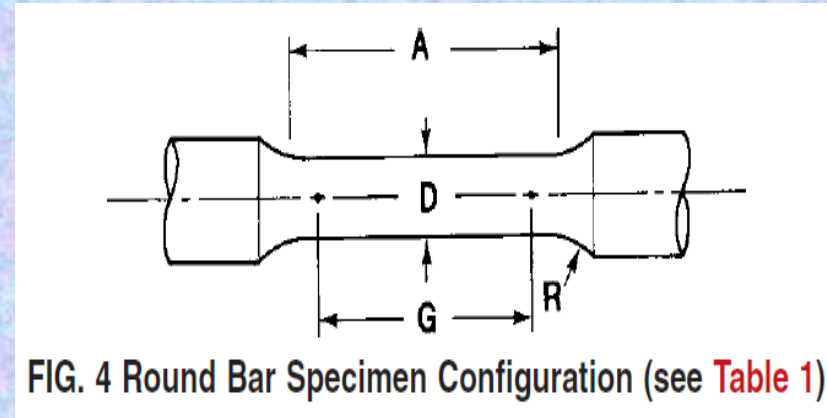
FIG. 4 Round Bar Specimen Configuration (see Table 1)

(b) U.S. Customary Versions G/D ratio = 4 (dimensions, in.)	Standard Specimen	Standard Small Specimen
Nominal Diameter	0.5	0.25
G, gage length	$2.000 \pm 0.005$	$1.000 \pm 0.005$
D, diameter	$0.500 \pm 0.010$	$0.250 \pm 0.005$
R, fillet radius	0.375	0.1875
A, reduced section	2.25	1.25

- Requirements
  - The specimen design was guided by ASTM Standard E8 and 1450. **Mechanical failure must occur in the gage length section**
  - Specimens must receive the same annealing schedule that the flight hardware in the Resolve ADR receives.

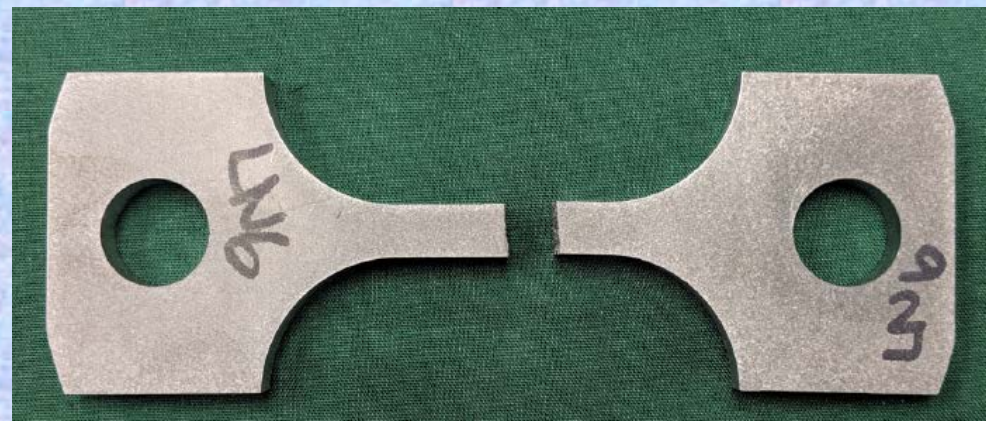
Broken Specimen  
in gage section

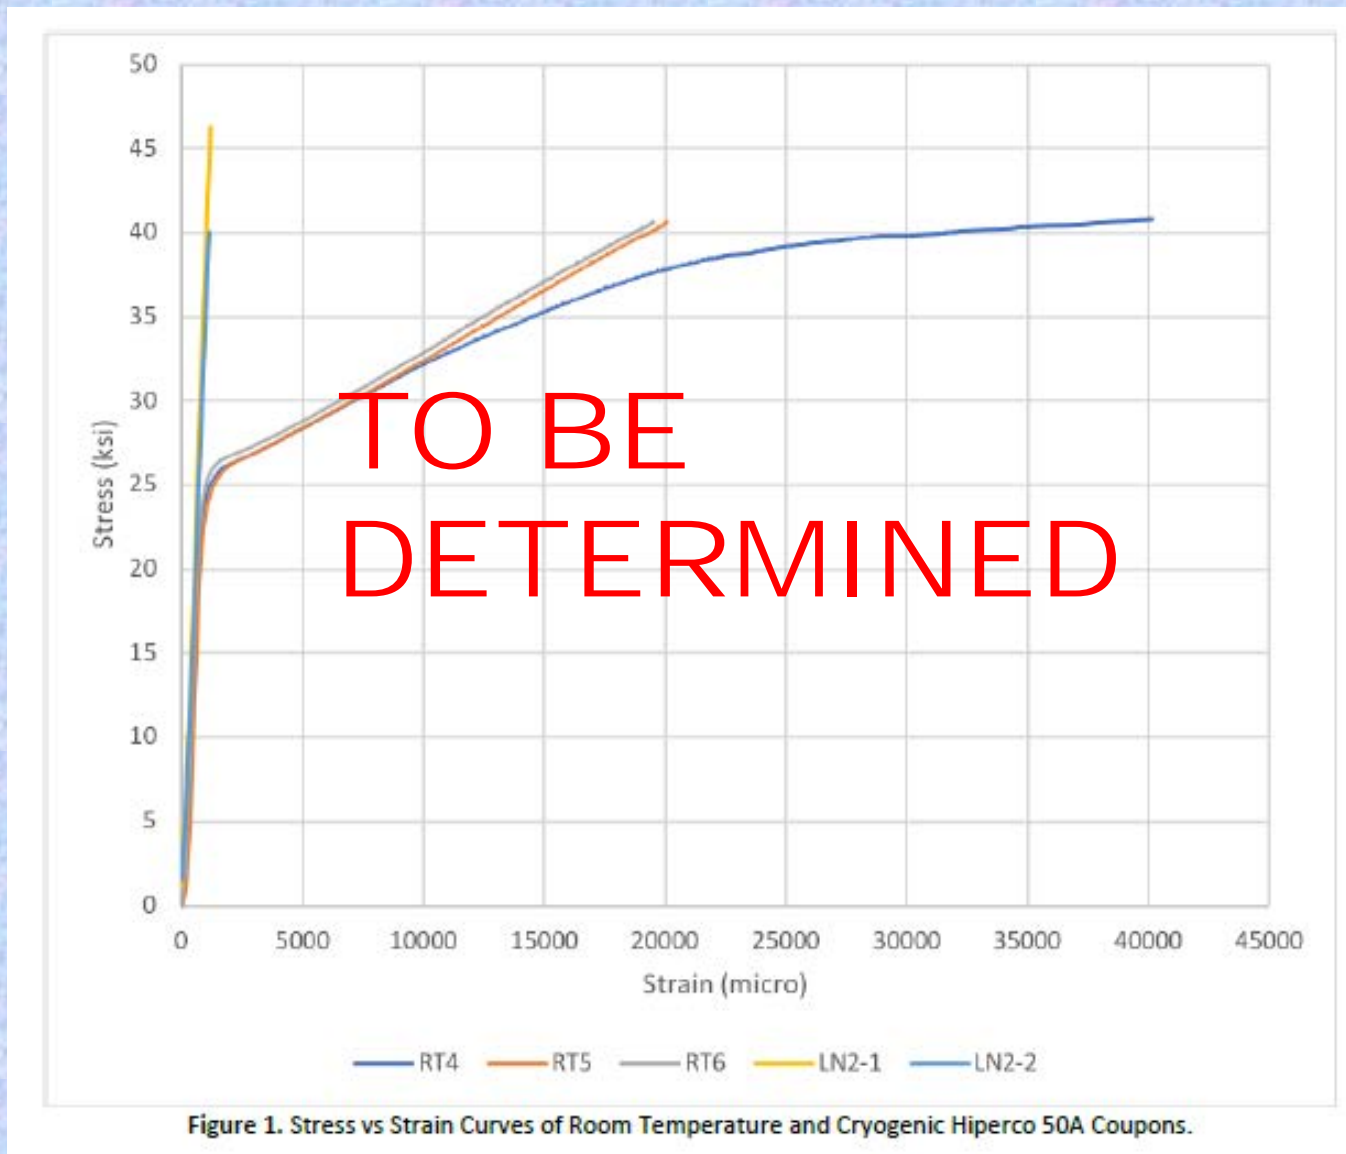
## Engineering Stress vs. Strain
