## **Proton Testing of AMD e9173 GPU**

Test Date: 2 June 2019  
Report Date: 22 July 2019

Single-Event Effects (SEE) testing was conducted on the AMD e9173 Graphics Processor Unit (GPU); herein referred to as device under test (DUT). A product brief<sup>1</sup> is provided below.

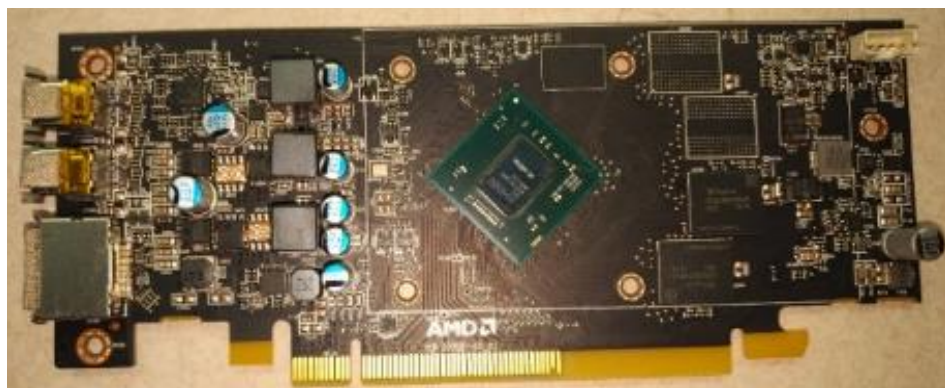
Figure 2: AMD e9173 GPU as-tested

The AMD e9173 GPU is a graphic coprocessor for use in a modern commercial off the shelf (COTS) computer. It was cannibalized from a Dell Wyse 5070 thin client computer. The carrier board is connected to the computer motherboard via a PCI-e x16 slot. The GPU die, itself, is the device under test (DUT) and is located underneath the unit's heat sink. Figure 1 shows pictures of the graphics card without its heatsink. Table 1 gives information on this part.

<b>Quantity</b>	1
<b>Part Model</b>	e9170
<b>Board Model</b>	e9173 AMD Radeon Embedded
<b>REAG ID</b>	19-022
<b>Manufacturer</b>	TSMC
<b>Technology<sup>2</sup></b>	14nm FF
<b>Packaging</b>	Flip Chip, BGA
