Basics of Failure Analysis

Lyudmyla Ochs, NASA GSFC 562

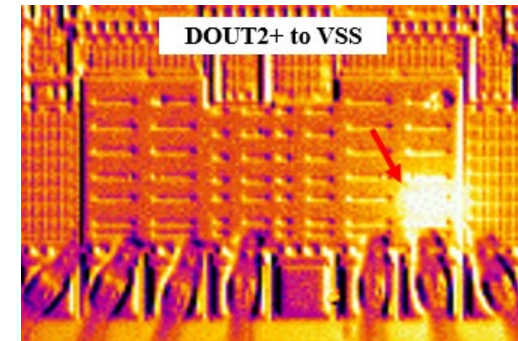
Example of Failure Analysis Flow

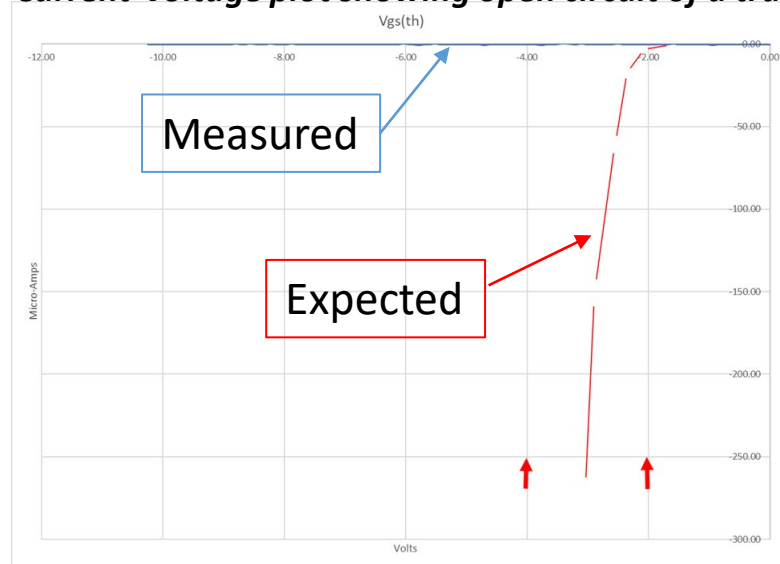
Current-Voltage plot showing open circuit of a transistor

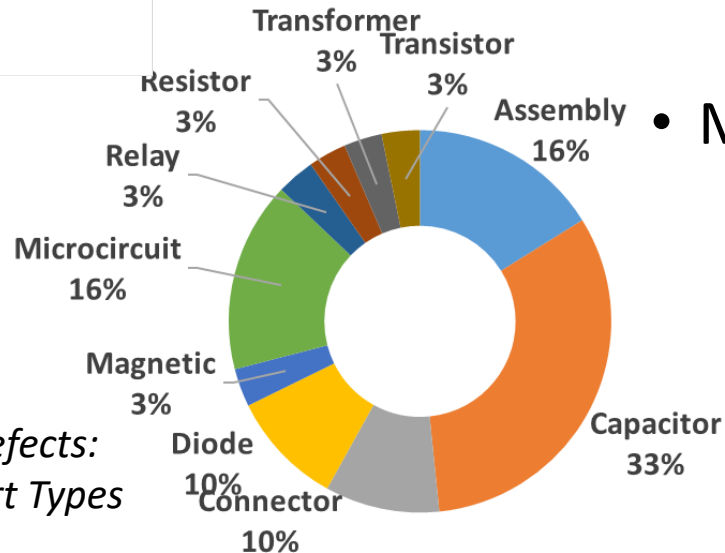
- Perform 20-30 failure analyses (FA) per year, mostly for NASA GSFC projects
- FA is usually requested when EEE part has been identified as suspect or faulty during assembly inspection or testing
- Most common EEEE parts submitted for FA:
 - Microcircuits - 37%
 - Capacitors - 17%
 - Hybrids , diodes, transistors- 6% each
- Most common failure categories:
 - Electrical Over Stress (EOS) – 29%
 - Lumping ESD and EOS together for this statistic
 - Manufacturing Defects – 24%
 - Most devices with manufacturing defects that come to FA are capacitors

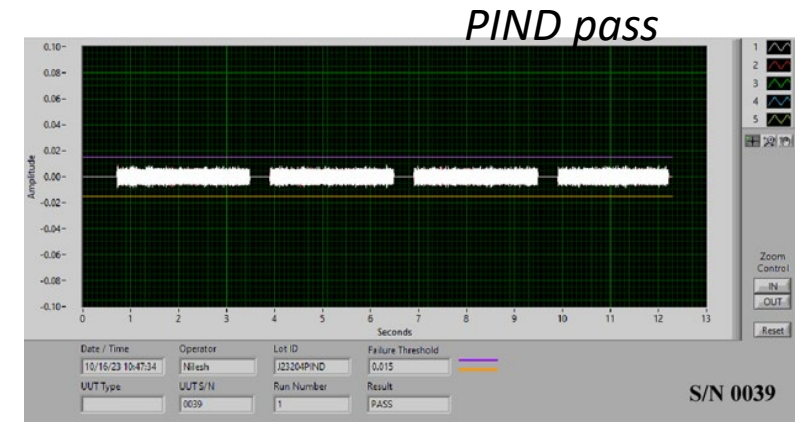
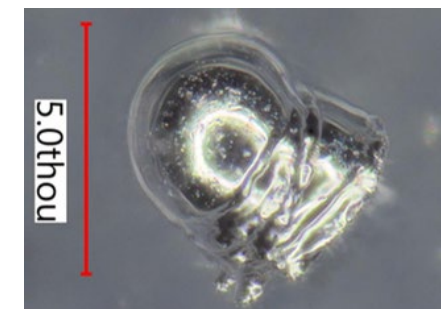
- Not very common in Failure Analysis, since aggressive shaking may dislodge a particle that is already causing a short
