Comparison of Anthropomorphic Test Device and Human Volunteer Responses in Simulated Landing Impact Tests of U.S. Space Vehicles

Teresa M. Reiber¹, Preston C. Greenhalgh, Keegan M. Yates, Rachel L. Thompson, Aaron M. Drake, and Nathaniel J. Newby
KBR, Houston, TX, 77058

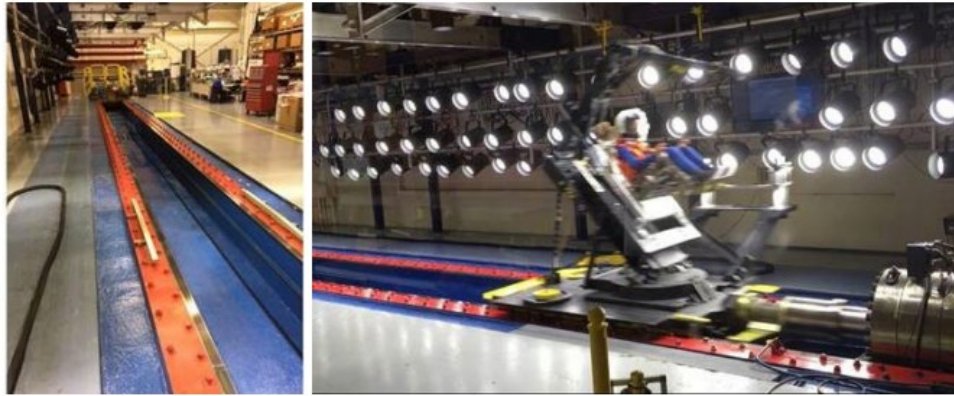
Figure 1. The horizontal impact accelerator (HIA) at Wright-Patterson Air Force Base. The photo on the left shows the sled track, and the photo on the right shows an ATD suited test [4].

All tests were conducted on the Horizontal Impulse Accelerator (HIA) and the Vertical Deceleration Tower (VDT) at WPAFB. The HIA is a horizontal impact facility that uses a thrust piston to impart an acceleration pulse to a stationary sled pushing it down a track at pre-determined acceleration levels and rise times [4]. The VDT is a vertical impact facility that raises a carriage up to pre-determined drop heights and then releases it into a free-fall guided by rails to achieve the desired acceleration and velocity levels when the carriage contacts an impact surface. Acceleration rise times, representing the rate of deceleration, are controlled with various shaped plungers mounted on the back of the carriage which displace water from a tank located at the base of the facility during the impact. With both test devices, the vehicle seat and restraint system were mounted to the HIA sled and VDT carriage. The test facilities have video systems to capture high-speed video at multiple angles and they also have on-board data collection systems to collect the carriage and sled accelerations, as well as the data from the instrumented ATD and human subjects.

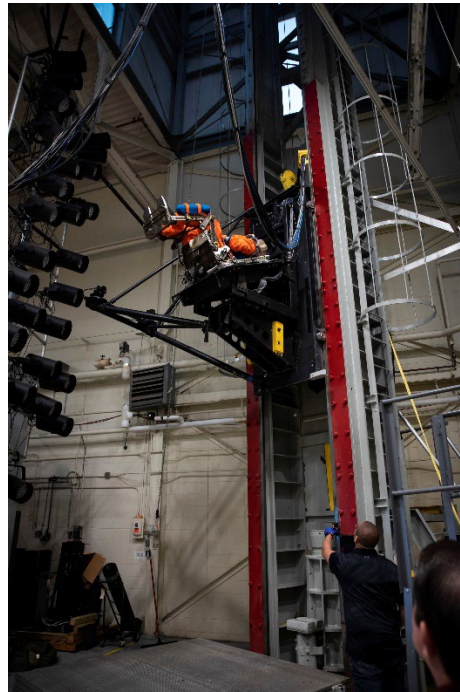
Figure 2. The vertical deceleration tower (VDT) at Wright-Patterson Air Force Base. The photo shows a human subject being raised to the required drop height [5].

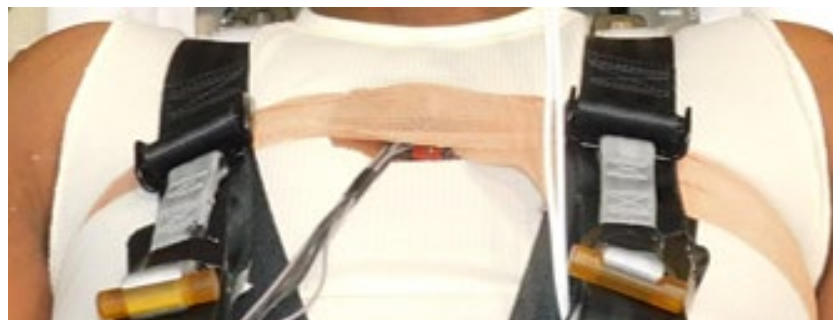
Figure 4. The chest accelerometer was affix to subjects with double-sided carpet tape in a whole in their shirt. The accelerometer was also wrapped in athletic tape around the torso to provide more stability.

sensor to measure head linear and angular acceleration and head angular velocity (Figure 3). In tests with the full IVA suit, including a “bubble” helmet, the bite-block was not compatible due to interference between the front of the helmet and bite-block. A novel mouth guard set-up was used when testing this suit configuration. This mouthguard was a commercial sports mouthguard composed of a flexible rubber compound that had a slot over the mouth where the sensor package could be inserted for a compression fit (Figure 3). An additional tri-axial accelerometer was mounted to subjects’ chests with two-sided carpet tape (Figure 4).
