ISS EXTERNAL MICROORGANISMS: COLLECTING PLANETARY PROTECTION SAMPLES DURING EXTRAVEHICULAR ACTIVITY

National Aeronautics and
Space Administration

310-02

05/08/2024

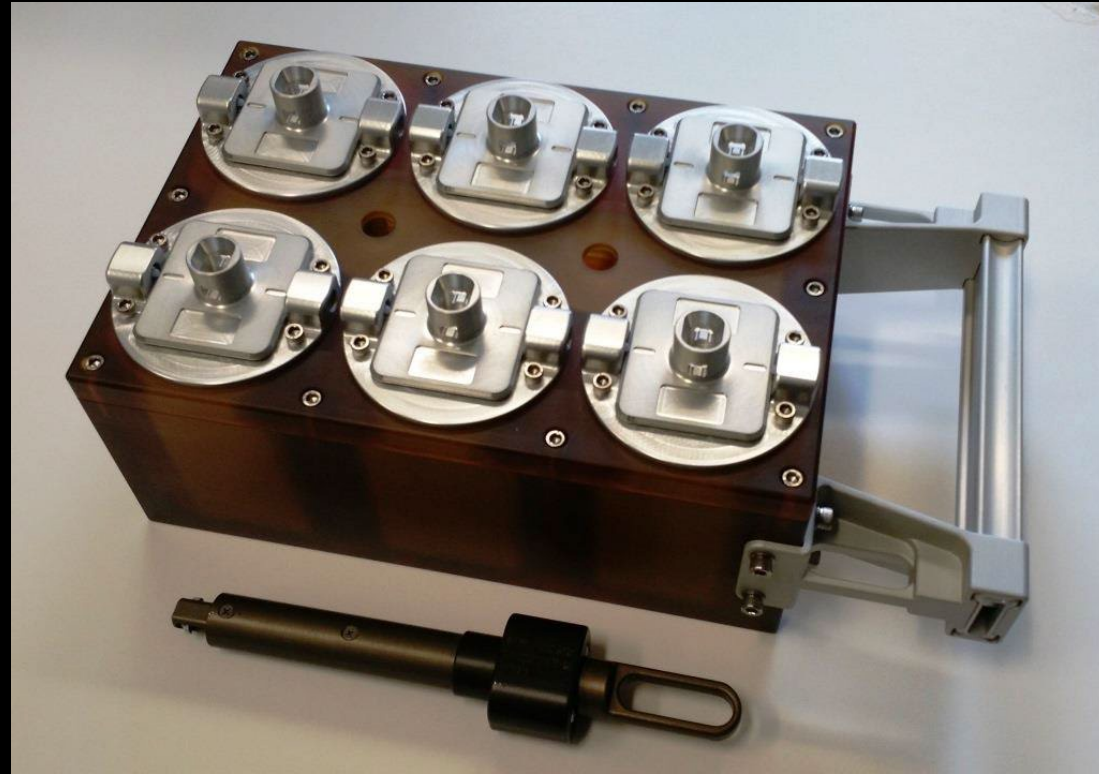
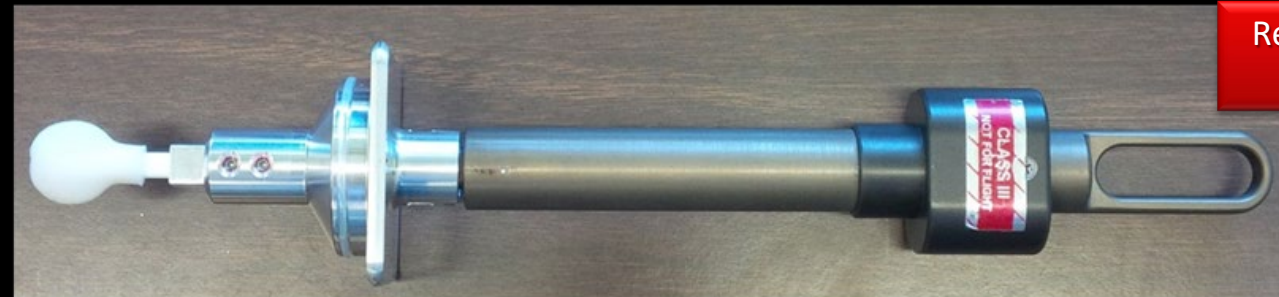
PROTOTYPE PAYLOAD 8-SAMPLE EVA SWAB KIT

- 6 on top, 2 on bottom (not shown)
- 0.22 micron pore Microbial filter in bottom of each container to accommodate pressure changes

Repurposed Shuttle tile repair handle

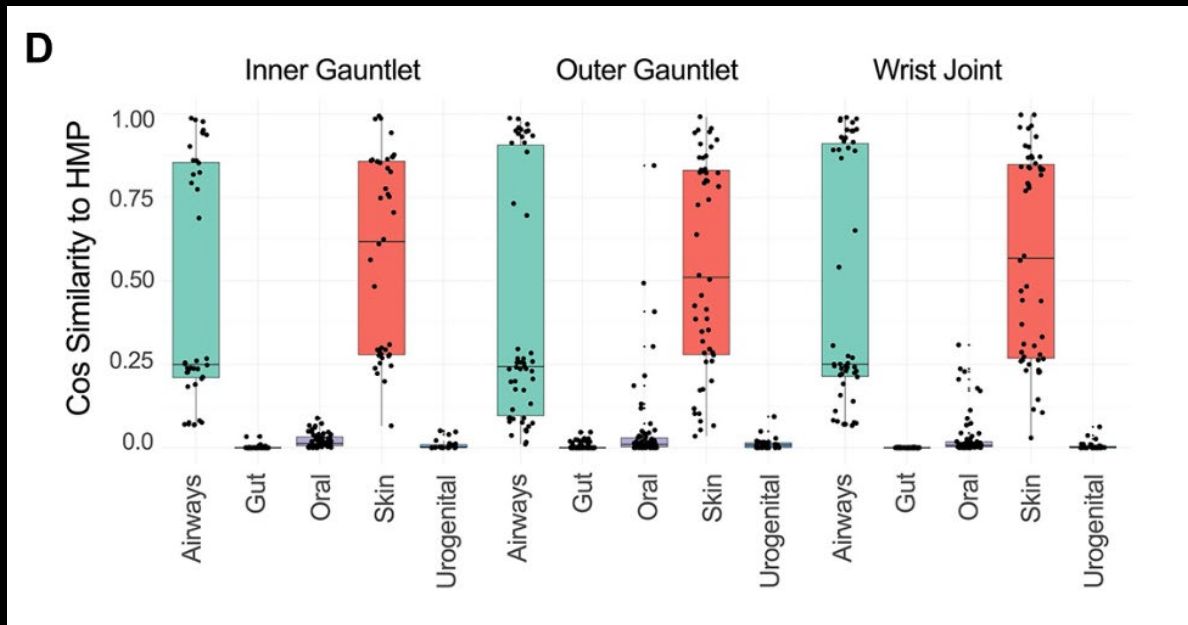
MICROBES ON SPACESUITS ARE SIMILAR TO MICROBES FROM HUMAN SKIN AND AIRWAYS

- We used Shotgun metagenomic sequencing to further characterize the microbial community in these samples
- Spacesuits are cleaner than human skin but external surfaces are not sterile.

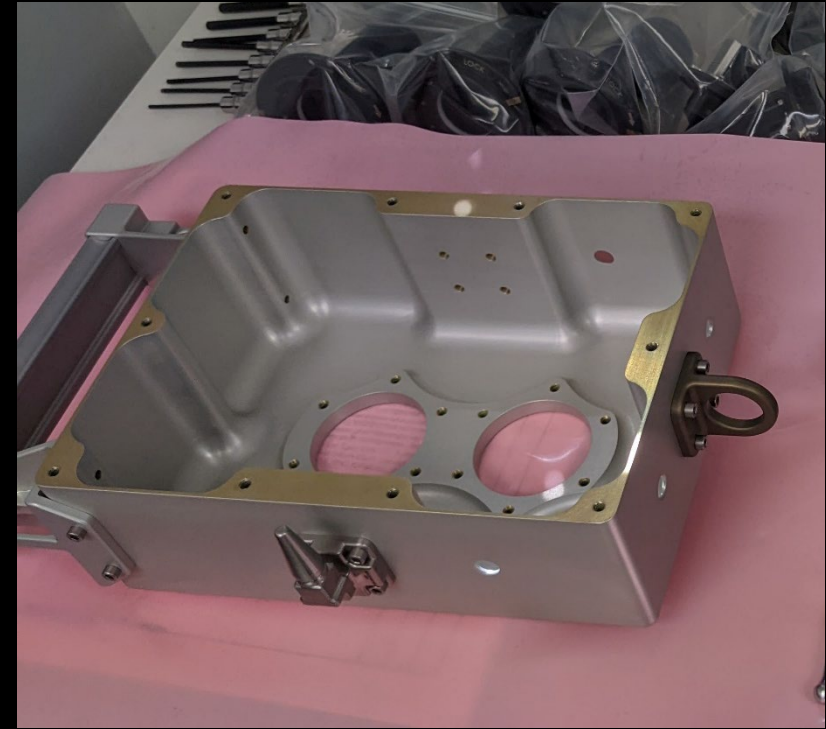
ULTEM replaced with Aluminum

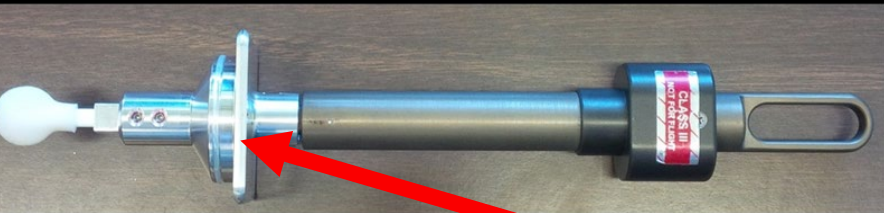
Tether point and bayonet probes added

ULTEM replaced with Aluminum

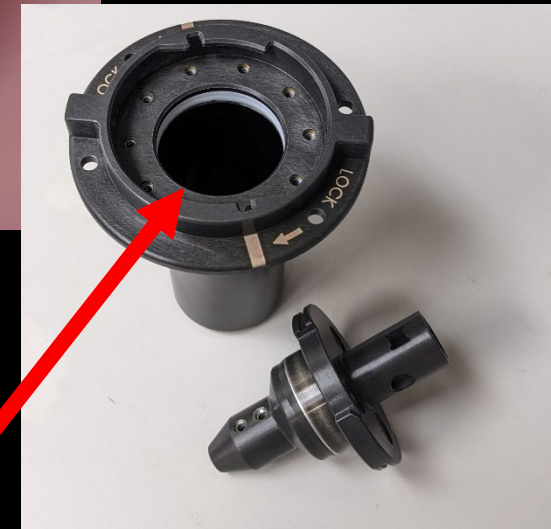
O-Ring replaced with a captured seal

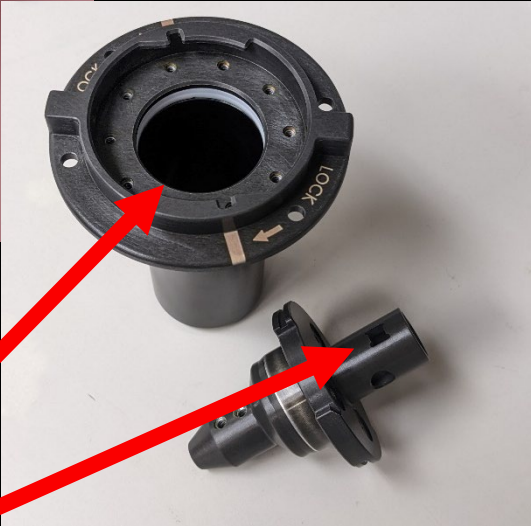
Twist to open with a secondary locking feature

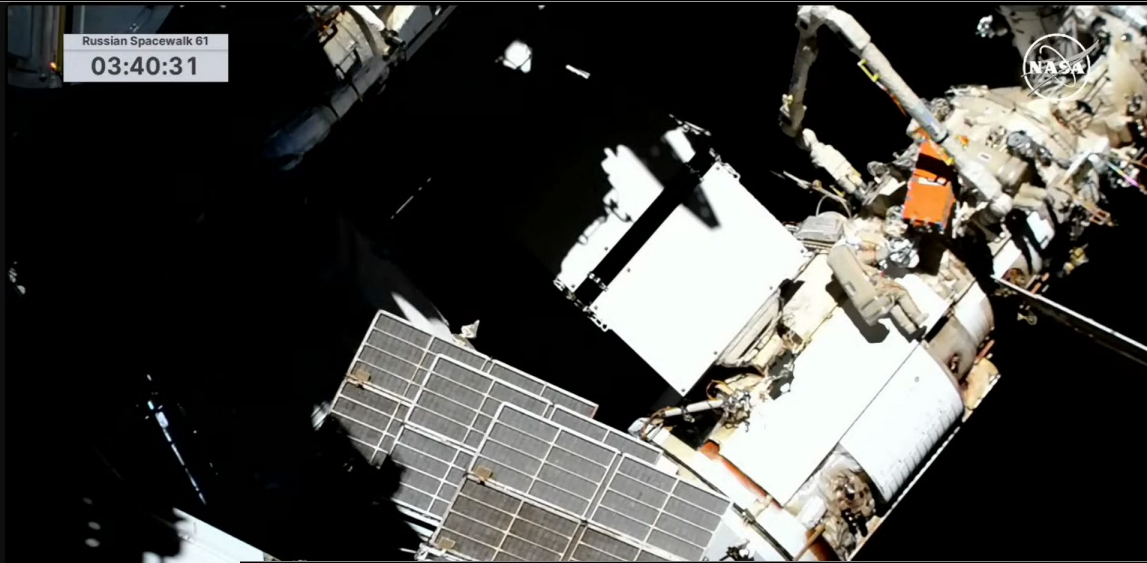
- Radiator coolant leak delayed US EVA's
- Coolant is non-toxic silicone oil
