Lessons Learned from Particulate Characterization Laboratory Anomalies*

Benjamin Greene, Ph.D.
Karysta B. Donisthorpe
Sierra Lobo, Inc.
NASA White Sands Test Facility
Las Cruces, New Mexico

Mark B. McClure
NASA White Sands Test Facility
Las Cruces, New Mexico

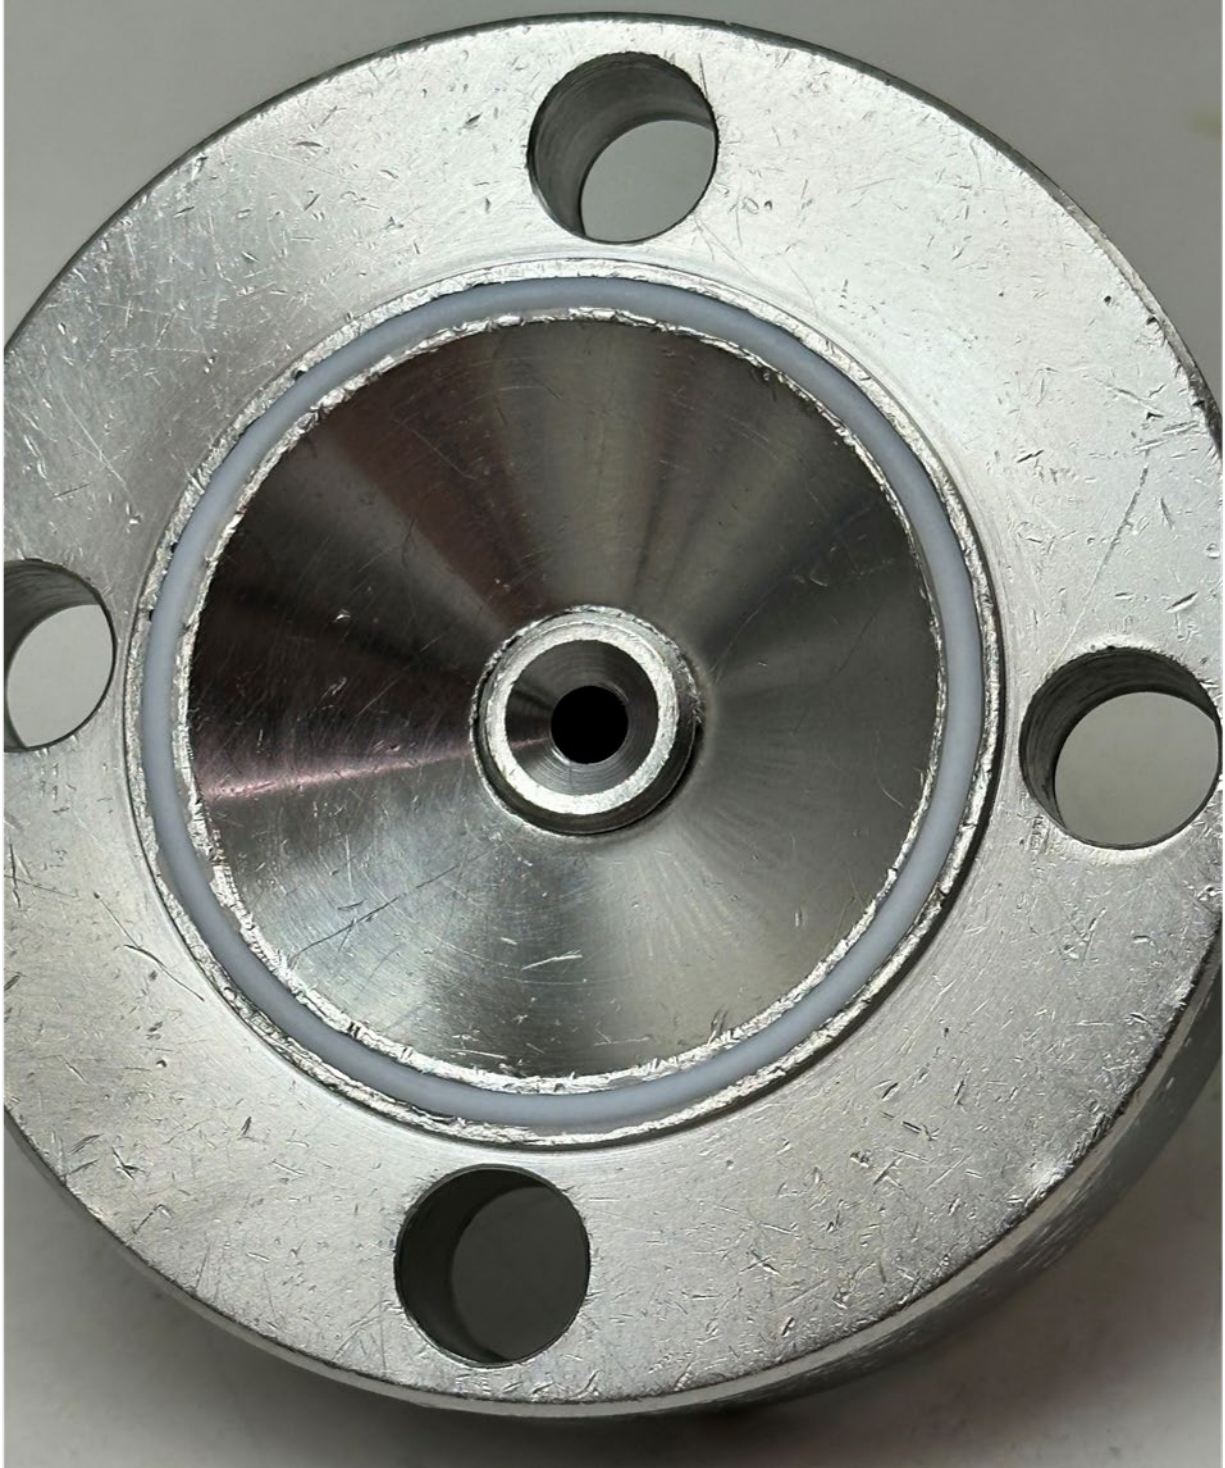
Figure 1. 4-Bolt Assembly

Note surface wear, abraded metal, and the O-ring extruding from the gland.

The 4-bolt assemblies are nominally 60 years old and show more visible wear than the 6-bolt assemblies. Many of the 6-bolt assemblies are at least 20 years old. Nevertheless, all filter holder surfaces showed abraded metal surfaces with the potential to release metallic particulate and compressed O-rings with the potential to release PTFE particulate with both metallic and O-ring particulate capable of being trapped on the membrane filter surface, be counted as particulate, and contribute if not cause particulate specification failure. In addition, a 4-bolt design is preferred over a 6-bolt because with less bolts, there is less chance of producing metallic and grease particulate. Some of the oldest 4-bolt assemblies were fitted with pipe-threaded connections creating areas of entrapment for particulate, and these were taken out of service. The lab is currently looking at options to replace existing Millipore filter housings with a more practical design and with O-ring glands and O-rings that fit properly. In future applications, pressure rating might be reduced over existing 10,000 psi filter holders because high pressure is rarely encountered when sampling from a pressurized source to ambient.

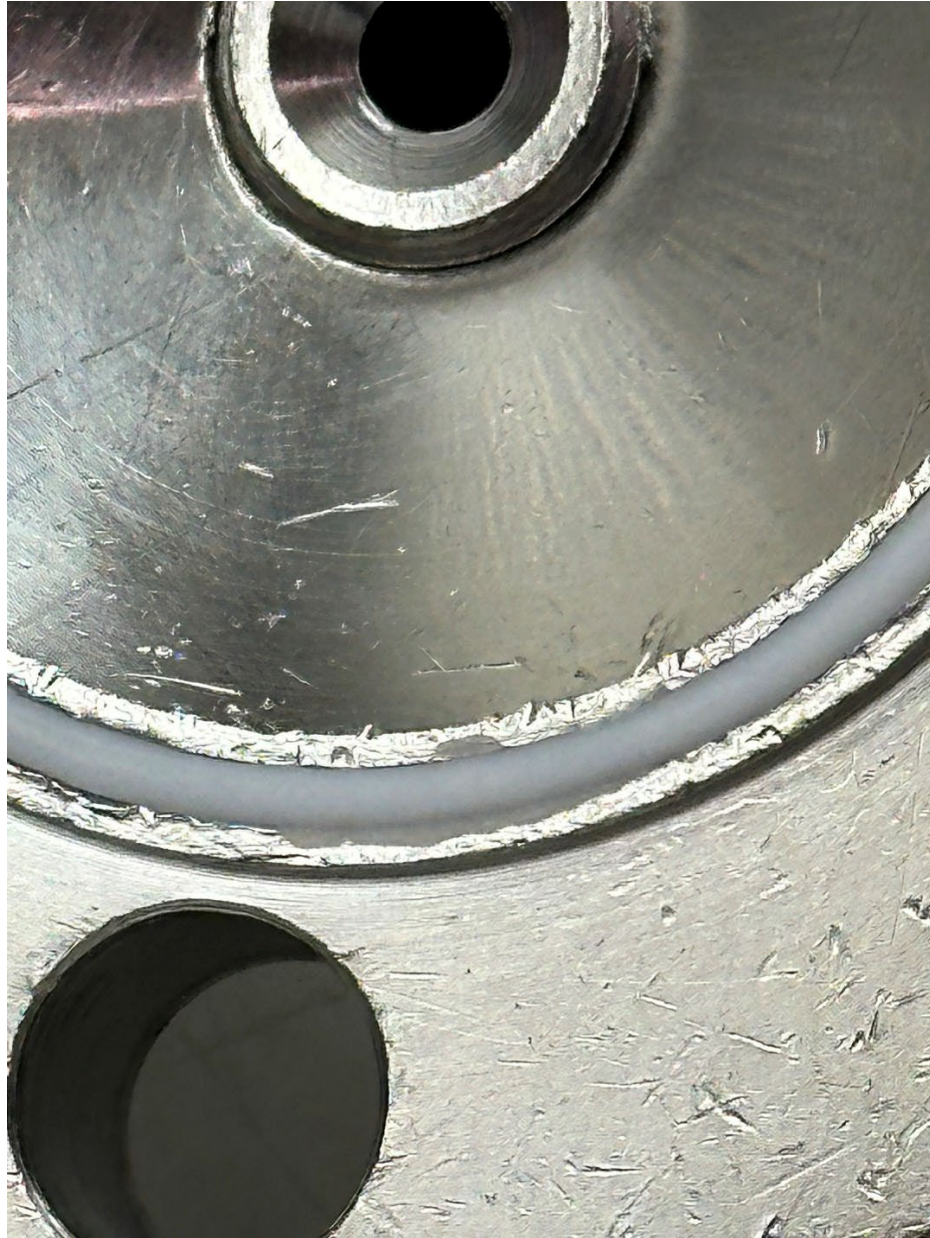
Figure 2. Close-Up of 4-Bolt Assembly

Note surface wear, abraded metal, and the O-ring extruding from the gland.

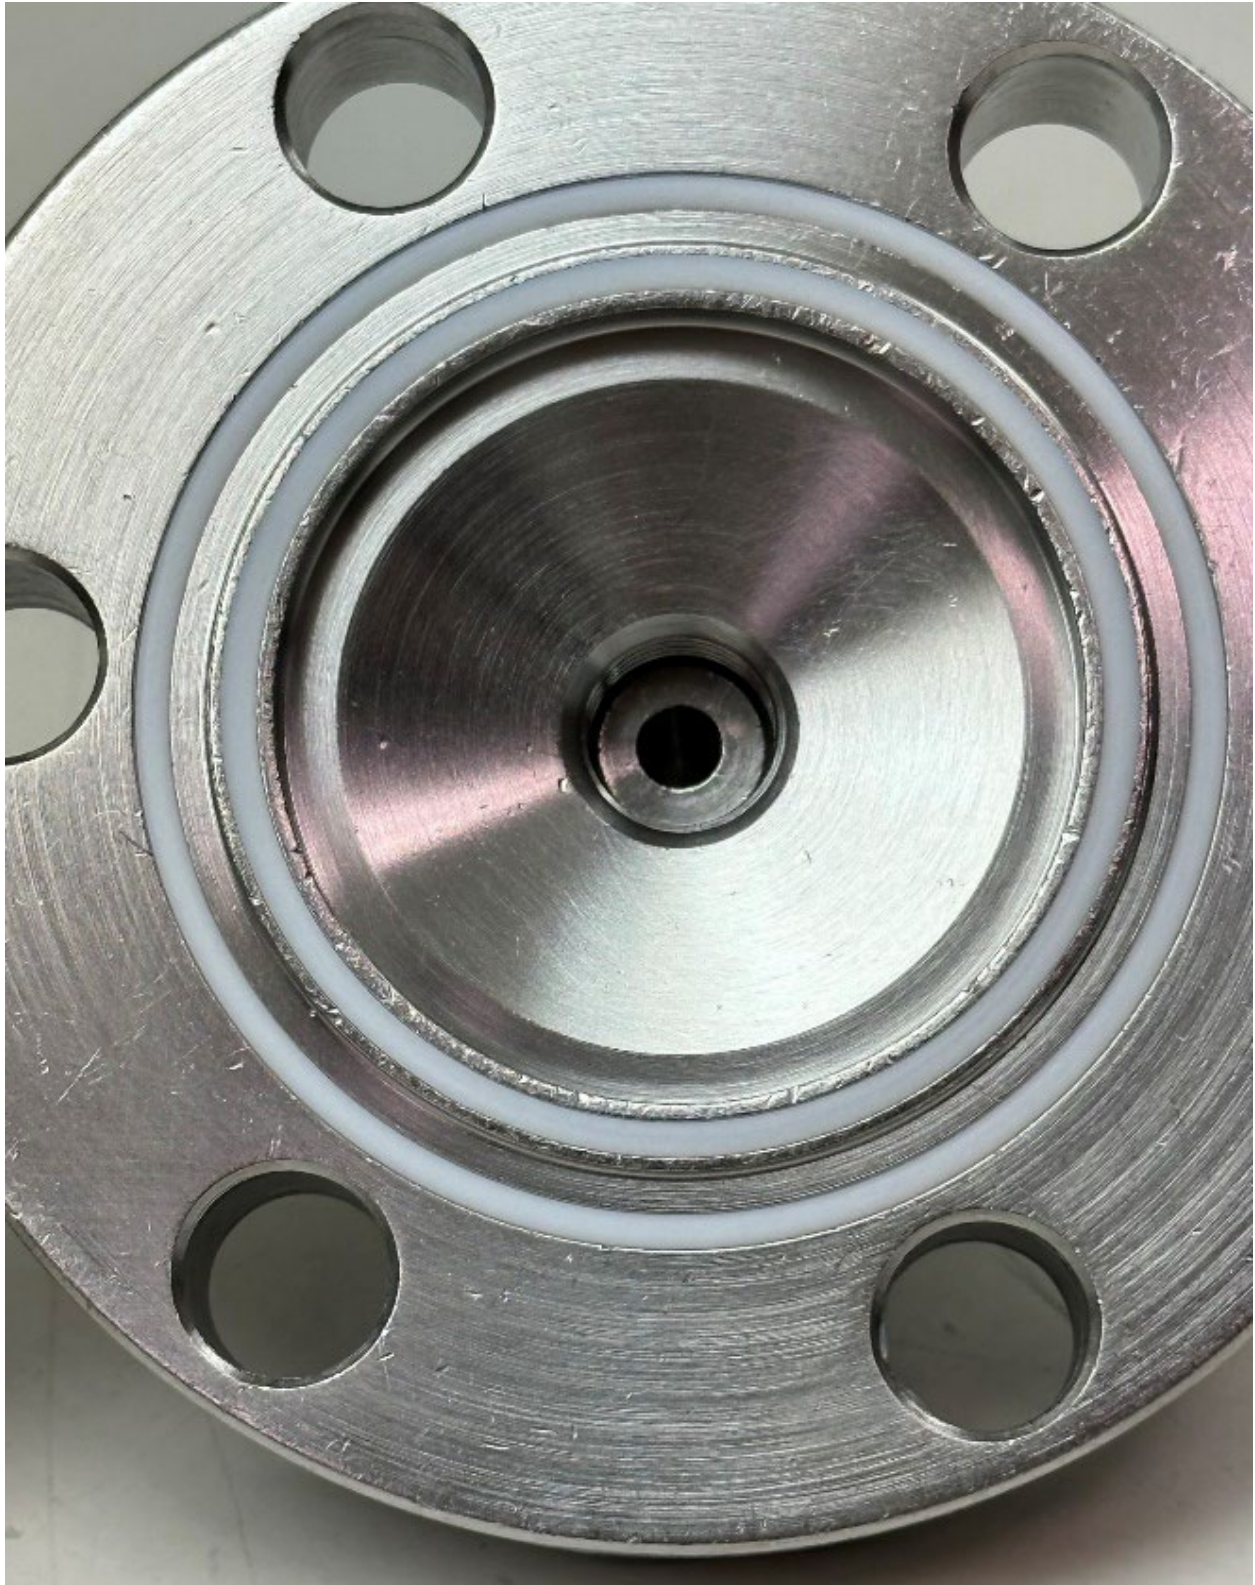
Figure 3. 6-Bolt Assembly

Note reduced but visible surface wear and abraded metal compared to a 4-bolt assembly.

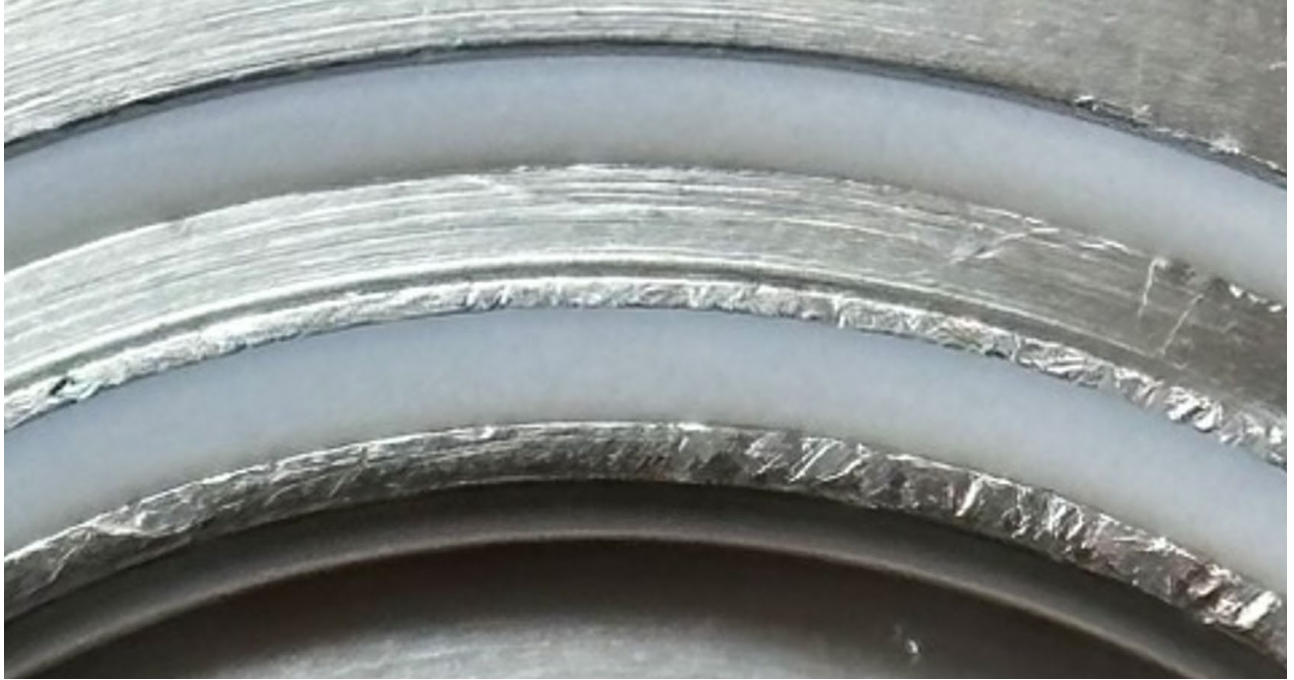
Figure 4. Close-Up of 6-Bolt Assembly
Note visible surface wear and abraded metal.

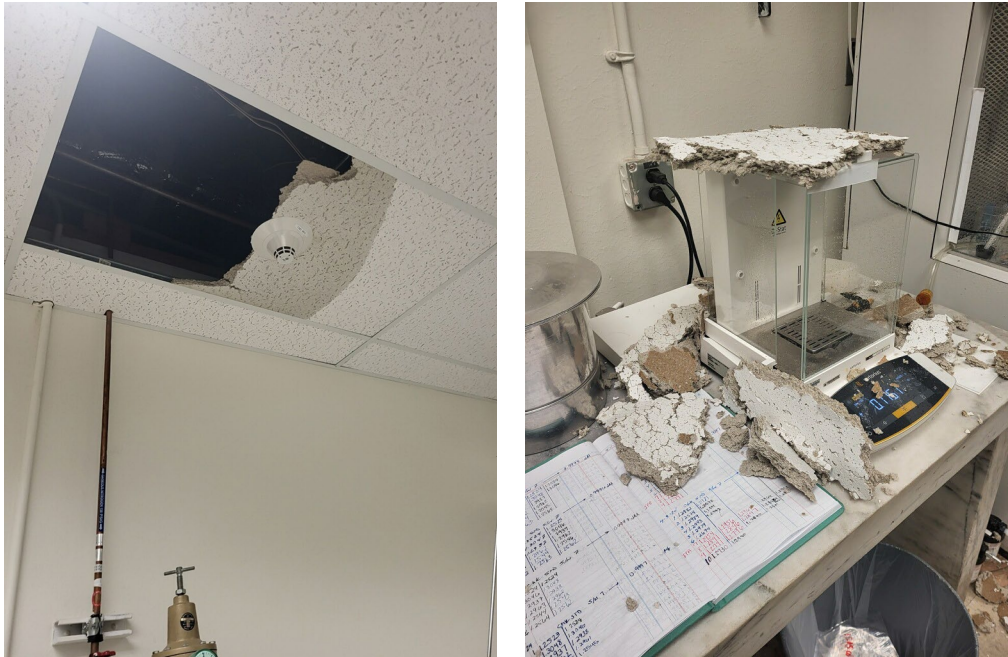
Figure 6. Ceiling Tile Collapse Causing Temporary Disruption in Workflow
Note the flow bench to the right of the balance.

To ready the lab for precision particle counting, the entire lab was cleaned, the balance was restored, and both the flow benches were recertified. The filtered nitrogen supply enabled the lab to validate gas samples could be collected, and particulate counts could pass specification without contamination from ceiling tile and construction FOD and demonstrated the resilience of the lab with the new procedures despite the interruption.
