# Impact Testing of 410 Stainless Steel for Material Impact Model Development

*Duane M. Revilock, Charles R. Ruggeri, and J. Michael Pereira*  
*Glenn Research Center, Cleveland, Ohio*

A project is underway to develop a consistent set of material properties, impact test data, and failure analysis for a variety of metallic aircraft materials that can be used to develop improved impact failure and deformation models. This project is jointly funded by the NASA Glenn Research Center and the Federal Aviation Administration William J. Hughes Technical Center. Particular features of this set of data are that all material property and impact test data are obtained using traceable material, the test methods and procedures are extensively documented, and all the raw data are available. Four parallel efforts are currently underway: measurement of material deformation and failure response over a wide range of strain rates and temperatures, failure analysis of material property specimens and impact test articles, development of improved numerical modeling techniques for deformation and failure, and impact testing of flat panels and substructures for model validation.

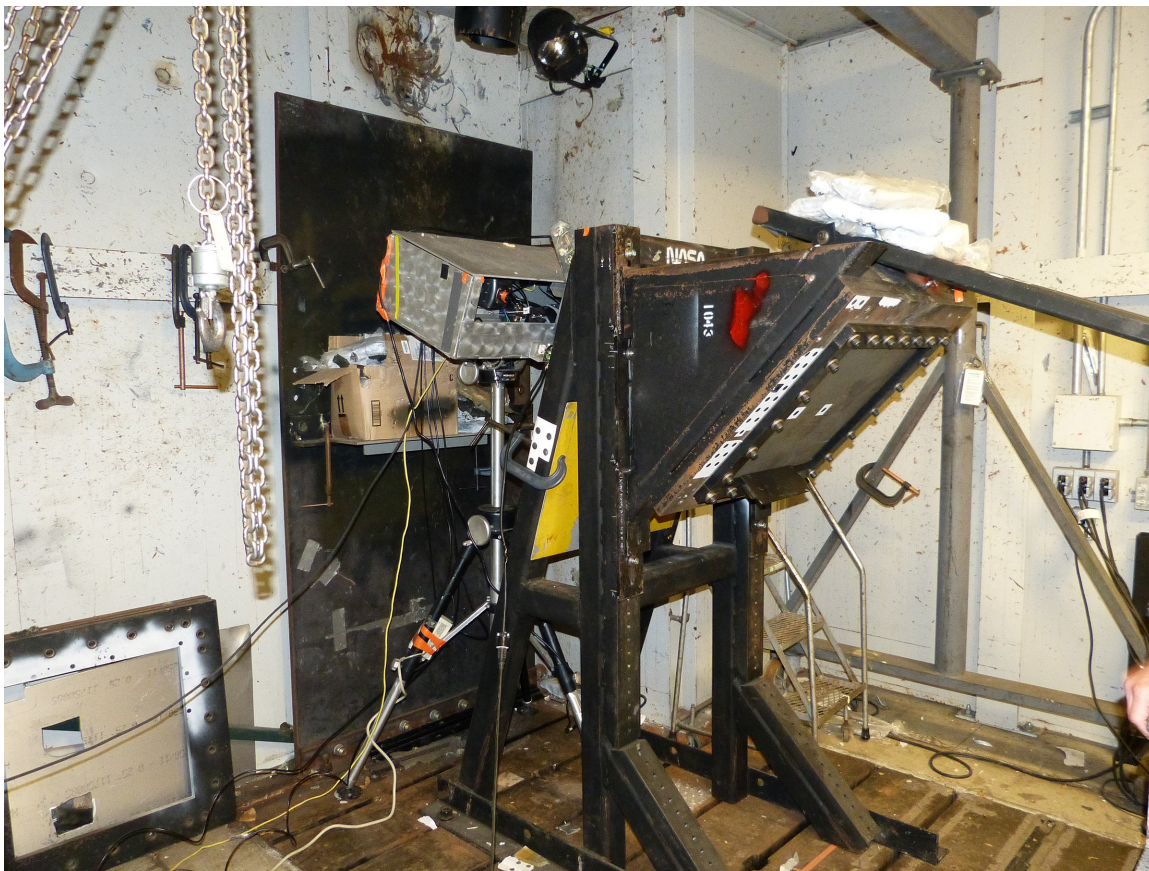
Figure 9.—Large panel test setup showing orientation of projectile and test specimen.

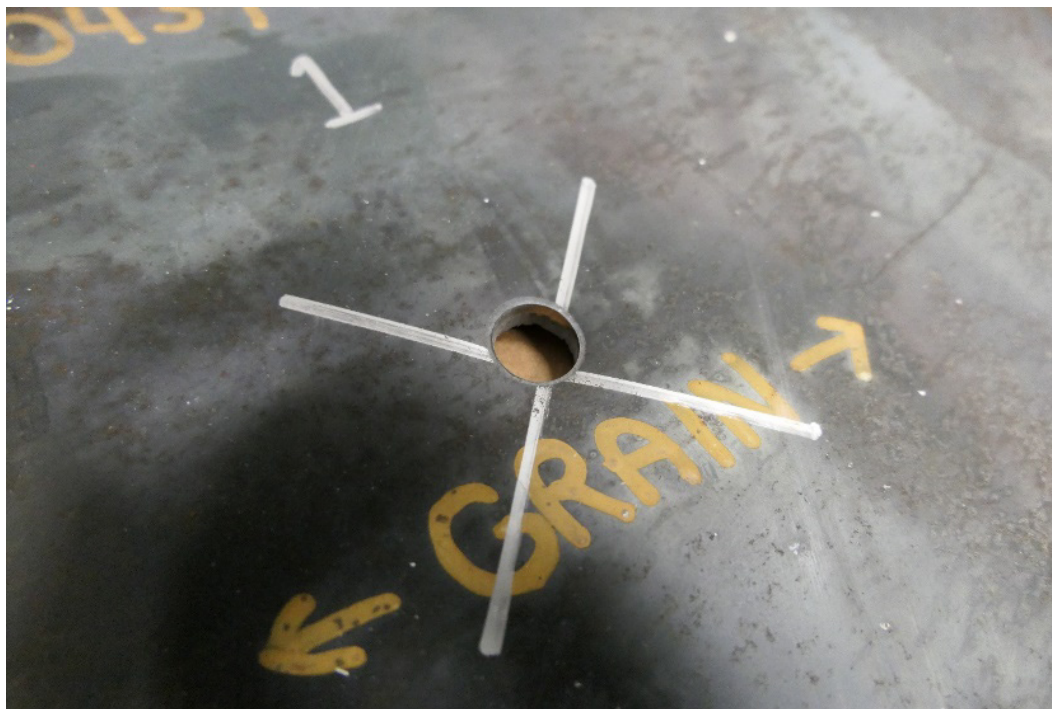
Figure C.4.—DB275: Posttest front view.
