# Harness Thermal Heat Loss Measurement for a Lunar Surface-Deployed LEMS Artemis III Payload

The Lunar Environment Monitoring Station (LEMS) is an autonomous, survive-the-lunar-night seismic suite to be deployed on the Lunar surface by the Artemis III crew and designed to operate continuously for two years. It will see the extremes of the Lunar south pole thermal environment where surface temperatures range from -200°C to +20°C and where nighttime duration is at least 354 hours. Given power and mass constraints, the thermal system is limited to 2.5 Watts of heat during the lunar night. The electrical harnessing named the Signal and Power Passthrough (SAPP) was designed to minimize heat loss while meeting power and signal integrity requirements. To mitigate risk due to uncertainty associated with the harnessing materials, routing, and tie-downs, a flight-like thermal conductance test was performed to measure the heat loss. The test methodology, results, and model correlation are presented.

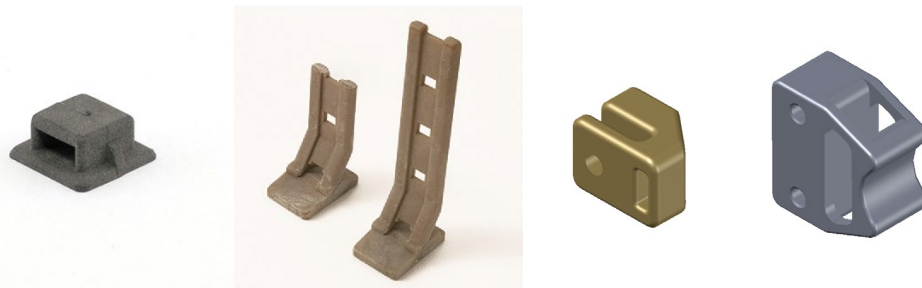
**Figure 7: SAPP standoffs for tiedowns. (left to right) ClickBond CB9302, ClickBond CB9257, custom external, custom internal**

In addition to low thermal conductivity wires, the SAPP heat loss was further minimized by maximizing the conductor length. The harness was secured to the structure with Ultem 1000 thermally insulating standoffs like the ClickBond CB9302, ClickBond CB9257 (a.k.a ClickBond tree), and two types of custom mounts (Figure 7). After it was wrapped with MLI, the SAPP was tied to the relevant mount with lacing cord. The standoffs were placed so that the distances between standoffs was the same as in-flight.
