NASA TN D-4894

## BLAST SHIELDS TESTING

*by Walter V. Medenica*

*George C. Marshall Space Flight Center  
Huntsville, Ala.*

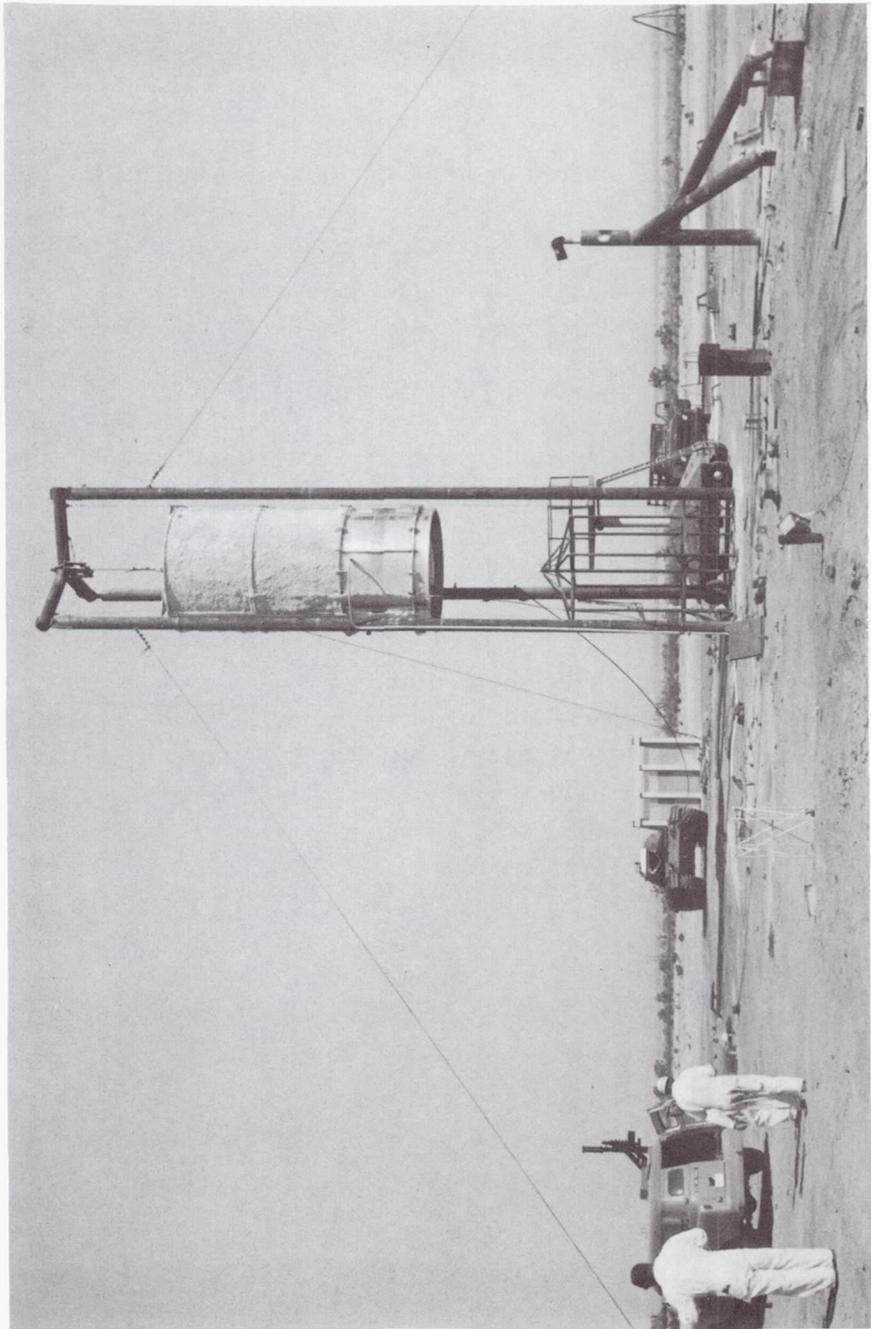
FIGURE 1. DROP TANK TEST FACILITY

This schedule intended to utilize six out of twelve "drop tests" planned in the Pyro Project. In drop tests (Fig. 1), a tank consisting of two compartments simulating the propellant and the oxidizer tanks in a stage is filled with RP-1 and LOX or with LH<sub>2</sub> and LOX in stage-determined proportions. Then the tank is dropped approximately 30 ft on a system of cutting edges which pierce the bottom and the middle bulkhead of the tank, bringing the propellant and the oxidizer together, and mixing them. This mixture explodes spontaneously (in most cases); however, an igniter located on the ground, is used if no spontaneous explosion occurs. (For these and other aspects of the Pyro Project, the reader is referred to the upcoming final report by the Air Force Rocket Propulsion Laboratory (AFRPL) at Edwards, Calif.)

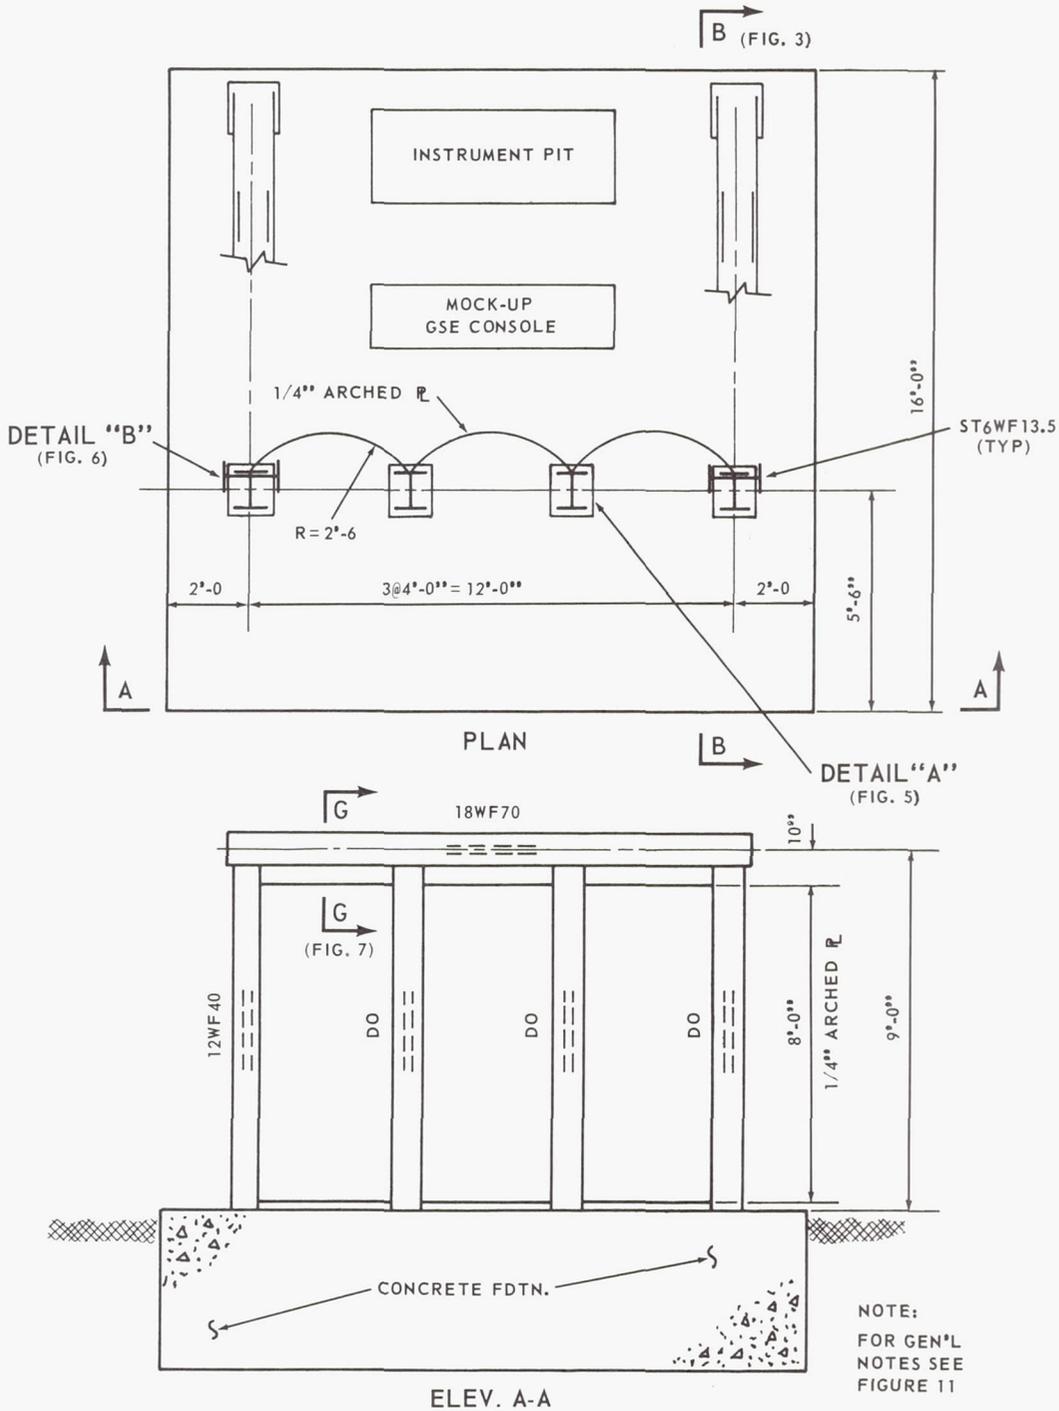
FIGURE 2. BLAST SHIELDS, ARCHED PLATES, PLAN AND ELEVATION VIEWS

1. The two test stands were designed by the Test Laboratory of MSFC and built by the Air Force Rocket Propulsion Laboratory, as shown on Figures 2 through 17 (which served as design drawings). The test stands were located as shown in Figure 18 (the difference in distances, 105.1 ft versus 104.1 ft, is unintentional).

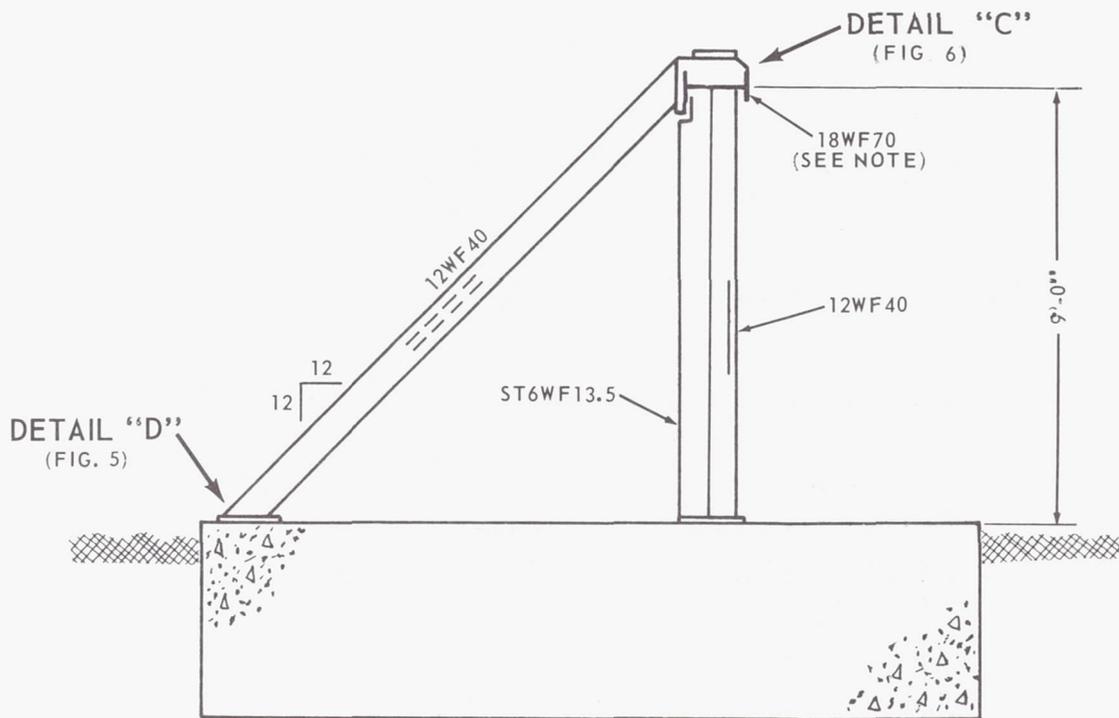
FIGURE 3. BLAST SHIELDS, ARCHED PLATES, SIDE VIEW

SECT. B-B

(ARCHED  $\bar{r}$  NOT SHOWN FOR CLARITY)

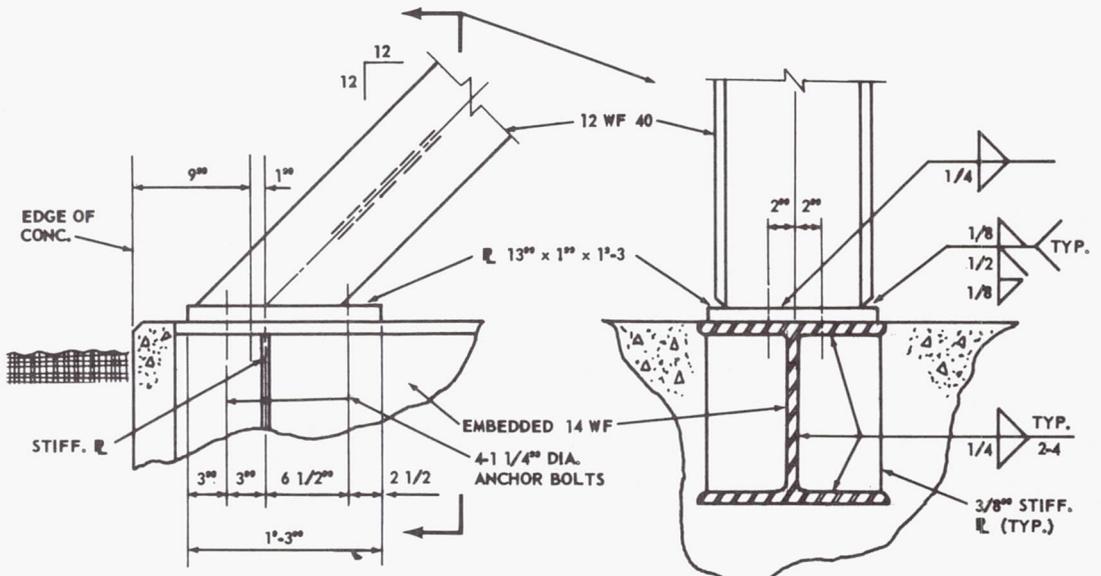
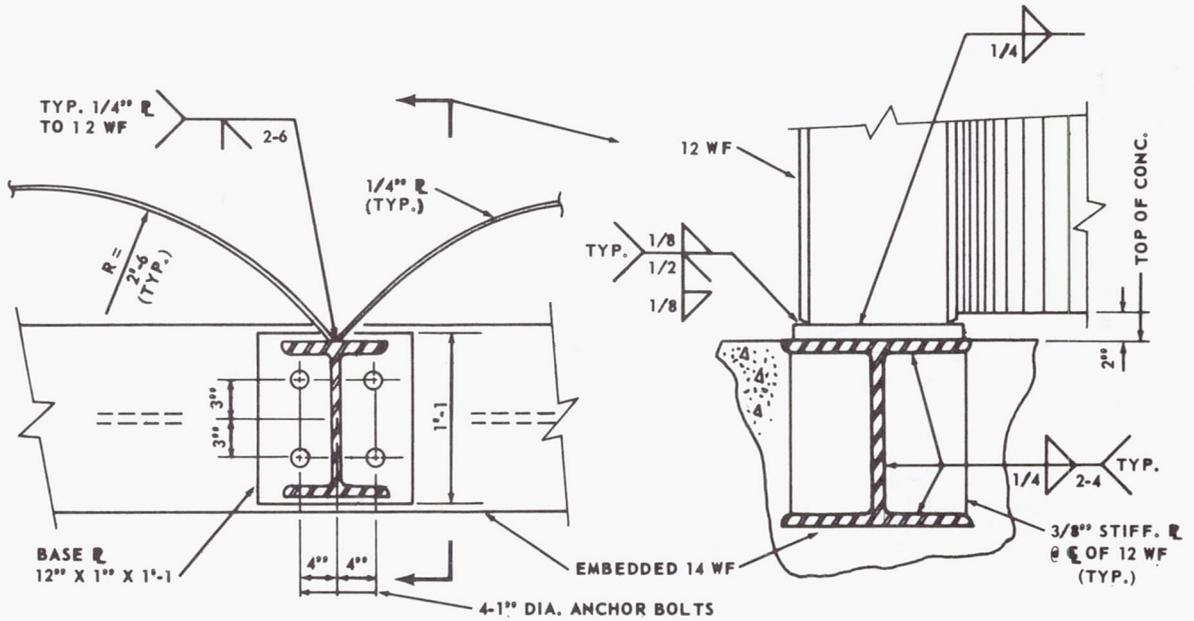
FIGURE 5. BLAST SHIELD DESIGN DETAILS

DETAIL "D"  
(FIG. 3)

DETAIL "A"  
(FIG. 2)

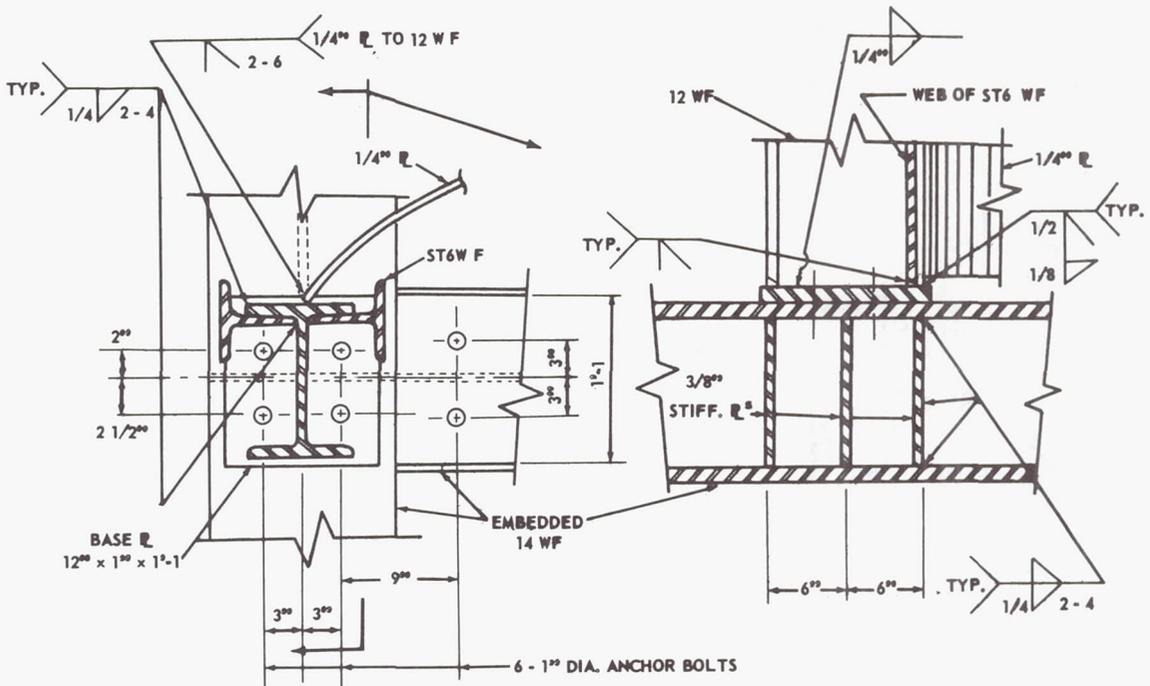
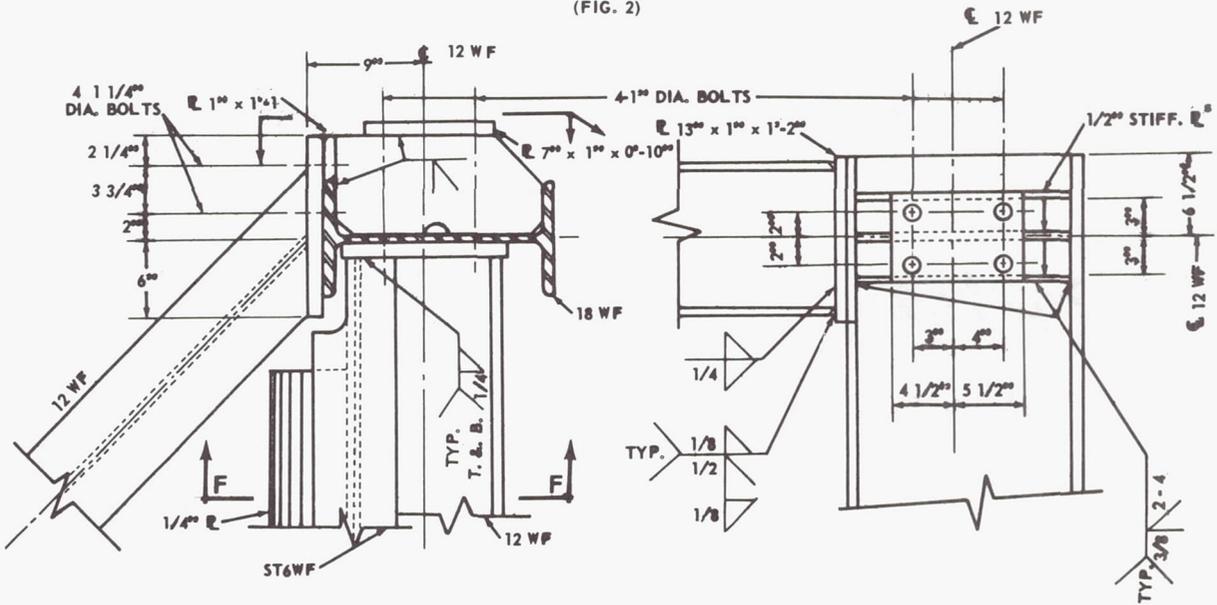
FIGURE 6. BLAST SHIELD DESIGN DETAILS

DETAIL "B" AS SHOWN  
 SECT. F - F - SIMILAR.  
 (FIG. 2)

DETAIL "C"  
 (FIG. 3)

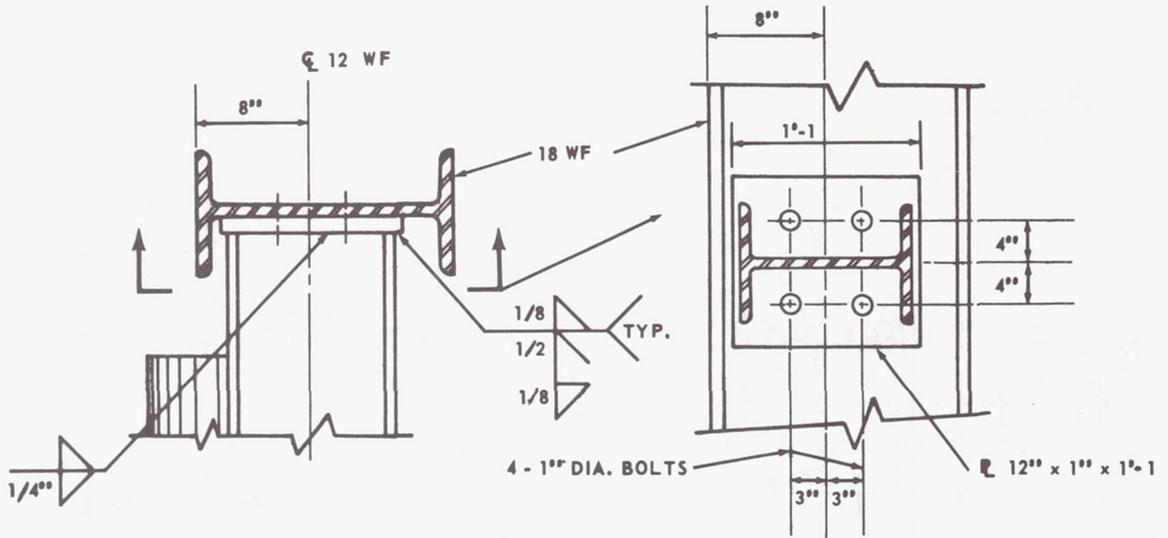
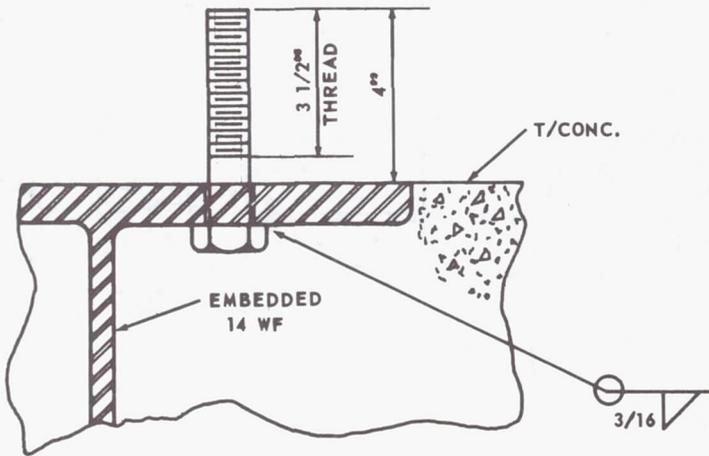
**FIGURE 7. BLAST SHIELD DESIGN DETAILS**

**SECT. G - G**  
 (FIG. 2)

**TYP. DETAIL FOR ANCHOR BOLTS**  
 (1" DIA. & 1 1/4" DIA.)

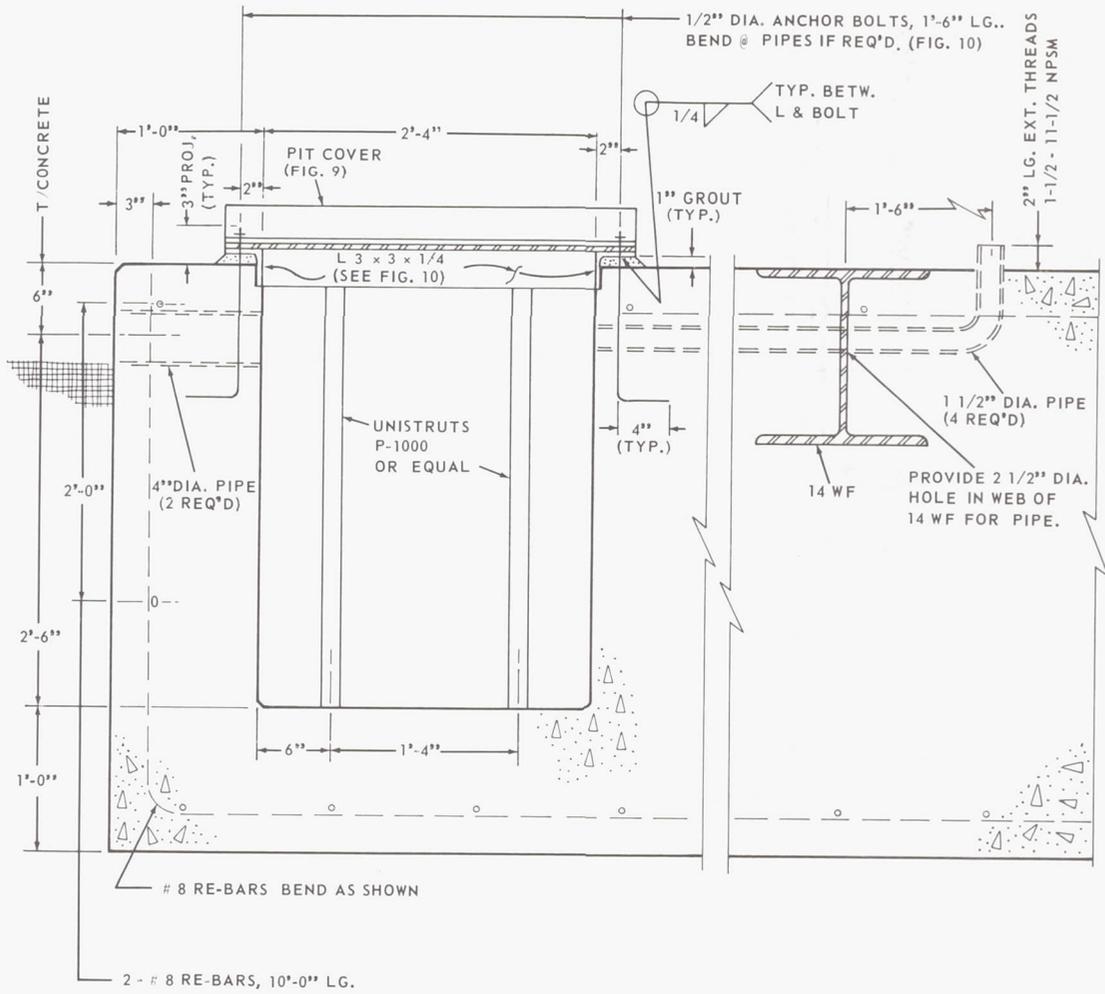
FIGURE 8. BLAST SHIELD INSTRUMENT PIT

NOTE: PROVIDE VERT. UNISTRUTS AS SHOWN IN BOTH SHORT WALLS OF INSTRUMENT PIT, AND 2'-0" C/C IN BOTH LONG WALLS (STOP @ EMBEDDED PIPES).

SECT. N - N  
(FIG. 4)

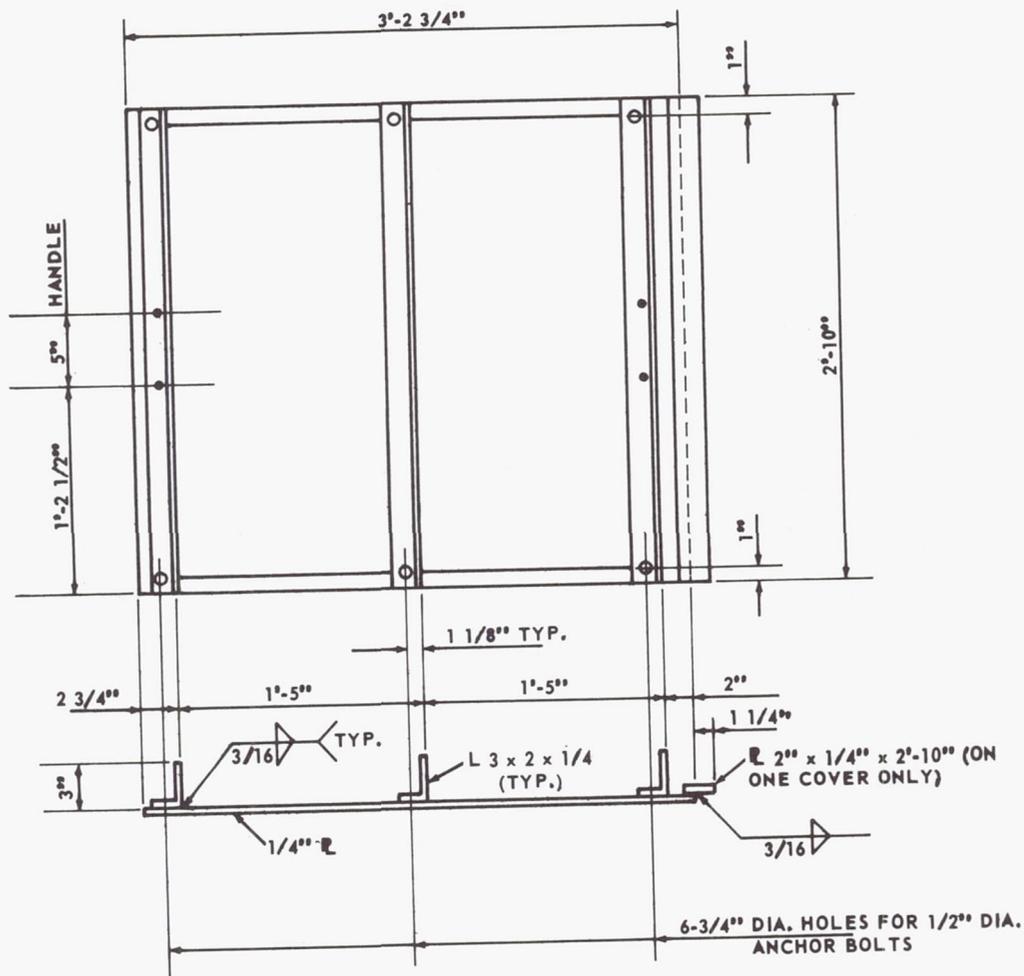
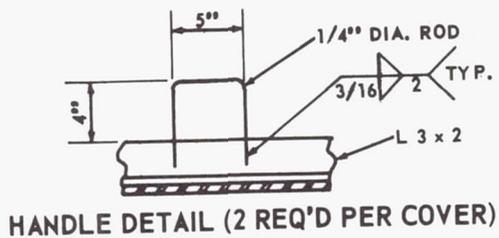
FIGURE 9. INSTRUMENT PIT COVER

COVER FOR INSTRUMENT PIT (2 REQ'D)

HANDLE DETAIL (2 REQ'D PER COVER)

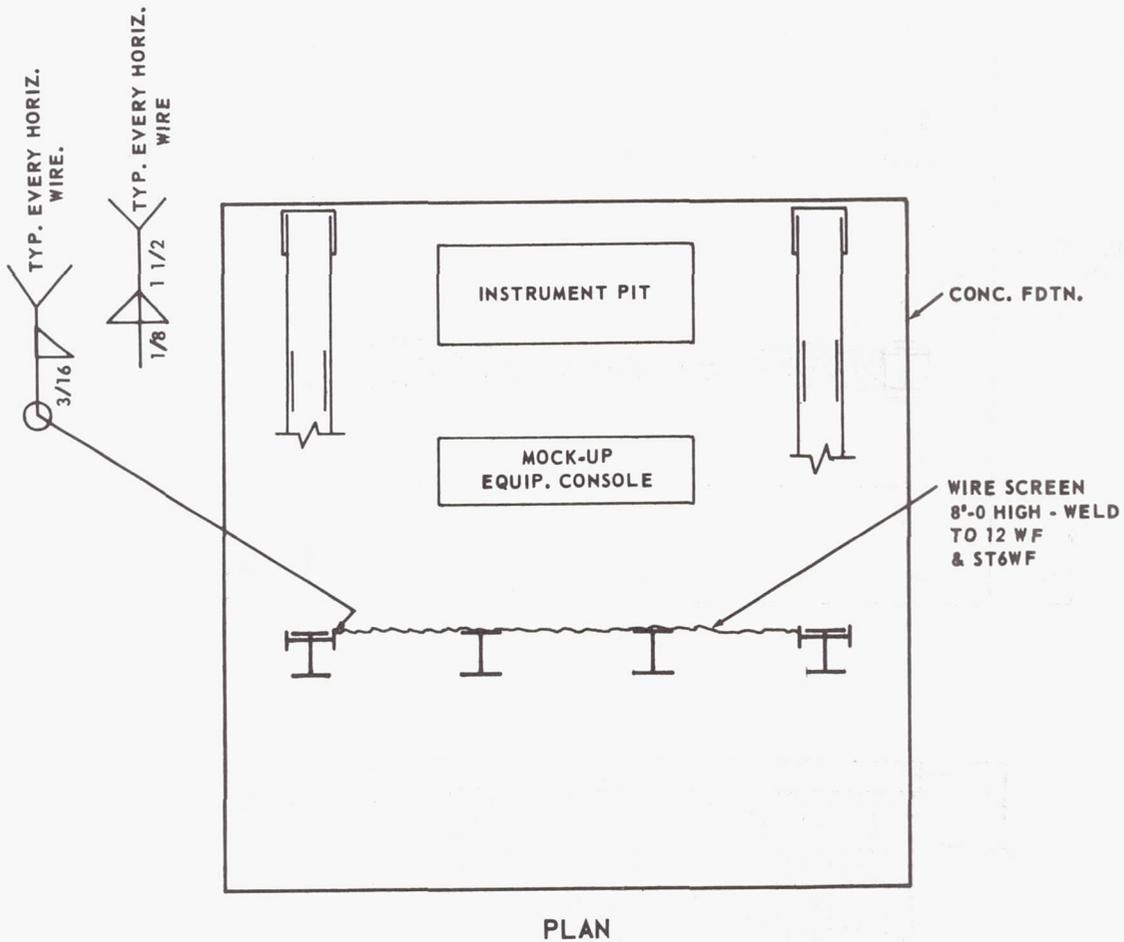
FIGURE 12. BLAST SHIELD, WIRE SCREEN, PLAN VIEW

ASTM A-36 STEEL; CAMBRIDGE  
WIRE CLOTH CO. OR EQUAL

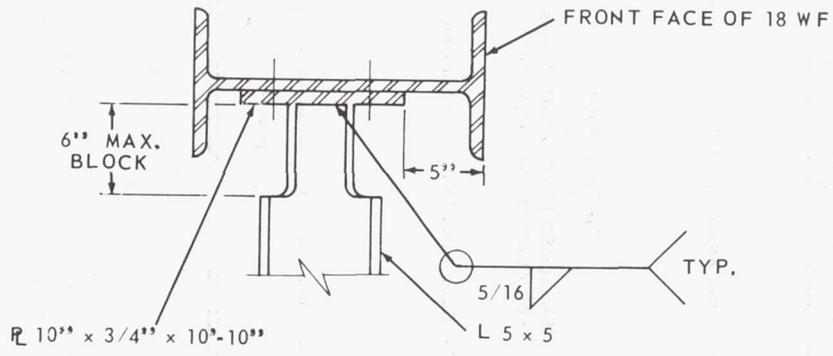
FIGURE 15. ANGLE DEFLECTOR DETAILS

SECT. P - P  
(FIG 14)

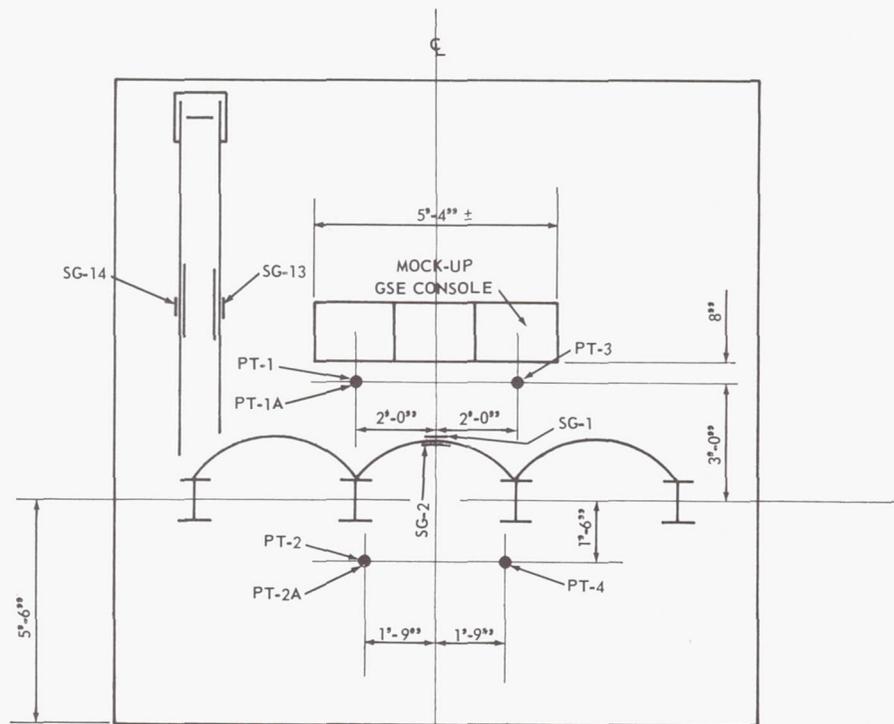
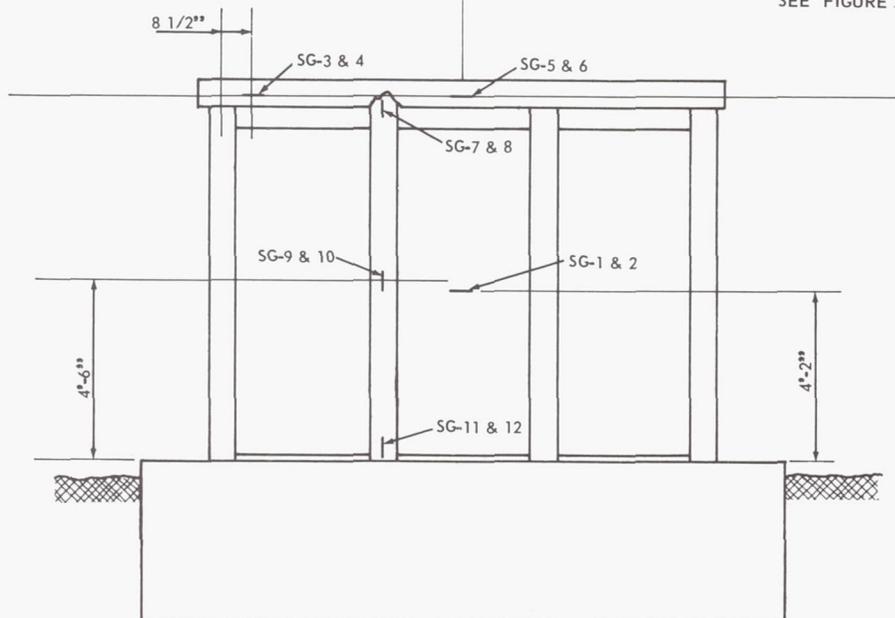
FIGURE 19. LOCATION OF INSTRUMENTATION

3. Three empty surplus cabinets ( 27 in. x 21 in. x 85 in. ) were placed beside each other behind each blast shield to simulate GSE to be protected ( Fig. 19).

2. The blast shields were instrumented by the personnel of MSFC Test Laboratory and the cables connected to three oscillograph recorders in the blockhouse ( Figs. 19, 20, and 21). Strain gauges SG-1 and SG-2 were eliminated on the Angle Deflector and on wire screens. Strain gauges SG-7 through SG-12 on the Angle Deflector were placed on the third angle from the center of shield ( Figs. 14 and 20) at the same vertical locations shown on Figure 20.

1. One 25-kips Drop Test was replaced by a Titan I explosion.
2. Another Titan I explosion was added.
3. Pressure transducers and strain gauges on the blast shields ( Figs. 19 and 20) were recorded during three tests only ( 284, 285, and 301).

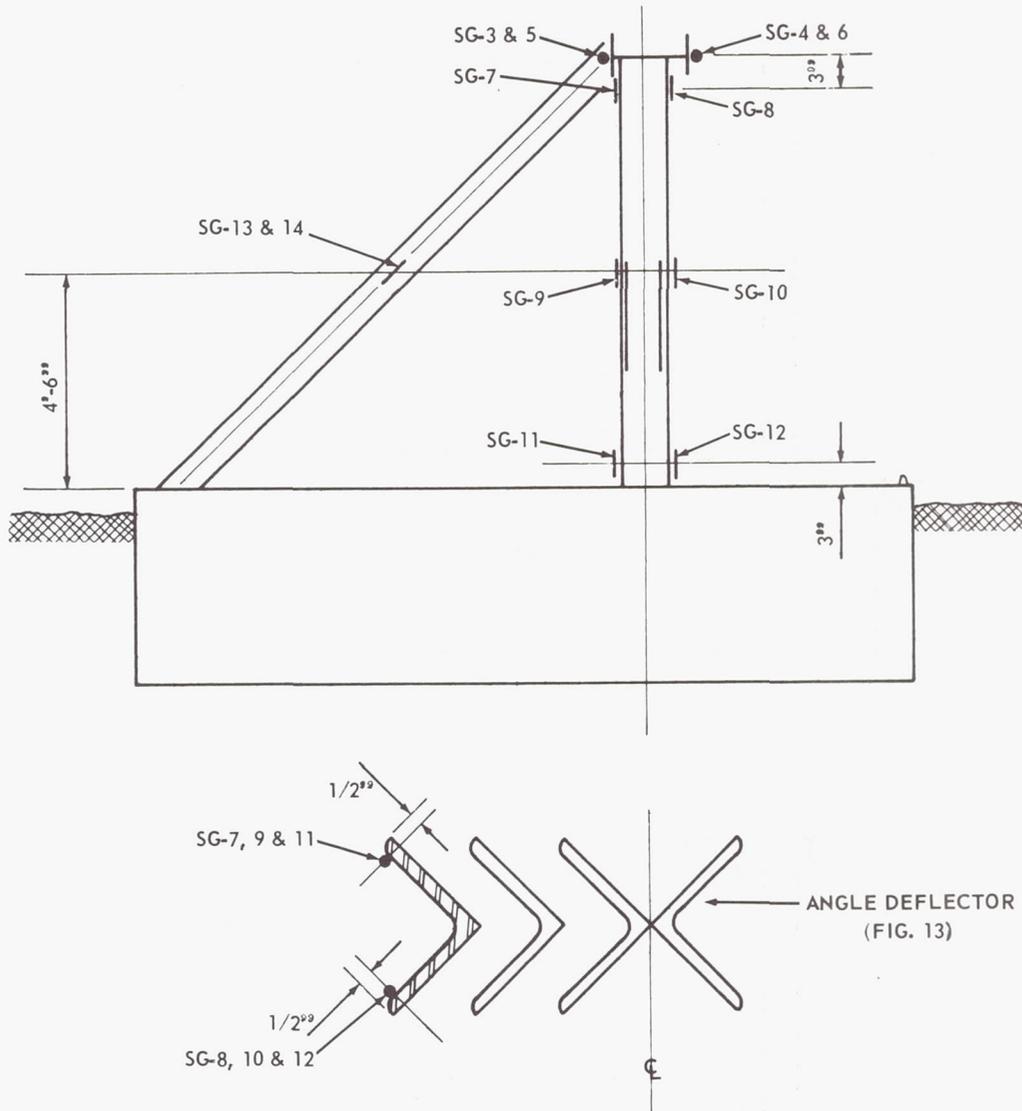
FIGURE 20. INSTRUMENTATION LOCATION

- 1) PT-1 = PRESSURE TRANSDUCER # 1 (DYNISCO)  
 PT-1A = PRESSURE TRANSDUCER # 1A (KISTLER)  
 SG = STRAIN GAGE (MICRO-MEASUREMENTS)
- 2) EVEN NUMBERED MEASUREMENTS FACE THE BLAST.
- 3) PRESSURE TRANSDUCERS ARE INSTALLED IN THE CAPS SCREWED ON ENDS OF 1 1/2" DIA. PIPES (FIG. 8), WHICH PLACED THEM 2 1/2" ABOVE TOP SURFACE OF CONCRETE FOUNDATION.

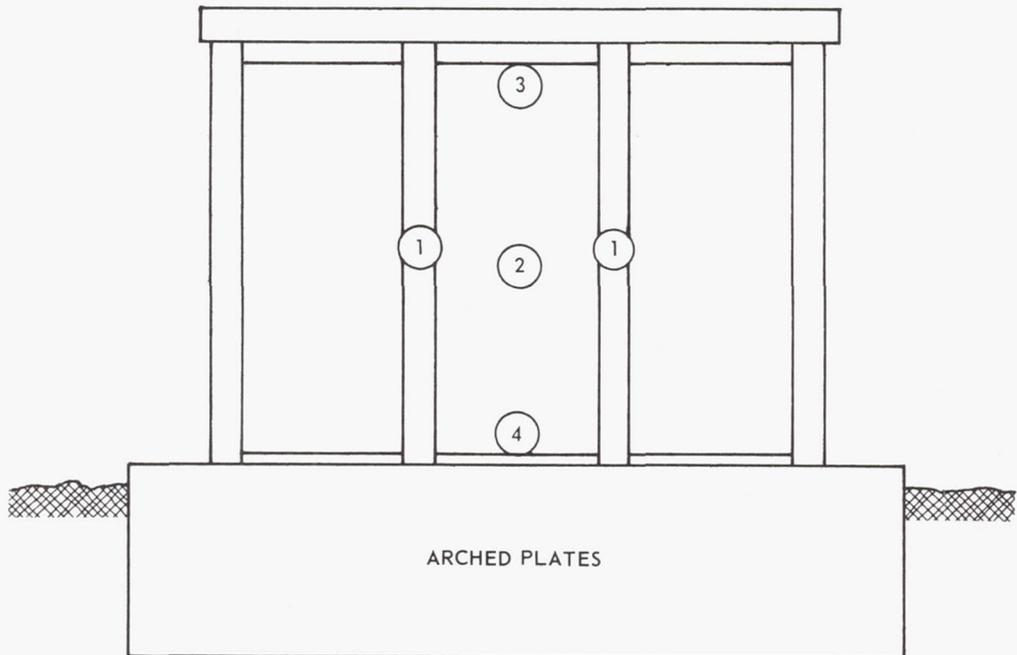
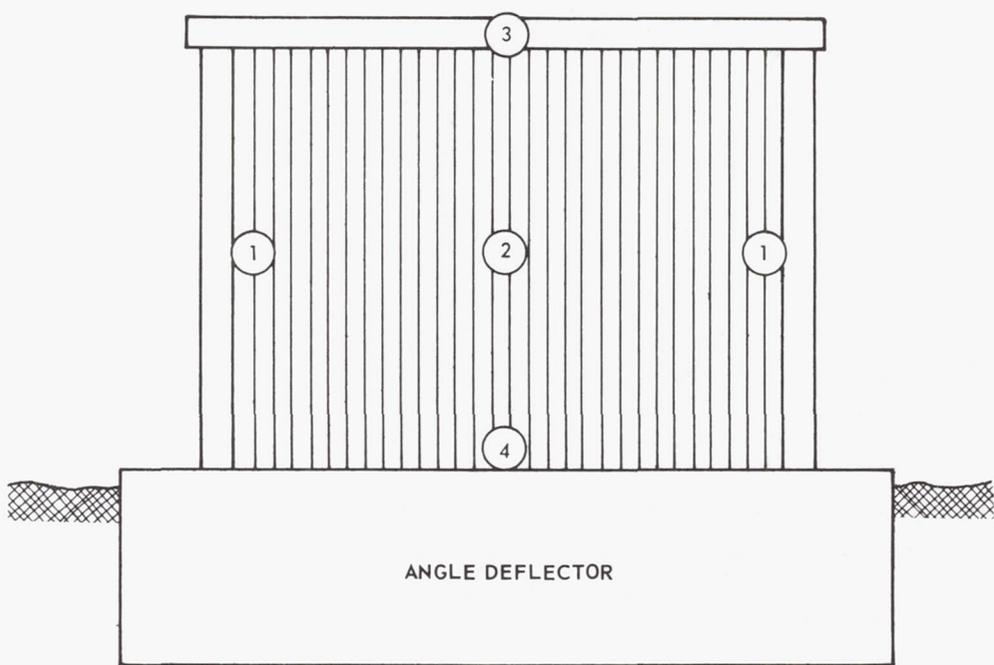
FIGURE 21. REFERENCE POINTS FOR TABLE III

\* Reference points are given in Figure 21.

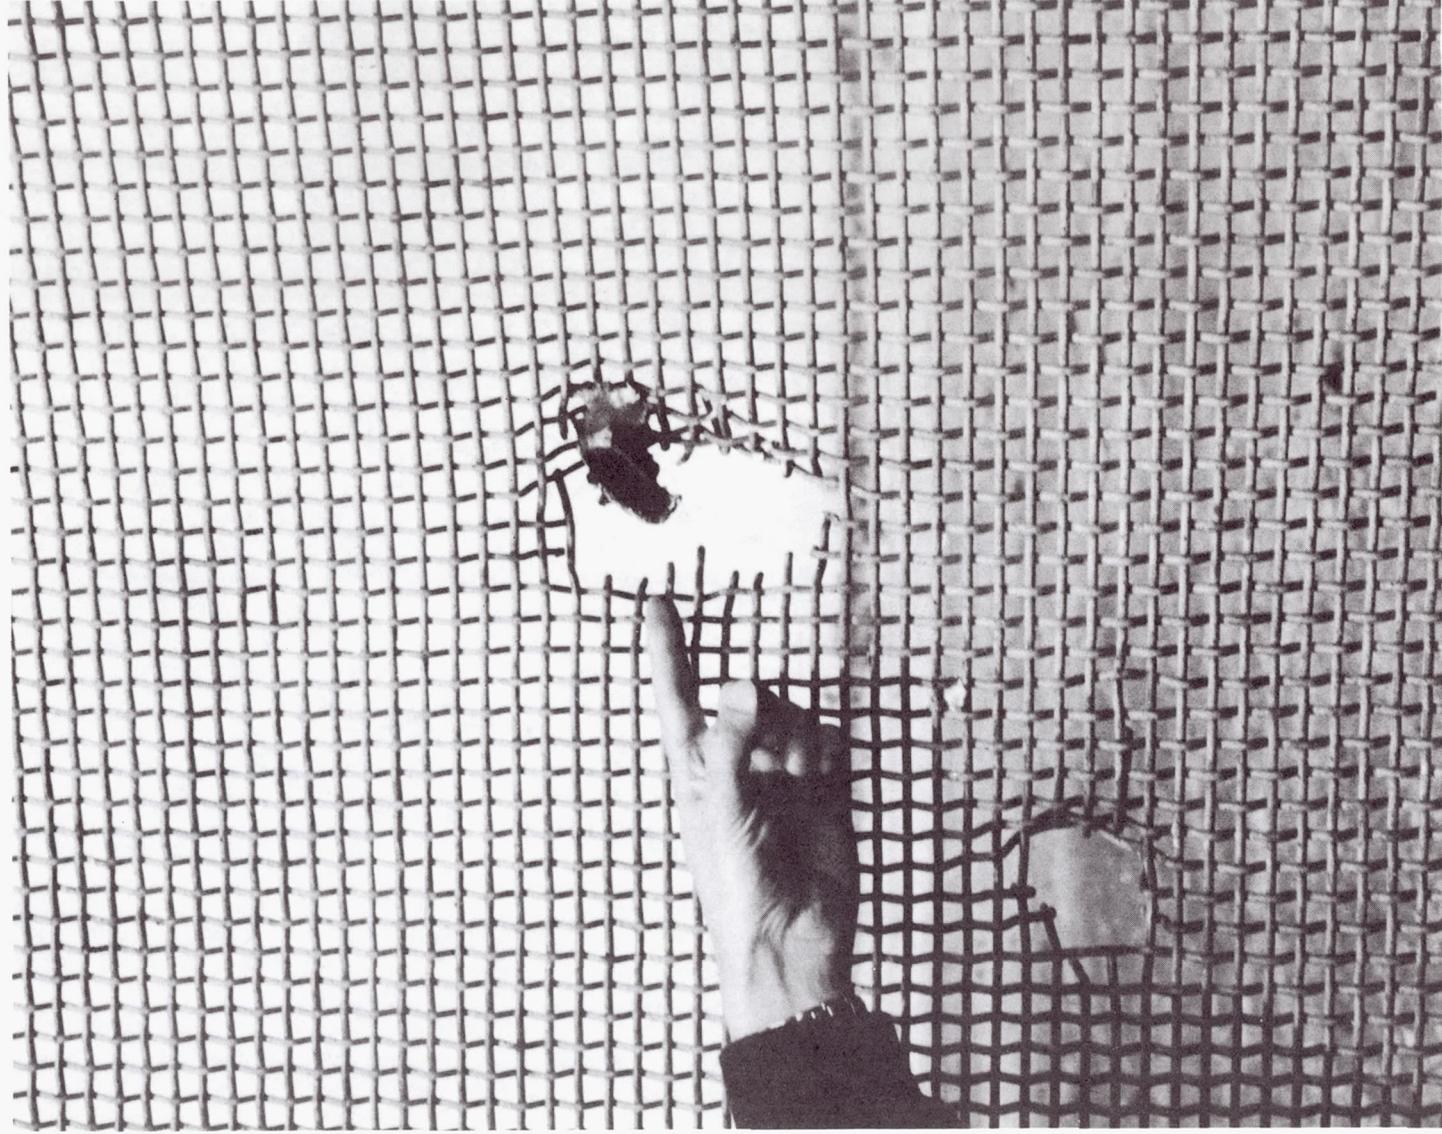
FIGURE 22. SHRAPNEL PERFORATION OF WIRE SCREEN,  
TEST 301

This Titan I test ( Fig. A-12) of low explosive yield caused slight damage to Wire Screen No. 2, and no damage to the angle deflector ( Figs. A-13 and A-14) . Some holes were perforated in the wire screen by flying fragments, and some bottom wires were ripped loose from their welded connections. Here again the failure occurred at the most rigid location of the blast shield as was the case with arched and flat plates.

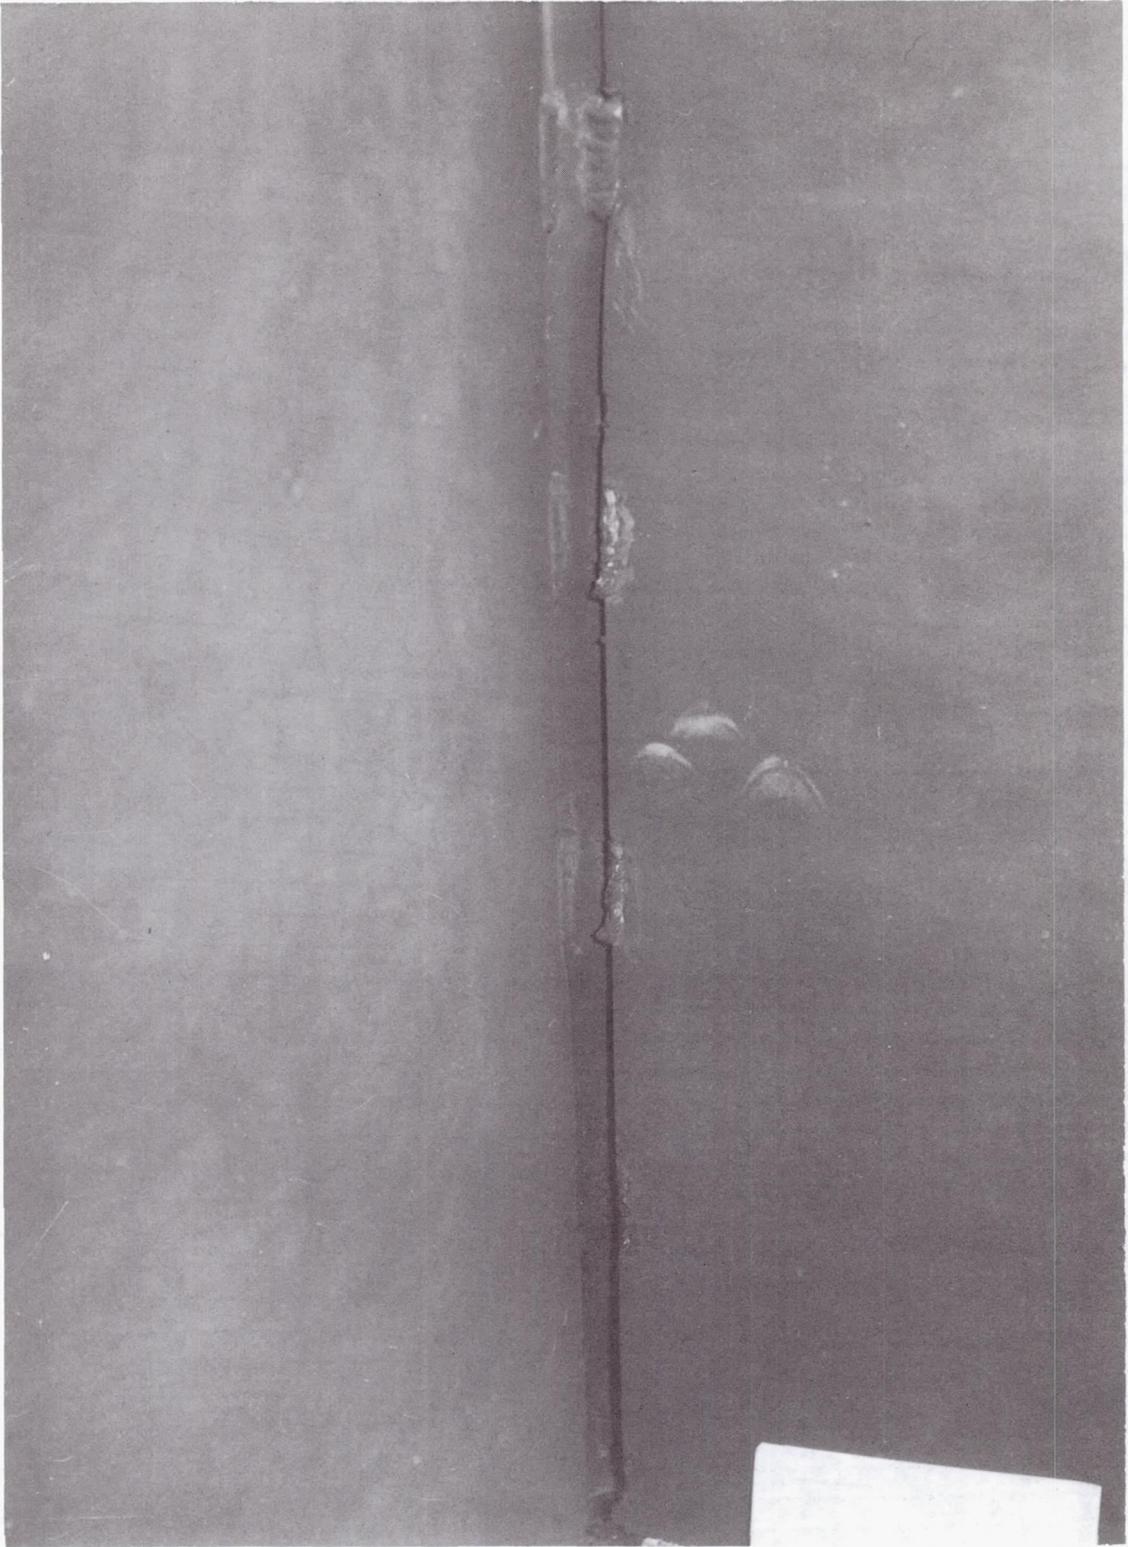
FIGURE 23. WELD CRACKS AT BOTTOM OF ARCHED PLATES,  
TEST 285

The high yield caused slight damage to the blast shields. Bottom welds of arched plates cracked (Fig. 23) and bottom wires of the wire screen failed (Fig. A-3). The GSE consoles stood freely, unanchored, during this test. They were knocked down and damaged at Test Stand No. 1 (Fig. A-4), and completely destroyed at Test Stand No. 2 (A-5).

blast shield and the supporting members should be as flexible as the shield itself if weld cracks are to be avoided. It is not an accident that welds cracked always at the bottom of the plates; the spring rates here are more than ten times as high as at higher locations of the blast shields (Table III).

5. The cracks caused by blast occurred always at the most rigid location, at the bottom of blast shields, confirming the theory that relative, energy absorbing flexibility of a structure can be beneficial for resisting blast.

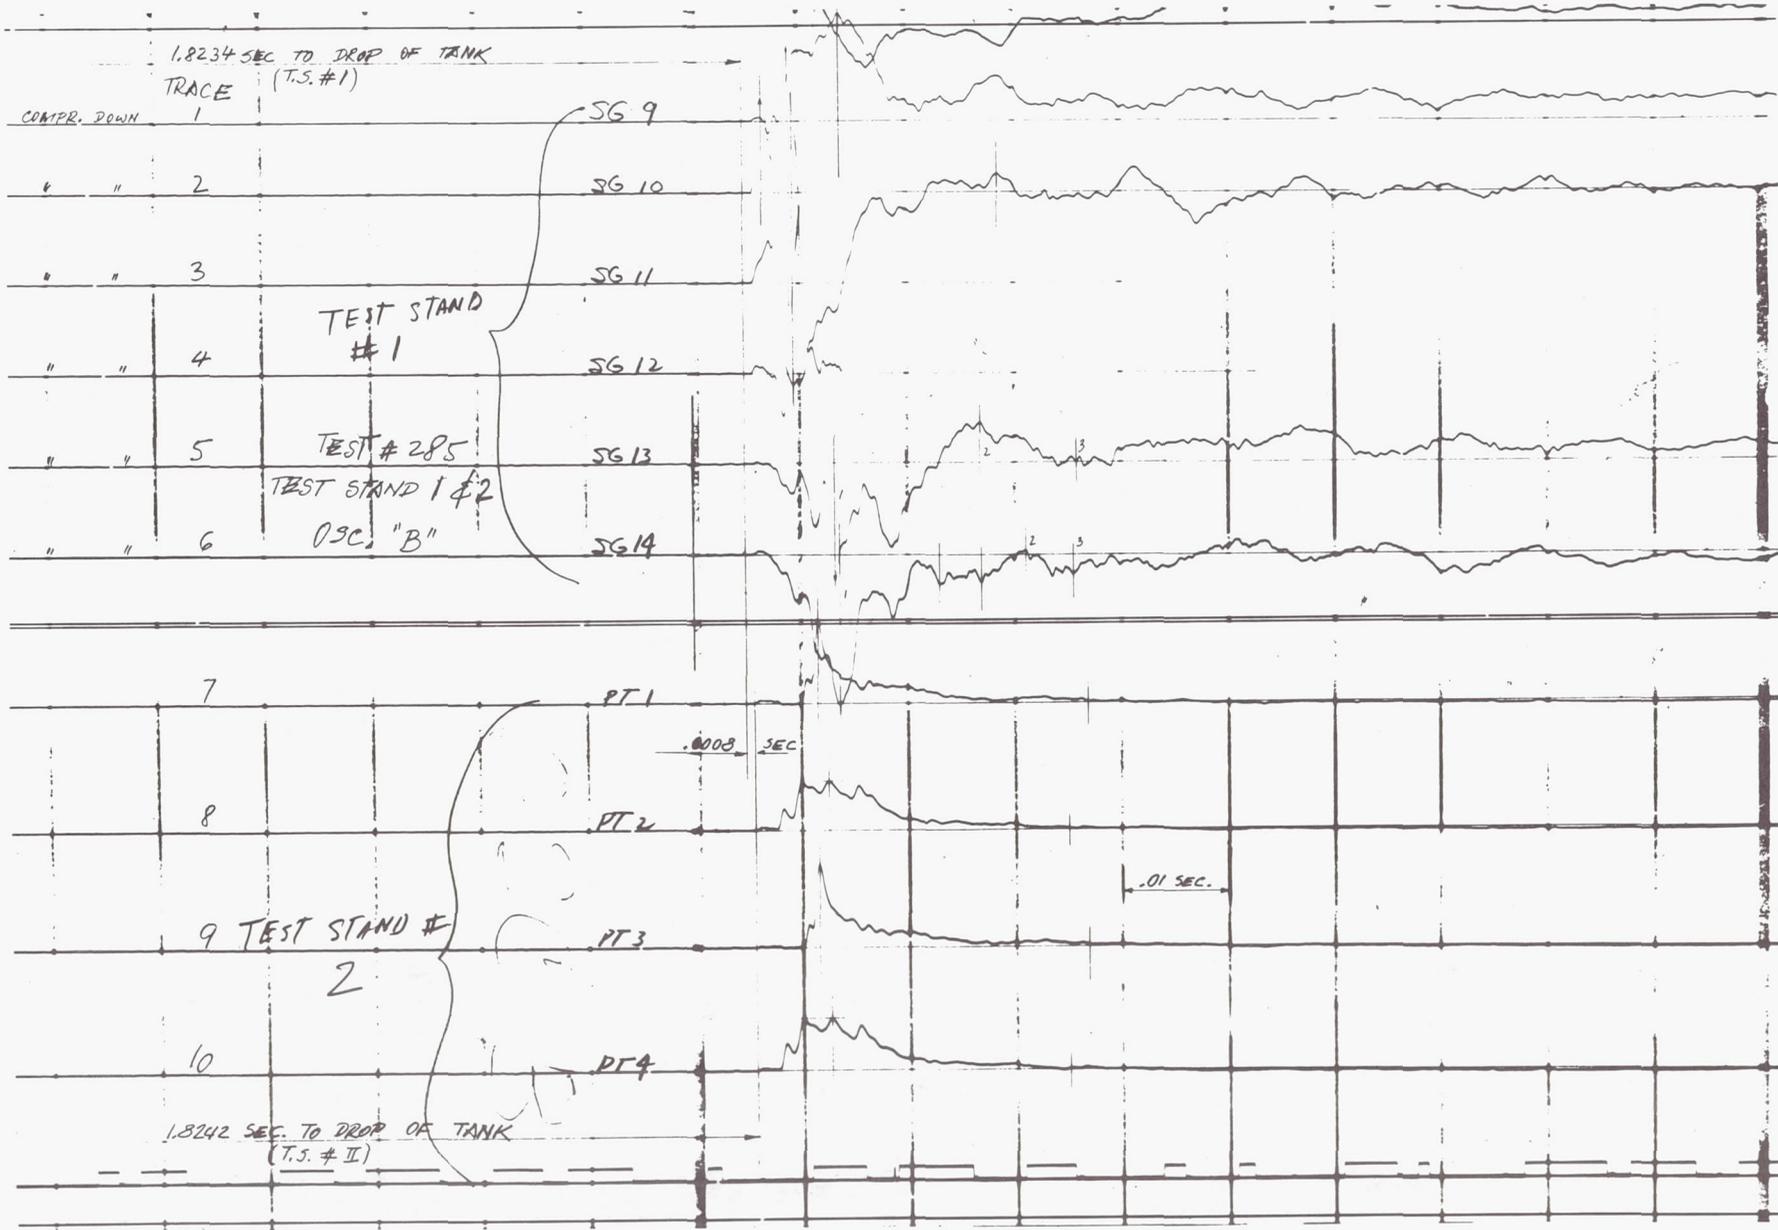
FIGURE 24. SAMPLE OF RECORDER OSCILLOGRAPHS, TEST 285

It will be noted on Figure 24 that traces of pressure transducers PT-2 and PT-4 indicate two peaks of practically equal magnitude, one immediately before and one immediately after PT-1 and PT-3 reached their peaks. The first peak on PT-2 and PT-4 is the reflected overpressure from the blast shield and the supporting structure; the second peak is the reflected overpressure from the GSE consoles (Fig. 19).

\* Listed overpressures are those of the first highest peak (Fig. 24)

\* Listed overpressures are those of the first highest peak ( Fig. 24).

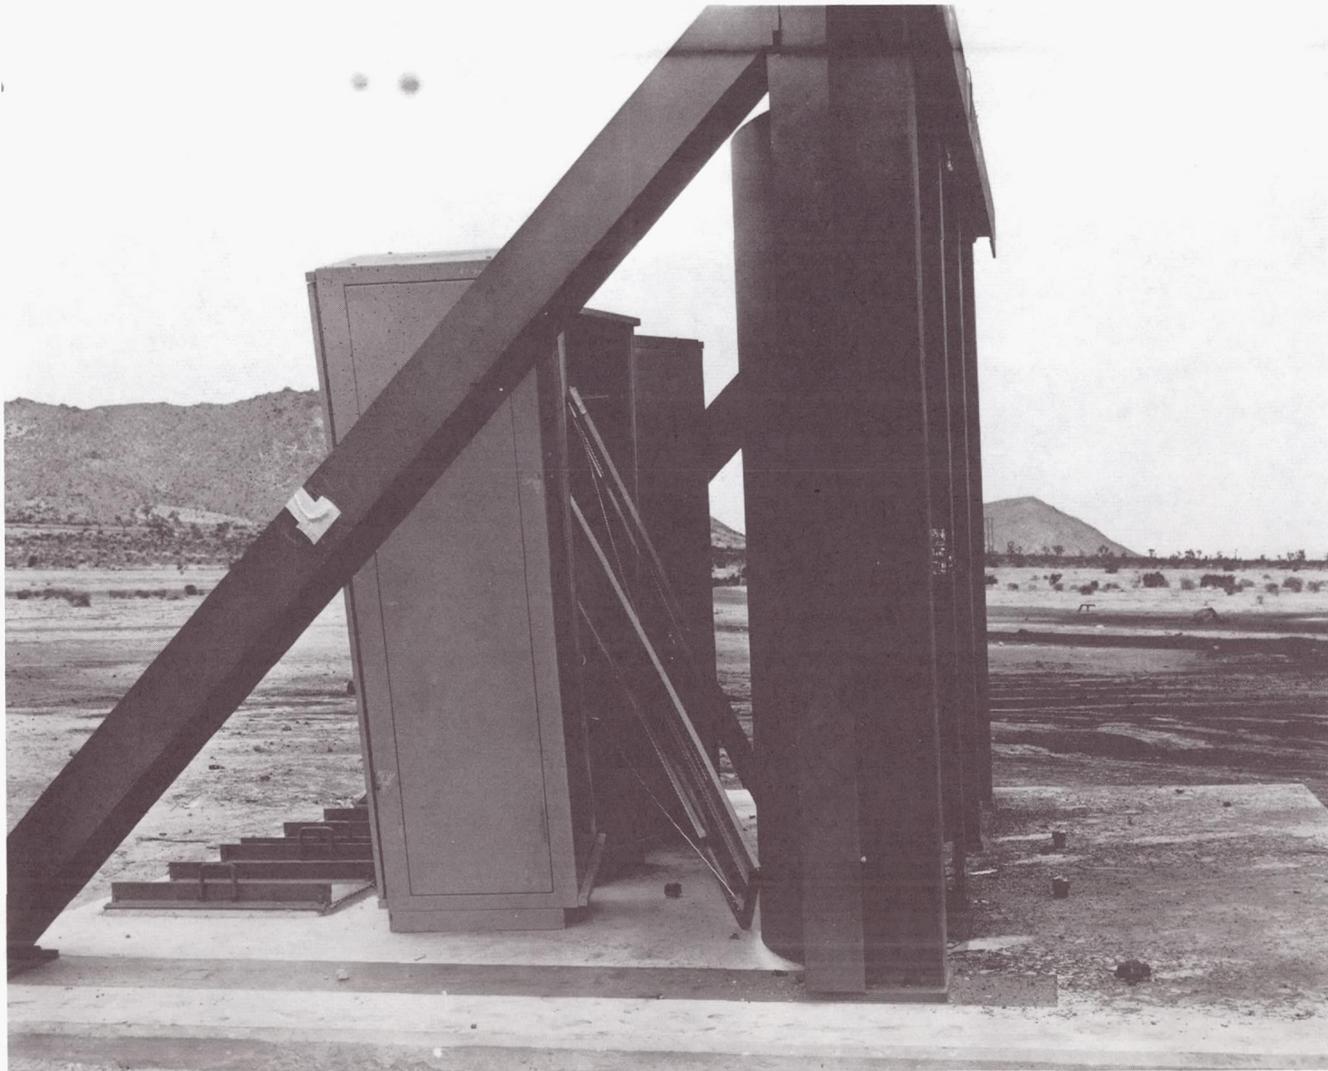
This was a test of low yield which caused no damage to either of the two blast shields. The GSE consoles stood freely, unanchored, during this test. They were not knocked down, but slightly damaged, at Test Stand No. 1 (Fig. A-1); and completely destroyed at Test Stand No. 2 (Fig. A-2).

FIGURE A-1. TEST STAND NO. 1 AFTER EXPLOSION, TEST 284  
(BLAST SHIELD: SOLID ARCHED PLATES)
