NASA TN D-4894

## BLAST SHIELDS TESTING

*by Walter V. Medenica*

*George C. Marshall Space Flight Center  
Huntsville, Ala.*

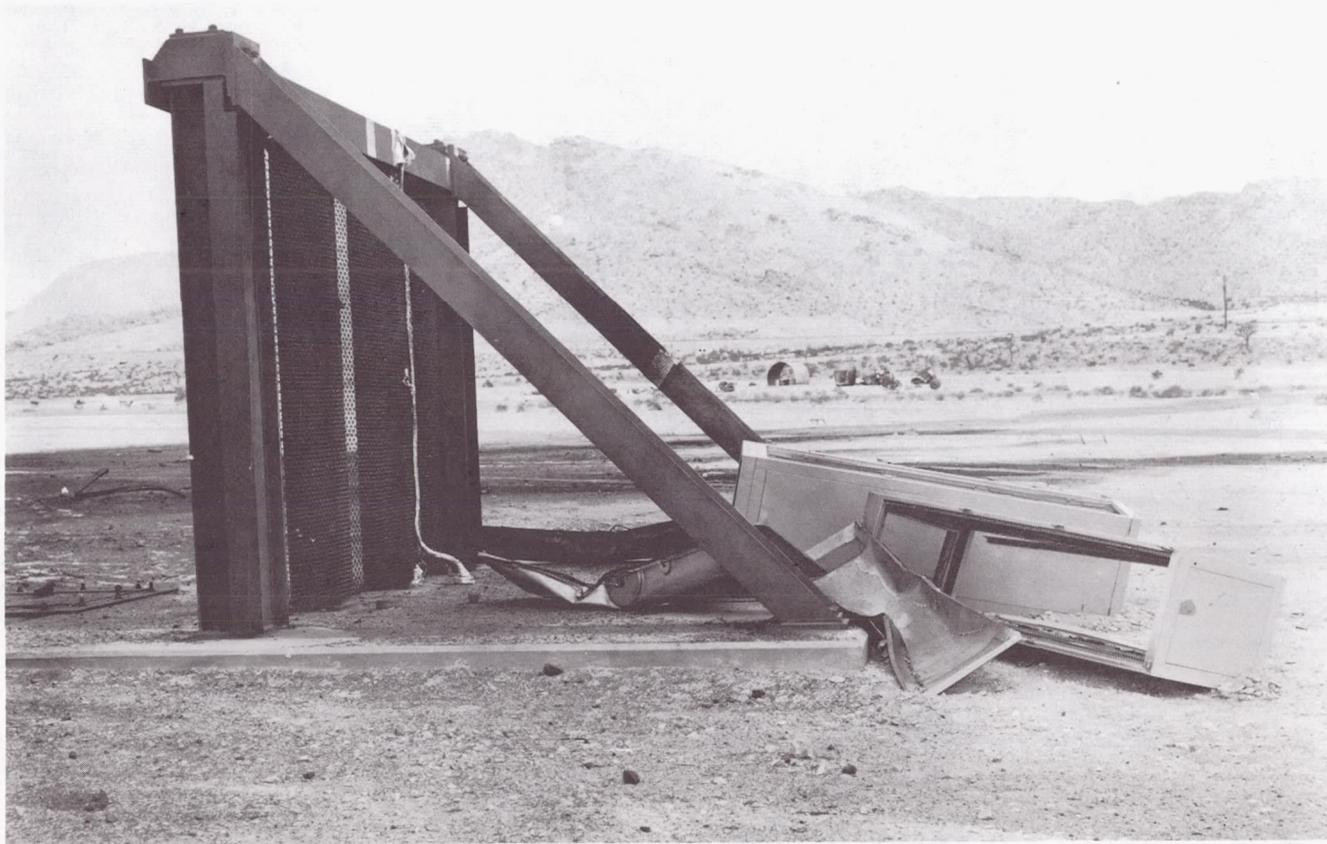
This was a test of low yield which caused no damage to either of the two blast shields. The GSE consoles stood freely, unanchored, during this test. They were not knocked down, but slightly damaged, at Test Stand No. 1 (Fig. A-1); and completely destroyed at Test Stand No. 2 (Fig. A-2).

FIGURE A-2. TEST STAND NO. 2 AFTER EXPLOSION, TEST 284  
(BLAST SHIELD: WIRE SCREEN NO. 1 WITH 65.3% OPEN AREA)

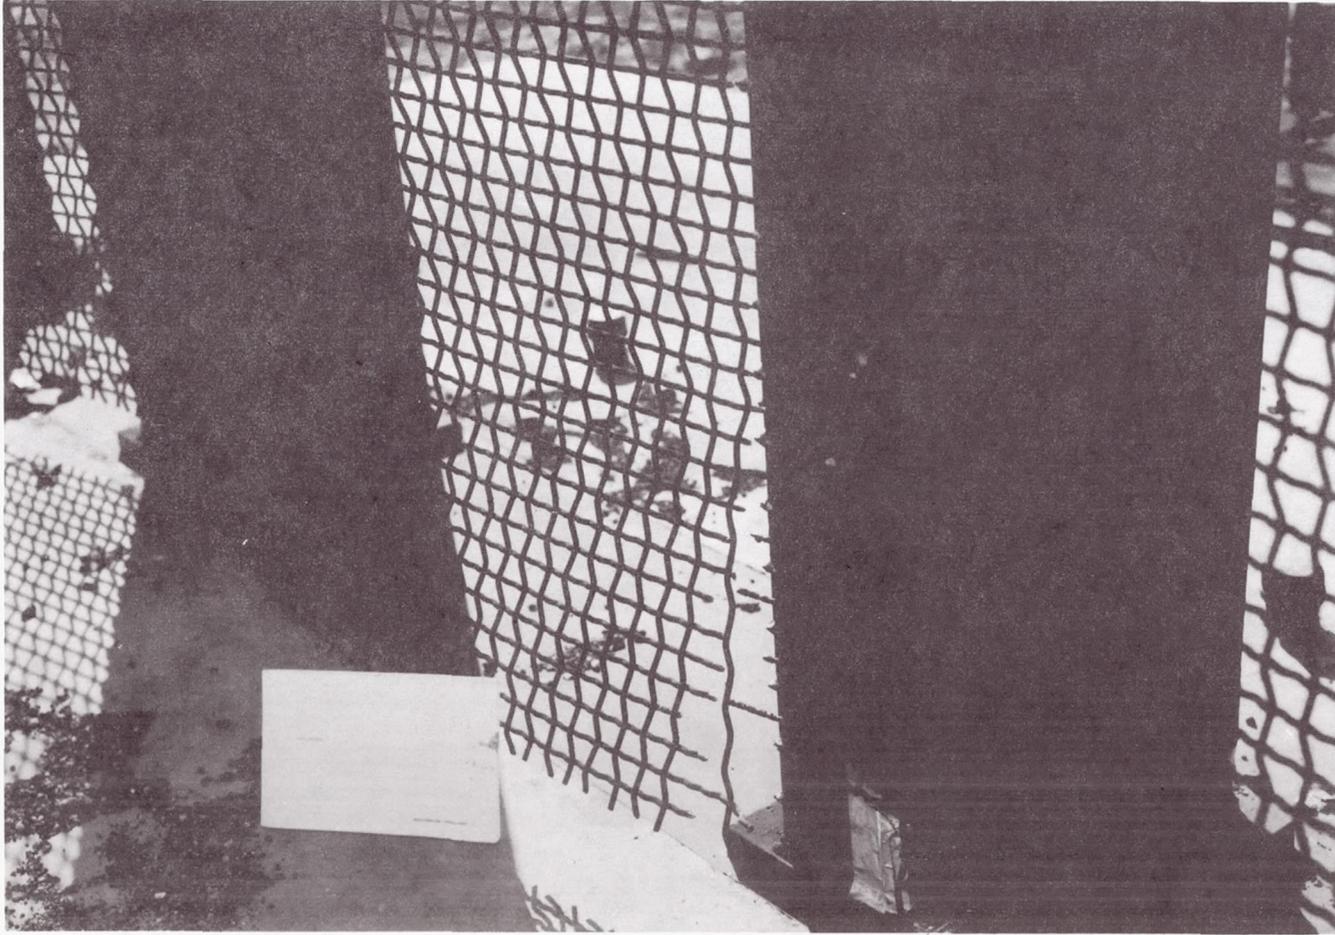
The high yield caused slight damage to the blast shields. Bottom welds of arched plates cracked (Fig. 23) and bottom wires of the wire screen failed (Fig. A-3). The GSE consoles stood freely, unanchored, during this test. They were knocked down and damaged at Test Stand No. 1 (Fig. A-4), and completely destroyed at Test Stand No. 2 (A-5).

FIGURE A-3. TEST STAND NO. 2, FAILURE OF BOTTOM WIRES, TEST 285

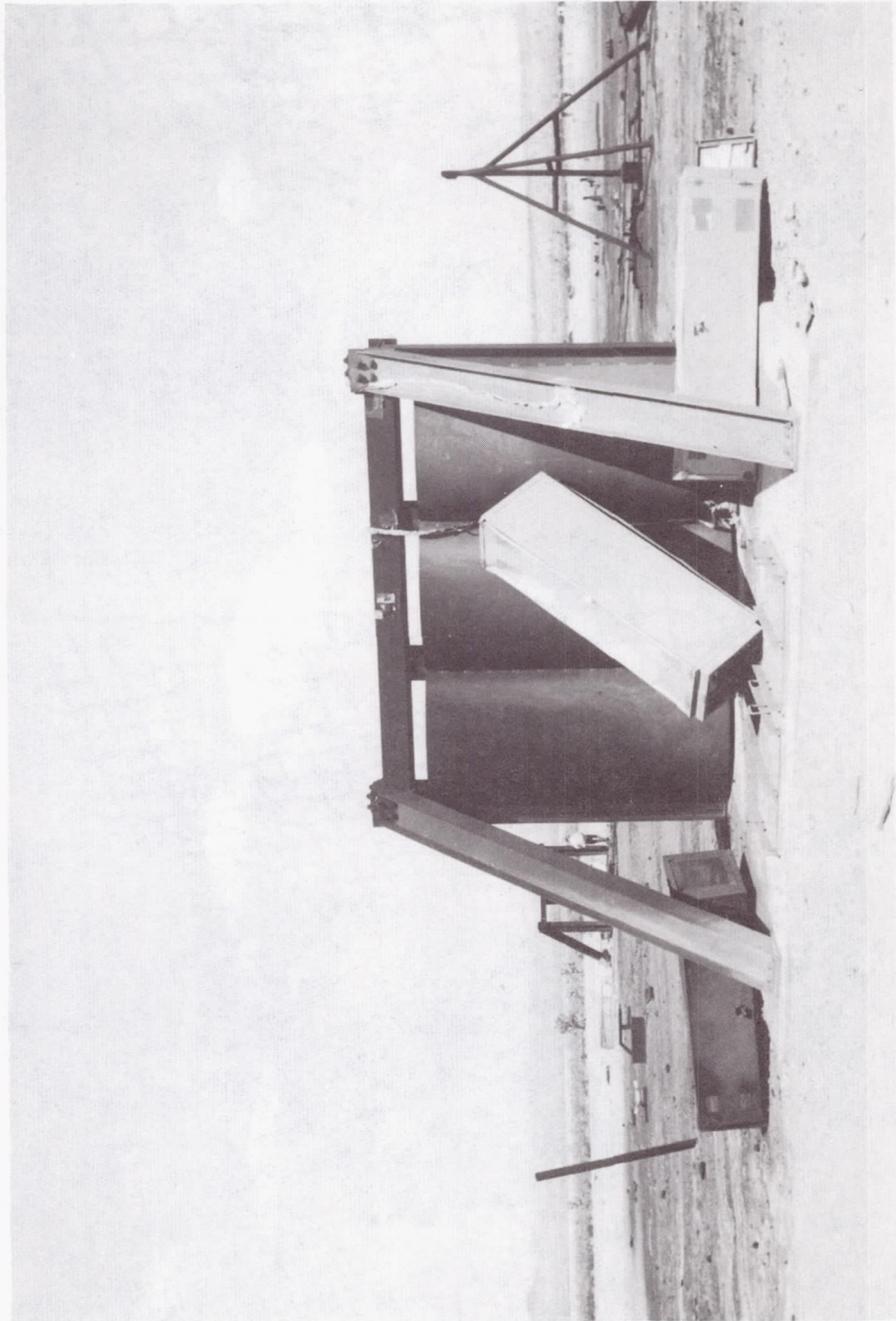
FIGURE A-4. TEST STAND NO. 1 AFTER EXPLOSION, TEST 285  
(BLAST SHIELD: SOLID ARCHED PLATES)

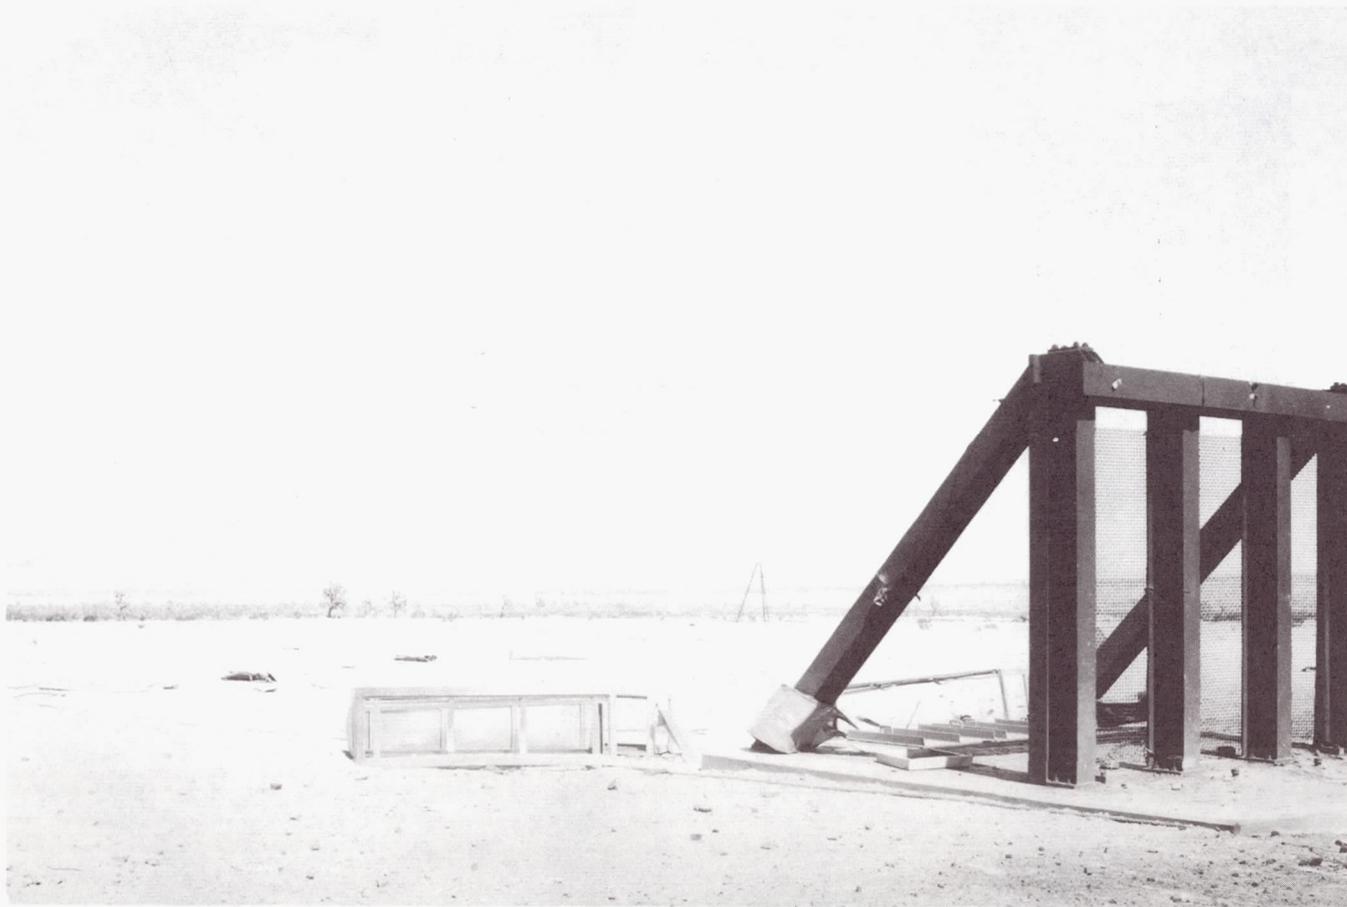
FIGURE A-5. TEST STAND NO. 2 AFTER EXPLOSION, TEST 285  
(BLAST SHIELD: WIRE SCREEN NO. 1 WITH 65.3% OPEN AREA)

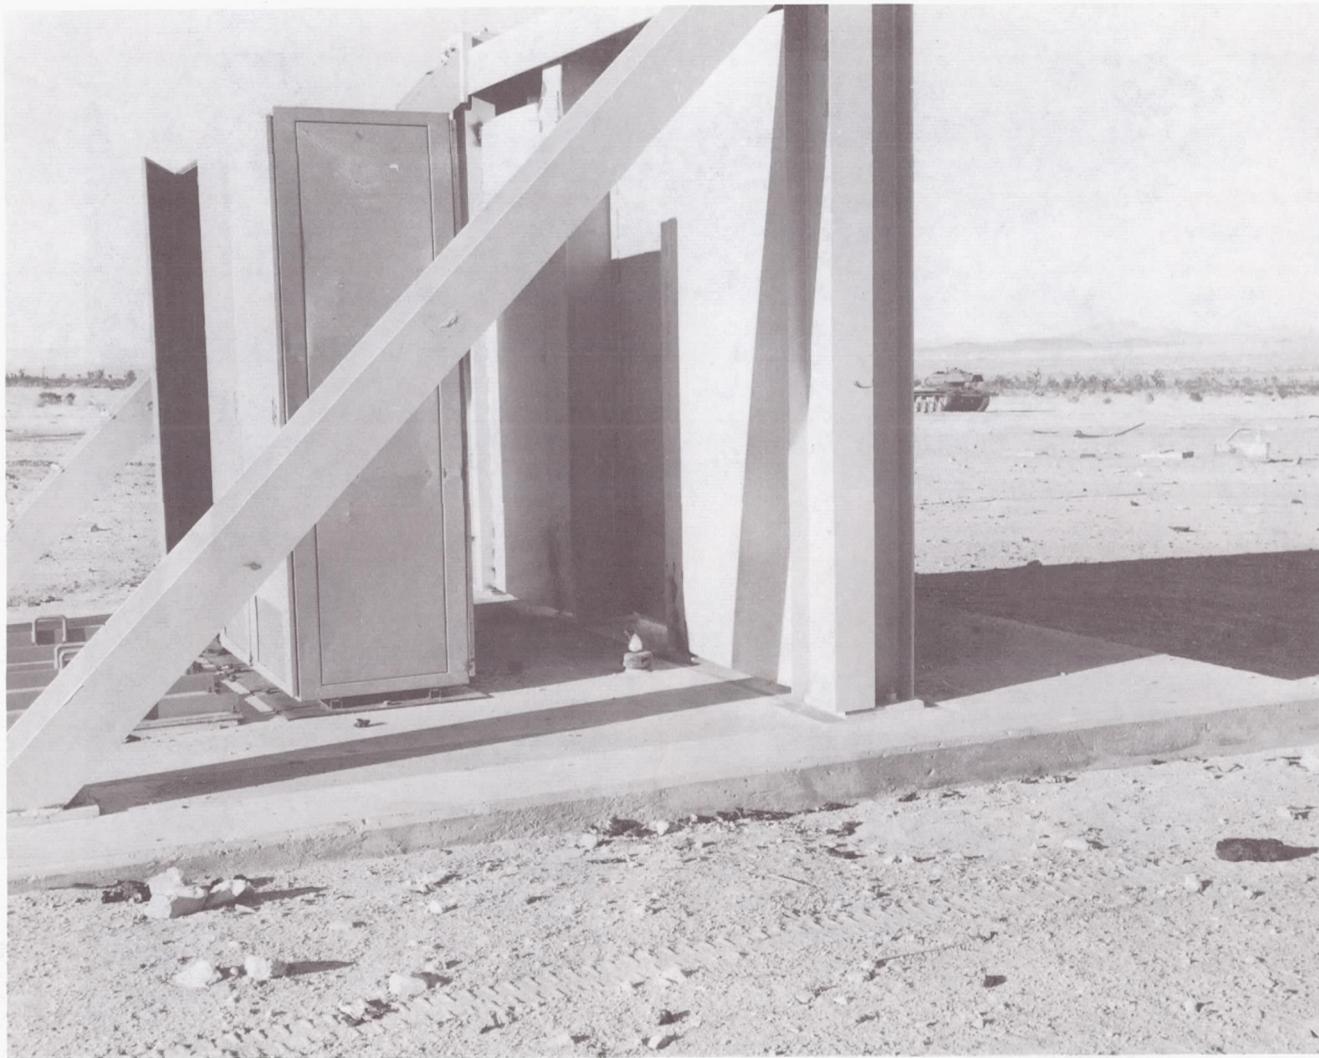
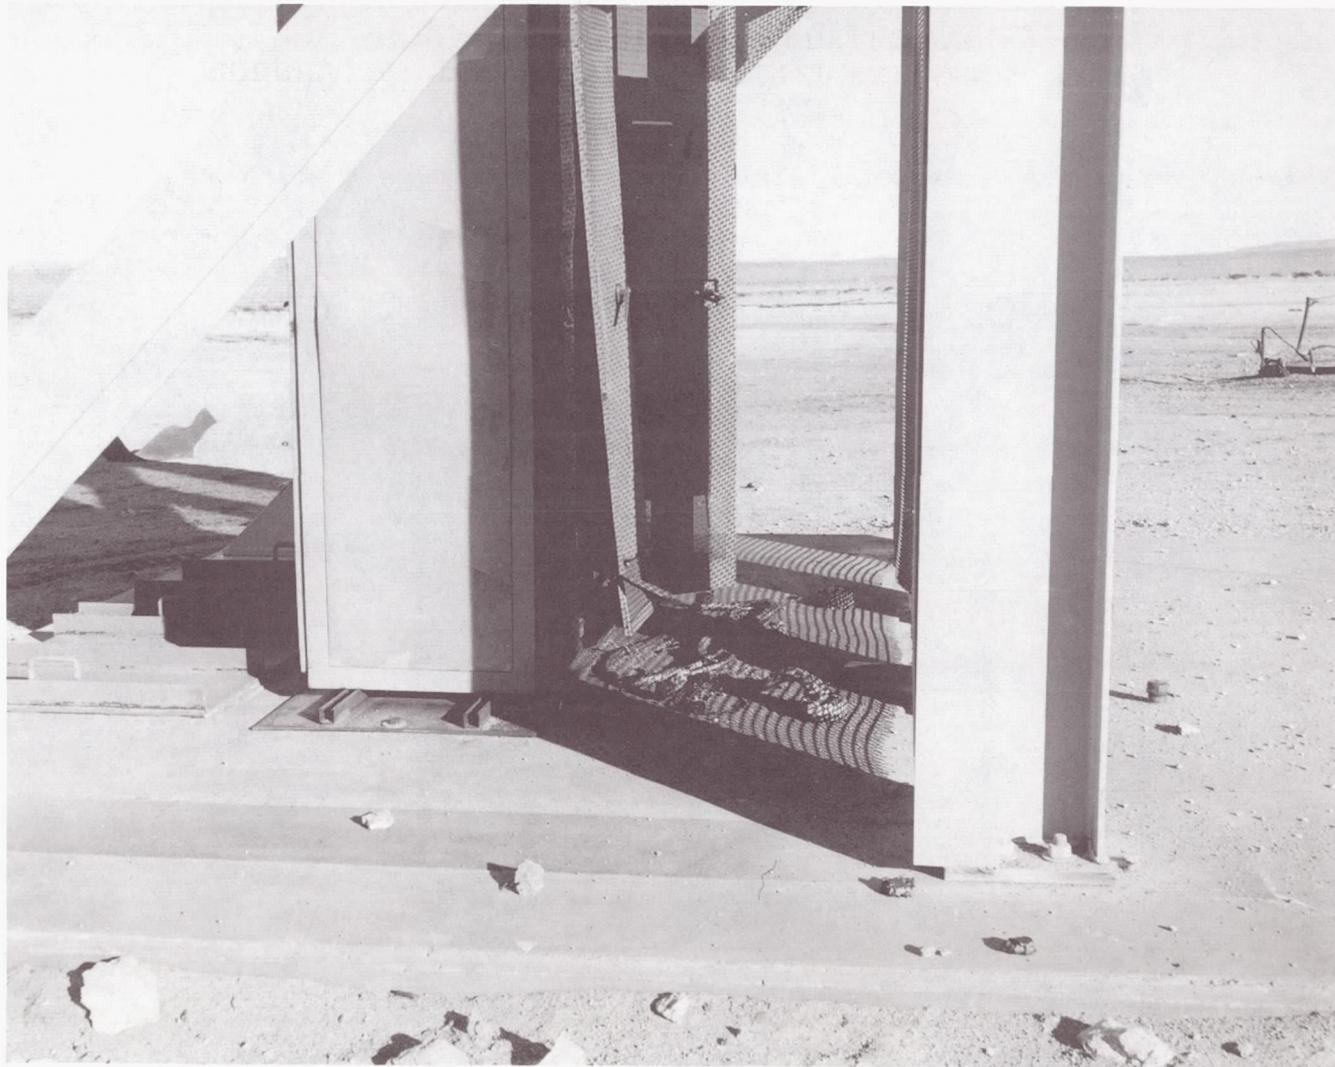
The explosive yield was approximately 2.5 percent, according to preliminary AFRPL report, which should be equivalent to approximately 2.2 percent at the blast shield distance. No damage was noted on the blast shields, and slight damage on the GSE consoles which were anchored to the concrete foundation for this test (Figs. A-8 and A-9).

FIGURE A-8. TEST STAND NO. 1 AFTER EXPLOSION, TEST 290  
(BLAST SHIELD: SOLID FLAT PLATES)

FIGURE A-9. TEST STAND NO. 2 AFTER EXPLOSION, TEST 290  
(BLAST SHIELD: WIRE SCREEN NO. 2 WITH 48.0% OPEN AREA)

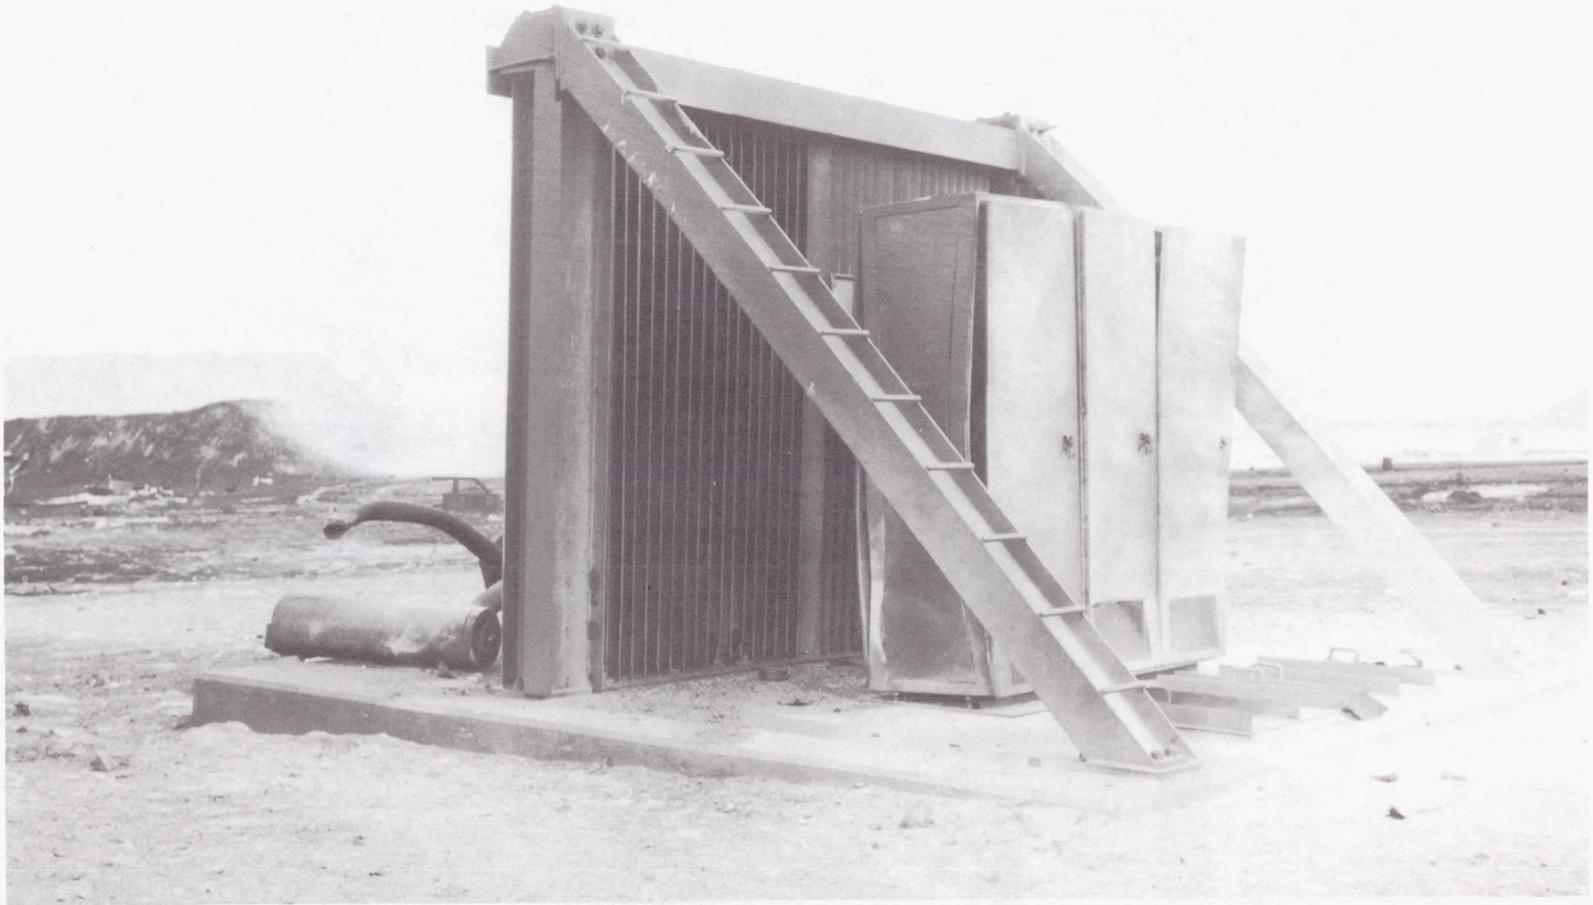
Test Stand No. 1, with the angle deflector and the GSE consoles, withstood the blast very well. Some plastic deformations were noted on the angle deflector and on the supporting frame, as would be expected from the design calculations, but they both remained quite usable. They were used as they were, with no repair, during Test 301. The anchored GSE consoles on Test Stand No. 1 suffered moderate damage ( Fig. A-10) .

FIGURE A-10. TEST STAND NO. 1 AFTER EXPLOSION, TEST 300  
(BLAST SHIELD: ANGLE DEFLECTOR)

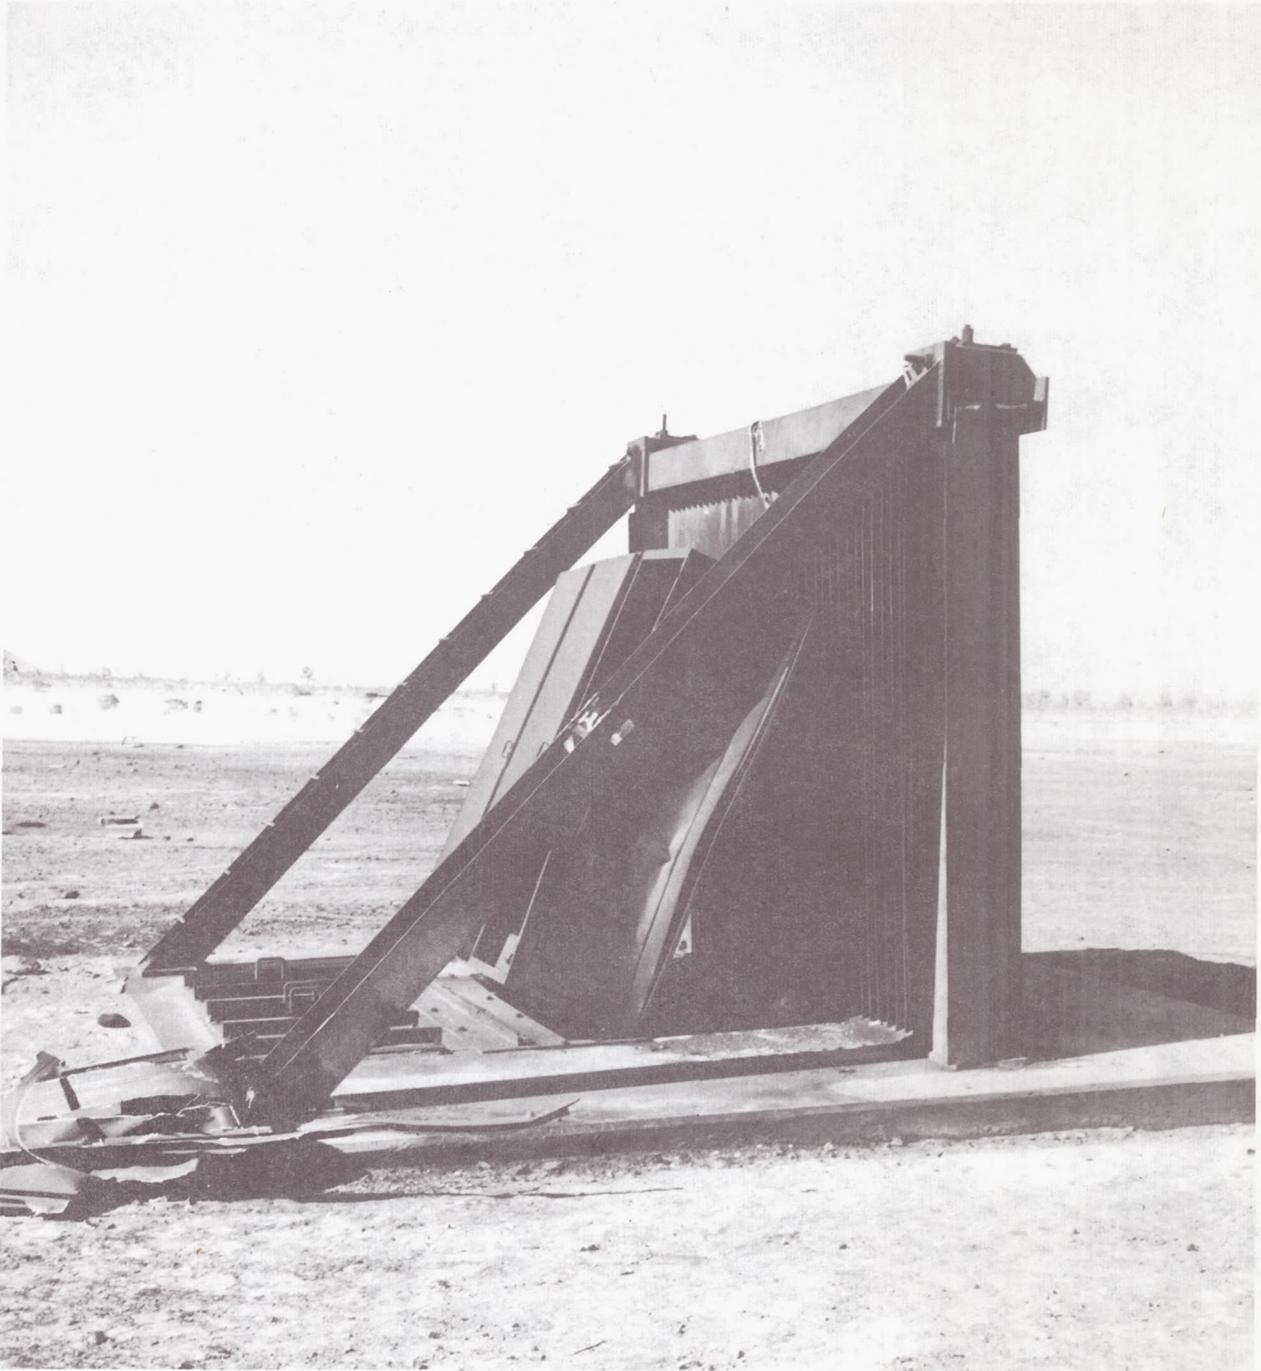
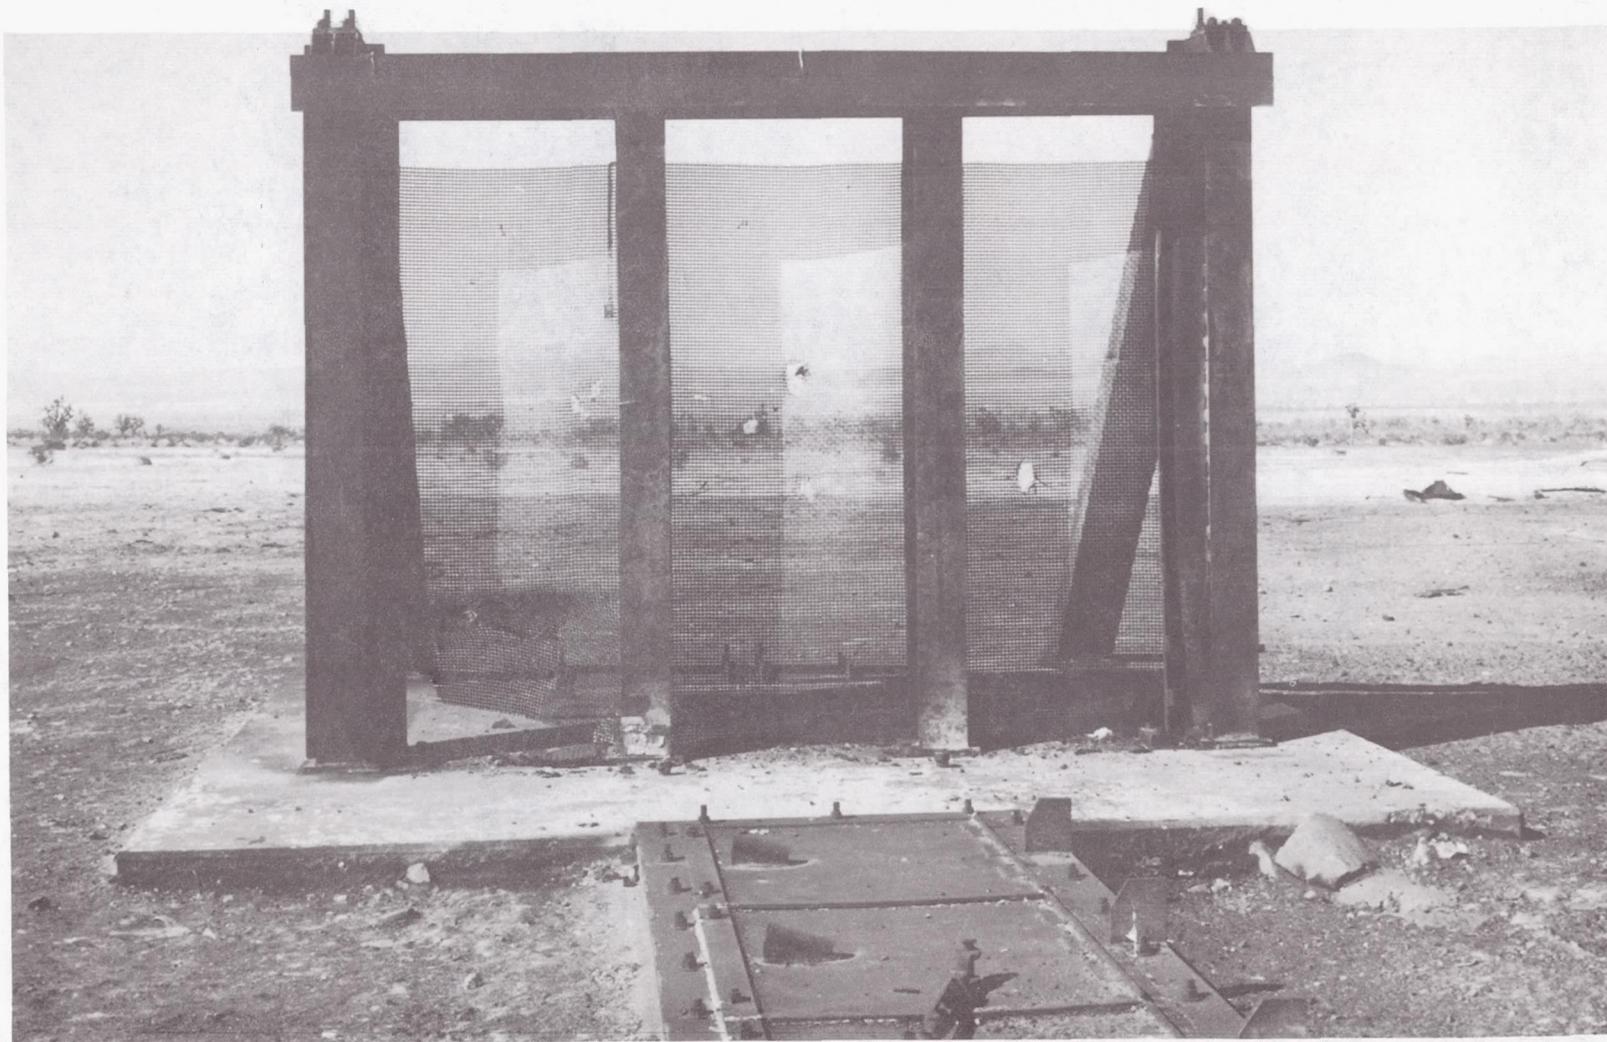
This Titan I test ( Fig. A-12) of low explosive yield caused slight damage to Wire Screen No. 2, and no damage to the angle deflector ( Figs. A-13 and A-14) . Some holes were perforated in the wire screen by flying fragments, and some bottom wires were ripped loose from their welded connections. Here again the failure occurred at the most rigid location of the blast shield as was the case with arched and flat plates.

FIGURE A-13. TEST STAND NO. 1 AFTER EXPLOSION, TEST 301  
(BLAST SHIELD: ANGLE DEFLECTOR)

FIGURE A-14. TEST STAND NO. 2 AFTER EXPLOSION, TEST 301  
(BLAST SHIELD: WIRE SCREEN NO. 2 WITH 48.0% OPEN AREA)
