**FUSED SLURRY SILICIDE COATINGS
FOR COLUMBIUM ALLOY REENTRY HEAT SHIELDS**

Volume I Evaluation Analysis

MCDONNELL DOUGLAS AERONAUTICS COMPANY - EAST

August 1973

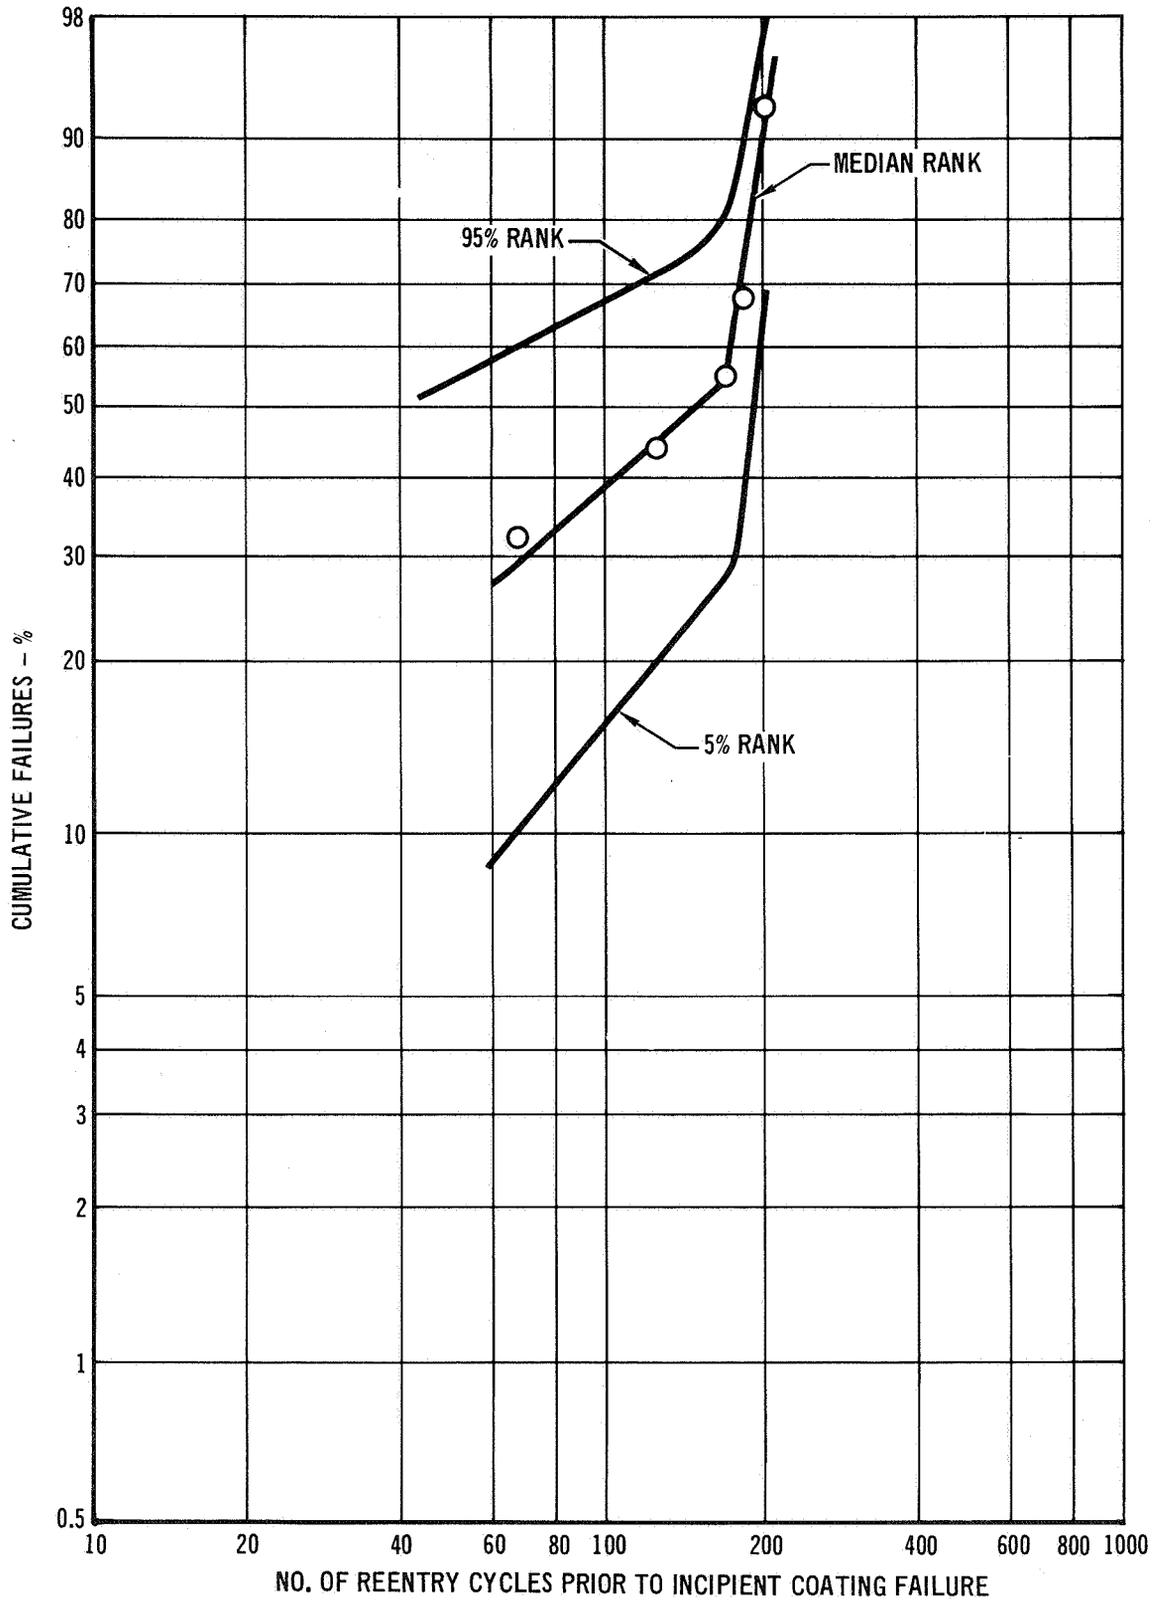
WEIBULL PLOT OF INCIPIENT COATING FAILURE ON 3' x 12' PANELS

NOTE: SAME AS TEXT FIGURE 11-12

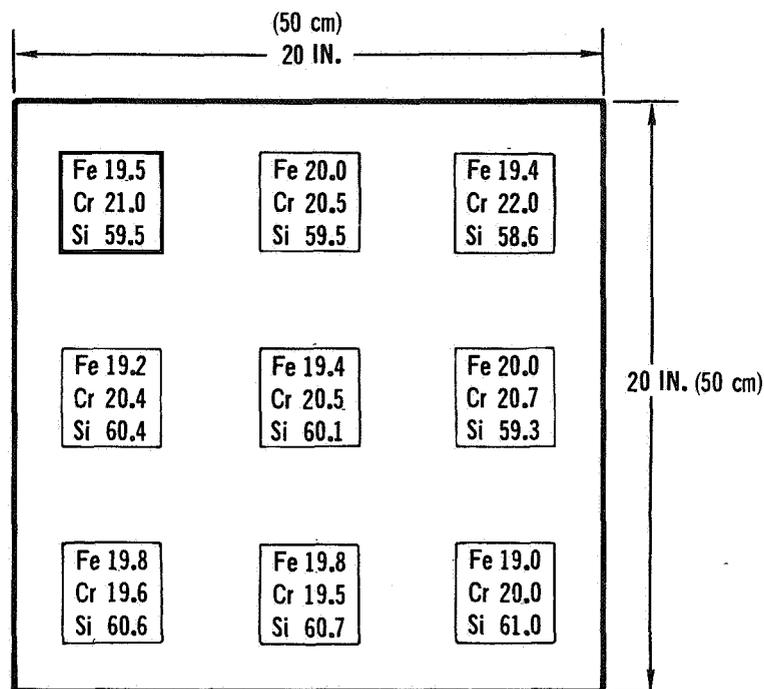
FIGURE 2

COATING COMPOSITION UNIFORMITY ON 20 IN. x 20 IN. (50 CM x 50 CM)
FLAT STAINLESS MOCKUP
NOTE: SAME AS TEXT FIGURE 8-3

Chemistry Variations - Possible variation in coating chemistry obtained with the dipping process were determined by coating a 20" x 20" (50 cm x 50 cm) flat stainless steel mockup. Samples from the green coating were selectively removed from 2" (5 cm) square areas in nine locations on the panel. The coating powder obtained was analyzed for chromium and iron by x-ray fluorescence techniques, the results are shown in Figure 2. The iron content was found to vary from 19.0 to 20.0%, chromium from 19.5 to 22%, and silicon from 58.6 to 61.0%. Since the nominal slurry composition is 60% Si, 20% Cr, and 20% Fe, the analyzed values indicate the effectiveness of the process and stability of the slurry.

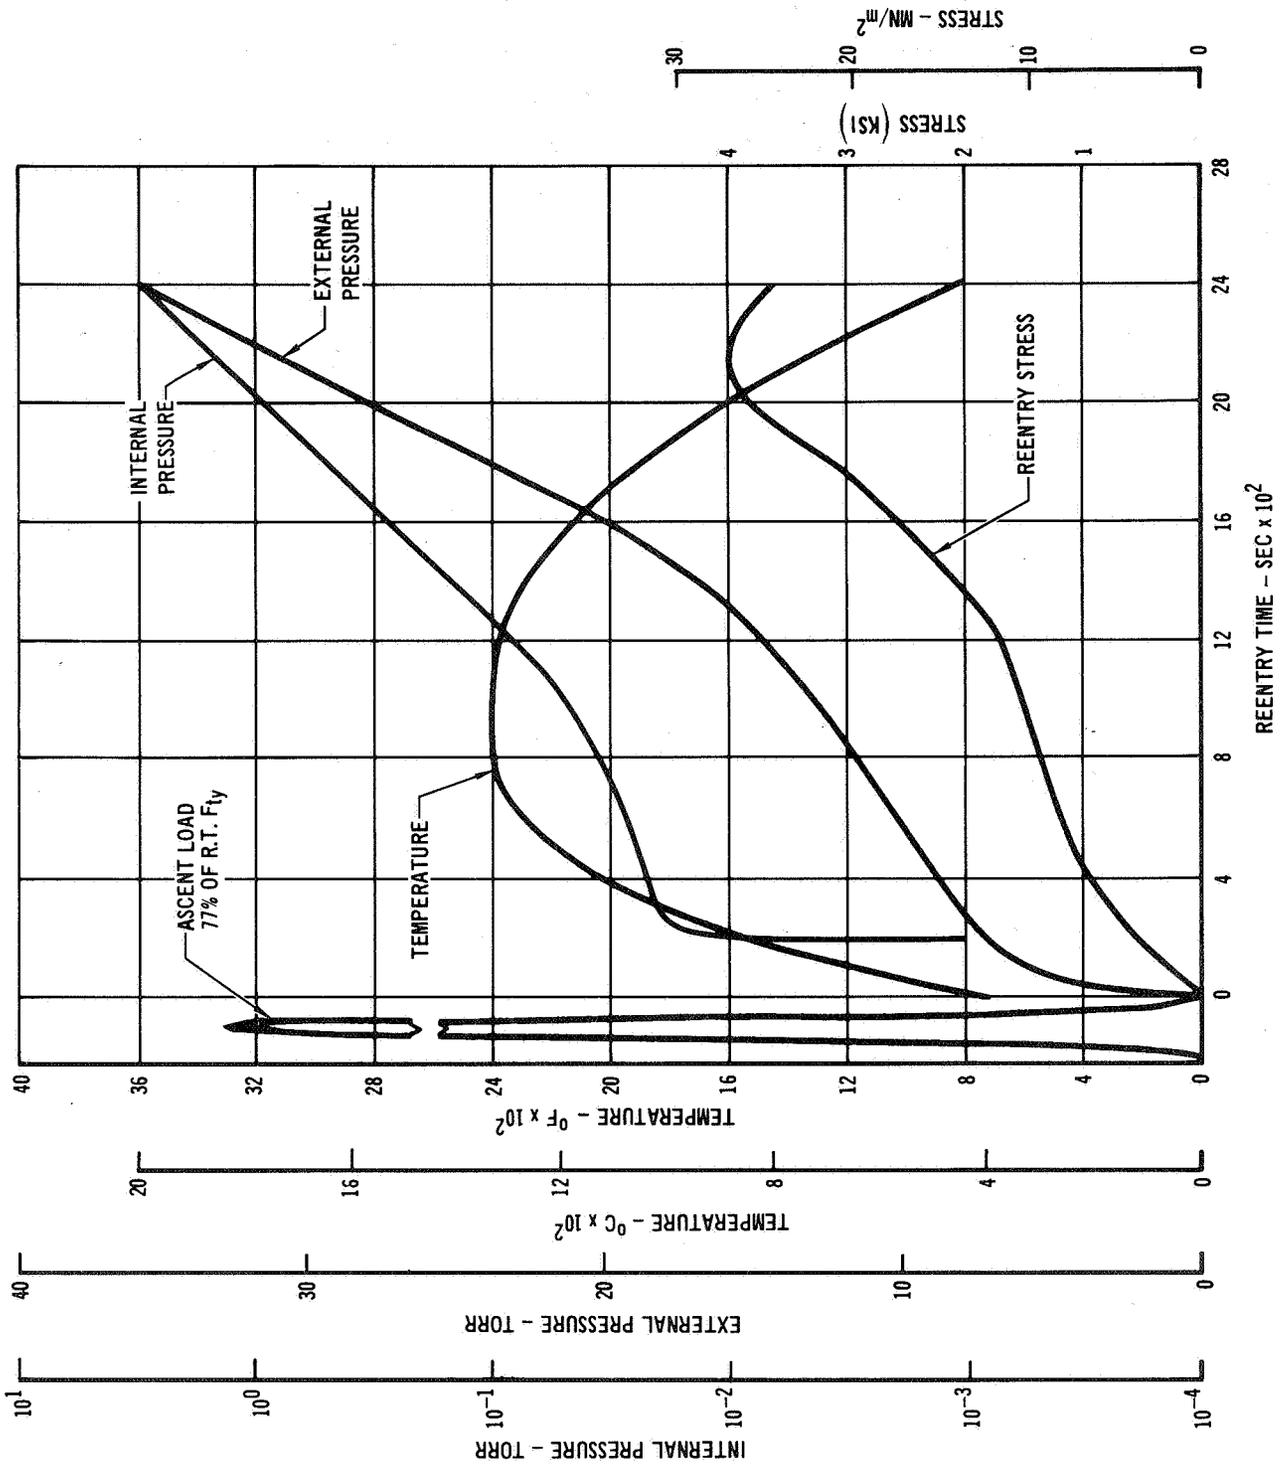
FIGURE 4-1

REENTRY PROFILE TEST CONDITIONS FOR TABS, TENSILE, AND
MINIATURE HEAT SHIELD PANELS

The initial test conditions selected are shown in Figure 4-1 and were used for evaluation of tabs, tensile specimens, and miniature heat shield panels.

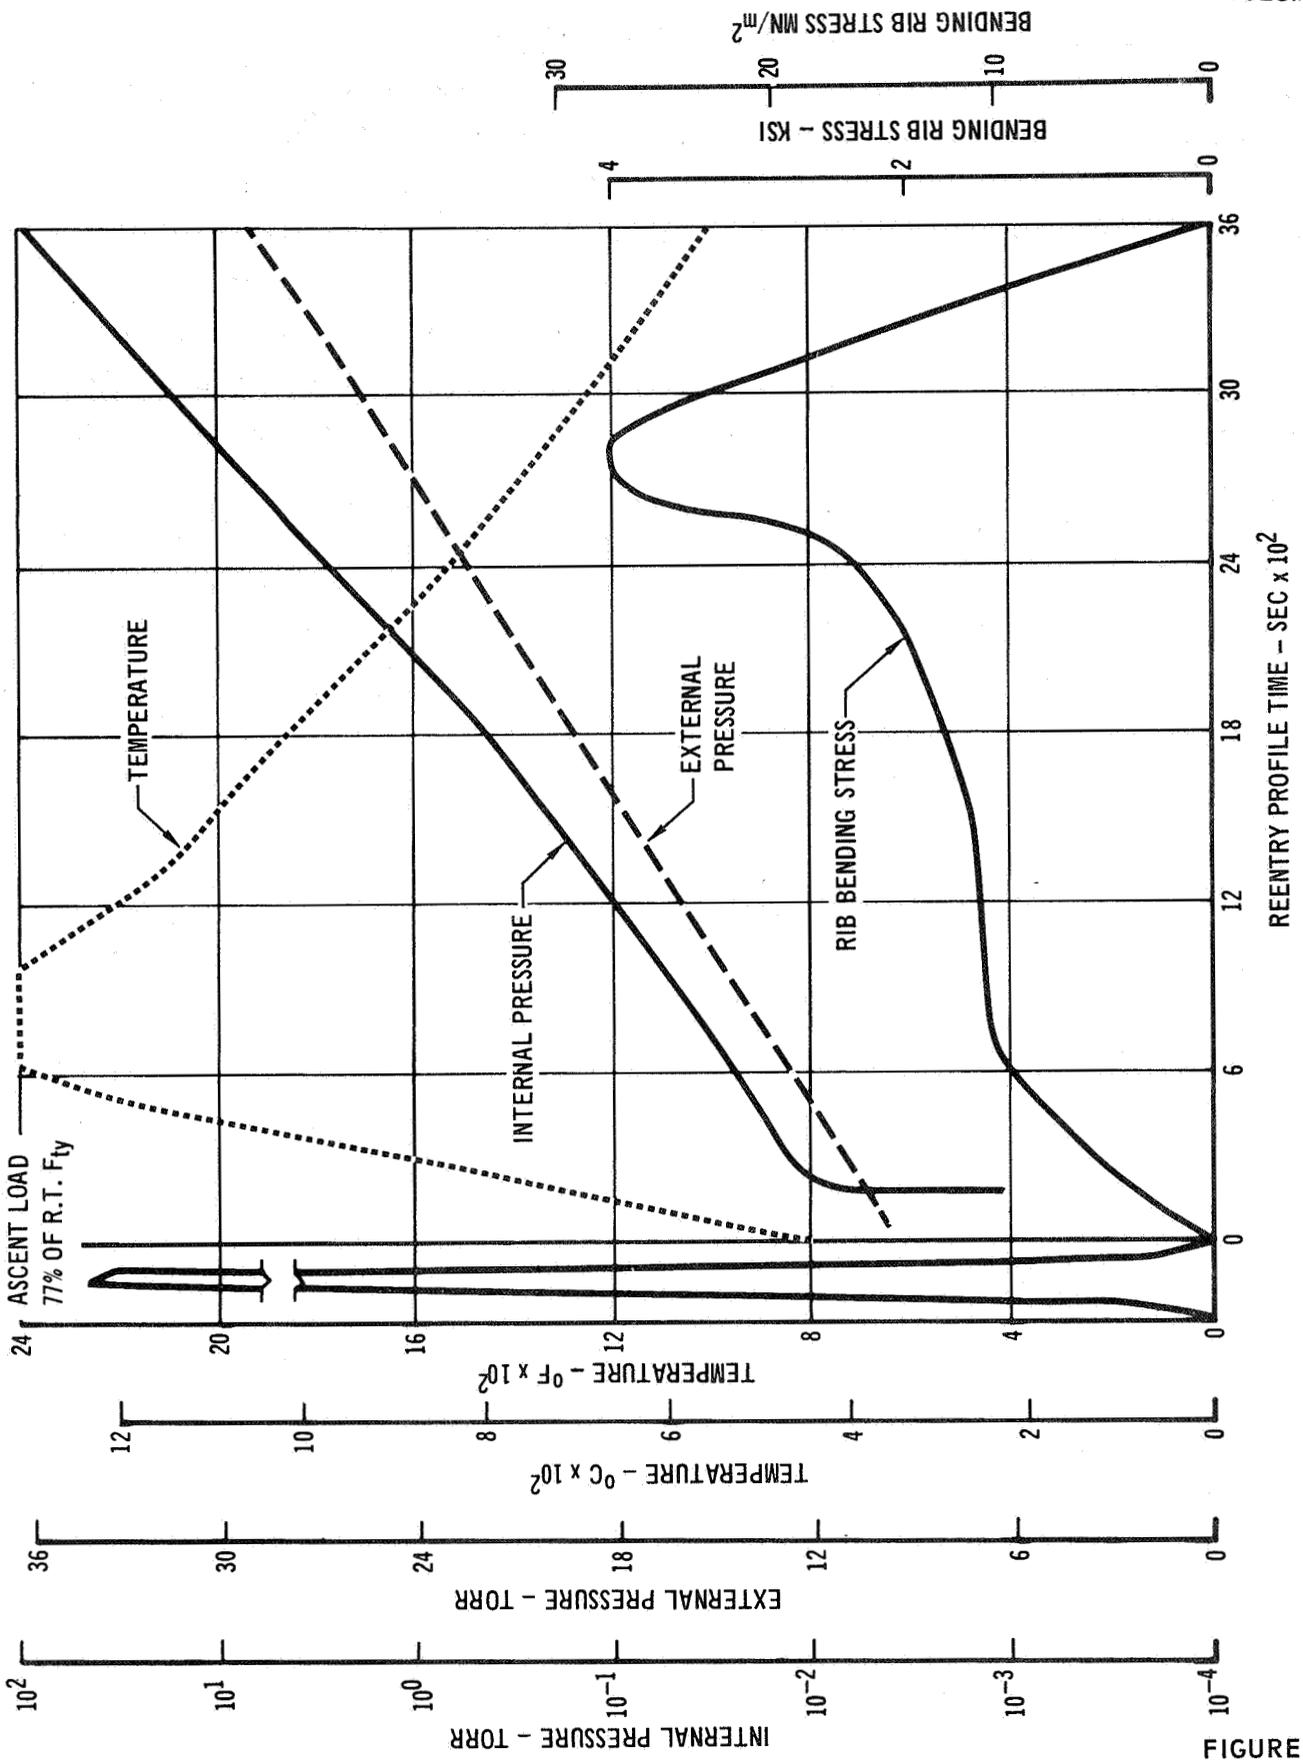
FIGURE 4-2

REENTRY PROFILE TEST CONDITIONS FOR SUB-SIZE PANELS

A part of the flight simulation which was performed on each subsize heat shield panel and not shown in Figure 4-2 was acoustic exposure to simulate the noise environment experienced during lift-off. Peak acoustic loading conditions are experienced for approximately 30 sec during each lift-off. Each of the test parameters will be discussed separately and the rationale for its definition is given in Volume II.

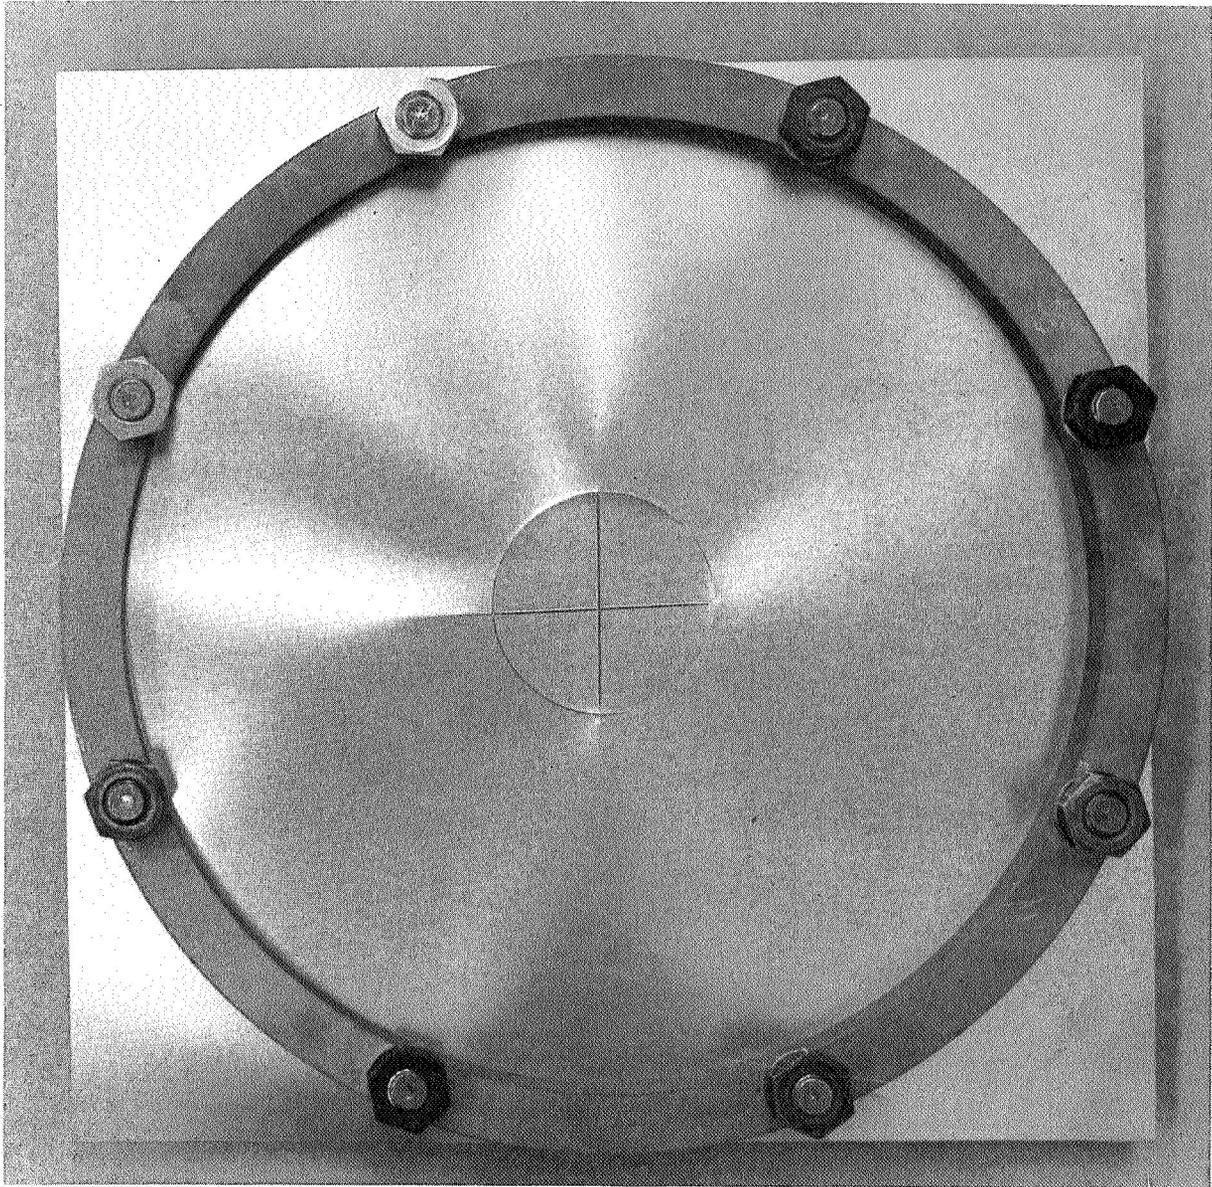
FIGURE 5-1

F5-85 WELD RESTRAINT SPECIMEN

5.1 Fabricability - Weldability was initially determined by performing a circular patch or a restraint weld on the 0.012" (0.03 cm) thick material. Restraint was accomplished by clamping an 8" (20 cm) ring over the sheet and then electron beam welding a 2" (5 cm) circle. The test fixture with one of the welded specimens is shown in Figure 5-1. All of the alloys were successfully welded with no evidence of cracking.

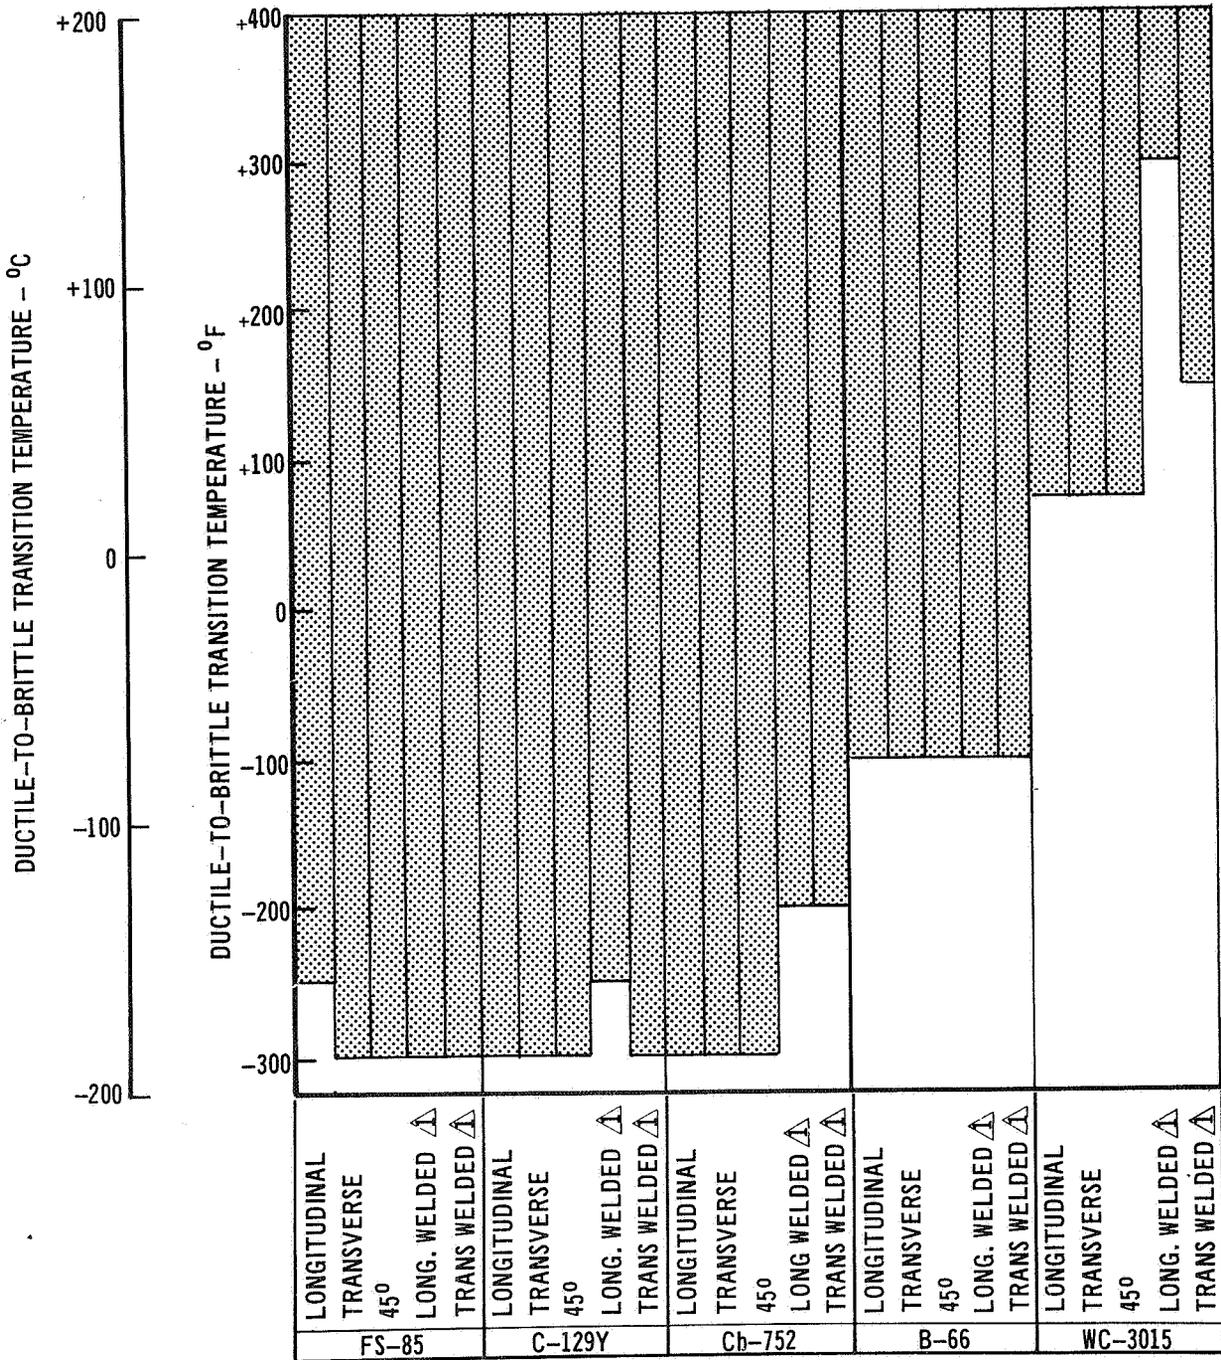
- 1 WELDS GIVEN POST WELD HEAT TREATMENT OF 1 HOUR AT 2450°F
- 2 SHADED AREA IS DUCTILE REGION

DUCTILE-BRITTLE TRANSITION TEMPERATURE

From this figure it can be seen that the WC-3015 alloy possessed the highest transition temperature in both the "as received" and "welded and stress relieved condition." The postweld heat treatment caused a significant increase in the transition temperature, making this alloy unacceptable for welded structures. In the case of the B-66 and Cb-752 alloys, the transition temperatures are lower than normally expected. This is primarily due to modifications in the alloy's final annealing temperature and the selection of a postweld thermal cycle that allowed overaging to occur. Previous in-house studies involving the Cb-752 alloy have shown that the conventional practice of annealing this alloy for 1 hour at 2200-2300°F (1200-1260°C) generally resulted in a transition temperature of +50°F (10°C) while anneals conducted above 2300°F (1260°C) usually caused lowering of this temperature. Based on this data a decision was made to request the material supplier to use a final annealing temperature of 1 hour at 2550°F (1400°C), which resulted in the lower transition temperature. The use of this technique is not

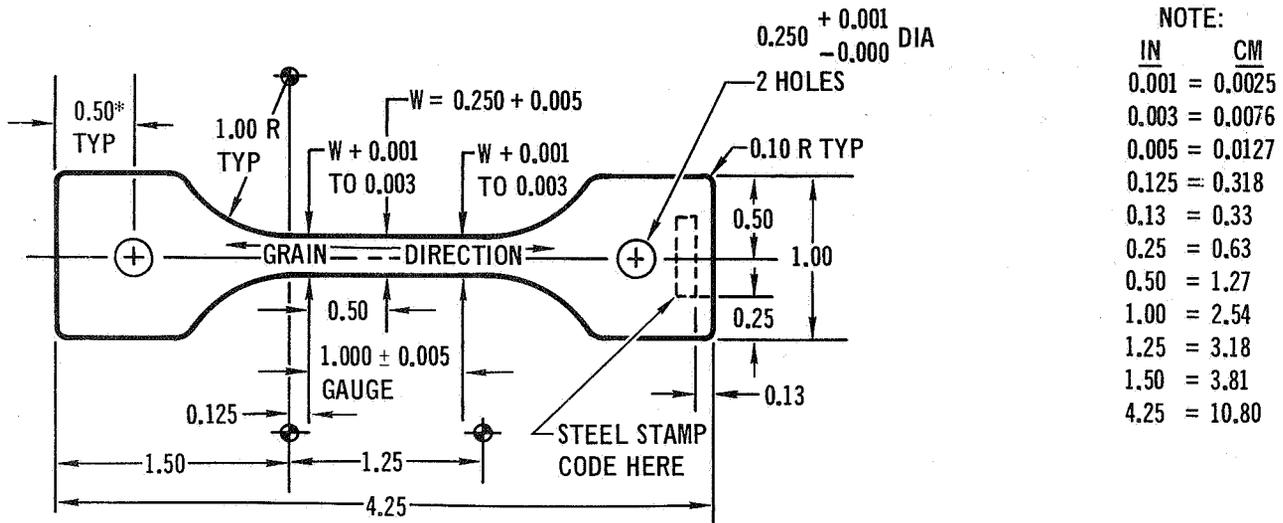
*DIMENSIONS ARE IN INCHES

TENSILE SPECIMEN

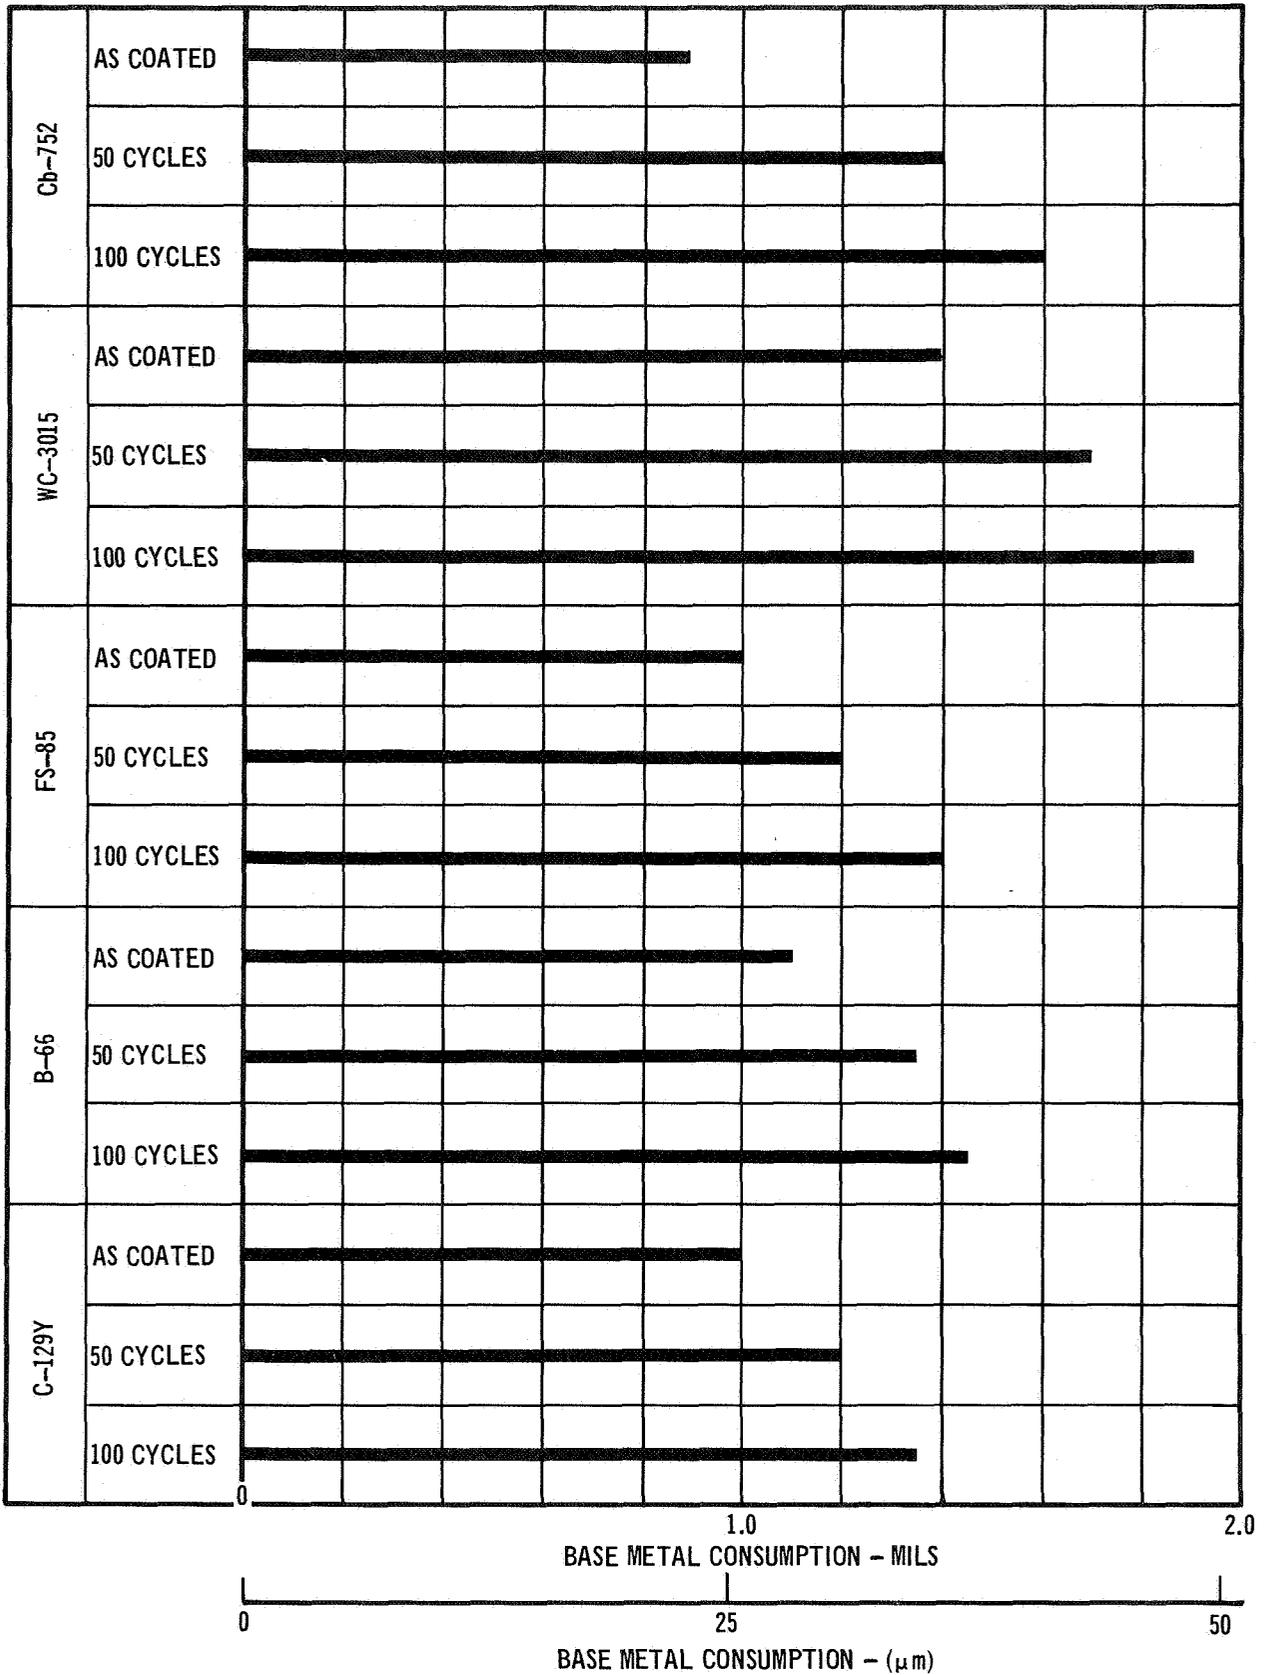
FIGURE 5-9

COMPARISON OF ALLOY BASE METAL CONSUMPTION PER SIDE

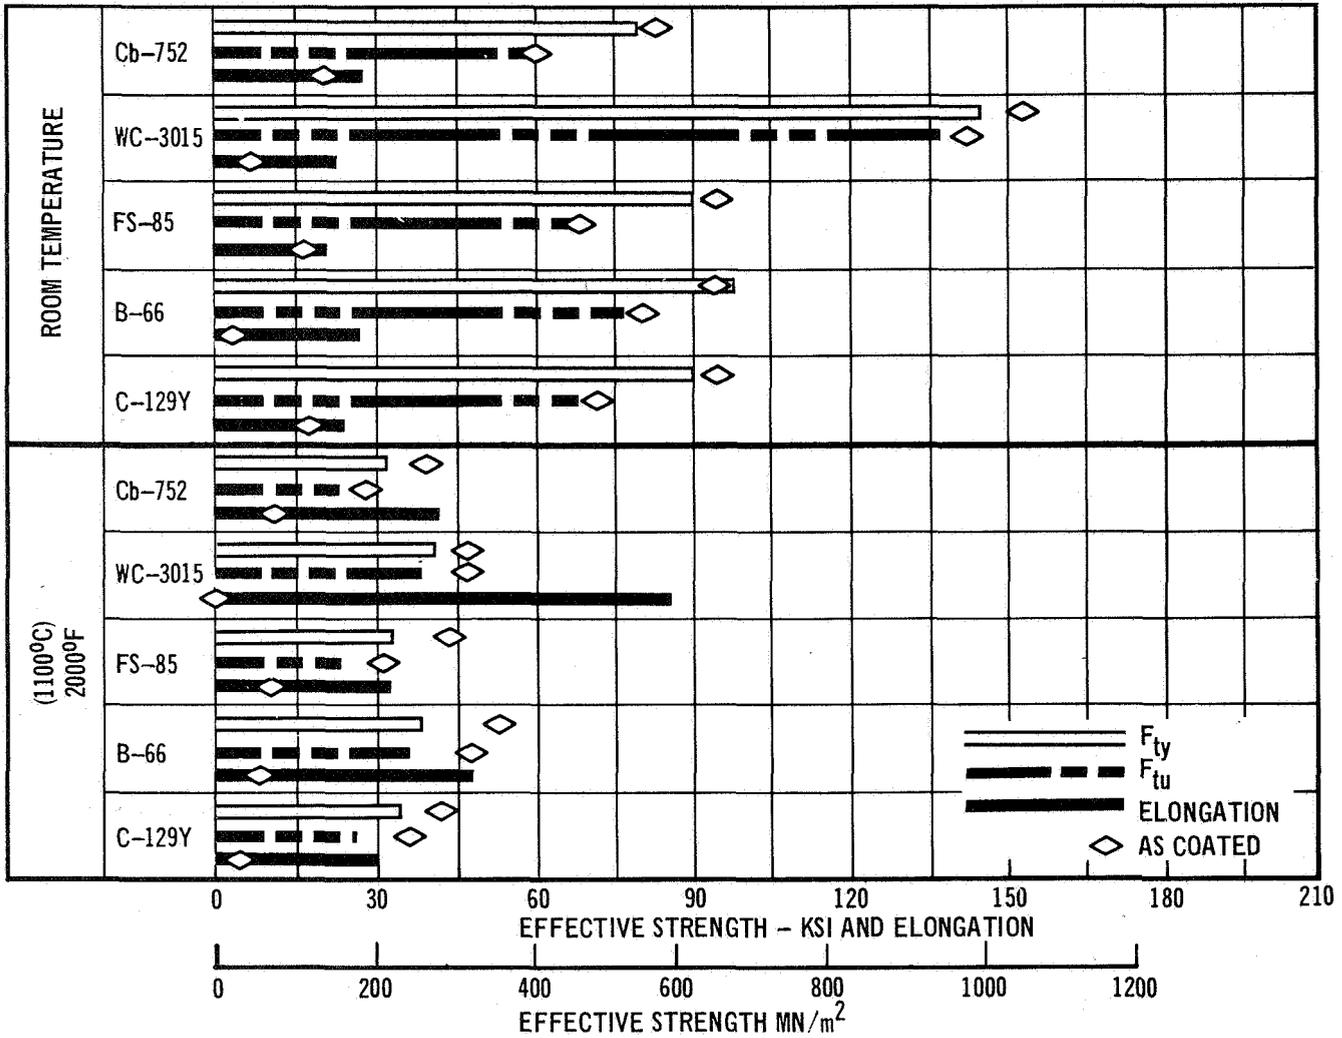
FIGURE 5-10

COMPARISON OF ALLOY MECHANICAL PROPERTIES (BARE AND AS COATED)

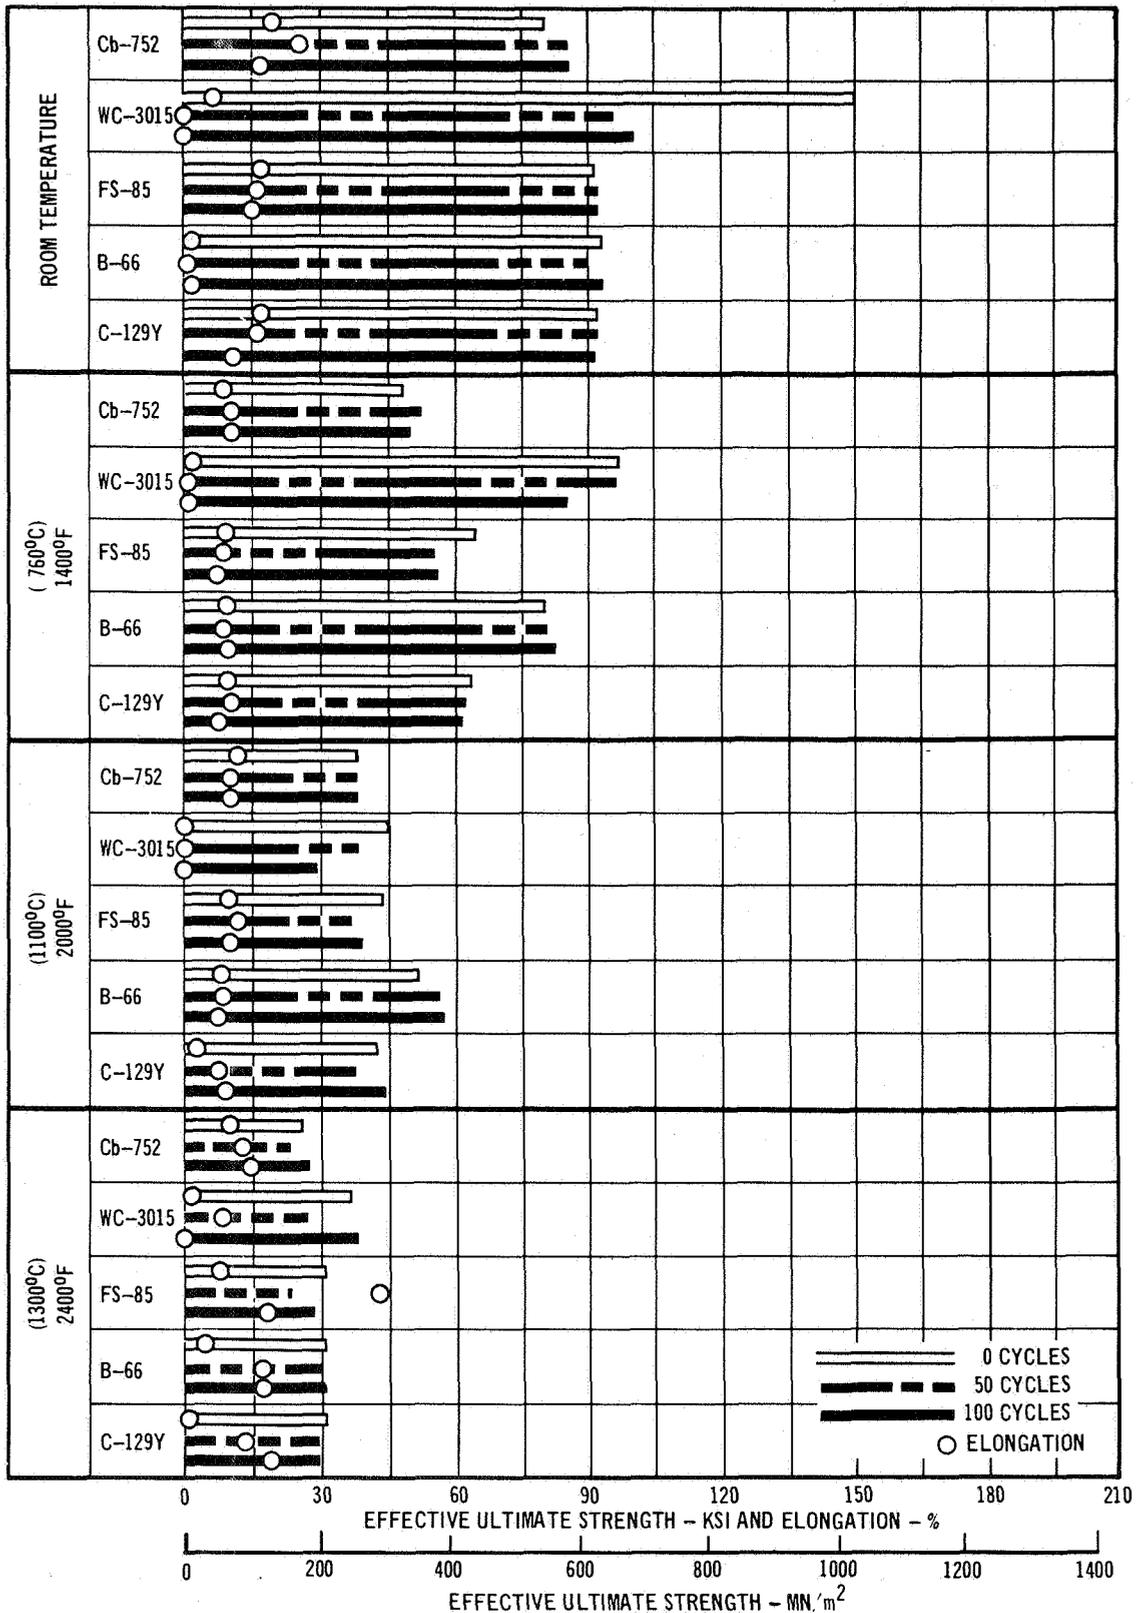
FIGURE 5-11

COMPARISON OF ALLOY ULTIMATE STRENGTHS AND ELONGATIONS
(AFTER REENTRY CYCLING AND AS COATED)

The elongation did not show much change due to cycling from the "as coated" condition.

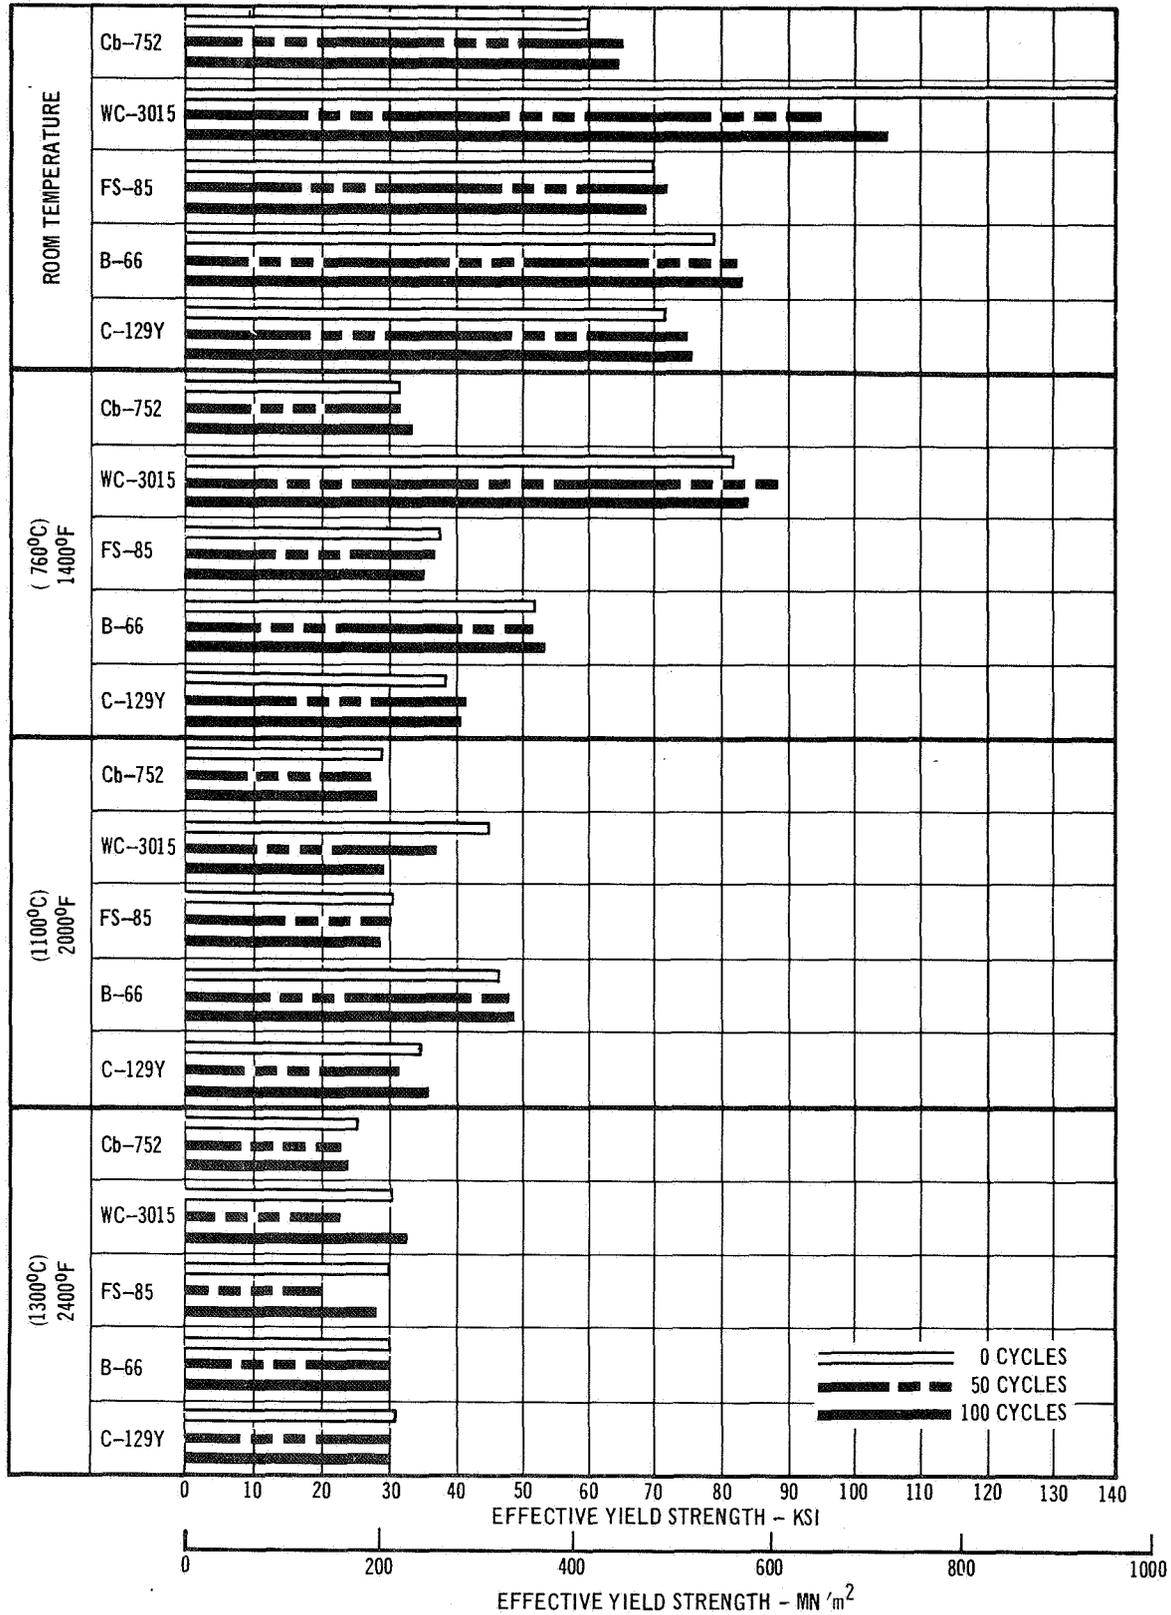
FIGURE 5-12

COMPARISON OF ALLOY YIELD STRENGTHS (AFTER REENTRY CYCLING AND AS COATED)

A comparison of the effective yield strengths for the "as coated" and cycled alloys is shown in Figure 5-12. The same trends that were evident in comparing the ultimate strengths are evident in the yield strengths. The general conclusion is that thermal cycling for up to 100 simulated shuttle reentries has very little effect on the mechanical properties of R-512E coated Cb-752, FS-85, B-66 and C-129Y.

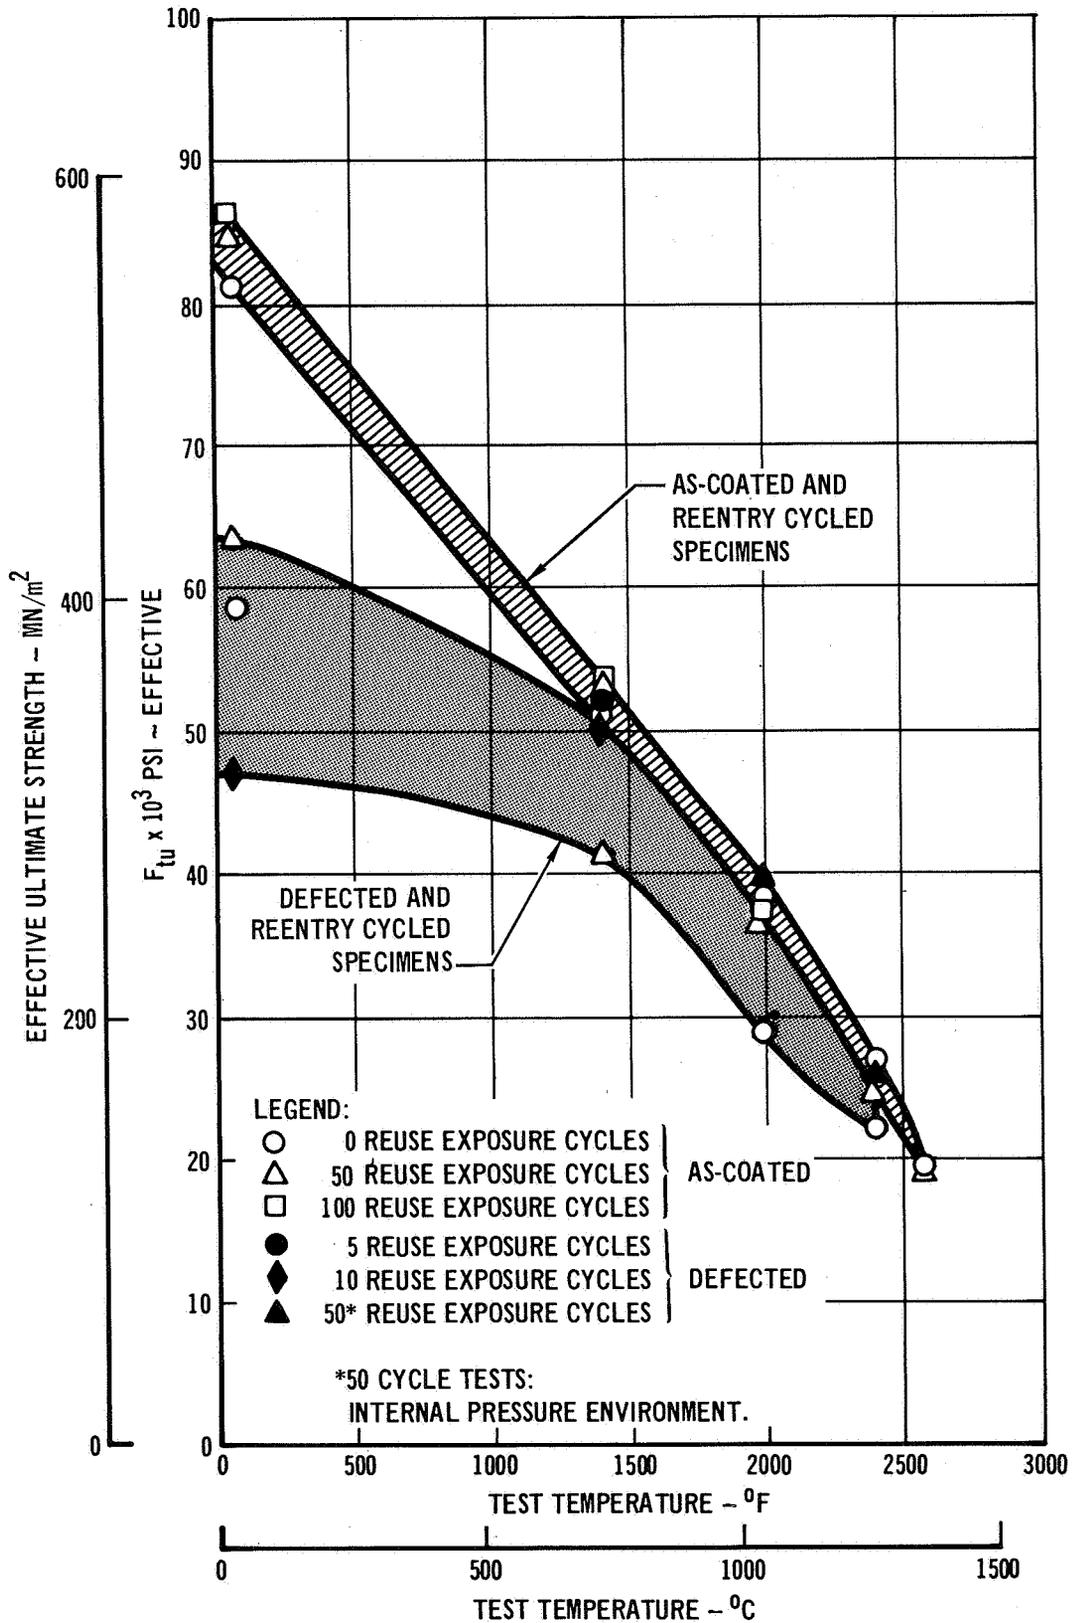
FIGURE 5-13

R-512E COATED Cb-752: EFFECTIVE ULTIMATE TENSILE STRENGTH
AS A FUNCTION OF REUSE AND COATING DAMAGE

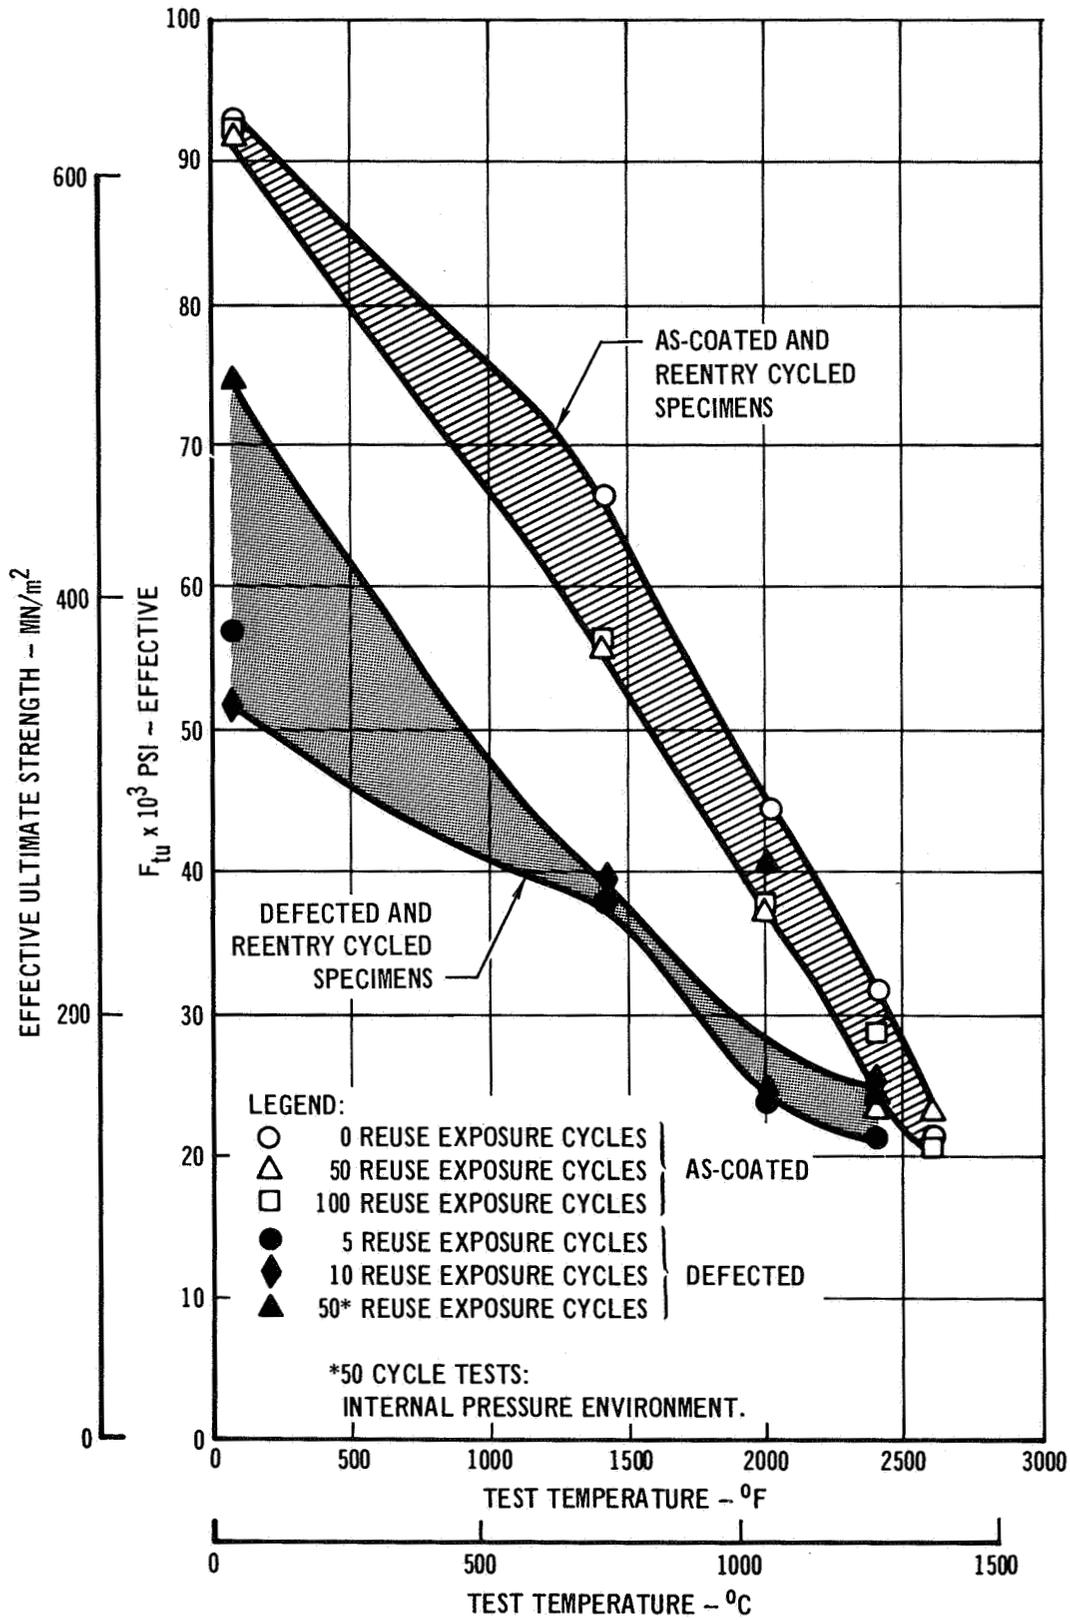
FIGURE 5-14

R-512E COATED FS-85: EFFECTIVE ULTIMATE TENSILE STRENGTH
AS A FUNCTION OF REUSE AND COATING DAMAGE
