**FUSED SLURRY SILICIDE COATINGS
FOR COLUMBIUM ALLOY REENTRY HEAT SHIELDS**

Volume I Evaluation Analysis

MCDONNELL DOUGLAS AERONAUTICS COMPANY - EAST

August 1973

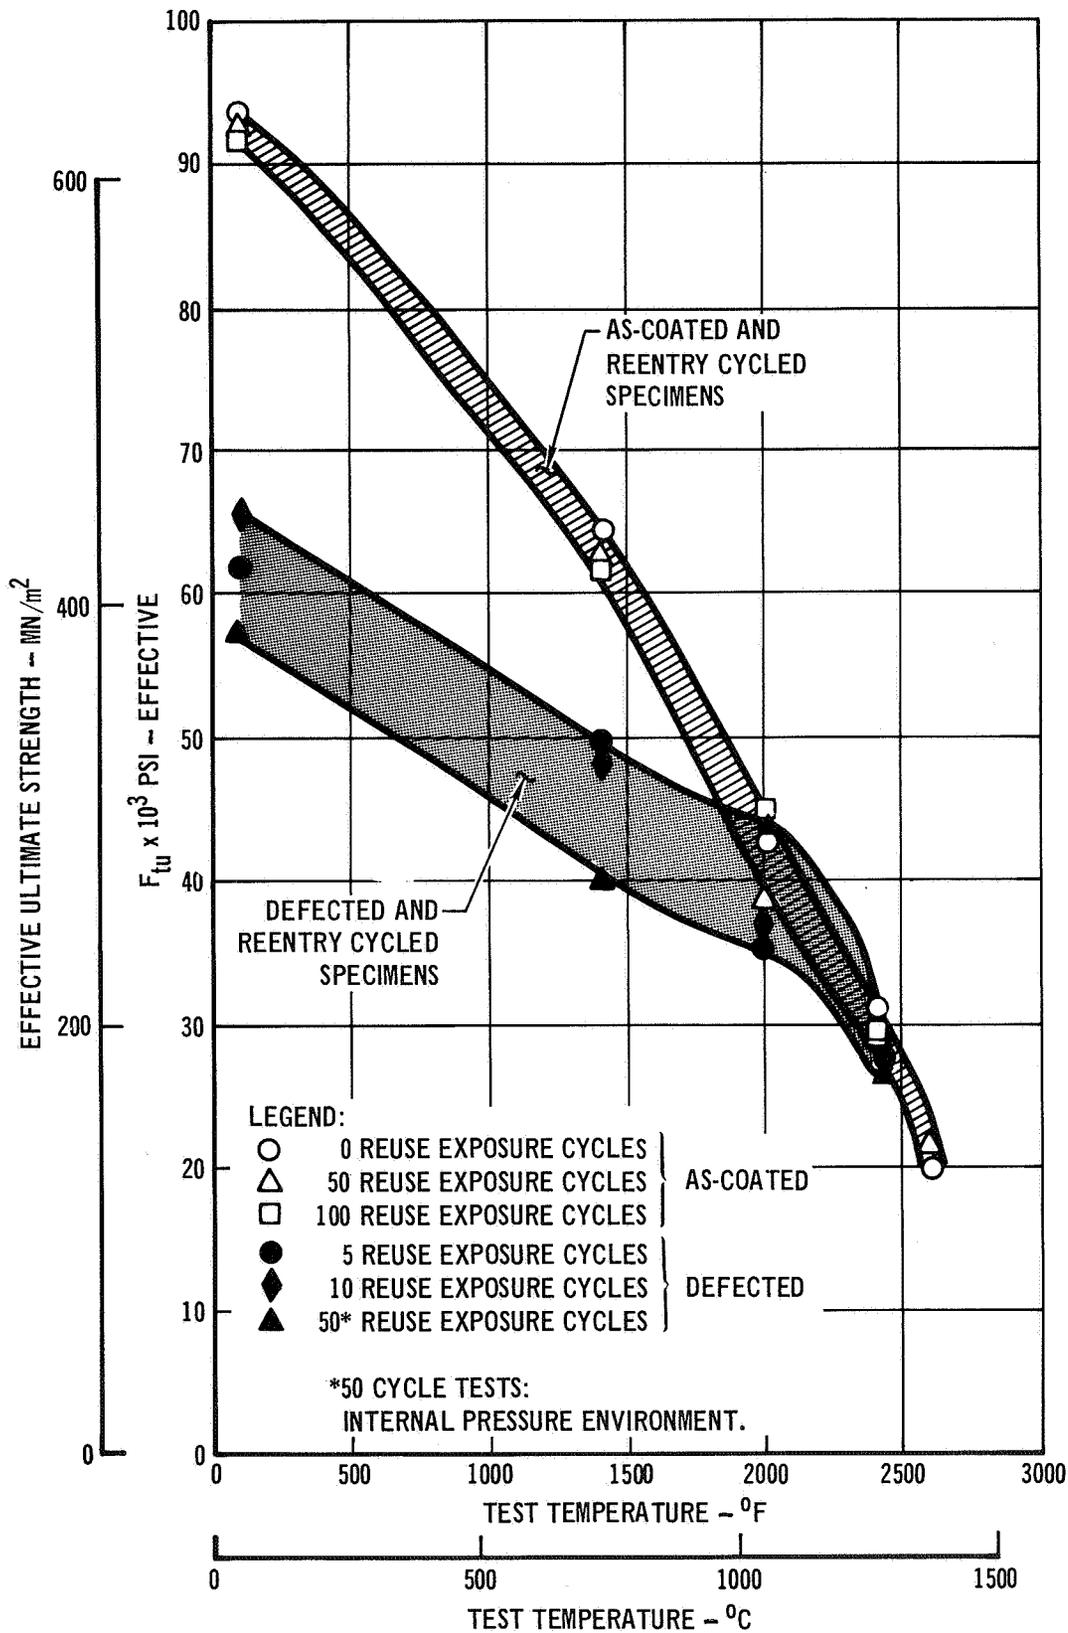
FIGURE 5-15

R-512E COATED C-129Y: EFFECTIVE ULTIMATE TENSILE STRENGTH
AS A FUNCTION OF REUSE AND COATING DAMAGE

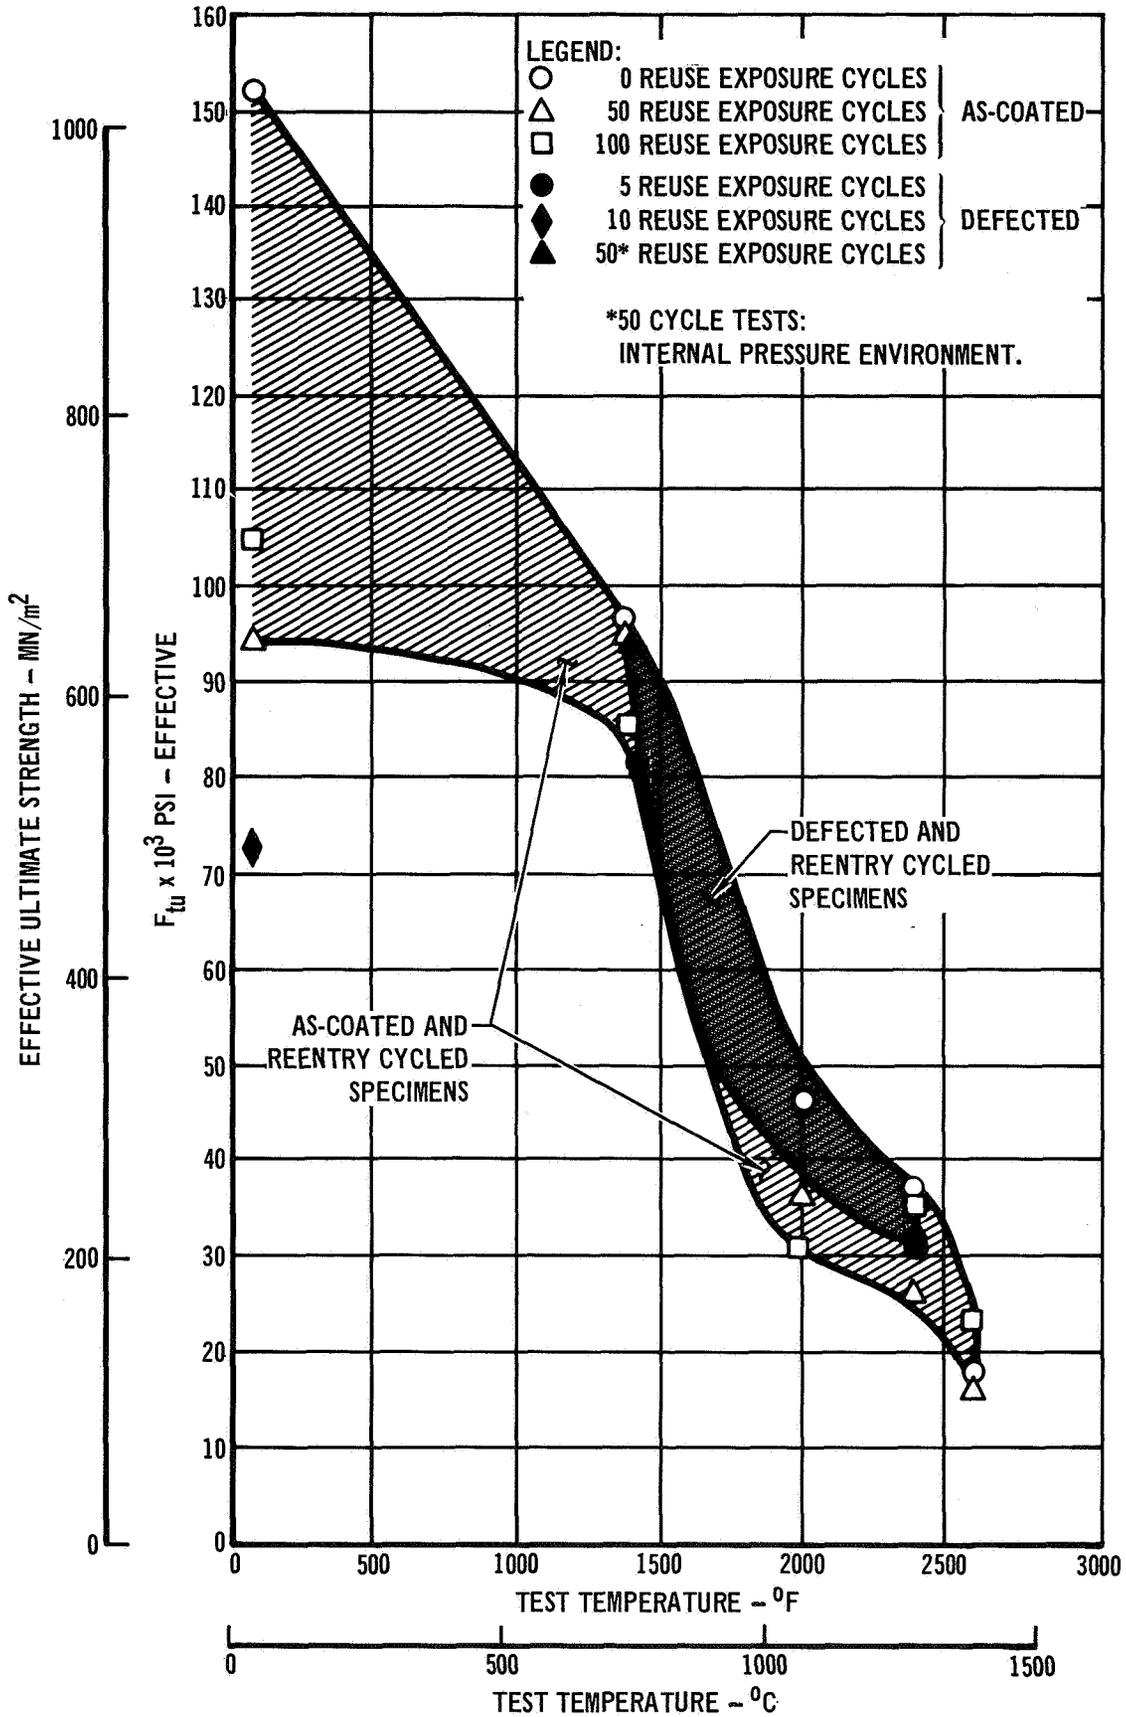
FIGURE 5-16

R-512E COATED WC-3015: EFFECTIVE ULTIMATE TENSILE STRENGTH AS A FUNCTION OF REUSE AND COATING DAMAGE

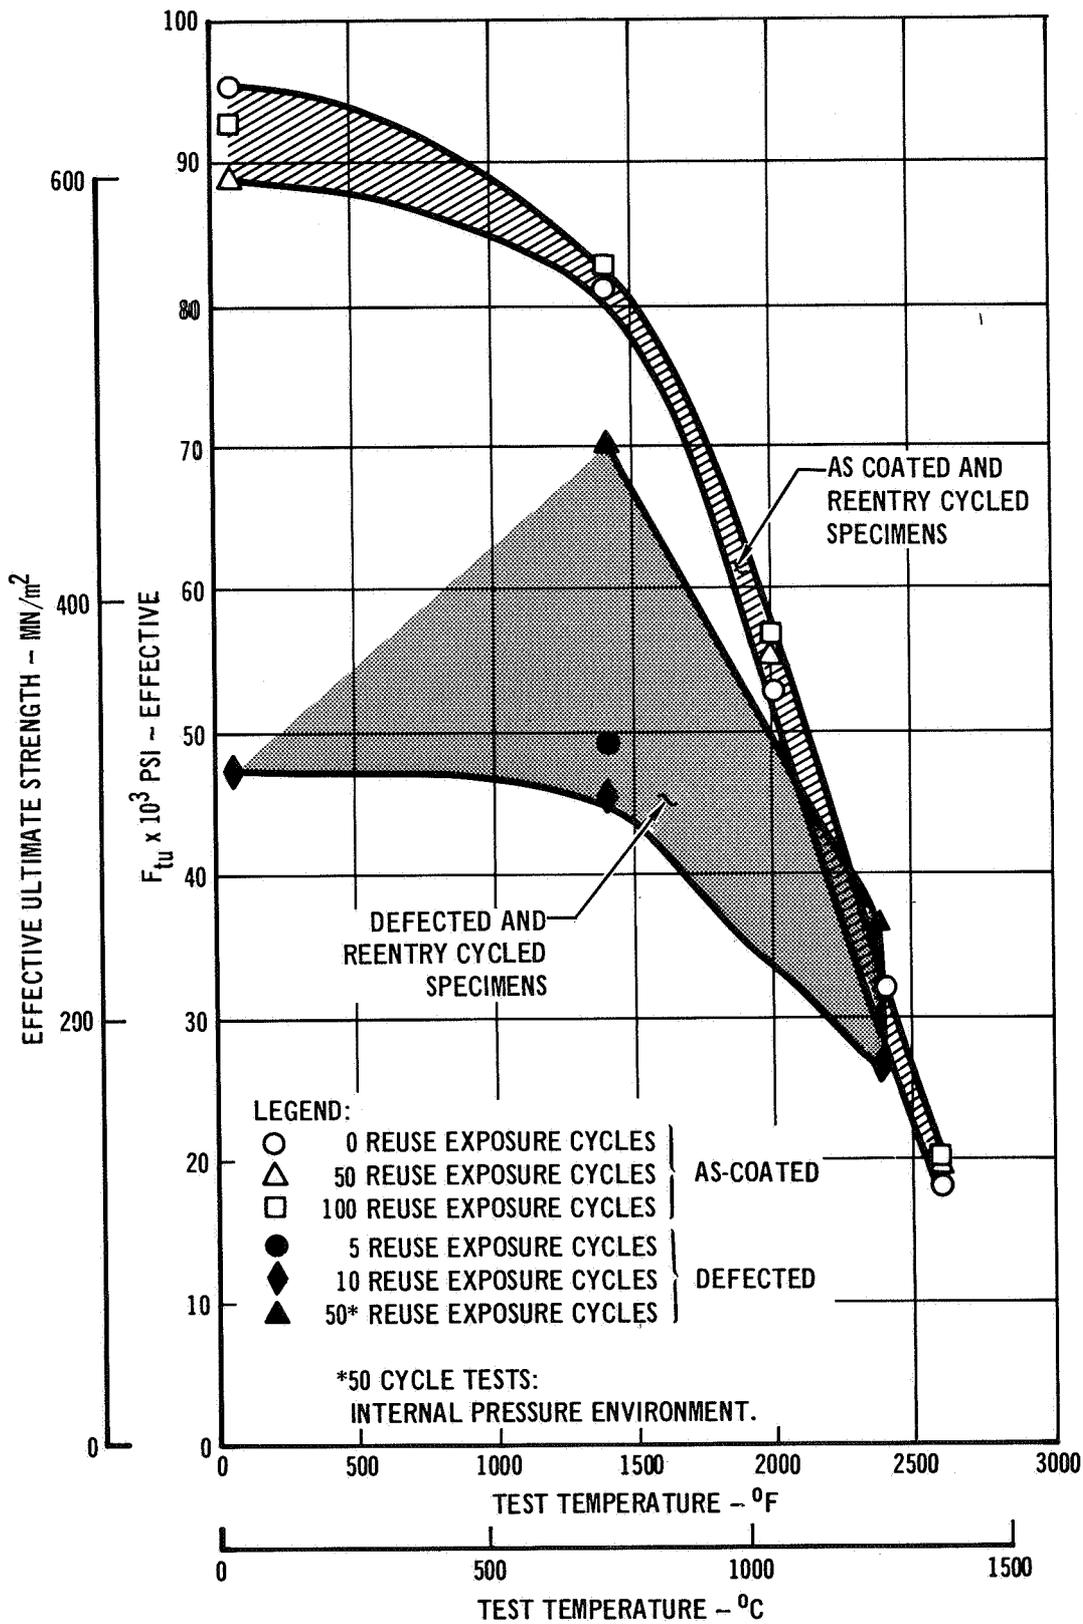
FIGURE 5-17

R-512E COATED B-66: EFFECTIVE ULTIMATE TENSILE STRENGTH
AS A FUNCTION OF REUSE AND COATING DAMAGE

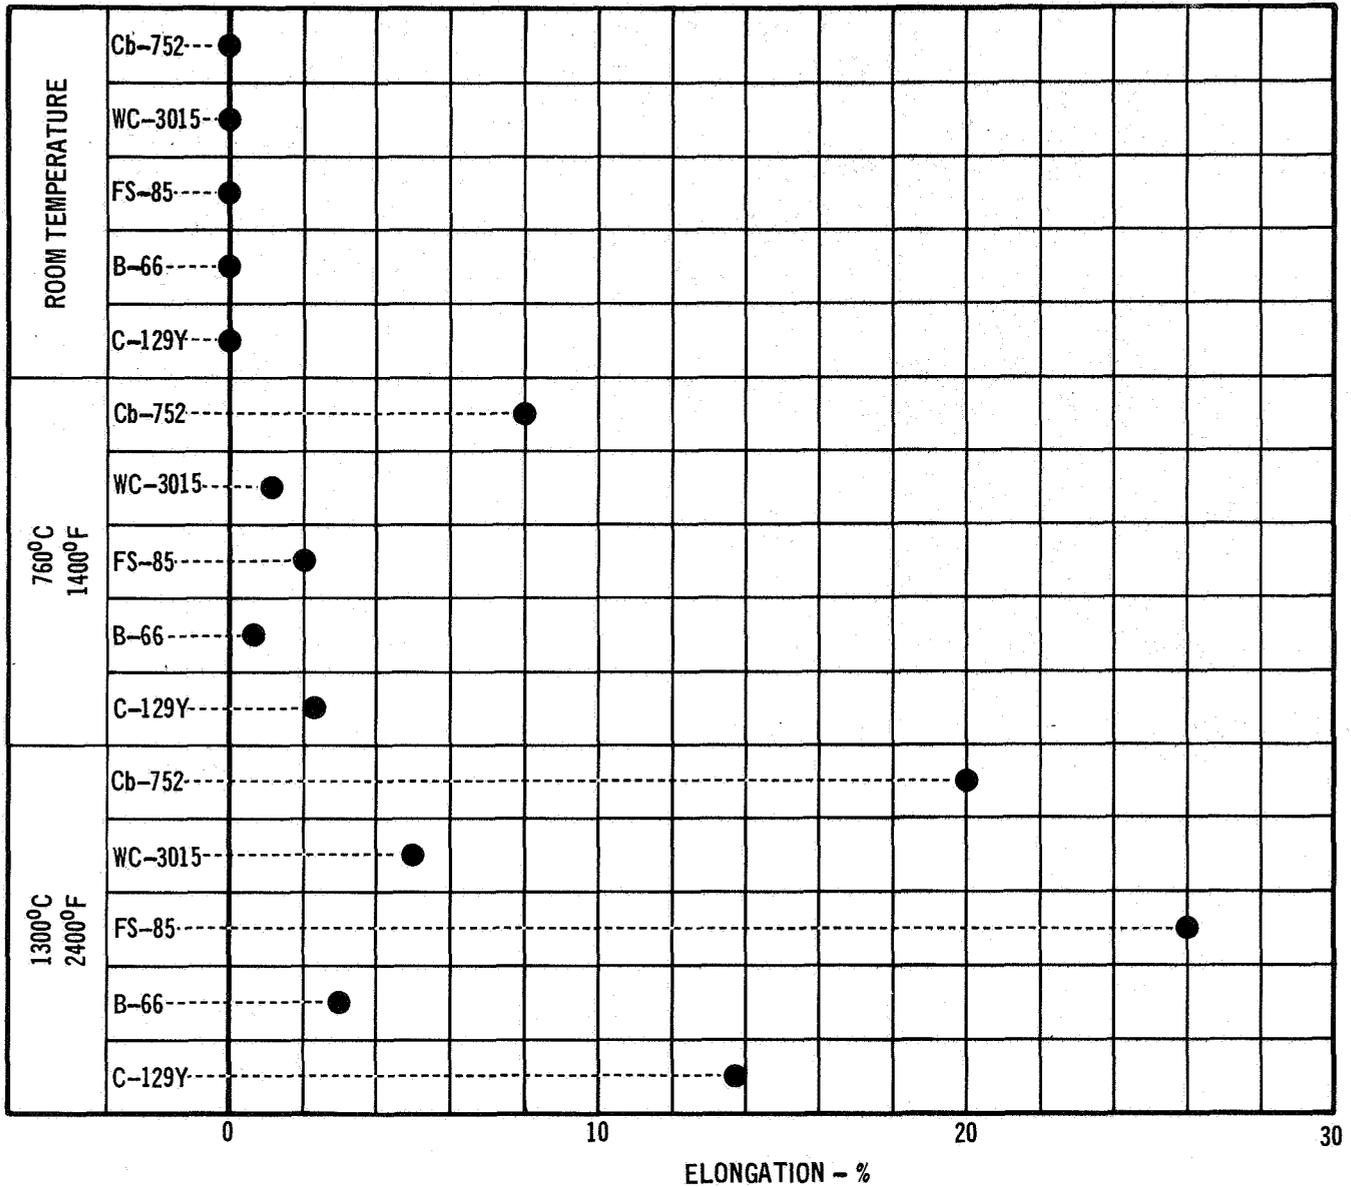
FIGURE 5-18

EFFECTS OF COATING DAMAGE ON TENSILE ELONGATION AFTER
EXPOSURE TO 10 REENTRY CYCLES

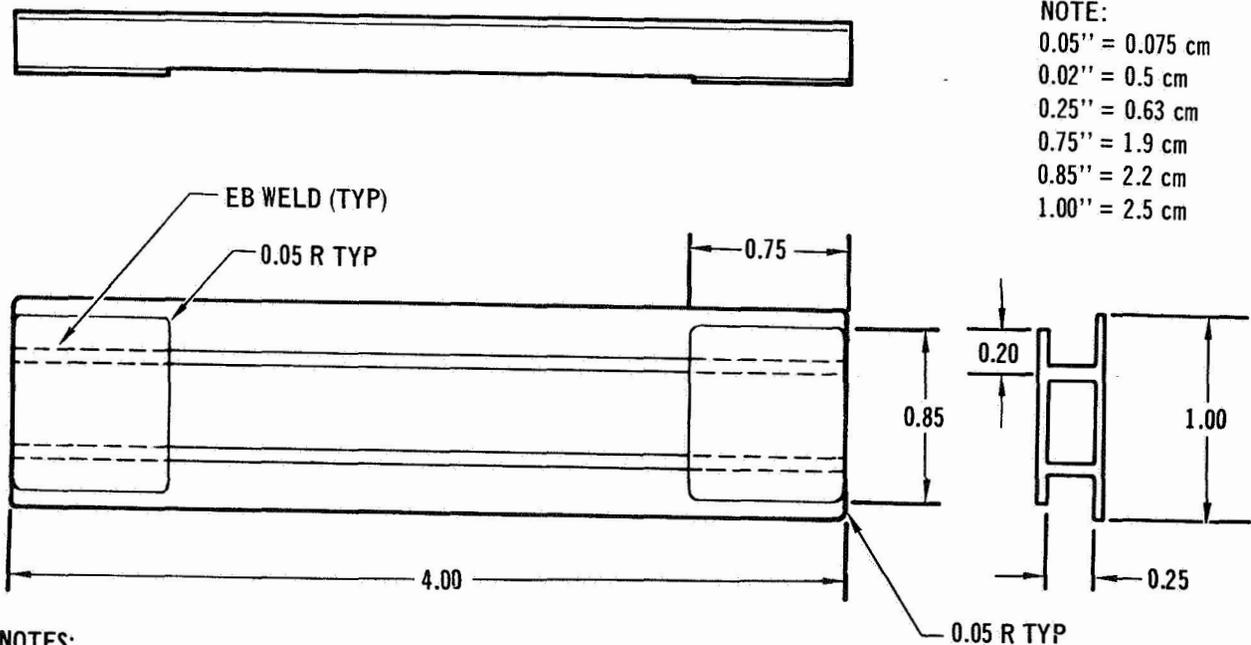
FIGURE 7-1

- (1) PANEL SKIN 0.008" (0.02 cm) AFTER COATING
- (2) PANEL RIBS 0.016" (0.04 cm) AFTER COATING
- (3) ALL DIMENSIONS ARE IN INCHES.

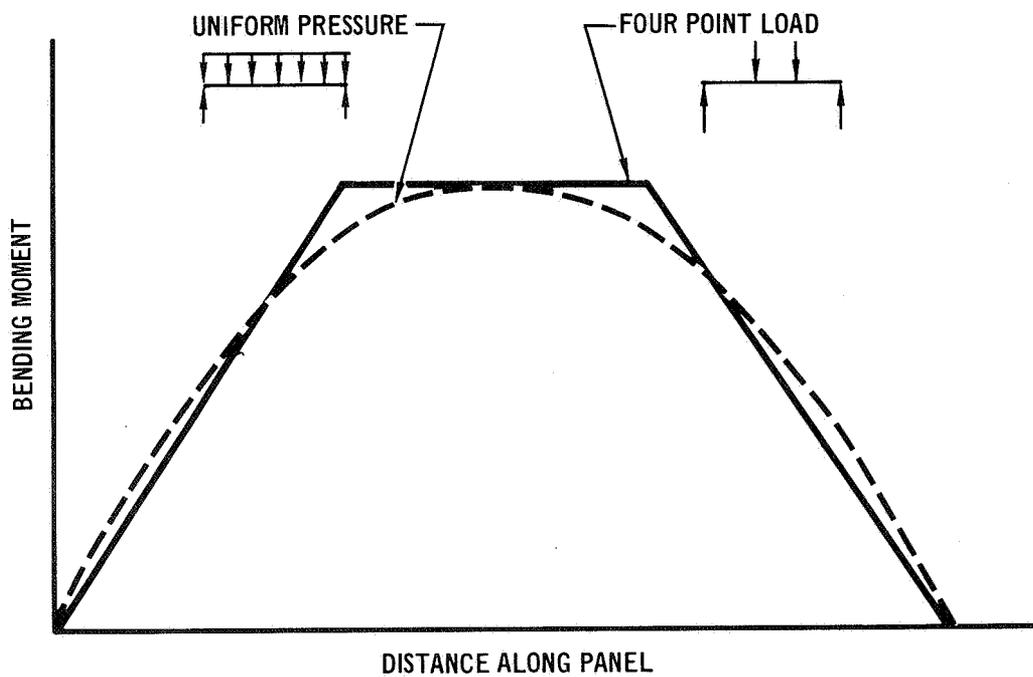
457-1156

Panel Bending Moment Distribution

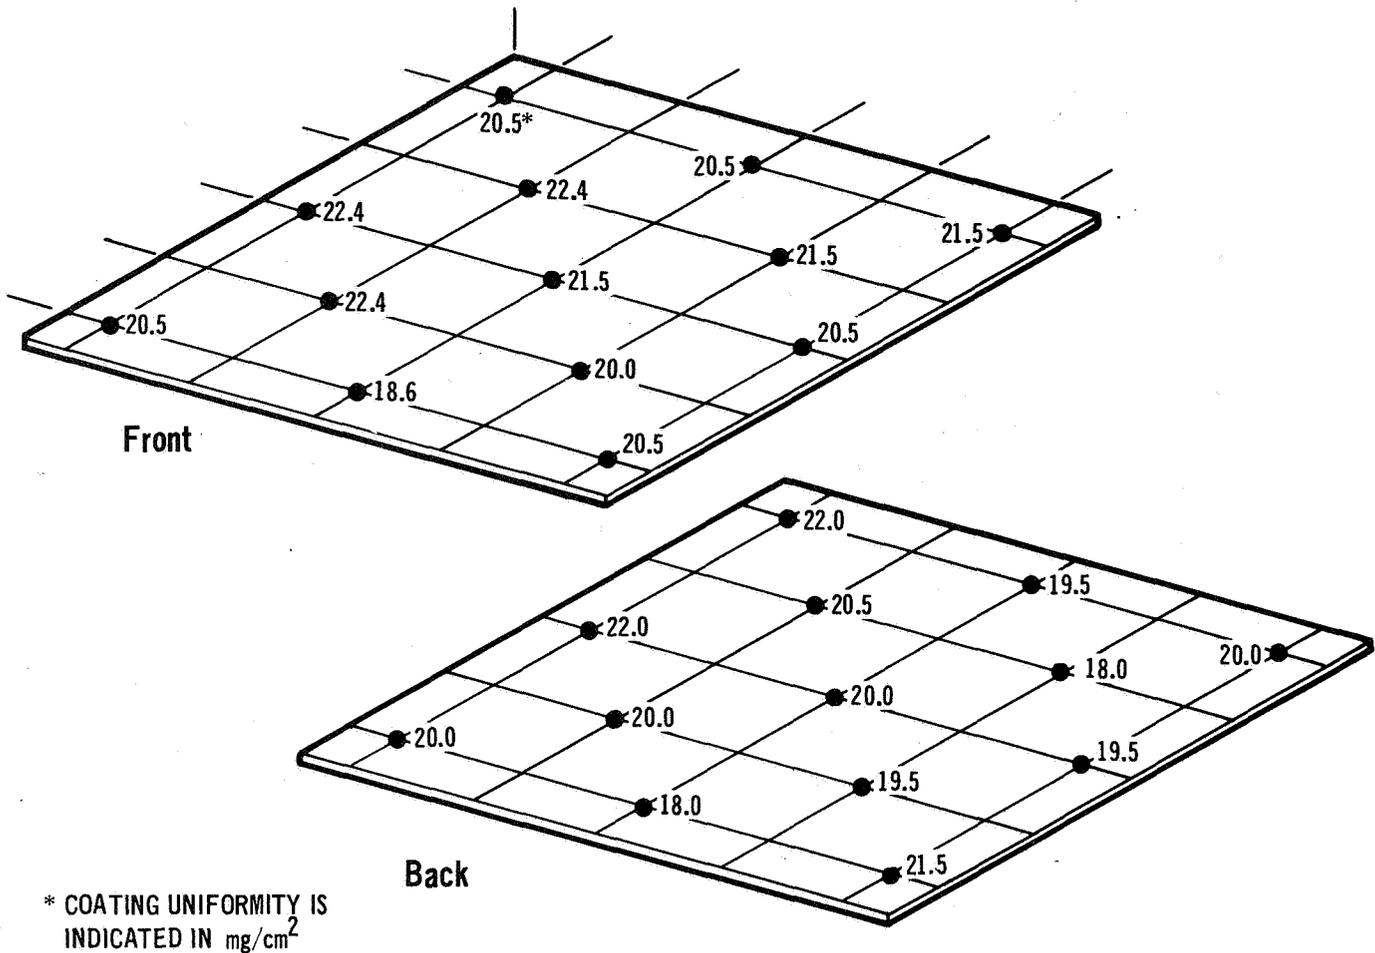
FIGURE 8-1

COATING UNIFORMITY STUDIES ON 20'' x 20'' (50 CM x 50 CM) FLAT PANEL MOCKUP

Evaluation of the large batch of acrylic based slurry A-22 indicated that there were problems with settling and aging. In order to obtain uniform coatings, it is necessary for the viscosity of the slurry at the surface of the batch to be constant for the time required to coat the hardware. The viscosity of the A-22 slurry was

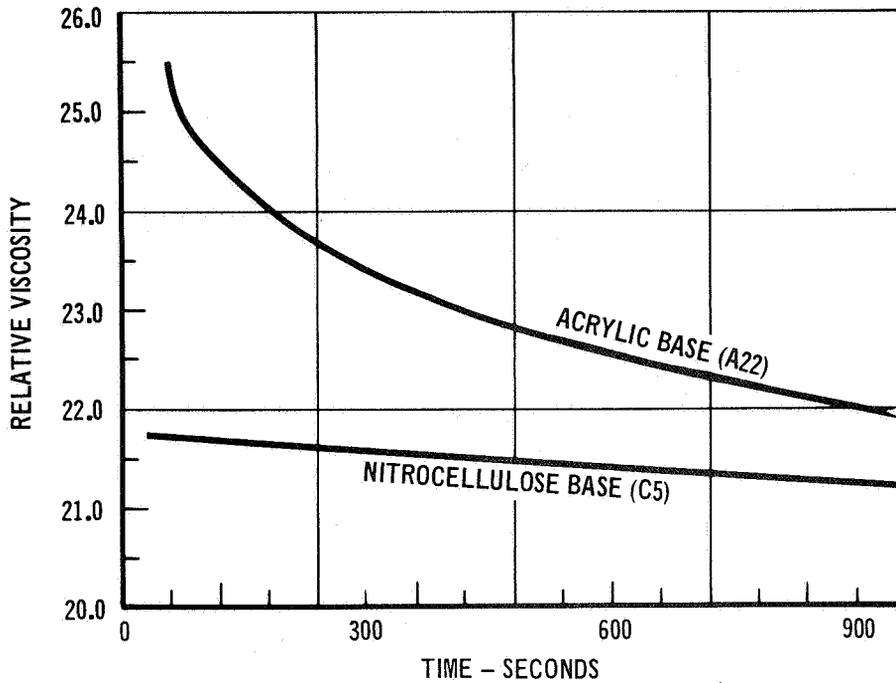
FIGURE 8-2

EFFECT OF SETTLING ON VISCOSITY 1/4 IN. (0.6 CM) BELOW SURFACE FOR
ACRYLIC BASE (A22) AND NITROCELLULOSE BASE (C5) SLURRIES

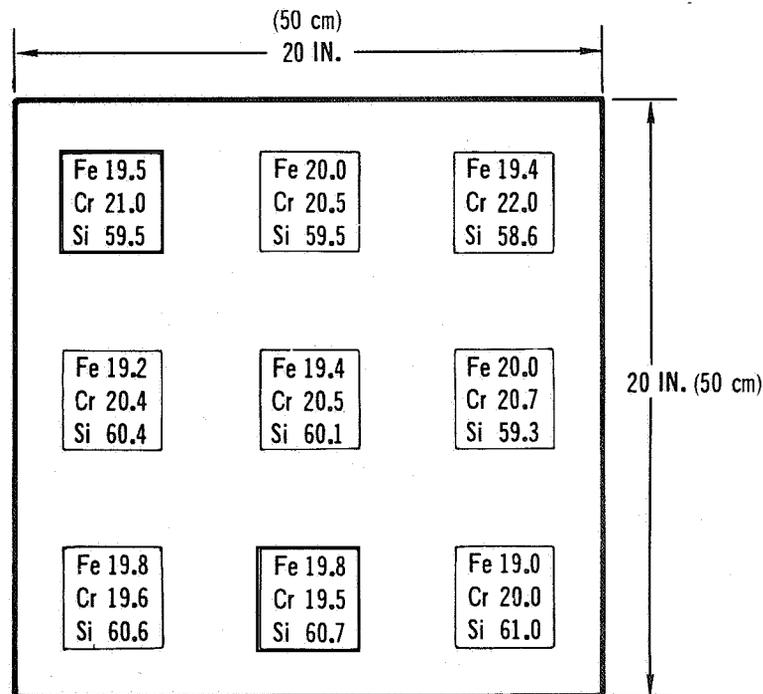
FIGURE 8-3

COATING COMPOSITION UNIFORMITY FROM C-5 SLURRY ON 20 IN. X 20 IN. (50 CM X 50 CM)
FLAT STAINLESS MOCKUP

The possible variations in coating chemistry obtained in this process at the slurry stage, were determined by coating a 20" x 20" (50 cm x 50 cm) flat stainless mockup in the C-5 slurry. The green coating was then selectively removed from 2" (5 cm) square areas in nine locations on the panel. The coating powder obtained was analyzed for Cr and Fe by x-ray fluorescence techniques, the results of which are shown in Figure 8-3. Silicon contents were determined by difference.

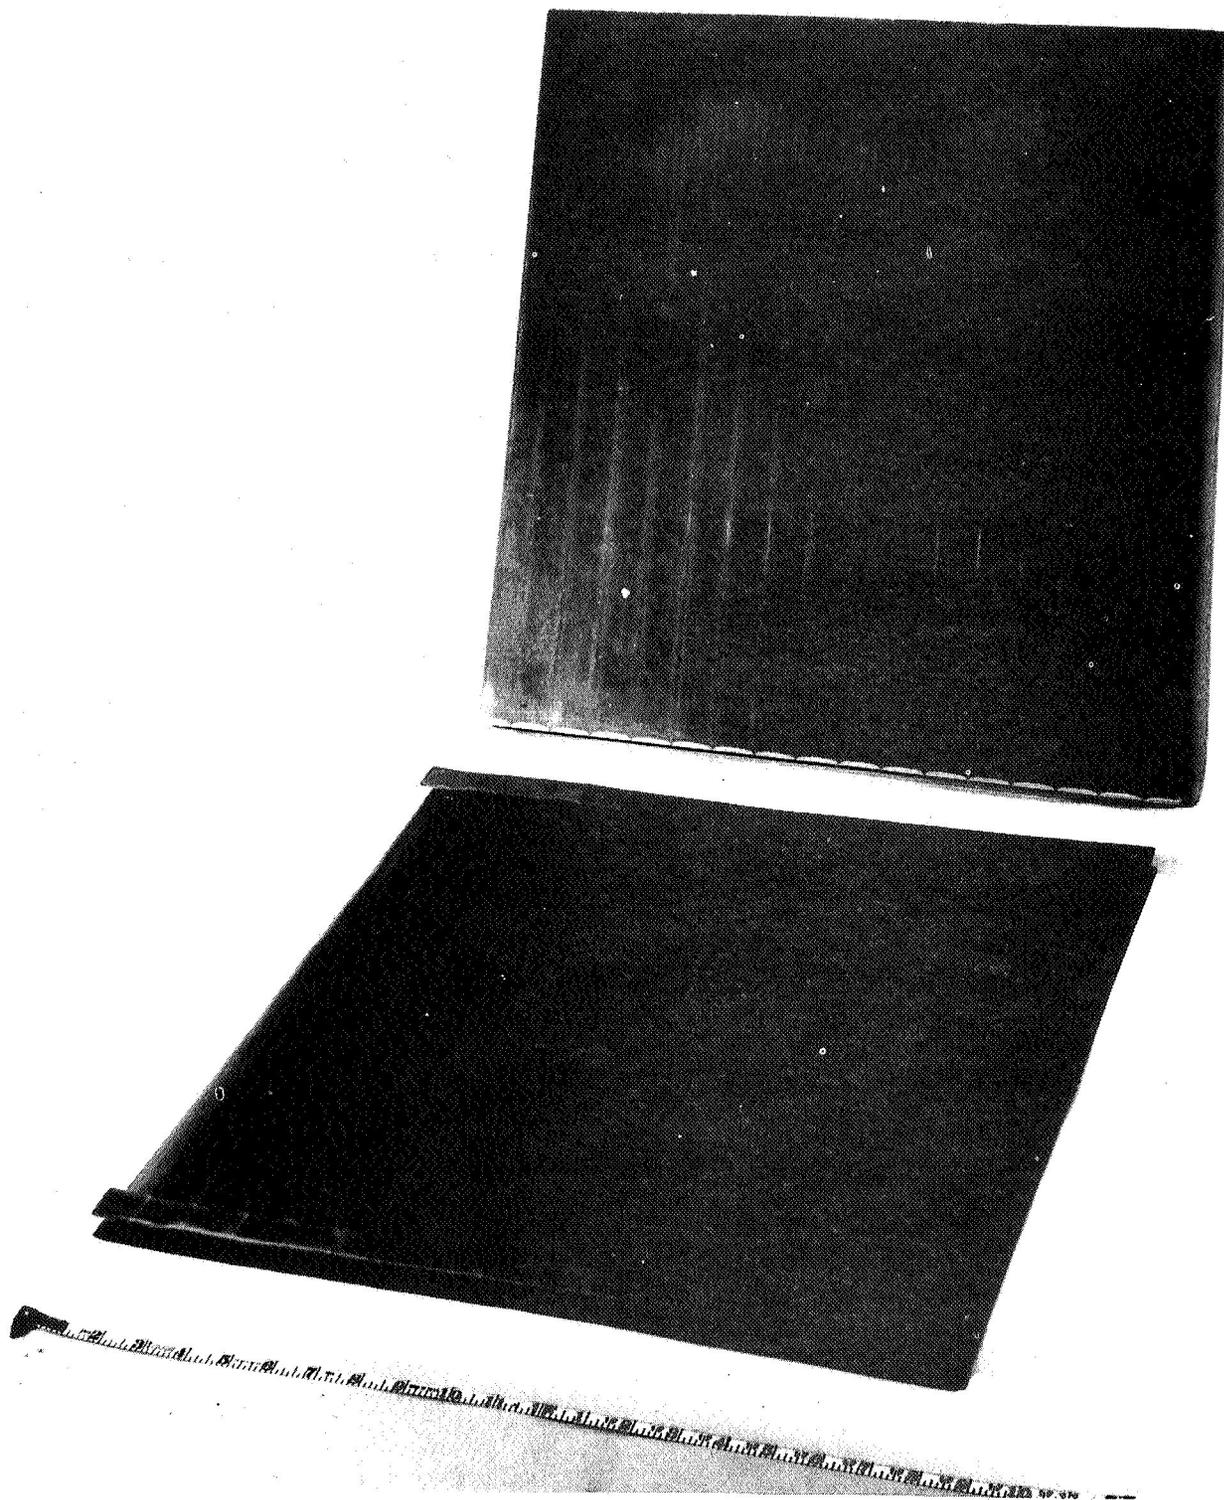
FIGURE 8-6

20' x 20' (50 CM x 50 CM) RIB STIFFENED FS85 ALLOY HEAT SHIELD PANEL

The 20" x 20" (50 cm x 50 cm) rib stiffened panels were coated by the process developed on this program, and a significant improvement in coating uniformity, edge coverage and slurry stability were demonstrated. The process specification for application of the R-512E coating to rib stiffened panels using the C-5 slurry and the details of this study are presented in Volume II. The full size coated panels are shown in Figure 8-6 with a closeup view in Figure 8-7.

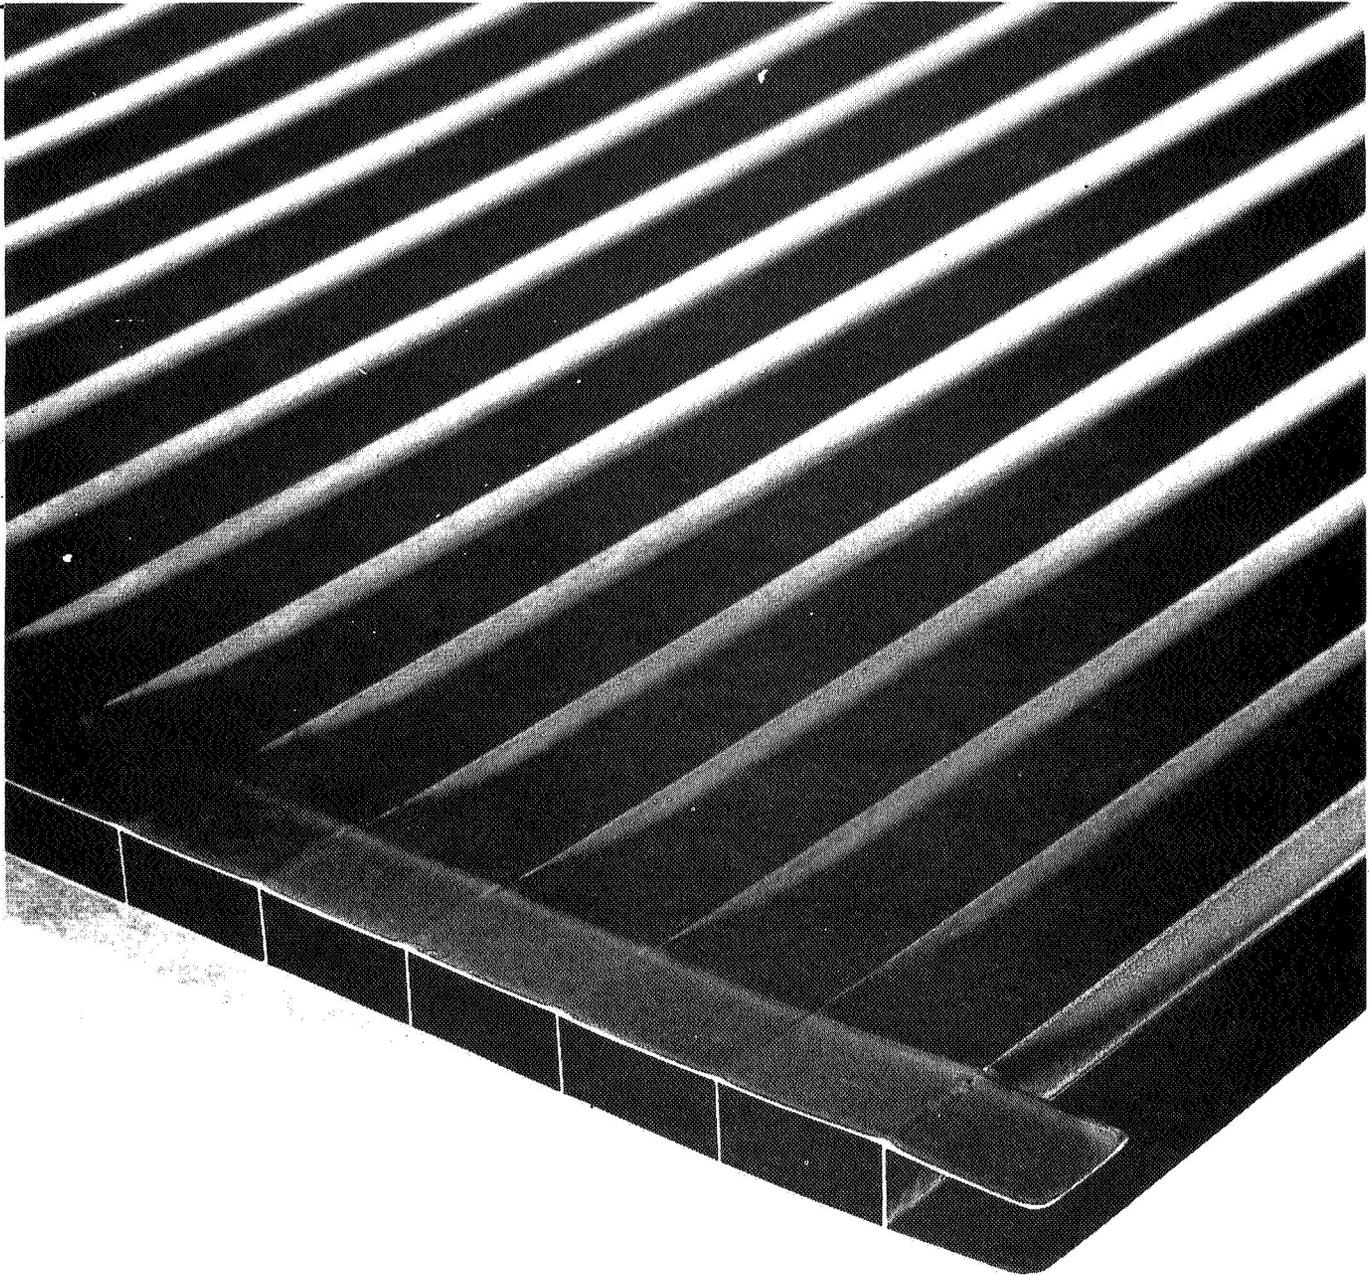
FIGURE 8-7

CORNER DETAIL OF 20' x 20' (50 CM x 50 CM) RIB STIFFENED FS85 ALLOY
HEAT SHIELD PANEL

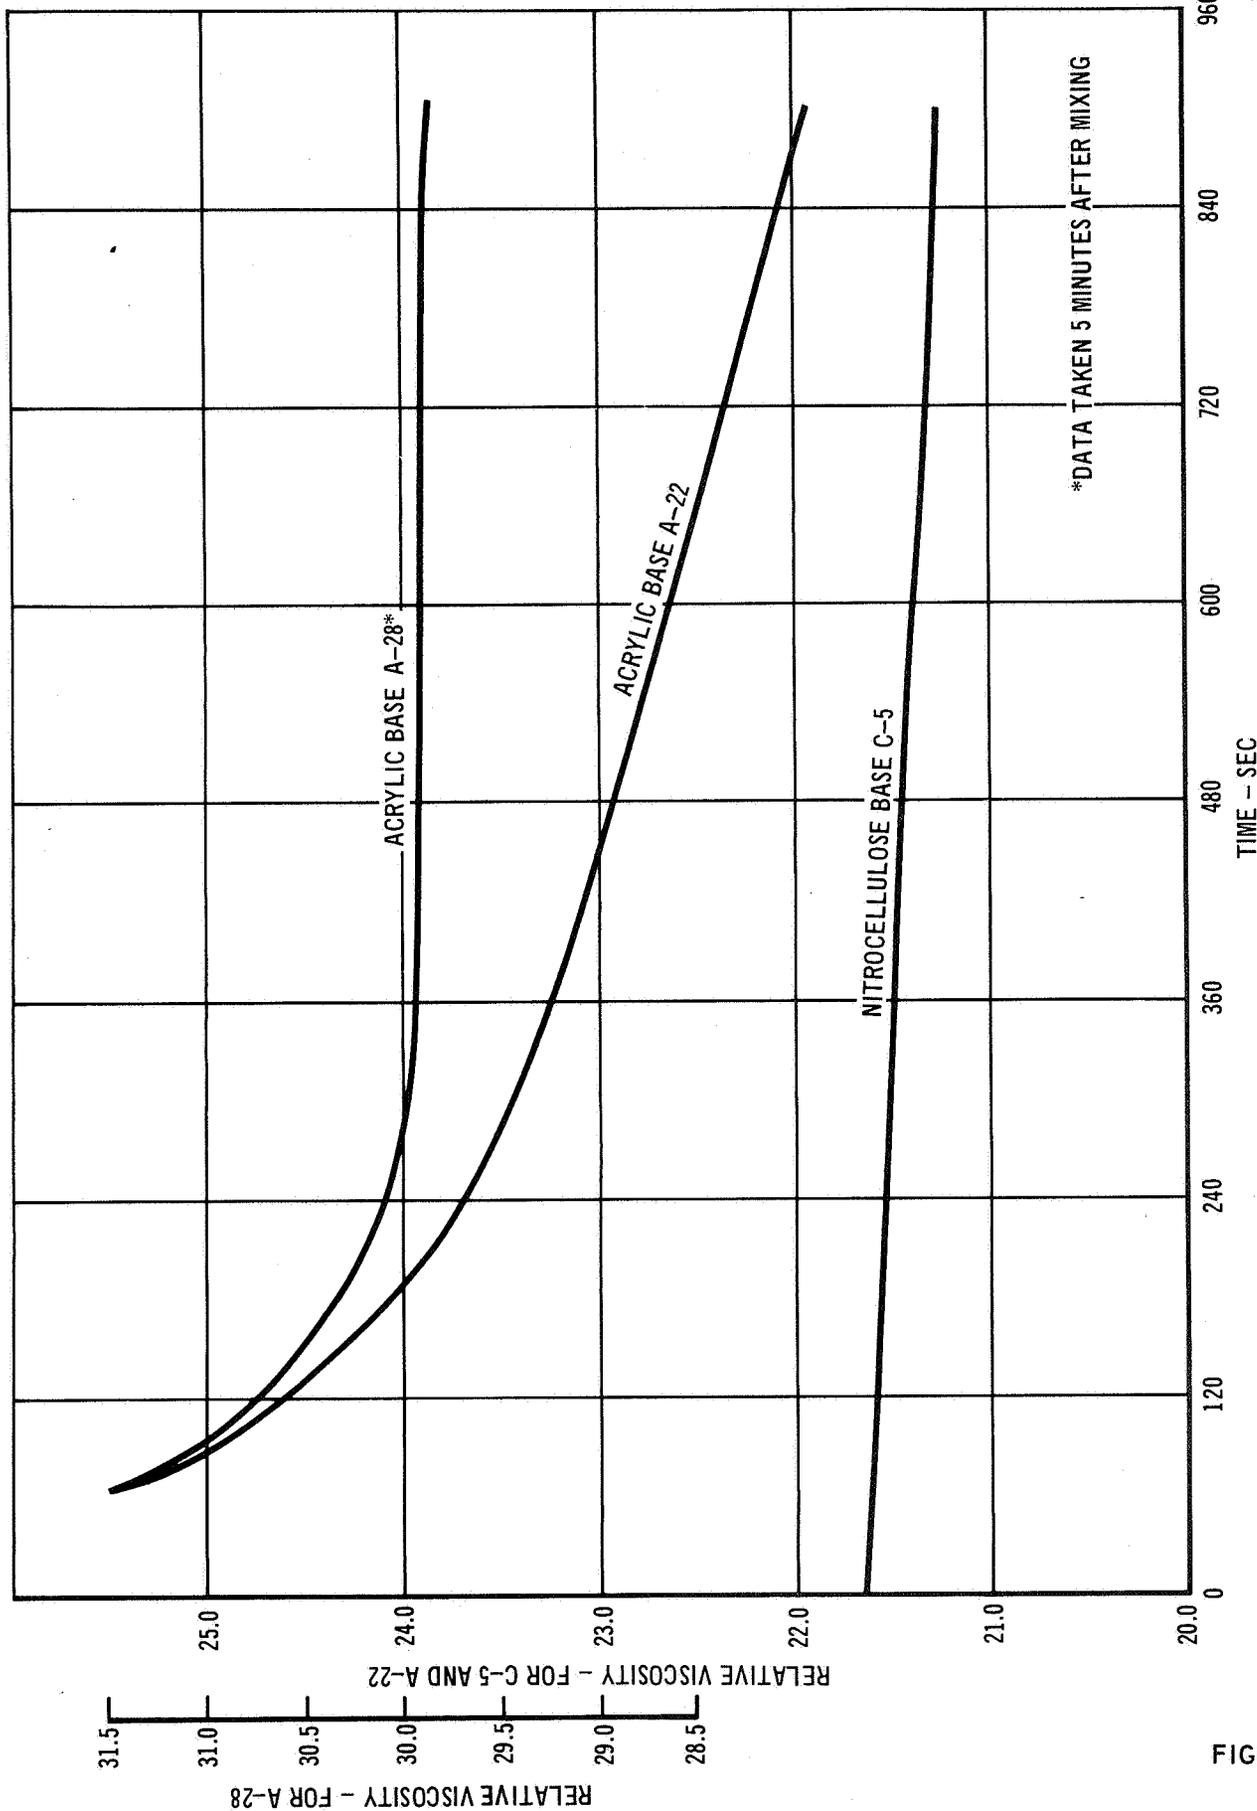
FIGURE 9-1

EFFECT OF SETTLING ON VISCOSITY 1/4" (0.6 CM) BELOW SURFACE FOR
ACRYLIC BASE A-22, A-28 AND NITROCELLULOSE BASE C-5 SLURRIES

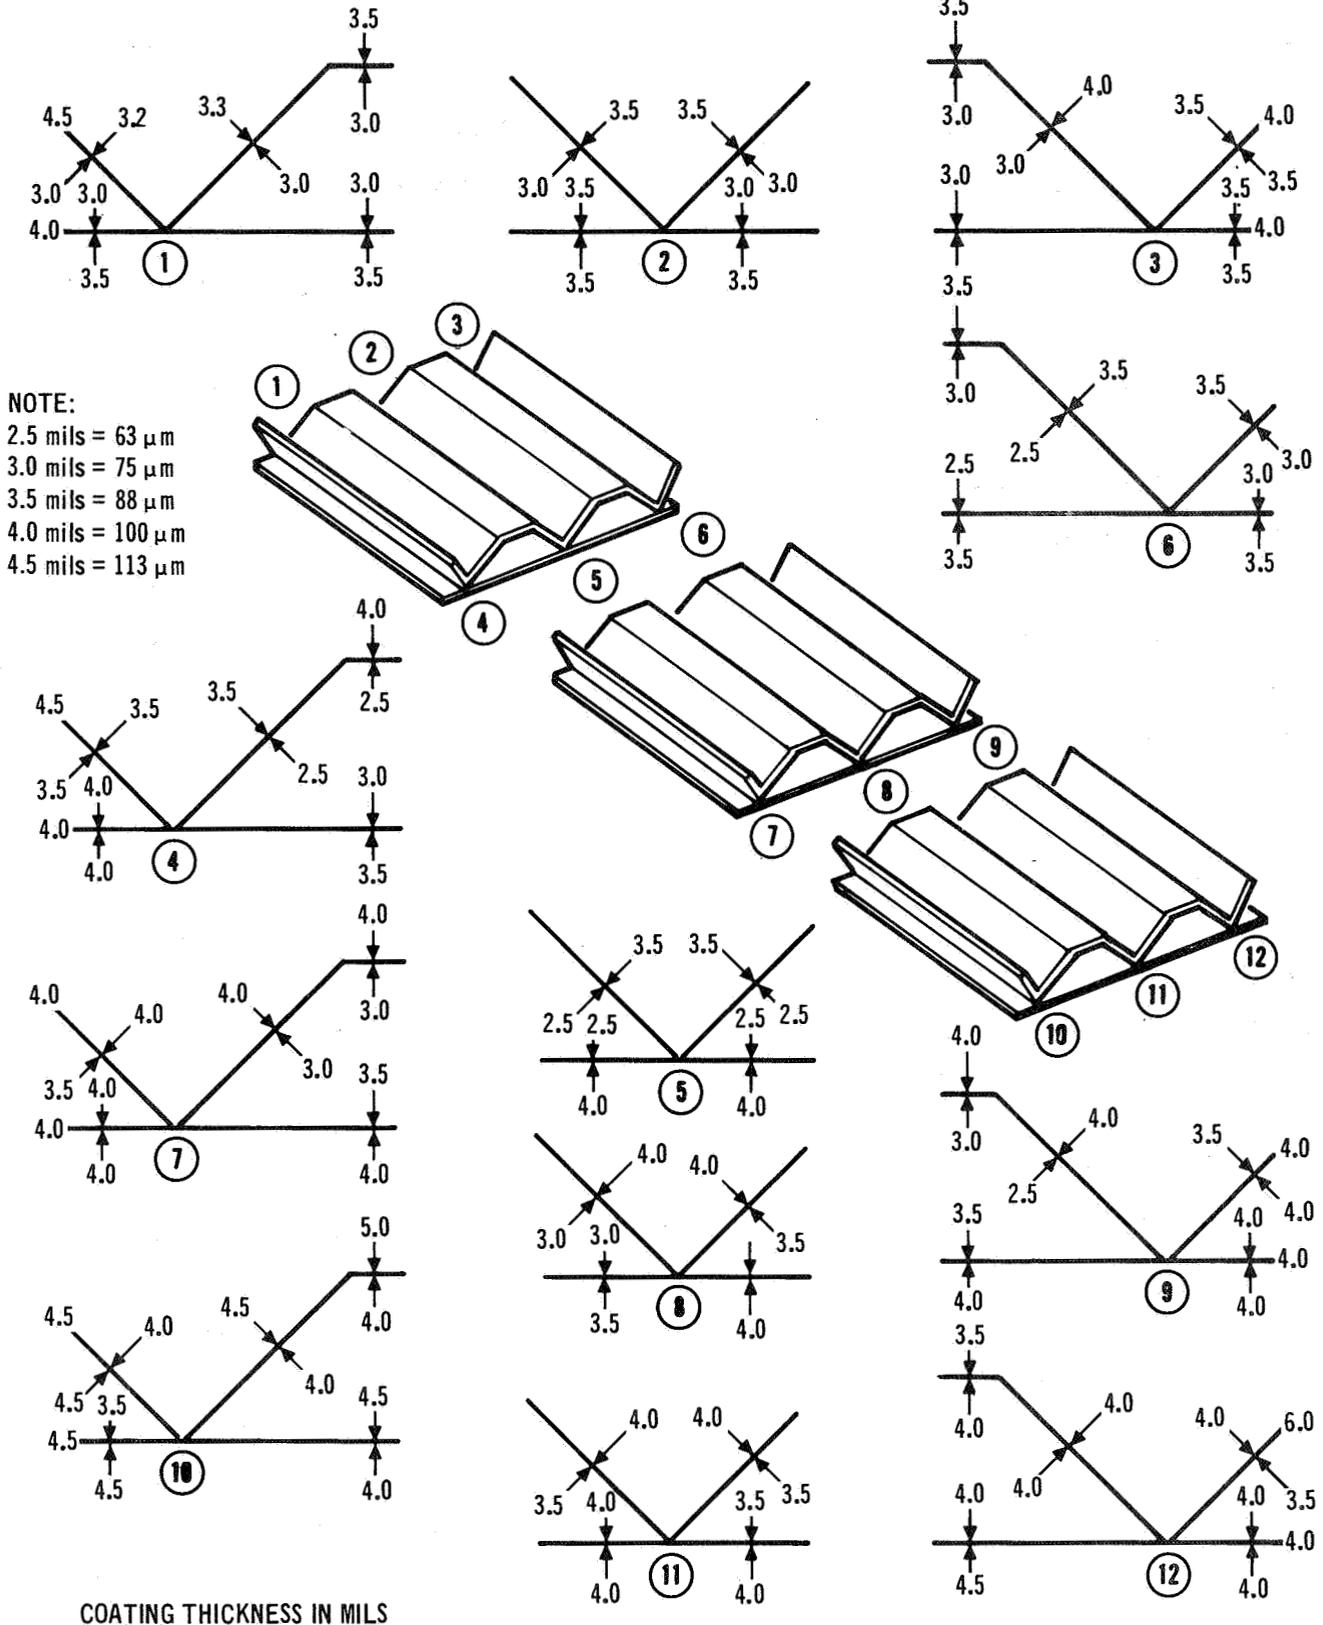
FIGURE 9-2

COATING UNIFORMITY STUDY ON SUB-SIZE CORRUGATED HEAT SHIELD PANEL

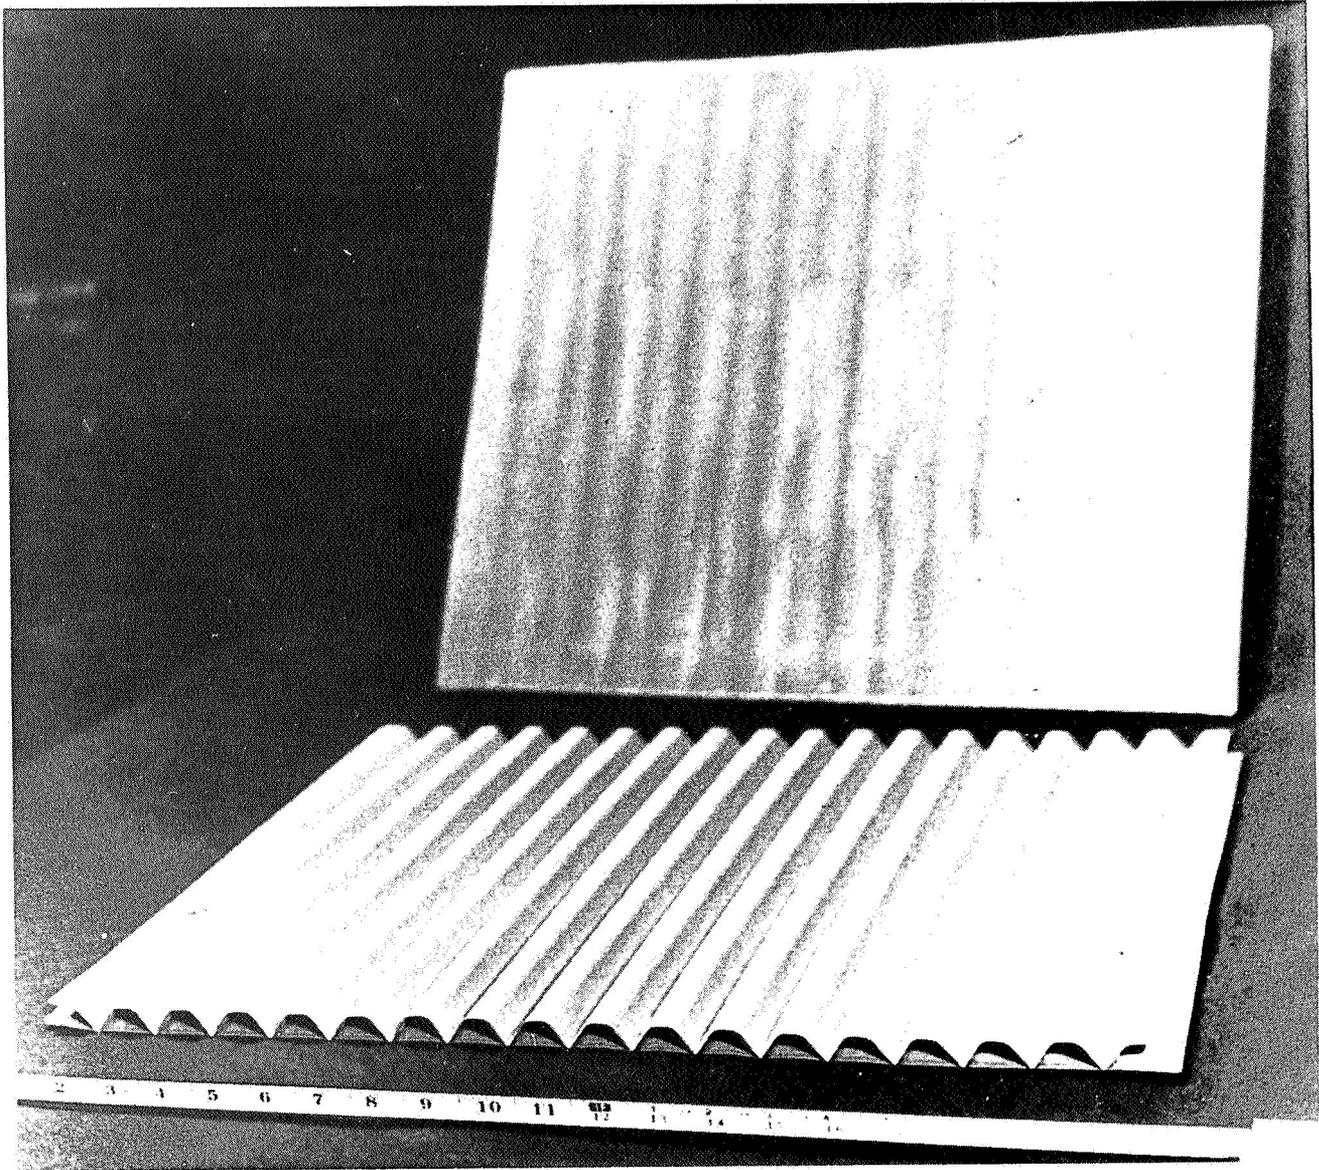
FIGURE 9-3

GENERAL APPEARANCE OF PANELS F-1 AND F-2 AFTER COATING

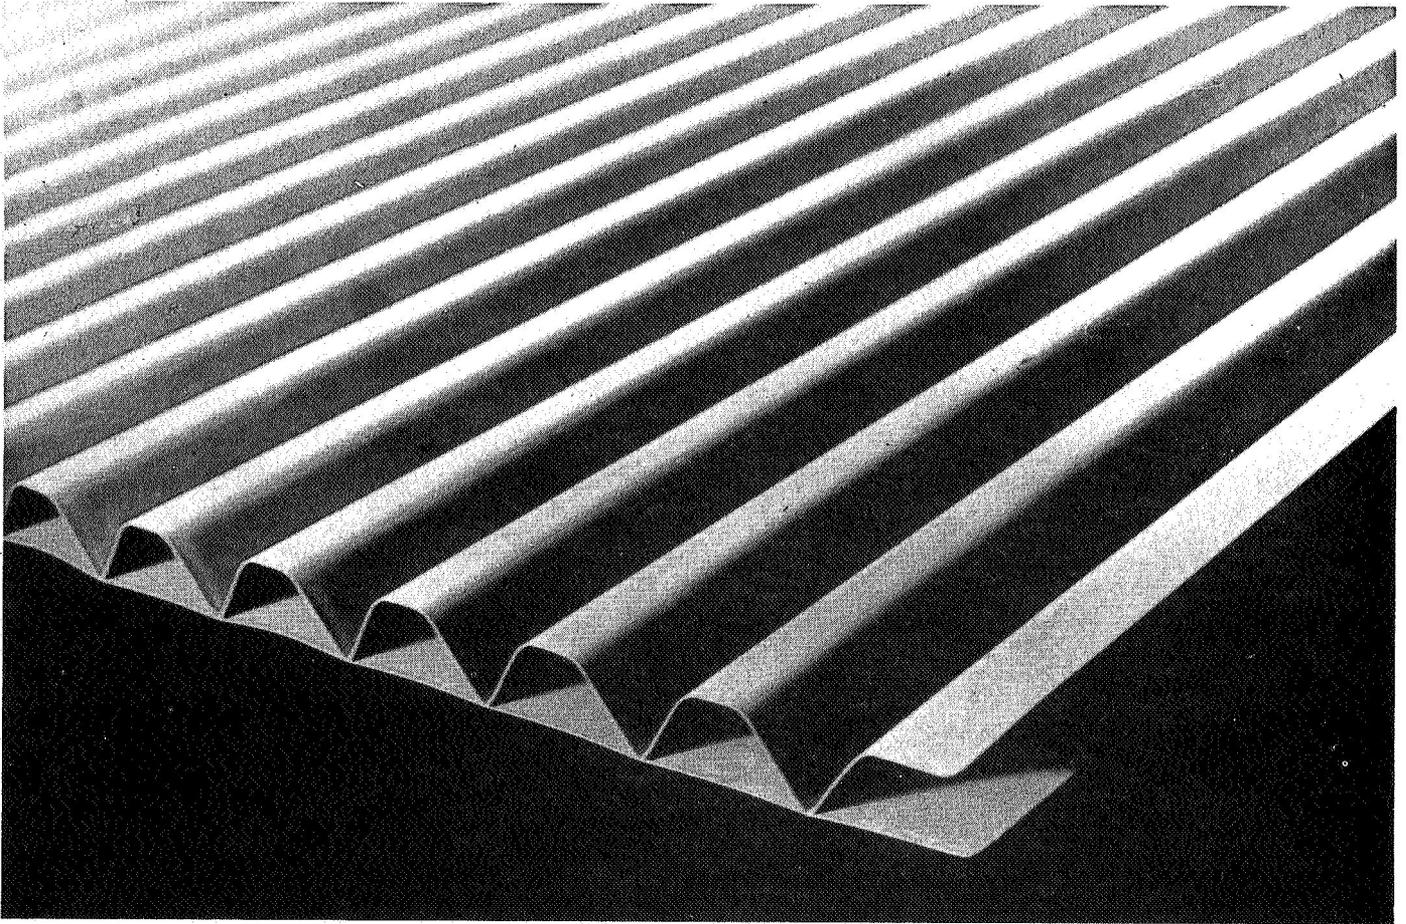
FIGURE 9-4

CLOSEUP VIEW OF CORNER AREA OF PANEL F-1 AFTER COATING
