**FUSED SLURRY SILICIDE COATINGS
FOR COLUMBIUM ALLOY REENTRY HEAT SHIELDS**

Volume I Evaluation Analysis

MCDONNELL DOUGLAS AERONAUTICS COMPANY - EAST

August 1973

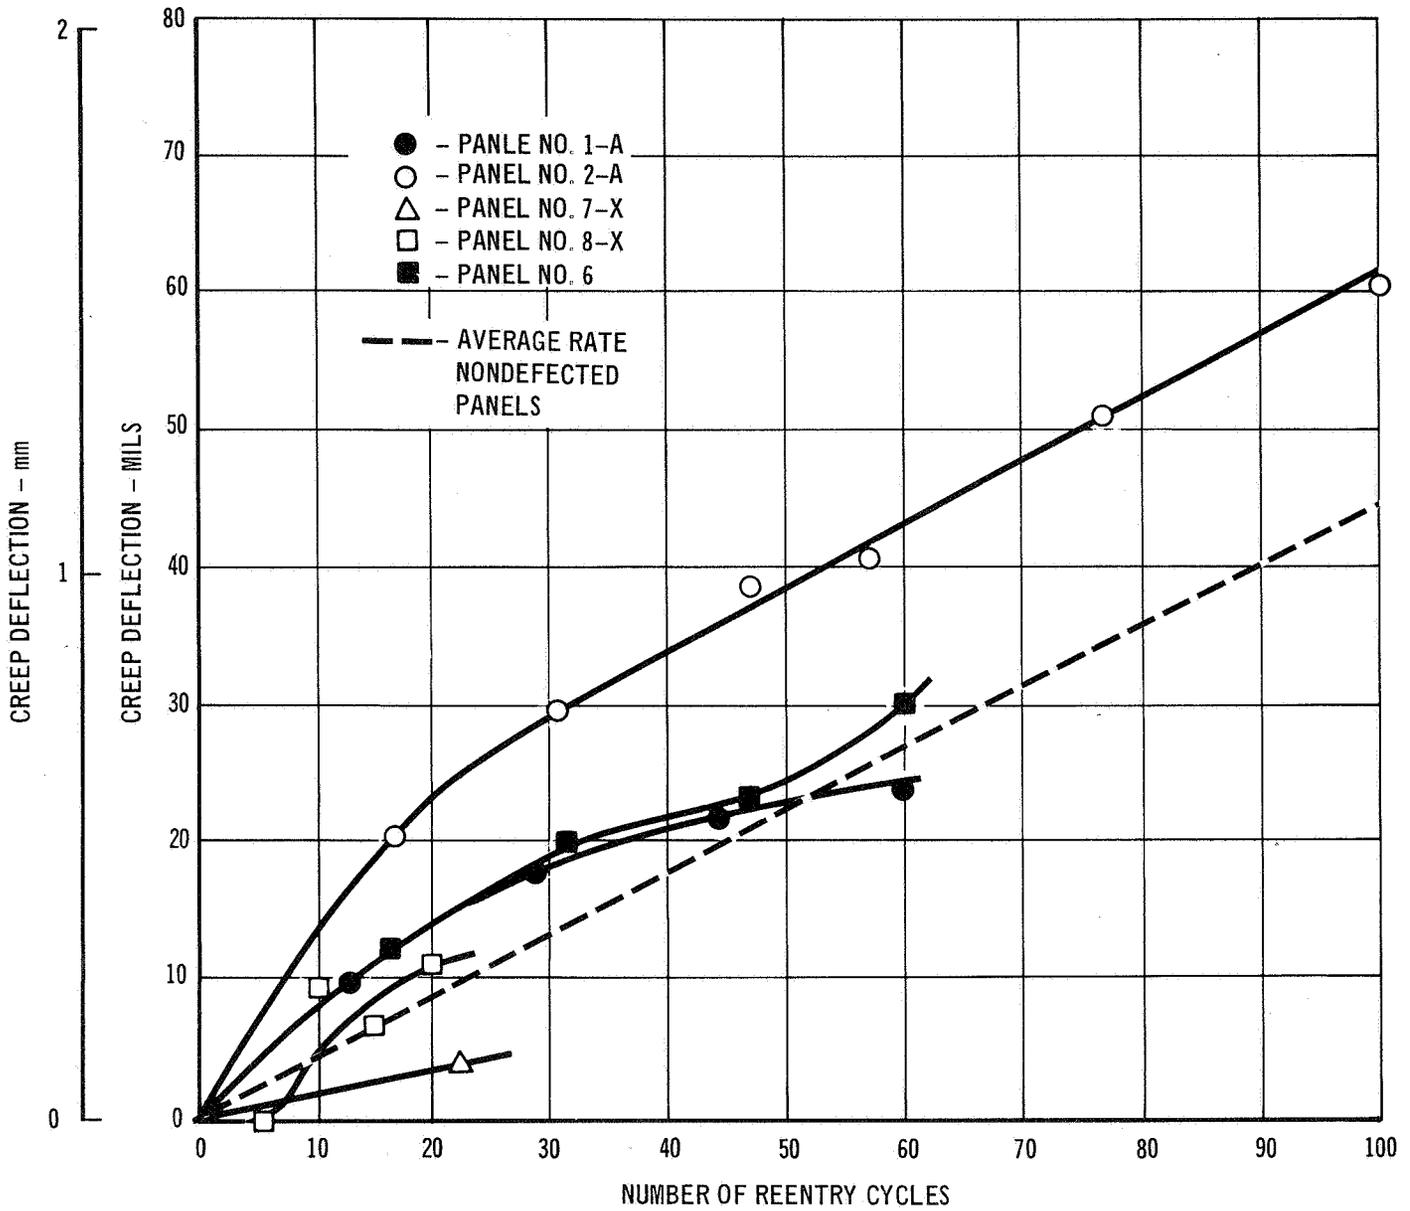
FIGURE 10-1

INTENTIONALLY DEFECTED SUB-SIZE RIB STIFFENED HEAT SHIELD
PANEL CREEP DEFLECTIONS

Defected panels 1-A, 2-A and 6 which were tested in the external pressure environment, had defect sites 1/8" (0.3 cm) in diameter located on the skin side of the panels, one directly above the center rib for Panel No. 1-A and one above each of the three ribs for Panel No. 6, and two between the ribs for panel 2-A. The location, size and growth of these defects can be observed in Figures 10-2, 10-3 and 10-4. Panels 1-A and 6 showed structural lives of 60 reentry cycles which were approximately 40 percent shorter than the nondefected panels. The two factors responsible for the major portion of the reduced life are loss of panel cross-section due to consumption by oxidation and premature crack formation and propagation in the contaminated columbium substrate. Structural failure for both panels occurred during acoustic testing. The 1/8" (0.3 cm) defects had grown to 0.6" (1.5 cm) diameter and had consumed approximately 1/3 of the rib cross-section. This amount of reduction in cross-section would lead to considerably higher

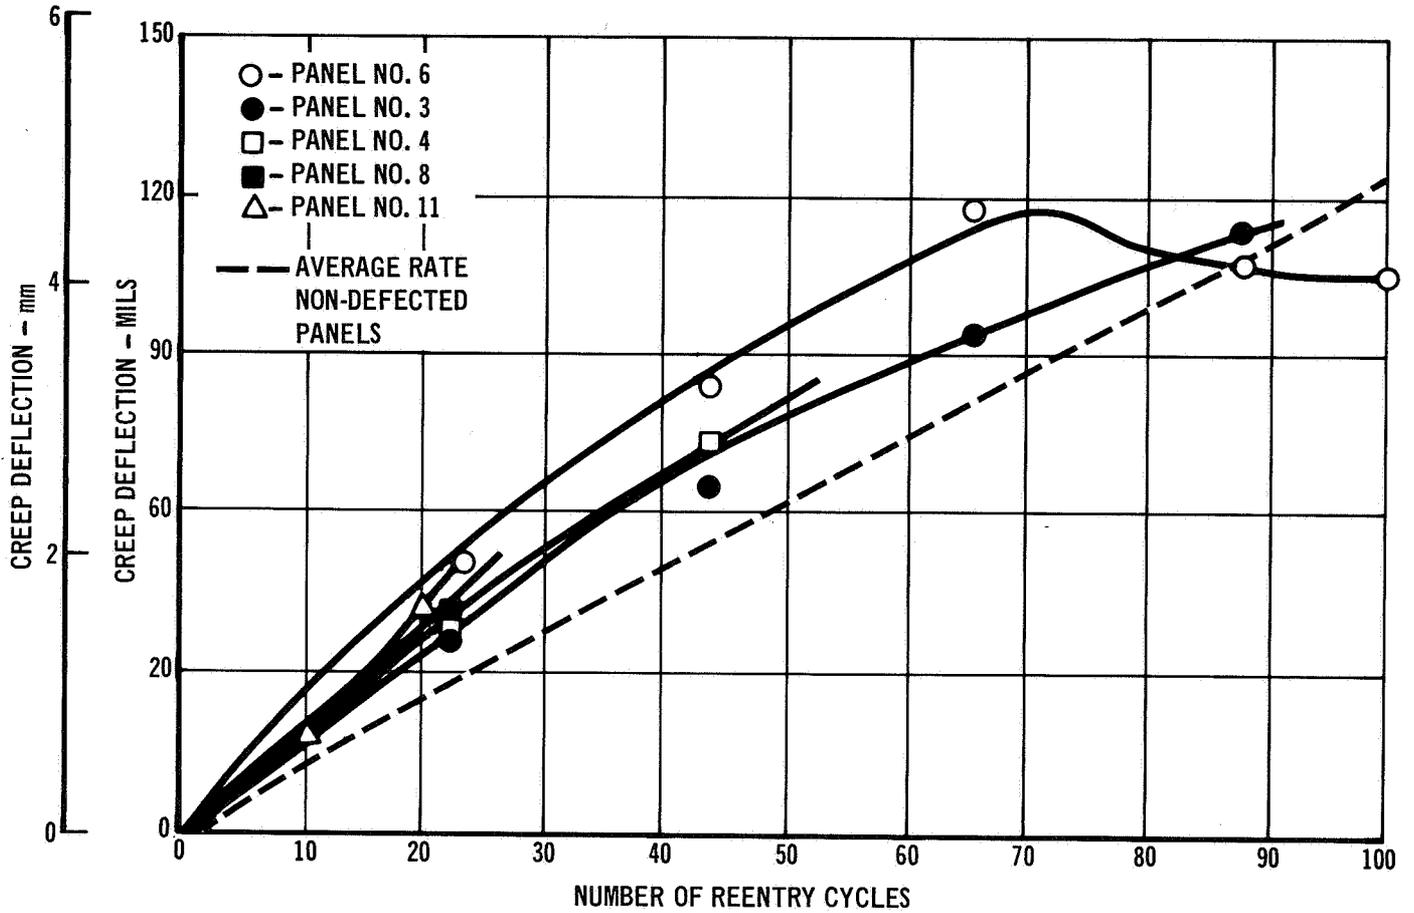
FIGURE 10-6

INTENTIONALLY DEFECTED SUB-SIZE CORRUGATION STIFFENED HEAT SHIELD
PANEL CREEP DEFLECTIONS

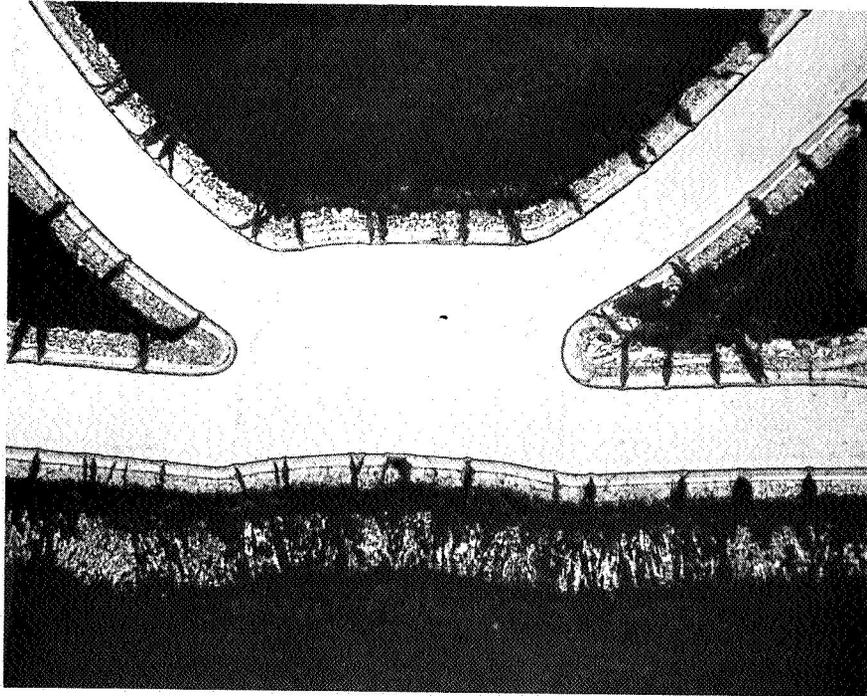
FIGURE 10-10

**CORRUGATION-SKIN JOINT OF PANEL NO. 6 AFTER 100 REENTRY
CYCLES – EXTERNAL PRESSURE ENVIRONMENT**

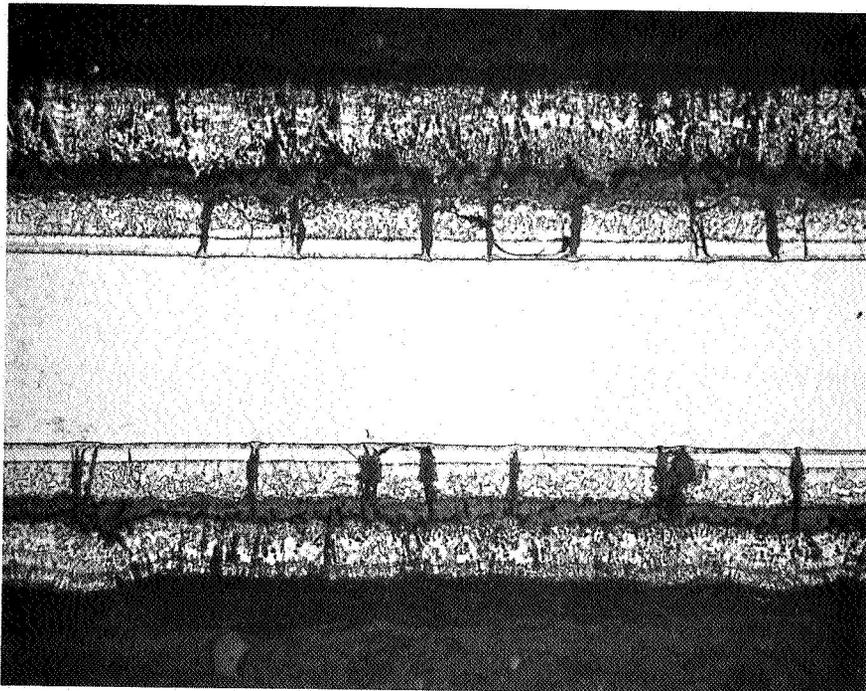
FIGURE 10-11

**SKIN CROSS-SECTION BETWEEN WELDS OF PANEL NO. 6 AFTER
100 REENTRY CYCLES – EXTERNAL PRESSURE ENVIRONMENT**

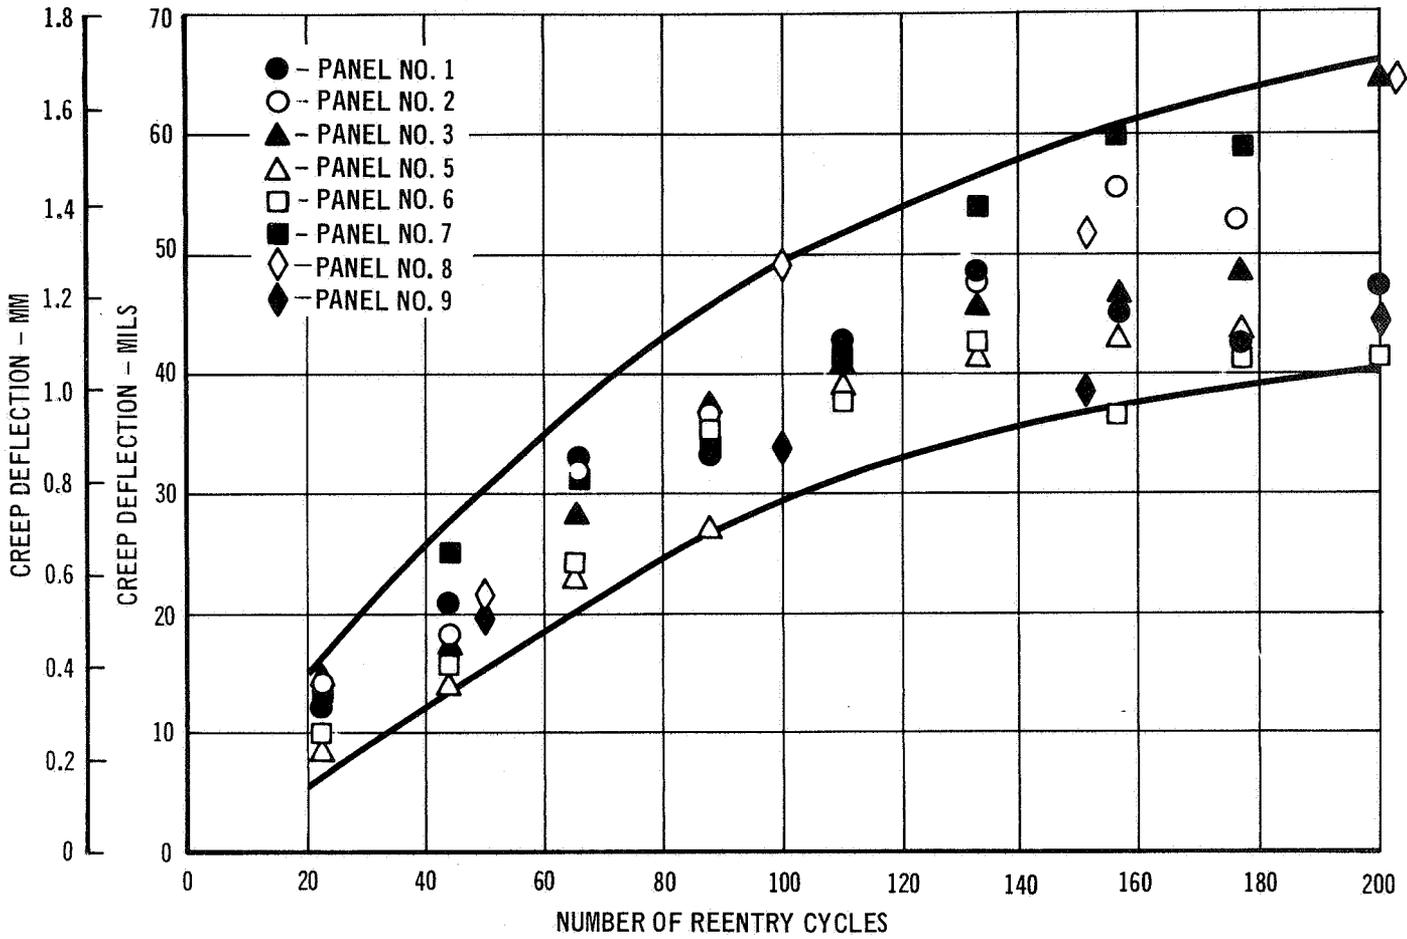
FIGURE 11-1

EFFECT OF REENTRY CYCLING ON CREEP DEFLECTION OF RIB
STIFFENED HEAT SHIELD PANELS

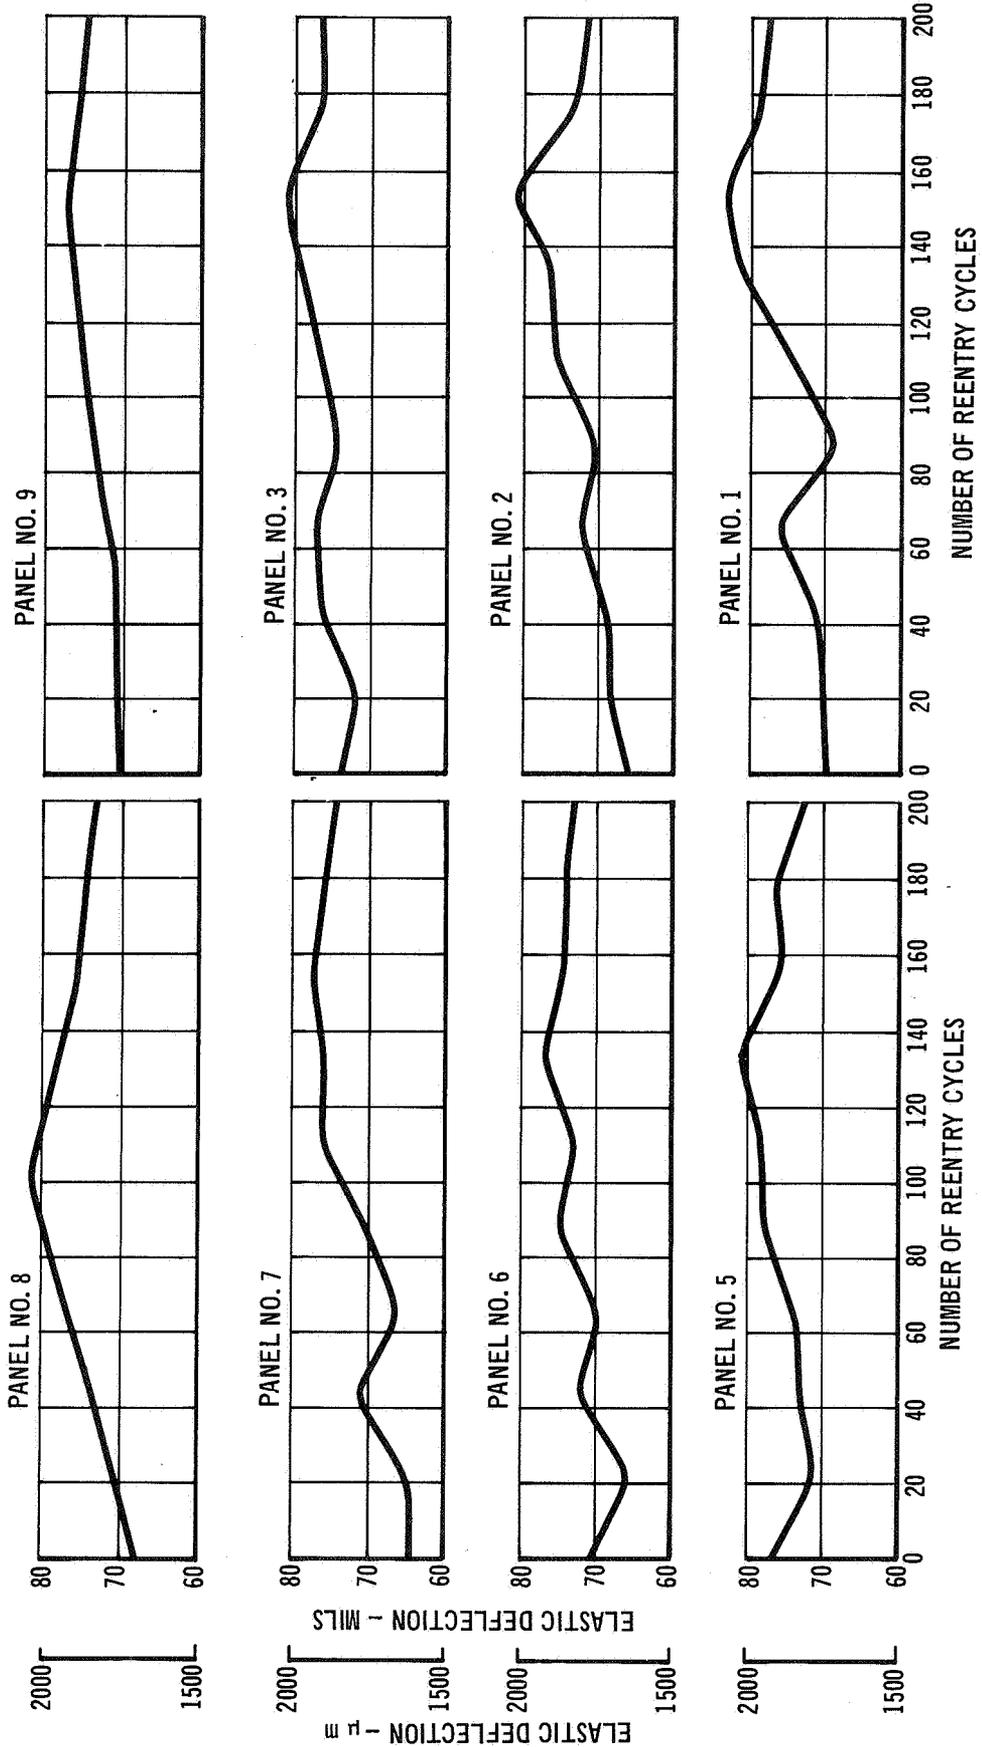
FIGURE 11-2

EFFECT OF REENTRY CYCLING ON ELASTIC DEFLECTION OF RIB STIFFENED HEAT SHIELD PANELS

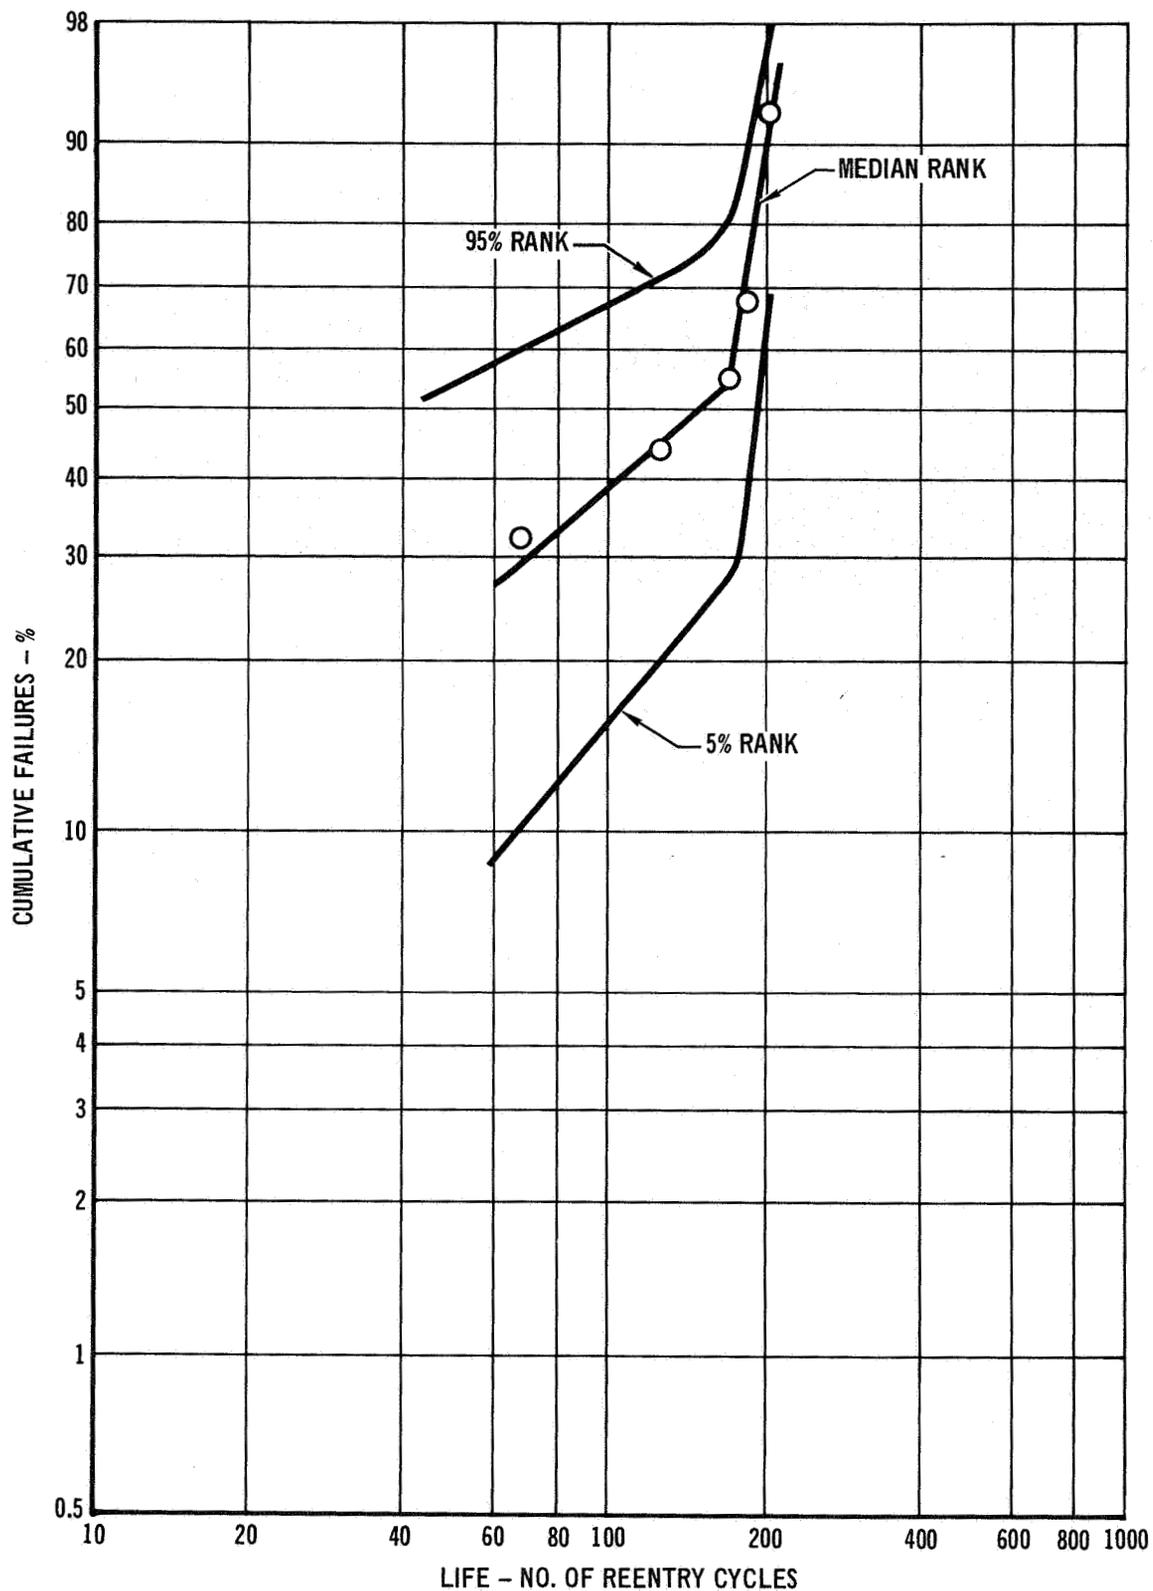
FIGURE 11-12

WEIBULL PLOT OF INCIPIENT COATING FAILURES

The times to incipient coating failure were examined statistically utilizing a Weibull analysis. The Weibull distribution is one of the more common and versatile mathematical probability density functions to which empirical life data can be fitted.

These data are shown plotted on Weibull probability paper in Figure 11-12. In constructing this plot the median rank points were fitted with straight lines and the 95% and 5% bands located from these lines with smooth curves. The Weibull plot clearly shows a mixed distribution consisting of two segments. The slope of the first segment is very near unity indicating random occurrence of failures in this region. At approximately 156 reentry cycles, wearout becomes the predominant mechanism of failure. The proportion of the population (60%) which showed random failures is estimated by dropping a vertical line from the upper bound of the
