21. A UNIQUE CHALLENGE: EMERGENCY EGRESS
AND LIFE SUPPORT EQUIPMENT AT KSC

By Henry M. Waddell, Jr.

Rockwell International

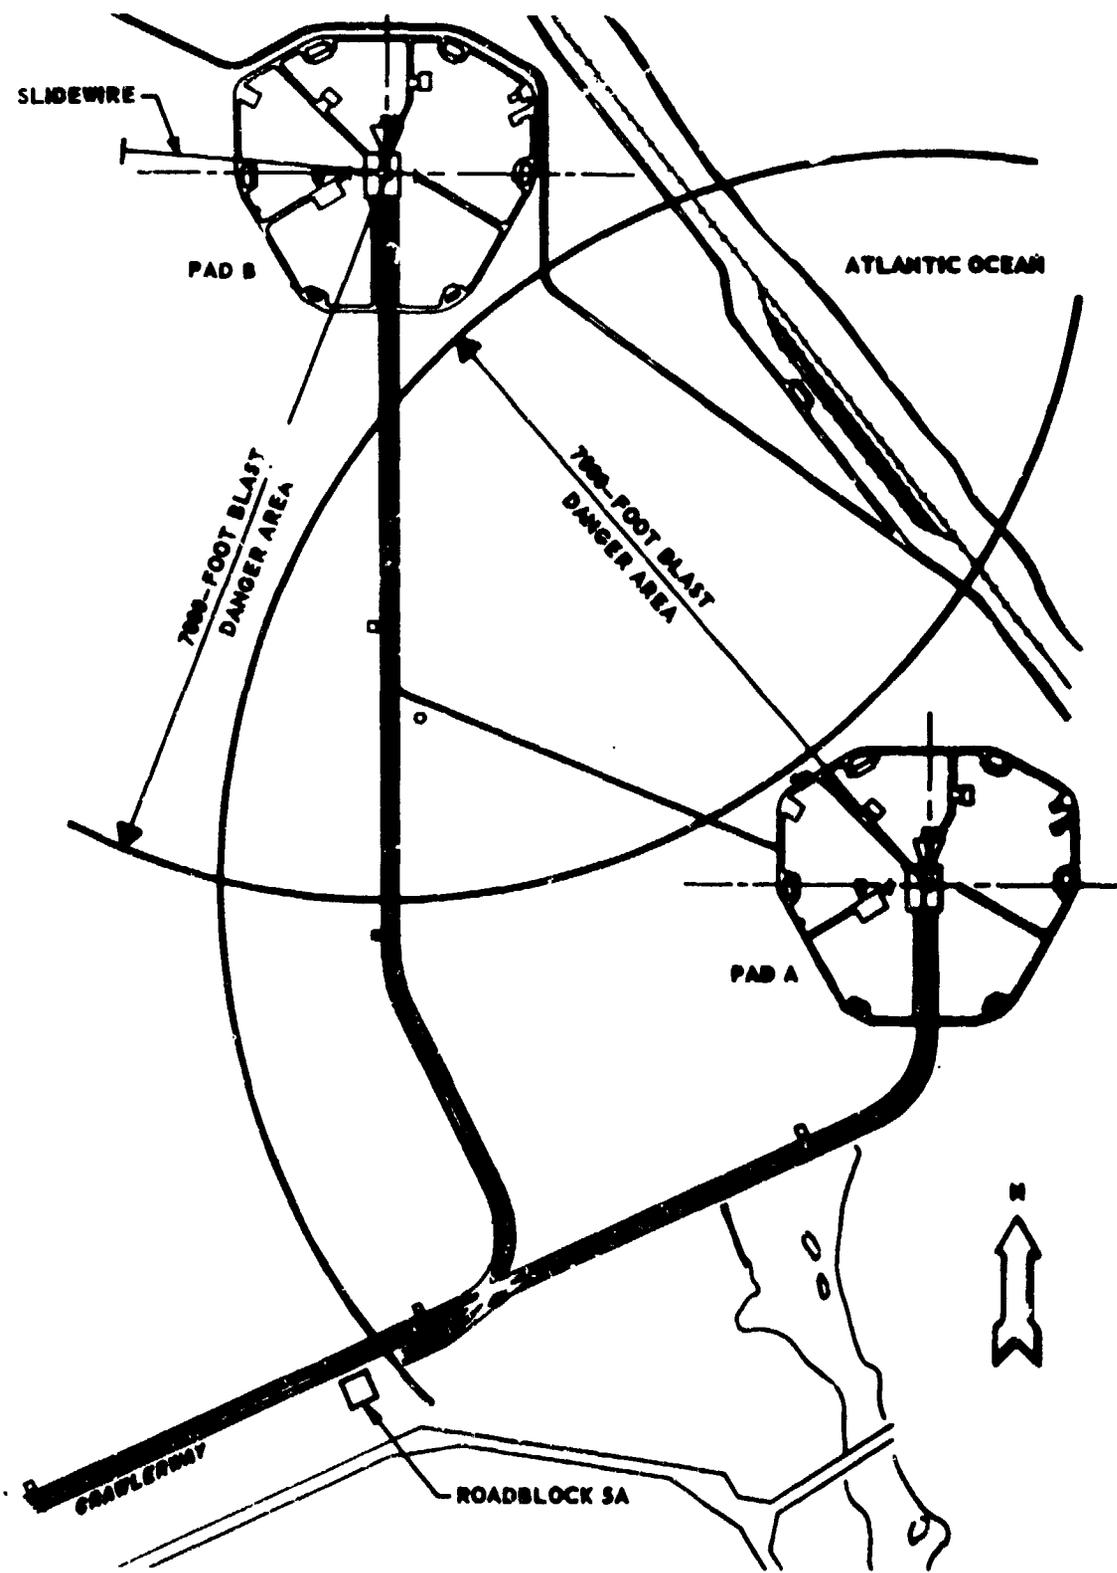
Figure 2. Launch Pad Ground Plan

Figure 2 is a ground plan of the KSC launch pads. The closeout crew left this area, at Roadblock 5A, about the time the cryogenic oxygen and hydrogen propellant loading of the launch vehicle was completed. From here, the closeout crew went up to prepare the command module for the astronauts, who arrived approximately an hour later. During this time and throughout the launch, a special KSC Fire Department rescue team was stationed about 610 meters (2000 feet) from the launch pad. It normally took this crew about 2.5 minutes to go from its station to the base of the launcher. This time plus the time required for the crew to ascend the umbilical tower to the command module level totaled five minutes. Actually, this time had been bettered, but under ideal drill conditions and after much practice. This five-minute response was a crucial factor because the human brain has little chance of surviving without damage after four minutes with no oxygen.

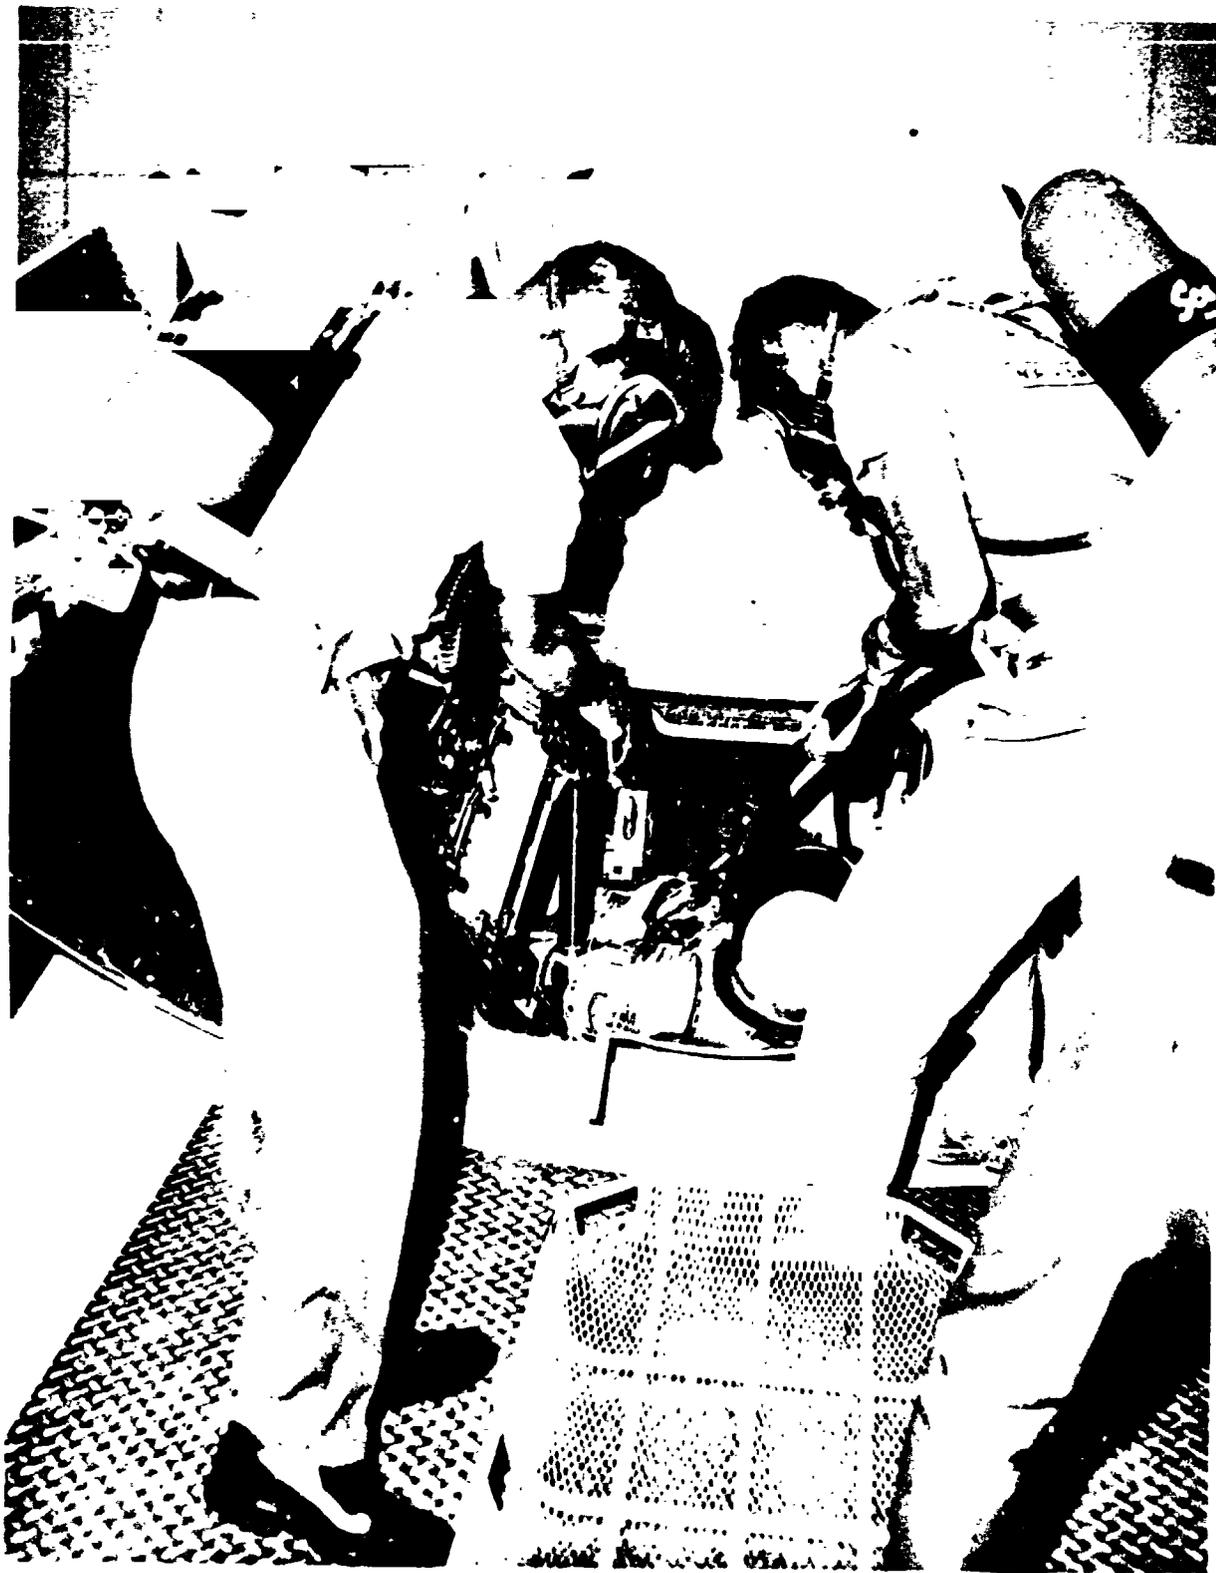
Figure 5. Test Rescuers, Wearing Scott Air Packs, Pulling "Victim" From Command Module Mockup

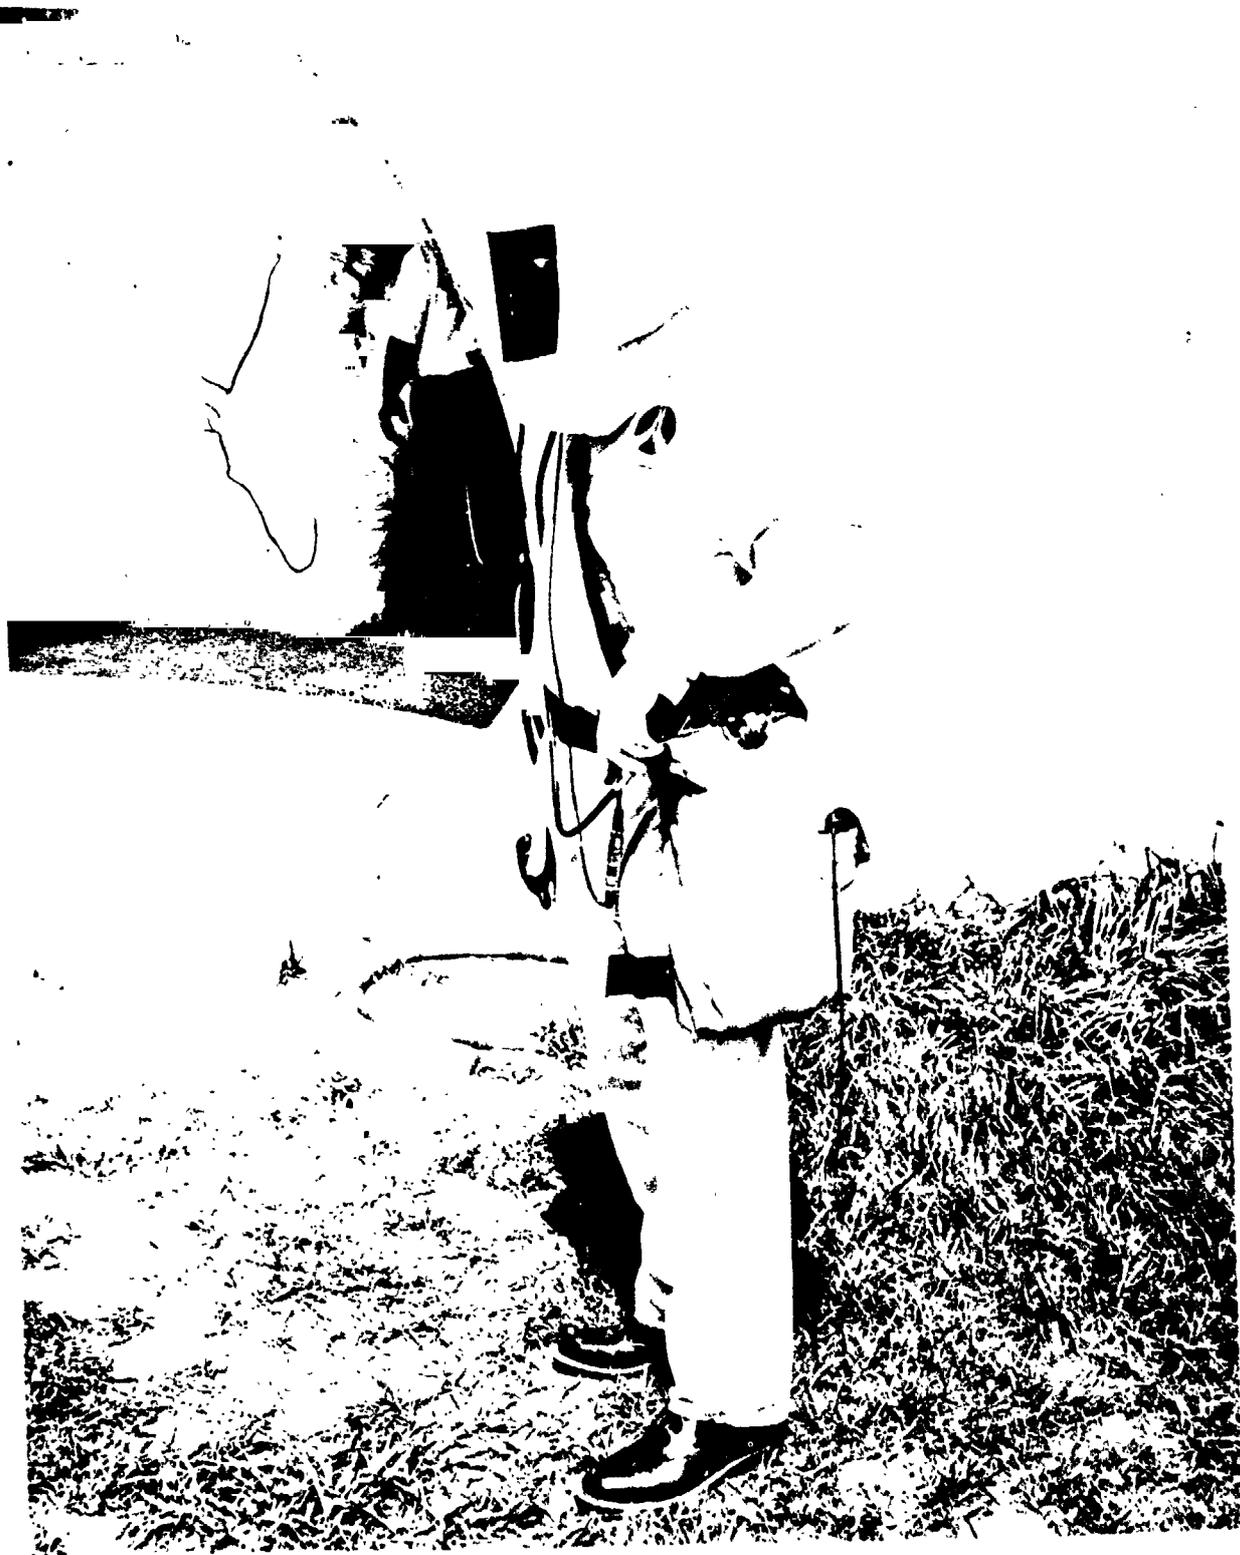
Figure 6. Closeout Crewman Dressed in Closeout Protective Clothing System

The resultant closeout-crew coveralls are shown in Figure 6. Actually, the suit was a protective clothing system. The elements were a miner's bump cap, race driver's gloves, heavy shoes, and inherently flame-retardant coveralls with Velcro closure and a protective hood that folds into a quick-opening pouch on the back of the coveralls.

The suit looked good, and the fabric tested better than was anticipated. However, one problem had to be corrected before the suit could be used. Like all nylon garments, the coveralls could build up sufficient static electricity to discharge a spark. In the oxygen-rich atmosphere surrounding closeout operations, a spark could have a catastrophic effect. The Nomex developer was aware of this problem and provided a wetting agent. By allowing the coveralls to soak in a washing machine filled with water and the agent, the fibers were coated with a thin film of hygroscopic material that ensured a conductive surface to dissipate static electricity before it built up.

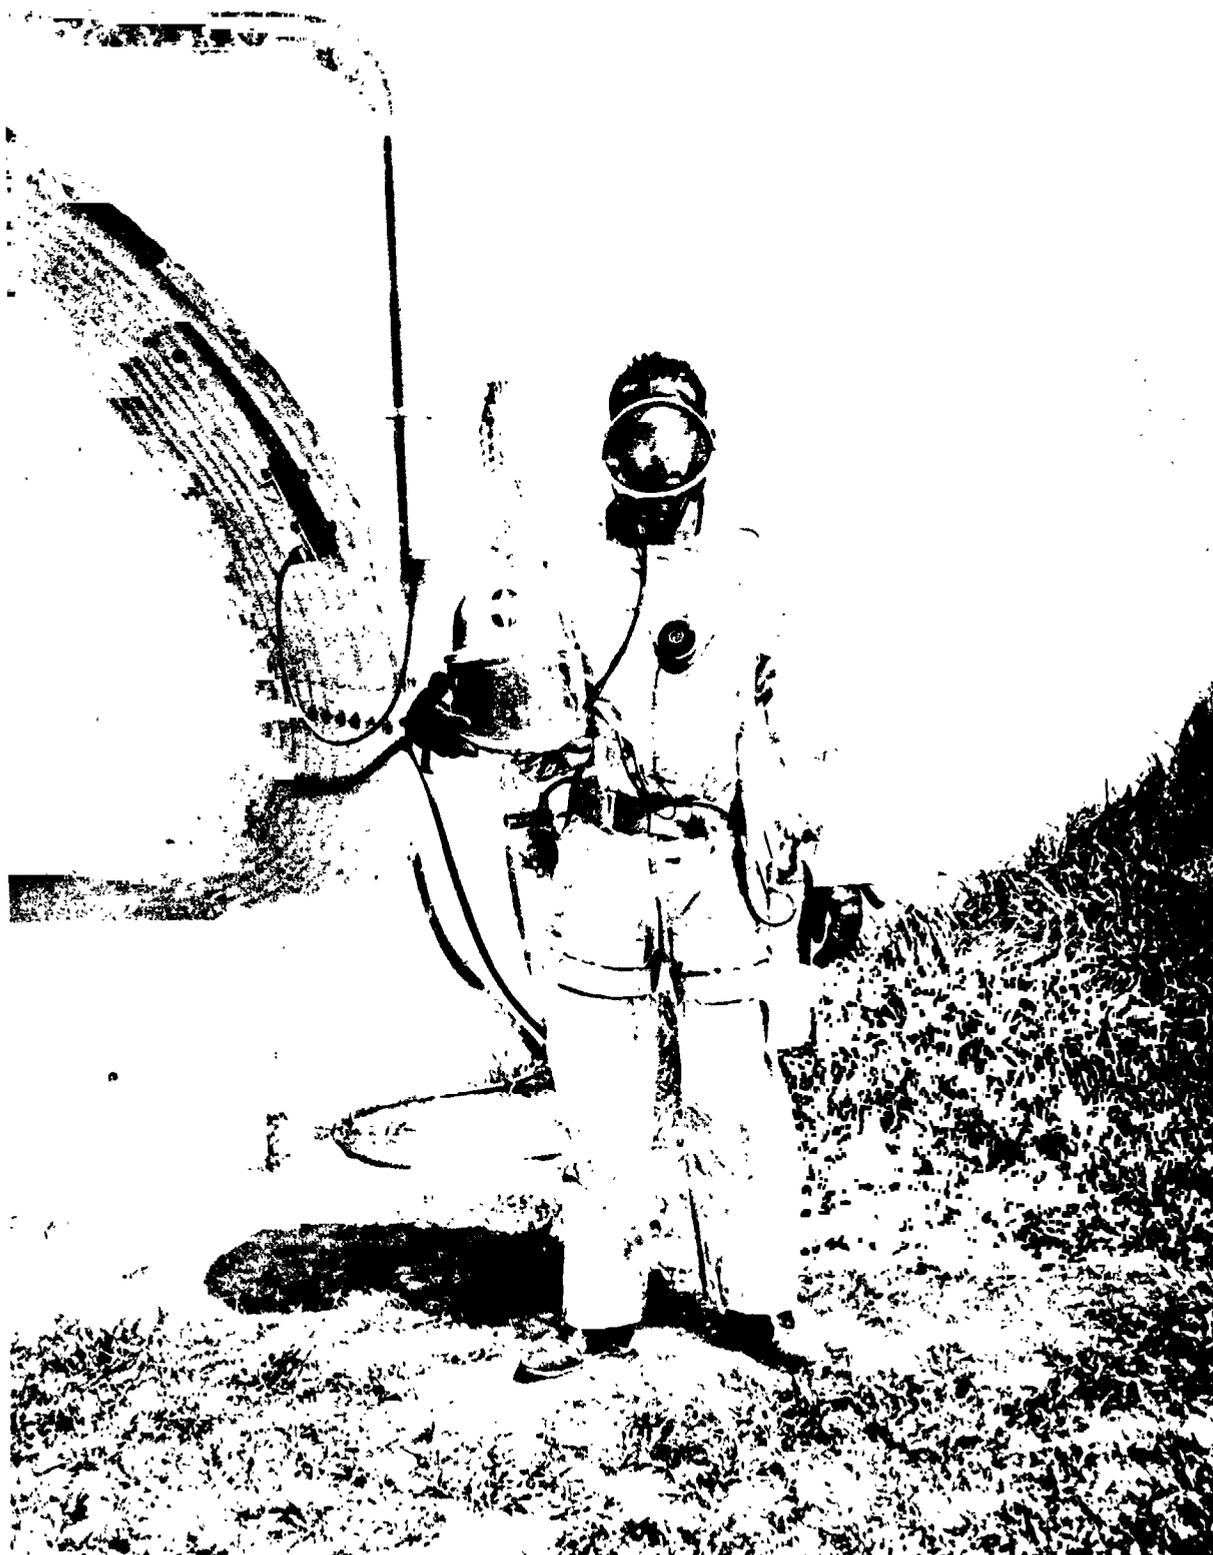
Figure 8. KSC Fire Rescue Technician Dressed in Aluminized Nomex Proximity Protective Clothing and Wearing ARAP

There were two designs of a lightweight, low-profile mobile rescue apparatus that provided a 15-minute air supply and a self-contained, two-way communications assembly. One, called Astronaut Rescue Air Pack (ARAP), was worn by the Fire and Rescue Team that stood by from the time the astronauts were placed in their couches through launch. If rescue should be necessary before launch, the team would rush up the umbilical tower to the command module and pull the astronauts to safety. Figure 8 shows a fire rescue man in ARAP, which he put on before entering the hazardous area.

Both the ARAP and the EEAP units used had a quick-don Wilson Tite-Seal mask to which 7.9 cubic centimeters (2.8 cubic feet) per minute of air was supplied at null pressure of 0 millimeter of water. To exclude toxic vapors, the face mask incorporated an exhalation valve with a cracking pressure of 58.42 ± 7.62 millimeters (2.3 ± 0.3 inches) of water, thus maintaining a positive gage pressure at all times. A low-profile alarm whistle warned the operator when the pressure in the cylinders indicated the breathing air remaining was

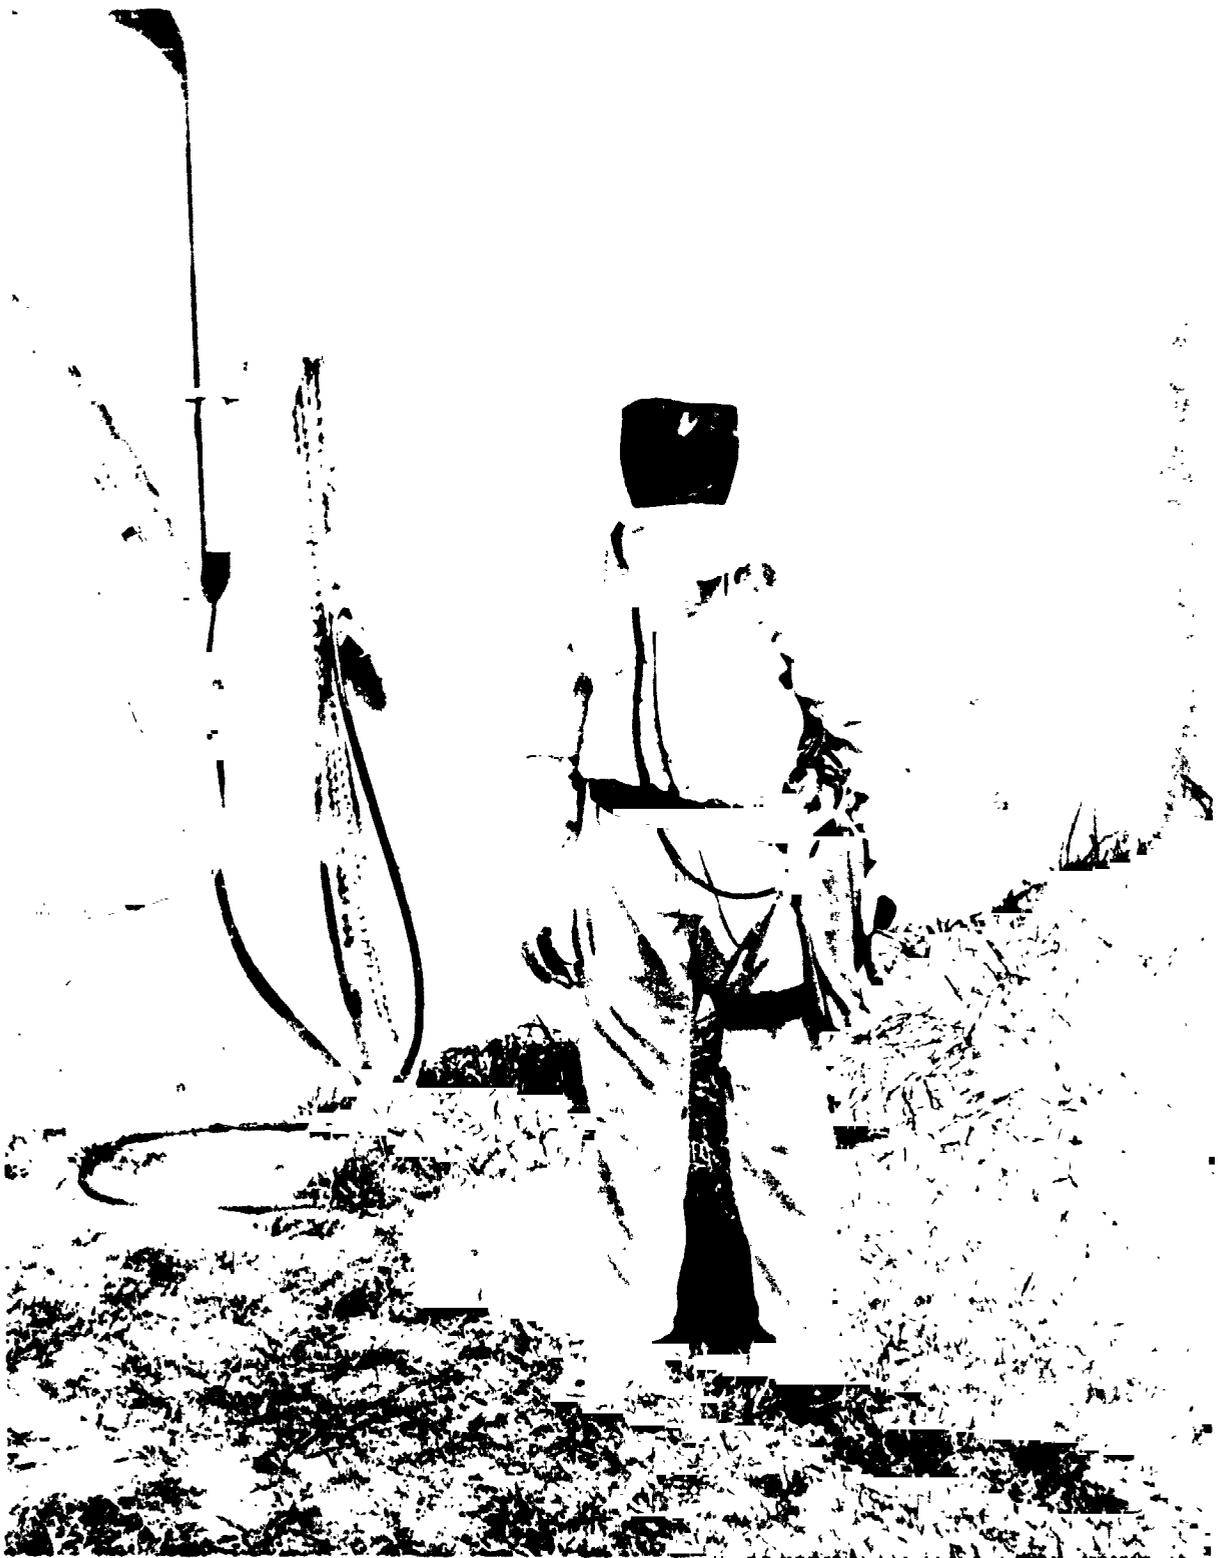
Figure 9. KSC Closeout Technician Dressed in Nomax Protective Coveralls and Wearing EEAP

The second unit, called Emergency Egress Air Pack (EEAP), was placed on the command module level, and could be quickly donned by the closeout crew in the event that a fire or a toxic propellant leak suddenly made the atmosphere in the White Room unbreathable. The astronauts could also use the EEAP as a breathing unit if they had to leave the command module in an emergency without assistance from the Fire and Rescue Team or the closeout crew. They would remove their protective plastic helmets before putting on the unit. Figure 9 shows a closeout crewman in protective coveralls wearing the EEAP.

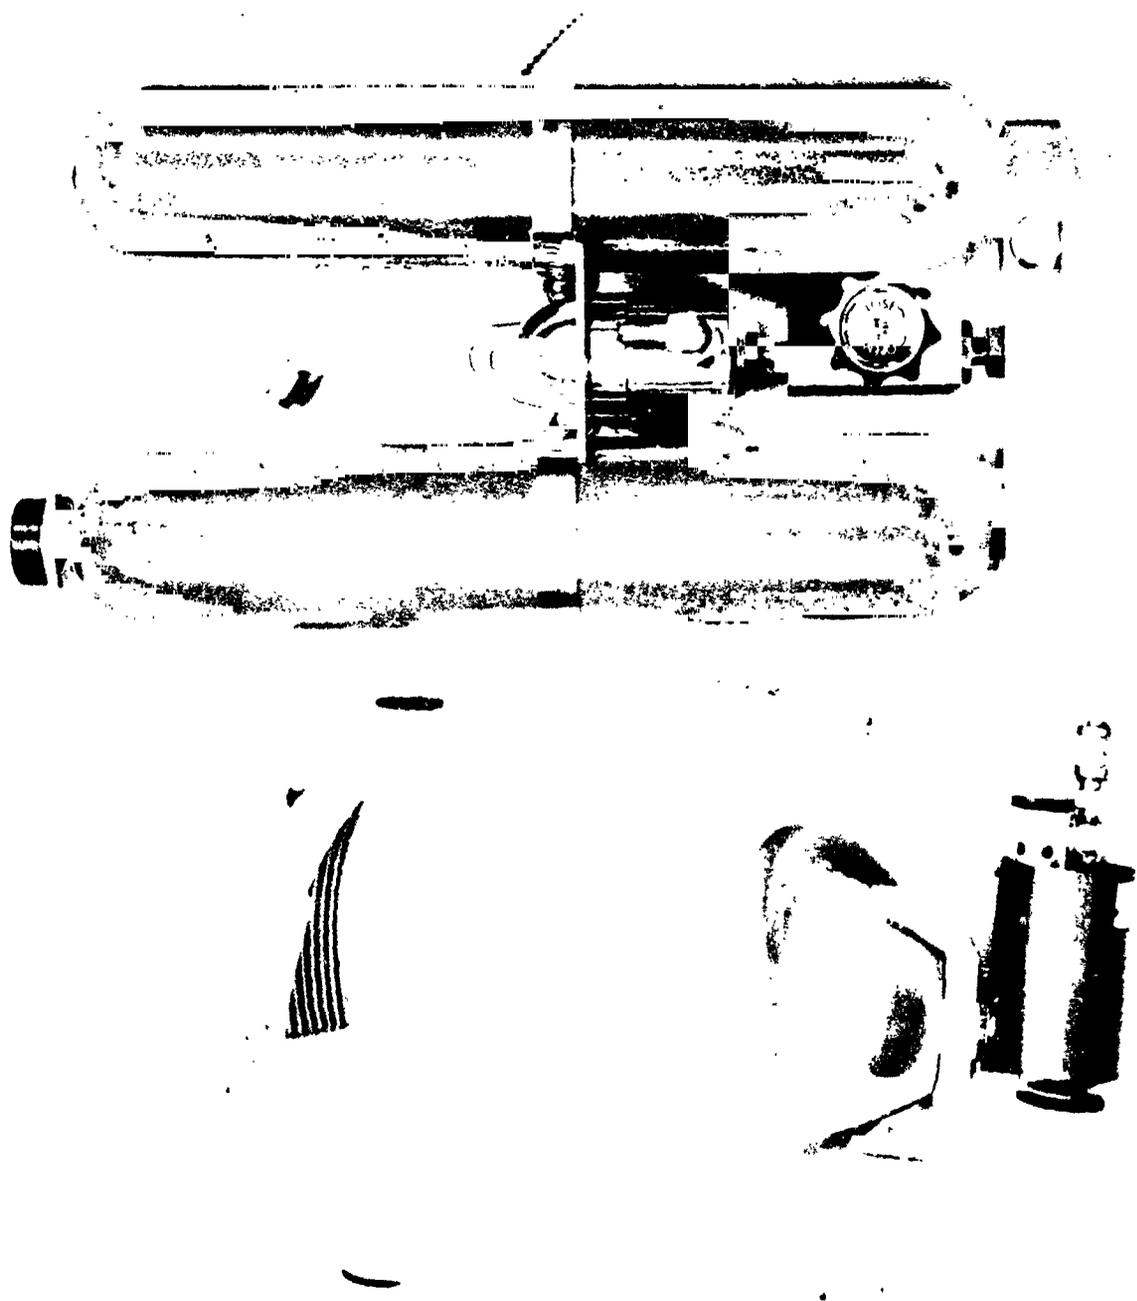
Figure 10. KSC Miniresuscitator

The compact miniresuscitator now being used at KSC is shown in Figure 10. It is operated by turning one valve, which starts the process of automatically inflating and deflating a victim's lungs if he cannot breathe, thus supplying life-giving oxygen. A clear plastic window in the top of the oral-nasal mask permits the operator to observe whether the patient has spit up anything that might block his breathing. (A more complete description of the miniresuscitator is included in NASA Tech Brief 69-10319, which may be obtained from the KSC Technology Utilization Officer.)
