NASA Technical Paper 1193

Influence of Fretting on Flexural Fatigue of 304 Stainless Steel and Mild Steel

Robert C. Bill and Douglas A. Rohn

APRIL 1978

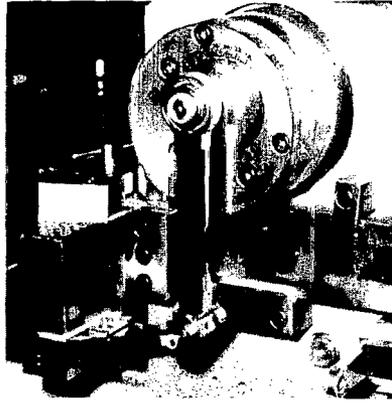
(a) Flexural fretting fatigue apparatus.

The fretting-fatigue apparatus used in this investigation is shown in figure 1(a). The standard flexural-fatigue machine consists of a variable-speed motor, eccentric head, connecting rod, specimen grip, and vise clamp. Rotation of the head causes the connecting rod to flex the end of the specimen. The eccentric head can be set to provide zero- to 5.08-centimeter (2-in.), peak-to-peak deflection at the end of the connecting rod. Flexural stresses can be calculated from this deflection considering specimen geometry and material constants. A counter records head revolutions, and after specimen failure a shutdown switch is tripped by the connecting rod.

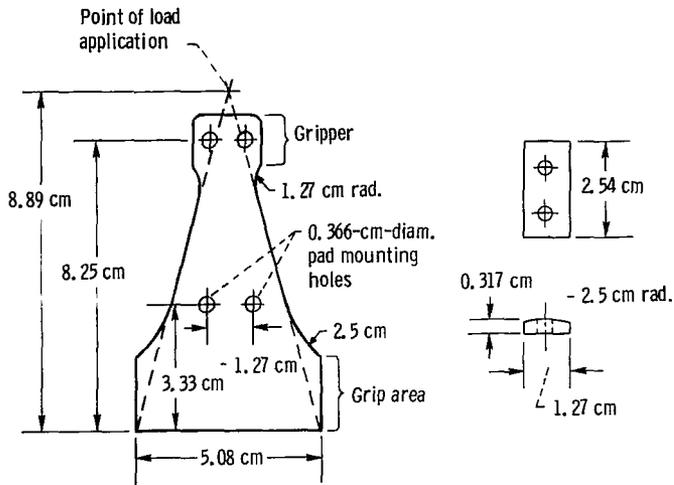
Figure 1. - Test apparatus and specimen.

(b) Flexural specimen.

(c) Fretting pad.

The fatigue specimen is in the form of a constant-stress-cross-section, flexural sheet, 0.75-millimeter (0.030-in.) thick. As indicated in figure 1(b) the specimen geometry is basically triangular. The relation between width and height of this triangle is determined so that, when end loaded as a cantilever beam, the ratio of bending moment to cross-sectional moment of inertia is the same at all points along the specimen. Thus the bending stresses are equal over the beam's length. Outside the constant-stress area are the vise mounting and connecting rod clamping areas, with fillets to reduce stress concentrations.

As indicated in figure 1(b), two holes are provided in the constant-stress portion of all specimens to permit mounting of the fretting pads. The stress concentration factor associated with the mounting holes is calculated to be 1.59 (ref. 13). All fatigue-stress levels discussed reflect nominal flexural stresses in the fatigue specimen, and do not consider stress-concentration effects due to the presence of the holes.

To produce fretting, pads were bolted to the upper and lower surfaces of the fatigue specimens, and the normal load was applied by tightening the bolts to a controlled torque. This normal loading results in a frictional force between the pads and the specimen surface which opposes the strain motion driven by the bending moment. Fretting occurs around the edges of the Hertzian contact area where the force that promotes slip exceeds the restraining friction. Further details are given in appendix A. A torque of 1.14 newton-meters (10 in.-lb) was applied in all fretting-fatigue experiments. With an assumed bolt-friction coefficient of 0.15, the corresponding peak Hertzian stress is 172 megapascals (25 000 psi) with a contact width of approximately 250 micrometers (0.010 in.).

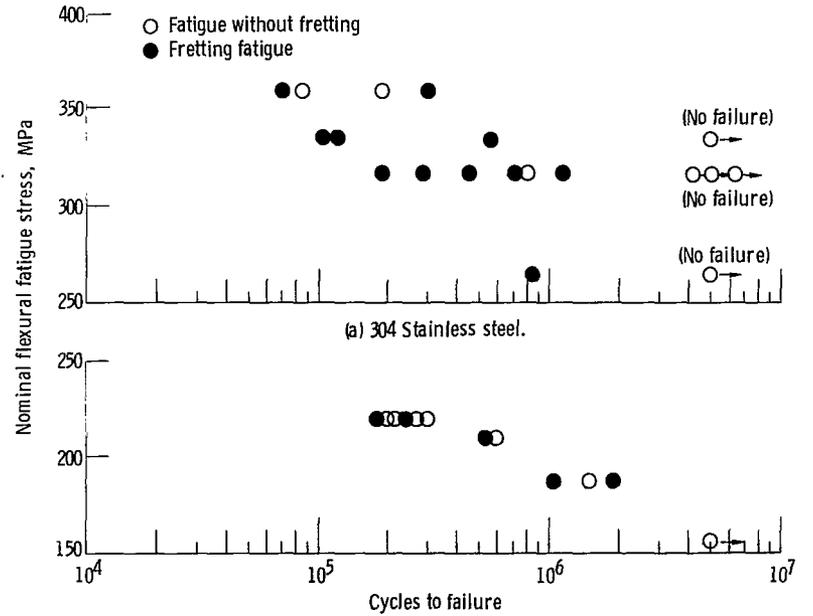
Figure 2. - Fretting fatigue life.

The fretted and unfretted fatigue lives of 304 stainless steel and 1020 steel at various flexural-stress levels are shown in figure 2. It is apparent that fretting effects the fatigue life of 304 stainless steel much more than 1020 steel. The greater resistance of 1020 steel to this type of fatigue may be a consequence of plastic flow in 1020 steel under the combined contact and flexural stresses. When plane-strain conditions prevail, the combined-stress condition may be expressed as

Local yielding will be initiated when the octahedral shear stress approaches the yield stress of the material. It is readily apparent from the preceding expression that the yield stress will first be reached when the flexural-fatigue stress σ_f is tensile, since the contact stress σ_c is always compressive (negative). When yielding occurs, a significant stress relaxation takes place, in effect resulting in the development of residual compressive stresses. These residual compressive stresses would tend to counter the effect of any early damage due to fretting of 1020 steel.

Fretting has a much more significant effect on the fatigue life of 304 stainless steel at the lower flexural-stress levels shown in figure 2. Fatigue-life reductions of as much as a factor of 10 are indicated at 265, 317, and 334 megapascals (38 500, 46 000, and 48 500 psi). No effect due to fretting is observed at 359 megapascals (52 000 psi). This might be expected because at the higher stress level, the unfretted fatigue life is so short that it is nearly the same as the number of cycles required to accumulate fretting damage.

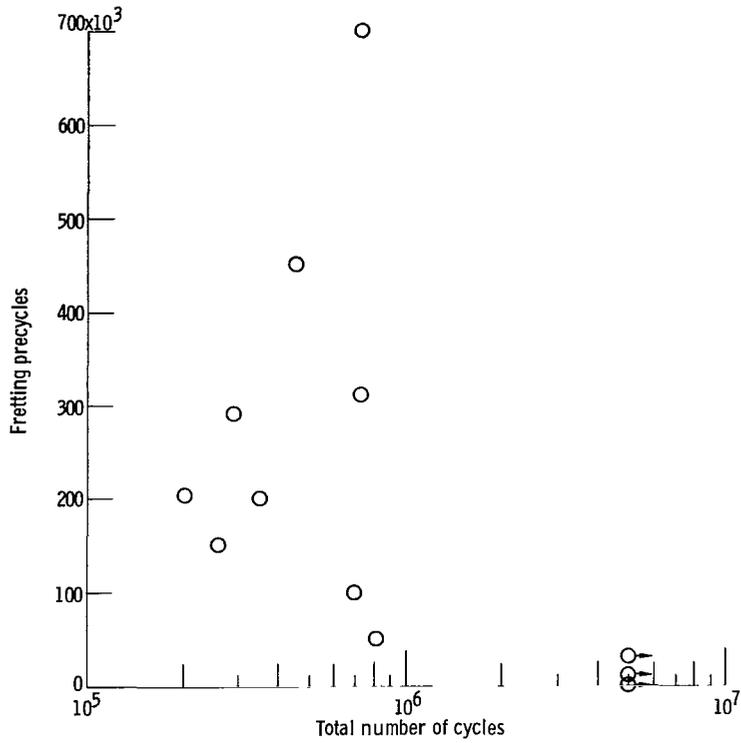
Figure 3. - Two part fretting fatigue of 304 stainless steel. Fatigue stress, ± 317 megapascals.

The results of the two-part fretting fatigue experiments on 304 stainless steel are summarized in figure 3. The salient point is the presence of a fretting-fatigue threshold as was reported by Hoepfner and Goss for Ti-6Al-4V in reference 10. It appears that fewer than 30 000 fretting cycles are insufficient to initiate the surface damage necessary to start a crack. After about fretting 50 000 cycles, the damage is done, so to

speak. Fatigue life is not systematically shortened by exposure to further fretting damage.

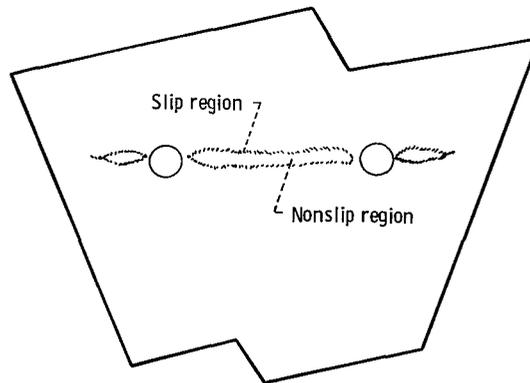
Figure 4. - Distribution of slip and nonslip regions in fretting pad contact area on fretting fatigue flexural specimen.

The fretting-pad contact pattern seen on the fatigue specimen surface after failure is shown schematically in figure 4. There are two distinct regions associated with the contact area, namely, regions of slip and regions of nonslip. Slip regions completely enclose the nonslip central regions, and are characterized by very fine fretting surface damage, as may be seen in figure 5. The nonslip central regions show virtually to evidence of surface distress.

The average width of the fretting pad contact area is about 750 to 1000 micrometers (0.030 to 0.040 in.), rather than the 250 micrometers (0.010 in.) predicted from Hertzian contact equations. There are two effects contributing to this discrepancy: First, the cylinder-on-flat contact is interrupted over the assumed 2.54-centimeter (1-in.) length by the relief around the bolt holes, with consequently reduced effective contact length, increased Hertzian stresses, and increased contact width. Second, since the flexural-fatigue specimen is only 750 micrometers (0.030 in.) thick, some overlap of the contact stresses due to the fretting pads clamped on either side of the specimen might occur. Again, increased contact width would be expected.

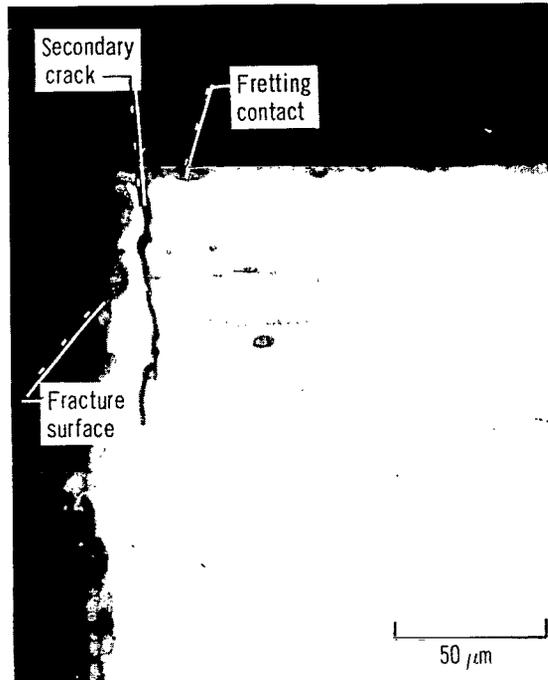
Figure 7. - Section through fracture surface. 304 stainless steel after fretting fatigue failure under ± 317 -megapascal flexural fatigue stress.

A section view of a fretting fatigue fracture surface is shown in figure 7. Evidence of surface pitting due to the fretting action may be seen. Of particular interest is the crack that was initiated in the fretting area but did not link up with the primary crack.

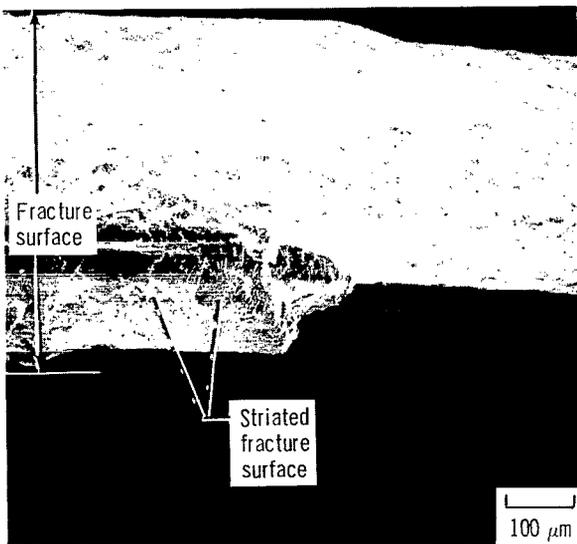
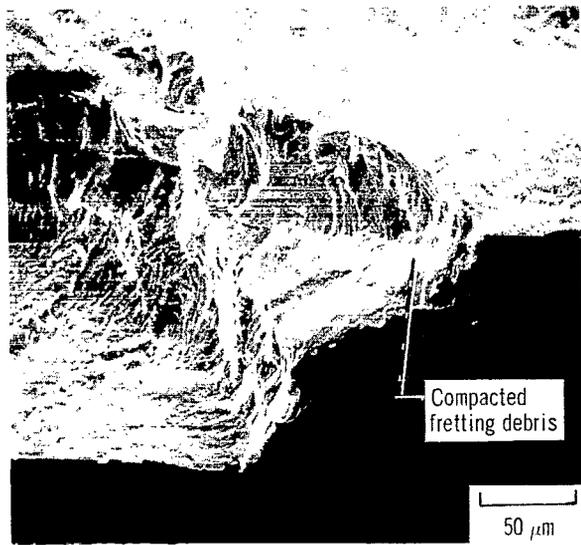
(a) Overview showing area of rapid crack propagation.

(b) Close-up showing adherent compacted fretting debris.

Figure 8. - Scanning electron micrographs of fretting fatigue fracture surface on 304 stainless steel. Flexural fatigue stress, ± 317 megapascals.

Fracture-surface features on the flexural-fatigue specimens are shown in figure 8. Two distinct regions are seen on the fracture surface. Near the contact surface where fretting takes place, there is evidence of rapid crack growth into the fatigue specimen, as indicated by the distinctly striated areas. With increasing depth into the fatigue specimen, a region is encountered in which cracks propagate parallel to the bending

axis as well as into the specimen. The "smeared" appearing areas on the fracture surface of figure 8(b) are caused by adherent, compacted fretting debris.

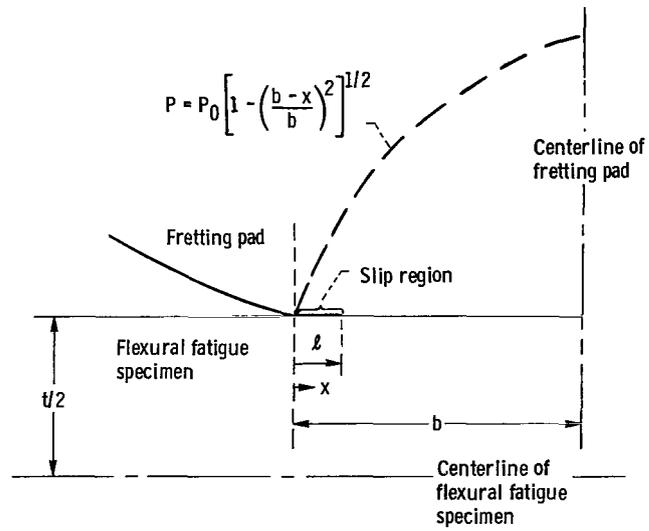
Figure 9. - Features of contact geometry of fretting pad and flexural fatigue specimen.

The portion of the contact region between the fretting pad and the flexural fatigue specimen actually undergoing slip, as shown in figure 9, is predicted based on analogy with some results developed for cracks (ref. 14). Shear displacement between the surfaces in the slip region follows from surface displacement distribution for an elliptical crack, according to the equation
