NASA Technical Memorandum 78716

Environmental Effects
on Composites for Aircraft

Richard A. Pride

MAY 1978

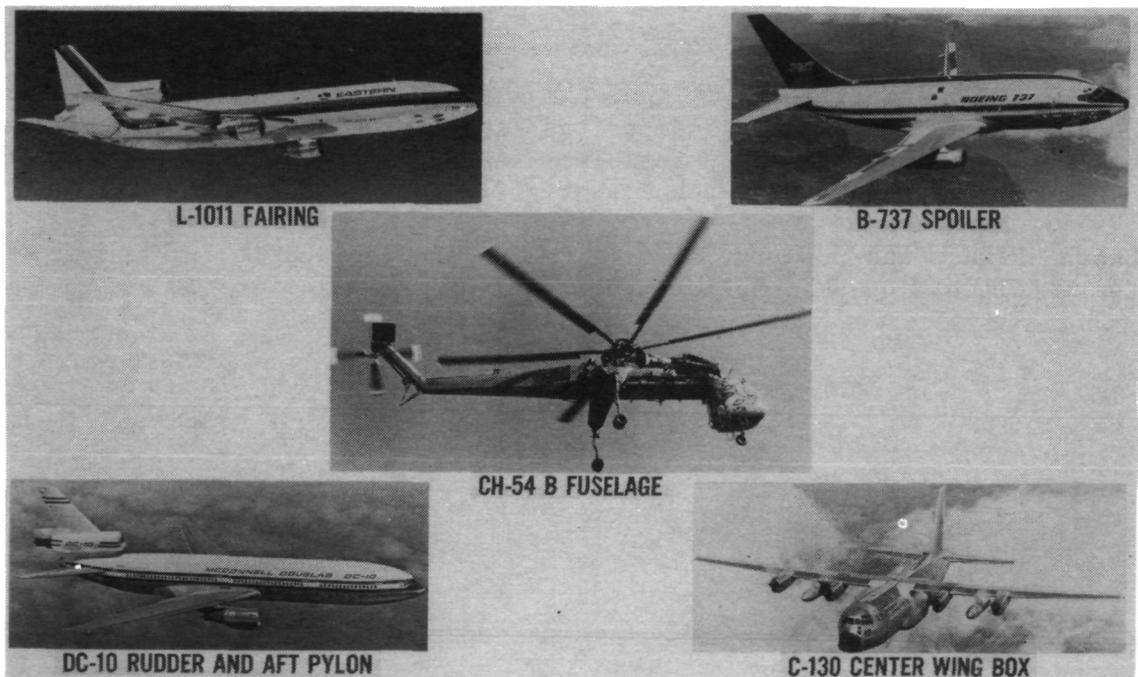
Figure 1.- Flight service evaluation of composite structural components.

A number of composite structural components have been designed, manufactured, tested, and placed in operational service on a variety of aircraft. This operational flight service is monitored periodically to evaluate the long-term experience with composite durability. The types of aircraft and composite components are shown in figure 1. The L-1011 application is six fuselage fairing panels involving two types of Kevlar 49 epoxy composite on each of three airplanes (ref. 1). Three graphite-epoxy material systems are used for the spoilers on 27 Boeing 737 airplanes (ref. 2). A fourth graphite-epoxy material is used in the upper, aft rudder segment on ten DC-10 airplanes (ref. 3), and boron-aluminum composite skin is used in a panel on the aft pylon adjacent to the engine on three DC-10 airplanes (ref. 4). Boron-epoxy is used as a selective reinforcement in the aluminum aft fuselage, or tail cone, of an Army CH-54B helicopter (ref. 5) and in the aluminum center wing box of two Air Force C-130 transports (ref. 6).

The status of these composite structural components in the Langley flight service program, as of January 1, 1978, is given in table I. The boron-epoxy composite in the CH-54B helicopter tail cone has been in service for the longest calendar time, six years, but it has been flown very little compared to the other types of aircraft. The Kevlar 49 epoxy in the L-1011 fairing panels has accumulated the greatest single component flight time, 13 138 flight hours in five years of service. The graphite-epoxy in the 108 spoilers on the 737 airplanes has accumulated the greatest total component flight hours, 921 600 in four and one-half years. The graphite-epoxy in one of the DC-10 upper aft rudders has been acquiring flight service time at the greatest rate of any of the components in the table, a rate of 400 hours per month or about 13 hours per day. Overall the 142 composite components have accumulated in excess of one million component flight hours in service around the world with 17 operators. Each of these composite components has been inspected at least annually by the manufacturer, under terms of the NASA contracts. There have been no significant incidents or damage detected in any of these flight components. Maintenance has been reported as less than that required on similar standard, production parts.

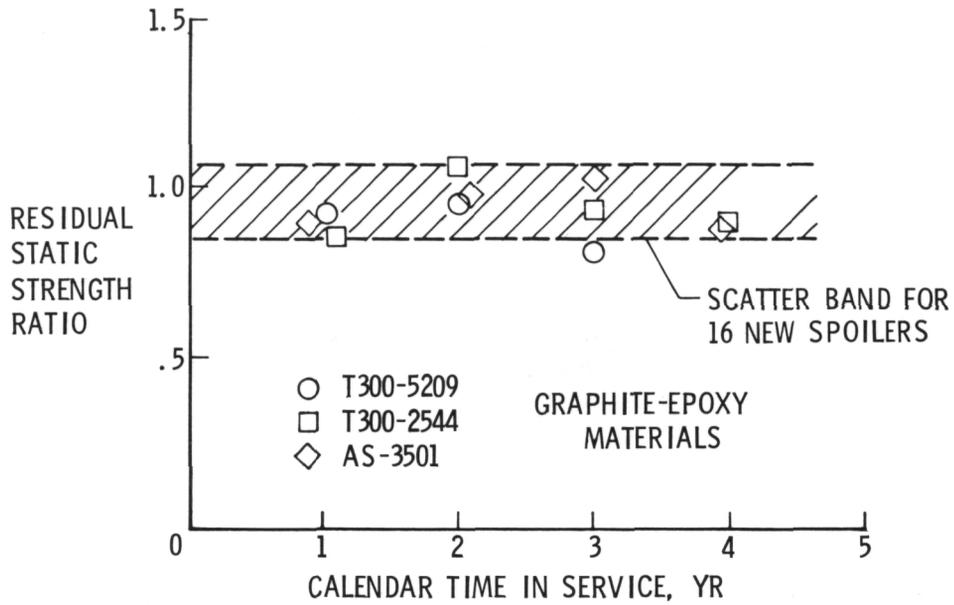
Figure 2.- Residual static strength of graphite-epoxy spoilers.

For destructive testing the spoilers are mounted in the same static test jig as was used for the initial airworthiness certification tests (ref. 2). A distributed load is applied to the outer surface of the spoiler, simulating aerodynamic loads, and the magnitude is increased until failure occurs. Results of these residual static strength tests on the graphite-epoxy spoilers are shown in figure 2. The residual strengths for each material system have been divided by the failure strength of the initial certification test for each material, and the results are presented nondimensionally as a function of the time in service. A scatter band for strength tests of 16 new replicate spoilers manufactured with the T300-5209 graphite-epoxy material has been superimposed on the individual tests of spoilers removed from service. In four years of service, the scatter in strength for the individual spoilers generally falls within the width of the new spoiler strength scatter band; an indication of essentially no degradation in strength.

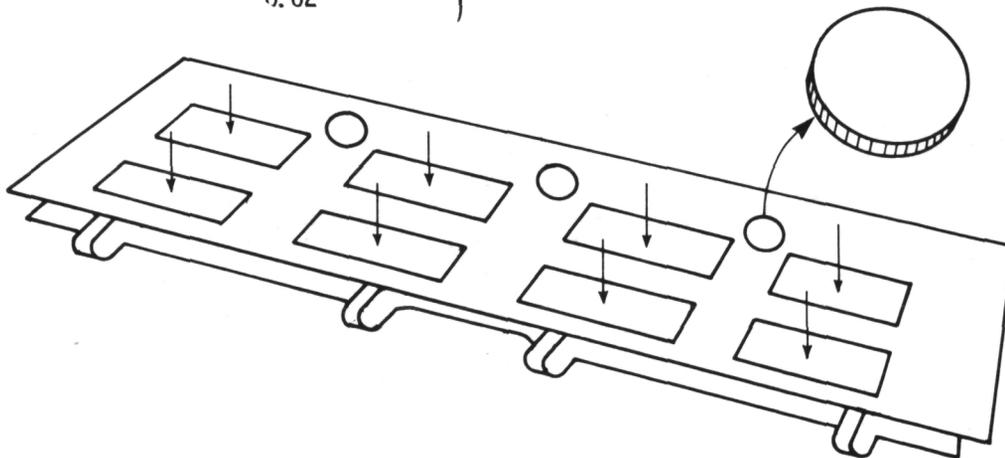
T300-5209 GRAPHITE-EPOXY AFTER
 THREE YEARS SERVICE WITH LUFTHANSA
 RESIDUAL MOISTURE
 0.63 PERCENT
 0.66
 0.62
 } AV = 0.64 PERCENT

Figure 3.- Spoiler moisture levels determined from plugs.

After several years of unsuccessfully attempting to determine the moisture absorbed by the graphite-epoxy spoilers in service, a technique of cutting plugs from near the trailing edge was developed (fig. 3). The eight rectangular areas shown with an arrow in the center of each represent the whiffletree loading areas for static strength tests. Since failures always have initiated near the leading edge at one of the center hinges, it has been determined that three plugs of 6.4 cm (2.5 in.) diameter could be cut from the region behind the loading areas without influencing the failure load. These plugs, which consist of aluminum honeycomb core, two graphite-epoxy face sheets, two layers of epoxy film adhesive and two exterior coats of polyurethane paint, have about 90 percent of their weight in the composite faces, including the paint and adhesive. A good determination of the moisture level in the spoiler can be made by drying the plug and noting the weight change. After three years of service with Lufthansa Airlines in Germany, plugs taken from a T300-5209 graphite-epoxy spoiler indicated a moisture content of 0.64 percent, based on the composite weight. Somewhat greater significance may be attached to this value when corrections have been determined for relative differences in equilibrium moisture levels in the paint, the composite matrix, and the adhesive.

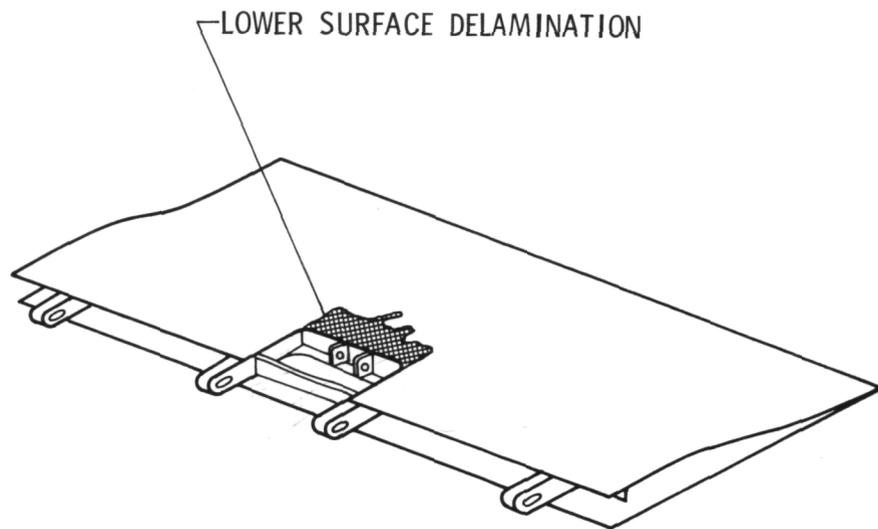
Figure 4.- General area of spoiler delamination.

these spoilers were fabricated and placed in service on six of the aircraft that were flying graphite-epoxy spoilers. After six months of operational flight service the two spoilers installed on Aloha Airlines were reported to have developed significant delamination of the lower surface skin directly aft of the actuator attachment fitting (fig. 4). Within a month a third spoiler was reported as starting to experience delamination, so it was decided to remove all the remaining graphite-polysulfone spoilers. A closeup view of the delaminated area is shown in the photograph in figure 5. This experience demonstrated the difficulty of performing adequate laboratory accelerated environmental testing and provided a good example of the necessity for flight service evaluation.

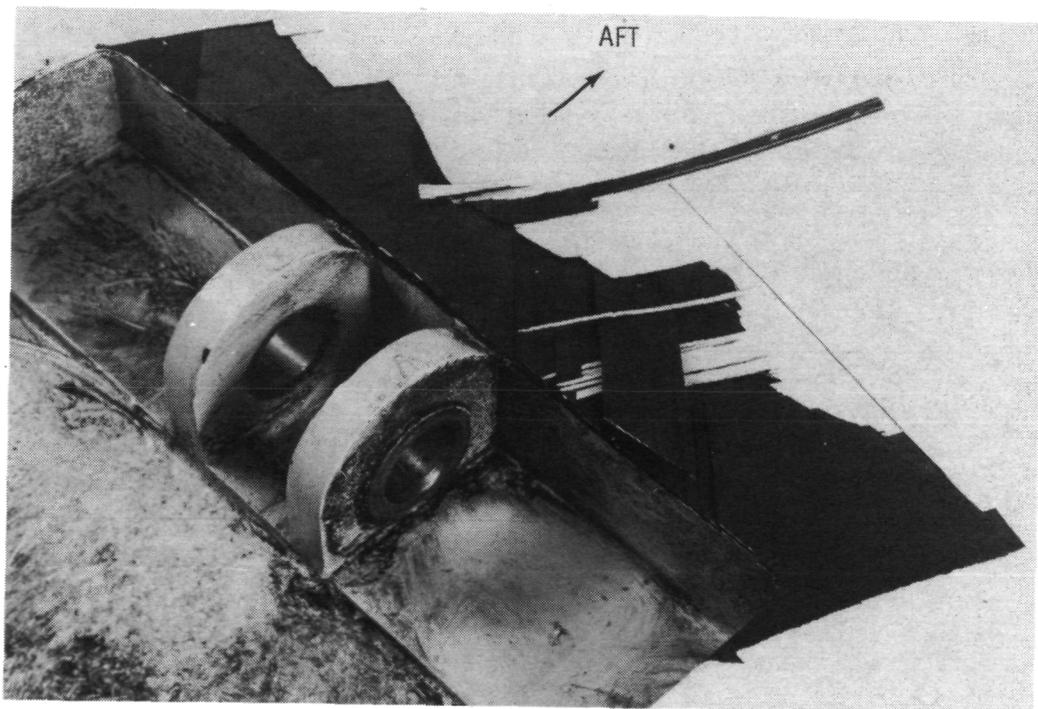
Figure 5.- Delamination of spoiler cover due to hydraulic fluid attack.

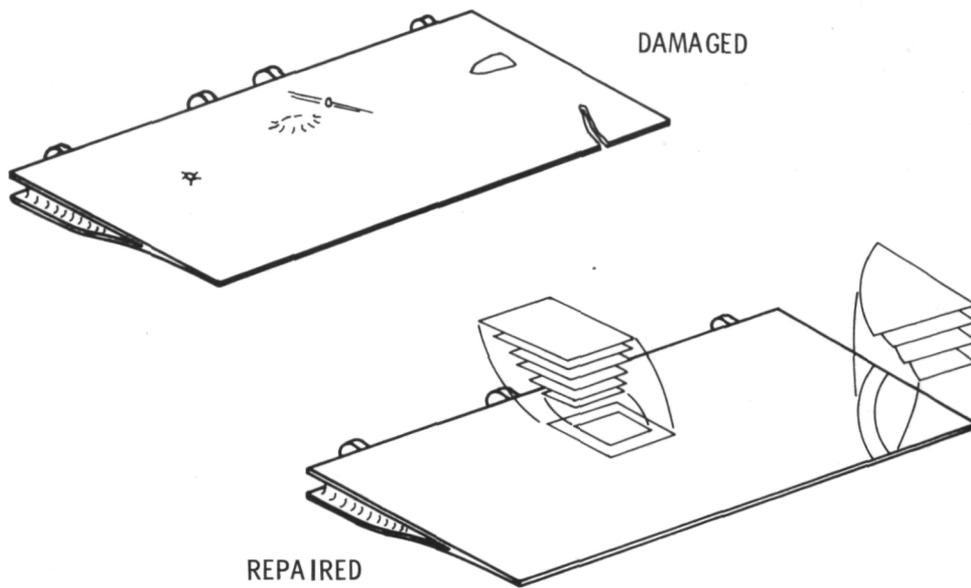
Figure 6.- Graphite-epoxy spoiler repair techniques.

There have been several instances in which the graphite-epoxy spoilers have received damage in service sufficient to require repairs. Examples of these are illustrated in figure 6. On this program, damaged spoilers are removed from the aircraft and returned to The Boeing Company for repair. Repairs are made by cutting out the damaged area, replacing honeycomb core as needed, and replacing graphite-epoxy plies on a one-for-one basis with each ply lapped over the underlying one by about 6 mm (0.25 in.). One piece of adhesive film is placed under the patch assembly and the built-up patch is cured and bonded in one cycle in an autoclave with the spoiler supported in its original assembly tooling (ref. 7). The repaired spoiler is ultrasonically inspected and returned to flight service with the airline which had previously used it.

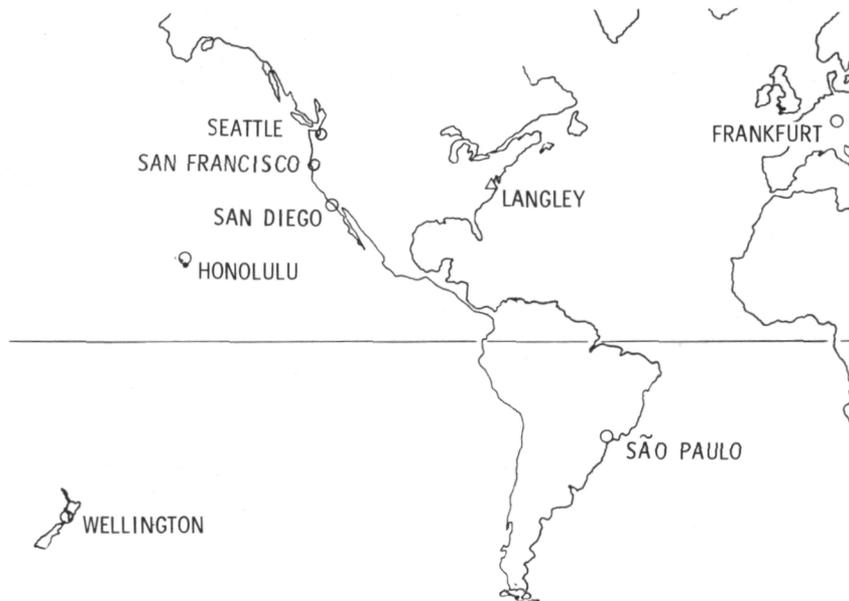
Figure 7.- Distribution of environmental exposure racks.

As a parallel part of the flight service exposures of composite components, a number of replicate mechanical property specimens have been manufactured from the same composite material systems used in the components. These specimens have been mounted in racks which are deployed on rooftops of airline buildings at a number of airports around the world so as to receive maximum exposure to the airport ground environment. The location of six of the exposure sites is shown on the map of the world in figure 7. Each of these locations has an exposure rack with unstressed specimens as indicated in figure 8. Each of the five panels mounted in the rack contains triplicate specimens of four graphite-epoxies, one graphite-polysulfone, and two Kevlar 49 epoxies in short beam interlaminar shear, flexure and compression configurations. After one year and three years of exposure a panel is removed from each rack and shipped to Langley Research Center for specimen testing and evaluation.

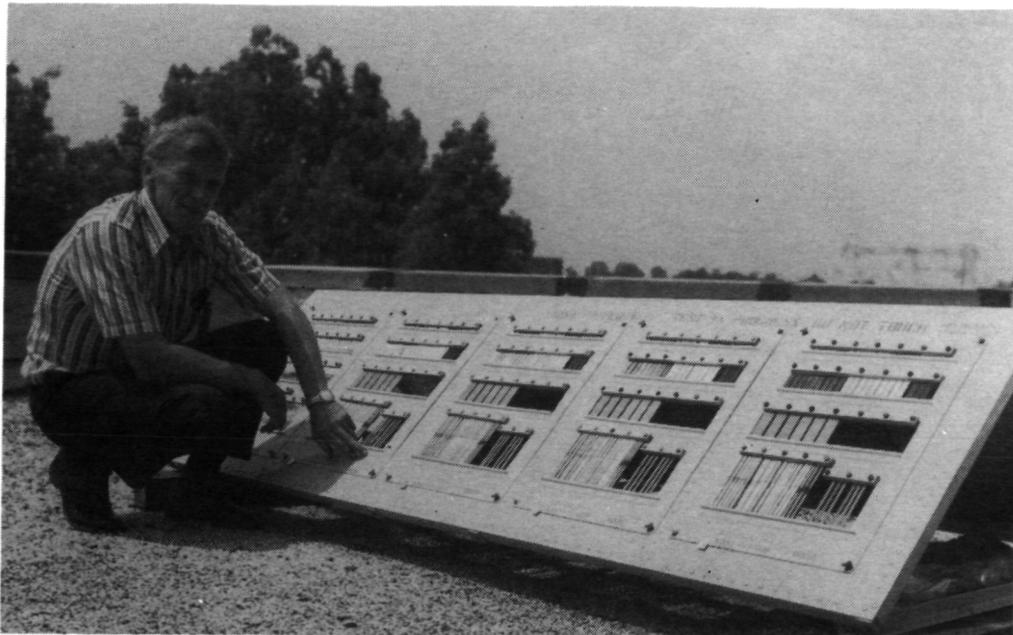
Figure 8.- Unstressed exposure rack.

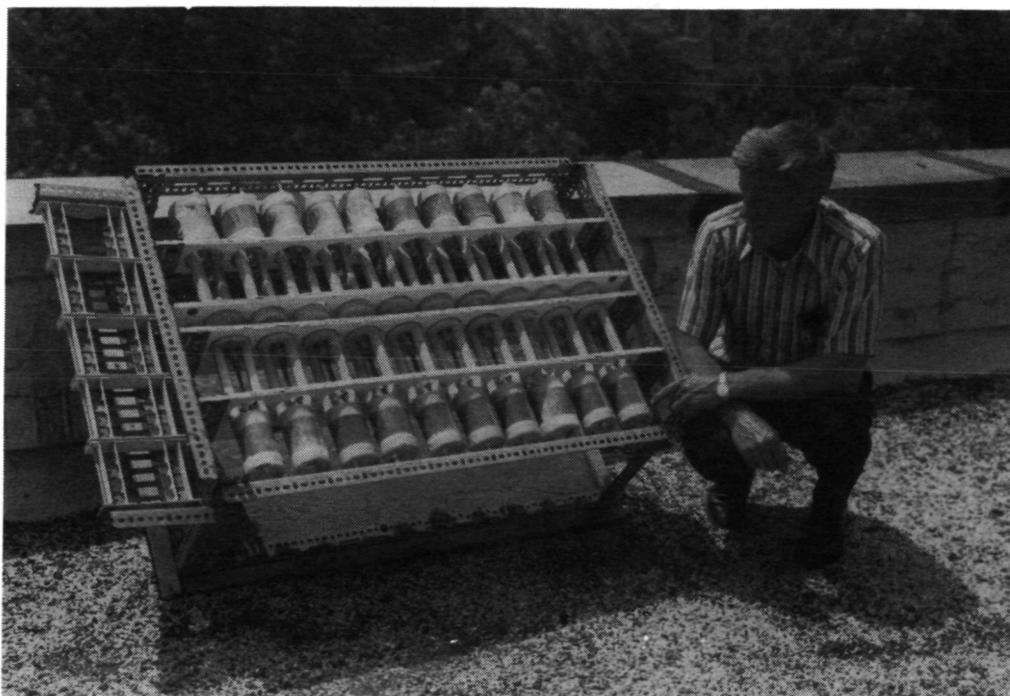
Figure 9.- Stressed exposure rack.

In addition to the unstressed exposures, three racks containing stressed tensile specimens (fig. 9) are also deployed, one each at San Francisco, Seattle, and Langley. Individual specimens are mounted in fixtures which apply a constant load through a compressed helical spring. Unstressed tensile specimens are also placed in these same racks for comparison.

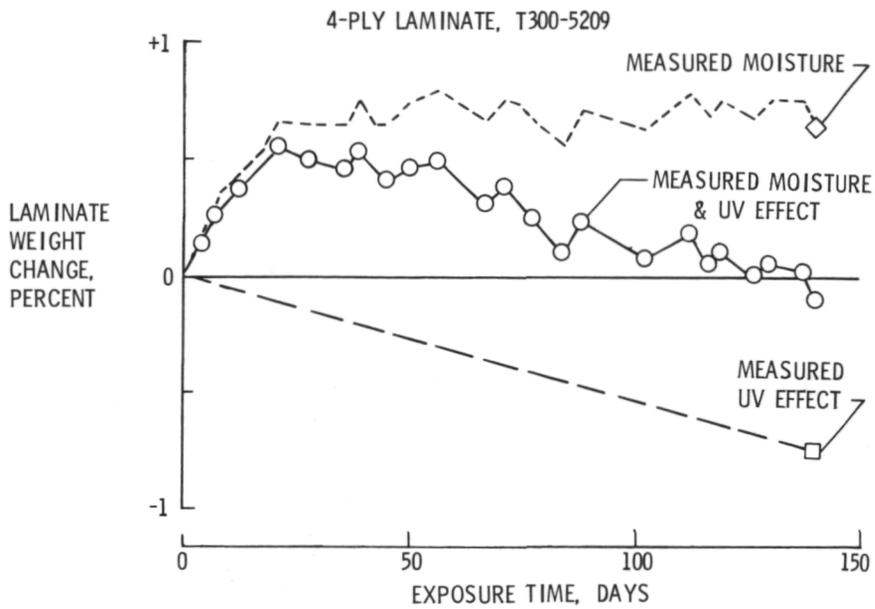
Figure 10.- Weight change in outdoor exposure; 4-ply laminate, T300-5209.

When specimens are removed and shipped to Langley periodically, they are weighed to determine weight changes associated with moisture absorption and weathering. An example of the specimen weight changes with exposure time is shown in figure 10 for a thin graphite-epoxy specimen in the unstressed rack at Langley. The solid curve in the center of the figure drawn through the

circular test points is the record of the repeated weighings. The specimen initially gained weight and then began to gradually lose weight as a result of the combined effects of moisture and solar ultraviolet exposure. The exposure of this specimen was terminated after 140 days and the specimen was then dried to a fully dry condition. The weight change associated with this drying indicated the actual measured moisture level in the specimen at 140 days. Comparing the fully dry weight to the initial fully dry weight showed the measured ultraviolet effect of a weight loss after 140 days. Since the ultraviolet effect is a loss from the exposed specimen surface, it is assumed to be linear with exposure time. Corrections can then be calculated for the measured weights at intermediate times, and an interpolated moisture curve can then be plotted as shown by the upper dashed line in figure 10. This curve appears to have reached an equilibrium level of moisture absorption between 0.6 and 0.7 percent. The small fluctuations correspond to changes in the daily levels of relative humidity.

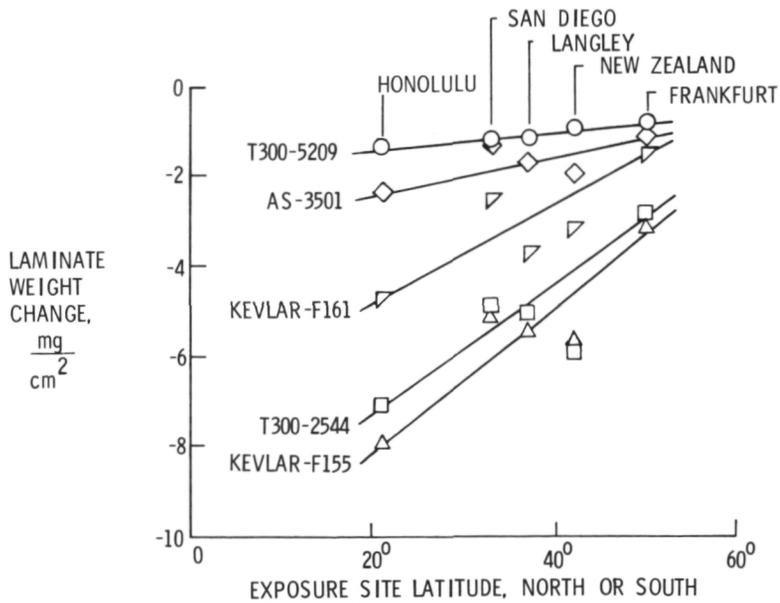
Figure 11.- Weight loss from three years outdoor ultraviolet exposure.

The results of fully drying the flexure specimens from five exposure sites after three years of exposure provided a pattern of weight losses due to ultraviolet exposure as shown in figure 11. For any given material, the weight losses are greater for exposure sites closest to the equator. Variations in the epoxy matrices for the different material systems seem to provide a greater variation in weight loss than changes in exposure site latitude. In all cases the specimens were exposed in an as-laminated condition without any protective coating. The weight losses in three years time correspond to less than 25 percent of one ply thickness.

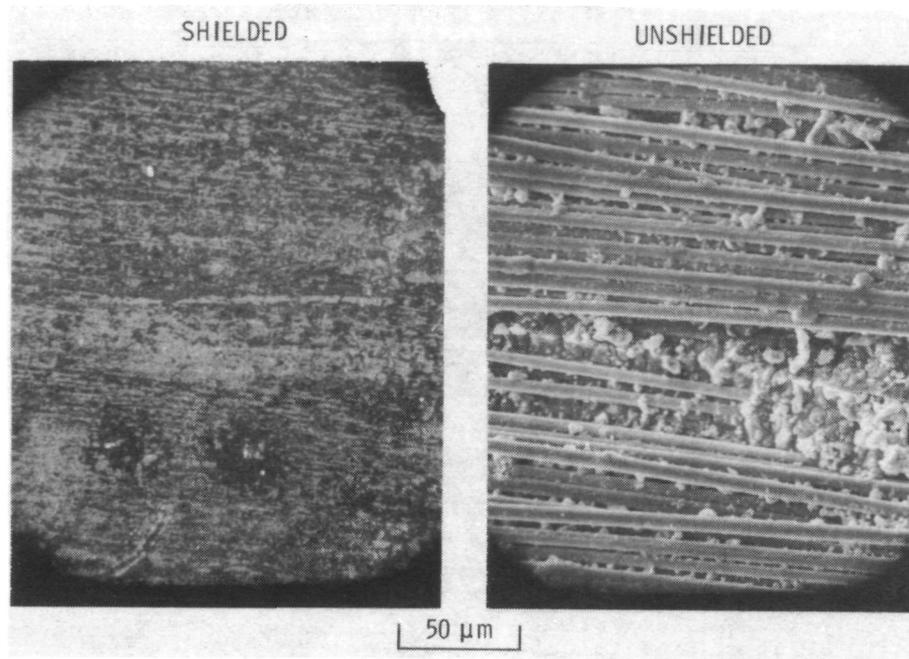
Figure 12.- Graphite-epoxy surface degradation; 3-year outdoor exposure.

Scanning electron micrographs of two areas on one of the T300-5209 graphite-epoxy specimens exposed at the Honolulu site are shown in figure 12. The left-hand area was shielded from the solar ultraviolet by the specimen mounting clamp on the exposure rack. The magnified view is essentially the original as-laminated surface, which is entirely epoxy. The right-hand area was typical of the unshielded portion of the same specimen. In this area the epoxy matrix has been removed by the ultraviolet weathering process, exposing a layer of individual graphite fibers. Although the effect looks bad, it really is quite superficial in three years time and it can be prevented by painting the exposed specimen surface.

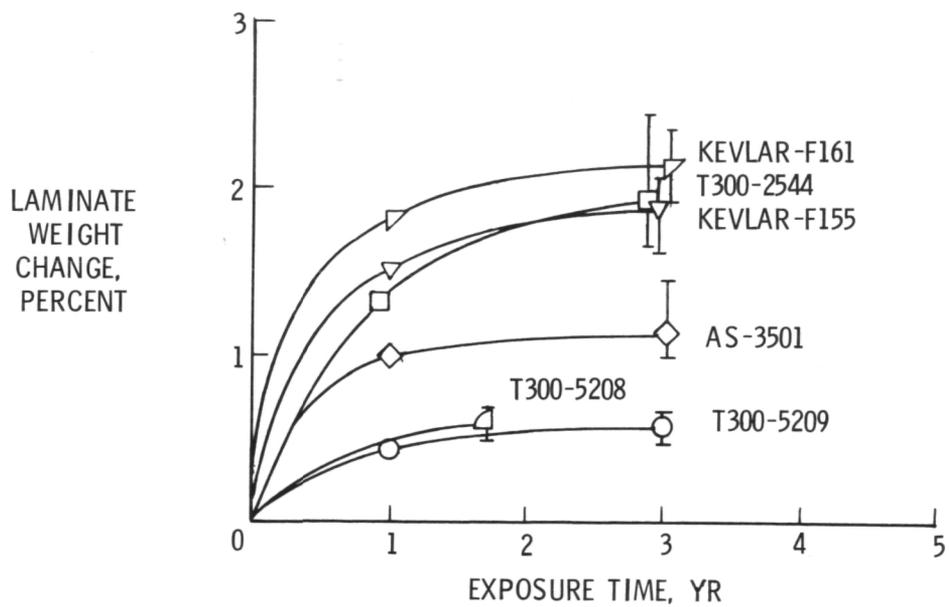
Figure 13.- Moisture pickup after worldwide exposures.

The amount of moisture absorbed by the various composite material systems is shown in figure 13. These results represent the determinations made on flexure specimens after their worldwide outdoor exposures for times up to three years. The weight gains shown have been corrected for the ultraviolet weight losses as described previously for figures 10 and 11. The scatter bands indicated for the three-year exposures contain all the data for triplicate specimens and five exposure sites. In general there is no separation of individual sites by the magnitude of absorbed moisture. The largest variable appears to be the type of epoxy matrix used in the composites. Even the Kevlar-epoxy values are in the same range as one of the graphite-epoxies. Data for T300-5208 graphite-epoxy is only shown for a 1.7-year exposure because the specimens which were made as a part of the graphite-epoxy rudder flight service program were not available to be deployed in the exposure rack panels until 1.3 years after the other specimens were deployed. However, the absorbed moisture for the T300-5208 is essentially the same as for the T300-5209

material, and both appear to be at an equilibrium level of about 0.5 percent of the laminate weight.

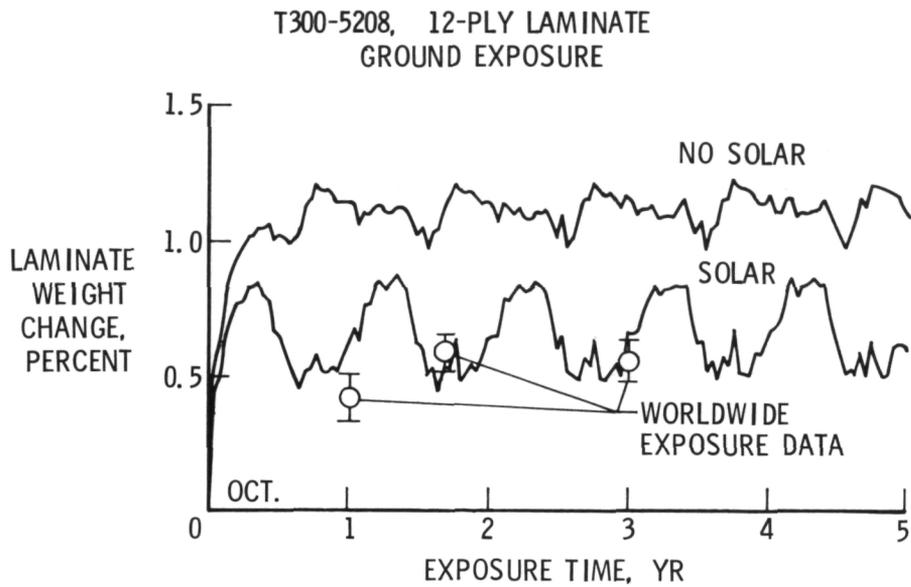
Figure 14.- Comparison of predicted and measured moisture contents; T300-5208, 12-ply laminate; ground exposure.

A comparison of the measured moisture contents for both T300-5208 and T300-5209 materials with predicted moisture contents for a 12-ply laminate of T300-5208 graphite-epoxy is shown in figure 14. The predicted moisture contents are based on calculations using the Fickian diffusion equations with varying inputs for relative humidity and temperature (ref. 8). These varying inputs are taken directly from tape recordings of the weather at Langley Research Center. The predicted curve marked "No Solar" was calculated assuming that the temperature of the specimen was the same as that of the ambient air. This is a reasonable assumption for specimens exposed in shade; however, if the specimens are exposed to the Sun, they will be heated to temperatures well above the ambient air temperature on clear, sunny days. This will increase the rate of moisture diffusion and, more importantly, decrease the local relative humidity at the surface of the specimens. Inclusion of these effects in the calculations results in the lower predicted curve marked "Solar". The weather data for the year 1962 were used repetitively in the calculations, starting at the first of October to correspond with the initial deployment of the exposure racks and specimens. The experimental data points at 1, 1.7, and 3 years are taken from the overall worldwide exposure data previously discussed in figure 13 for T300-5208 and T300-5209 graphite-epoxies. The correlation between prediction and experiment is good.

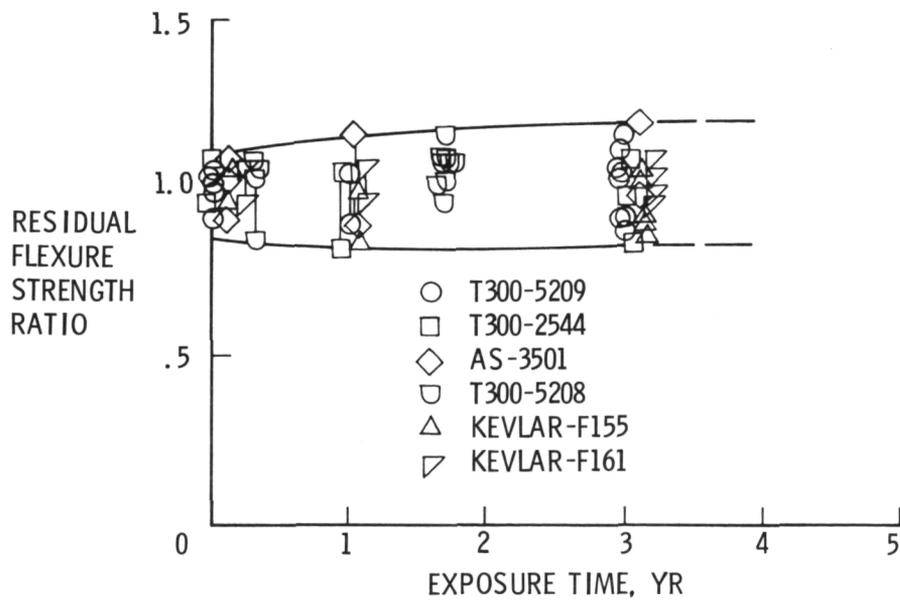
Figure 15.- Residual flexure strength after worldwide exposure.

The observed loss of material from ultraviolet exposure and pickup of moisture from the relative humidity leads to a concern for the effect on residual mechanical properties. Figure 15 shows the results of flexure strength tests performed after various exposure times at all of the worldwide exposure sites for six composite materials. The data are shown in nondimensional form obtained by dividing residual strengths by the initial as-laminated strengths. The width of the scatter band for strength is largely a function of the scatter in triplicate tests from various exposure sites. However, it is not sufficiently greater than the scatter in the initial replicate tests to justify any conclusions. It is evident that for three years of outdoor ground-based unstressed exposure there has been no indication of degradation in flexure strength. Similar conclusions can be drawn from results of the short beam interlaminar shear and the compression tests also, after three years of unstressed outdoor exposure.

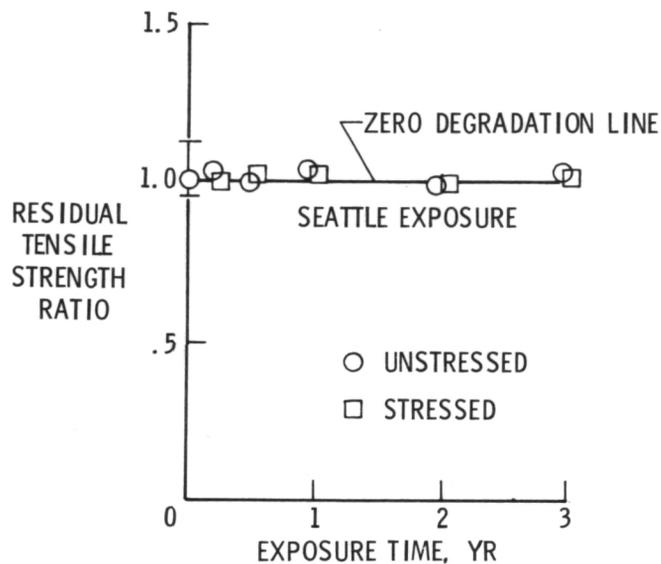
Figure 16.- Residual tensile strength after sustained stress outdoor exposures; T300-5209, $\pm 45^\circ$ laminate stressed at 25 percent ultimate.

To consider the possible influence of constant stress during the outdoor exposure, three sets of tensile specimens have been included in the program. The first set consists of T300-5209 graphite-epoxy material laminated at $+45^\circ$ ply orientation and stressed during exposure at 25 percent of the initial ultimate strength. Exposure and residual strength testing have been conducted in the Seattle, Washington area by The Boeing Company under NASA contract. Results shown in figure 16 indicate essentially no difference between stressed and unstressed exposure and no degradation in tensile strength for up to three years of exposure. The second and third sets of tensile specimens are T300-5208 graphite-epoxy material laminated in a $[0^\circ, +45^\circ, 90^\circ]$ quasi-isotropic ply orientation and stressed during exposure at 40 percent of the initial ultimate strength. Exposure sites for these are located at the San Francisco airport and at Langley. Specimens have been retrieved and tested at Langley after

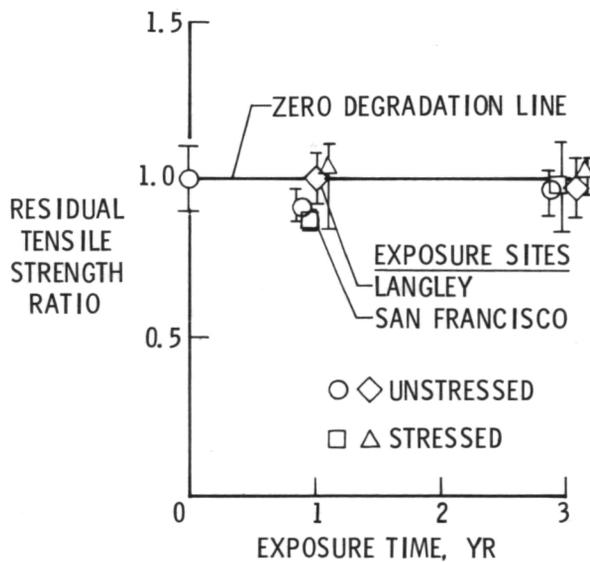
Figure 17.- Residual tensile strength after sustained stress outdoor exposures; T300-5208, $[0^\circ, \pm 45^\circ, 90^\circ]$ laminate stressed at 40 percent ultimate.

one and three years exposure. The results shown in figure 17 indicate about the same amount of scatter as shown previously for the flexure strengths and indicate essentially no difference between stressed and unstressed exposures and no degradation in tensile strength.

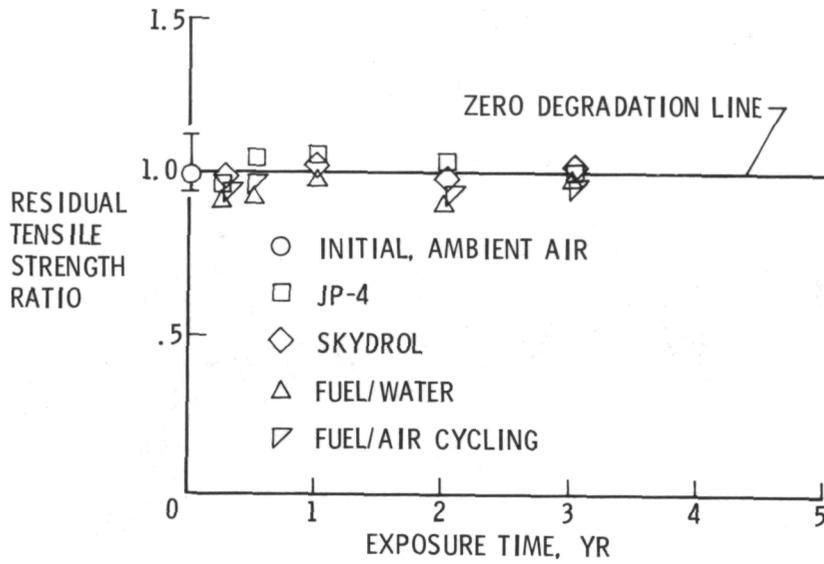
Figure 18.- Effect of fuels and fluids on strength; T300-5209, $\pm 45^\circ$ tensile specimens.

Another type of environmental exposure includes the interaction of composite materials with extended exposure to aircraft fuels and hydraulic fluids. Under NASA contract The Boeing Company has conducted a series of exposures of several composite materials in JP-4 jet fuel, a commercial aviation phosphate-ester hydraulic fluid, a fuel-and-water mixture, and a fuel-and-air cyclic environment. All exposures are outdoors in an unheated shed in the Seattle area. Short beam interlaminar shear and tensile specimens are being exposed. Typical results are shown in figure 18 for T300-5209 graphite-epoxy material laminated at a $+45^{\circ}$ ply orientation. The data indicate no degradation in tensile strength for up to three years exposure in any of the above environments.

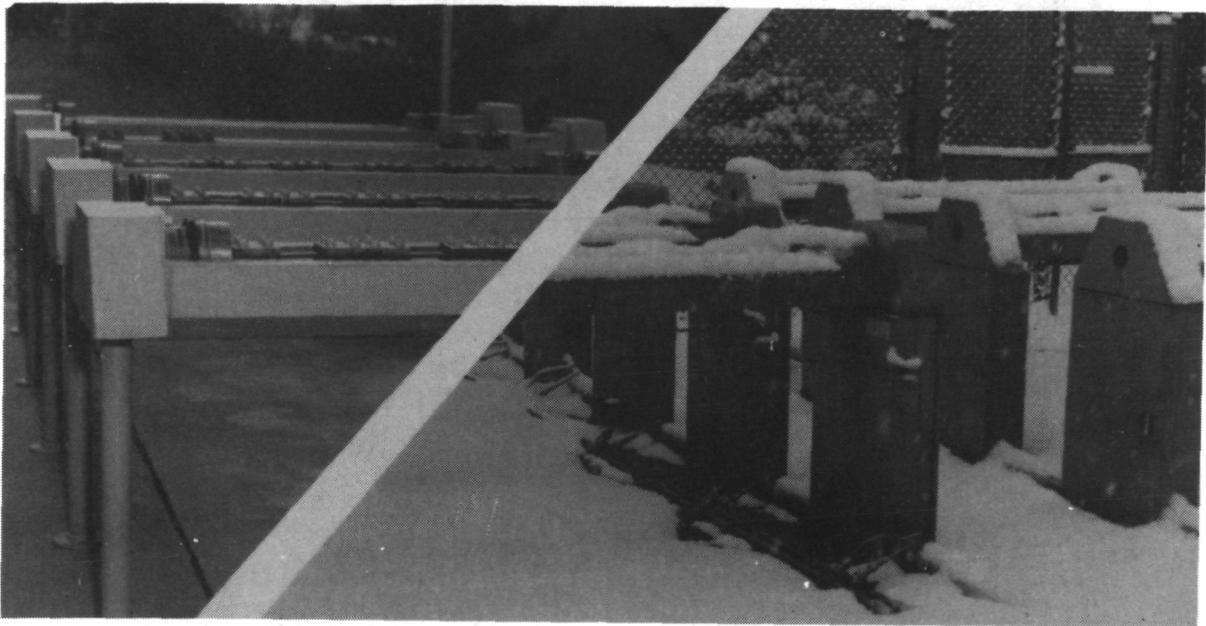
Figure 19.- Environmental fatigue tests on composites.

Figure 19 shows two views of an outdoor environmental exposure site at Langley in which the Structural Integrity Branch is conducting flight-by-flight spectrum loading on chains of composite materials specimens. The two views provide graphic evidence that the specimens see the full extremes of summer and winter weather. Specimens with and without open-hole stress concentrations are being exposed. Similar chains of specimens are being subjected to the same loads inside a controlled-environment laboratory for comparison.

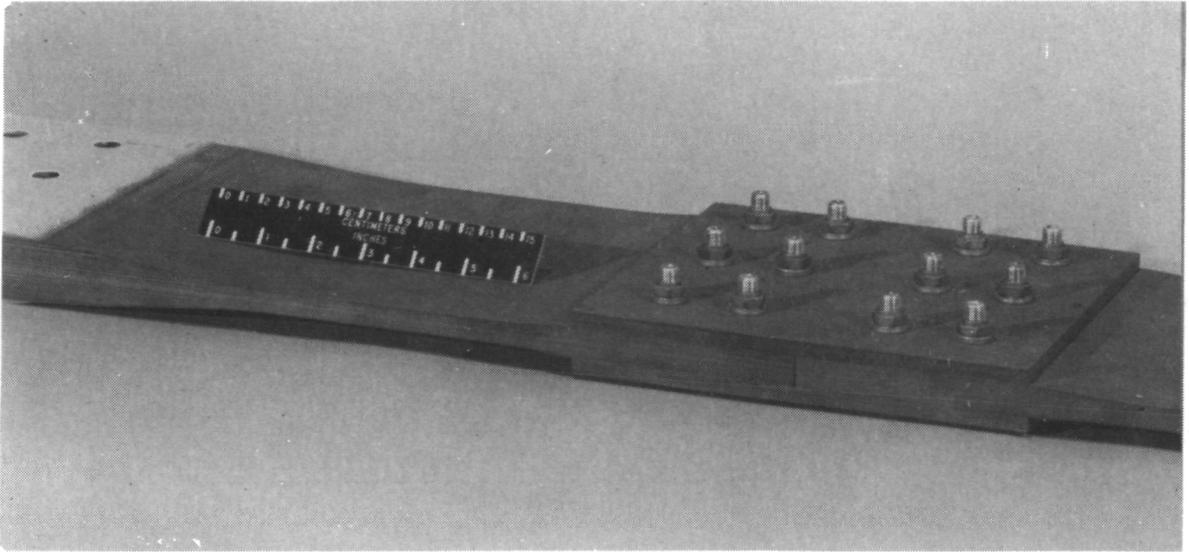
Figure 20.- Bolted joint for graphite-epoxy wing splice.

Technology for designing primary structural discontinuities such as bolted joint wing splices in composite materials is being developed in programs like the one discussed in reference 9. Test specimens with multiple, repeating patterns of bolted fasteners (fig. 20) have been fabricated with laminate thicknesses of 1.37 cm (0.54 in.) and static strength tested successfully. With the validation of the static design, replicate specimens have been fabricated and are under long-term stressed exposure outdoors at Langley as shown in figure 21. The sustained stress level has been set at 25 percent of the static ultimate.

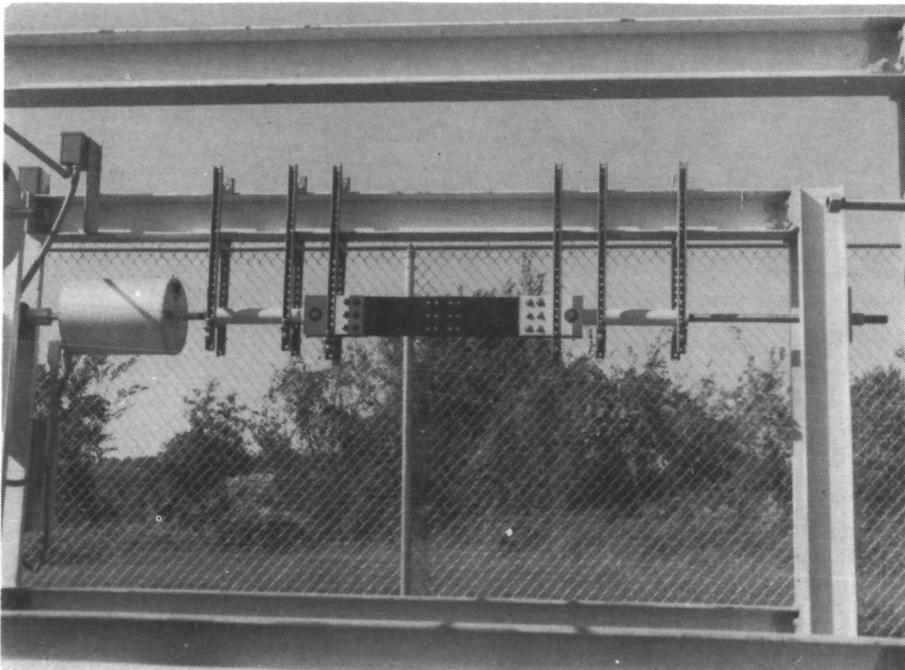
Figure 21.- Wing splice environmental exposure.

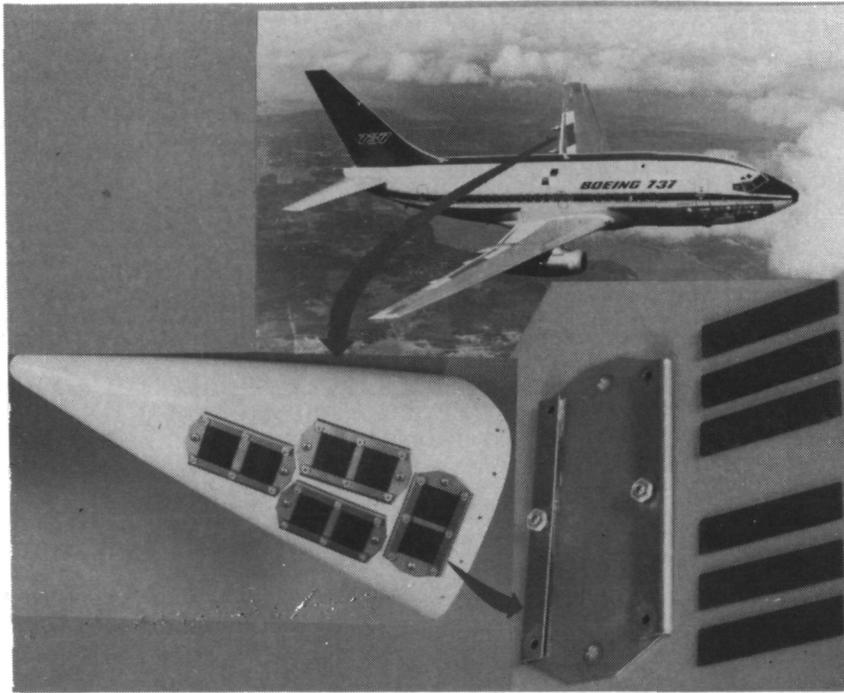
Figure 22.- Exterior moisture pickup in flight.

specimens mounted on both the upper and lower surfaces of the flap track fairing tail cone as shown in figure 22. Specimens are mounted in titanium holding fixtures which are attached to the fiberglass tail cone. Periodically one upper and one lower surface fixture are removed and sent to The Boeing Company where they will be weighed and fully dried. Moisture pickup in flight on interior surfaces of parts which are vented to the atmosphere on DC-10 airplanes will be determined from specimens mounted in a holding fixture attached inside the wing leading edge as shown in figure 23. Periodically these specimens will be removed, weighed, and reinstalled by Douglas Aircraft Company personnel during normal aircraft stopovers at Los Angeles or San Francisco.

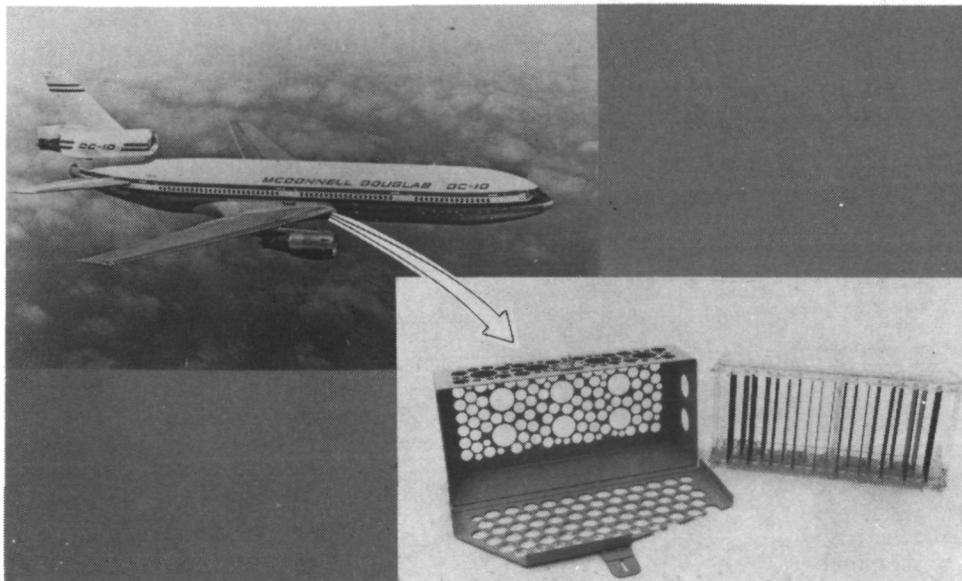
Figure 23.- Interior moisture pickup in flight.
