(NASA-CR-161155) DIODE STEP STRESS TESTING  
PROGRAM FOR JANTX1N3031B Final Report (DCA  
Reliability Lab., Sunnyvale, Calif.) 40 p  
HC A03/MF A01 CACL 09A

## DIODE STEP STRESS TESTING PROGRAM

FINAL REPORT  
FOR  
JANTX1N3031B

DCA RELIABILITY LABORATORY  
SPECIAL PRODUCTS DIVISION  
975 DENICIA AVE  
SUNNYVALE, CALIFORNIA 94086

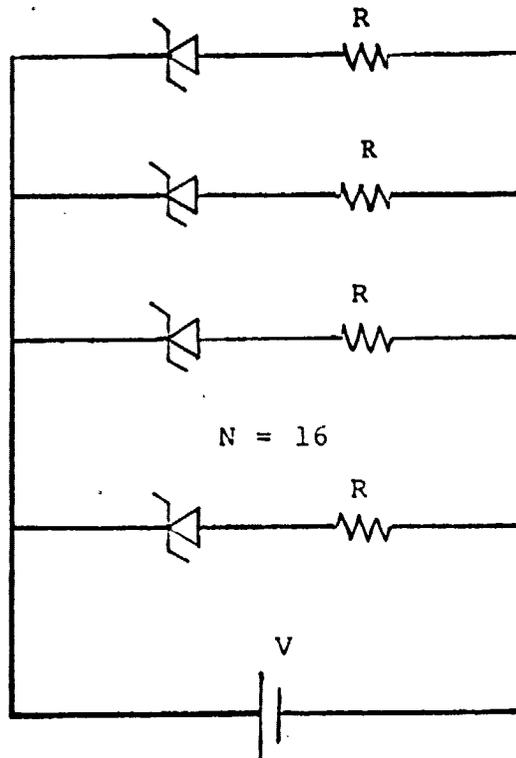
FIGURE 1  
Temperature/Stress Circuit  
for JANTX1N3031B

$$R = VZ \div 1.75 I_{Z_{MAX}} \pm 50\%$$

$$P_d = VZ^2 \div R$$

The test circuit shown in Figure 1 was used to power all the test devices during the power/temperature stress conditions. The voltage was set by  $V_Z$  and the current was varied in order to comply with the specified power rating for the device. At least one of the devices was subjected to maximum rated power (MRP). All remaining devices were subjected to no less than 90% of MRP. See Figure 1

for load resistance values and voltages.

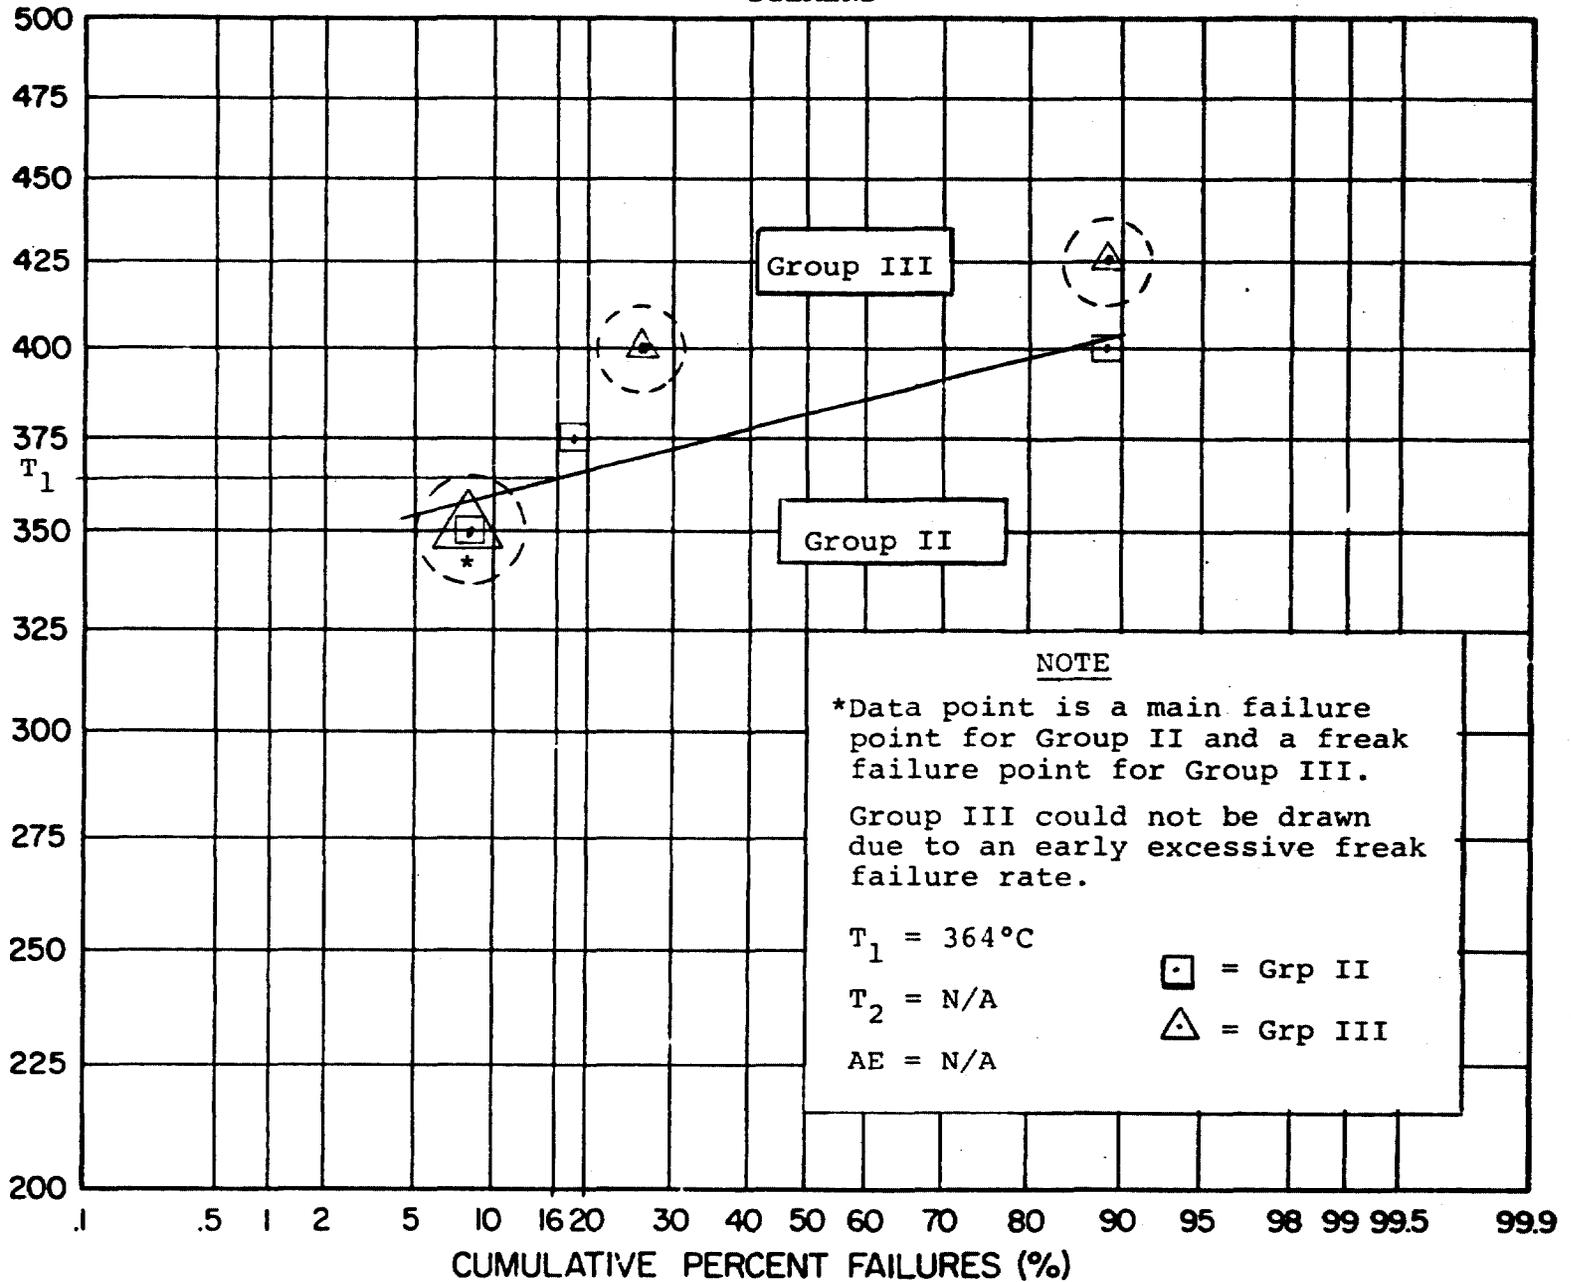
FIGURE 2  
Cumulative Percent Failures Versus Junction Temperature, Siemens

$T_J \approx T_A + 175^\circ\text{C}$

Table 7 statistically summarizes the change in the mean value from the zero-hour data to the final data. The graphs of Figures 2 and 4 plot the cumulative percent failures versus the temperature stress level for Group II - Temperature Stress I, and Group III - Temperature Stress II. The graphs of Figures 3 and 5 plot the time step for Group II (160 hours) and Group III (16 hours) versus the temperatures  $T_1$  and  $T_2$  calculated from Figures 2 and 4. Tables 8 and 9 summarize the failures encountered for all three stress groups. The failures are separated into two categories: catastrophic failures in Table 8 and parametric failures in Table 9. The data from Table 3 were used as a source for the graphs in Figures 2 and 4. Figures 2 and 4 were used as a source for the graphs in Figures 3 and 5, respectively. Junction temperature is plotted on an inverse hyperbolic scale.

A plot showing cumulative failure distribution of Group II was drawn for the Siemens sample lot (Figures 2 and 3) but due to an early excessive freak failure rate in the Group III Testing, a complete plot for Group III could not be drawn. A complete plot could not be drawn for the Motorola sample lot (Figures 4 and 5) due to an absence of Group III failure points.

A broken circle around a marked point on the graph indicates a freak failure not calculated as part of the regression line. A solid circle around a marked point indicates an isolated main failure point. The regression line was calculated using the least square method.

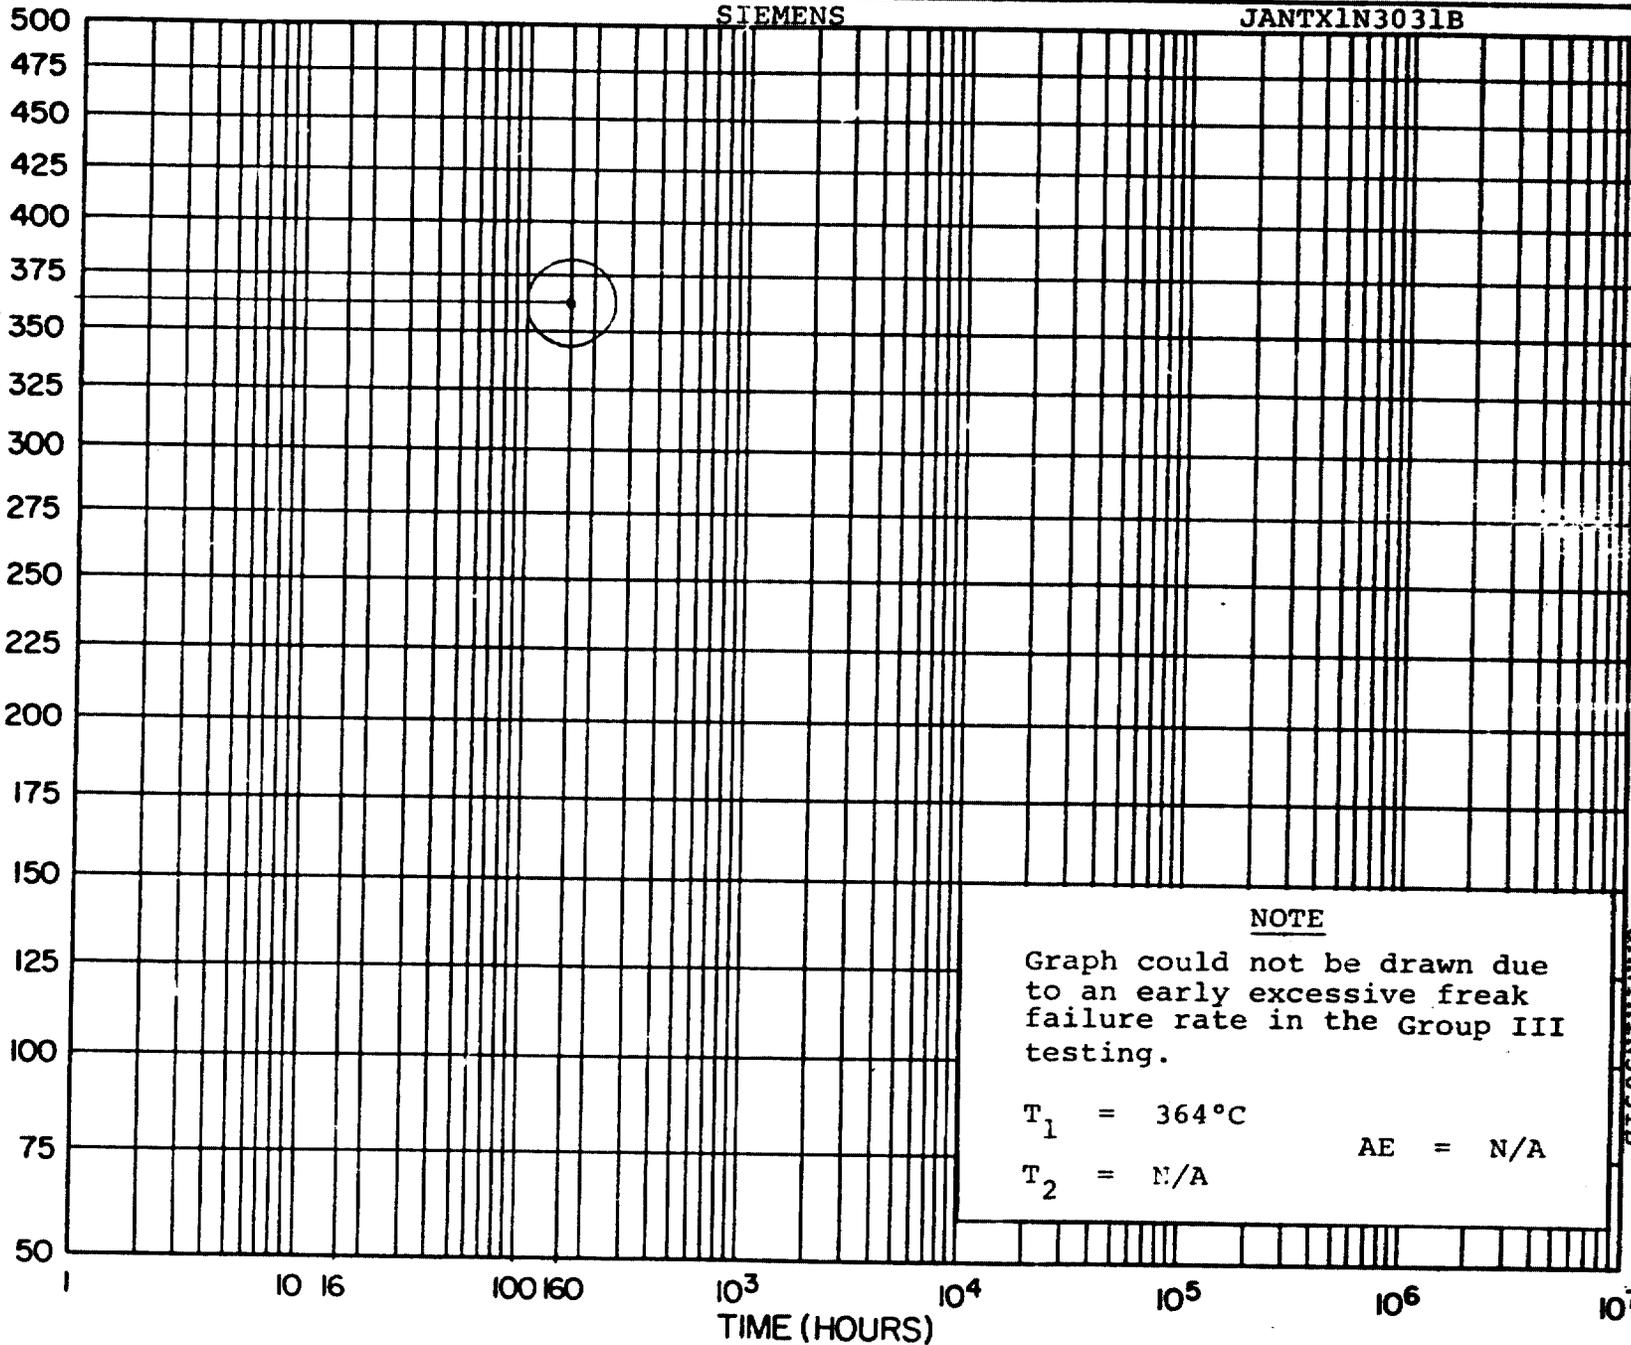
FIGURE 3

**NOTE**  
 Graph could not be drawn due to an early excessive freak failure rate in the Group III testing.

T<sub>1</sub> = 364°C

AE = N/A

T<sub>2</sub> = N/A

Time Steps Versus Junction Temperature, Siemens

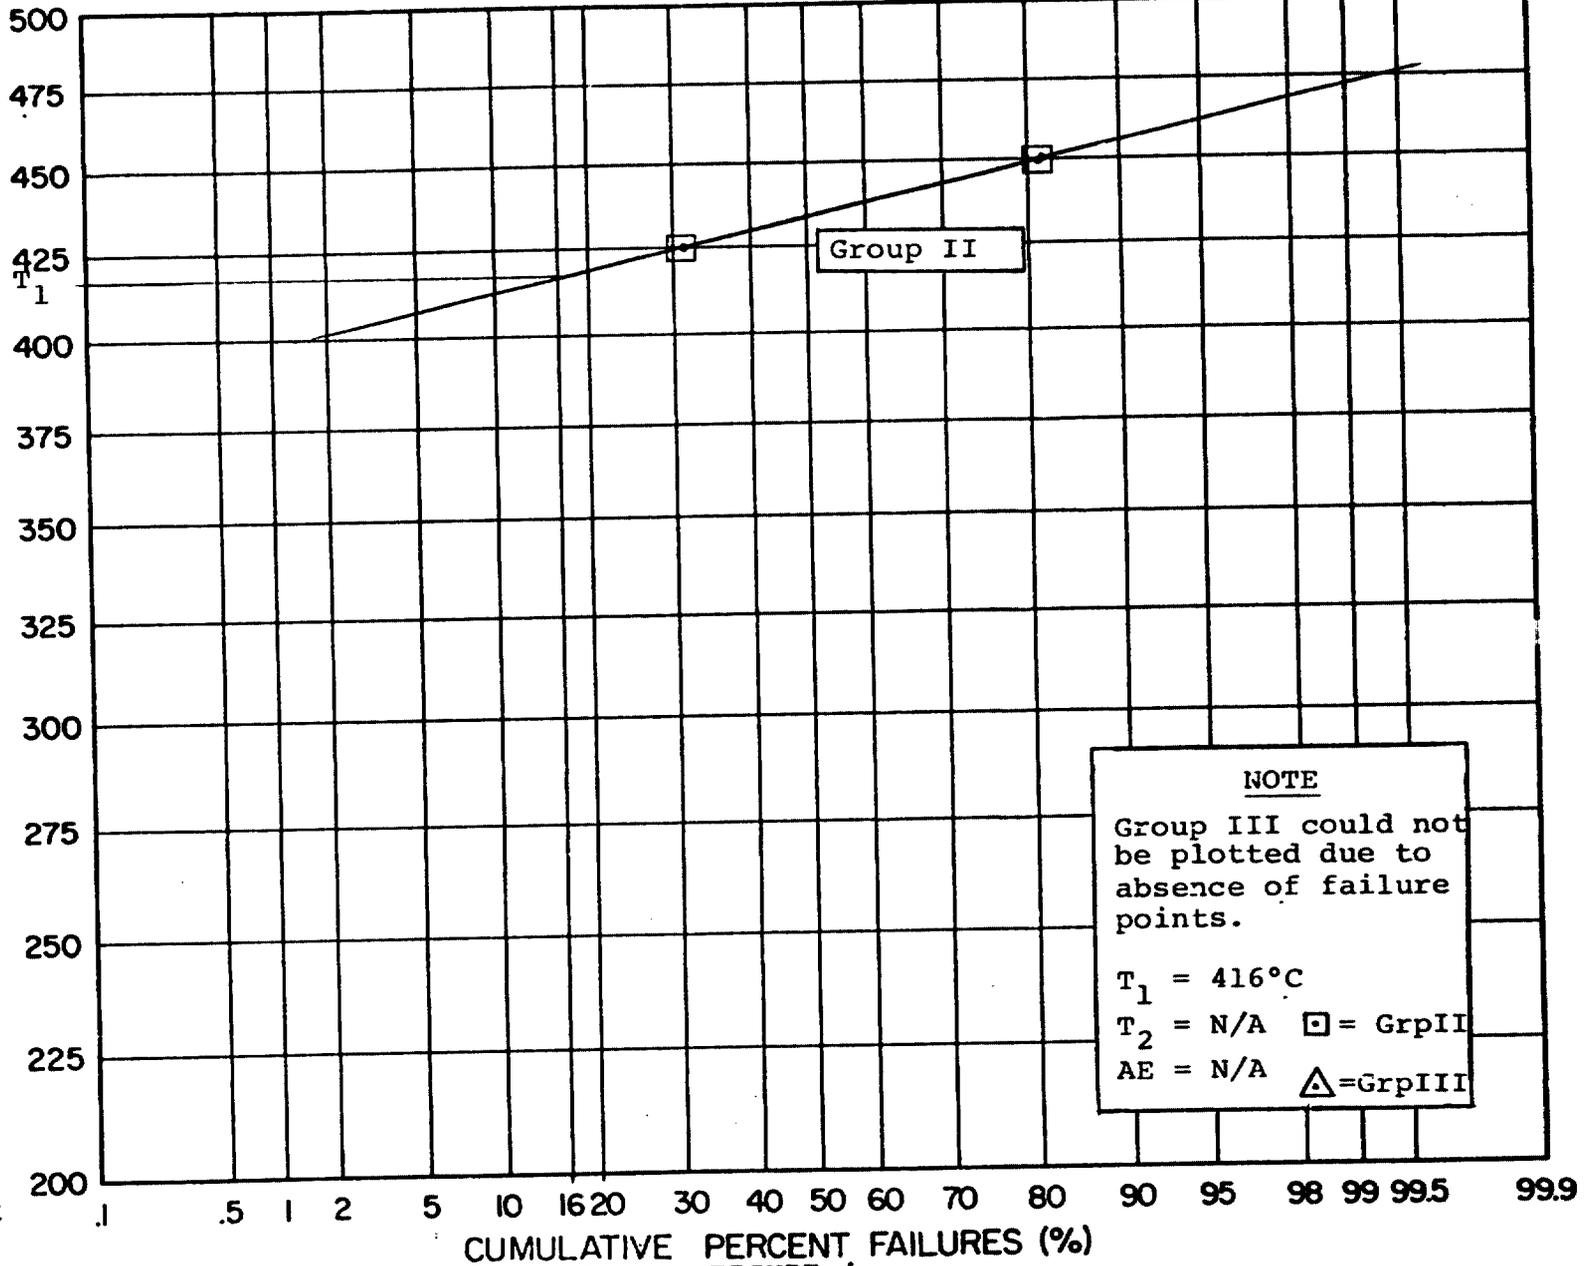
FIGURE 4

$T_J \approx T_A + 175^\circ\text{C}$

Cumulative Percent Failures Versus Junction Temperature, Motorola

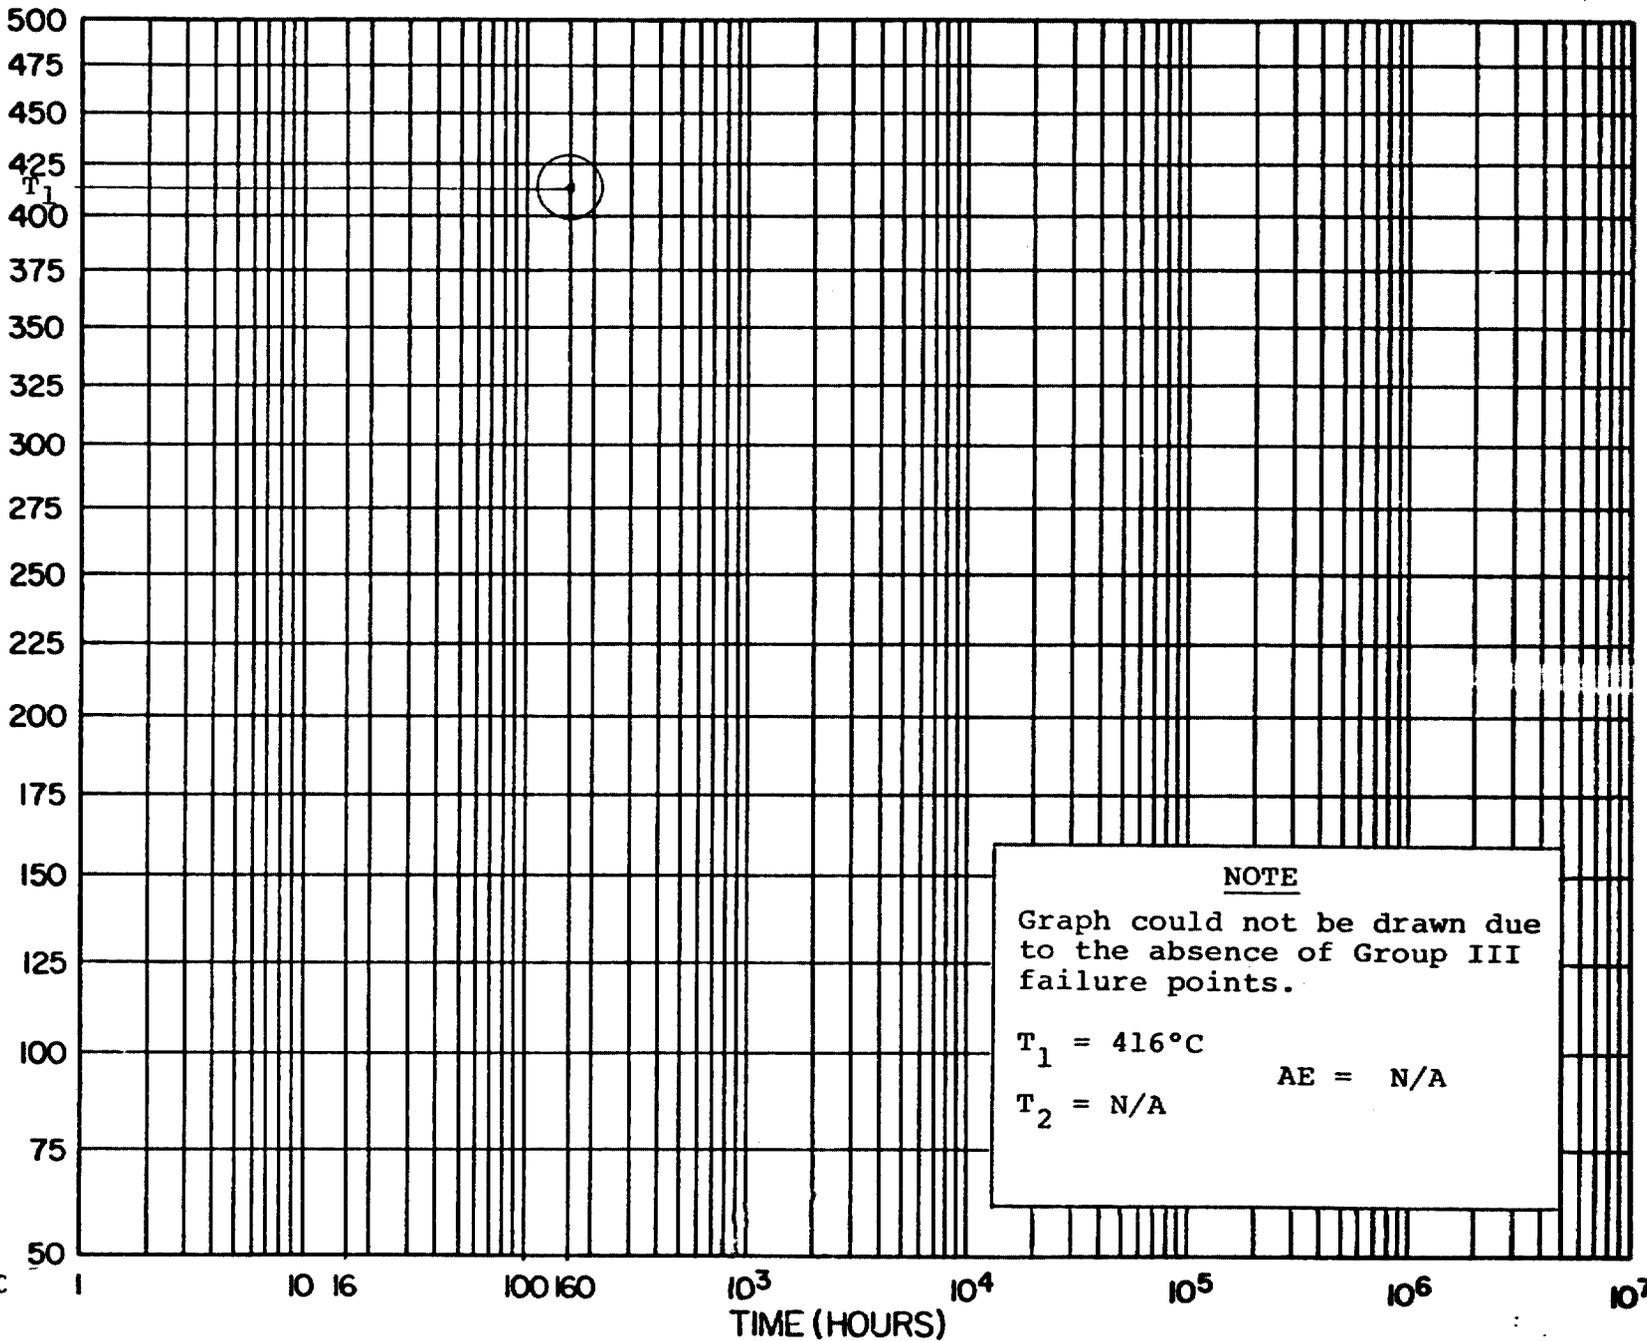
FIGURE 5

$T_J \approx T_A + 175^\circ C$

Time Steps Versus Junction Temperature, Motorola

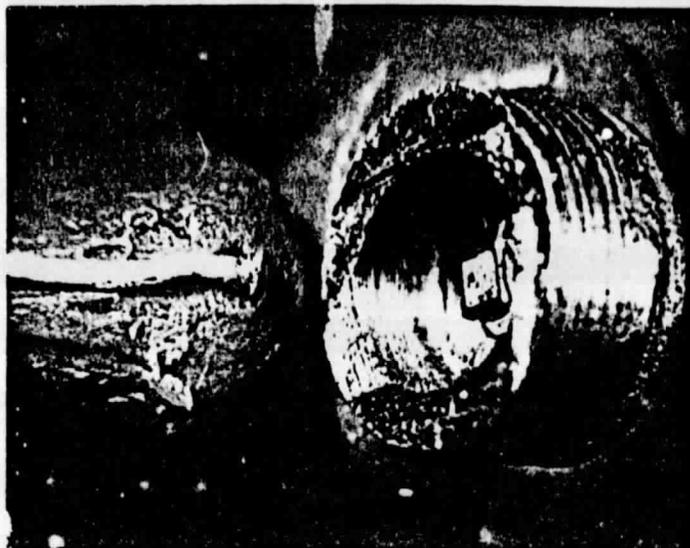
There is significant electrical leakage across the glass-to-metal seals on S/N 5083 and 5084.

S/N 5084 has a detached internal lead (see Figure A-1).

FIGURE A-1  
S/N 5084, Typical Siemens Internal Appearance  
Showing Detached Top Contact, 8X.

All the samples except Siemens S/N 5084 were making electrical contact when received for analysis. However, the internal bonding material melted and flowed away from the dice on all the Siemens samples and Motorola S/N 5142, causing them to fall apart when delidded.

All the Siemens and Motorola devices failed due to the melting of the bonding material at the die connections caused by excessive temperatures. The molten metal shorted out the silicon die on two of the Motorola parts. The electrical test results on the remaining parts suggests that the long dwell time of the molten metal has caused it to alloy with the silicon dice, thus shorting out their junctions.

Serial numbers 5083 and 5084 of the Siemens samples also had significant electrical leakage of the glass in the glass-to-metal seal. These samples exhibit resistances of  $1.6 \times 10^5$ , and  $6.7 \times 10^7$  ohms, respectively. The glass is conductive when probed either internally or externally, with the internal conductivity being somewhat greater.
