NASA CR-165297  
PWA-5512-75

PERFORMANCE DETERIORATION  
BASED ON SIMULATED AERODYNAMIC LOADS TEST

JT9D JET ENGINE DIAGNOSTICS PROGRAM

UNITED TECHNOLOGIES CORPORATION  
Pratt & Whitney Aircraft Group  
Commercial Products Division

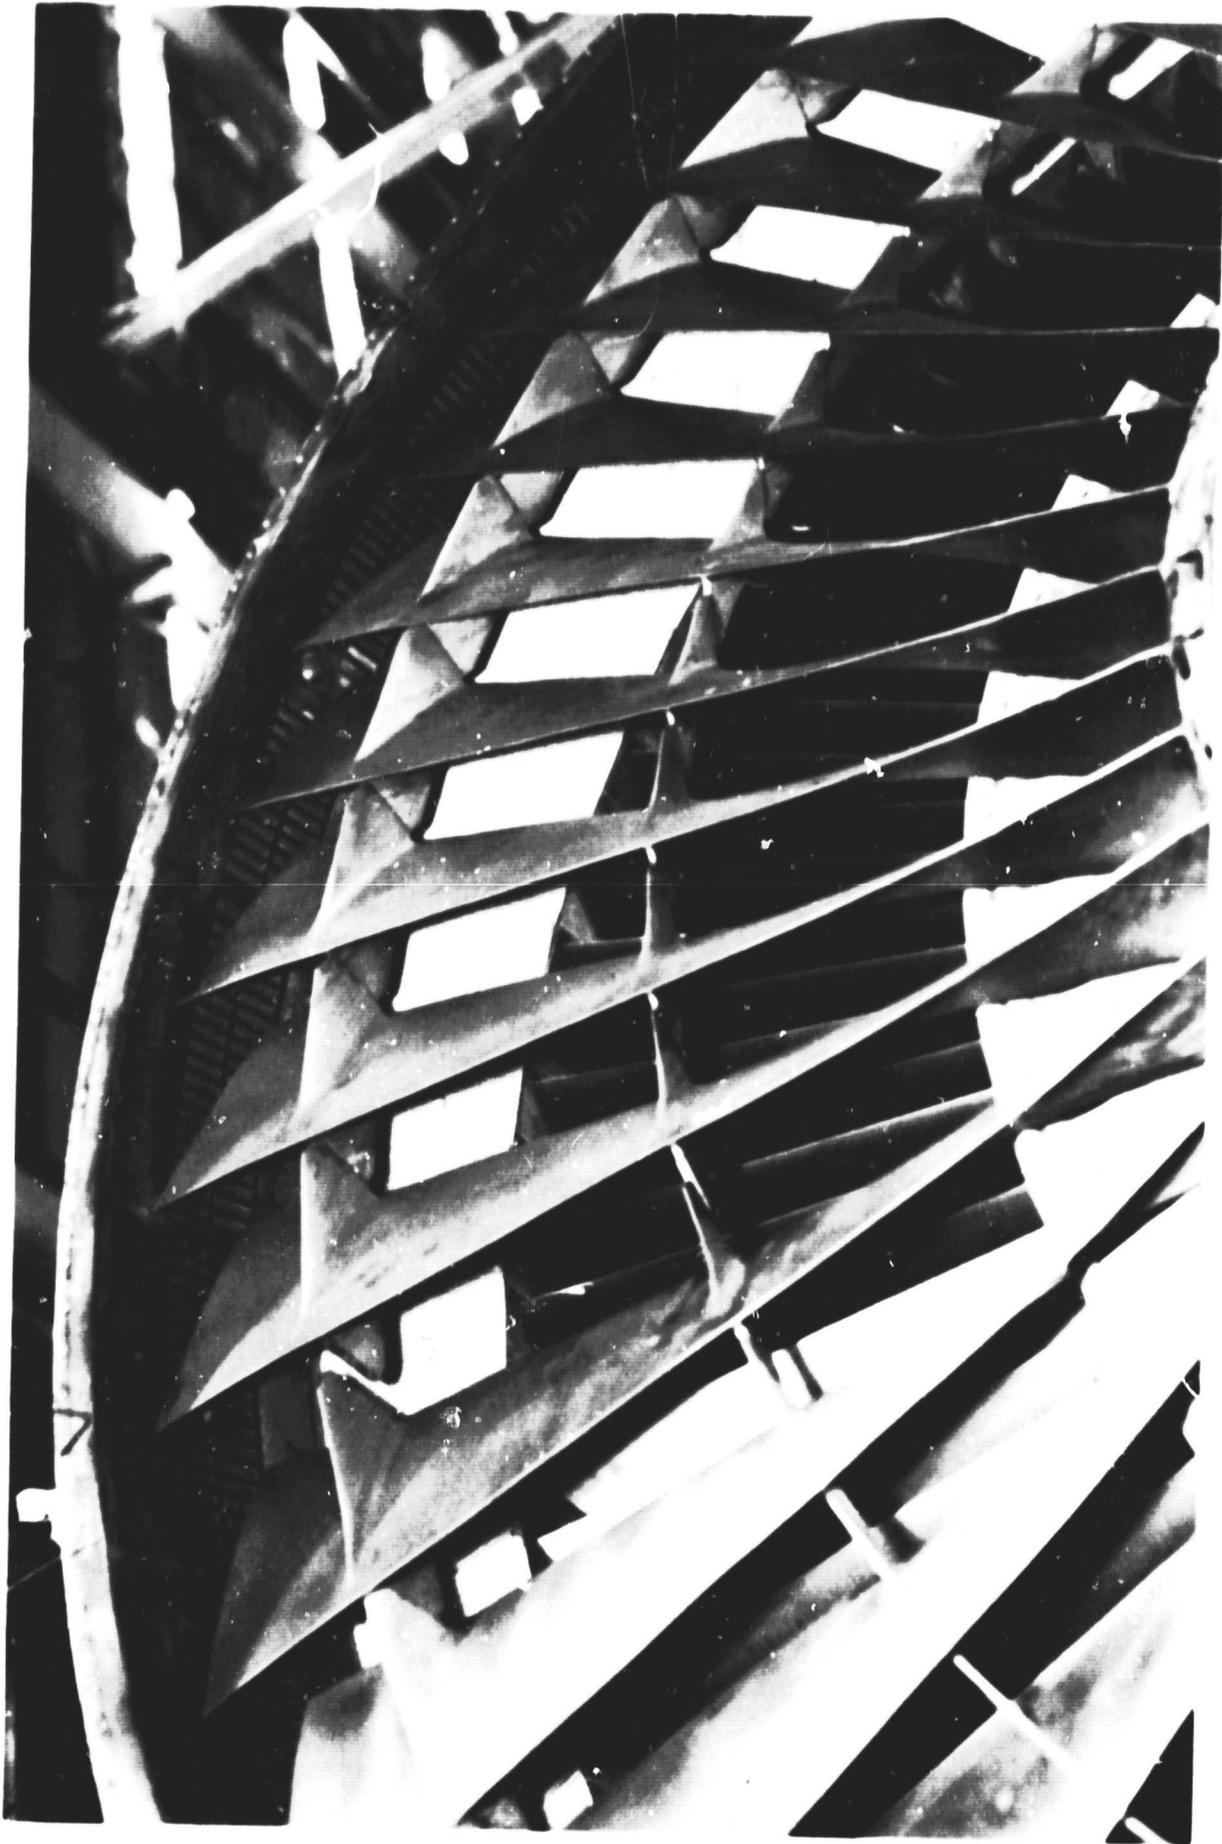
**PRATT & WHITNEY  
AIRCRAFT GROUP** P-662211 - FAN RUBSTRIP WEAR AT 30°

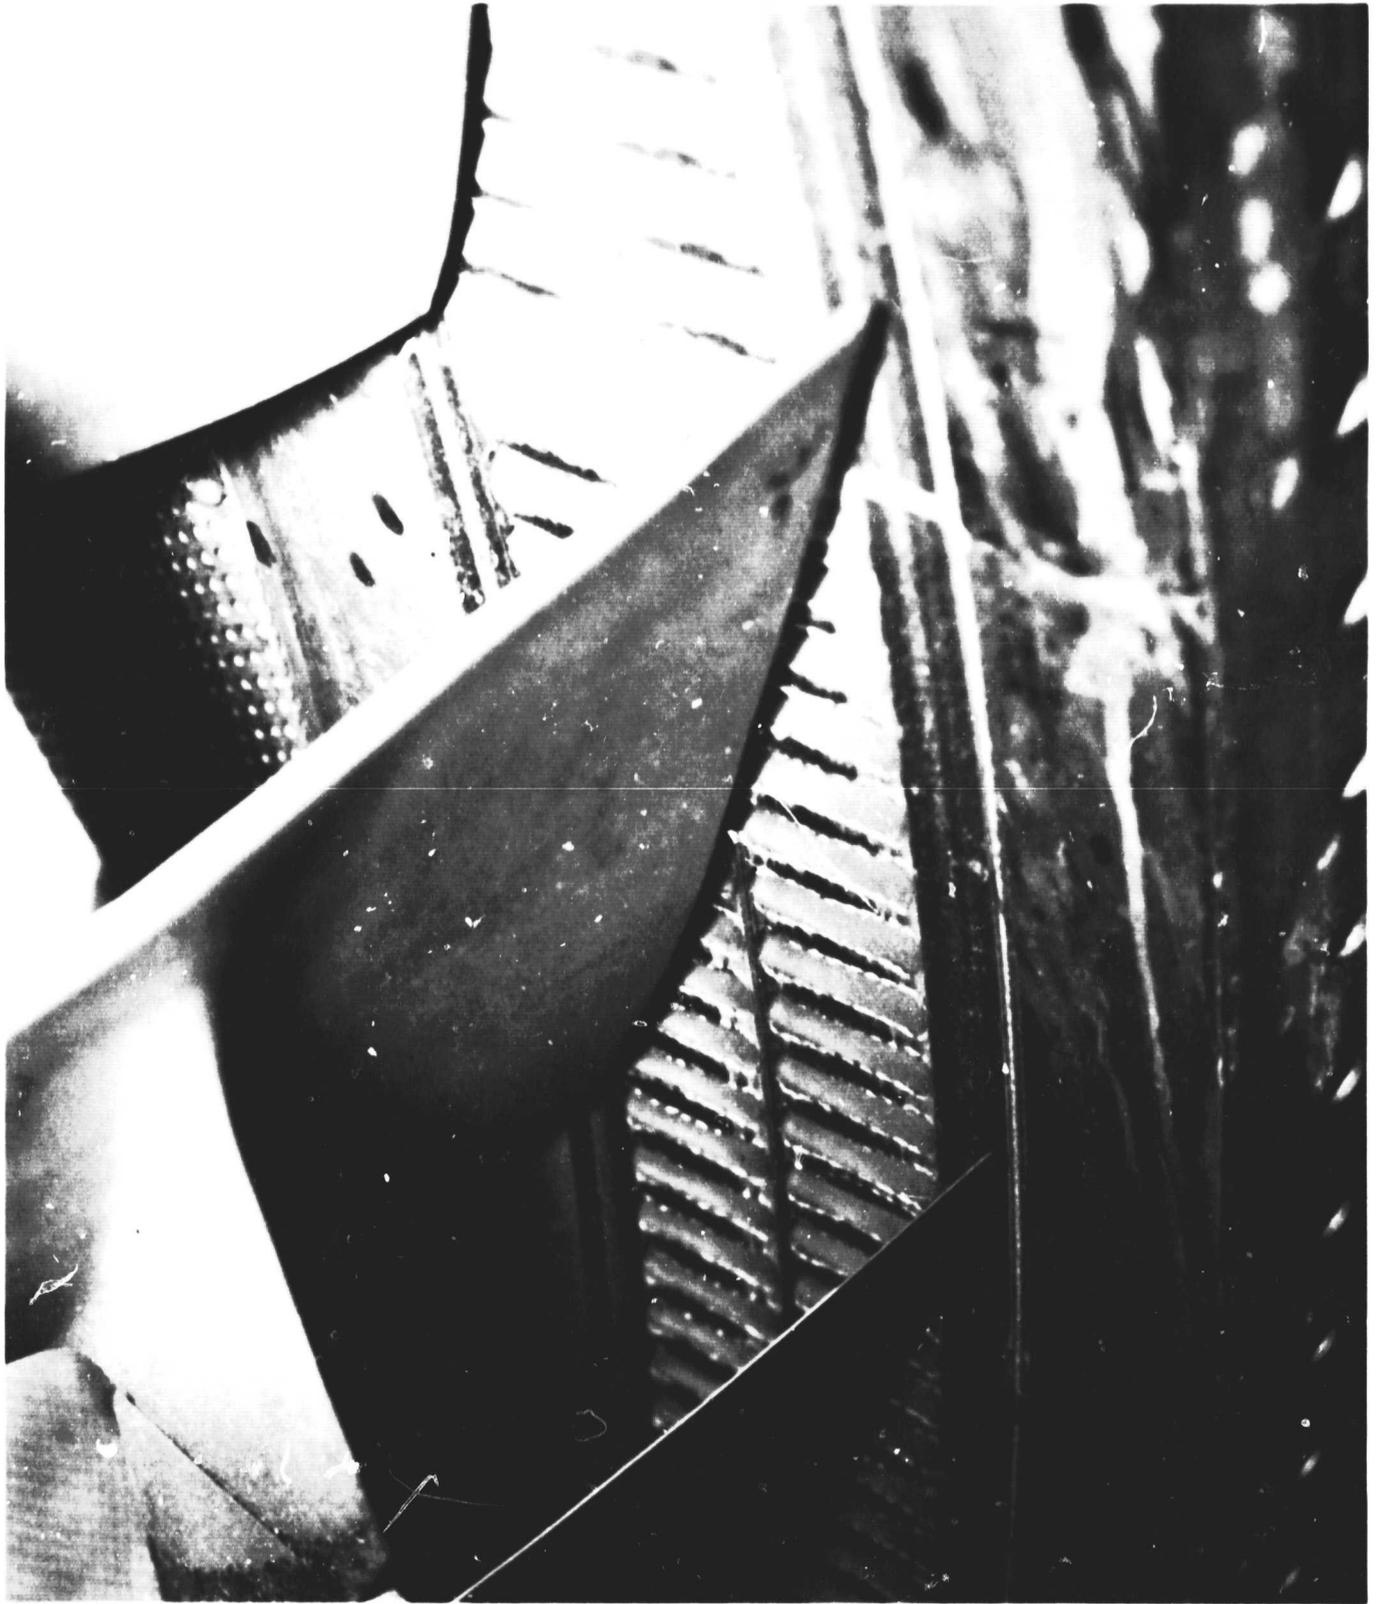
**PRATT & WHITNEY** P-662211 - FAN RUBSTRIP WEAR AT 135°  
**AIRCRAFT GROUP**

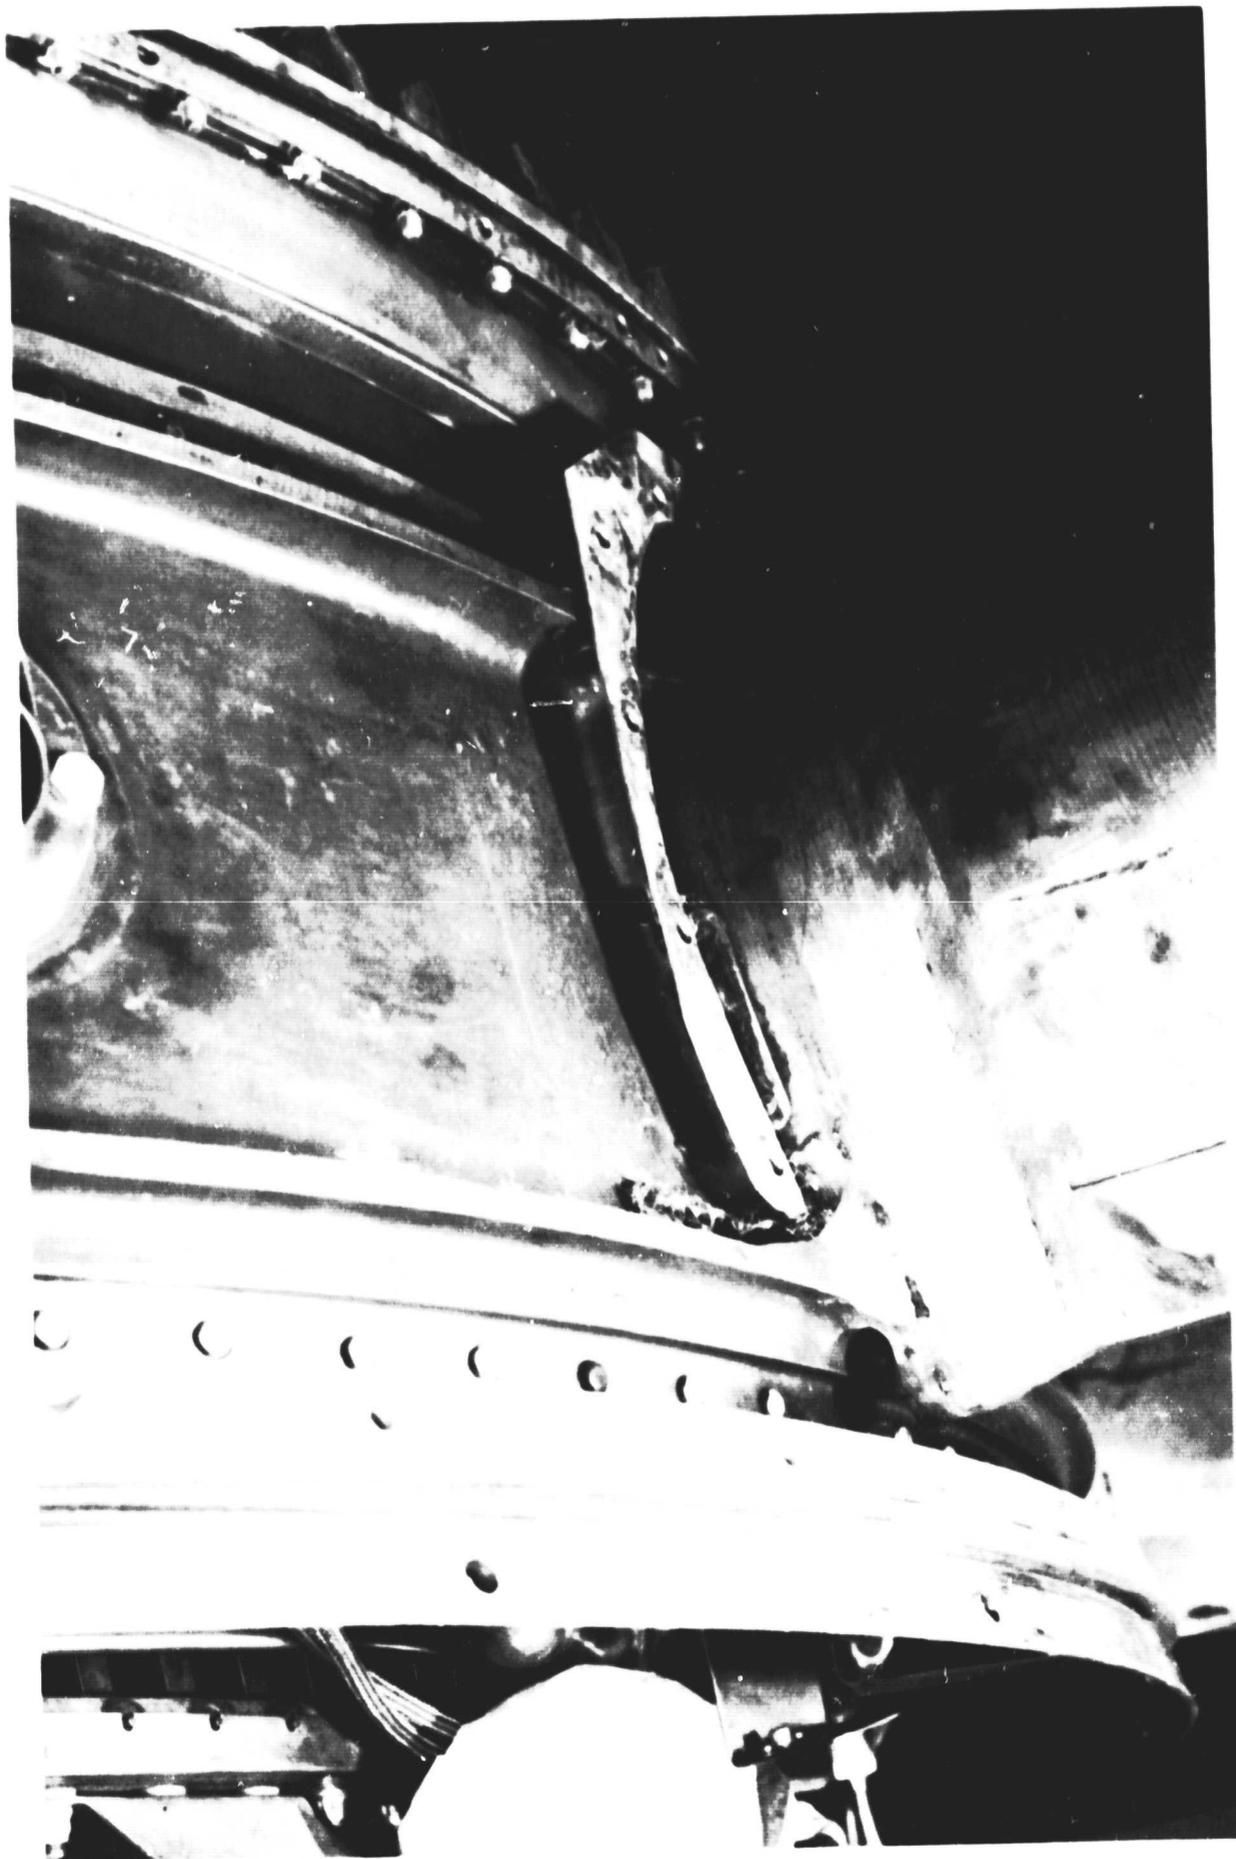
P-662211 - SIDE VIEW OF FAN EXIT CASE WITH INNER SOUND PANEL  
REMOVED SHOWING DEBRI AT 11:00 O'CLOCK POSITION FROM REAR  
80-444-0372-C
