Solar Thermal Power Systems Project
Research and Advanced Development

DOE/JPL-1060-44
Distribution Category UC-62

Evaluation of the Effects of a Freeze/Thaw Environment on Cellular Glass

(JPL PUBLICATION 81-29)

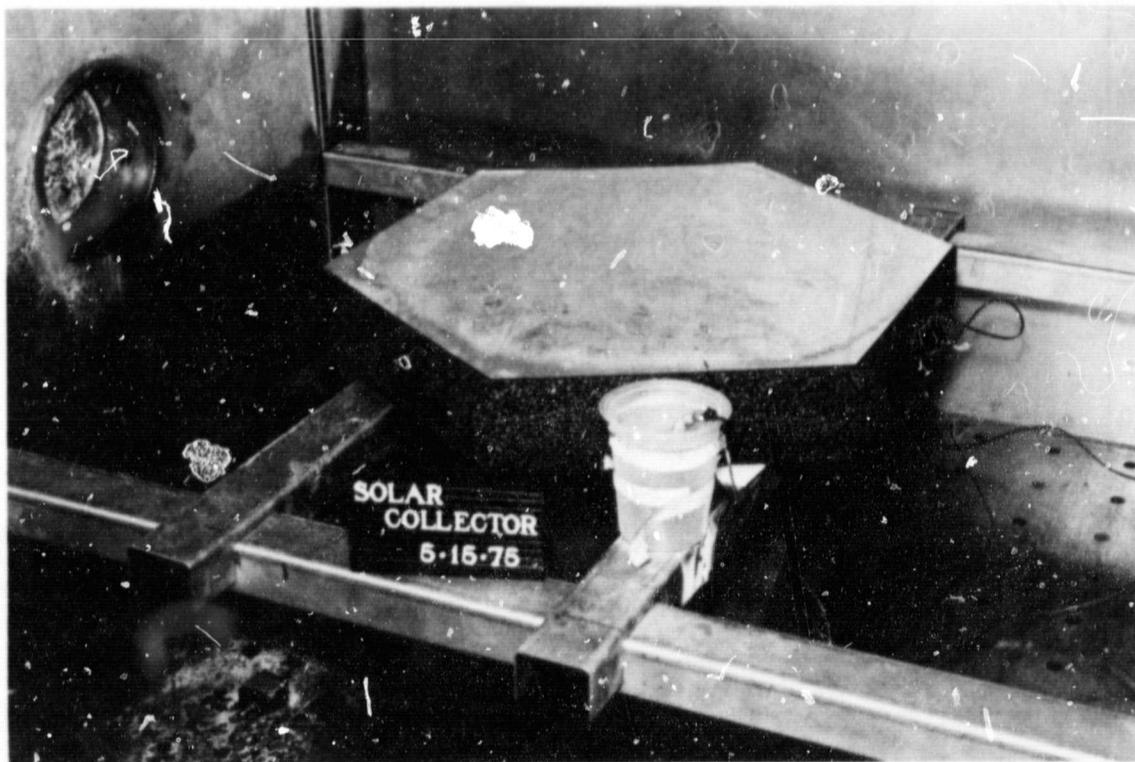
Figure 3. Foamglas[®] with Glass Mirror (Argoud)

The next known study which included cellular glass was by Argoud in the spring of 1975.⁽⁶⁾ He submitted bare Foamglas[®] with mirrored glass bonded to it to approximately 400 freeze/thaw cycles (see Figure 2). Occasionally, throughout the cycle, water was manually poured onto the mirror surface. The bare edge of the Foamglas[®] was observed to partially spall away, resulting in a rounding off of the corners (see Figure 3). No major fractures or disbonding were observed; however, the retained mechanical strength of the material was not evaluated.

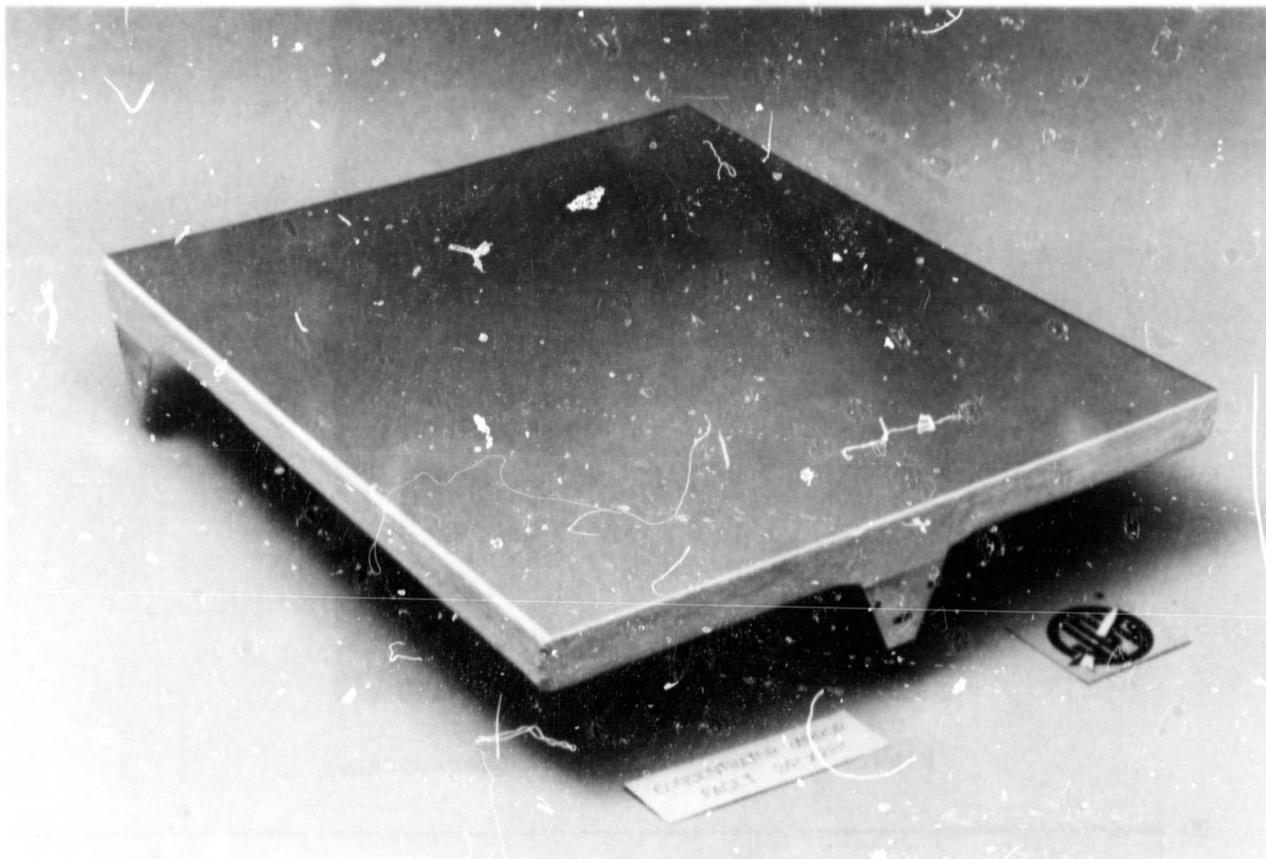
Figure 4. Test Bed Concentrator Reflector Panel.

From 1976 to 1978, work began on two projects which used Foamglas[®] as a glass mirror substrate for a solar collector: the Test Bed Concentrator (TBC) at JPL (Argoud) and the Sunfire Project directed by F. Broyles (see Figures

4 and 5). The Sunfire Project used materials and processes which were basically adapted from the techniques developed by Argoud. A major difference was that the Sunfire reflective panels did not have a protective coating on the Foamglas[®], whereas the TBC reflective panels ultimately did.
