NASA Technical Memorandum 82704

Creep Shear Behavior of the Oxide Dispersion Strengthened Superalloy MA 6000E

Thomas K. Glasgow
Lewis Research Center
Cleveland, Ohio

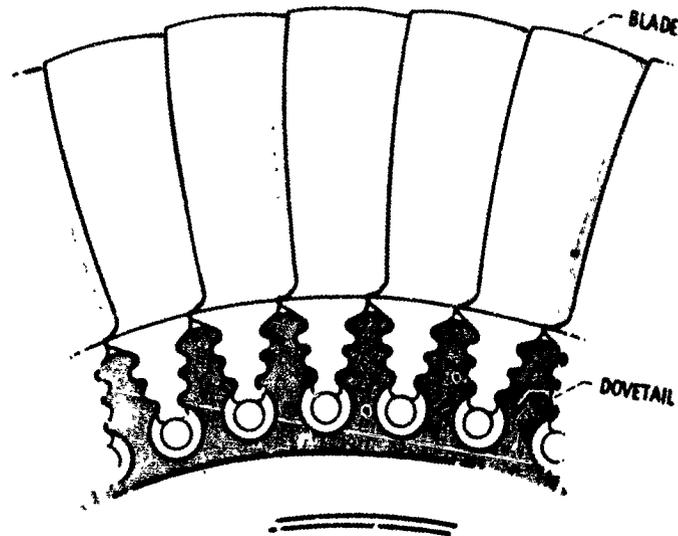
Figure 1. - Dovetail mechanical joint between gas turbine disk and blade.

Several of the mechanical properties of MA 6000E have been determined and reported elsewhere (Refs. 1 and 2). One of the properties which has received little attention, however, is shear strength. Gas turbine blades are fastened to the periphery of disks by a mechanical attachment (variously called dovetail or firtree, Fig. 1). The dovetail must withstand the centrifugal force tending to pull the blade from the rapidly rotating disk. The resulting stress state includes a significant shear stress (Ref. 6) tending to separate the tangs (projections) from the dovetail. When the blade material has microstructural elements such as interfaces or grain

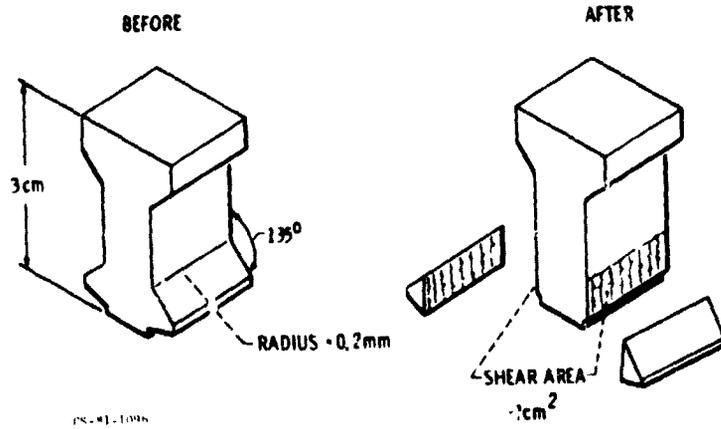
Figure 3. - Test specimen configuration, before and after shearing.

To evaluate the materials under loading conditions simulating those prevailing in a root attachment, a special specimen, shown in Fig. 3, was devised. The angle between the loading surface and the specimen axis was 135° . The notch radius at the intersection of the tang protrusion and the specimen axis was sharper ($r = 0.2$ mm) than in an actual turbine blade dovetail (e.g., $r = 0.8$ mm); this could be expected to give a greater stress concentration. While the choice of a sharp radius to some extent penalized materials of low ductility, it resulted in data that can probably be taken as a lower limit of material behavior or a worst case of dovetail design. The data of Ref. 6 was obtained using a much more complex design more closely simulating a fir-tree root attachment. It is, therefore, not strictly comparable to the data of this study; it has, however, been taken as representative of the capability of the eutectic alloy γ/γ' - δ in the figures and discussions that follow.

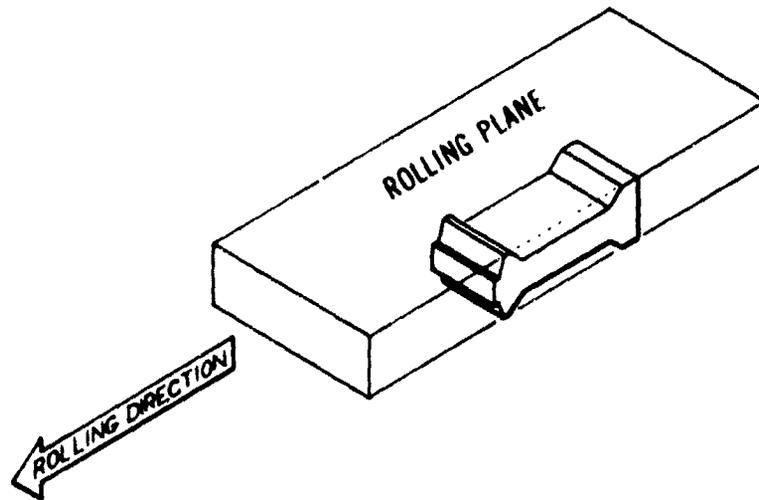
Figure 4. - Creep shear specimen orientation with respect to the rolling direction and rolling plane of MA 6000E and MA 754.

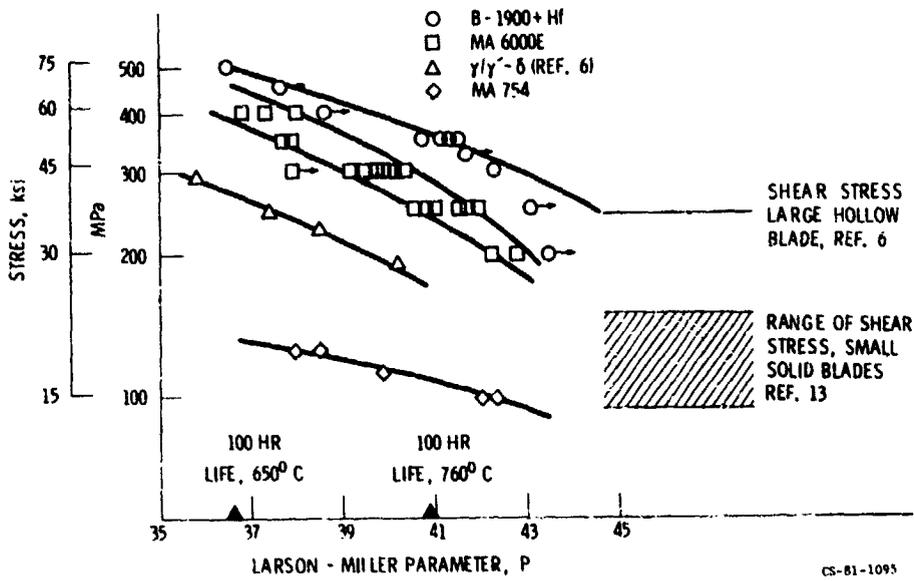
Figure 5. - Results of simulated root attachment shear rupture tests.

$P = 1.8T (20 + \log t)$ where the temperature, T , is in $^{\circ}K$ and the time to failure, t , is in hours. A plot of creep shear data of this study and data from Ref. 6 for $\gamma/\gamma'-\delta$ is given in Fig. 5. Parameter values for 100 hour lives at 650° and $760^{\circ}C$, $P = 36.6$ and 40.9 , respectively, have been marked on the abscissa. Also plotted in Fig. 5 are calculated shear stresses for a specific large hollow (cooled) blade and a range of shear stress characterizing modifications of a small solid blade (Ref. 13).

As shown in Fig. 5, the alloy of highest shear rupture capability was B-1900+Hf. Most of the B-1900+Hf data were obtained at 350 MPa to establish confidence in a value representing its $760^{\circ}C$ 100 hour shear rupture strength. Some of the B-1900+Hf specimens tested at higher loads failed as in notched conventional rupture tests, i.e. non-shear failures (see Table II). Those tests of B-1900+Hf conducted at much lower stresses were terminated to avoid inordinately long test times. The $760^{\circ}C$, 100 hour shear rupture capability of B-1900+Hf determined in this study was 360 MPa.

The shear rupture data for MA 6000E are represented as a band in Fig. 5 lying well above that for $\gamma/\gamma'-\delta$, but below that of B-1900+Hf. The $760^{\circ}C$, 100 hour shear rupture strength of MA 6000E was 250 MPa. While the shear rupture data from Ref. 6 for $\gamma/\gamma'-\delta$ fall well below that of MA 6000E, an exact comparison cannot be made because the test specimens differed. The indicated $760^{\circ}C$, 100 hour shear strength of $\gamma/\gamma'-\delta$ was 170 MPa. The lowest shear rupture capability, 110 MPa at $760^{\circ}C$ for 100 hours, was exhibited by MA 754.

Very little data concerning actual levels of shear stress in current blade attachments were found in the literature, and the stress levels in future engines are not yet defined. The data, which were found, are indicated in Fig. 5 as a single line for a particular large hollow blade considered in Ref. 6, and a range of stress for a variety of root configurations of a small solid blade (Ref. 13). Perhaps the most interesting point is that depending on the root design, the shear stress may vary widely for the same airfoil; this is shown by the width of the band in Fig. 5.

The data for MA 6000E indicate that it could serve well as a small solid blade under the conditions of stress described in Ref. 13. The intersection of the stress level in a large hollow blade and the lower edge of the MA 6000E data band in Fig. 5 occurs at a Larson-Miller parameter indicating only a few hundred hours life at 760° C. This rather marginal result indicates that care must be taken in the choice of root design to be used with this alloy as a large hollow blade. It also suggests the attractiveness of bonding a conventional superalloy, e.g., B-1900+Hf, root to a MA 6000E airfoil for cases in which the shear stress cannot be decreased by altered design. Finally, it can be recommended that before efforts are undertaken specifically to improve the shear strength of MA 6000E, actual shear stress levels be identified for current and anticipated cooled gas turbines.

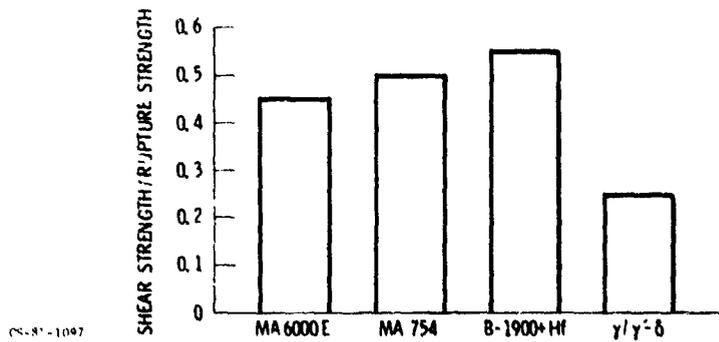
Figure 6. - Ratio of 100 hour 760°C shear rupture strength to uniaxial tension rupture strength.

A graphic comparison of each alloy's shear rupture strength to its uniaxial tension rupture strength is given in Fig. 6 as the ratio shear divided by tensile rupture strength. The rupture strengths of B-1900+Hf, MA 6000E, MA 754, and $\gamma/\gamma'-\delta$ were taken from Refs. 14 (extrapolation), 1, 15, and 8, respectively. The ratios of shear to uniaxial tension rupture strength ranged from a low of 25 percent for $\gamma/\gamma'-\delta$ to a high of 55 percent for B-1900+Hf. The latter value is about the expected ratio for an isotropic material.

The levels of shear rupture capability found in this study and in Ref. 6 may be rationalized by considering the normalized shear rupture strengths of the alloys, their microstructures, and their fracture characteristics. Figure 6 presents the ratios of shear to uniaxial tension rupture strength for the four alloys.
