ANNUAL TECHNICAL REPORT

A FUNDAMENTAL APPROACH TO THE STICKING
OF INSECT RESIDUES TO AIRCRAFT WINGS

N. S. Eiss, Jr., J. P. Wightman, D. R. Gilliam
and E. J. Siochi

April, 1984

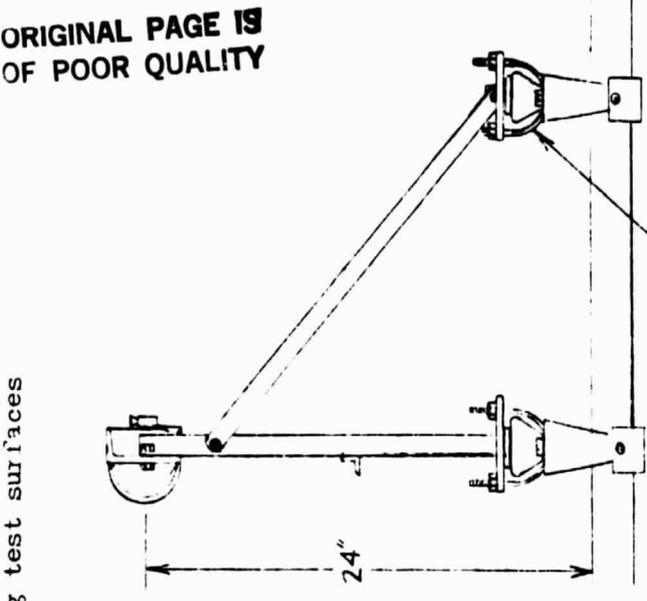
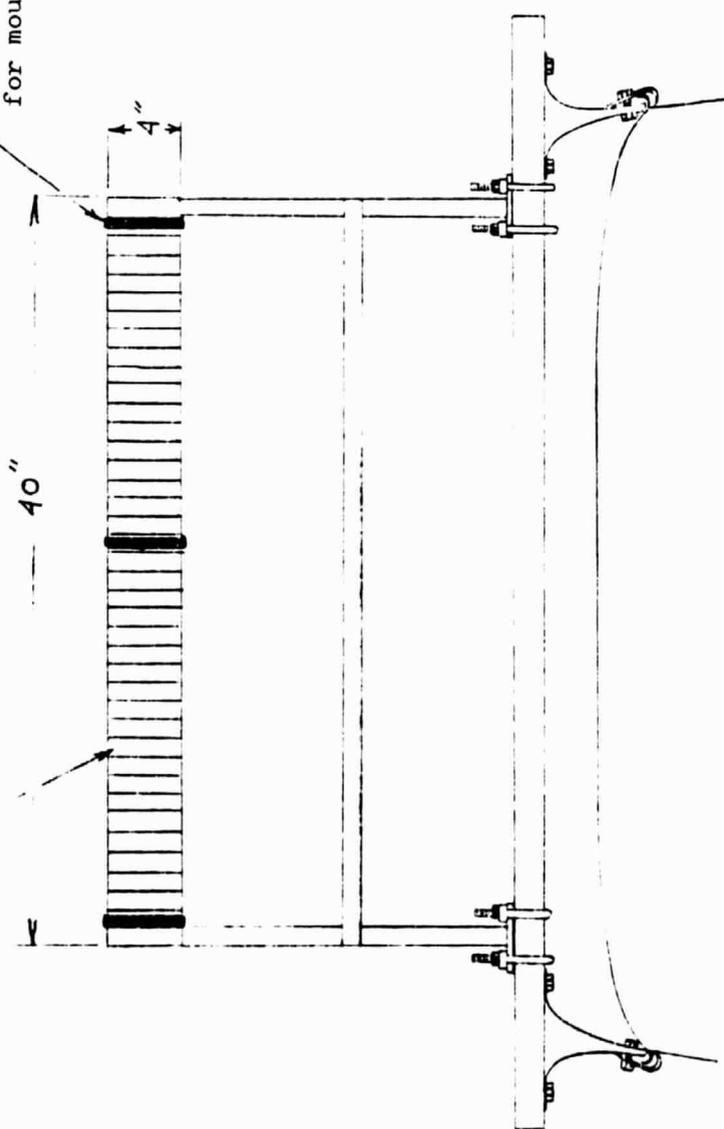
Hose clamps or pipe clamps
for mounting test surfaces

Test surfaces

Figure 1. Front and side views of the experimental set-up. The frame is of welded aluminum construction for light weight.

An apparatus has been constructed for collecting insect impact data on polymer-coated surfaces of varying roughness. A sketch of the experimental set-up is shown in Figure 1. The apparatus will be mounted on a canoe rack on the roof of a car in order to perform road tests on the prepared specimens. Two factors influenced the apparatus design. (1) The effects of the car's flow field must be minimized or eliminated from the test specimens, (2) the test surfaces must resemble a wing leading edge to account for the various angles at which insects impact an aircraft wing.

To minimize the effect of the car's flow field in the test specimens the apparatus was designed to position the test surfaces approximately 2 feet above the roof of the car. To simulate wing leading edge geometry, the specimens will be of a semicircular shape. This configuration will facilitate the study of the effects of angle of impact on insect adhesion. To achieve the semicircular shape, the specimens material will be very thin aluminum or steel sheet. The thin sheets will be wrapped around a 4" O.D. aluminum tube which has been cut lengthwise along a diameter. The specimens will be attached to the tube using screws or by folding the ends of the specimens under the edges of the tube and clamping the tube securely to the channel section. A possible specimen mounting configuration is shown in Figure 2.

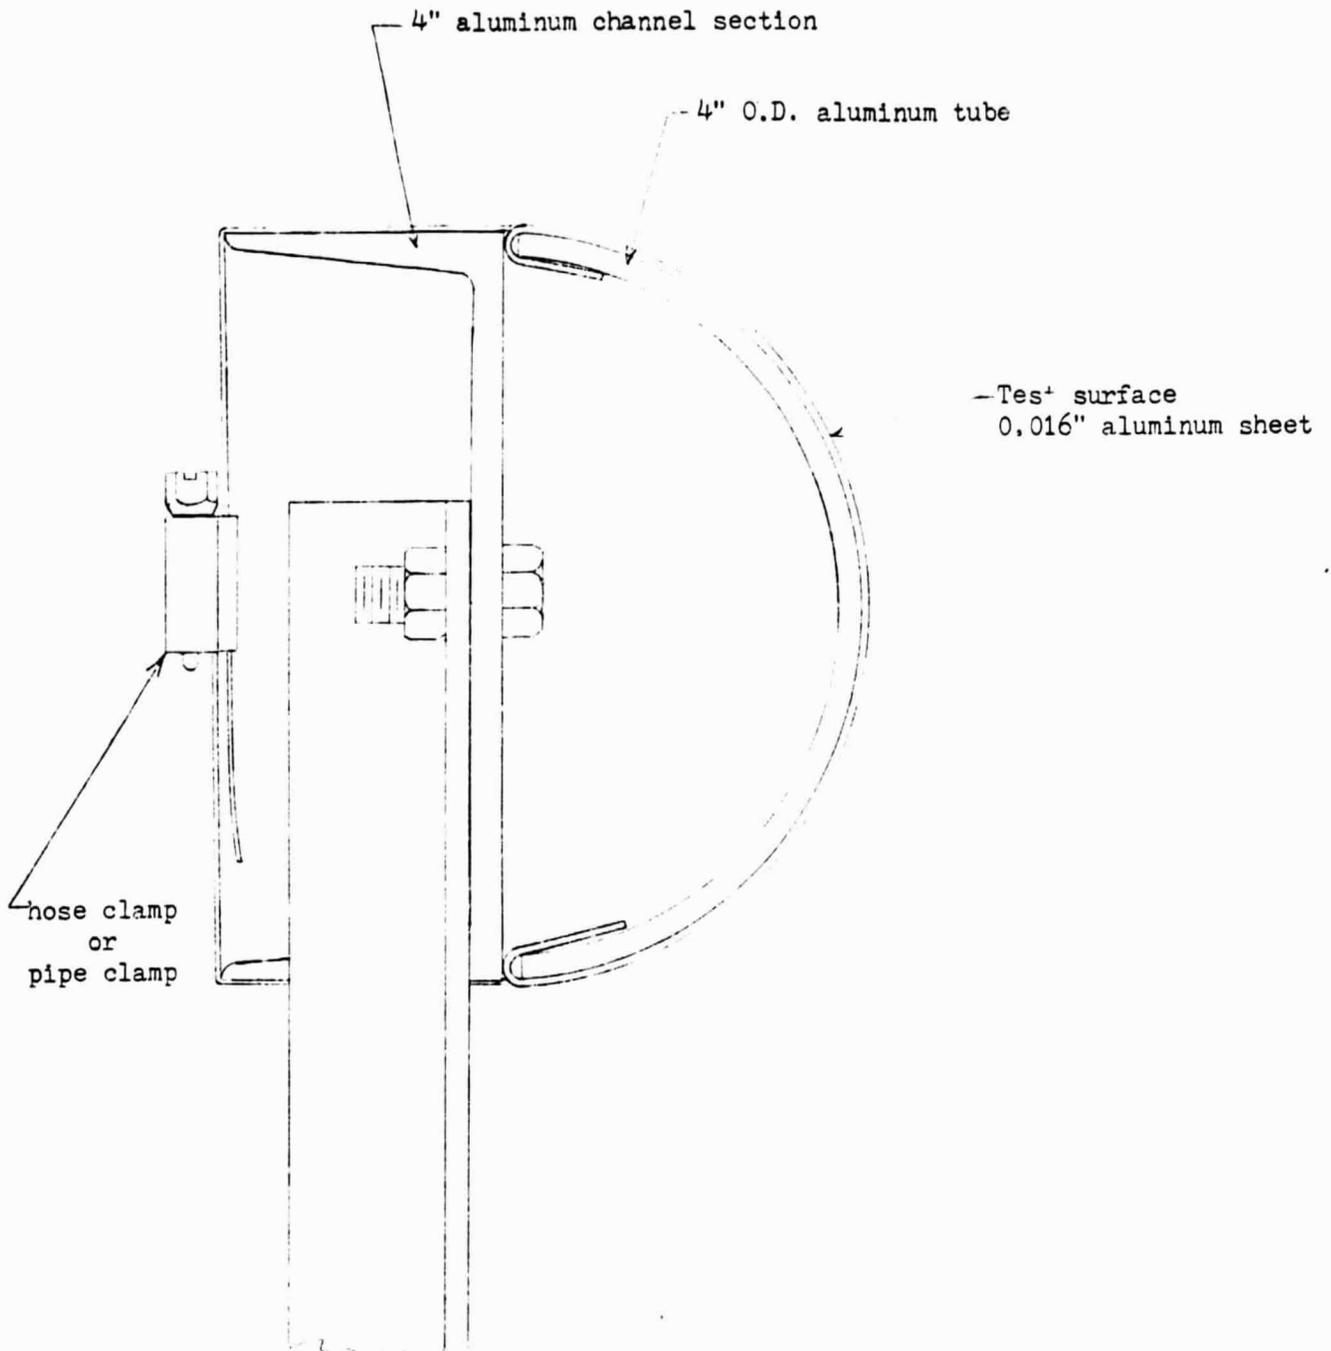
Figure 2. Possible specimen mounting configuration, side view.

Calculations have indicated that a 0.016 in. thick aluminum plate can be bent around the 4 in. diameter tube without yielding. Thus, the specimens can be bead blasted to create the desired surface finish and coated with the polymer while flat, and then bent around the tube for the field tests. After the tests and the specimens are removed from the test apparatus, they will

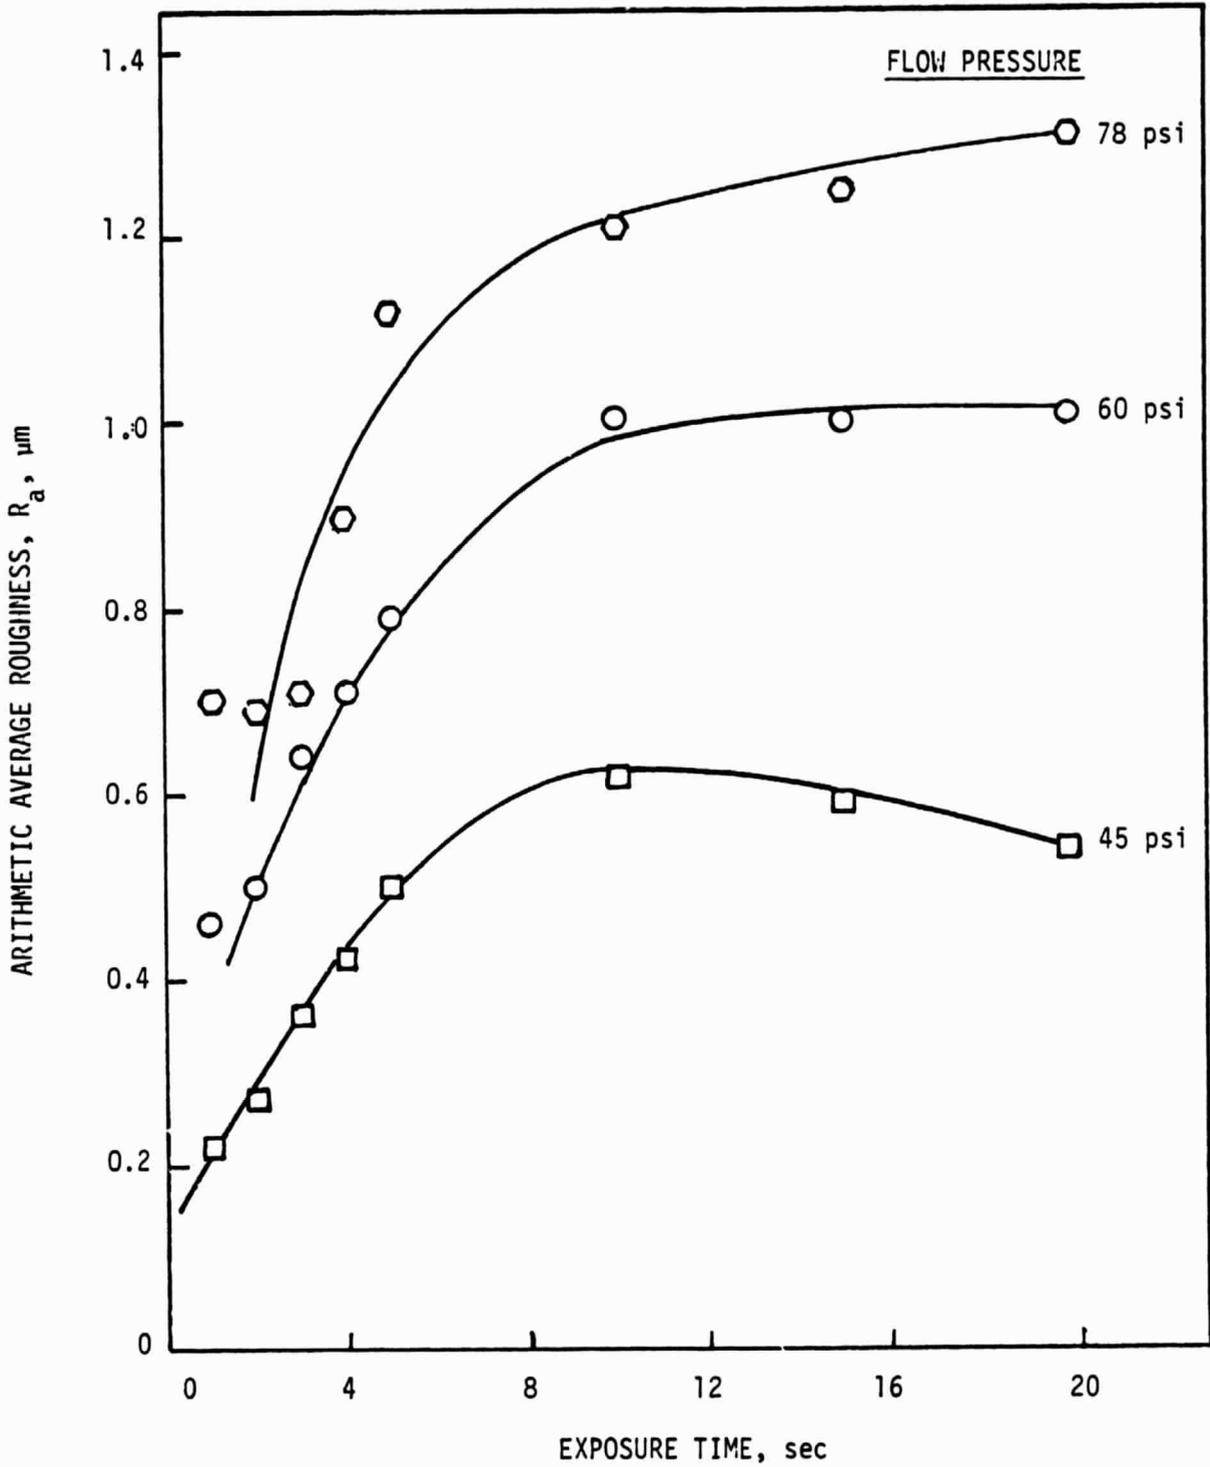
Figure 3. Results of glass bead blasting experiments on steel plate showing the effects of flow pressure and time of exposure of the bead stream on the surface roughness.

Glass bead blasting experiments on steel plate have been conducted by varying the flow pressure and the time of exposure of the bead stream to the test surface. The results show that a satisfactory surface roughness range can be obtained. Figure 3 shows curves of surface roughness against time of exposure for different flow pressures of the glass bead stream. It would be more desirable to use a material with a lower elastic modulus, such as aluminum, so that specimens can be more easily bent into a semicircular shape and then straightened back after testing for easier analysis. However, glass bead blasting of 1100 Aluminum sheet has not been satisfactory. The minimum surface roughness was found to be about 2.0 $\mu\text{m } R_a$. In an attempt to alleviate this problem, a harder aluminum alloy sheet, namely 7075-T6, will be investigated to determine if the desired surface roughness range can be achieved. This study will be performed when the necessary materials have been received.

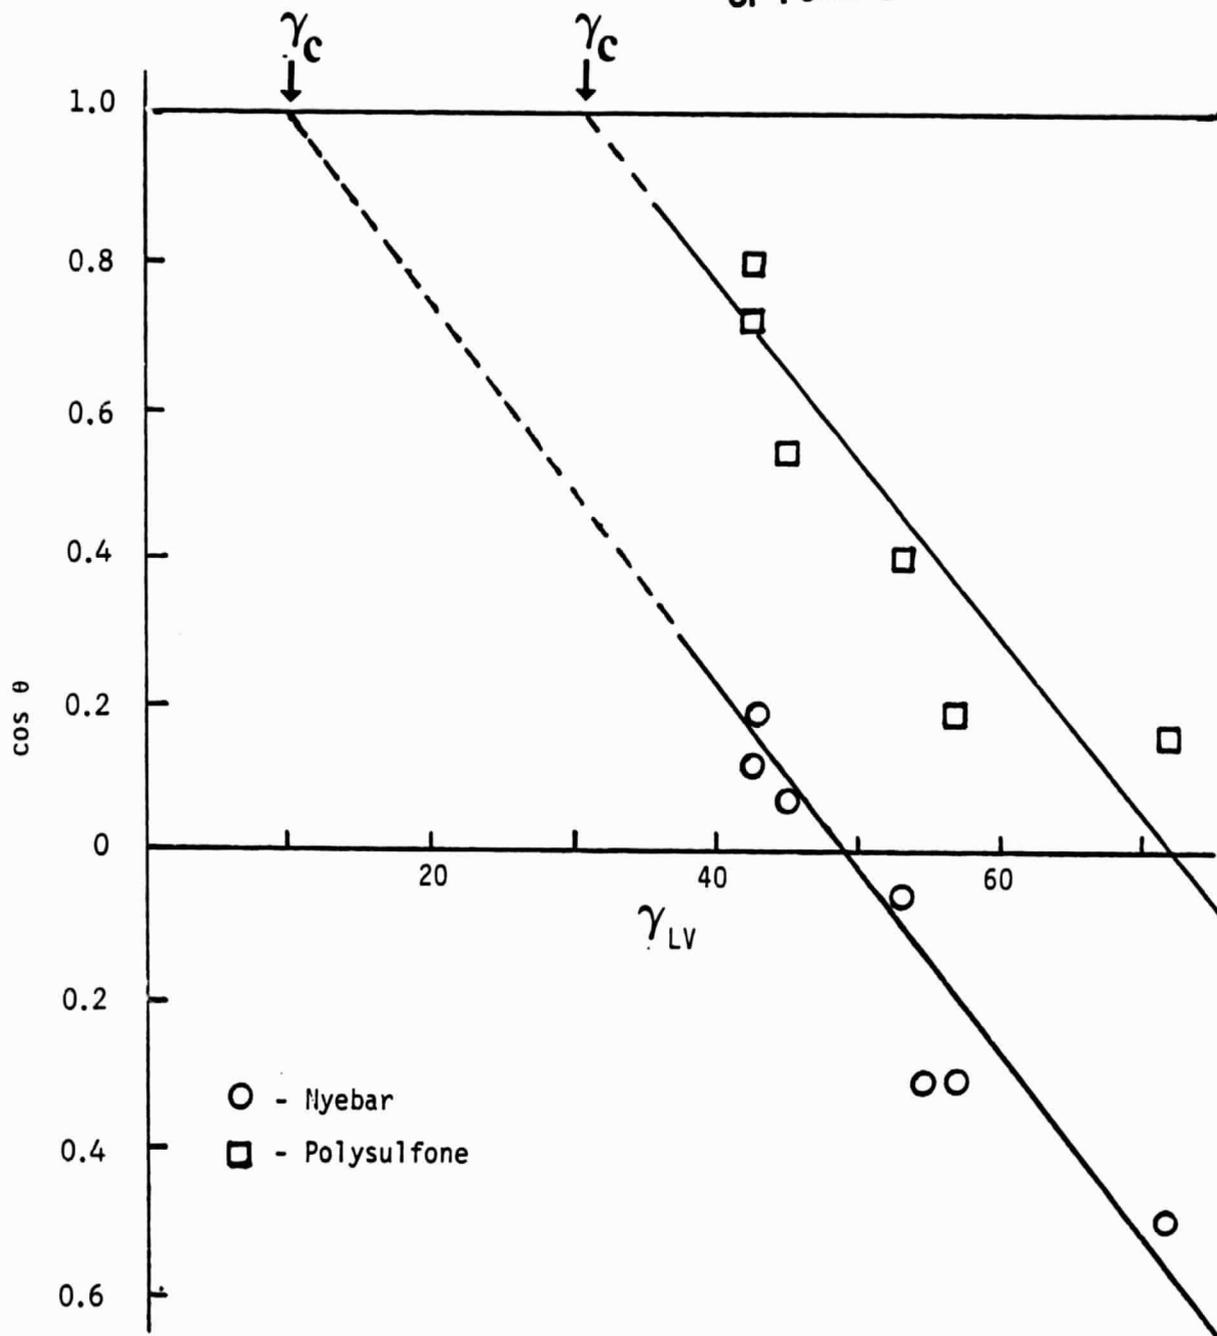
Figure 4. Determination of critical surface tension of polymer coatings.

Contact Angles - The values for the surface tensions of the ethanol/water solutions and contact angles for Nyebar and polysulfone coated plates are listed in Table II. For each polymer, the contact angle decreased as the surface tension of the solution decreased. The critical surface tension of the polymer coating was determined by plotting cosine of the contact angle (θ) versus surface tension (γ_{lq}) as shown in Figure 4. The best straight line through the data points was determined by linear regression. Values for the critical surface tension are the values of surface tension corresponding to $\cos \theta$ equal to 1 obtained by extrapolation. These values are listed in Table III and are in good agreement with values on similar systems reported in the literature.

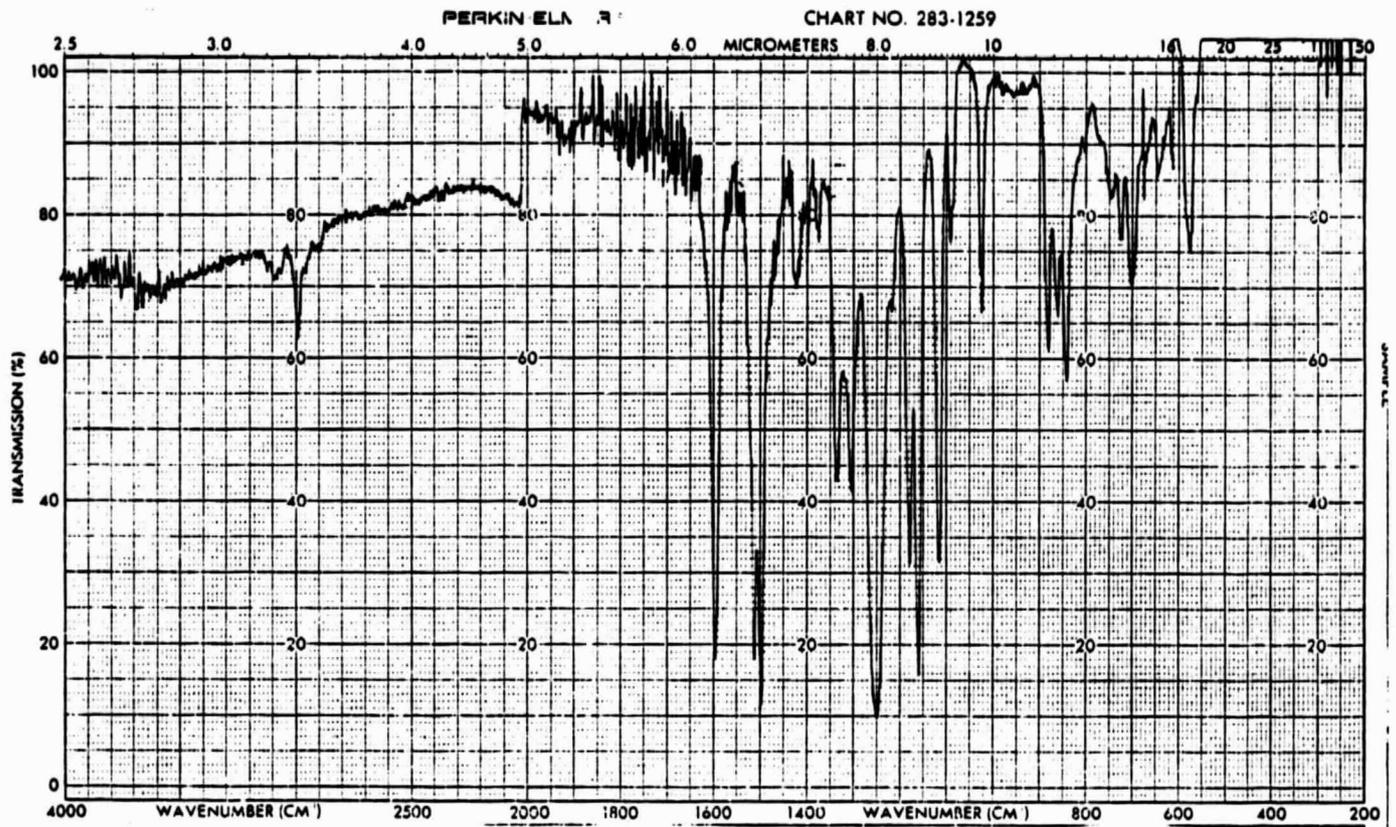
Figure 5. IR spectrum of polysulfone film.

IR - Analysis by IR has been completed for polysulfone. Figure 5 is a spectrum of freshly cast polysulfone coated plate. Fig. 6 is the spectrum of a sample taken from a polysulfone coated plate that was tested on the road.

A comparison of the two spectra shows that there is no qualitative change in the polymer film after exposure to road conditions. Again, the IR results are consistent with the ESCA results in that no significant contamination of the polysulfone coated plates has occurred. The structure and peak assignments for this polymer are given in Table V.

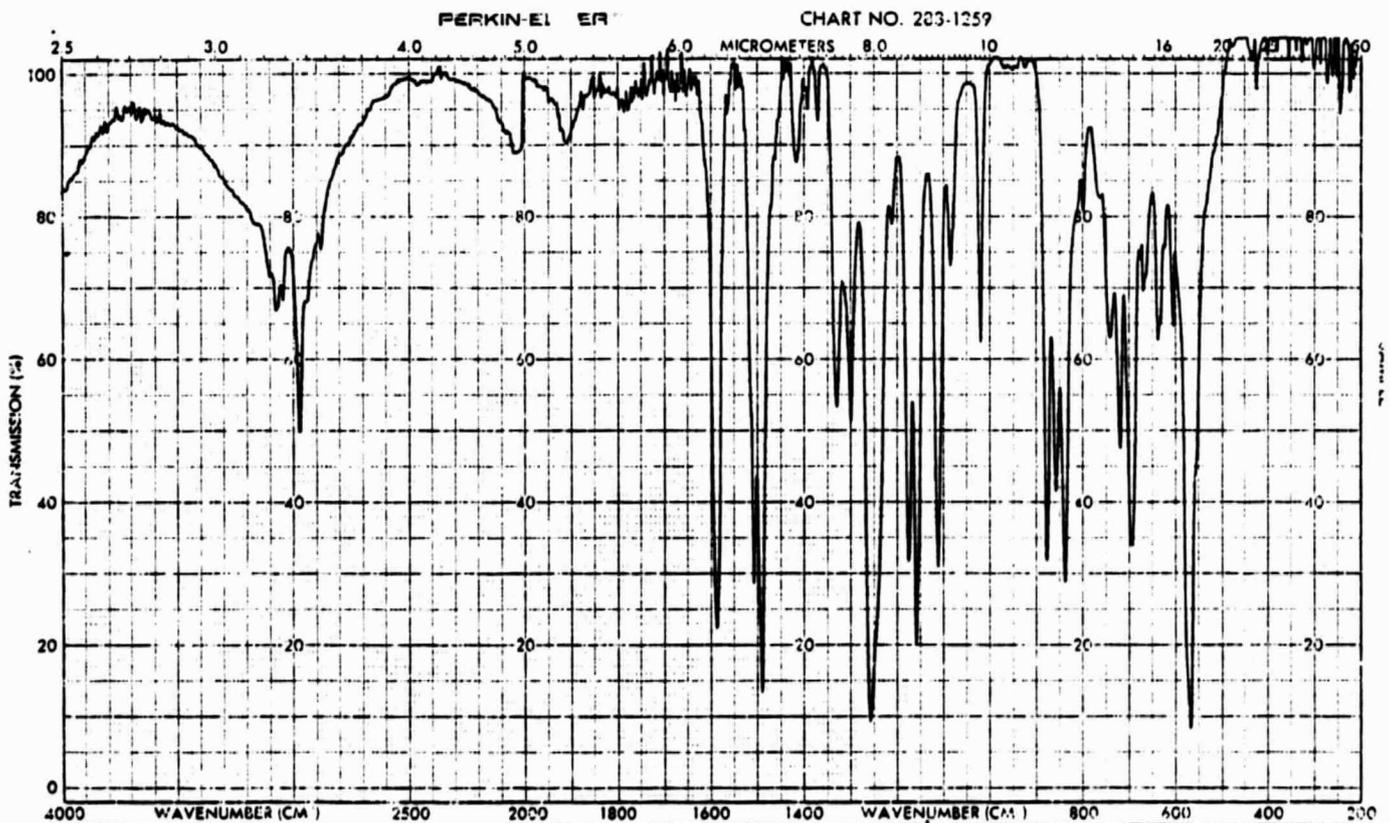
Figure 6. Infrared spectrum of exposed polysulfone film.

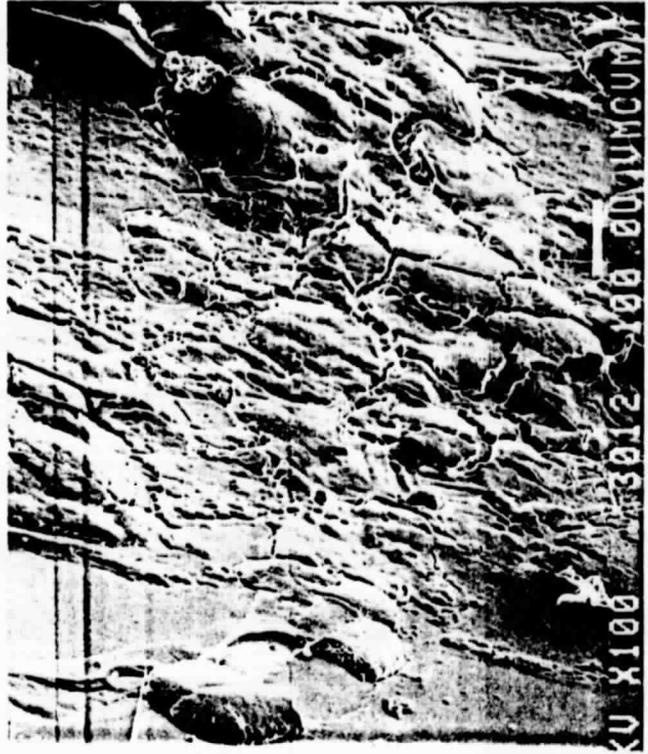
Figure 7. SEM photomicrographs of exposed polysulfone film.

SEM - SEM is being used to determine if differences in surface energy of the polymer films will show up as differences in the way bug splats and residues wet the surface. SEM photomicrographs of typical debris are given in Figures 7 and 8. Figure 7 shows representative areas on polysulfone coated plates and Figure 8 shows examples of bug residues on Nyebar coated plates. The bug debris appears to wet the polysulfone coated plates better than the Nyebar.
