NASA Contract Report CR-172211

A Study of Stiffness, Residual Strength and Fatigue Life Relationships for Composite Laminates

**LOCKHEED-CALIFORNIA COMPANY
A Division of Lockheed Corporation
Burbank, California 91520**

**Contract NAS1-16406
October, 1983**

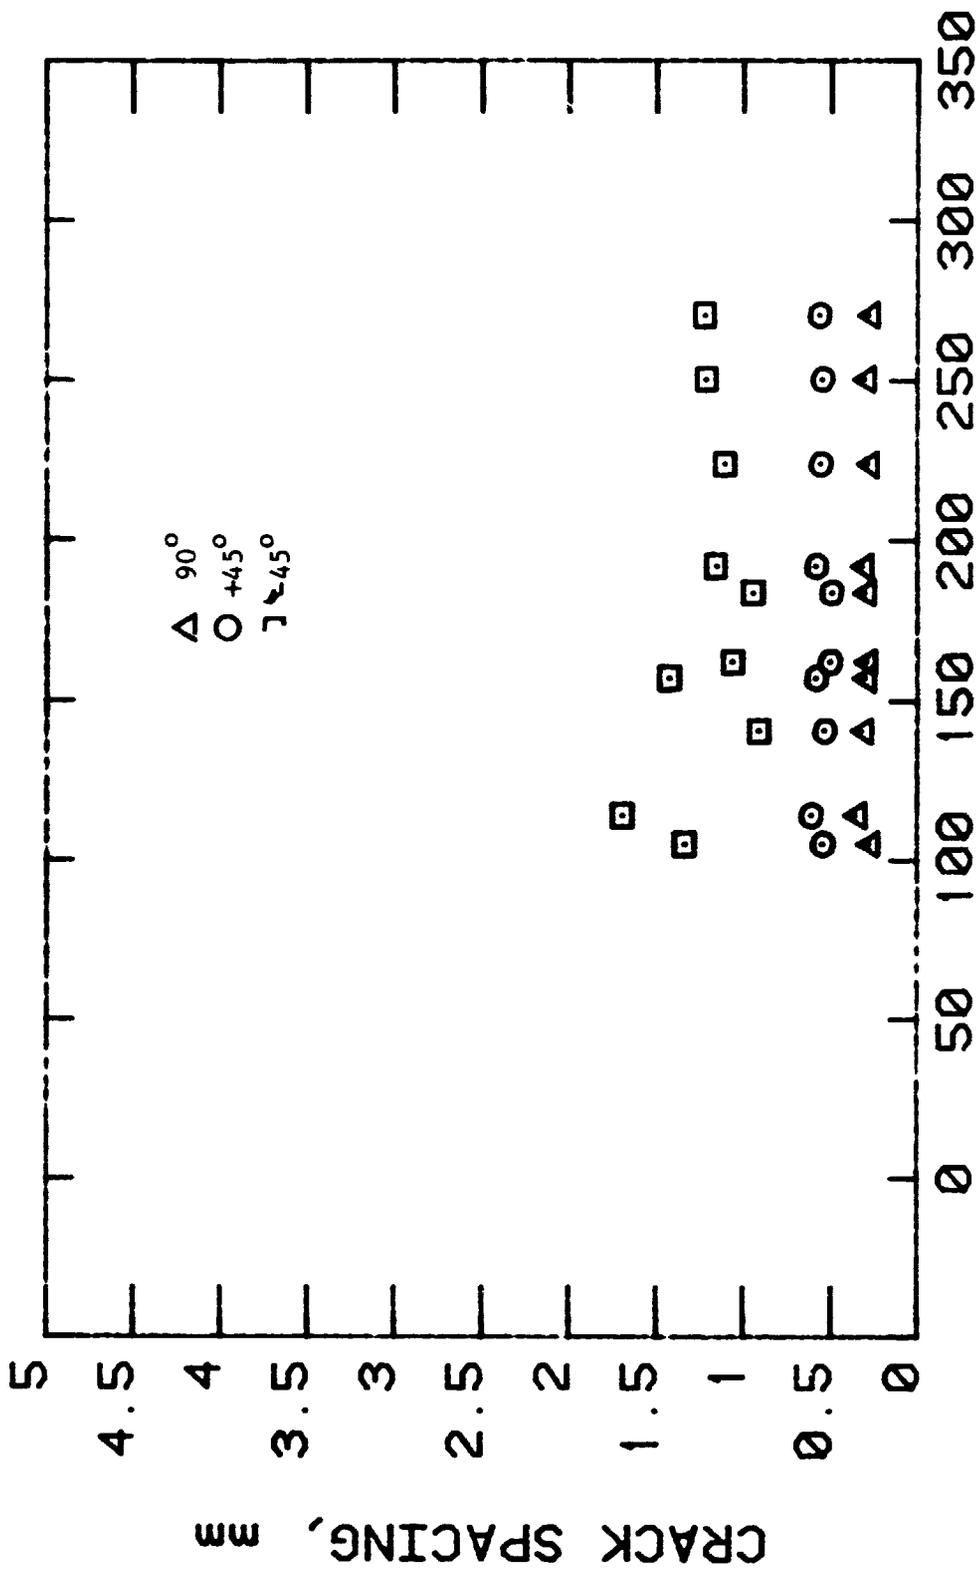
Figure 3: Average crack spacing as a function of fatigue cycles for (0/90+45)_s Coupons at $\sigma_{max} = 379$ MPa (55 ksi).

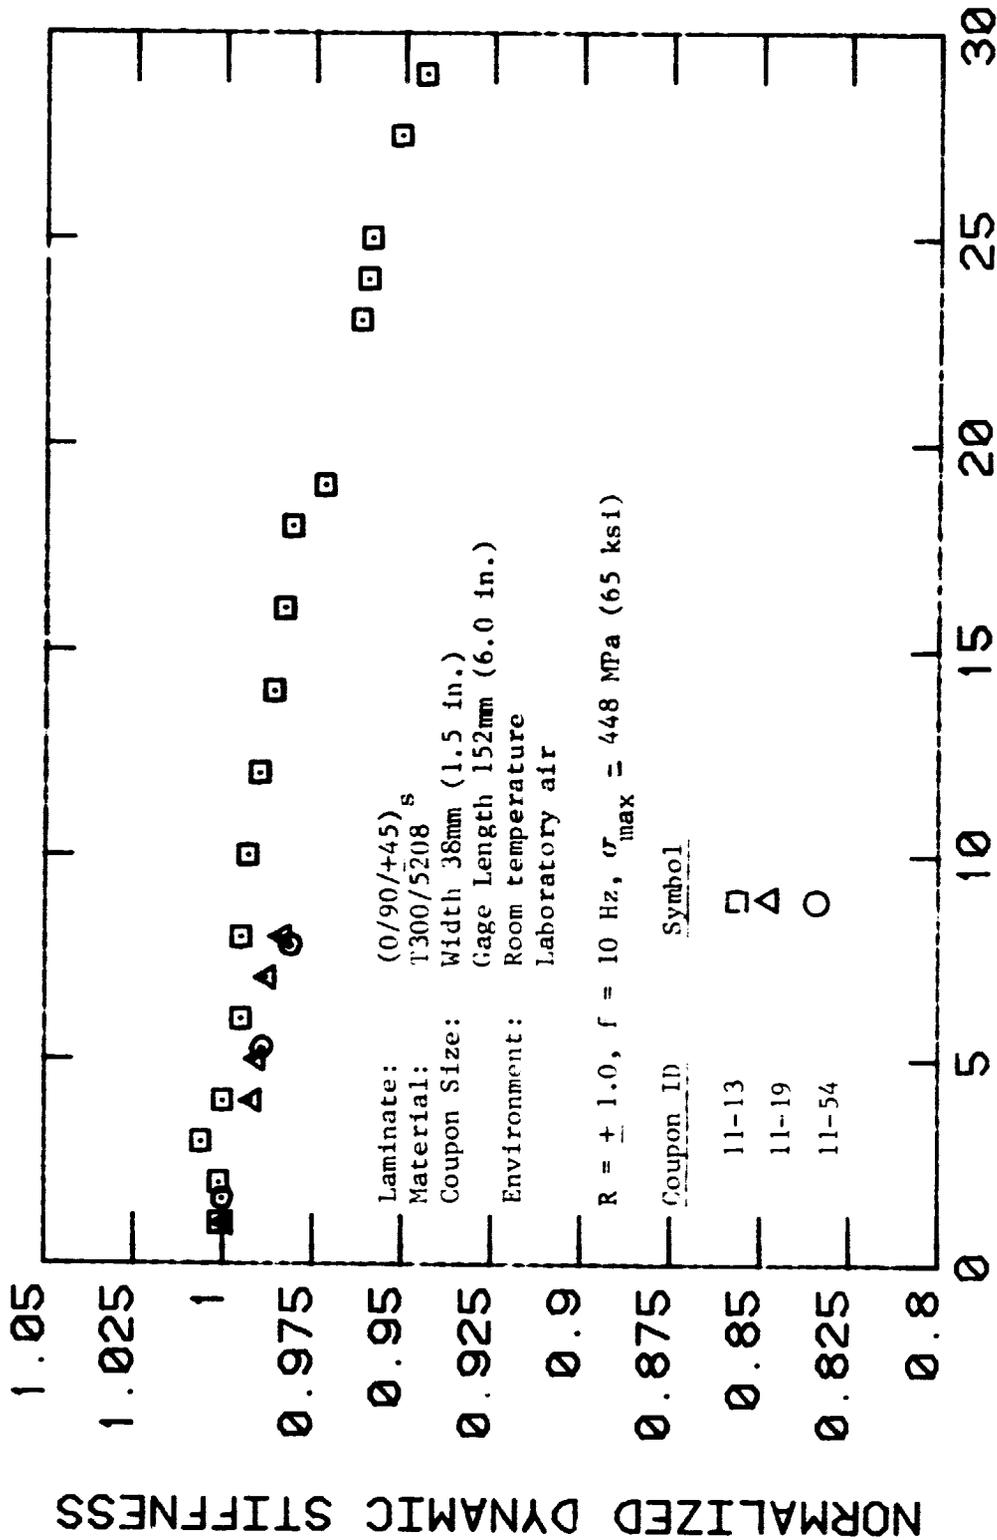
Figure 6: Normalized dynamic stiffness vs. constant amplitude fatigue load cycles for (0/90/+45)_s laminate, $\sigma_{max} = 448$ MPa (65 ksi)

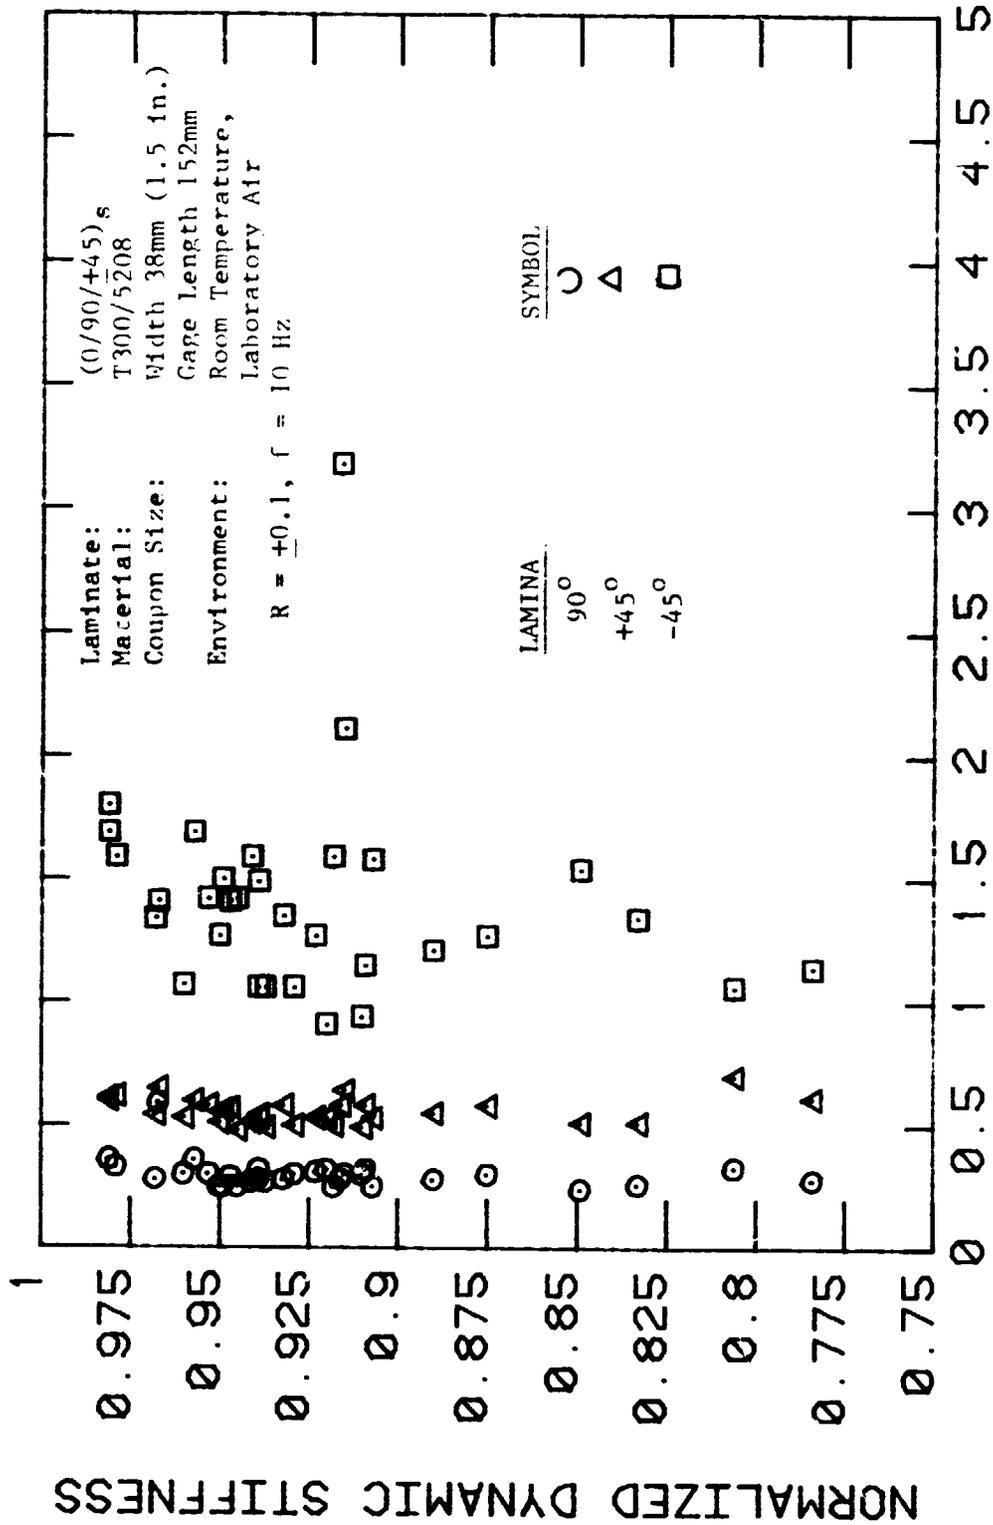
Figure 7: Normalized dynamic stiffness vs. average matrix crack spacing for (0/90/+45)_s laminate coupons subjected to constant amplitude fatigue load.

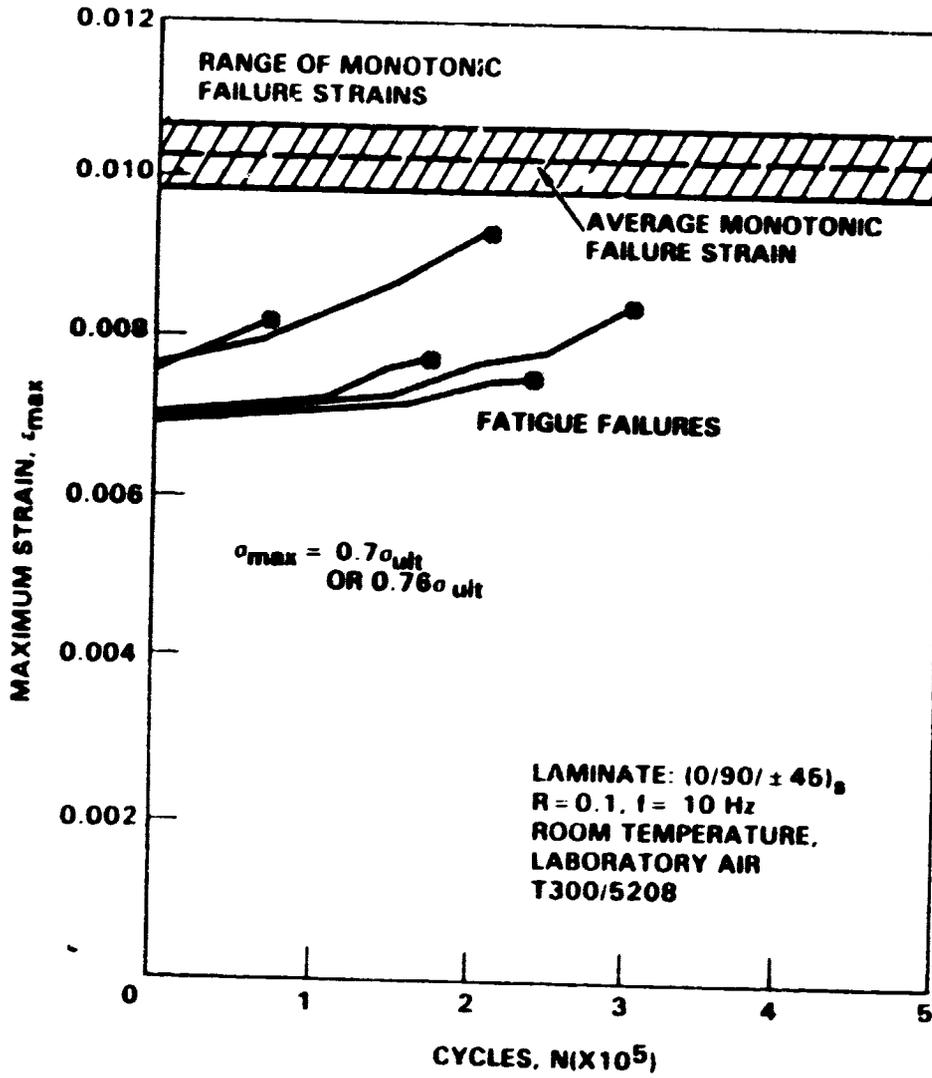
Figure 17: Increase in strain due to fatigue loading of (0/90/+45)_s coupons.

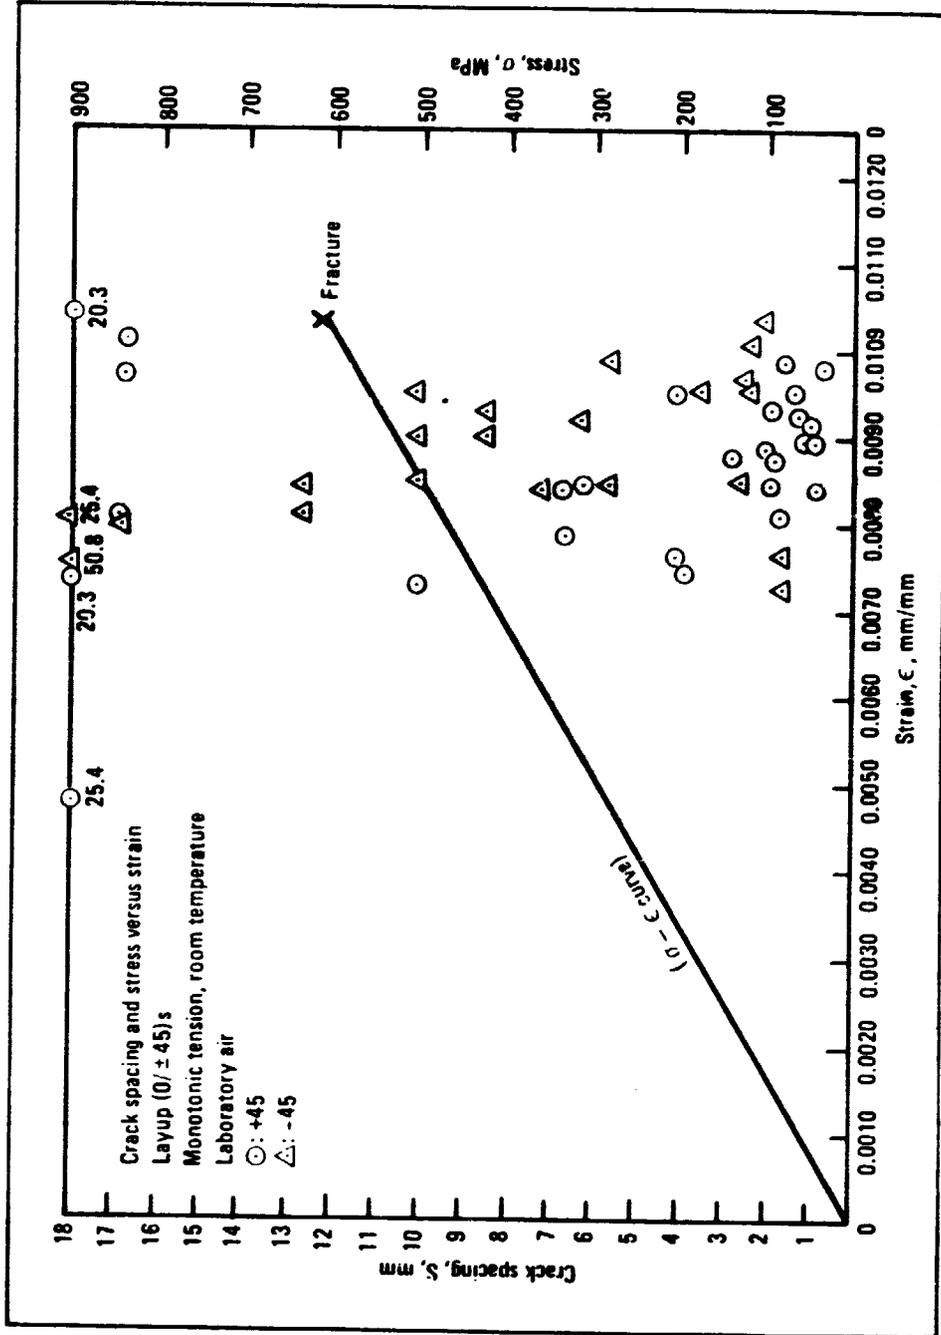
Figure 18 - Crack spacing and stress vs. strain

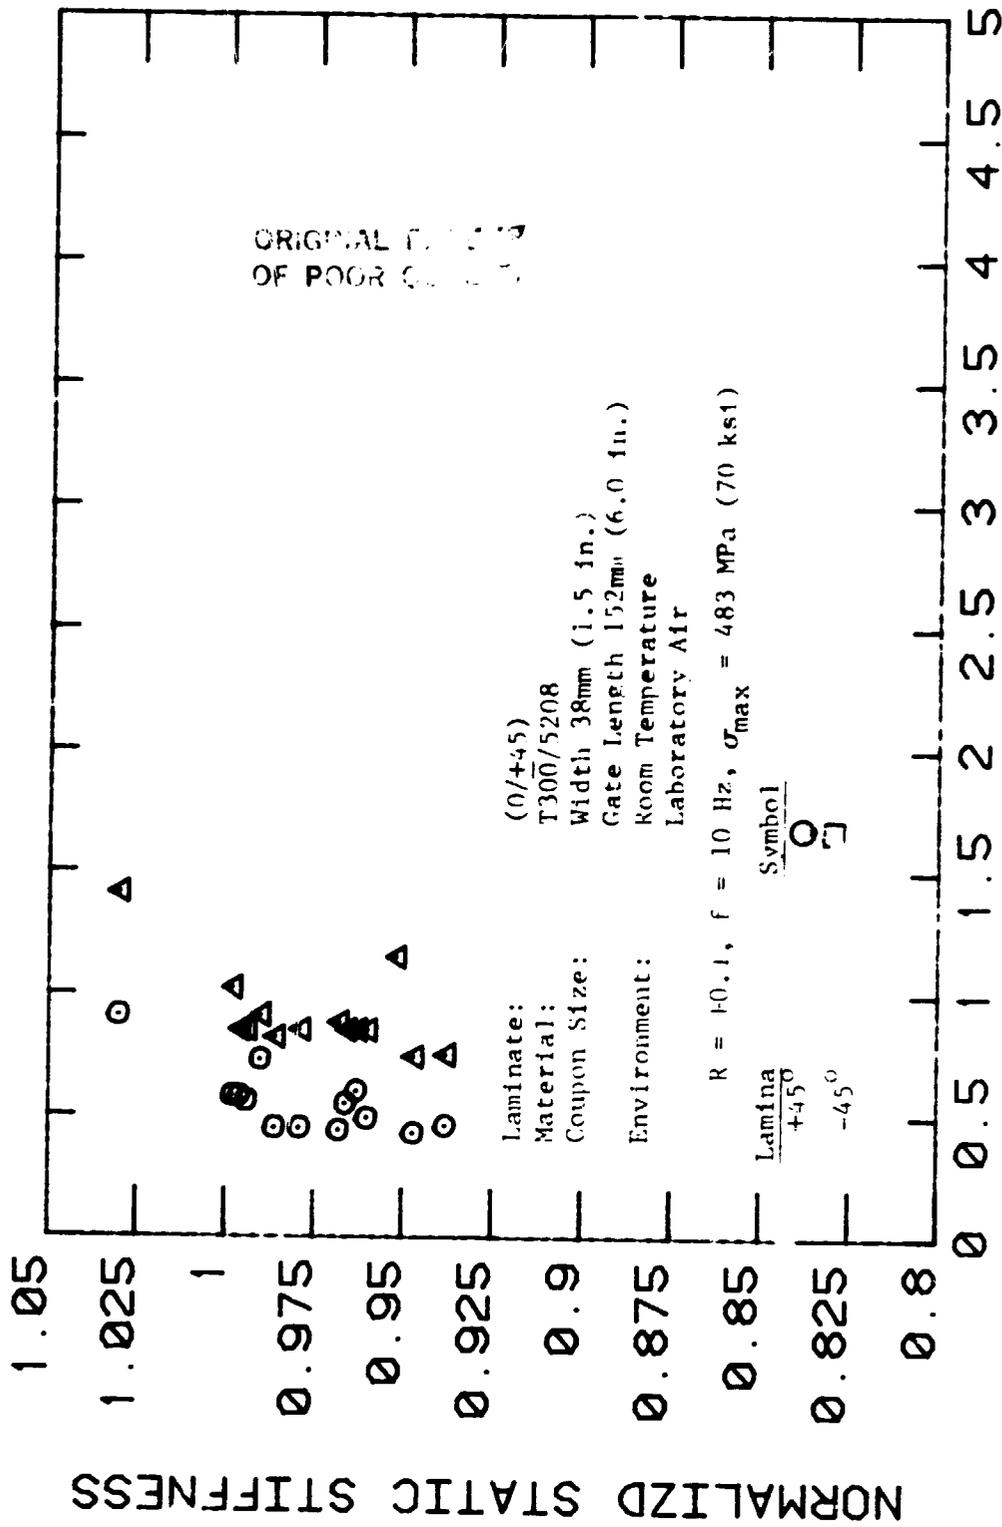
Figure 23: Normalized noncyclic stiffness vs. average matrix crackline spacing for (0/+45) laminate coupons subjected to sinusoidal fatigue loading at four loads, σ_{\max} = 483 MPa (70 ksi).

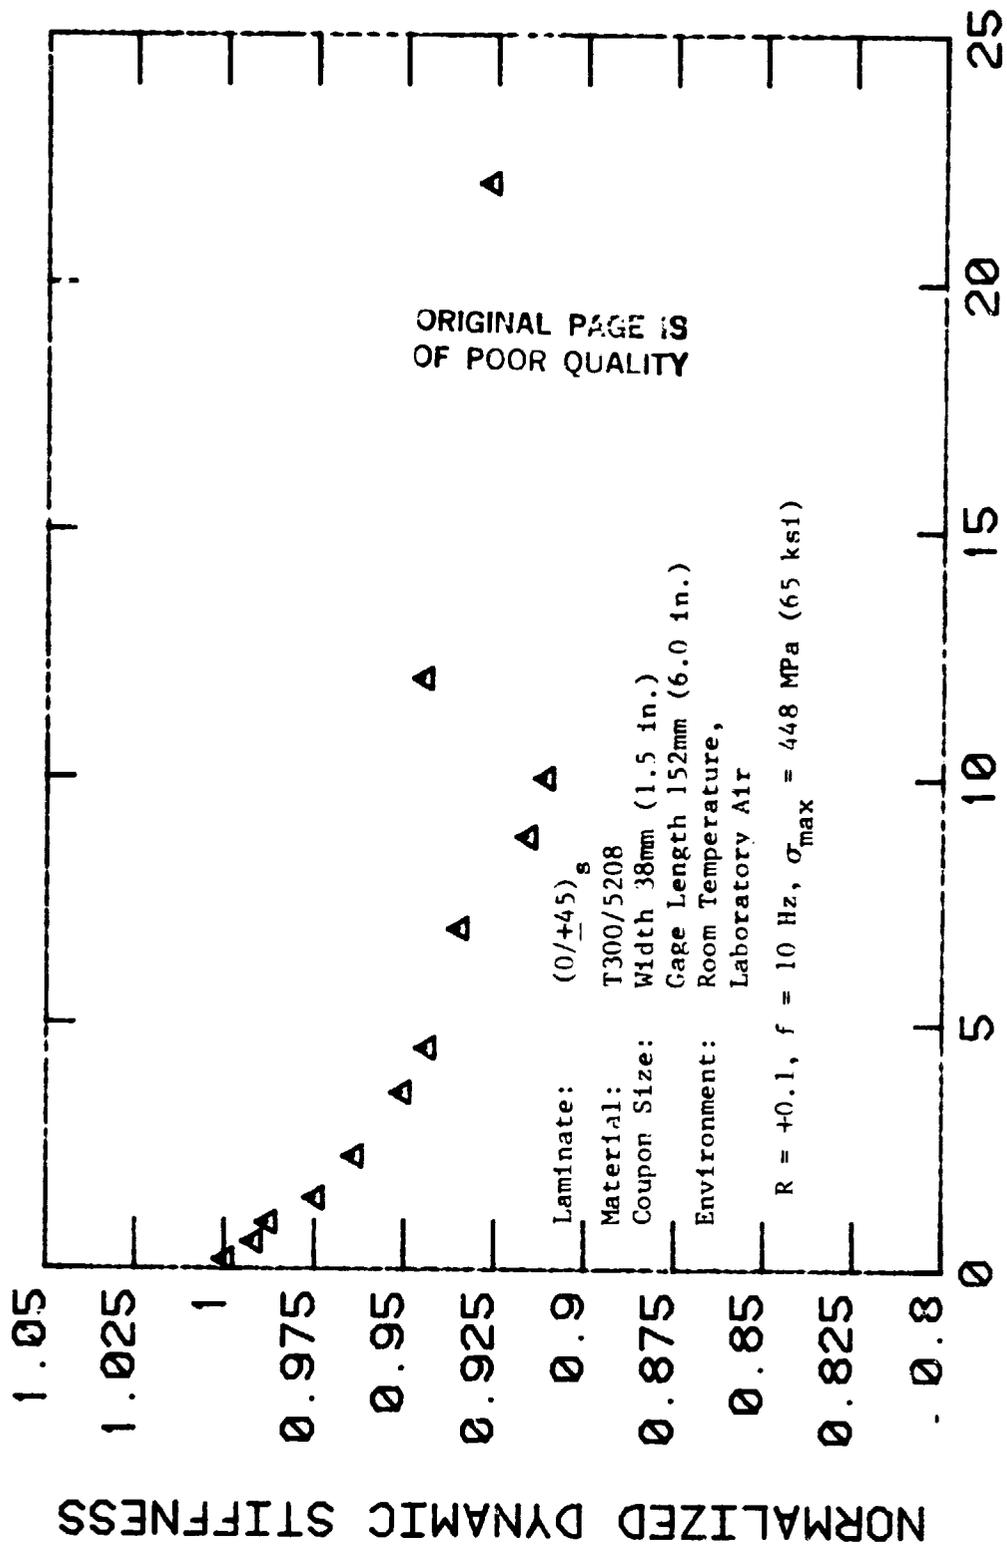
Figure 24: Normalized dynamic stiffness vs. constant amplitude fatigue load cycles for (0/+45)_s laminate coupon 8-30, $\sigma_{max} = 448$ MPa (65 ksi)

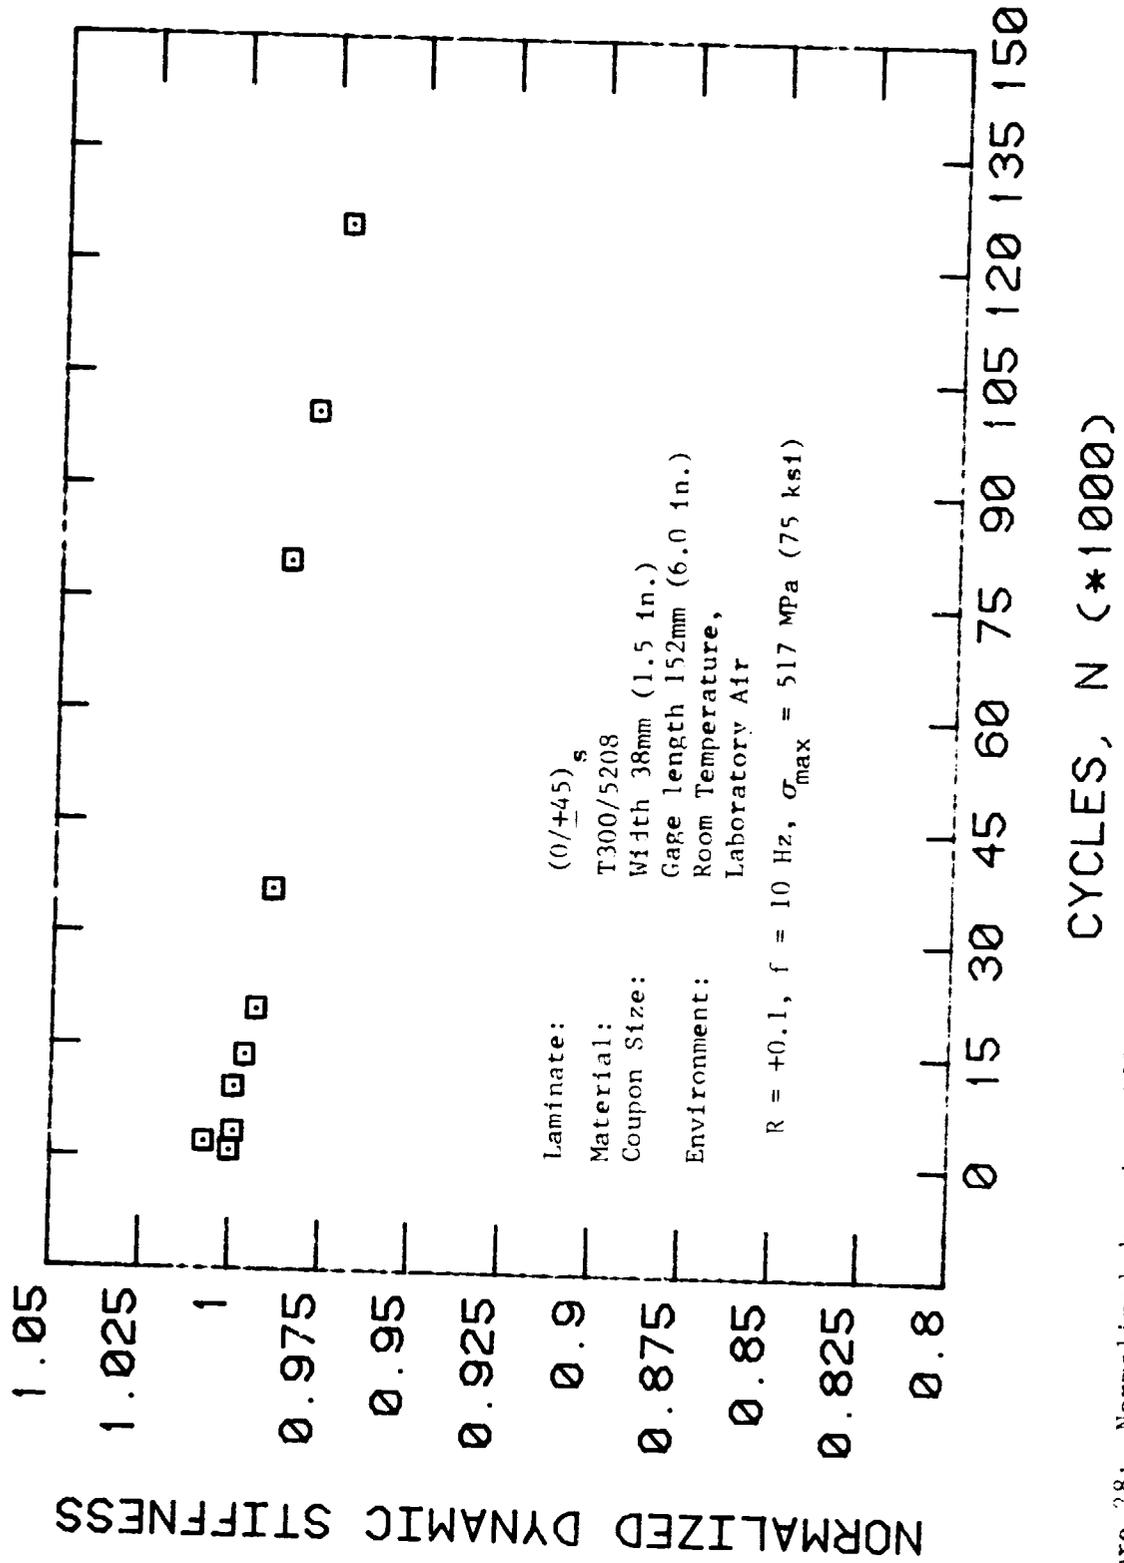
Figure 28: Normalized dynamic stiffness vs. constant amplitude fatigue load cycles for (0/+45)_s laminate coupon 8-45, $\sigma_{max} = 517$ MPa (75 ksi).

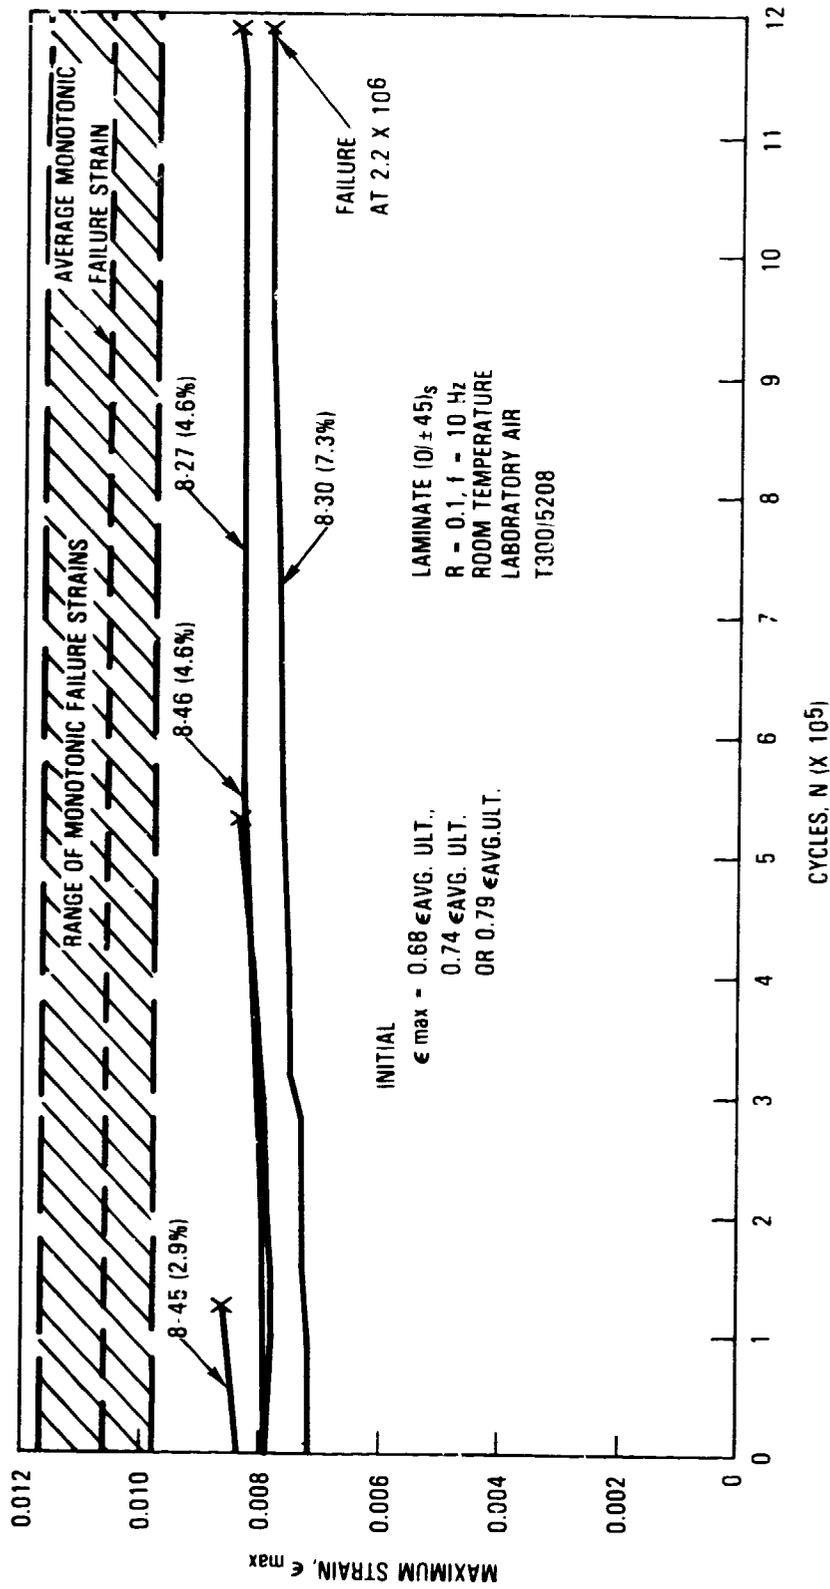
FIGURE 29. INCREASE IN STRAIN DURING FATIGUE LOADING OF (0/±45)_s COUPONS.

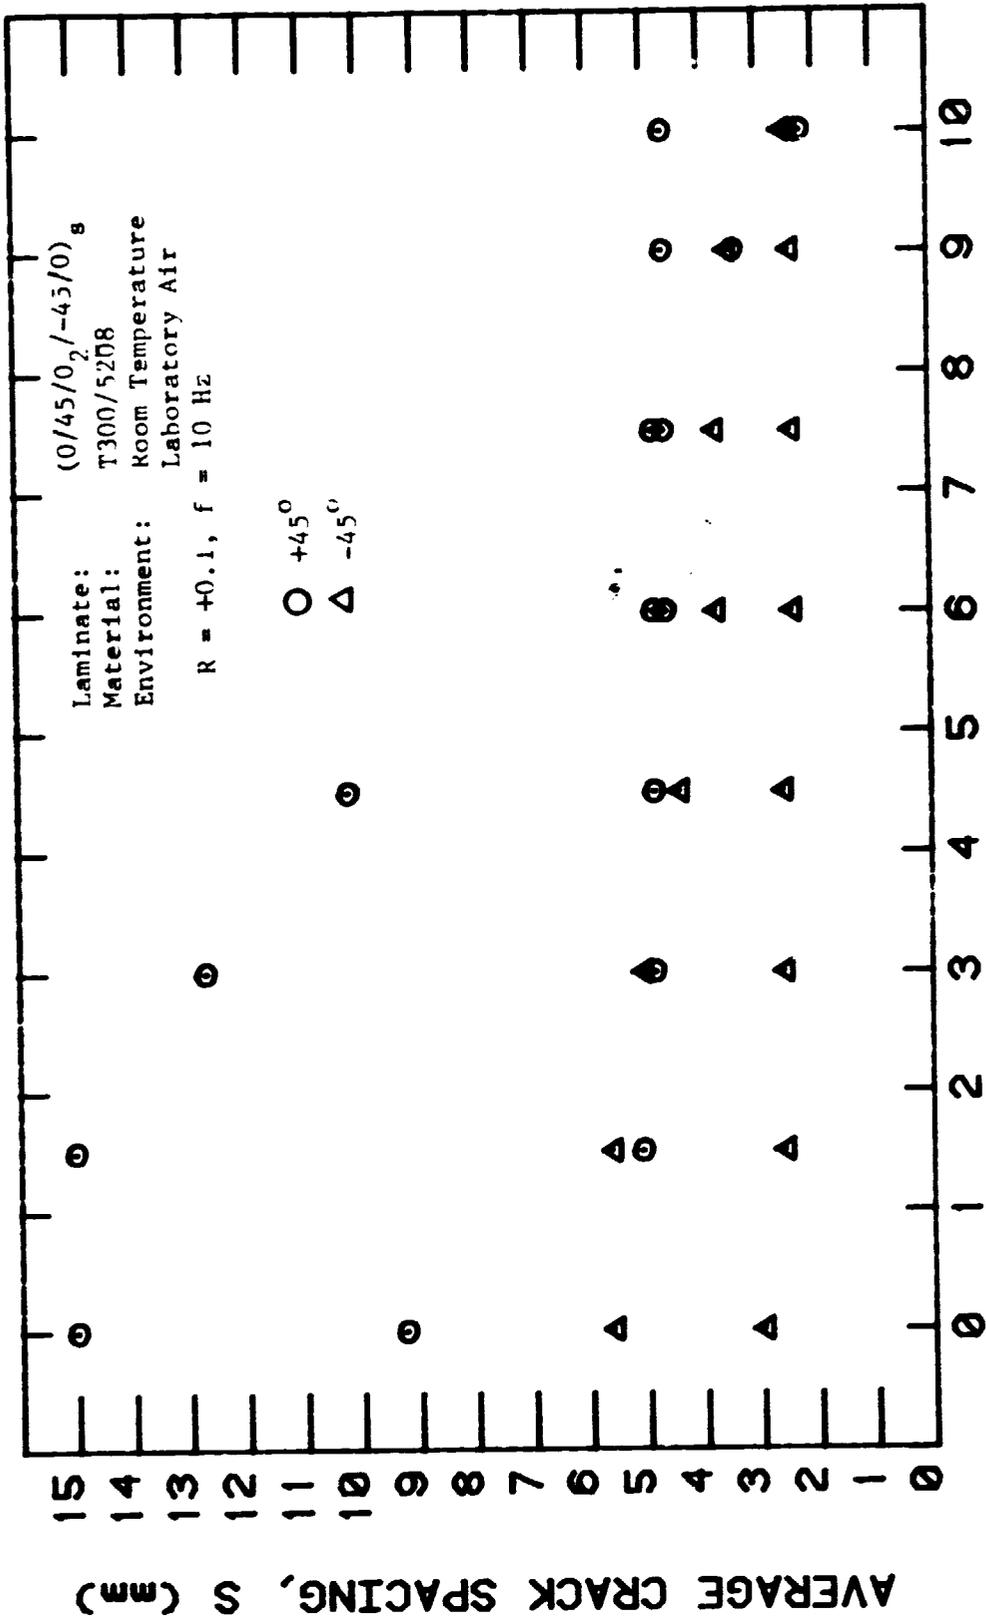
Figure 32: Average crack spacing vs. cycles for (0/45/0₂/-45/0)_s coupons fatigue loaded at an initial strain of 0.0075.

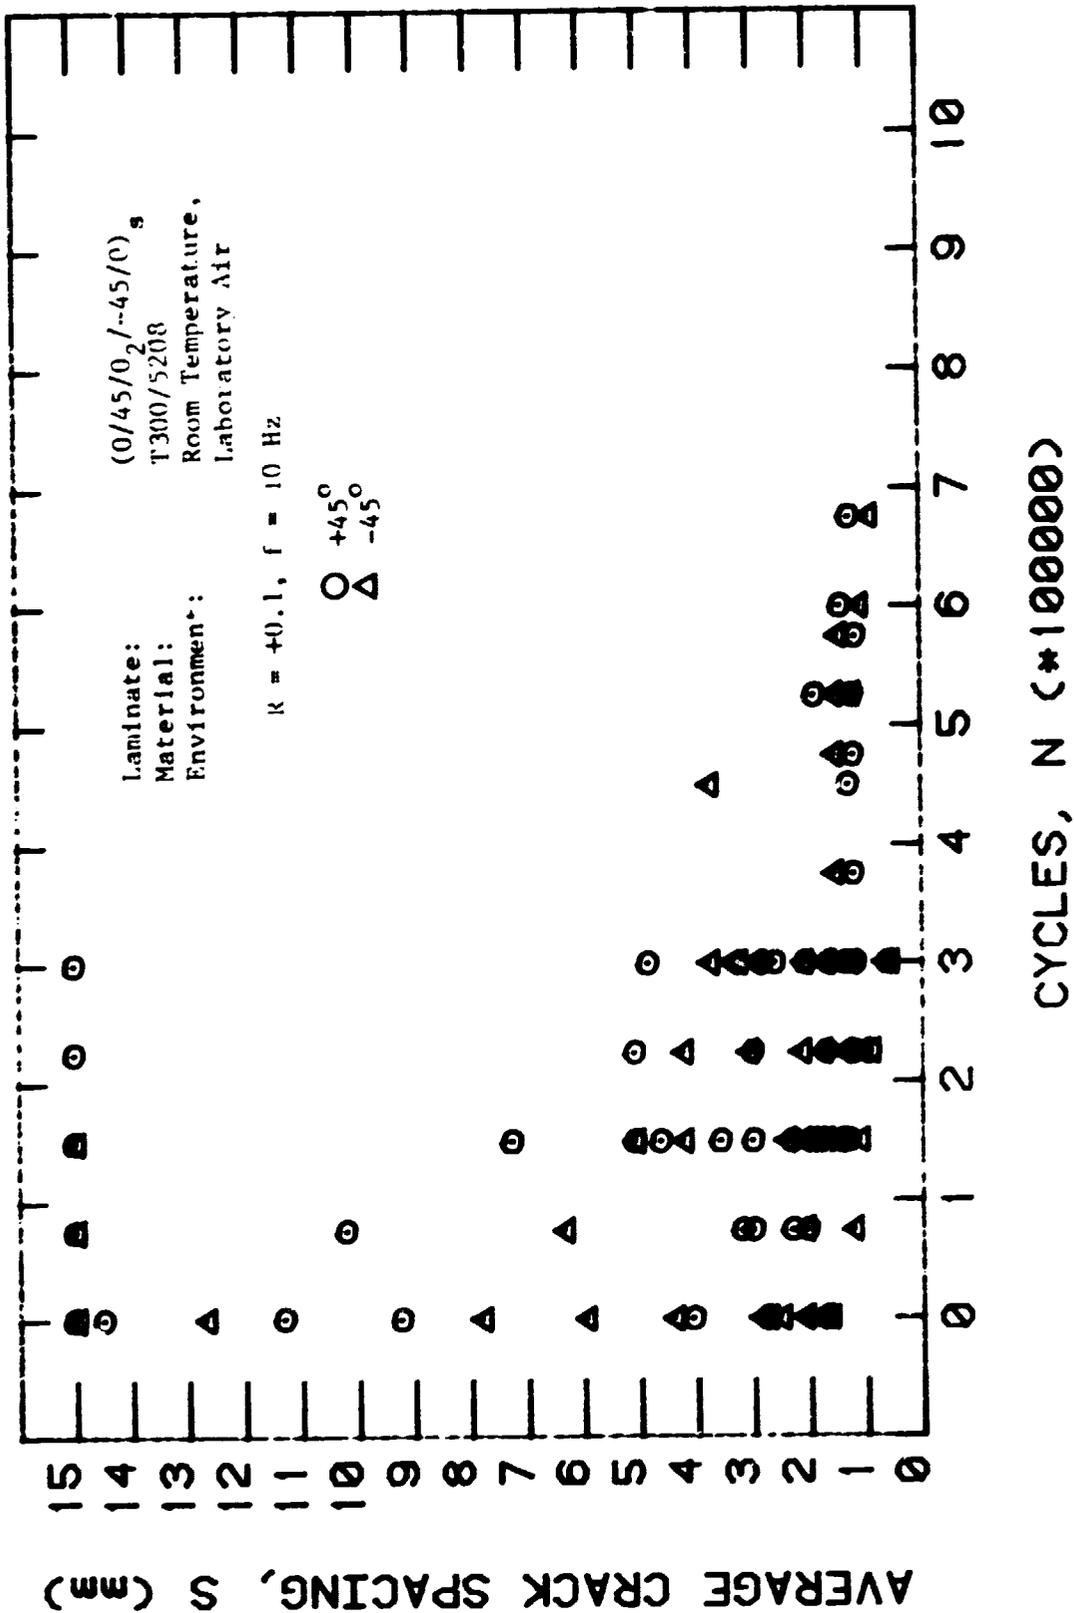
Figure 33: Average crack spacing vs. cycles for (0/45/0₂/-45/0)_s coupons fatigue loaded at an initial strain of 0.0080.

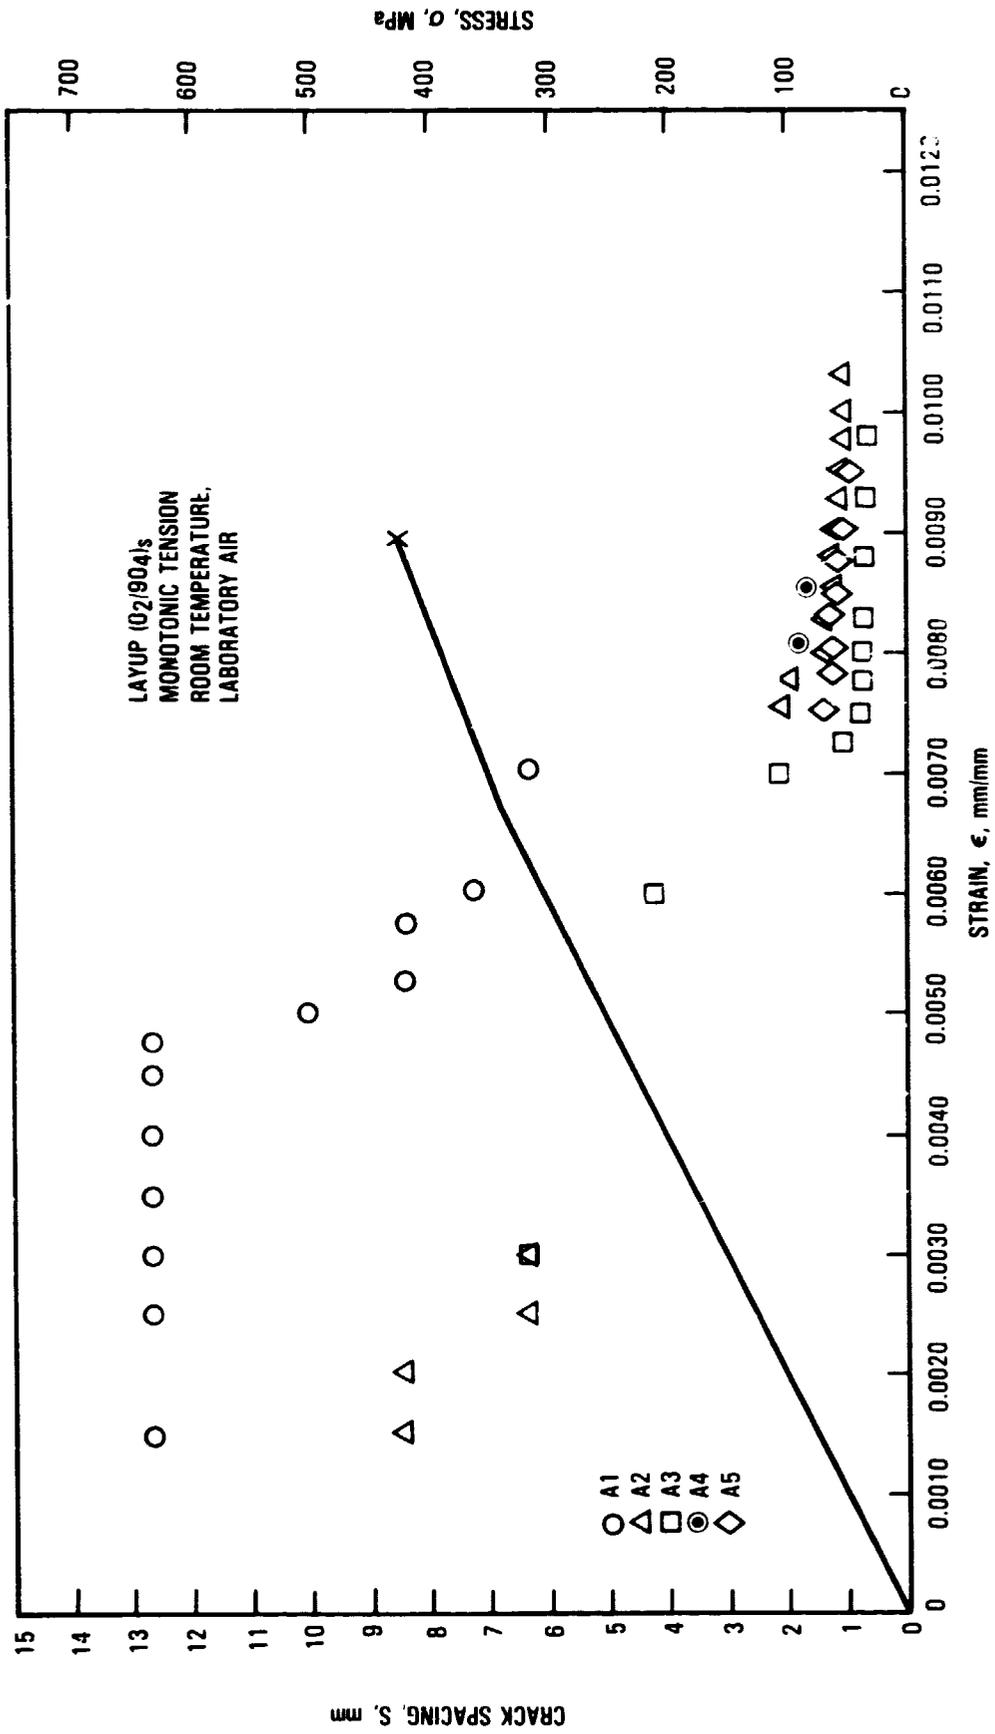
FIGURE 35. CRACK SPACING AND STRESS AS A FUNCTION OF STRAIN FOR (02/904)s COUPONS

Damage progression during monotonic tension loading consisted primarily of 90° ply matrix cracks perpendicular to the load direction. Delamination during monotonic loading was not observed by enhanced x-ray, and on the edge replicates delamination extending from the ends of 90° plies was usually short, but obvious and often absent until near coupon failure. At that point, 0/90 delaminations on the coupon edges nearly, but not completely linked together. The spacing of the 90° ply matrix cracks decreased as load increased and tended towards an apparent plateau spacing. However, as in the case of coupon A1, fracture sometimes occurred prior to reaching that

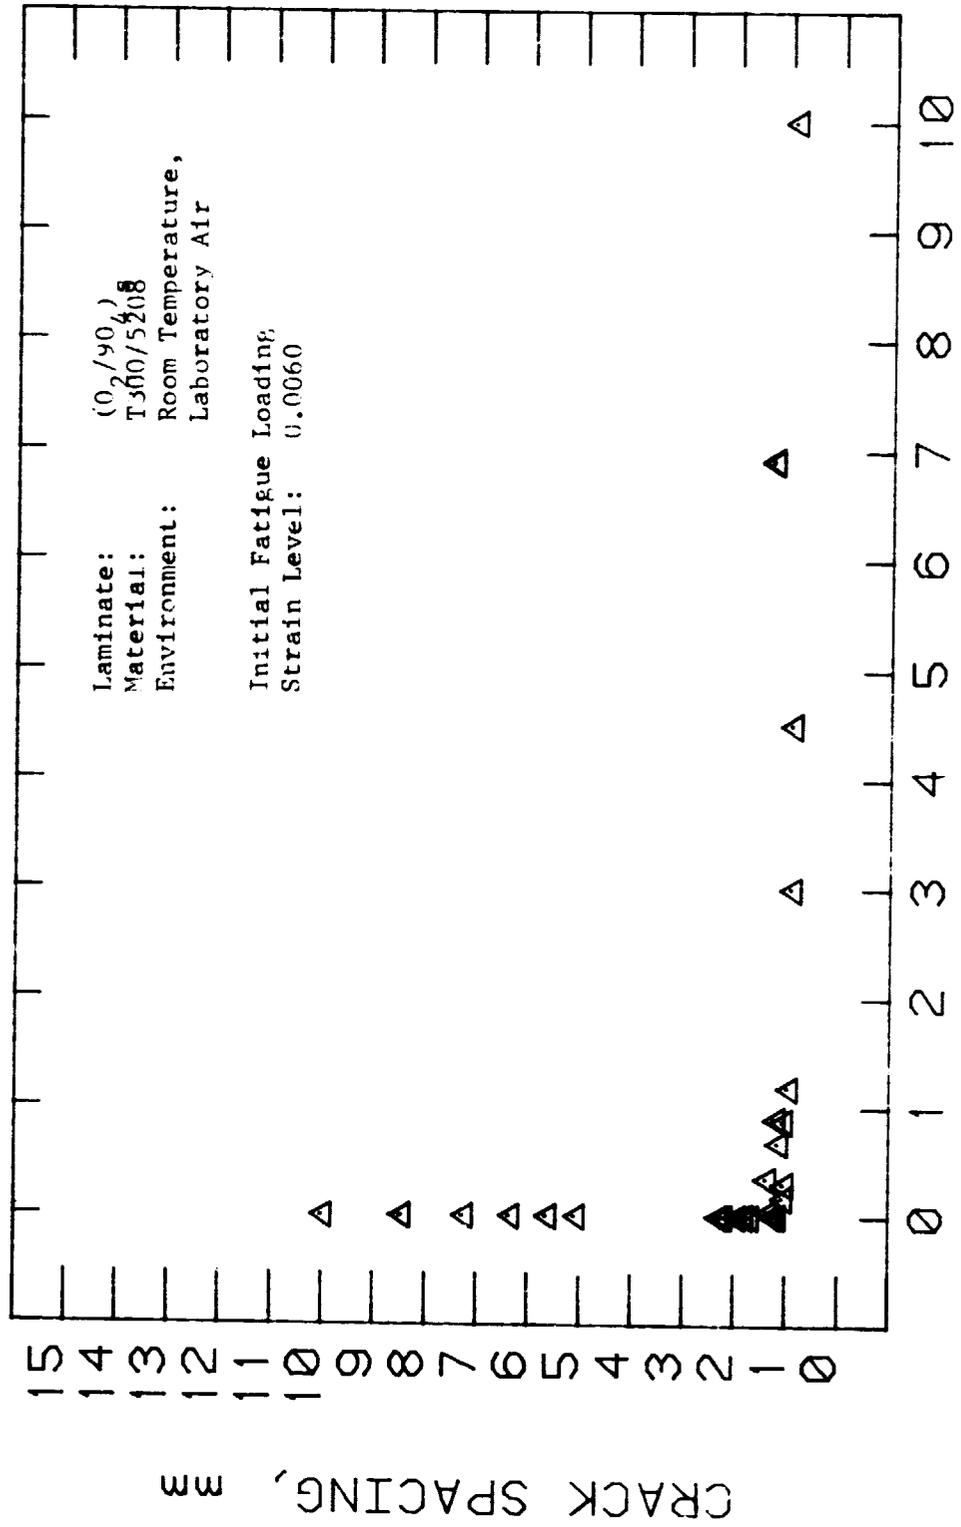
Figure 43: Average matrix crack spacing in the 90° plies vs. cycles for (0_s/90_s)₄s coupons [fatigue cycled at an initial strain of 0.0060].

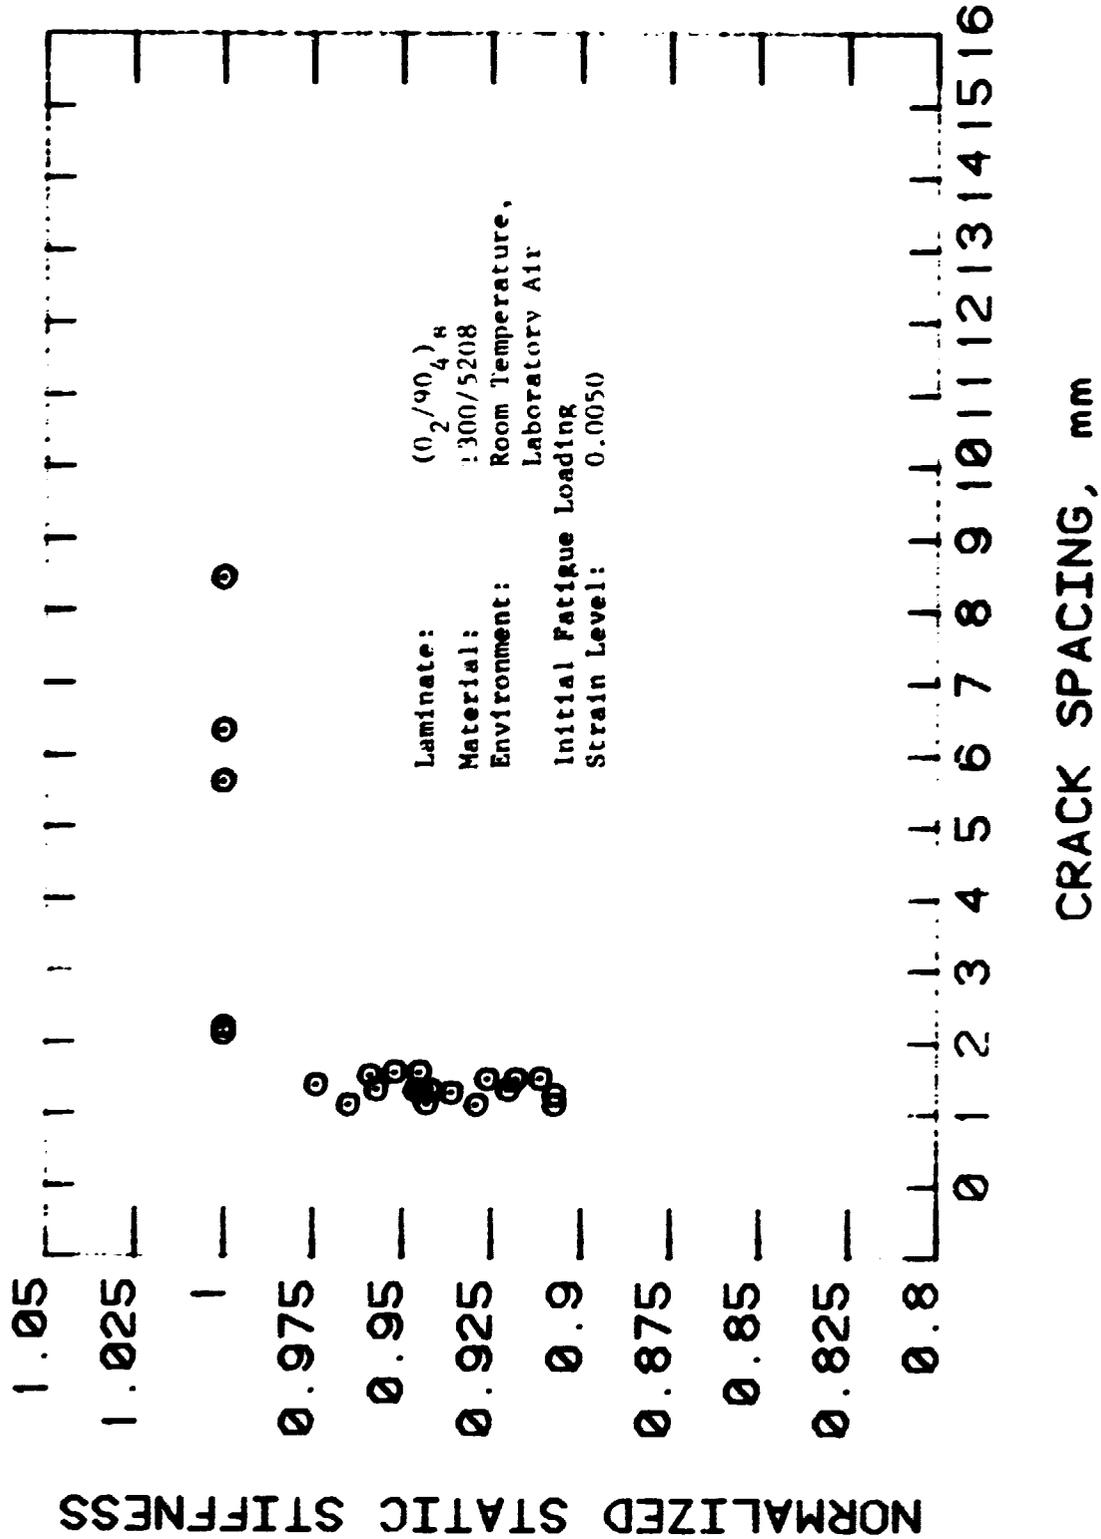
Figure 45: Normalized static stiffness vs. 90° matrix crack spacing for $(0_2/90_4)_s$ coupons fatigue cycled at an initial strain of 0.0050.
