NASA Contract Report CR-172211

A Study of Stiffness, Residual Strength and Fatigue Life Relationships for Composite Laminates

**LOCKHEED-CALIFORNIA COMPANY
A Division of Lockheed Corporation
Burbank, California 91520**

**Contract NAS1-16406
October, 1983**

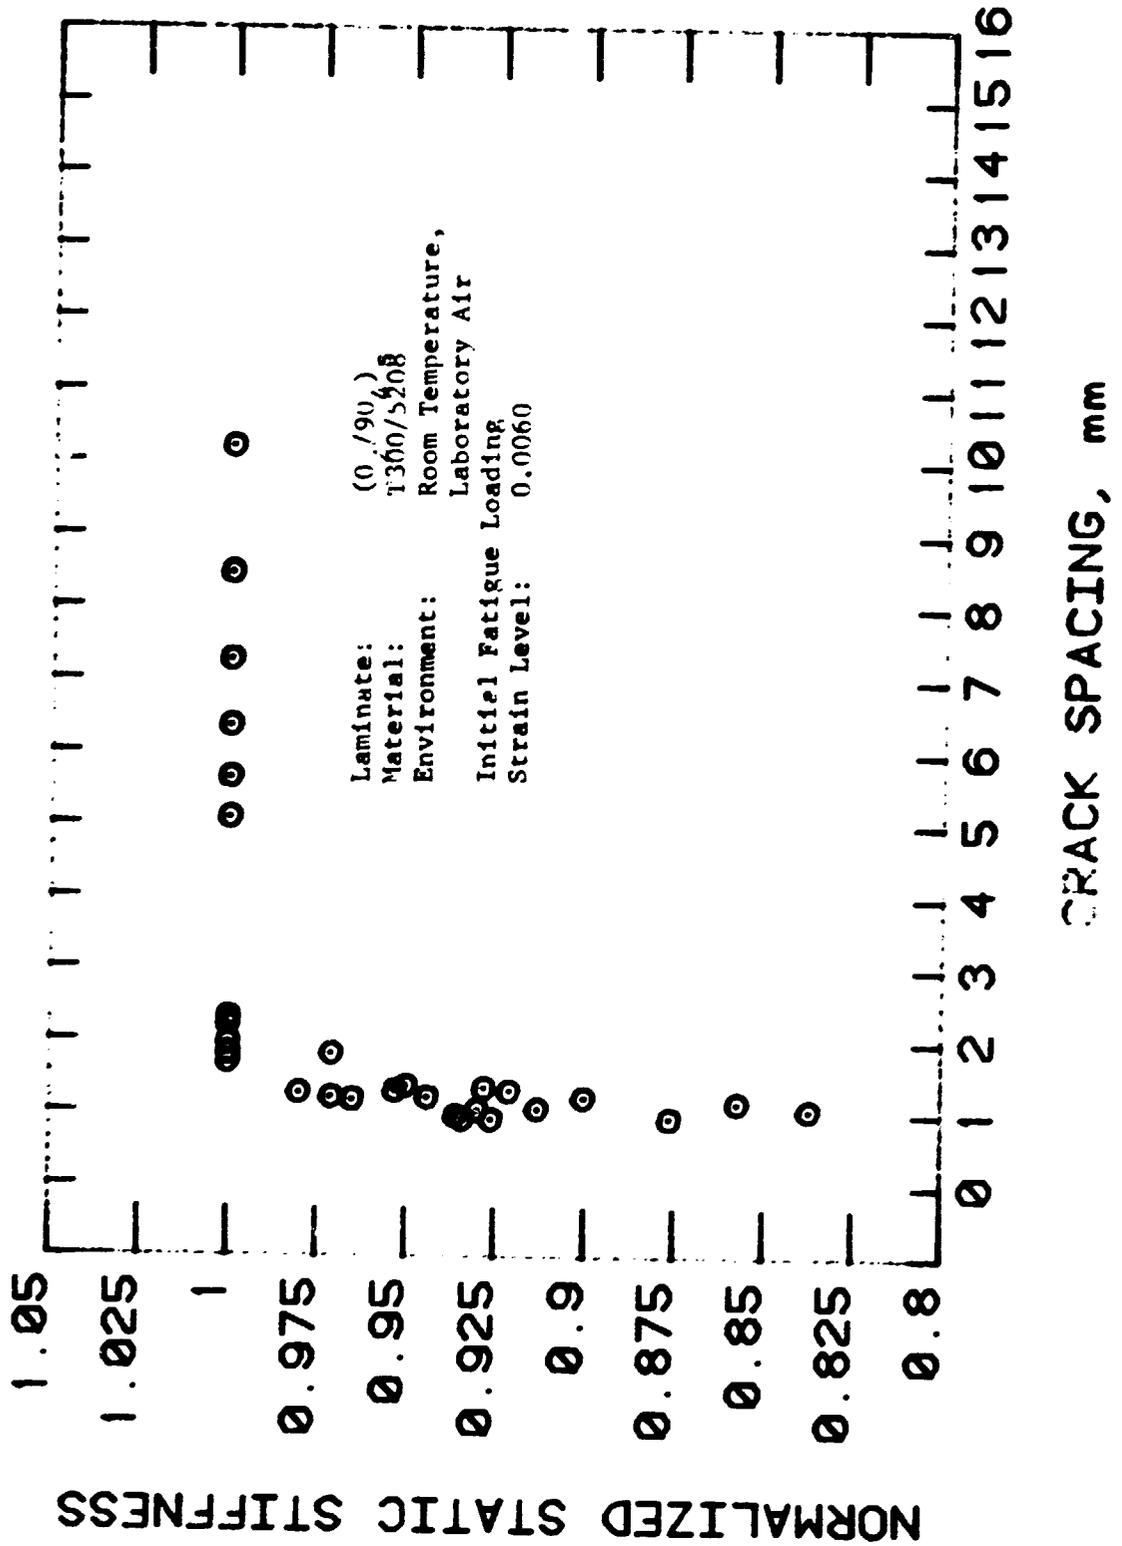
Figure 46: Normalized static stiffness vs. 90° matrix crack spacing for (0./90.)₄s coupons fatigue cycled at an initial strain of 0.0060.

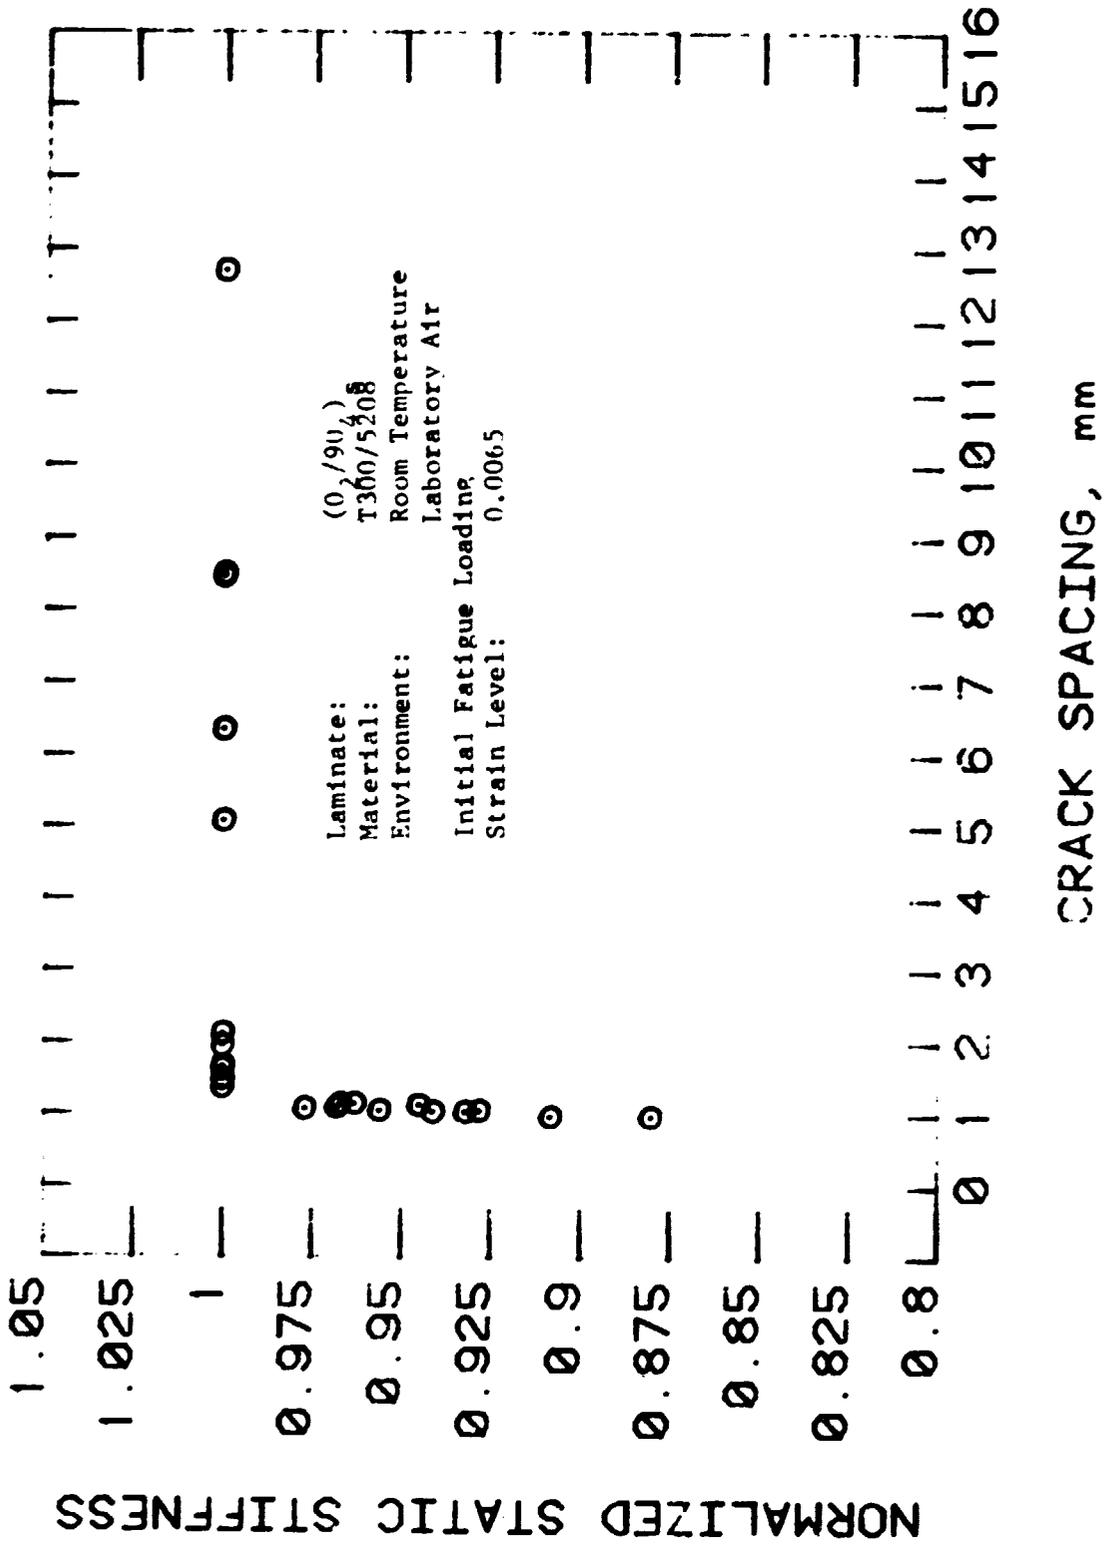
Figure 4/: Normalized static stiffness vs. 90° matrix crack spacing for (0₂/90)_s coupons fatigue cycled at an initial strain of 0.0065.

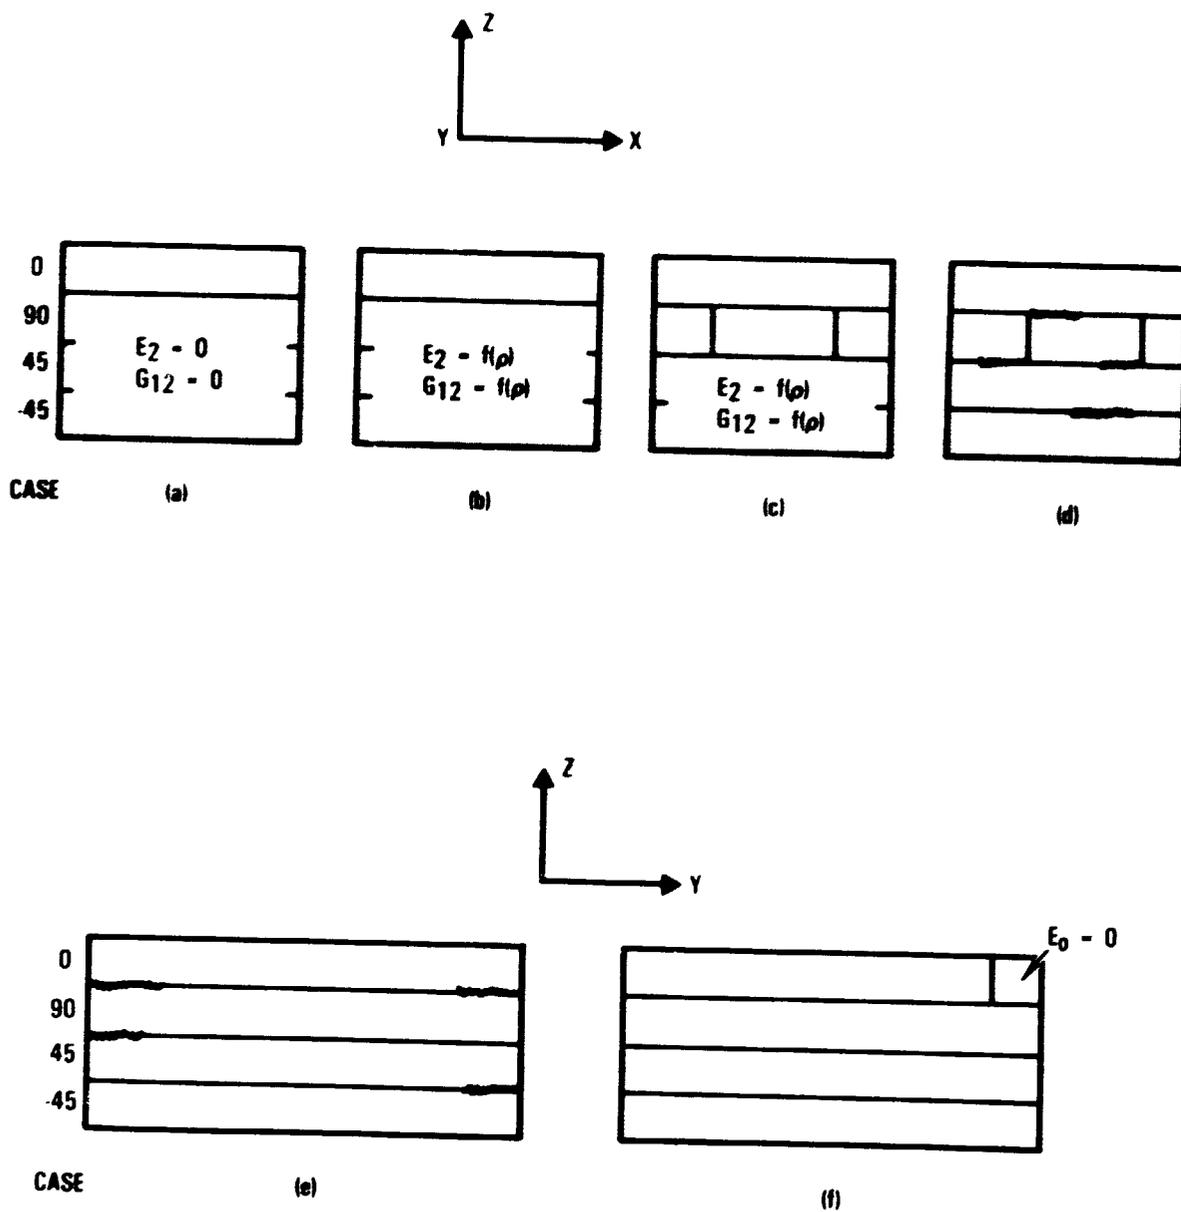
Figure 52: Section models of damage state in a $(0/90/+45)_s$ laminate.

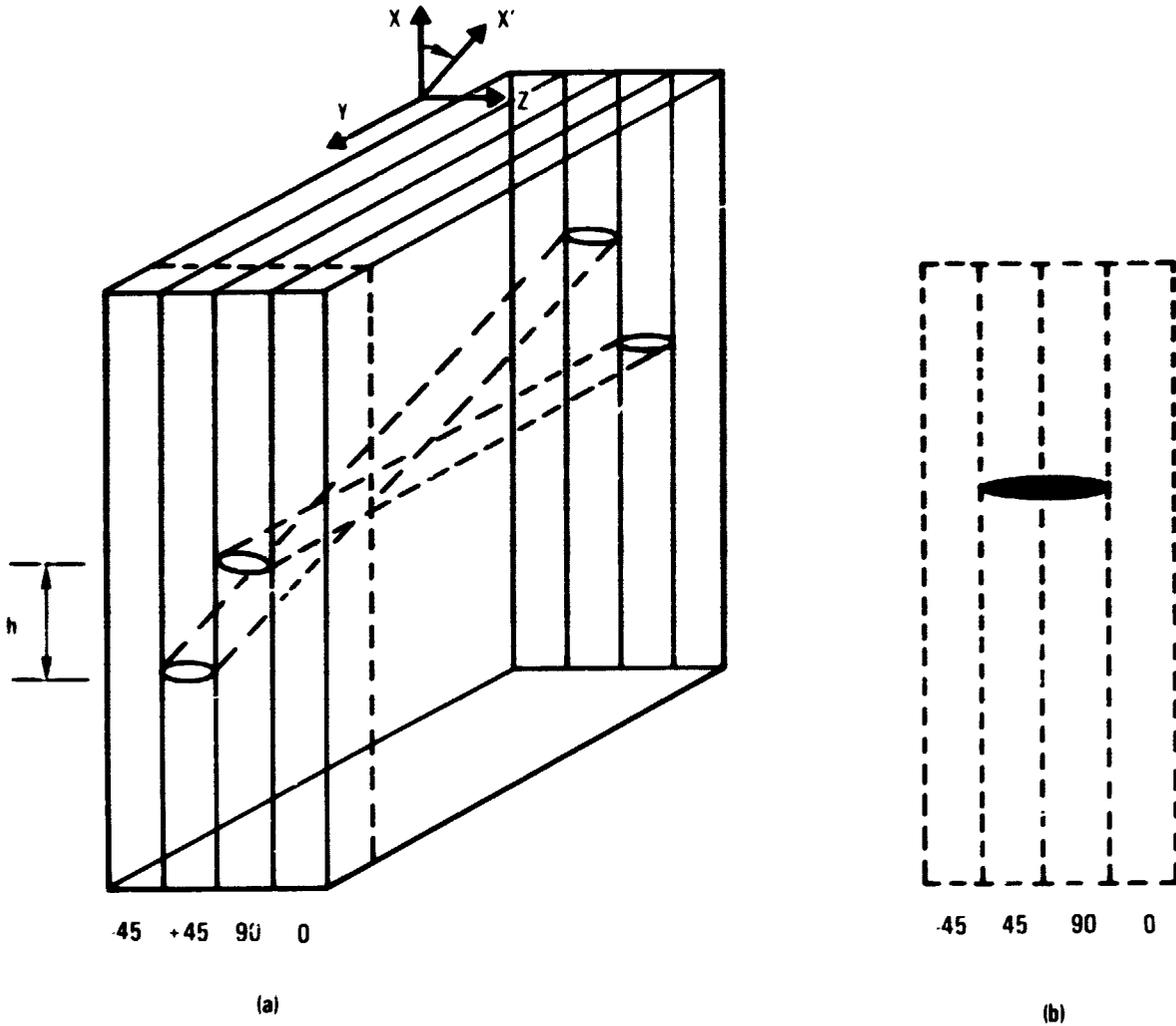
Figure 53: Intersection of 45° and 90° ply matrix cracks.

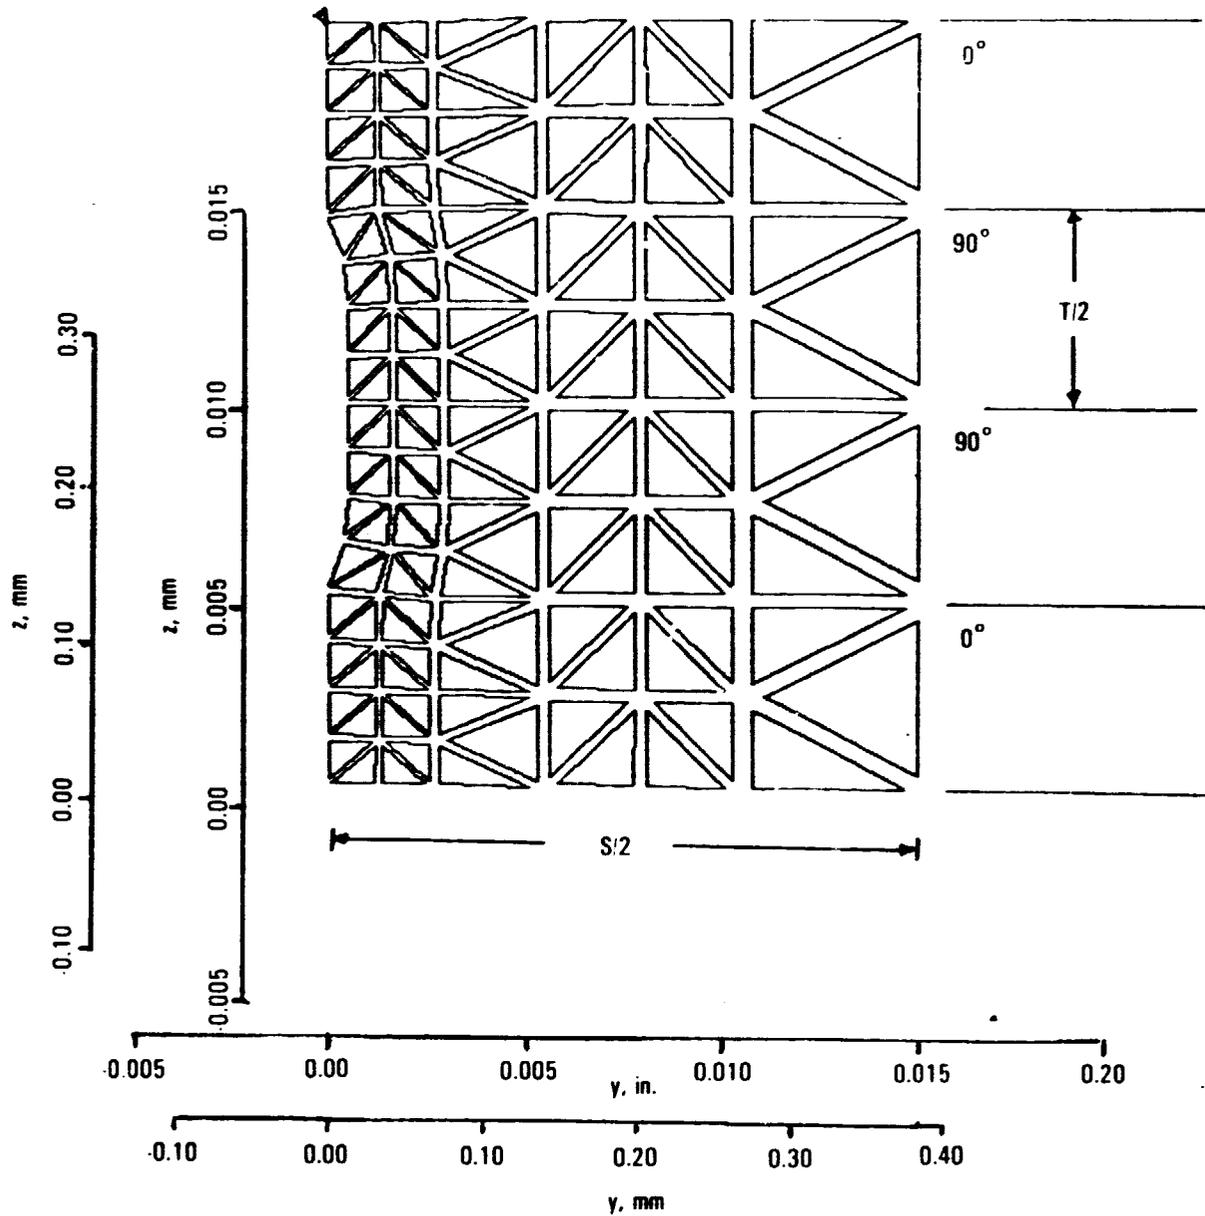
Figure 55: Crack Plane Detail of Finite Element Model Shown in Figure 54.

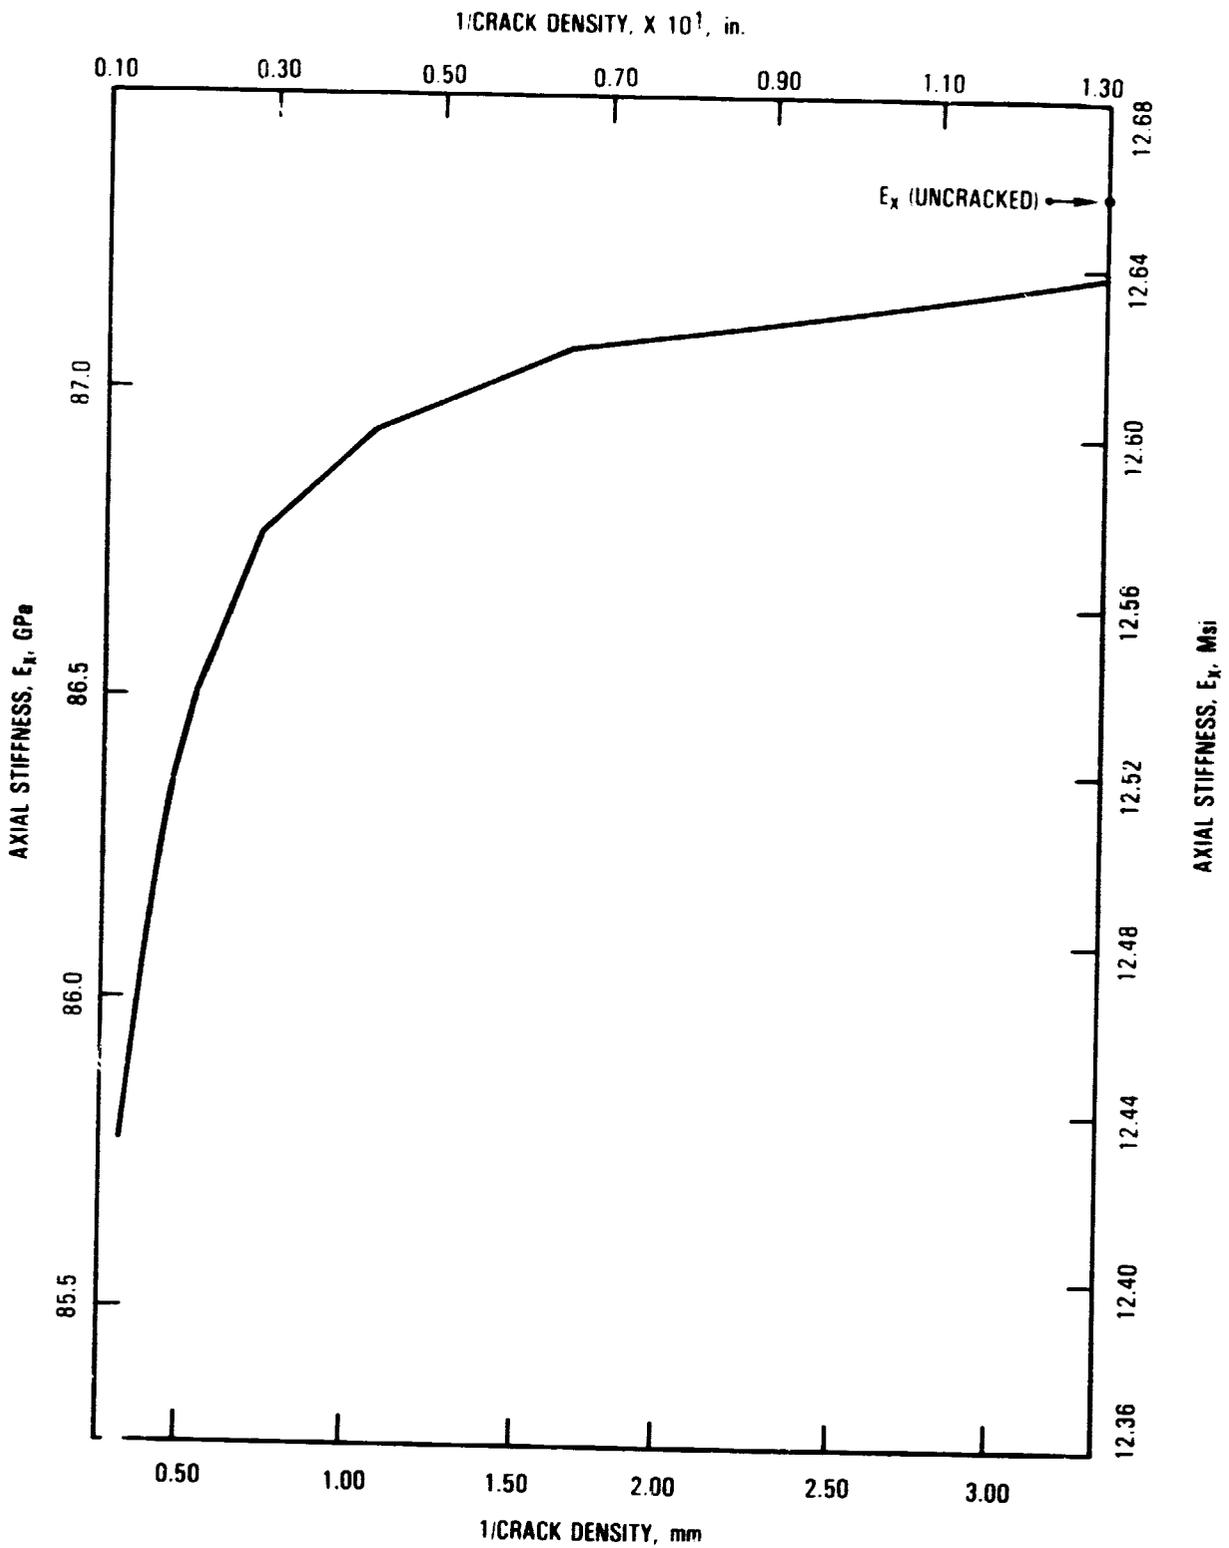
FIGURE 56 (0/90)₅ LAMINATE STIFFNESS VS CRACK DENSITY (E_x VS ρ^{-1})

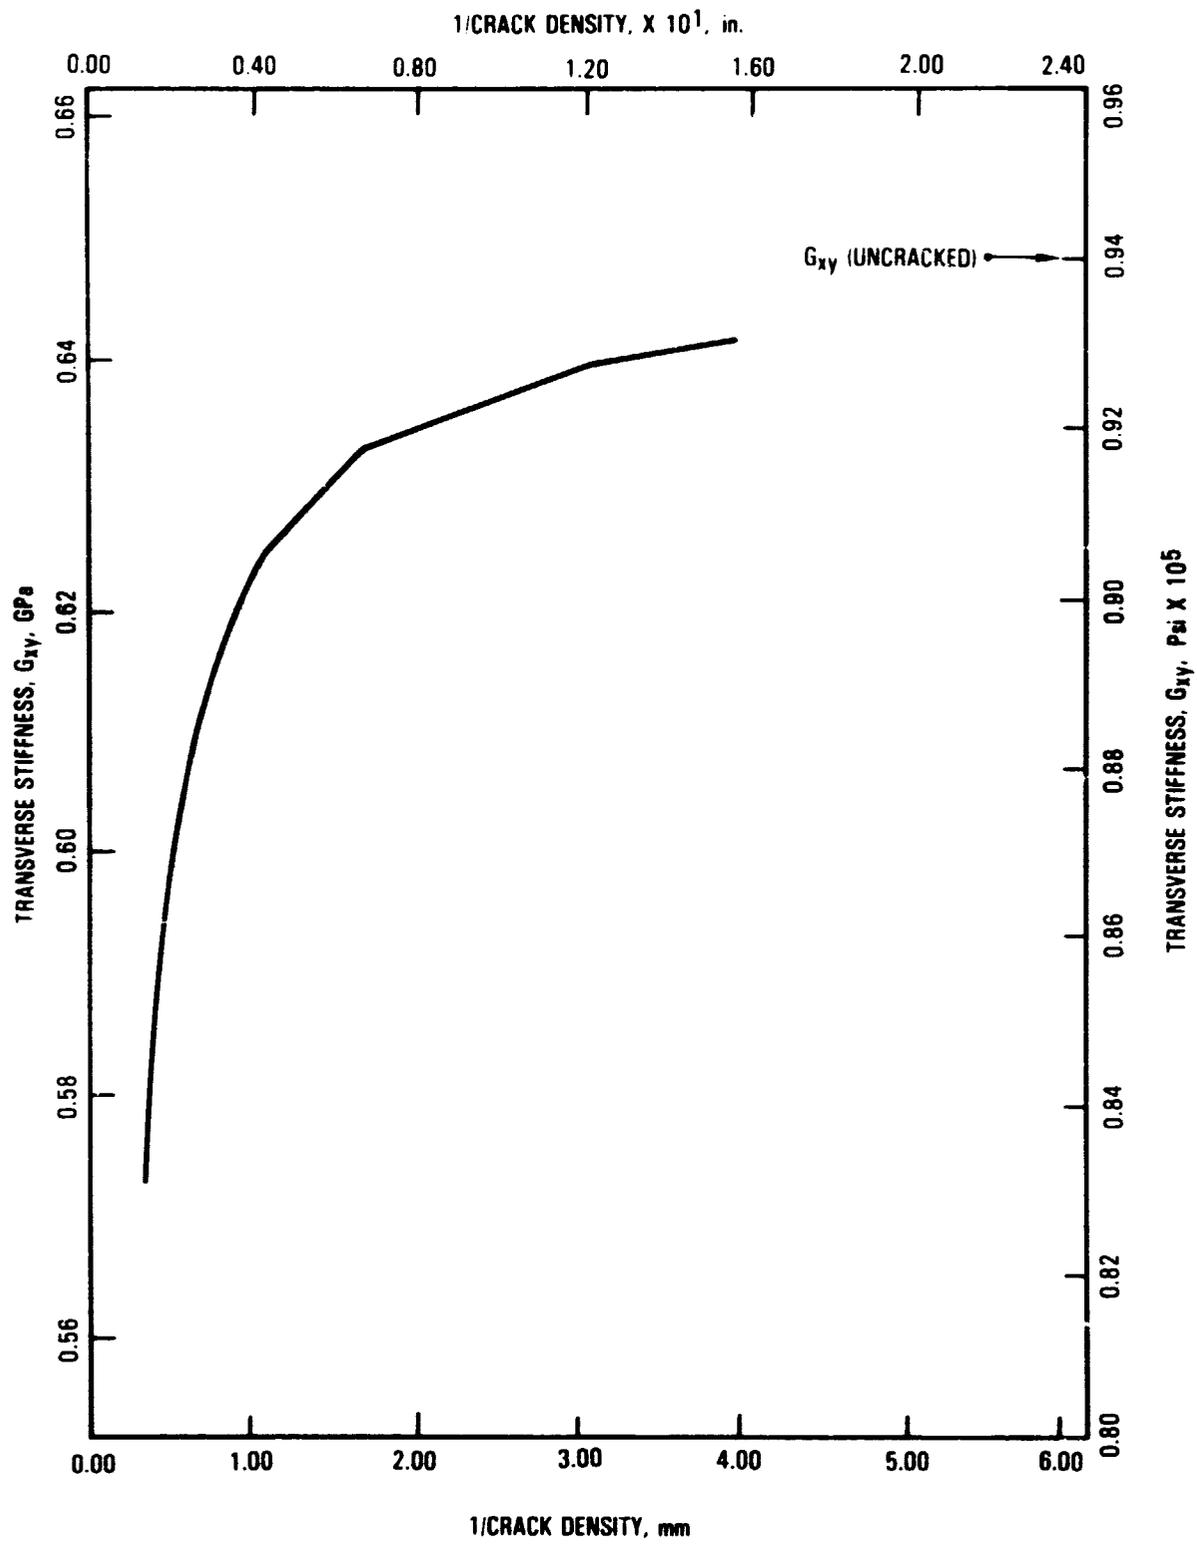
FIGURE 57. (0/90)_S SHEAR STIFFNESS VS CRACK DENSITY (G_{xy} VS ρ^{-1})

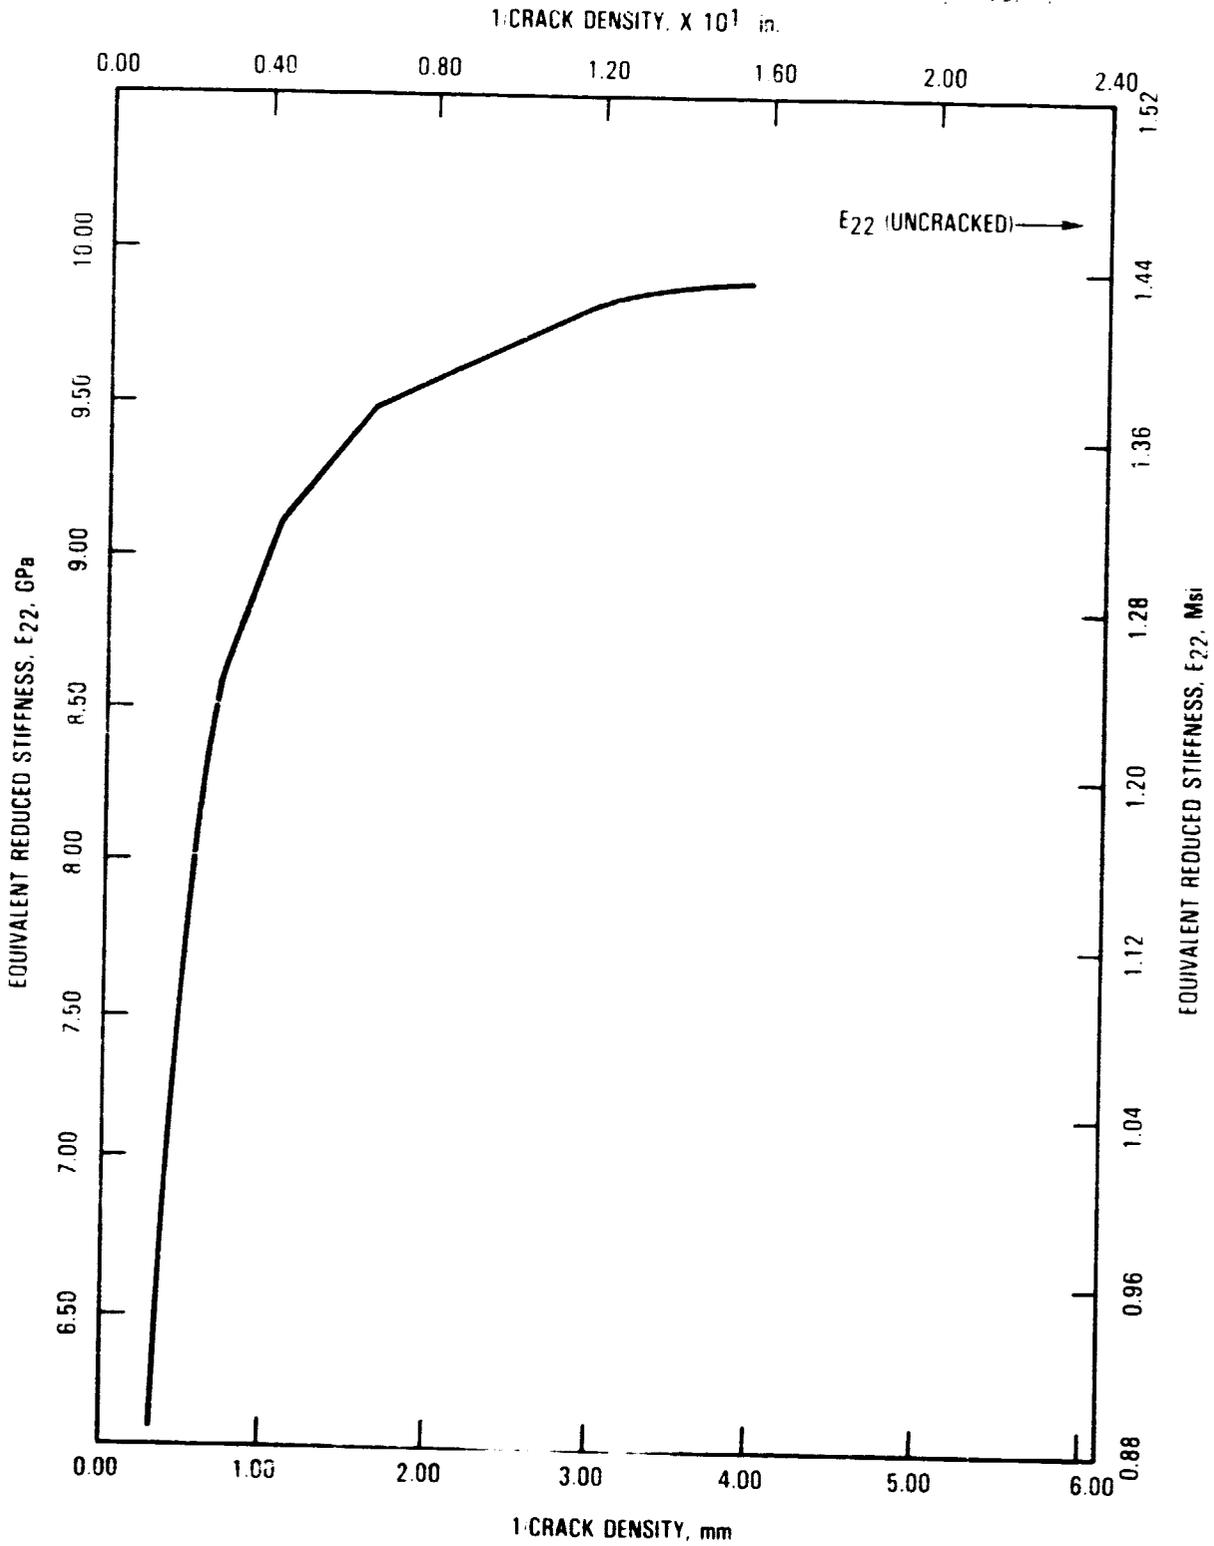
FIGURE 5-1. EQUIVALENT STIFFNESS VS CRACK DENSITY E_{22}^{EQUIV} VS P 1)

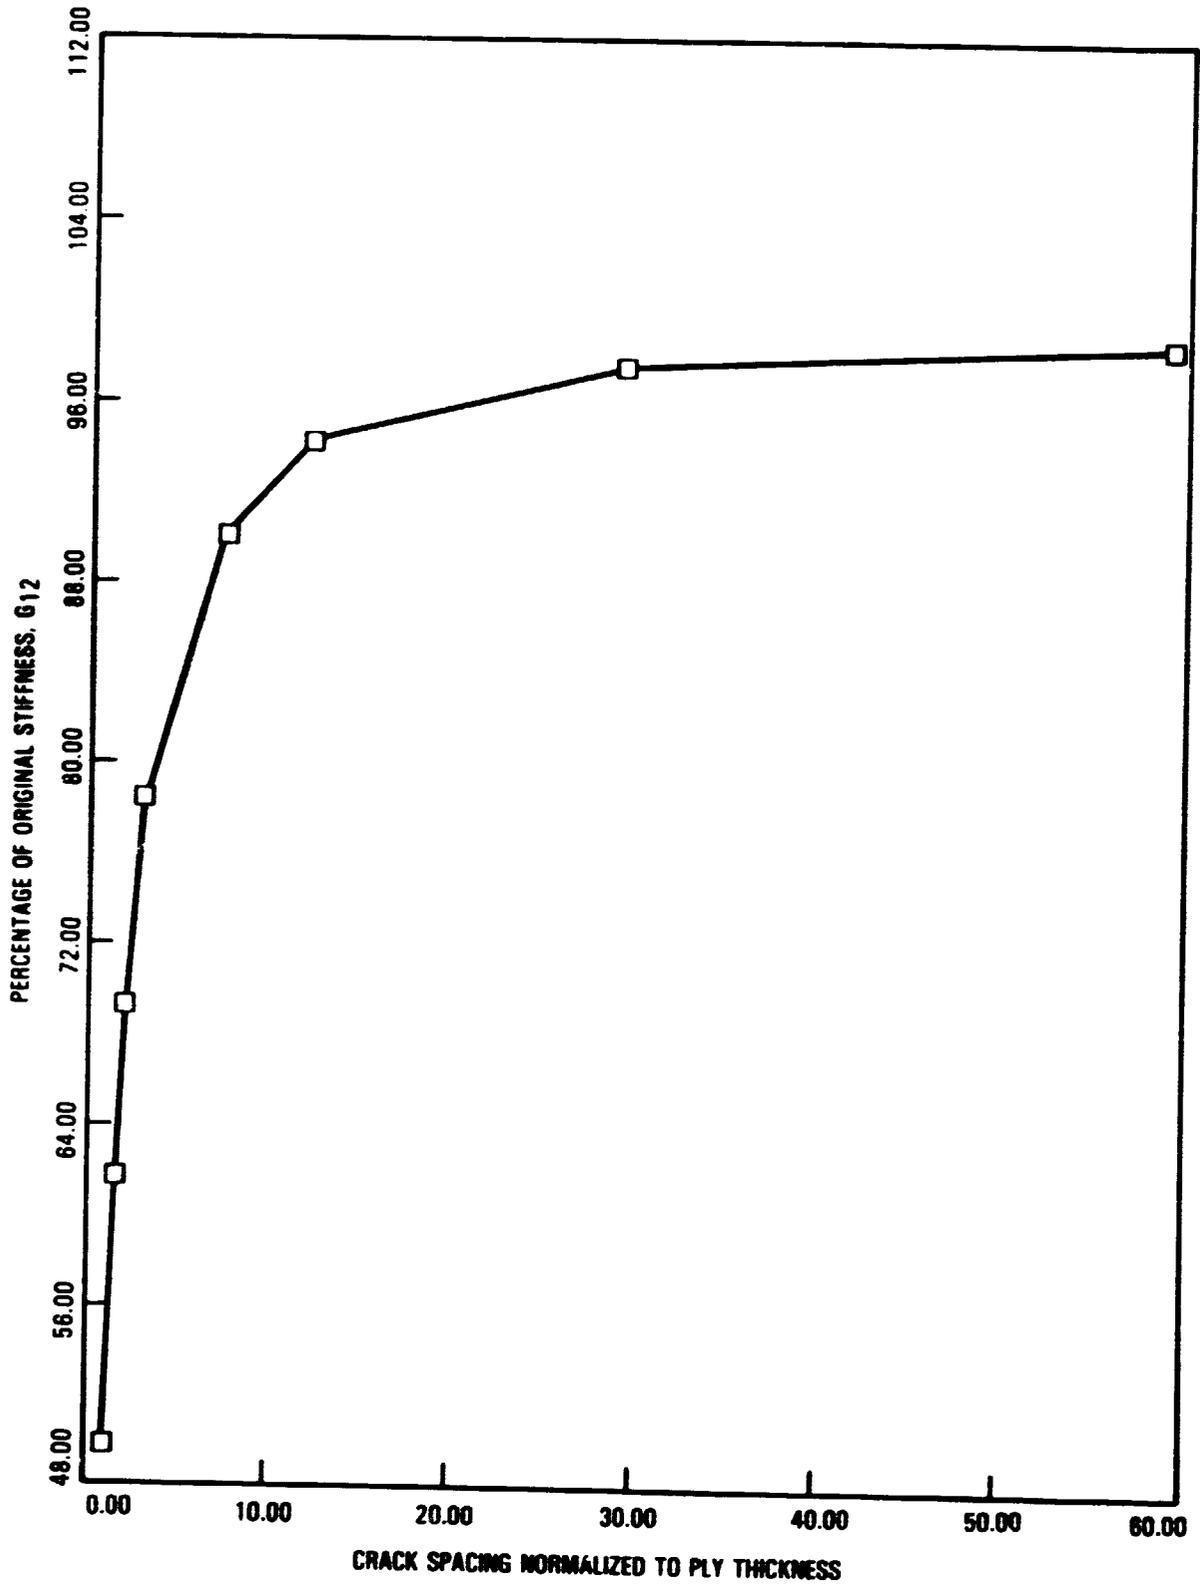
Figure 61: Effective modulus G_{12} for a $(0/90)_s$ laminate.

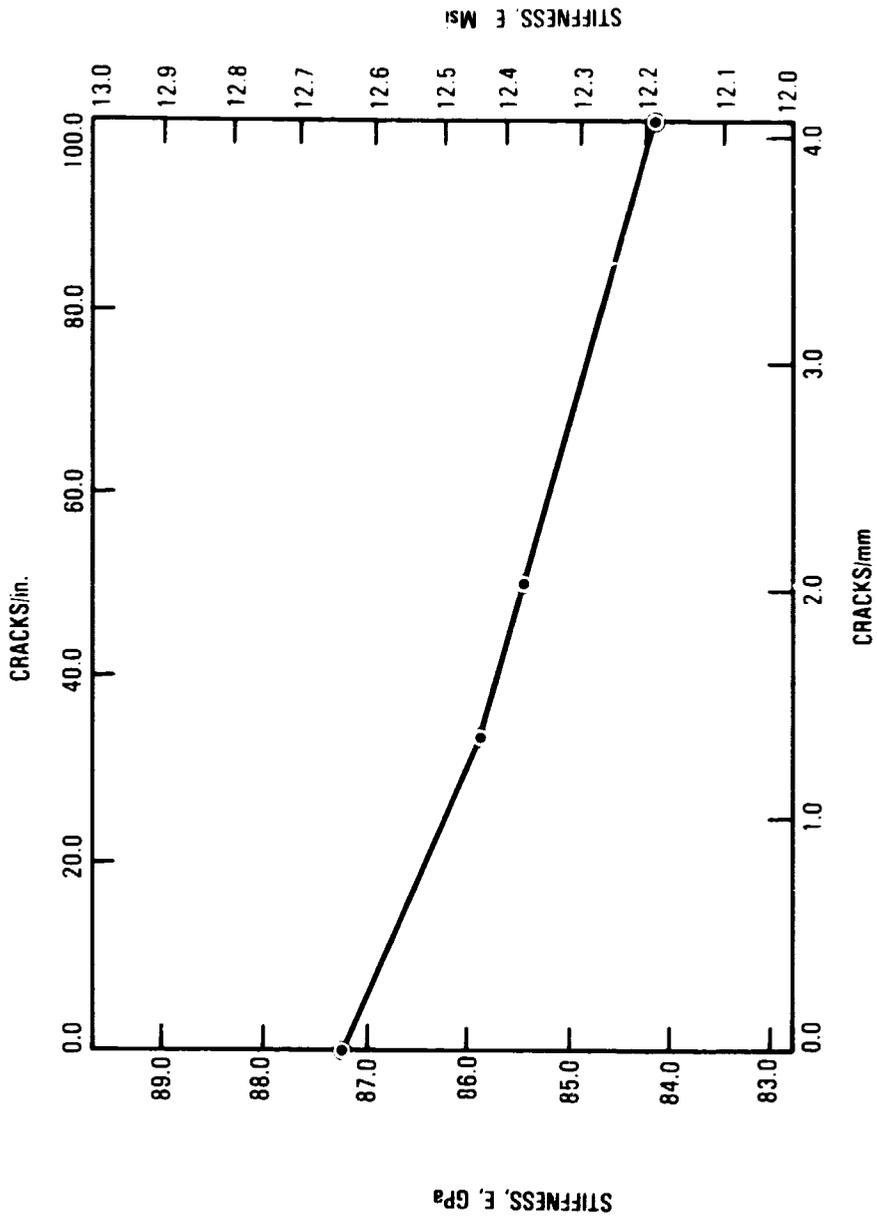
FIGURE 6: (0/90)_s LAMINATE MODULUS VERSUS 90° PLY TRANSVERSE CRACK SPACING.

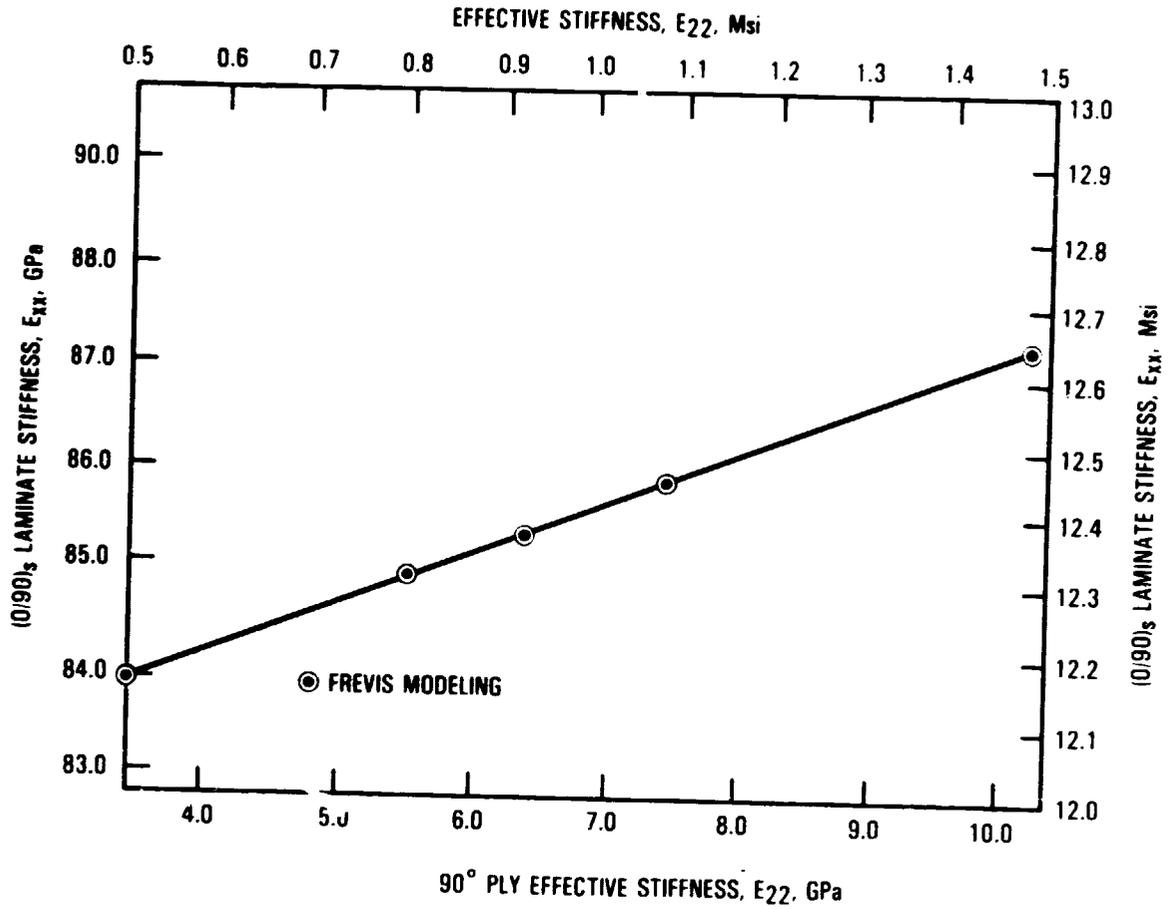
FIGURE 63. LAMINATE MODULUS VERSUS 90° PLY TRANSVERSE MODULUS REDUCTION FOR A (0/90)₅ LAMINATE.

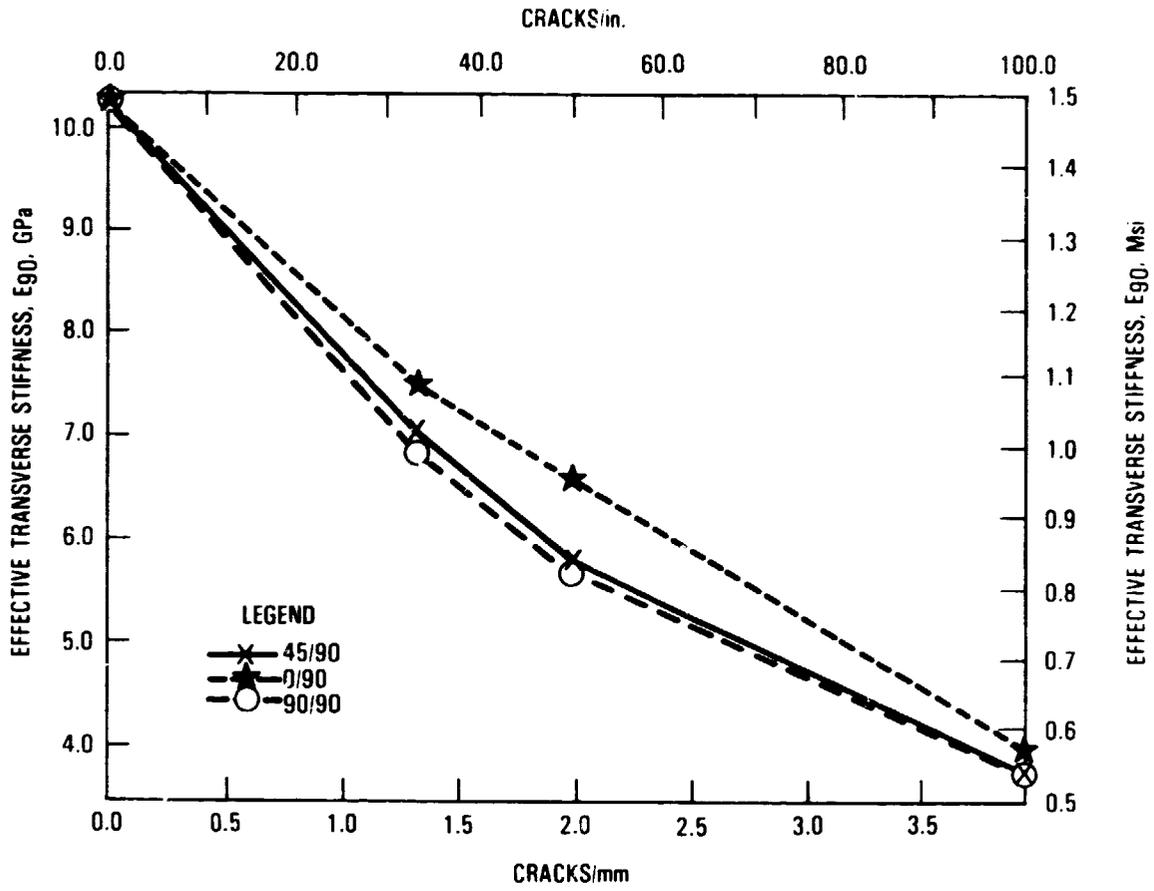
FIGURE 6: MASTER CURVES OF EFFECTIVE TRANSVERSE MODULUS VERSUS CRACK SPACING FOR VARIOUS LAYUPS.

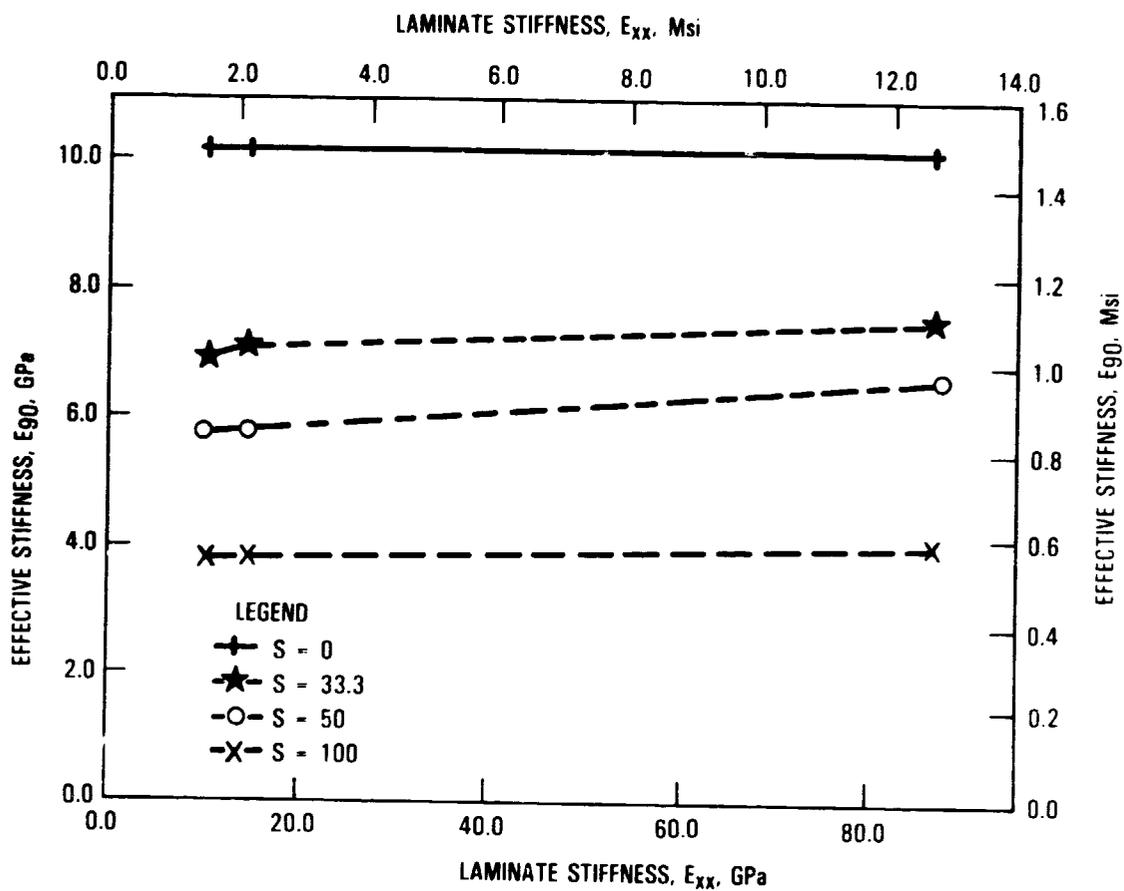
FIGURE 65 . EFFECTIVE STIFFNESS AS A FUNCTION OF INITIAL LAMINATE STIFFNESS

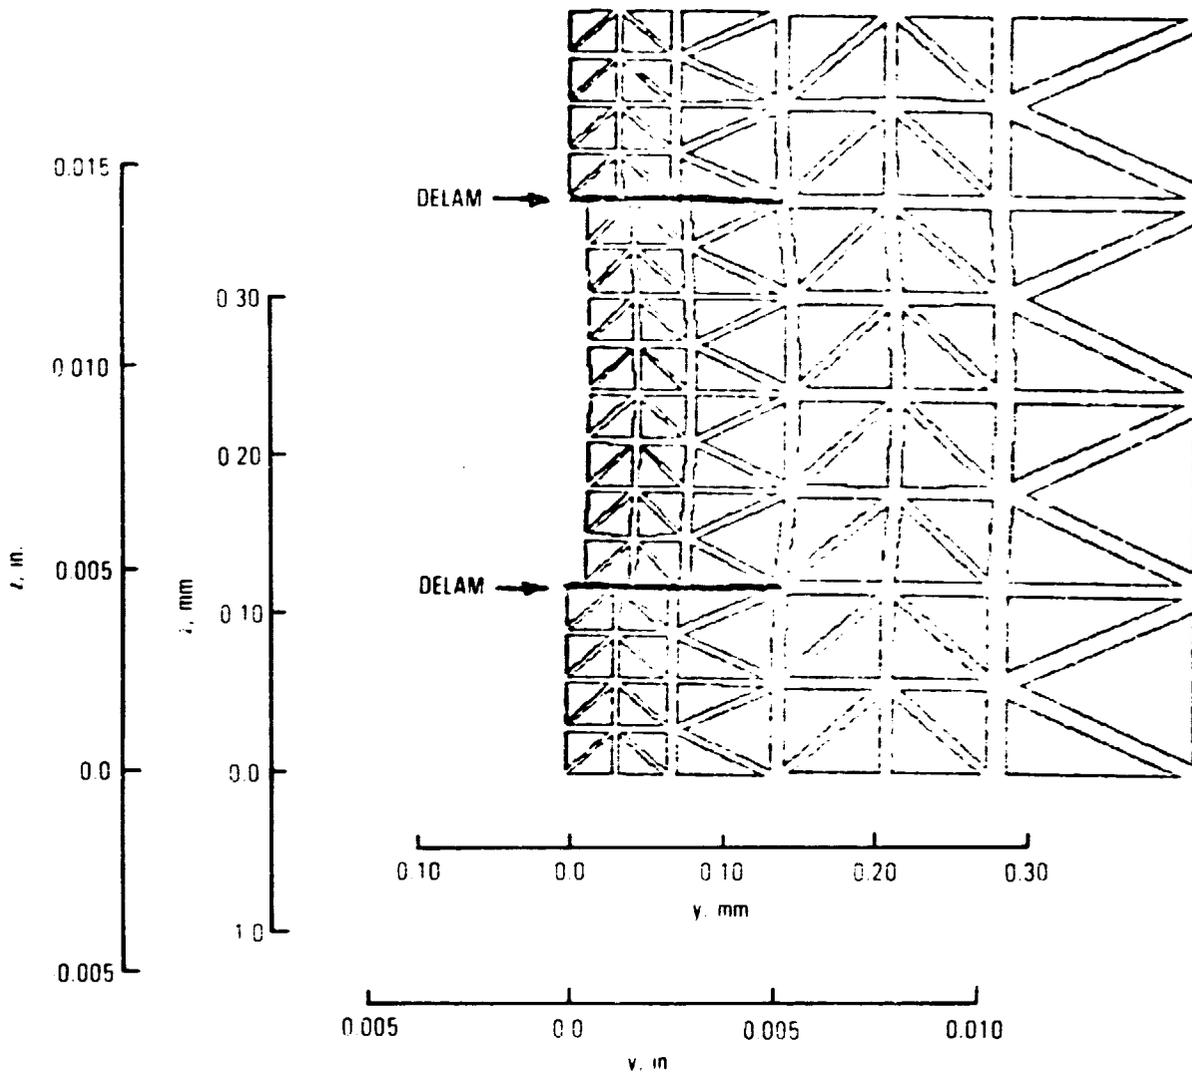
FIGURE 69. FINITE ELEMENT MODEL USED FOR ANALYZING COMBINED EFFECT OF A TRANSVERSE CRACK AND DELAMINATION IN A $(O_2 90_4)_S$ LAMINATE

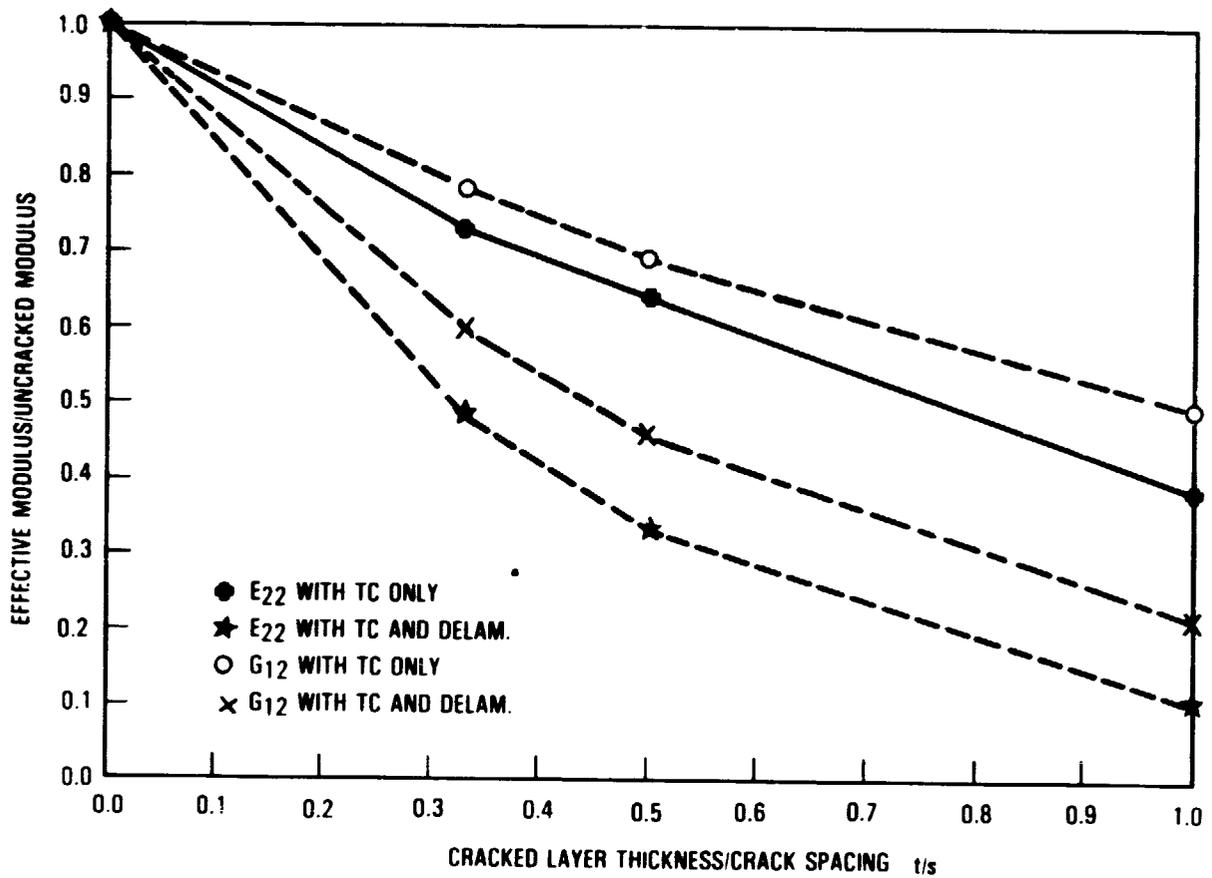
FIGURE 70. NORMALIZED EFFECTIVE MODULUS VERSUS CRACK DENSITY

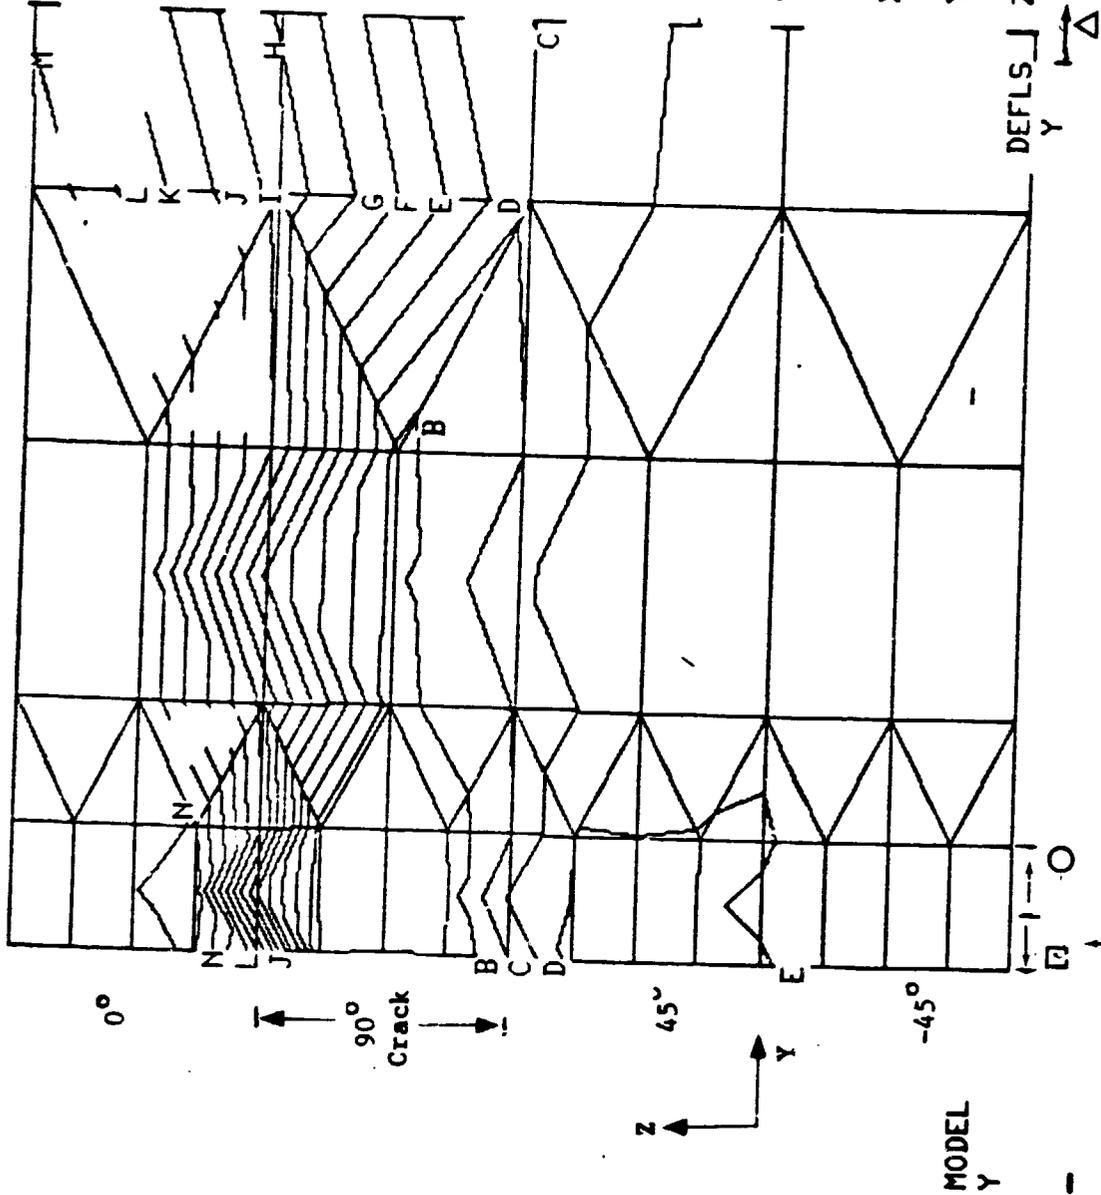
Figure 72: σ_{yy} applied stress model for $(0/90/45/-45)_s$ laminates.
