NASA Contract Report CR-172211

A Study of Stiffness, Residual Strength and Fatigue Life Relationships for Composite Laminates

**LOCKHEED-CALIFORNIA COMPANY
A Division of Lockheed Corporation
Burbank, California 91520**

**Contract NAS1-16406
October, 1983**

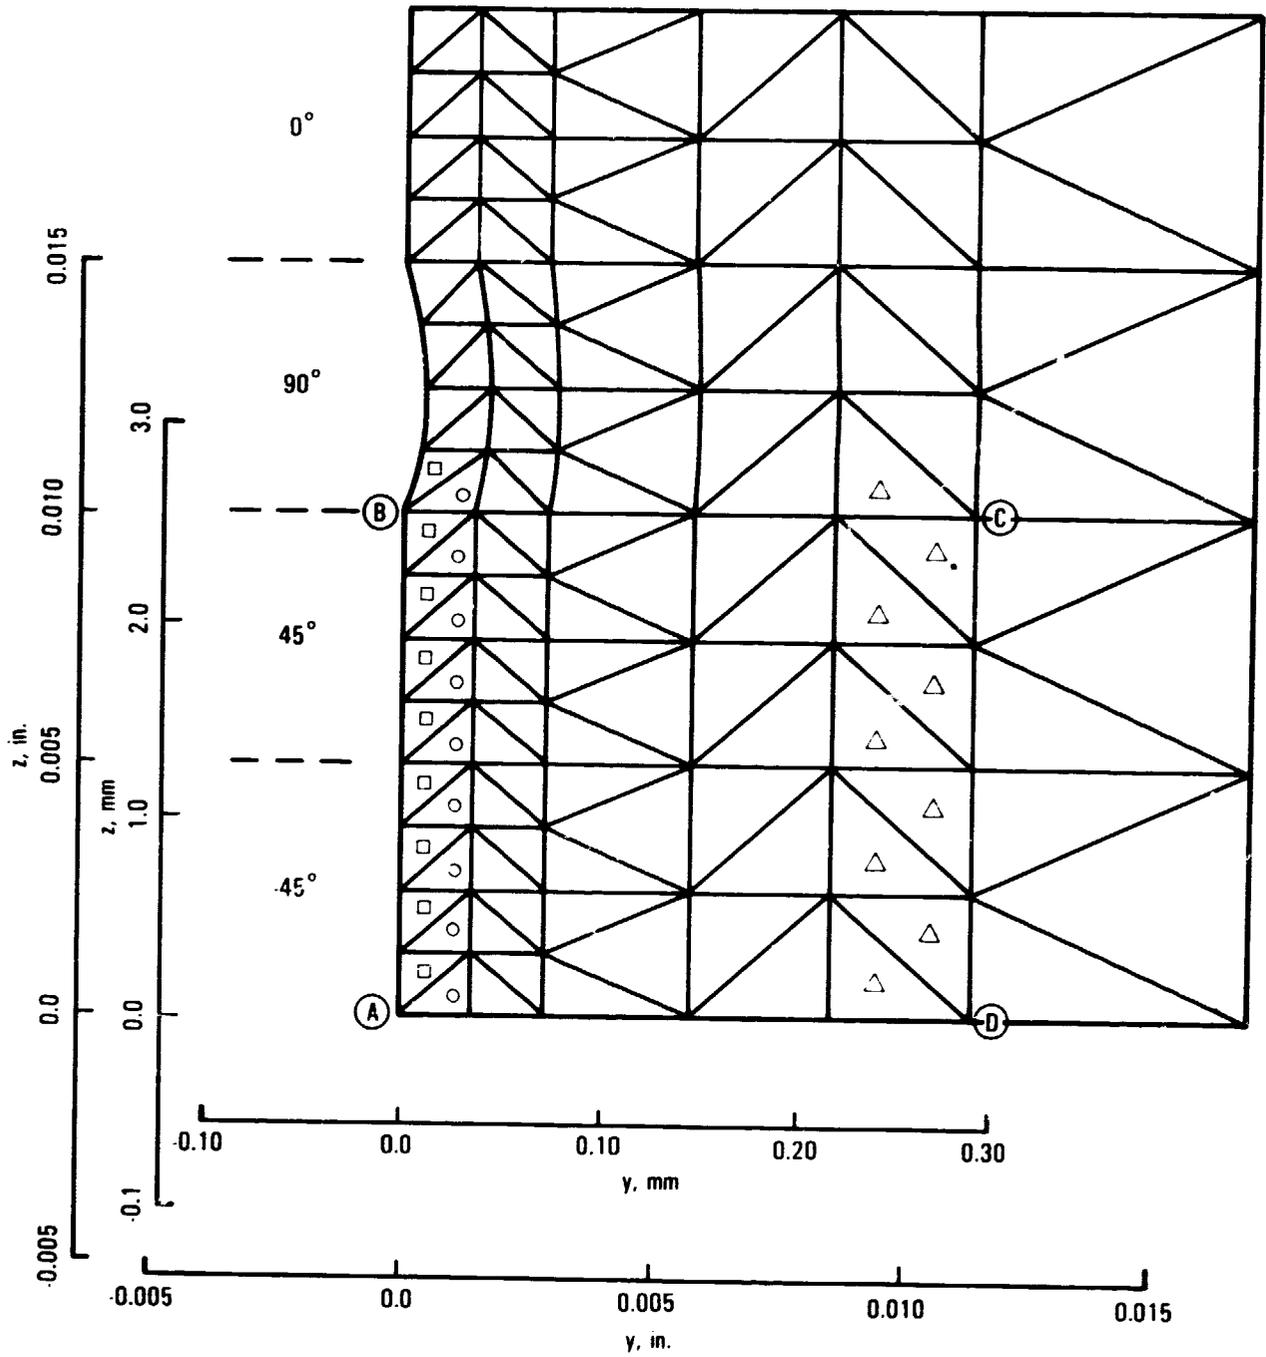
Figure 73: Finite element grid used to model the effect of 90° ply cracks on the stress state in 45° plies of a $(0/90/+45)_s$ laminate.

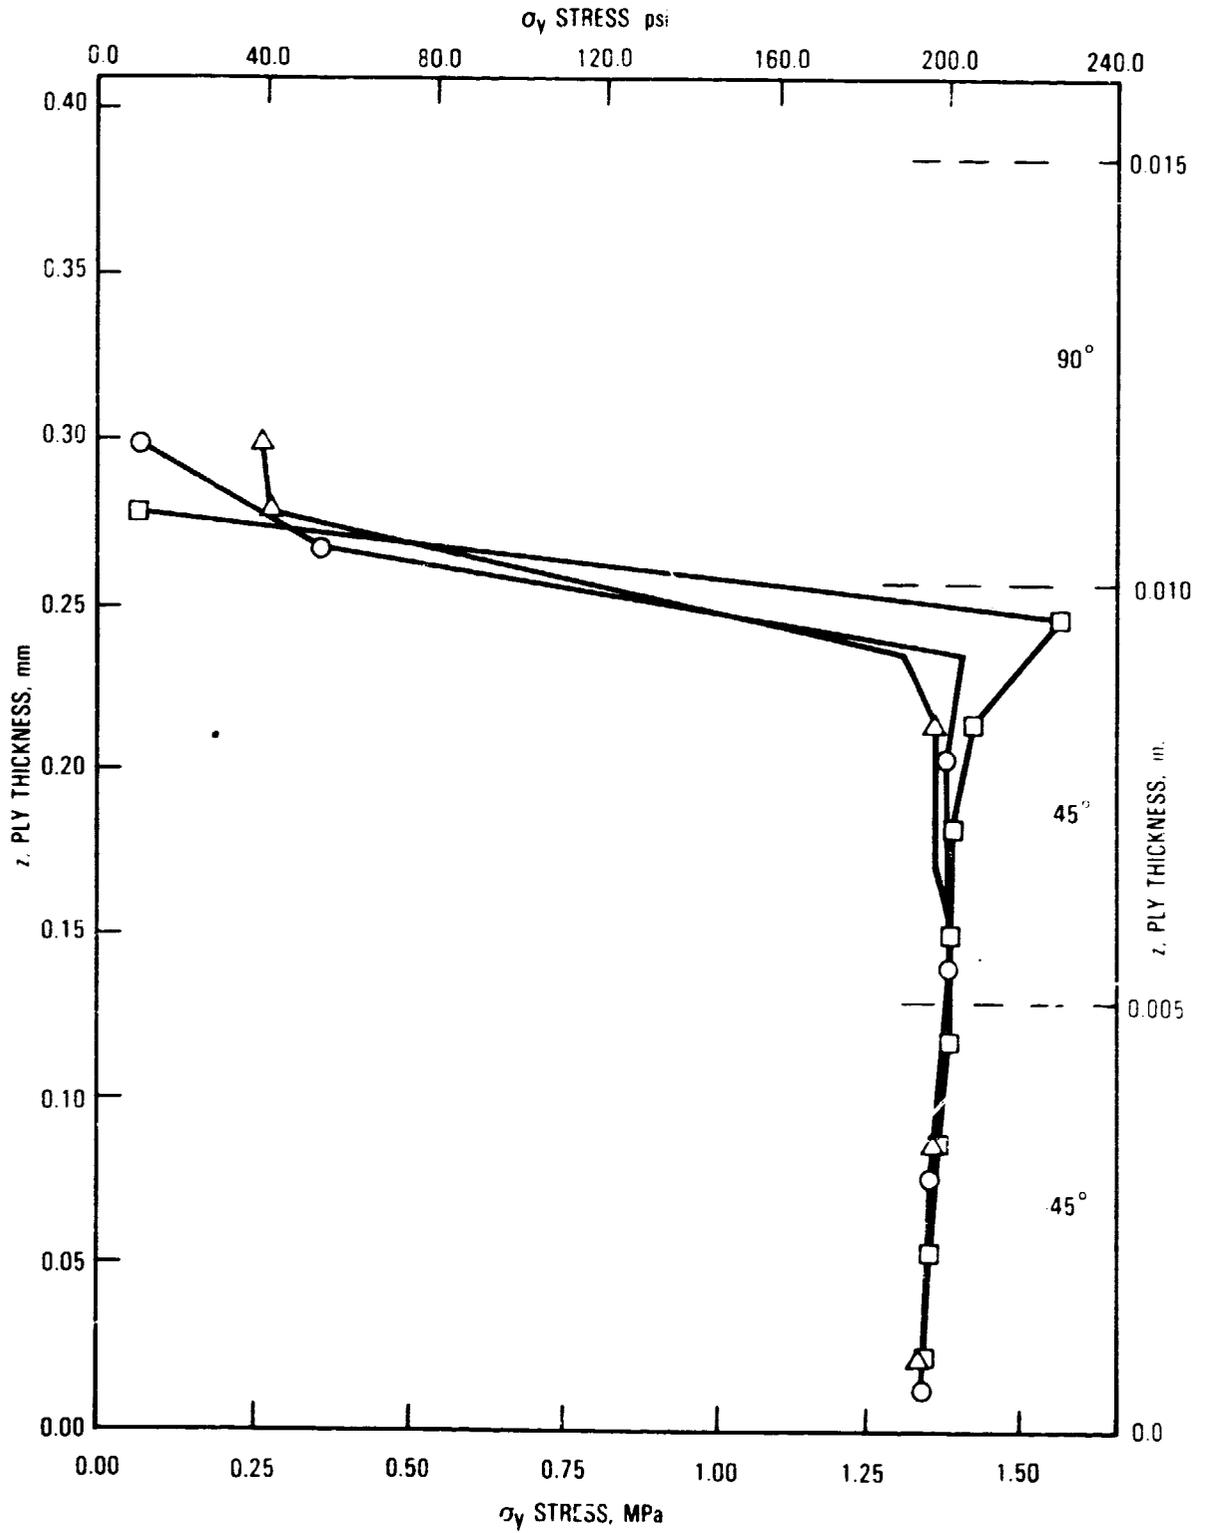
Figure 74: σ_y stress state as a function of z for model of Figure 73.

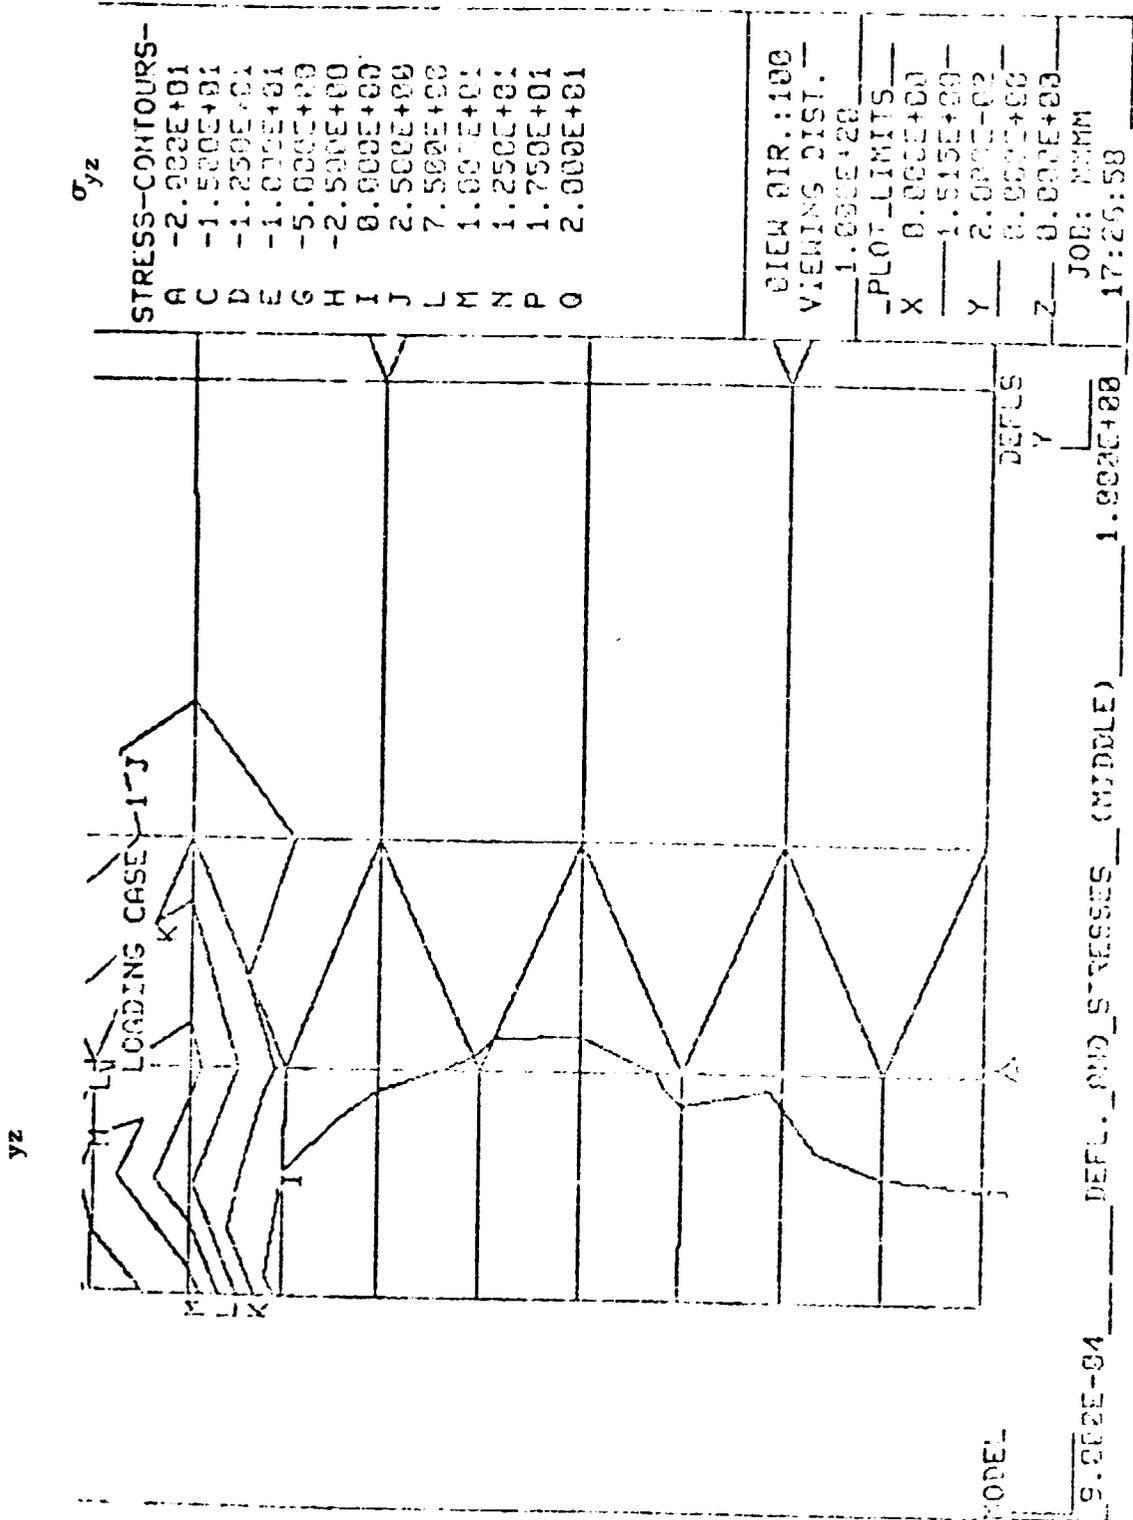
Figure 83: σ_{yz} Stress Contours for Region A-B-C-D of Figure 73.

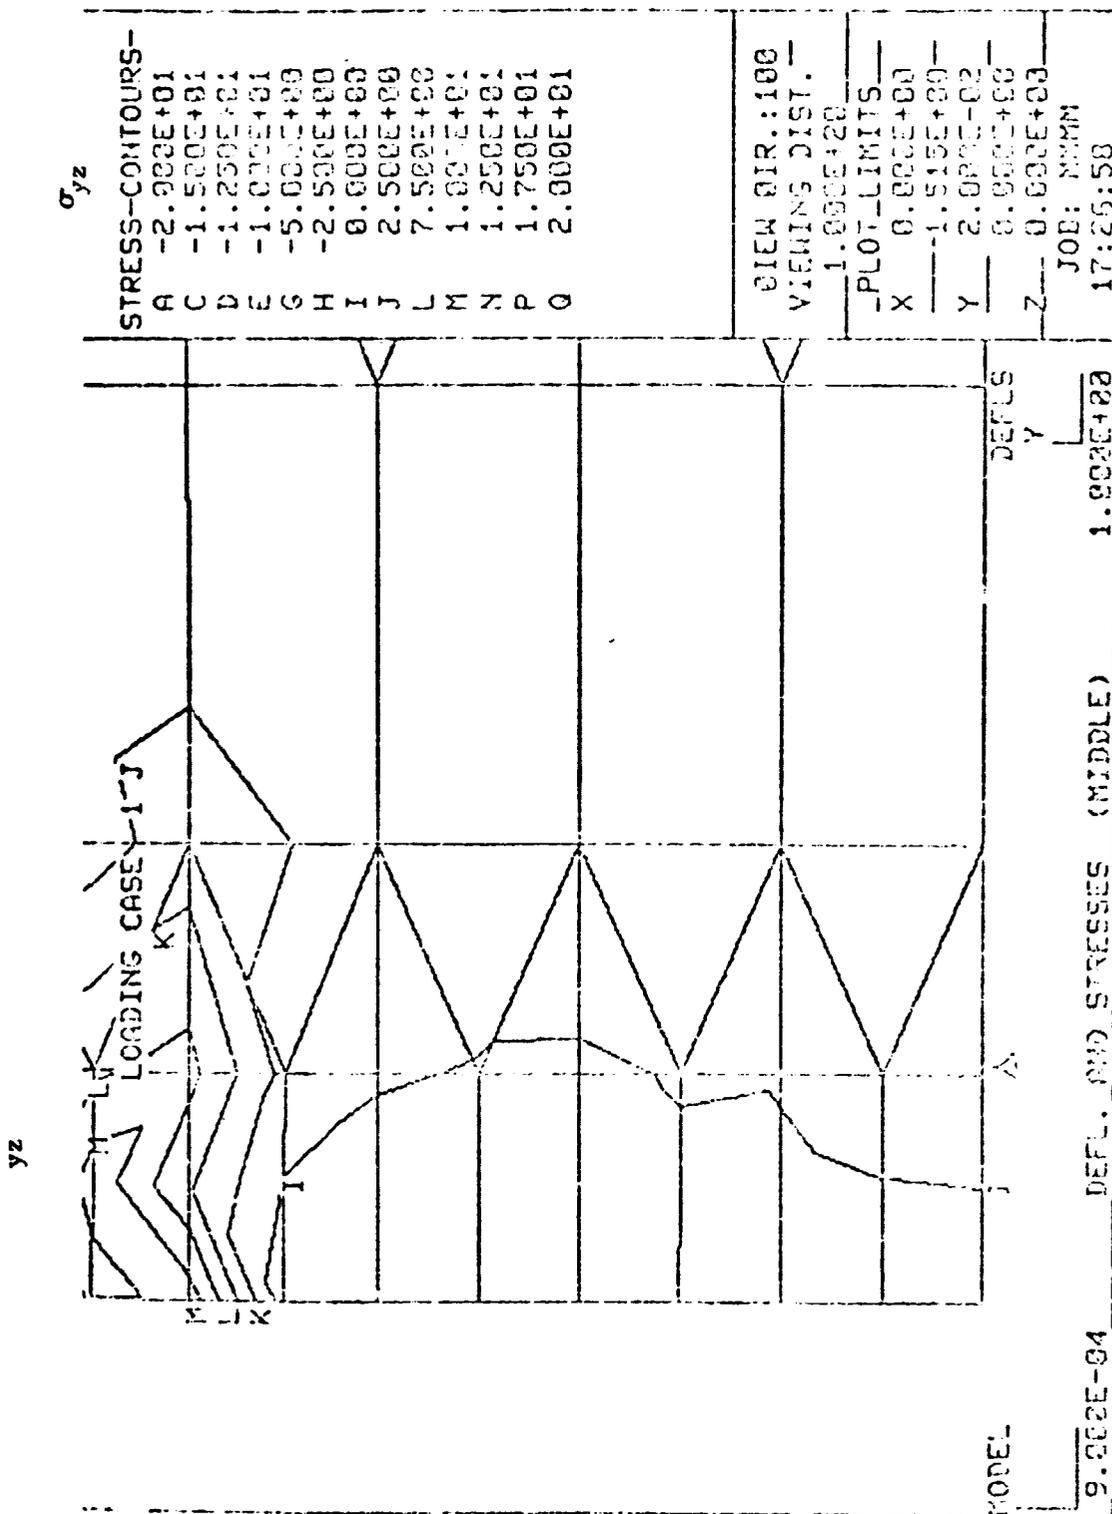
Figure 83: σ_{yz} Stress Contours for Region A-B-C-D of Figure 73.

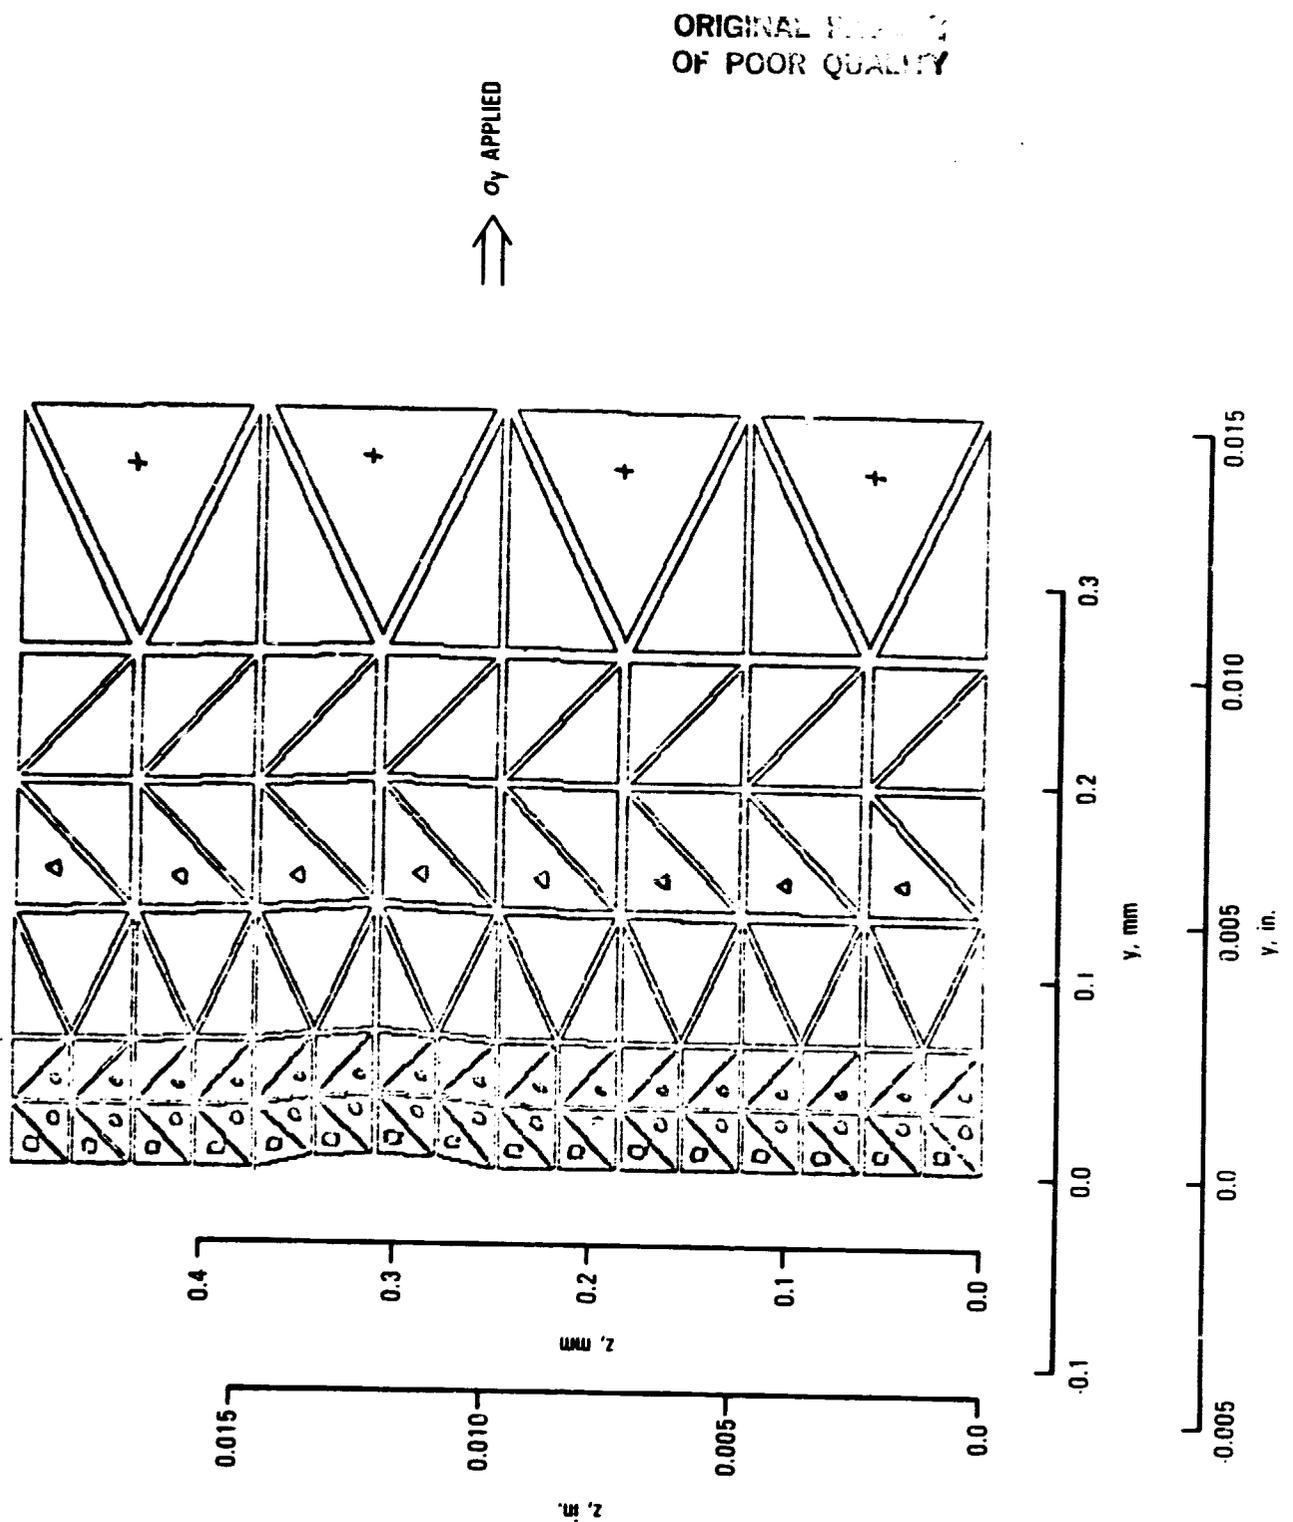
Figure 84: Finite element grid used to model influence of a neighboring ply stiffness on the stress gradient near a crack.

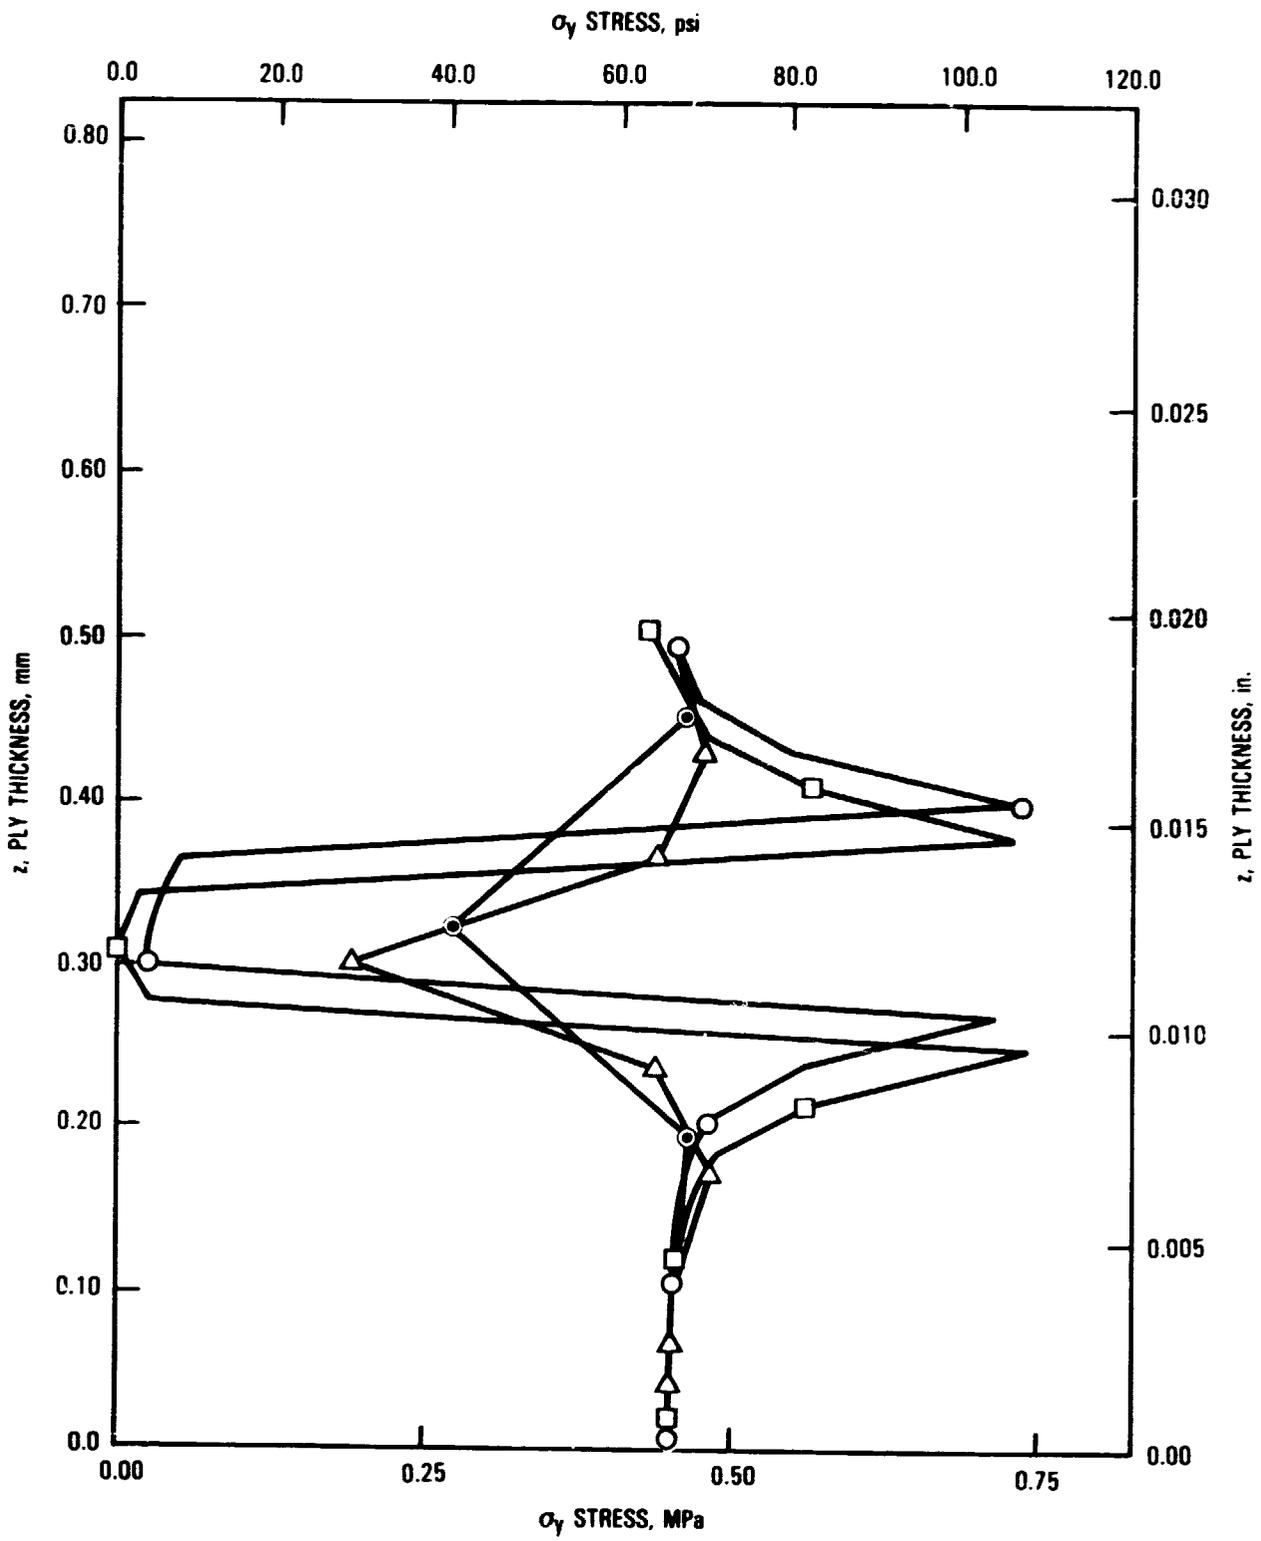
Figure 85: σ_y stress gradients near a crack for $(0)_8$ laminate.

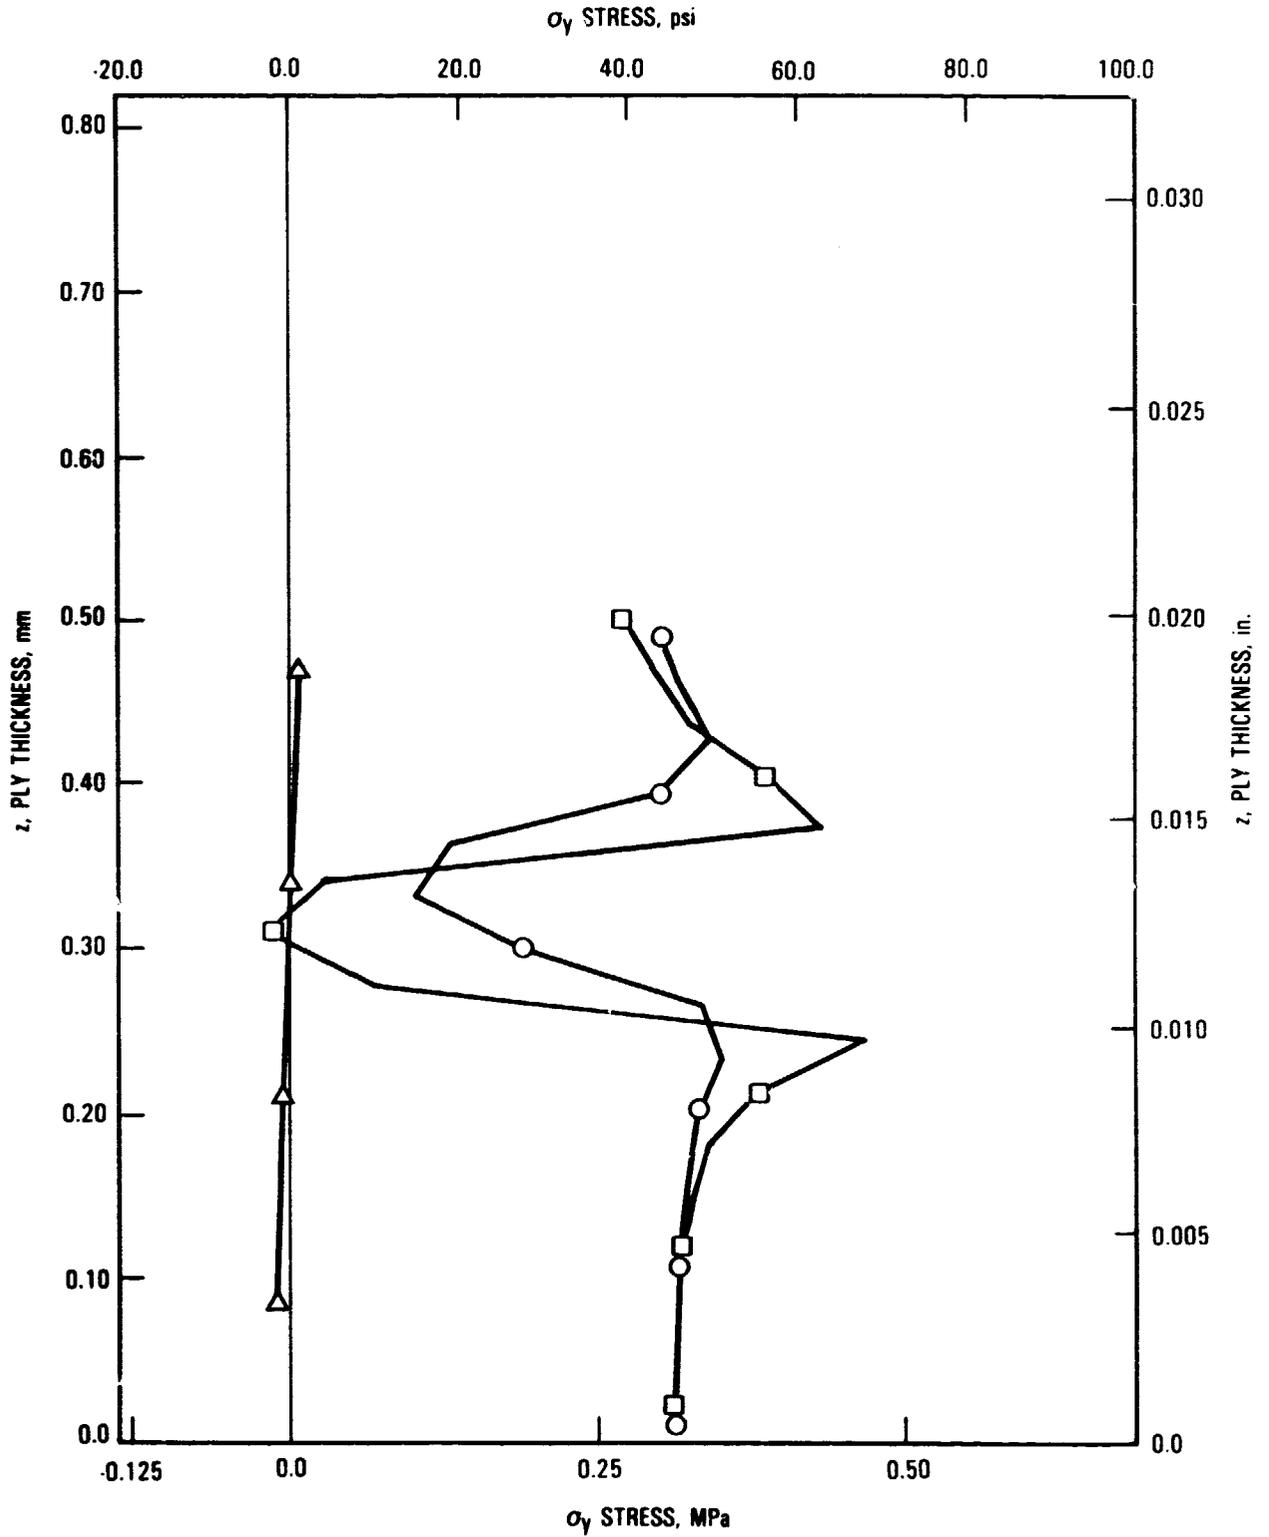
Figure 86: σ_y stress gradients near a crack in a $(90)_8$ laminate.

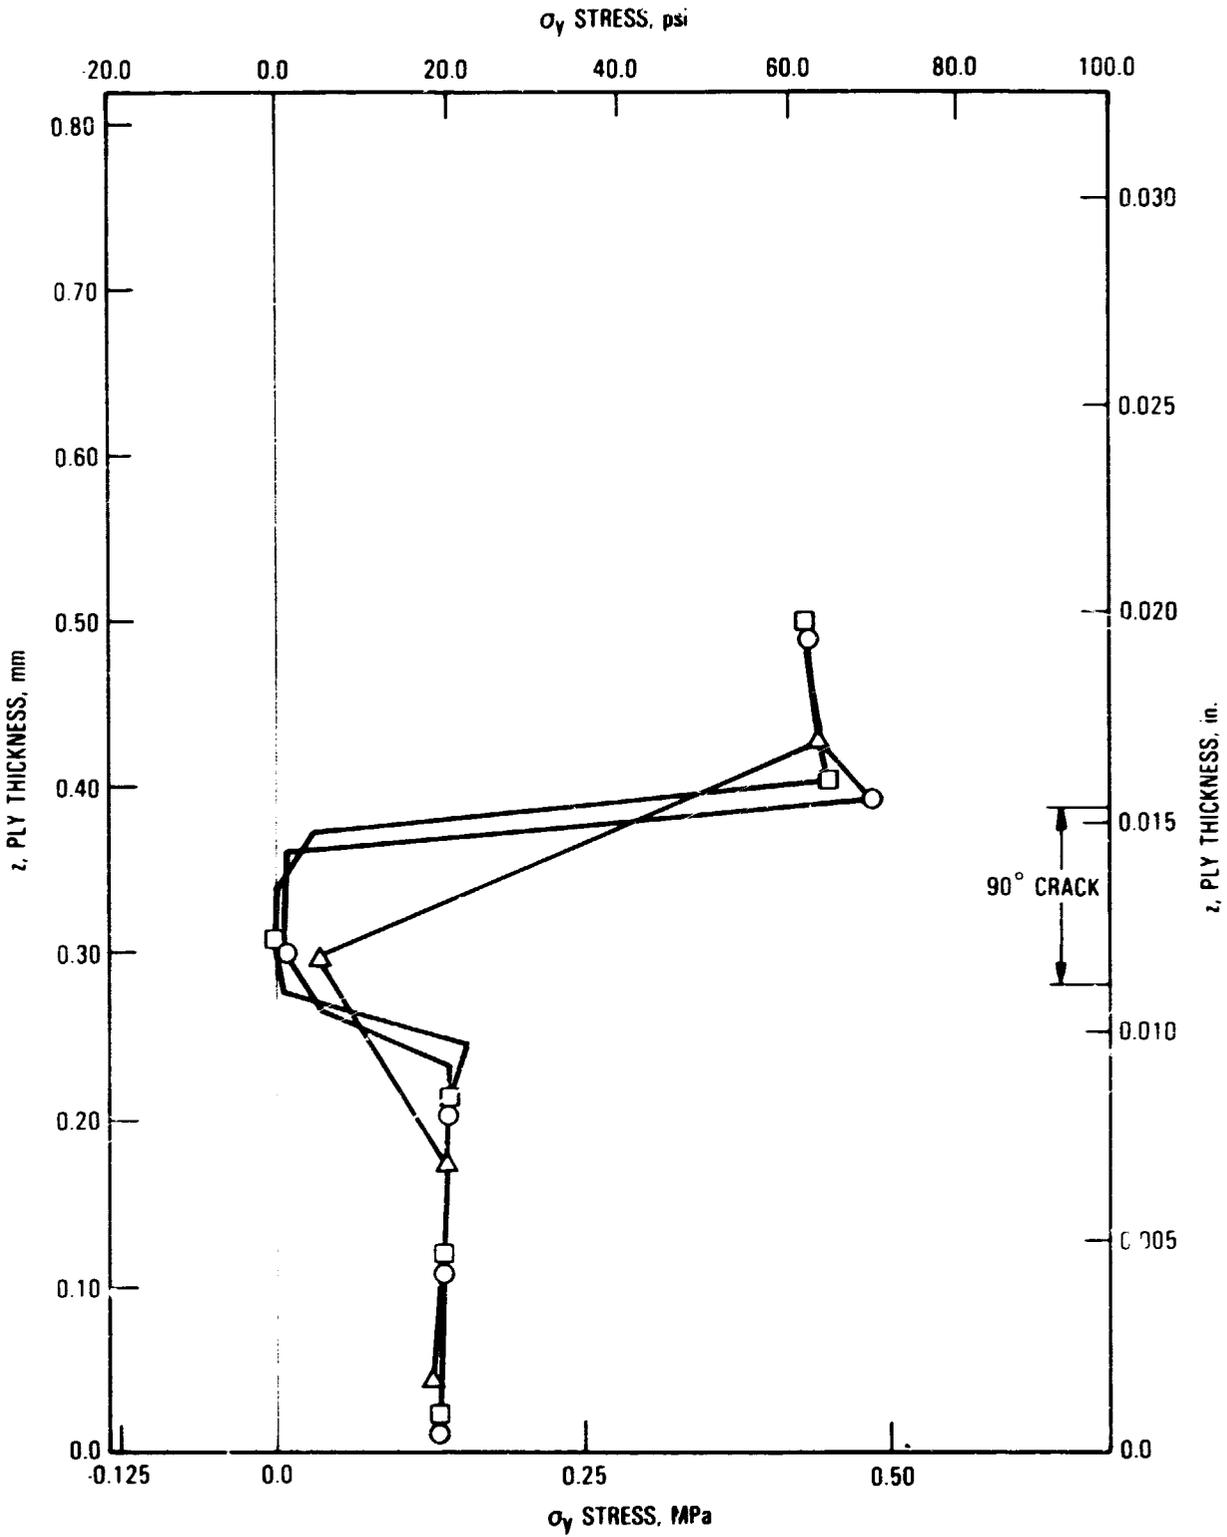
Figure 87: σ_y stress gradients near a 90° ply crack in a $(0/90/+45)_s$ laminate.

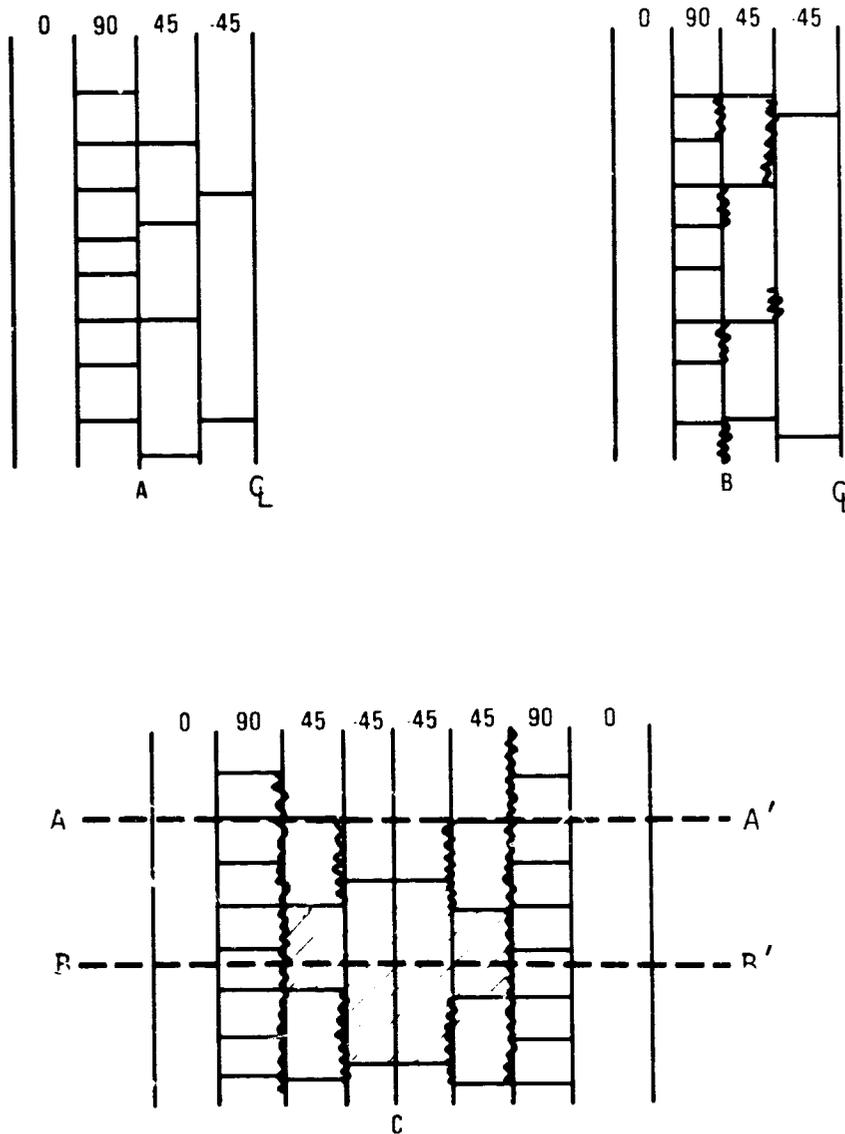
NOTE: "Wiggly" lines indicate de-
lamination, horizontal lines
indicate transverse matrix
cracking.

Figure 94: Example of various possible damage states in $(0/90/+45)_5$ laminate.

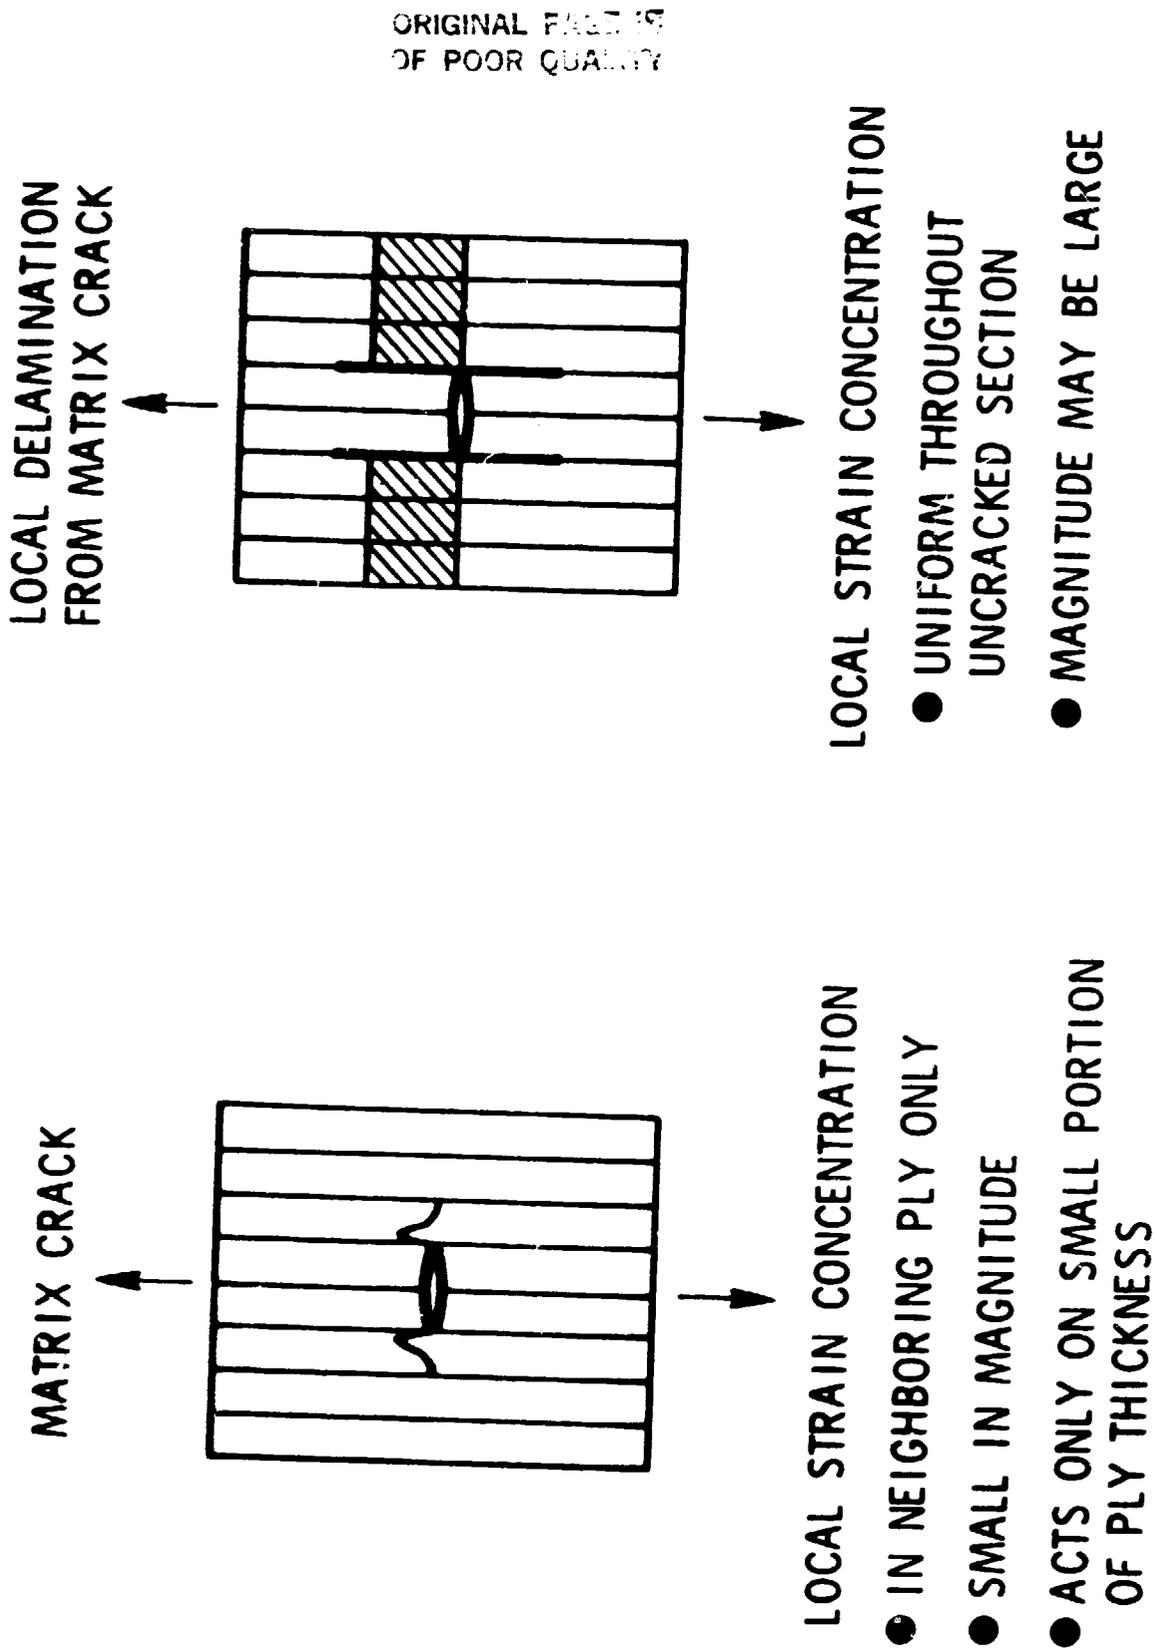
Figure 95: Strain concentrations due to local damage in unnotched laminates.

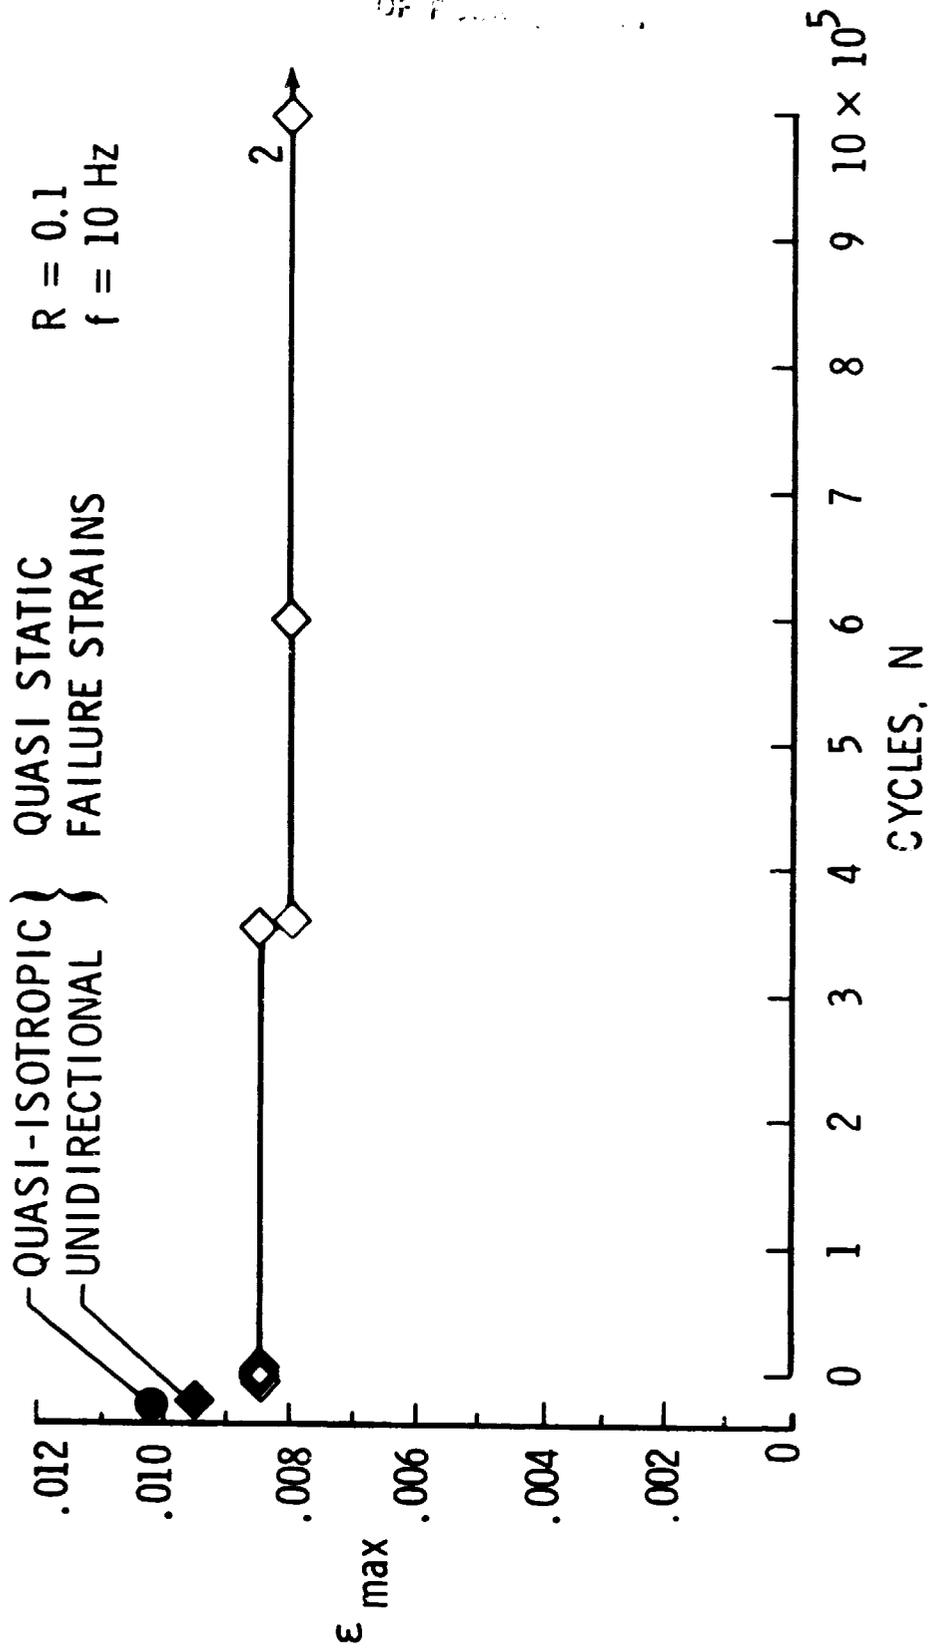
Figure 97: Fatigue behavior of unidirectional (0)₄ graphite/epoxy laminates.

The two 0° fiber fracture criteria, when combined, led to several conclusions which are discussed in detail in Section 4. They constitute two of the the primary hypothesized reasons that failure by 0° ply fiber fracture occurs. They must be combined with the fact that even in 0° unidirectional laminates, fiber fracture and coupon failure occur under fatigue load, see Section 2.1. This begins to happen at any strain level above approximately 0.0070^[38] and occurs significantly above 0.0080 strain, see Figure 97. Any

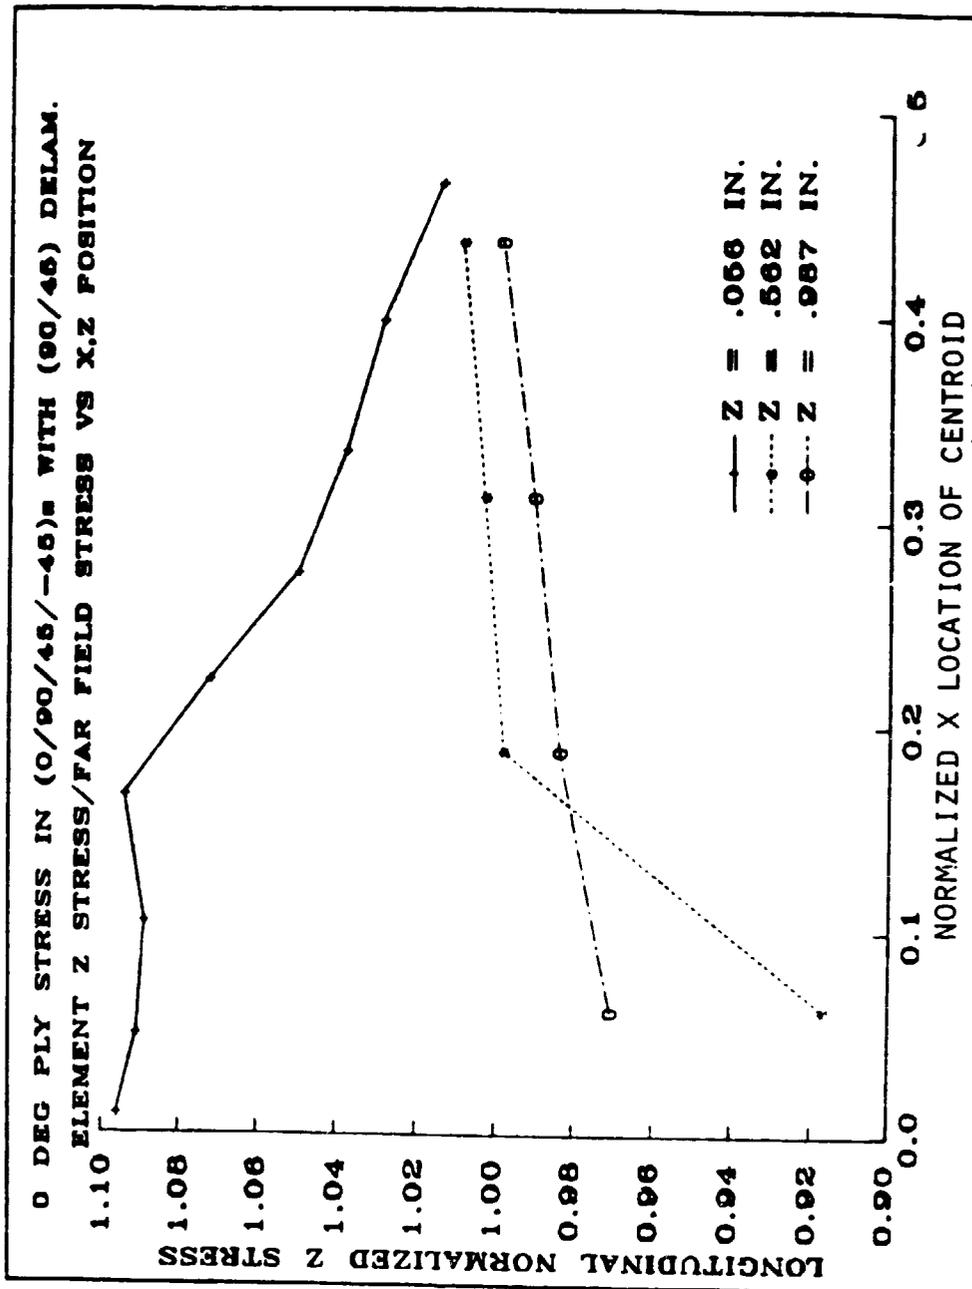
Figure 104: Distribution of longitudinal stress in the 0° ply for the (0/90/45/-45) 90/45 interface delamination model.

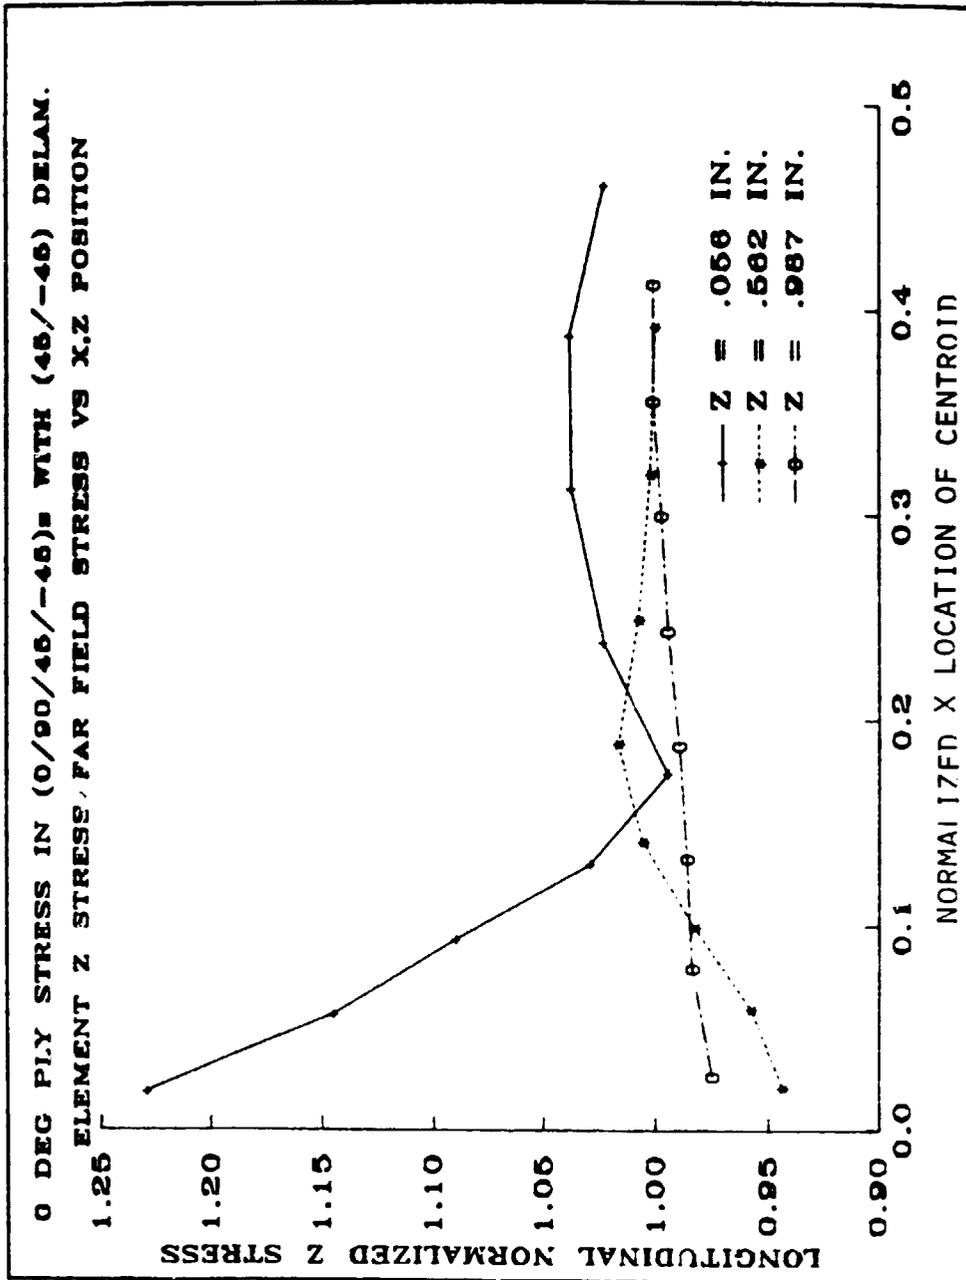
Figure 106: Distribution of longitudinal stress with 0° ply for the (0/90/45/-45)_s 45/-45 interface delamination model.
