NASA Contract Report CR-172211

A Study of Stiffness, Residual Strength and Fatigue Life Relationships for Composite Laminates

**LOCKHEED-CALIFORNIA COMPANY
A Division of Lockheed Corporation
Burbank, California 91520**

**Contract NAS1-16406
October, 1983**

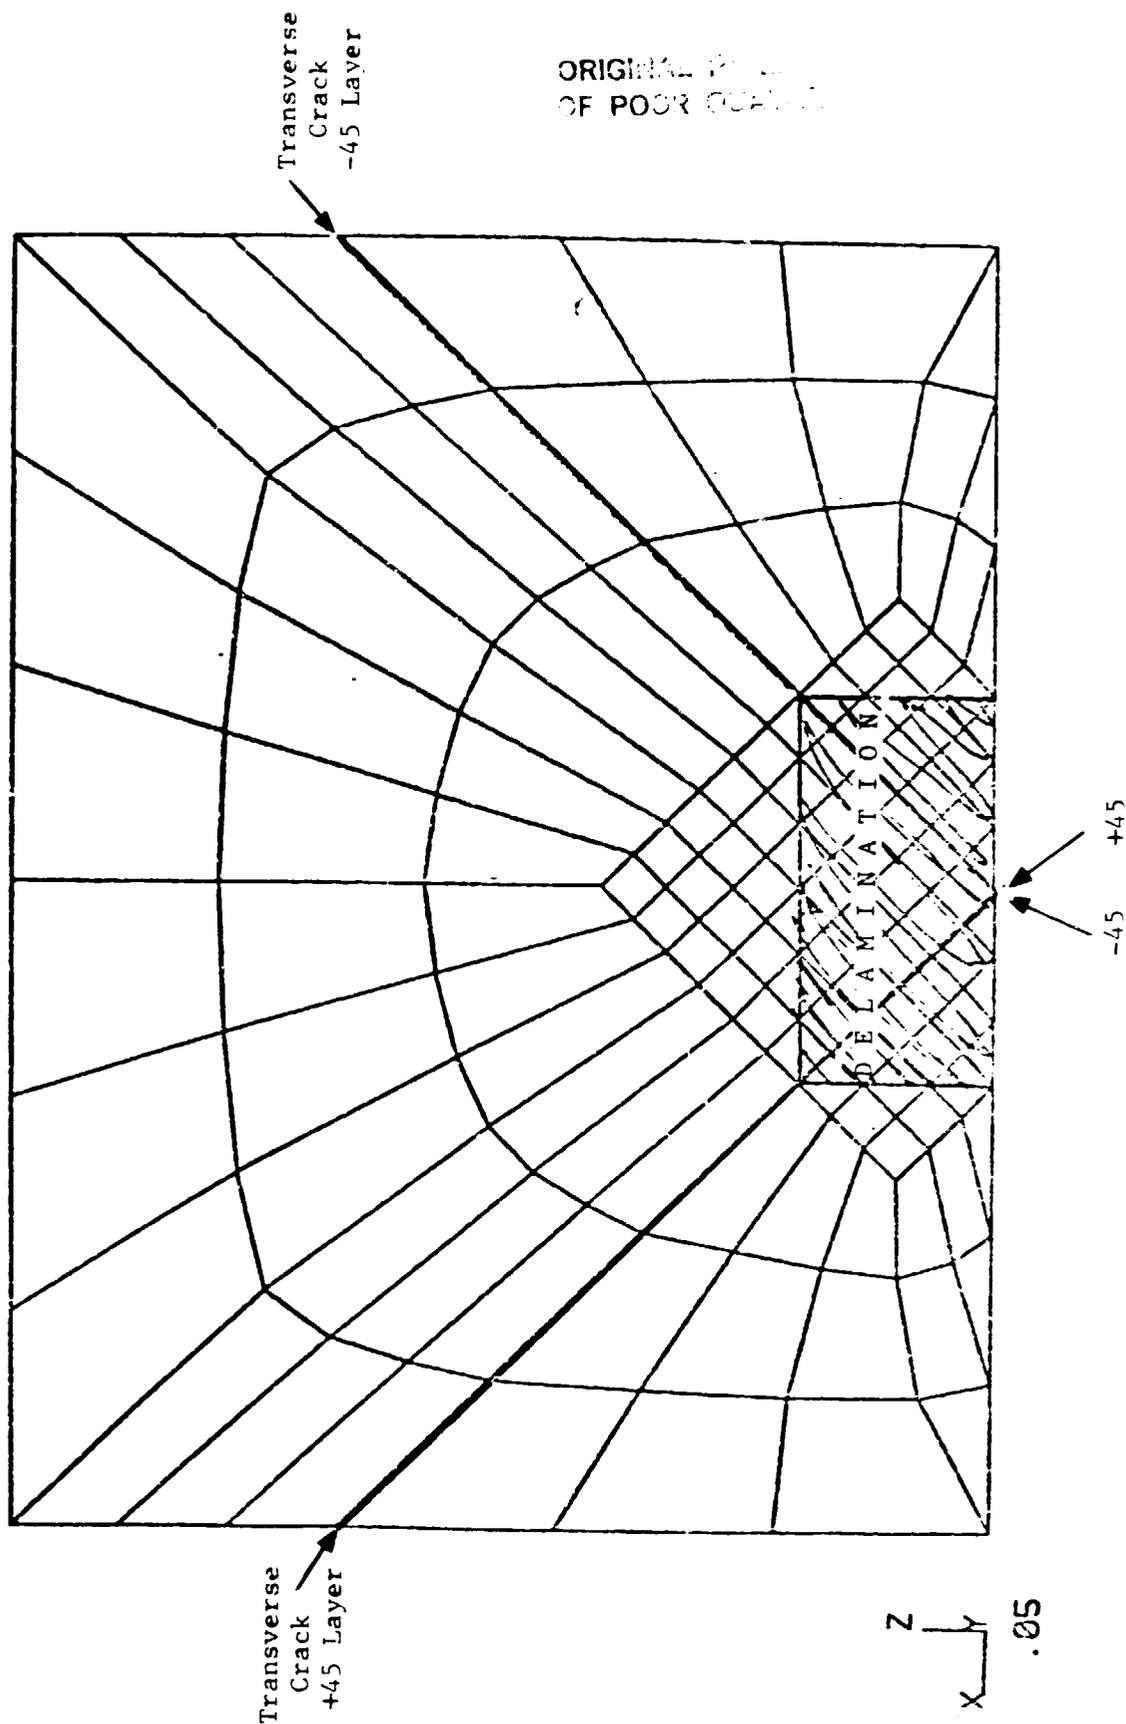
Figure 107: Model of delamination and transverse cracking in 45 and -45 layer of a (0/90/45/-45)_s laminate

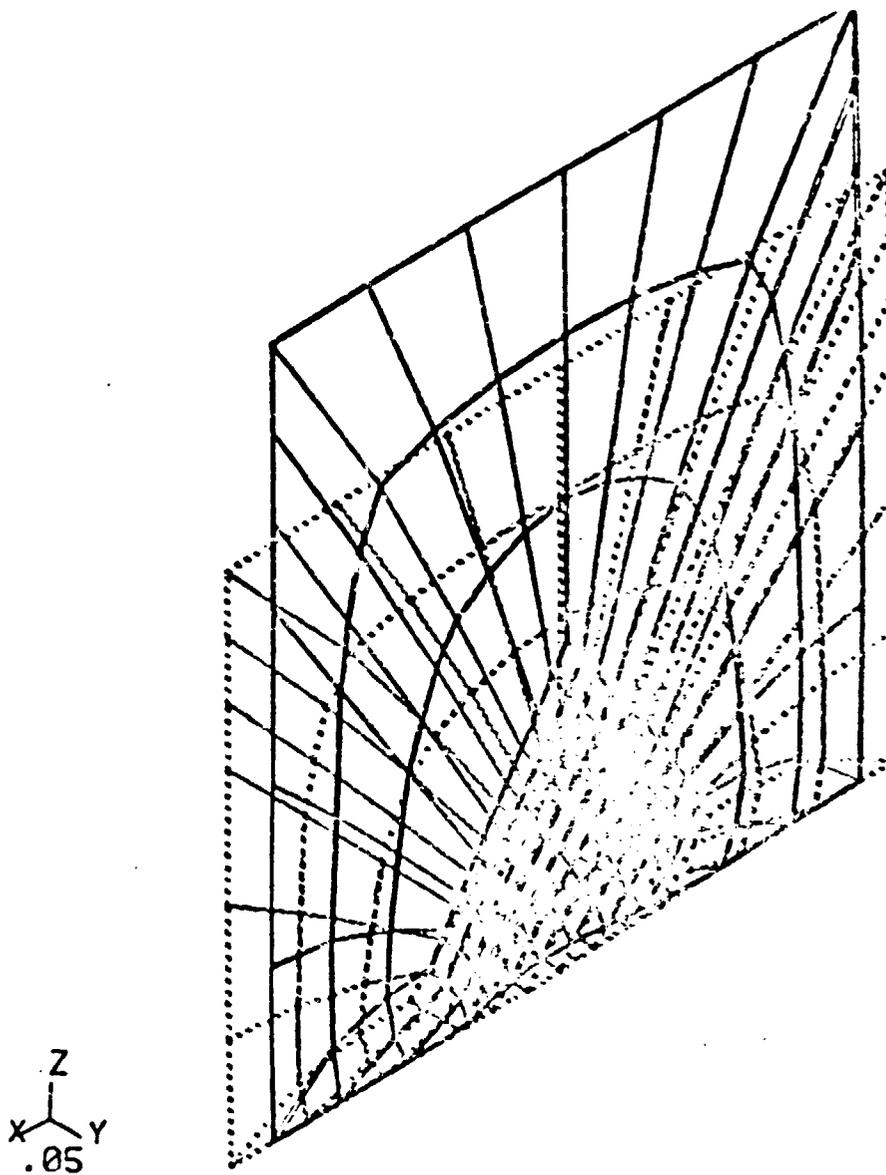
Figure 108: Distortions due to loading on the -45° layer for the model of Figure 107.

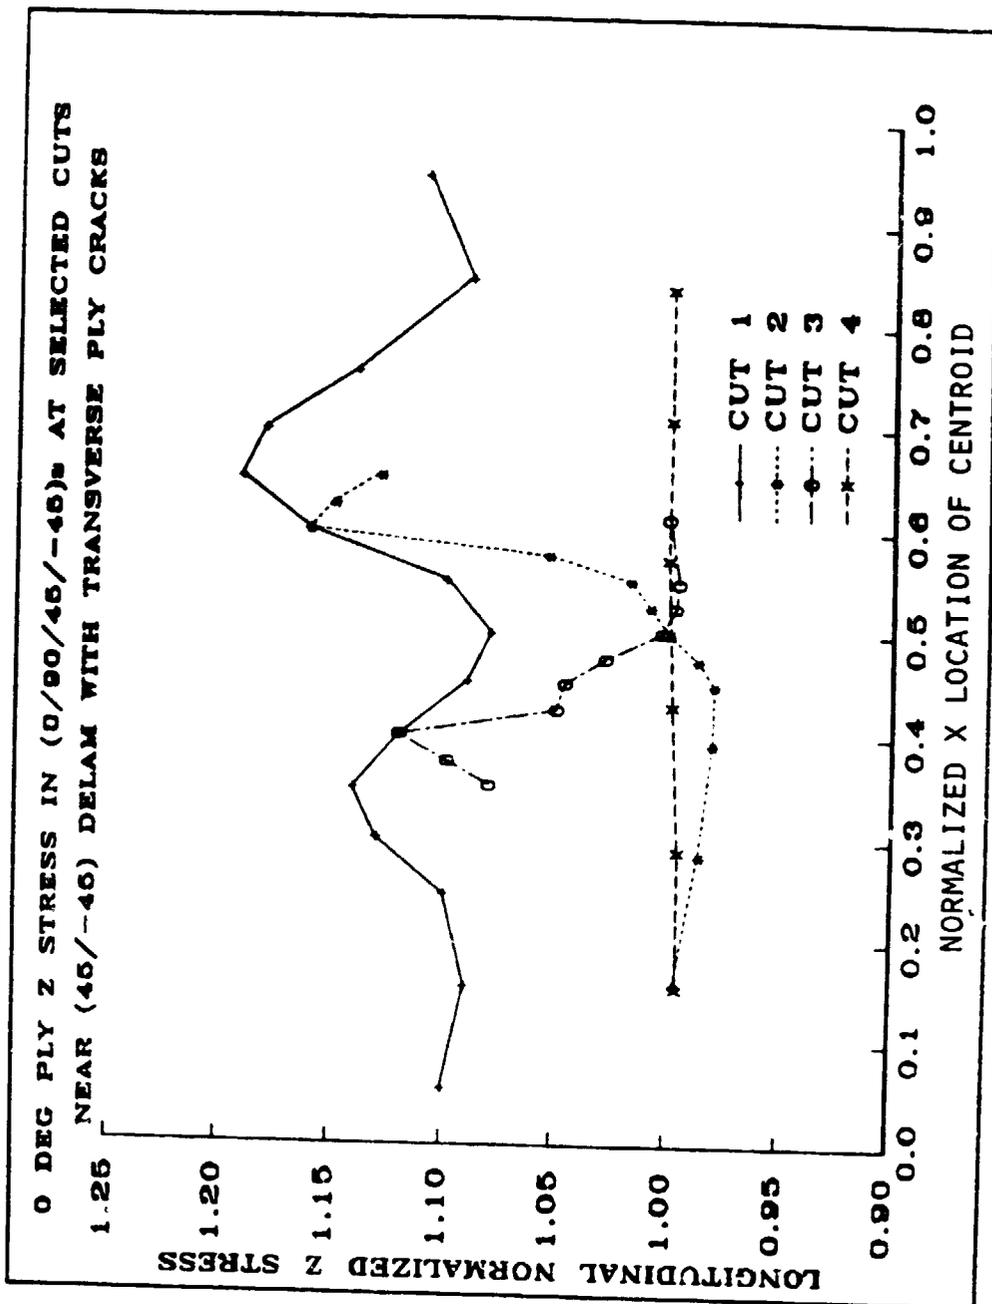
Figure 113: Distribution of longitudinal stresses in the 0° ply for the model of Figure 107 with a delamination.

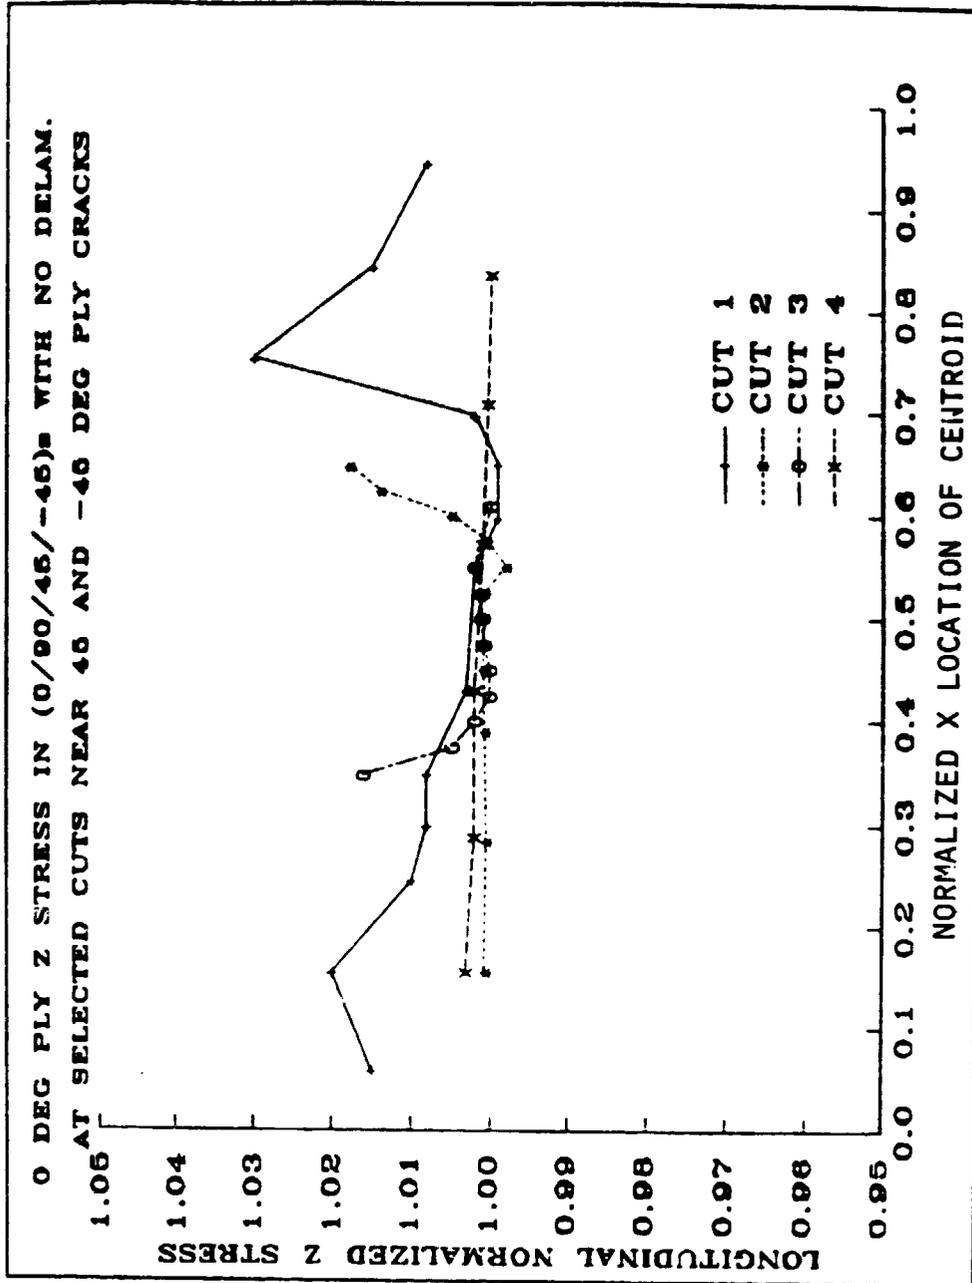
Figure 114: Distribution of longitudinal stresses in the 0° ply for the model of Figure 107 without a delamination.

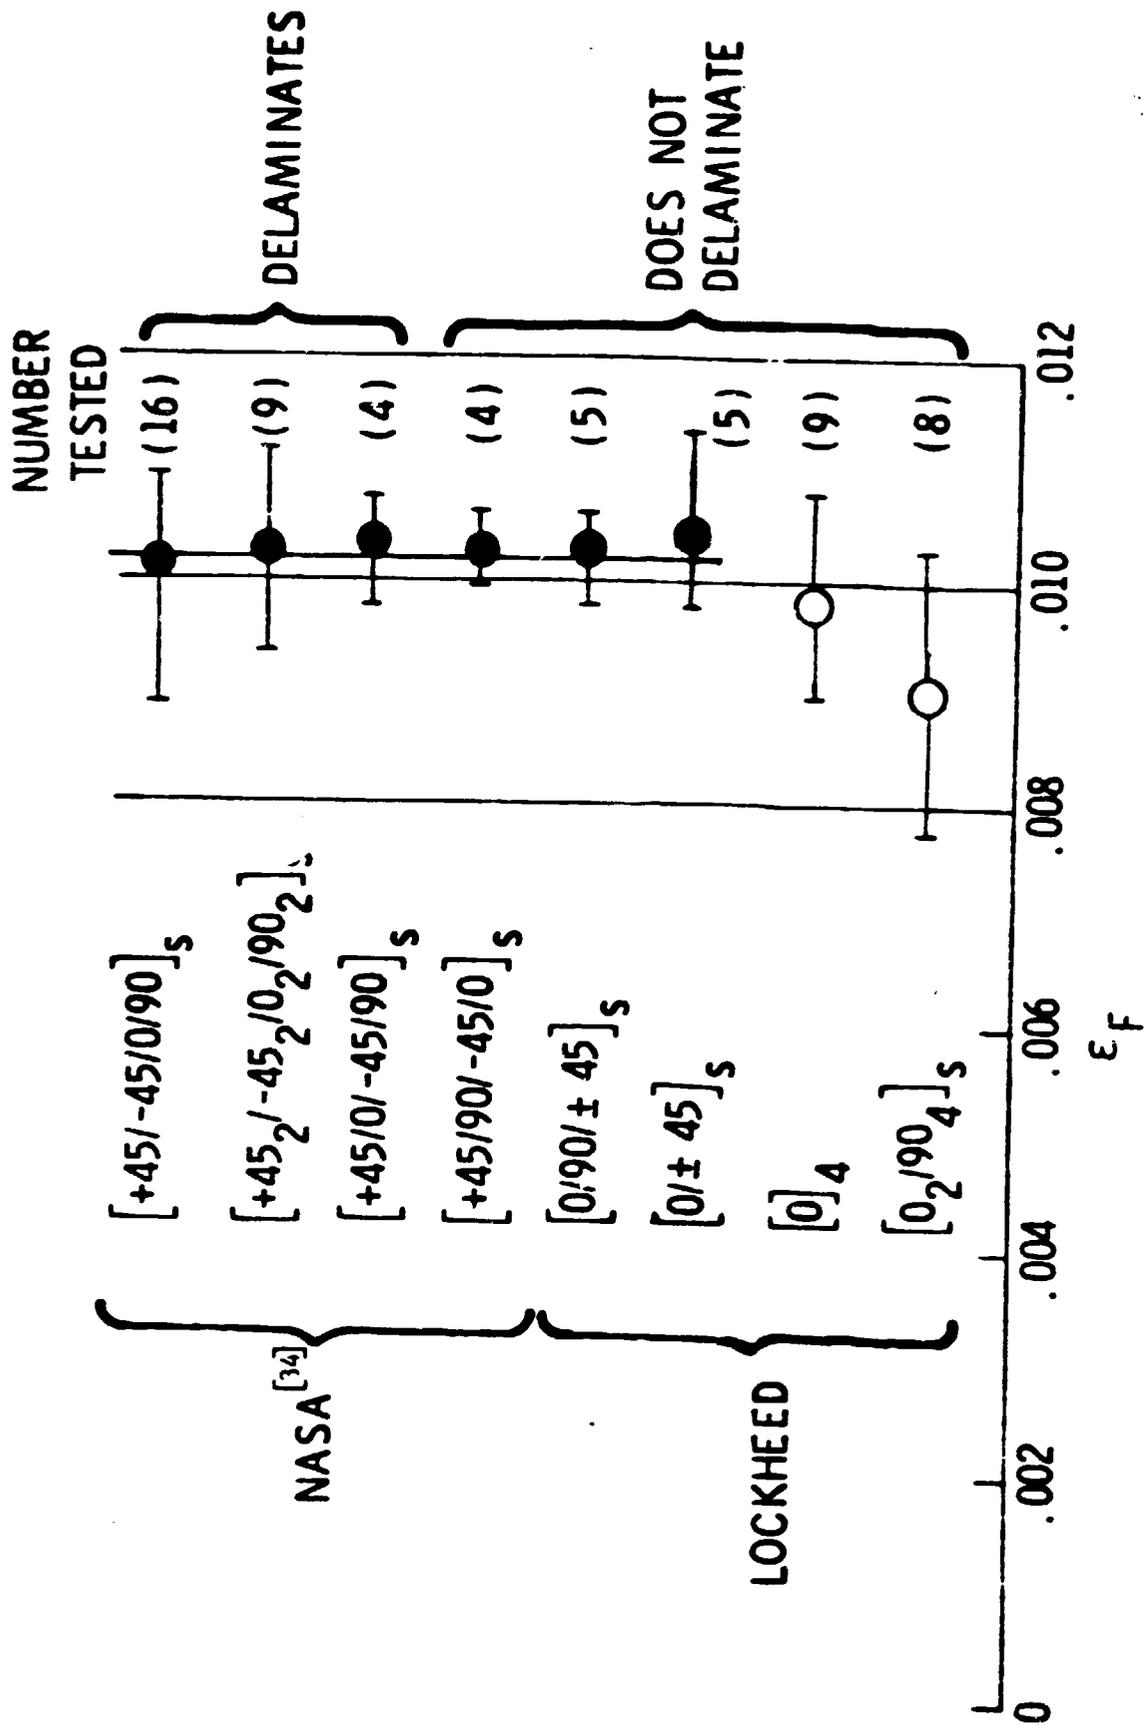
Figure 115: Comparison of average strains to failure under monotonic tension load of various T300/5208 laminates.

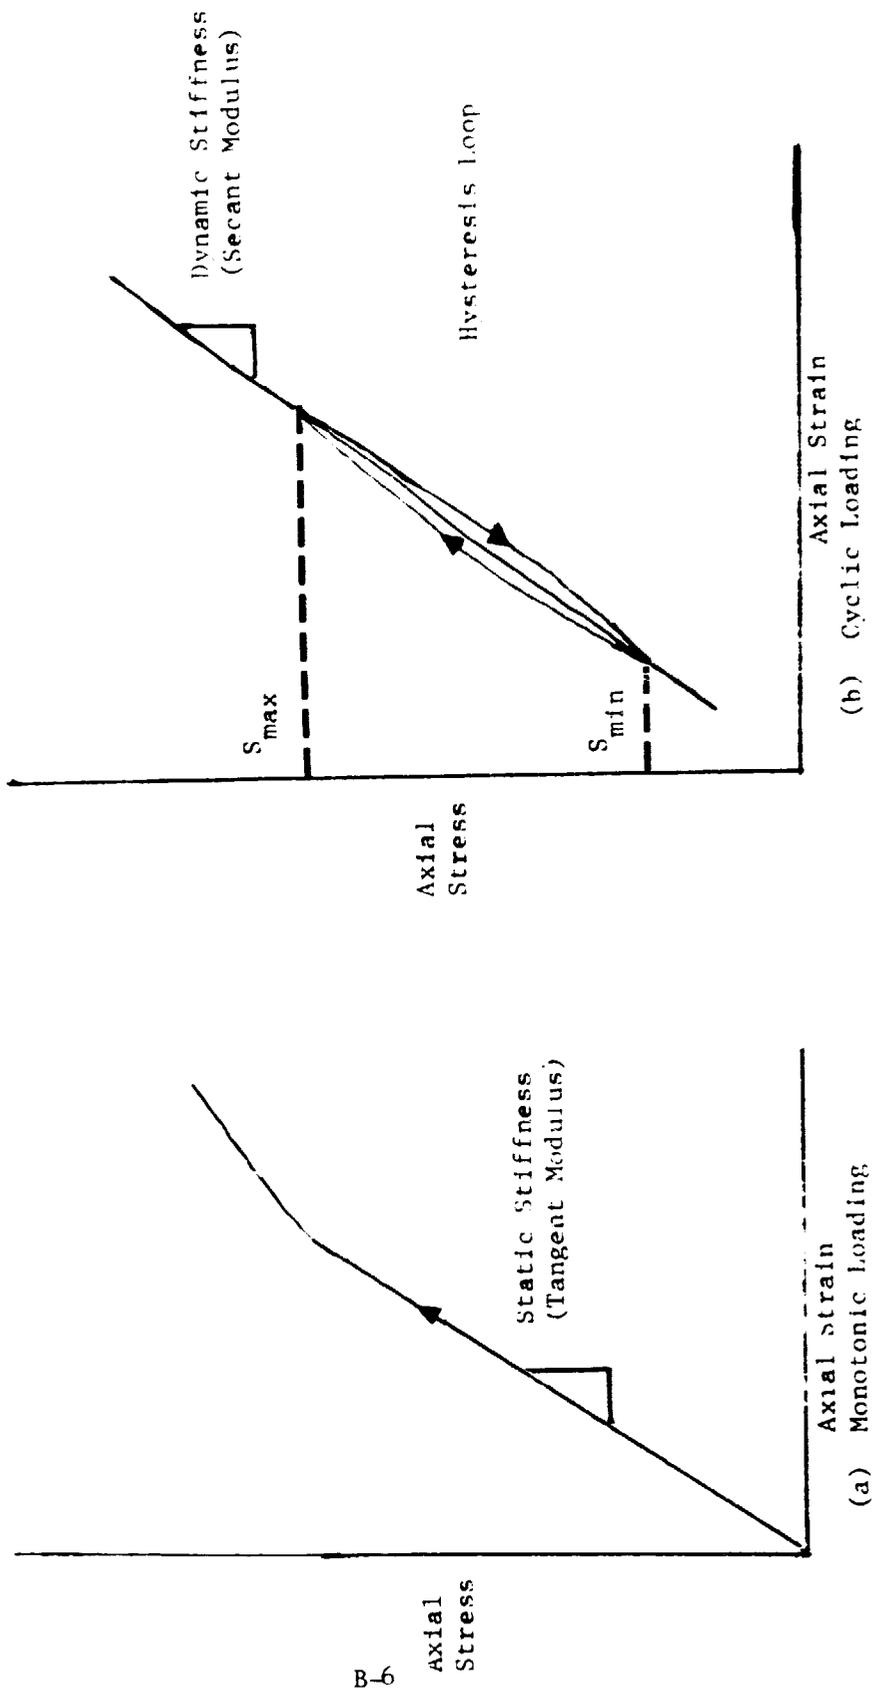
Figure B2: Examples of stiffness measurement.

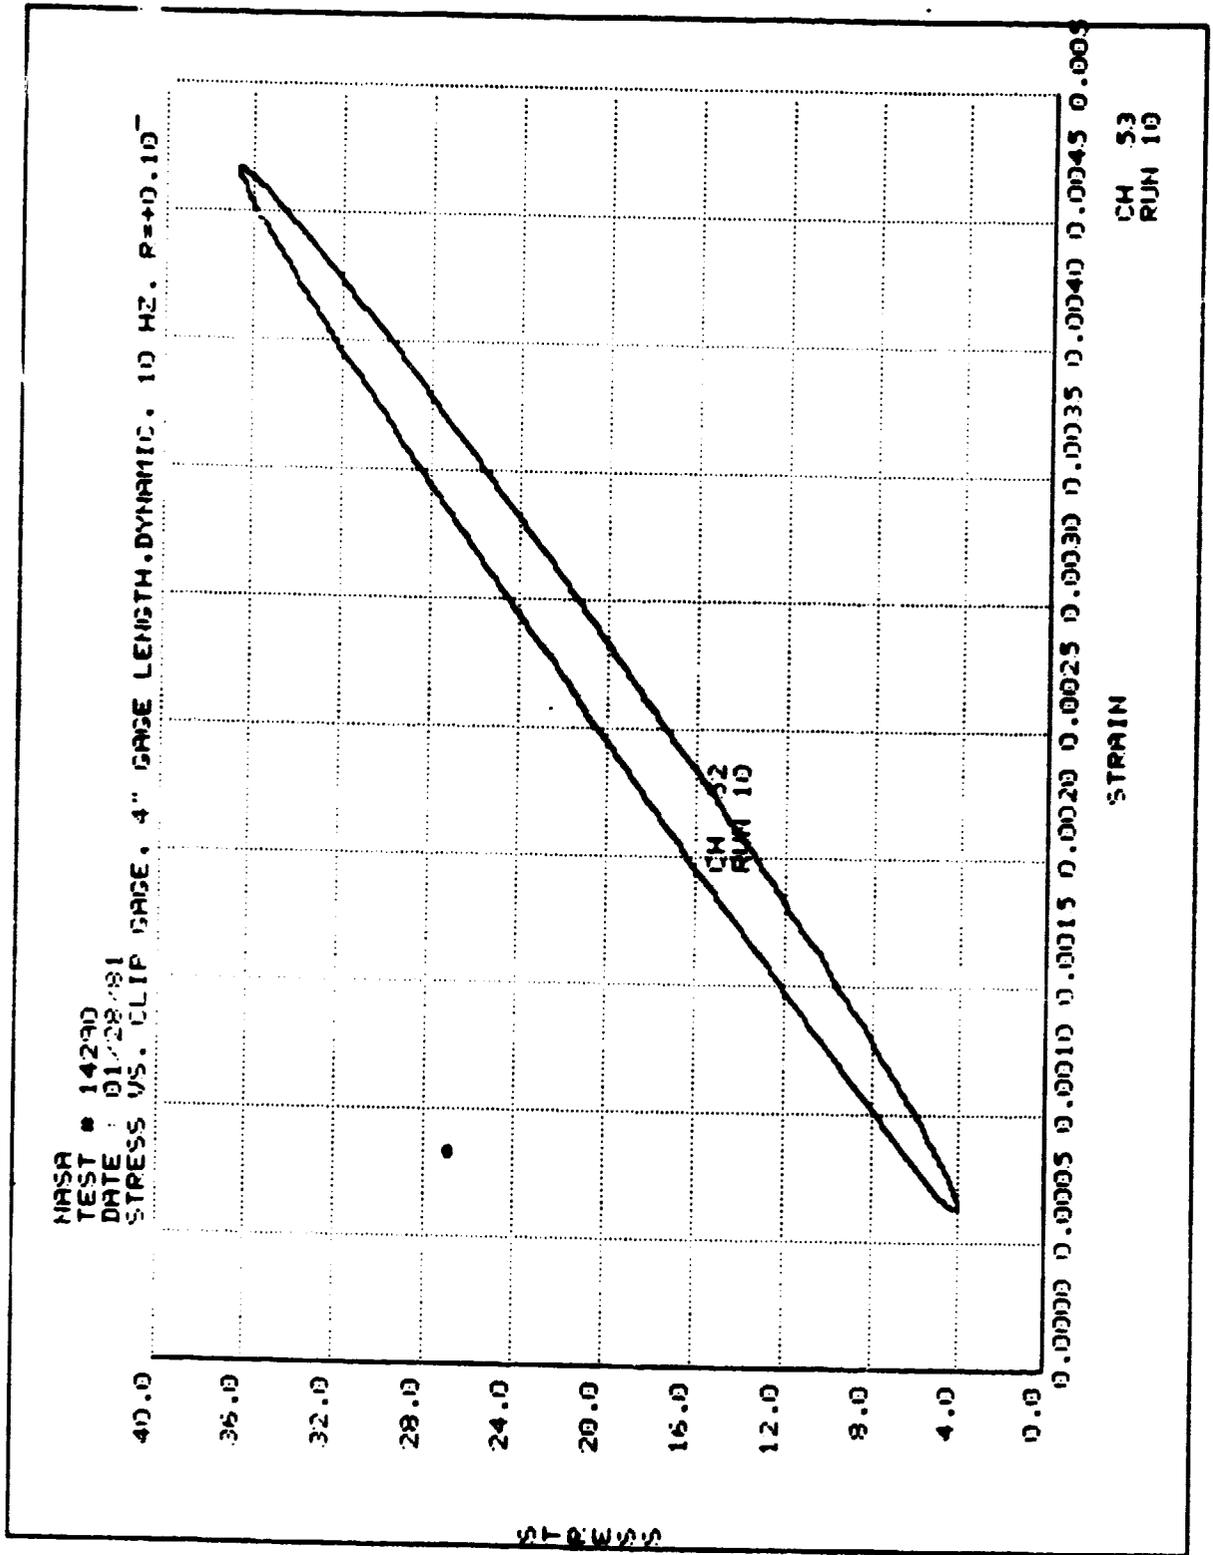
Figure B6: Dynamic load stress-strain plot of a 16-ply quasi-isotropic coupon obtained with a 4 inch extensometer.

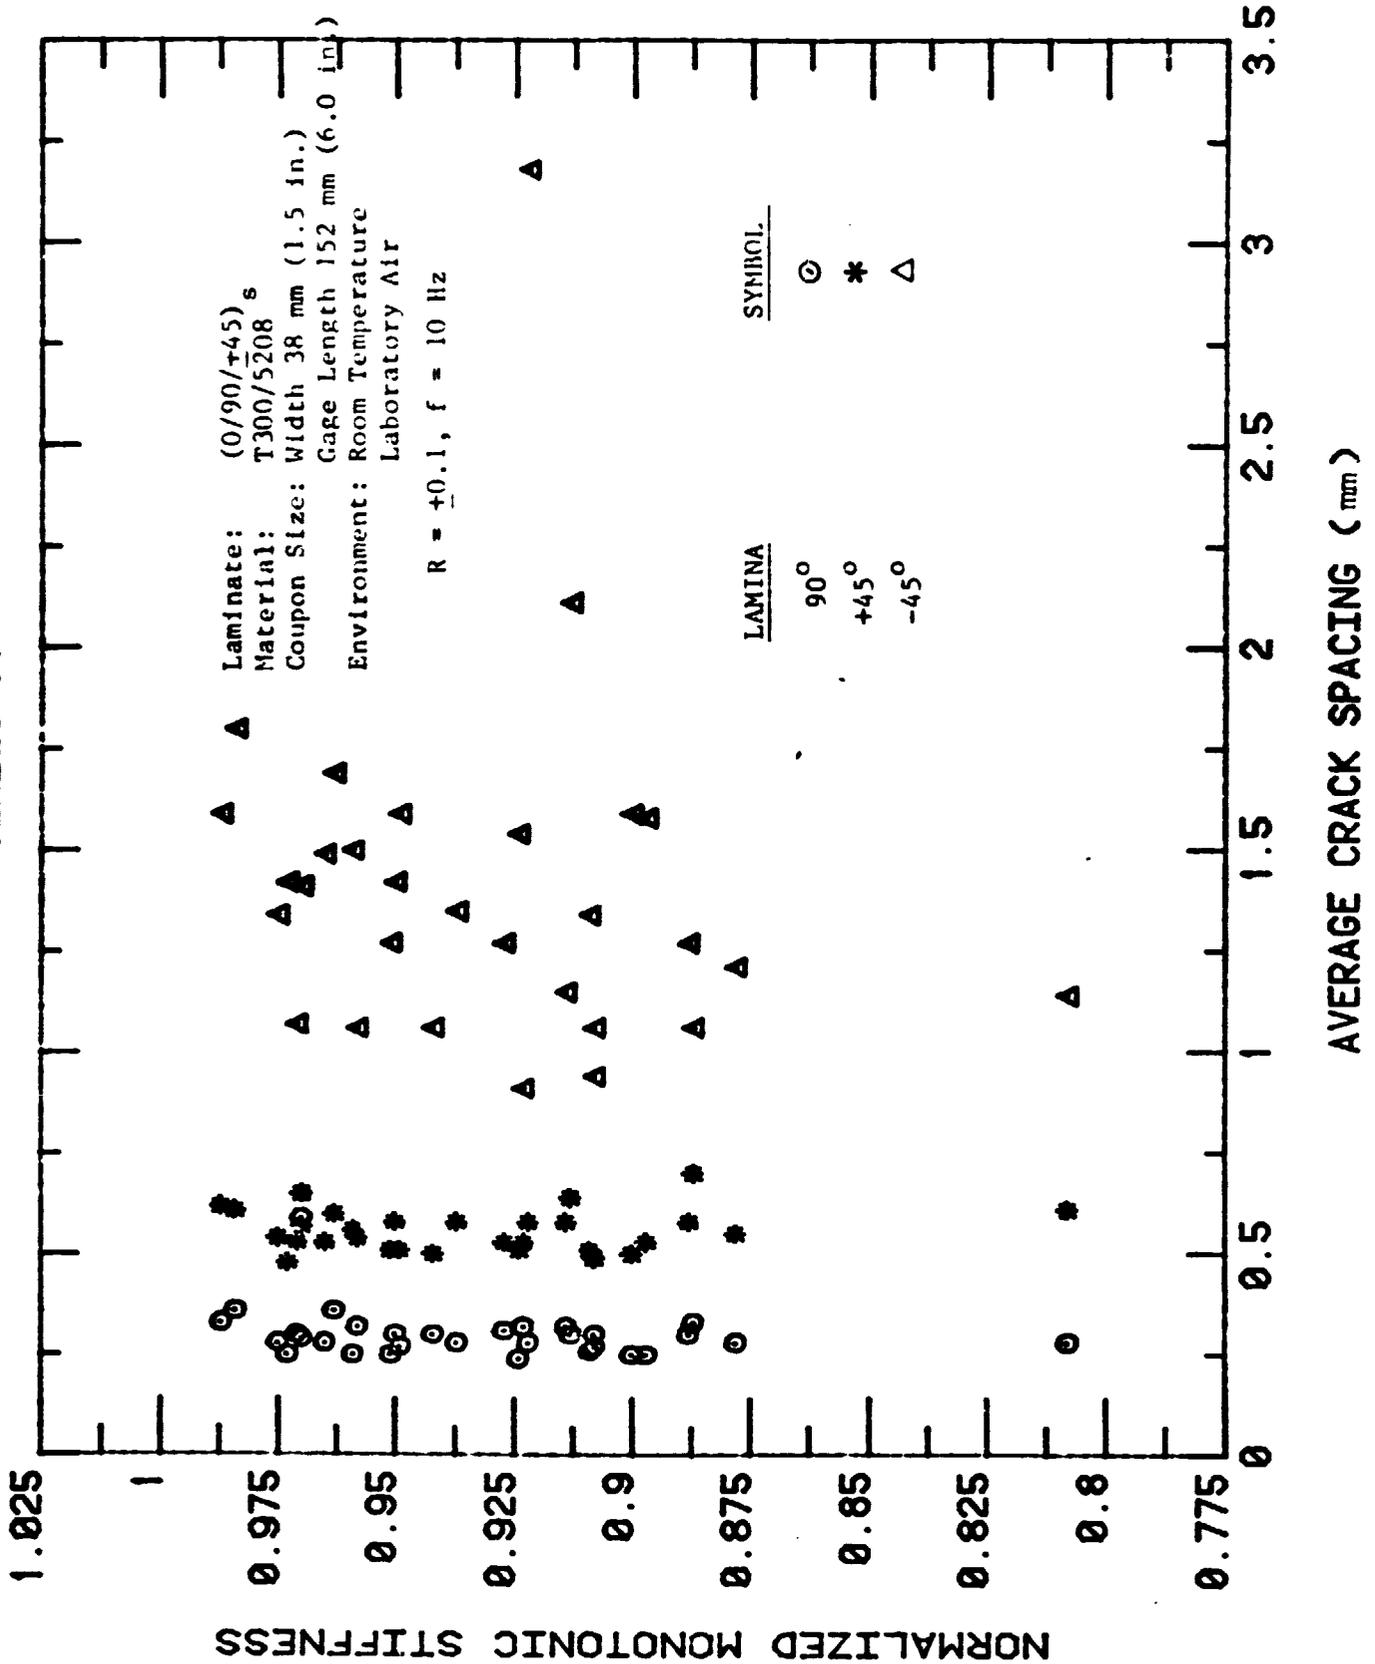
Figure C1: Normalized Monotonic Stiffness vs. Average Matrix Crack Spacing for (0/90/+45)_s Laminate Coupons Subjected to Constant Amplitude Fatigue Load.

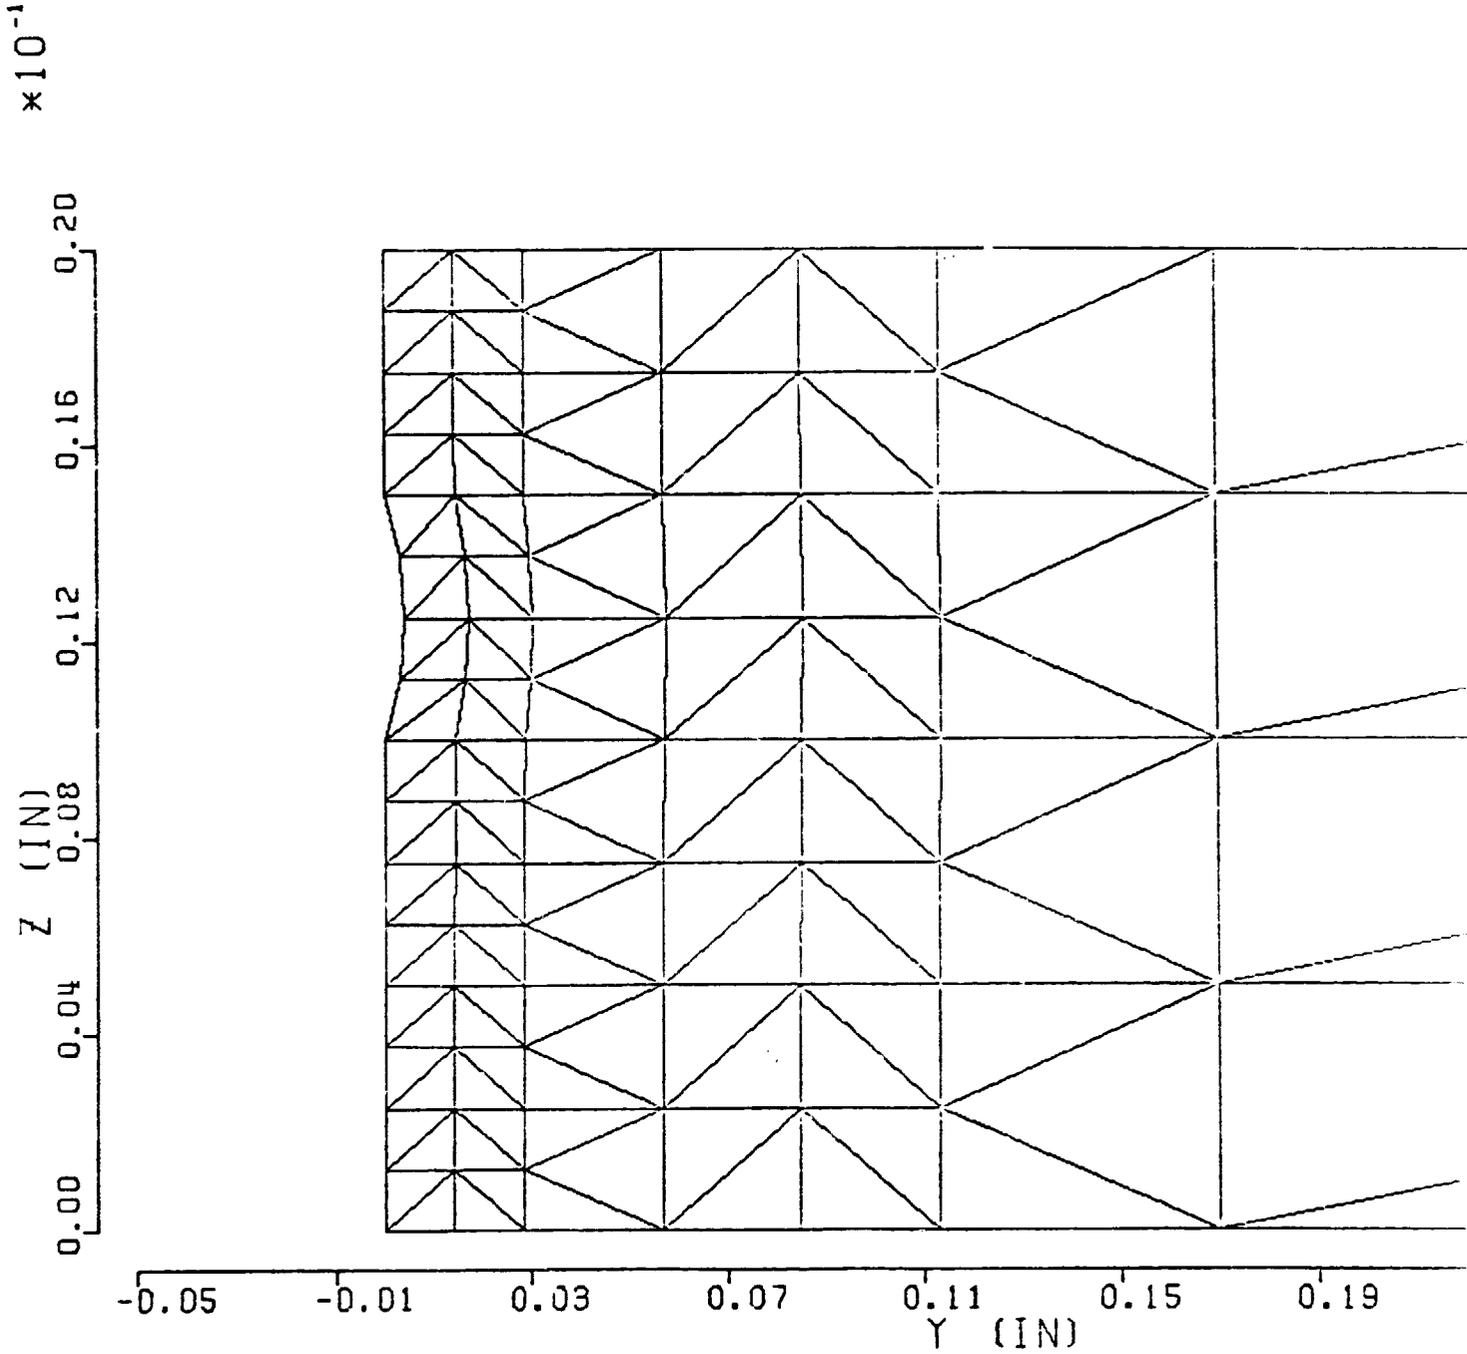
FIGURE D13: Example of Versatek Plot Showing Correct Crack Displacements
