TECHNICAL NOTE 2572

CERAMIC COATINGS FOR PREVENTION OF CARBON ABSORPTION  
IN FOUR HEAT-RESISTANT ALLOYS

By Joseph W. Pitts and Dwight G. Moore

National Bureau of Standards

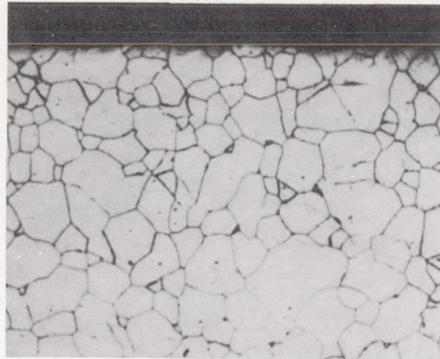
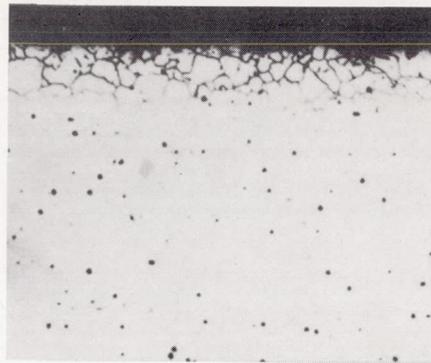
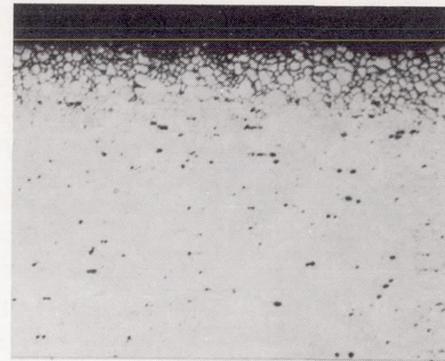
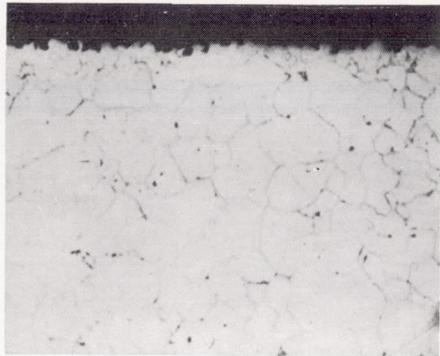
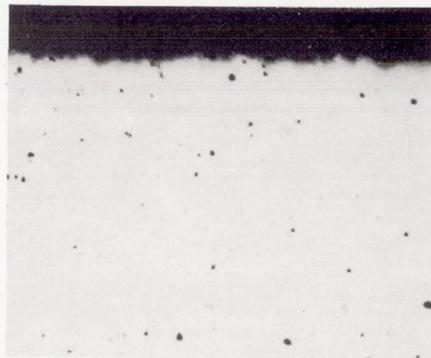
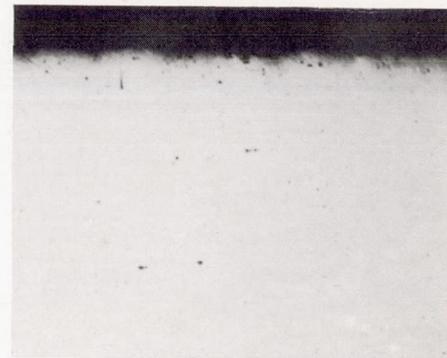
(a) Uncoated.

(b) Coated.

Figure 1.- Photomicrographs (X100, cupric-picral-nital etch) of sections through the surface of both coated (A-19H) and uncoated stainless-steel specimens after box carburizing for 4 hours at 1500° F.

Figures 1 and 2 are photomicrographs of sections taken through the surface of the three stainless steels after the carburizing treatments at 1500° and 1650° F, respectively. The upper picture in each case is the uncoated alloy while the lower picture is the same alloy that has been protected with A-19H. No carbide precipitation was noted with the Type 321 and Type 347 alloys after the carburizing treatment at 1350° F. The Type 304 steel did show the type of carbide precipitation that would be expected from an unstabilized steel after a sensitizing treatment of 4 hours at 1350° F. At the same time there was no evidence of a concentration of carbides near the surface such as would be expected if there had been an absorption of carbon.

Table 3 and figures 1 and 2 indicate that ceramic coatings qualify for this purpose. Of the three coatings studied, A-19H proved to be the most effective in preventing carbon absorption under all test conditions, but it should be pointed out that pack carburizing represents an extremely severe carburizing condition. In operation, carburizing gases from high fuel-air ratios are common in aircraft exhaust systems, especially during take-off and during flight at high altitudes. However, even under the highest fuel-air ratios encountered, the carburizing conditions would probably never reach the severity encountered in pack carburizing. Also, in aircraft exhaust systems, high gas velocities may cause flow of the coated material if the coating lacks sufficient refractoriness. For both of these reasons, the pack-carburizing treatment cannot be considered as a suitable test for coating selection and, at the present time, it is believed that the only reliable criterion for establishing the superiority of one coating over another is by the service testing of coated exhaust parts.

The Type 304 steel, which is unstabilized, showed carbide precipitation throughout its entire structure at all three carburizing temperatures. However, at 1500° and 1650° F there was evidence of carbon absorption into the steel surface and this was evidenced by a greater amount of carbide formation. As shown in figures 1 and 2, the line of demarcation representing the case depth due to carbon absorption was poorly defined, but the photomicrographs nevertheless illustrate that some carbon absorption has occurred with the uncoated steel. The same

figures show that this absorption has been prevented when the steel was protected with the A-19H coating.

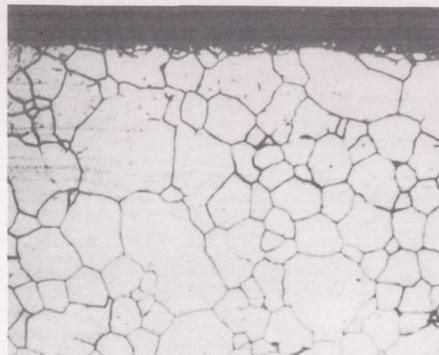
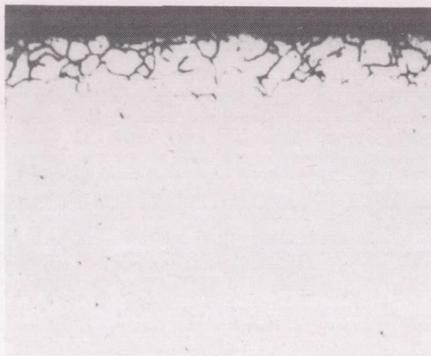
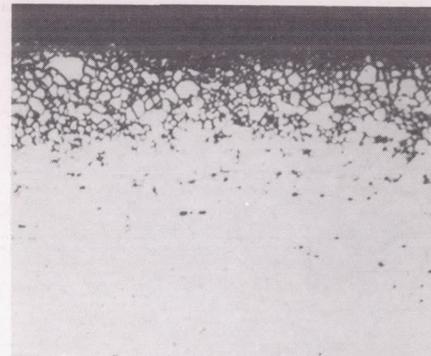
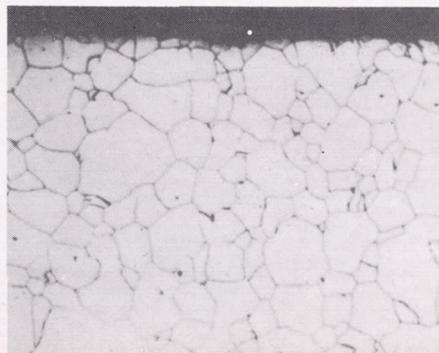
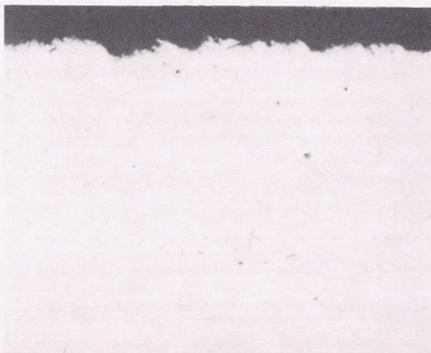
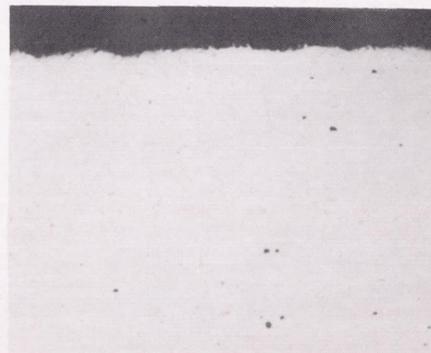
(a) Uncoated.

(b) Coated.

Figure 2.- Photomicrographs (X100, cupric-picral-nital etch) of sections through the surface of both coated (A-19H) and uncoated stainless-steel specimens after box carburizing for 4 hours at 1650° F.

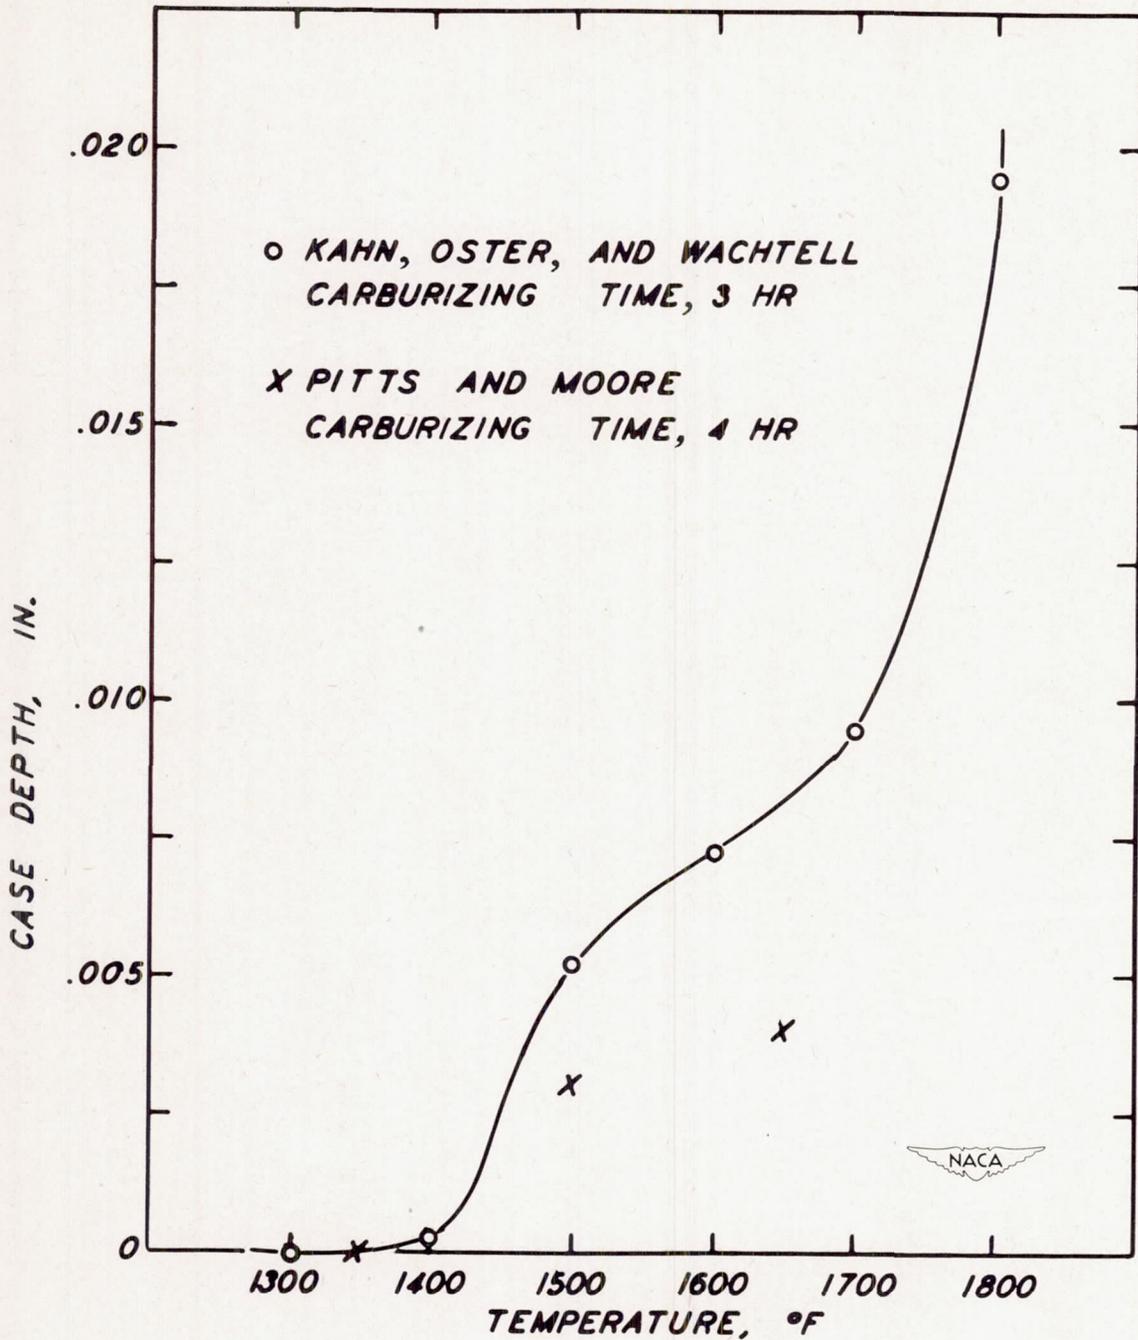
Figure 3.- Case depth plotted against temperature for AISI Type 321 stainless steel after box carburizing for the times indicated. Case depth represents average depth to which alloy showed carbide precipitation at grain boundaries.

Figure 3 is a curve of case depth plotted against temperature for Type 321 stainless steel as taken from the paper by Kahn, Oster, and Wachtell (reference 5). Points representing data from the present study are included for comparison.

promote carbon absorption in the alloys and the same etchant was used to bring out carbides. Figure 3 shows that only fair agreement was obtained for the Type 321 alloy which was the only alloy studied by the aforementioned authors. There is good agreement at 1350° F but at 1500° F smaller case depths were obtained in the present study although a longer carburizing time was used. The cause of this discrepancy may be due to differences in the carburizing compounds or to minor differences in the steels.
