ELIMINATION OF RUMBLE FROM THE COOLING DUCTS OF A  
SINGLE-ENGINE PURSUIT AIRPLANE

By Howard F. Matthews

MEMORANDUM REPORT

Air Materiel Command, U.S. Army Air Forces

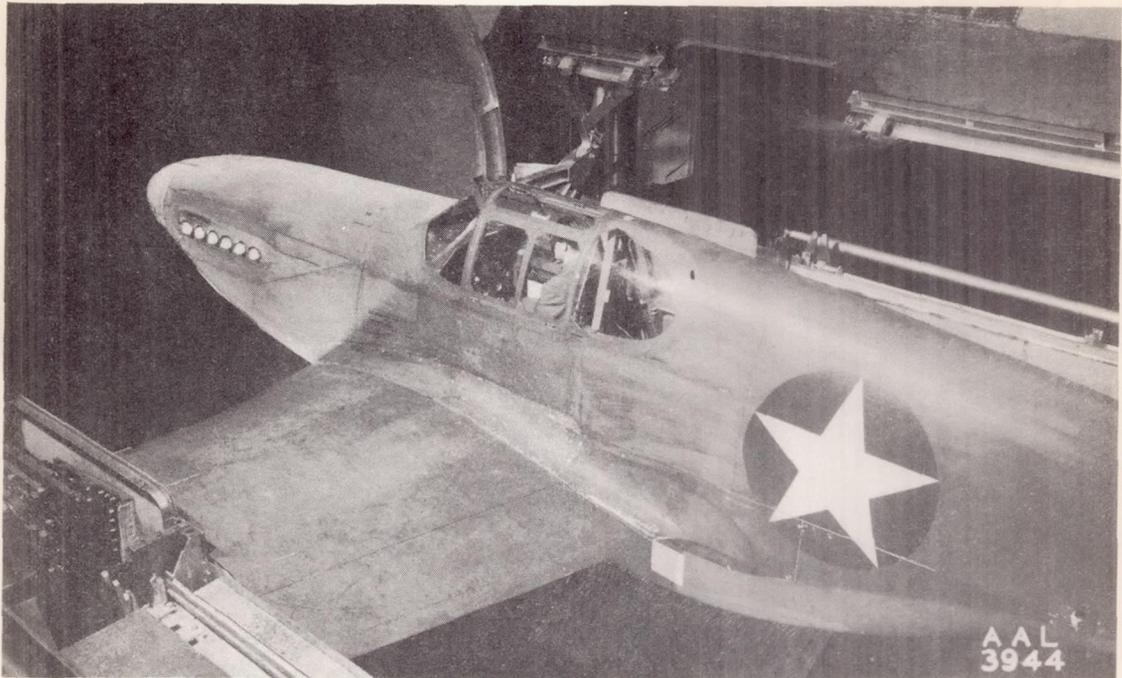
Figure 1.- Three-quarter rear view of the airplane mounted in the 16-foot wind tunnel.

For tests at speeds up to 260 miles per hour, the airplane was supported only on the trunnion plates (fig. 1). The angle of attack was varied by rotating the trunnion plates, and the forces on the airplane were measured by the self-balancing, recording beam scales of the regular balance system.

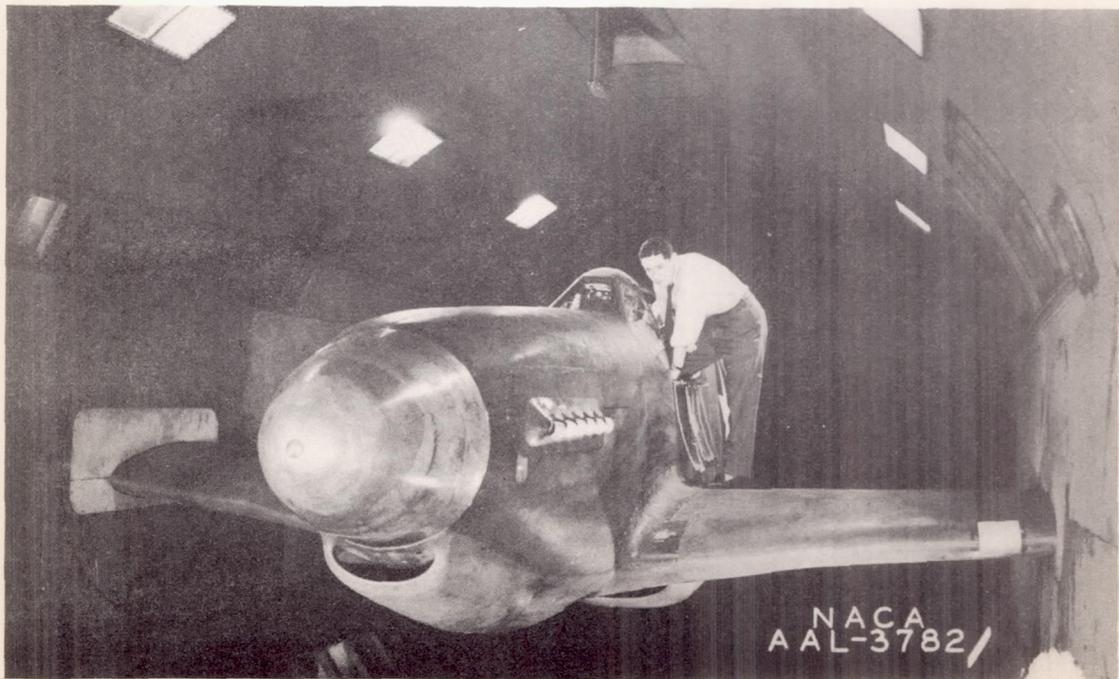
Figure 2.- Three-quarter front view of the airplane mounted in the 16-foot wind tunnel.

For the high-speed tests, the airplane was given additional support by a tail strut (fig. 2) which was securely fastened to the top of the tunnel shell. Force measurements were not made for this type of mounting.

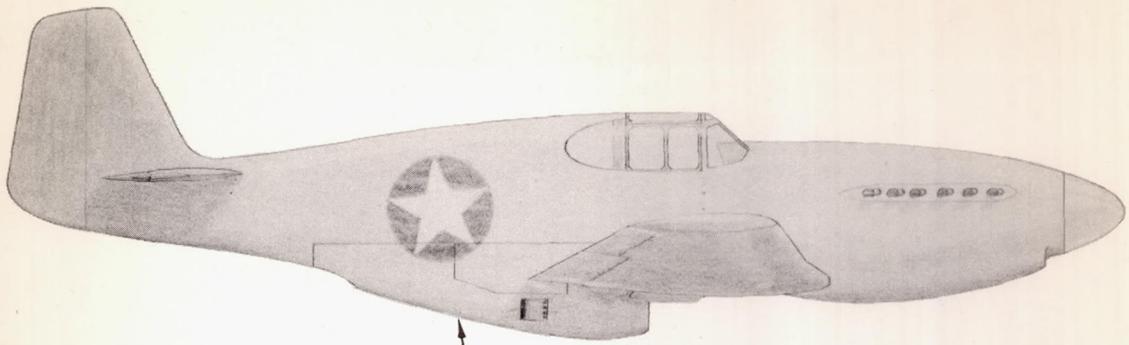
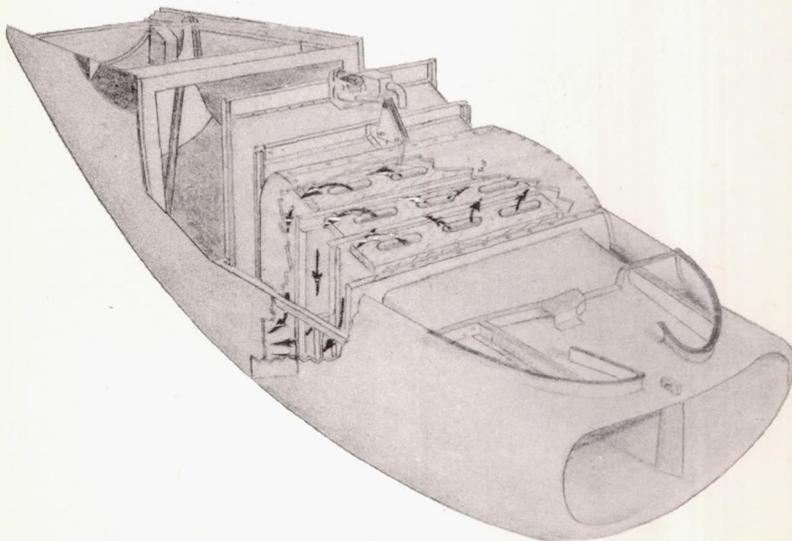
FIGURE 3.- BY-PASS ARRANGEMENT ON ORIGINAL DUCT

RADIATOR DUCT HOUSING

RADIATOR DUCT HOUSING REMOVED ; SHOWING LOCATION  
OF LOUVERS ; SHIELD OVER LOUVERS ; AND FLOW OF AIR  
FROM LOUVERS , DOWN THE SIDE AND OUT THE SIDE  
EXIT.

Since the rumble did not occur when the coolant-duct-exit opening was large, the first modification was to provide an increase in the minimum value of the entrance velocity relative to the free-stream velocity. A bypass arrangement, shown in figure 3, was designed to achieve this purpose. The results were encouraging in that, with the bypass louvers at the most effective opening, the velocity at which the rumble began was raised approximately 150 miles per hour.

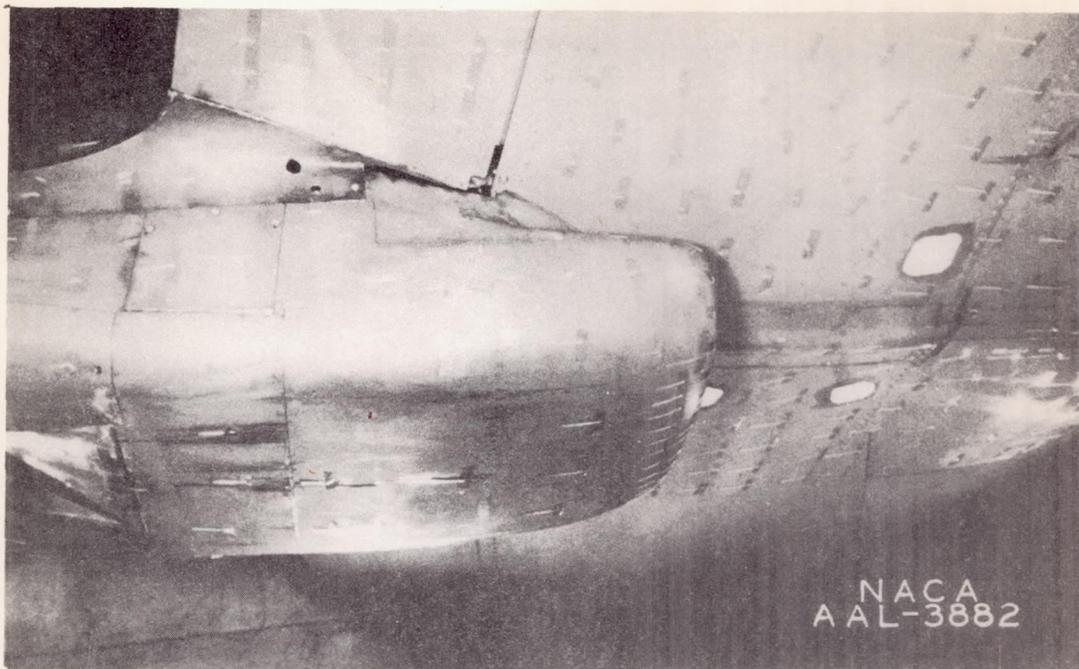
A study of the tufts (figs. 4 and 5) indicated that the bottom of the wing near the duct was in a stalled condition and that the flow along the inside of the duct at the top of the entrance was reversed. The upper lip of the entrance was

Figure 4.- Side view of original duct.  
 $\alpha = -2^\circ$ , flaps closed.

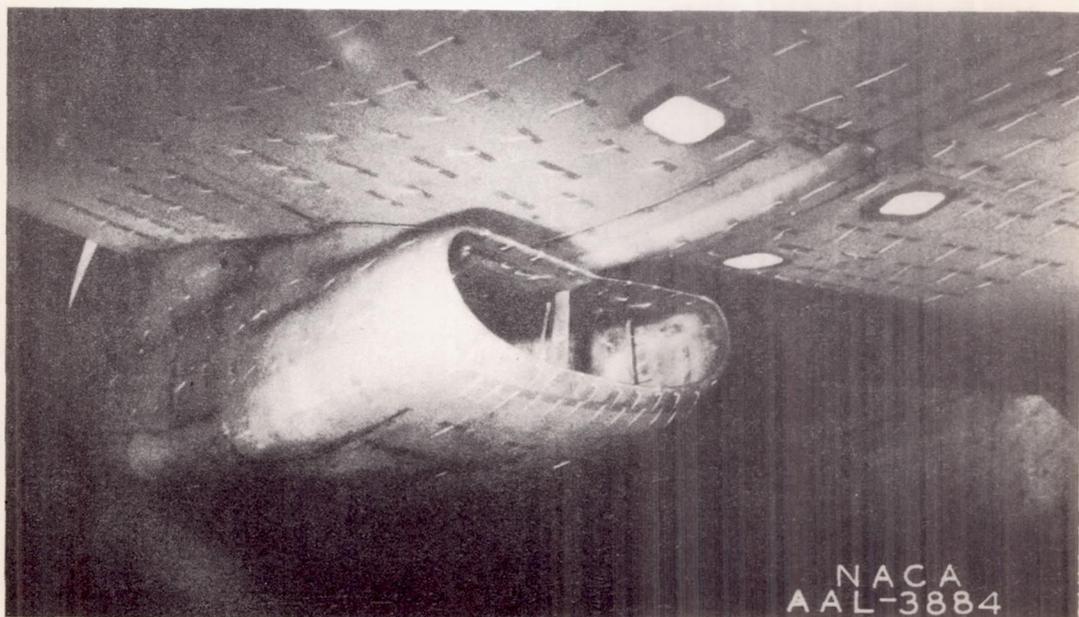
Figure 5.- Three-quarter front view of original  
duct entrance.  $\alpha = -2^\circ$ , flaps closed.

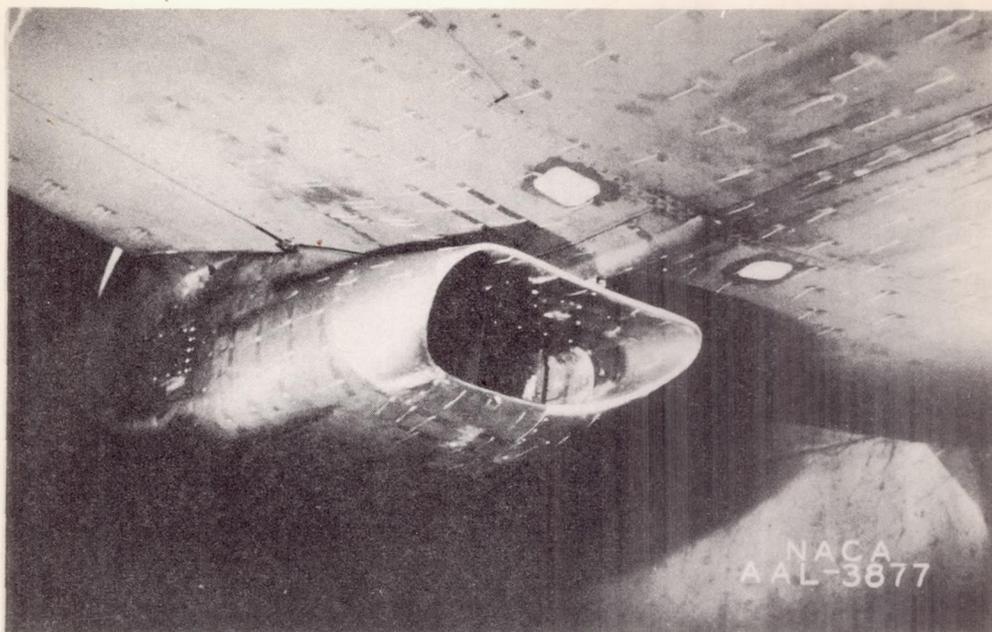
Figure 6.- Three-quarter front view of original duct with lip extension.  $\alpha = -2^\circ$ , flaps closed, bypass half open

extended 13-3/4 inches ahead of its original position and was faired into the original lower lip. The leading edge of the extension was made straight at the top and was placed about five-eighths of an inch away from the wing-bolt fairing at the center line of the airplane. The extension was faired into the lines of the original duct. The lip extension and the resulting improvement in the flow are shown in figure 6. With the bypass open, the duct, thus modified, had only a slight rumble at 429 miles per hour.

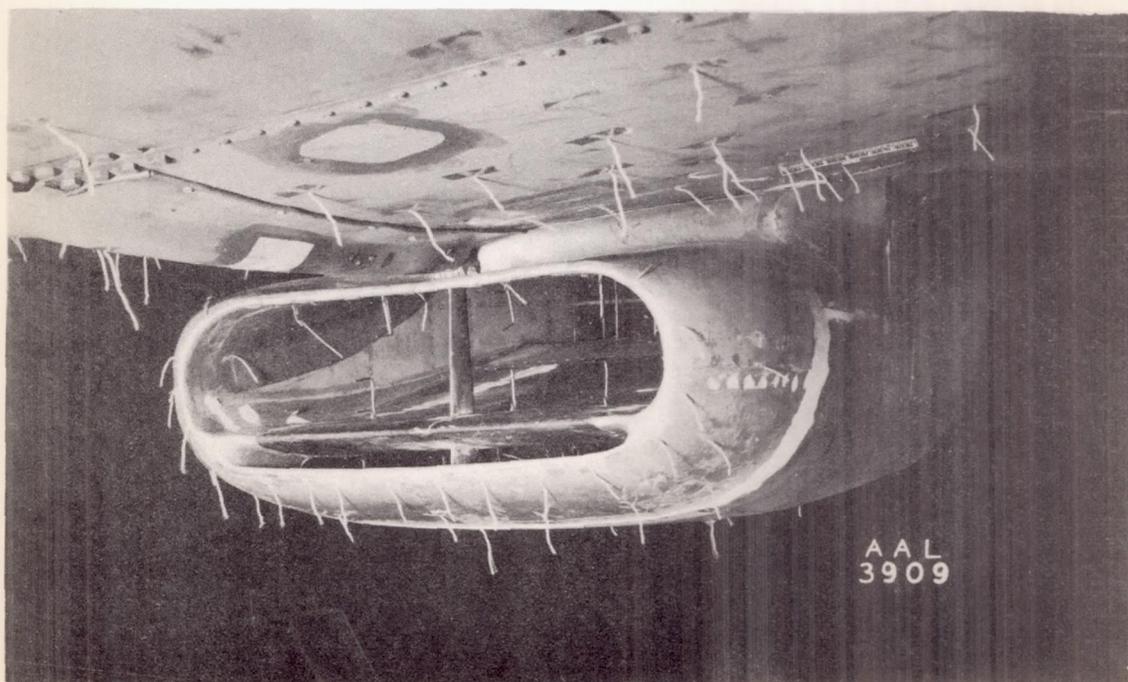
The next modification of duct tried was one conforming to loft lines designed by the manufacturer to provide a higher entrance velocity and to reduce the separation at the top portion leading to the coolant radiator. This was accomplished by extending the partition between the coolant- and oil-radiator ducts to the entrance, and redesigning the coolant-duct diffuser. A flap was incorporated by the Ames Aeronautical Laboratory to provide a bypass from forward of the coolant radiator to aft of the oil radiator. This revision, shown by figure 7, is called the "divided duct." It proved to have a later and less intense rumble than the original, but was inferior to the original as modified by an extended upper lip at the entrance. As before, the bypass removed the rumble to a degree (up to 337 miles per hour) but did not eliminate it at the higher speeds.

Figure 7.- Three-quarter front view of the divided duct.

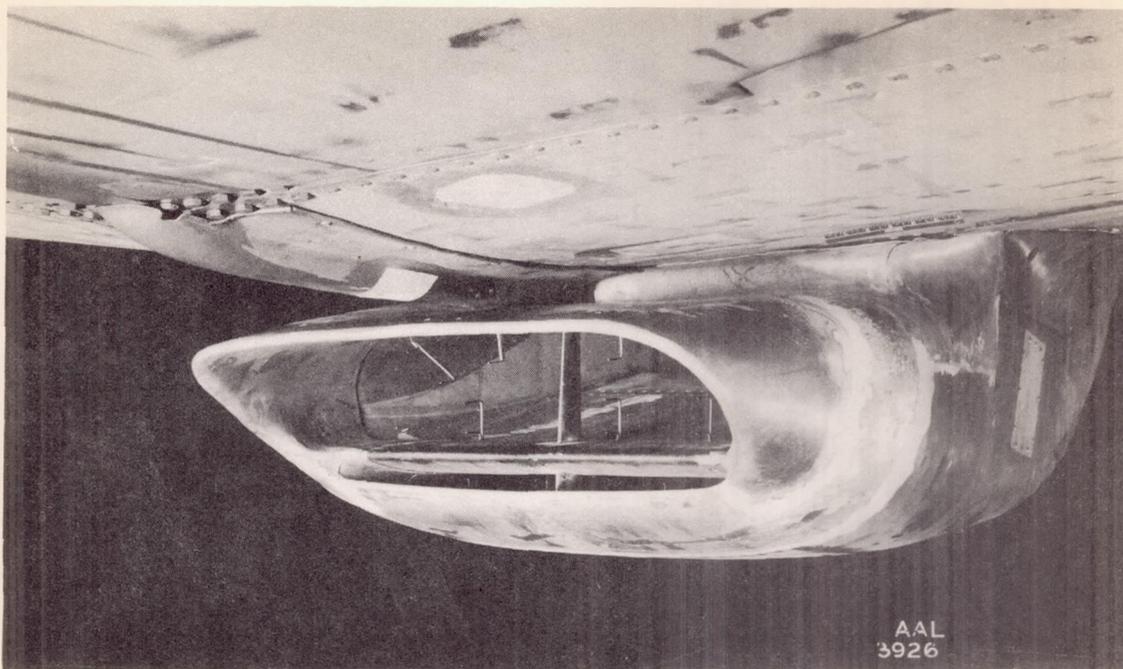
Figure 8.- Three-quarter front view of the divided duct with lip extension.

Another lip extension was made (fig. 8) and attached to the divided duct. This extension was similar to that used on the original duct, with the exception that it was carried only 10-7/8 inches forward and the leading edge was placed 1 inch away from the wing-bolt fairing. This modification reduced the rumble to a point where it was not discernible from the general vibration of the airplane at 500 miles per hour, the highest speed attained in the tests.

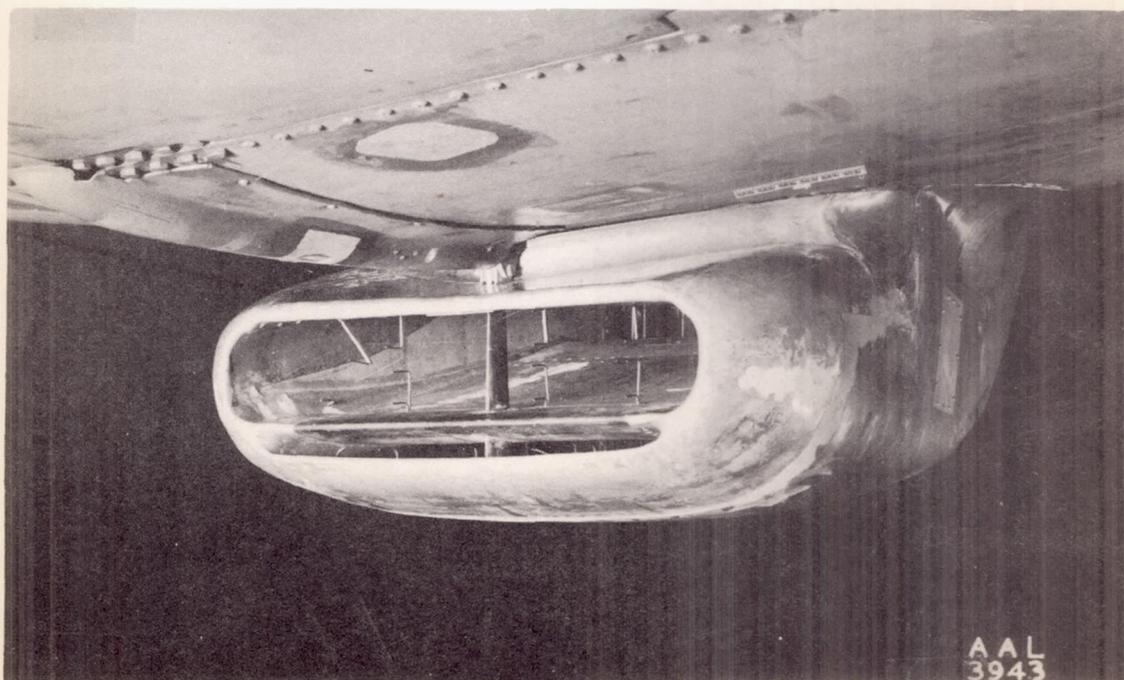
Figure 9.- Three-quarter front view of the modified divided duct.

An alternate change was made in the divided duct to determine if placing the entrance farther from the lower surface of the wing or extending the upper lip forward was the more important factor in removing the rumble. The top of the entrance, without lip extension, was lowered about 1 inch farther from the wing surface, and this drop was carried along the top inner surface of the coolant duct to within a few inches of the radiator. From this point, it was faired into the previous lines. The oil-radiator duct was left unchanged. Figure 9 shows this modification. This form, like

the divided duct with the extended lip, did not rumble at 500 miles per hour even with both duct-exit flaps closed and the airplane at an angle of attack of  $-2^{\circ}$ .

The second successful design was a modification of the divided duct. It likewise moved the entrance to the coolant duct away from the lower surface of the wing, but it did not change the depth of the gutter. The revision reduced the inlet area of the coolant duct from 163 square inches to 138.7 square inches.

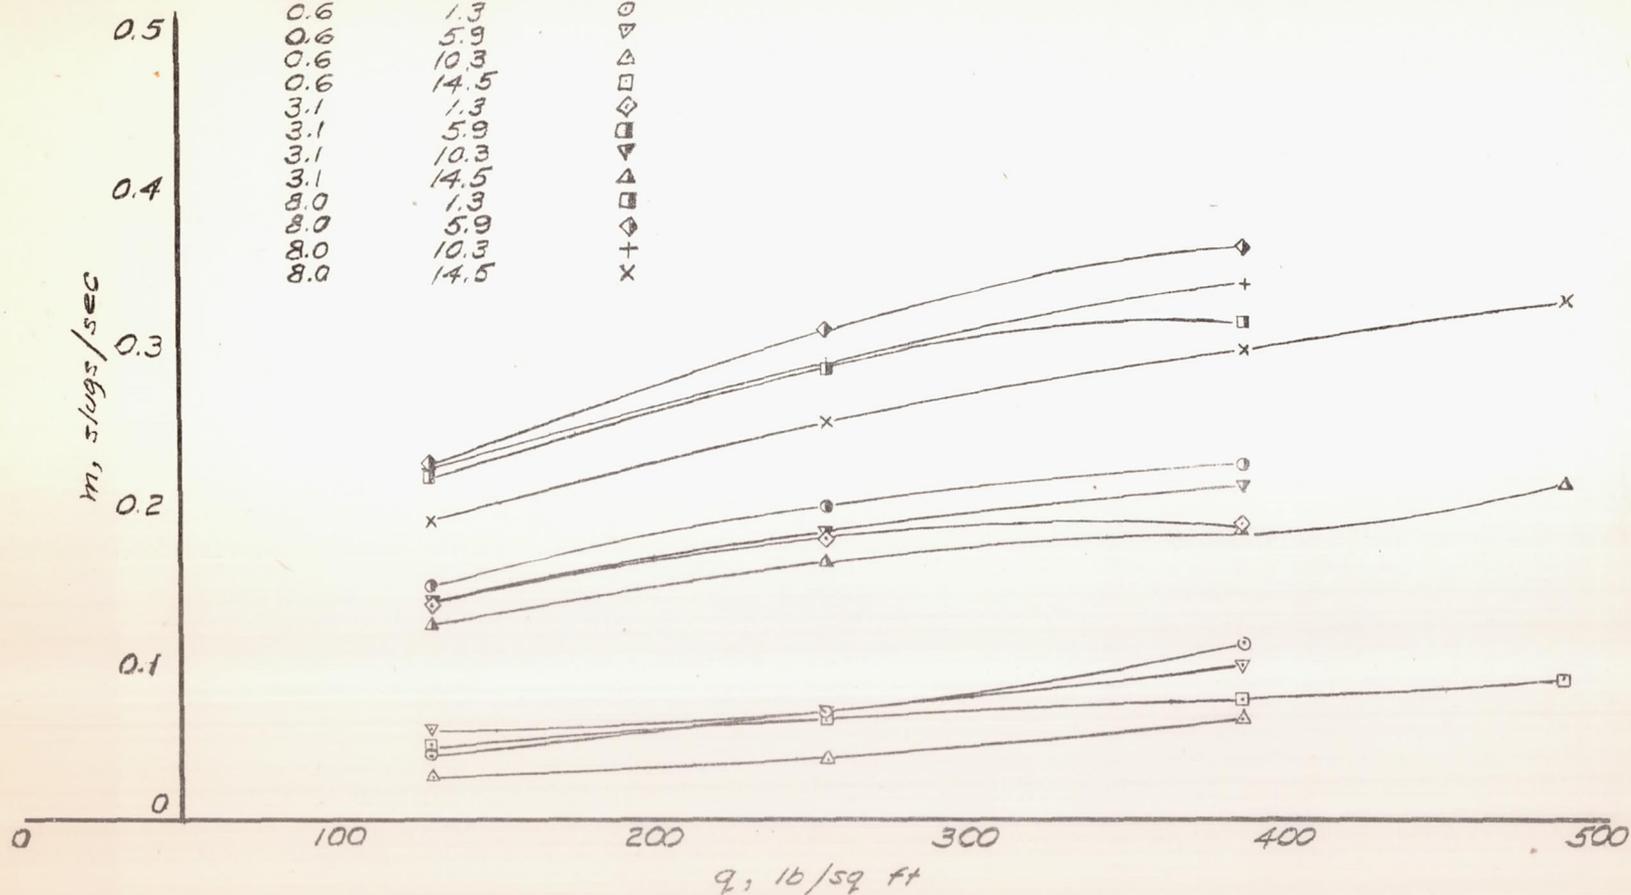
Cooling air.— The mass flow through the oil-radiator duct for the original design, and for the two that were successful in eliminating the rumble, is shown in figures 10 to 14. The curves indicate that either of the latter (the divided duct with lip extension or the modified divided duct) are satisfactory for cooling the oil. The most noticeable difference among the three is the greater scatter of the curves with changes in coolant-duct flap setting for the original design. This difference may be explained as an effect of the partition between the coolant- and oil-radiator ducts in the divided duct design. The partition, being extended to the entrance, might be expected to reduce the effect of coolant-duct flap setting on the flow through the oil radiator.

FIGURE 10.- MASS FLOW THROUGH OIL-RADIATOR DUCT FOR ORIGINAL DESIGN.  $\alpha = -2^\circ$

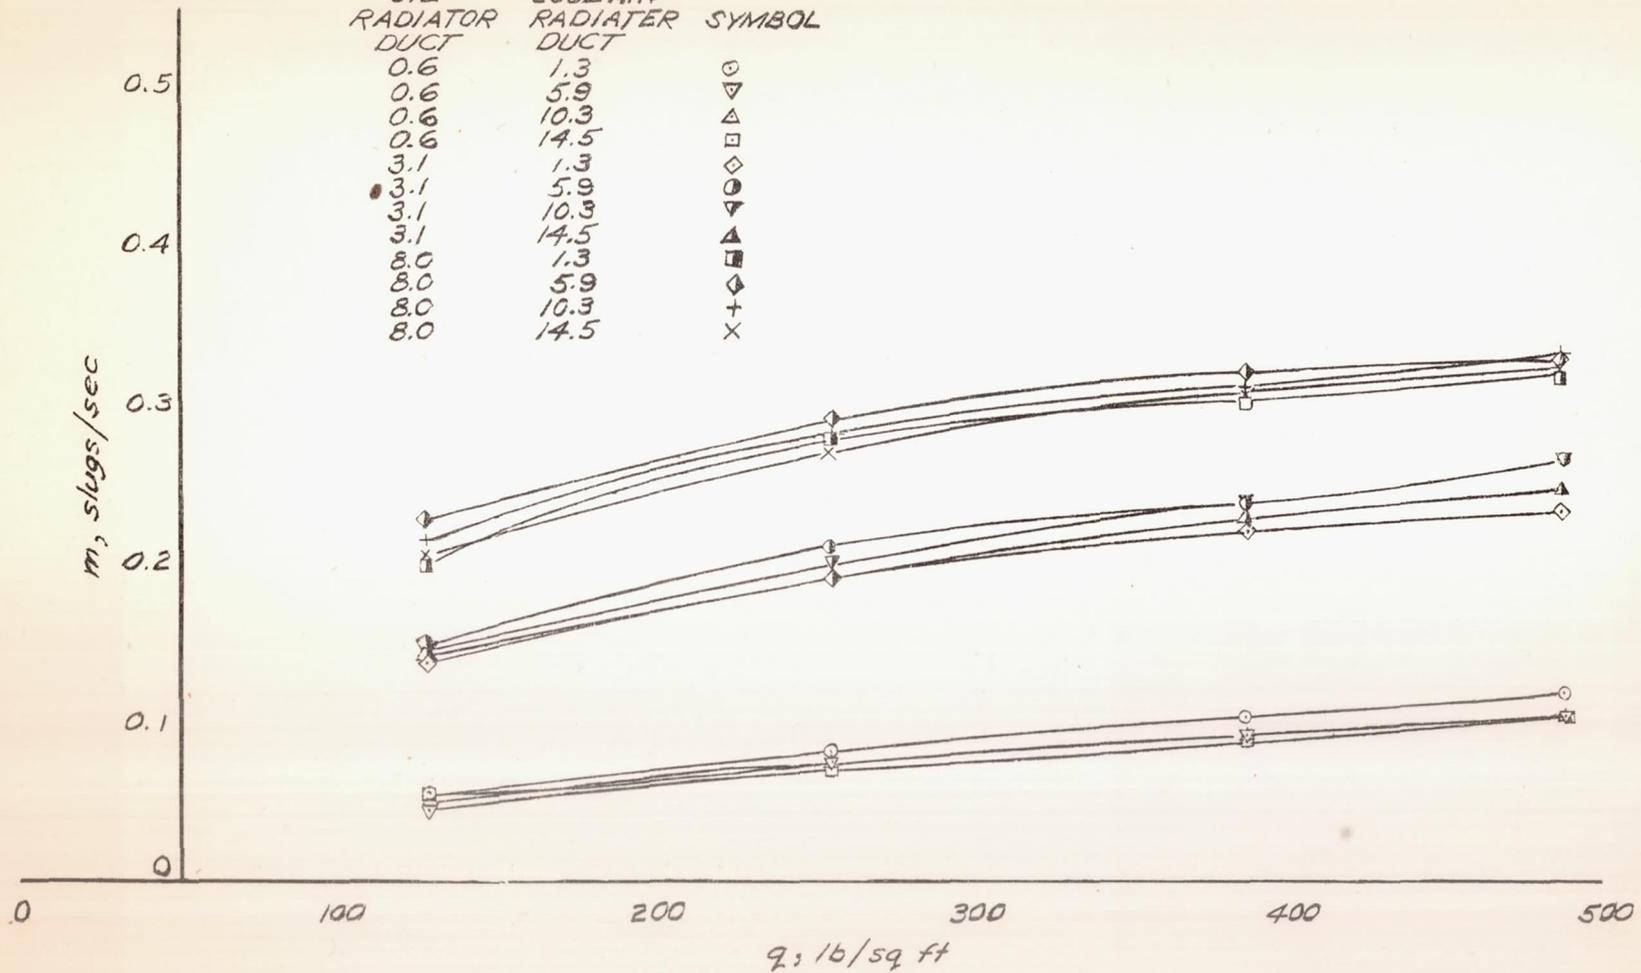
FIGURE 11.-MASS FLOW THROUGH OIL-RADIATOR DUCT FOR DIVIDED  
DUCT WITH LIP EXTENSION.  $\alpha = -2^\circ$

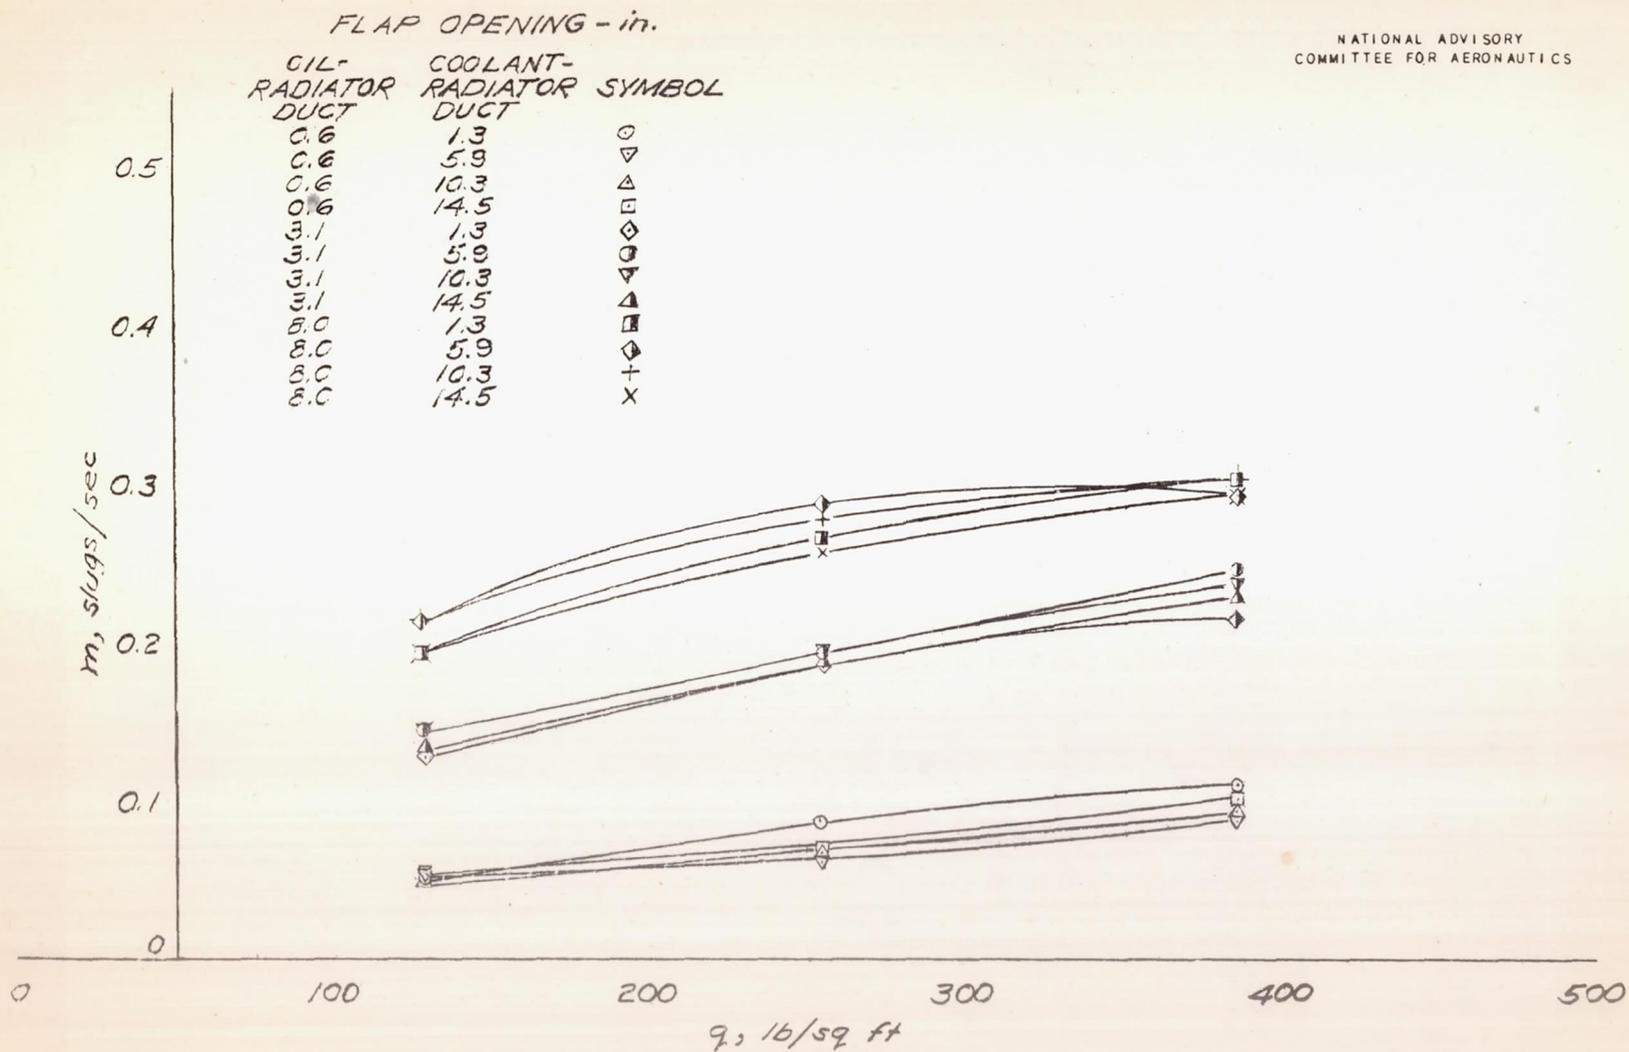
FIGURE 12.- MASS FLOW THROUGH OIL-RADIATOR DUCT FOR DIVIDED DUCT WITH LIP EXTENSION.  $\alpha = 0.56^\circ$

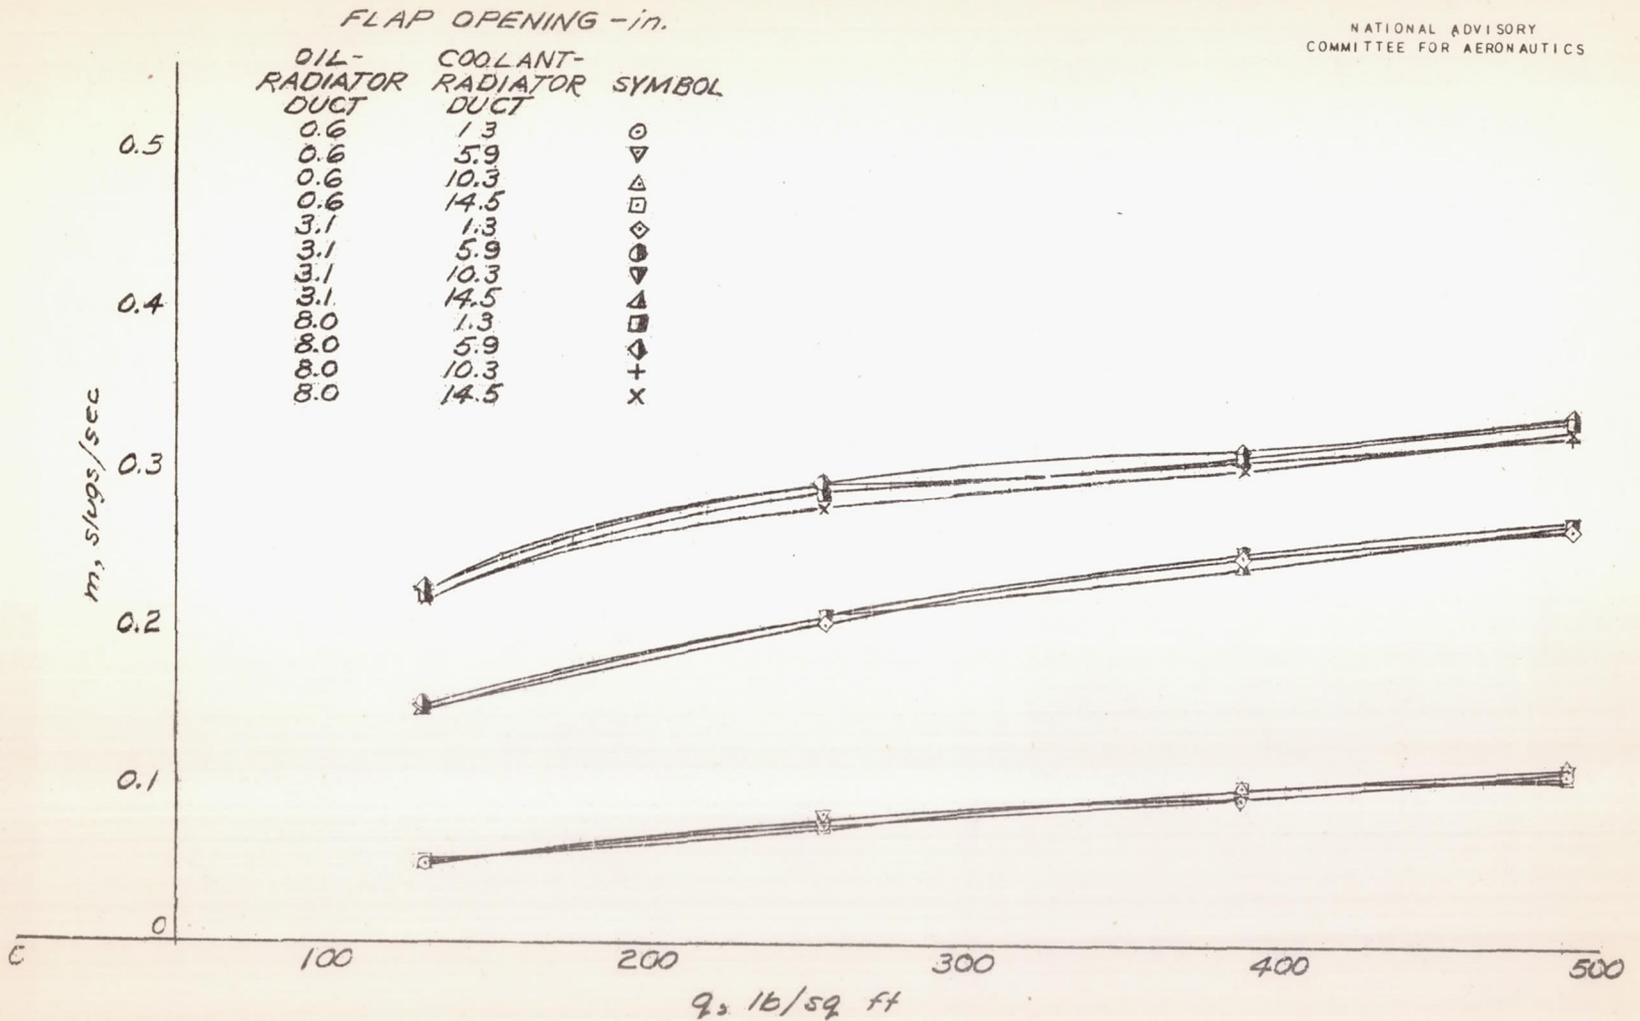
FIGURE 13.- MASS FLOW THROUGH OIL-RADIATOR DUCT FOR DIVIDED  
DUCT  $\alpha = -2^\circ$

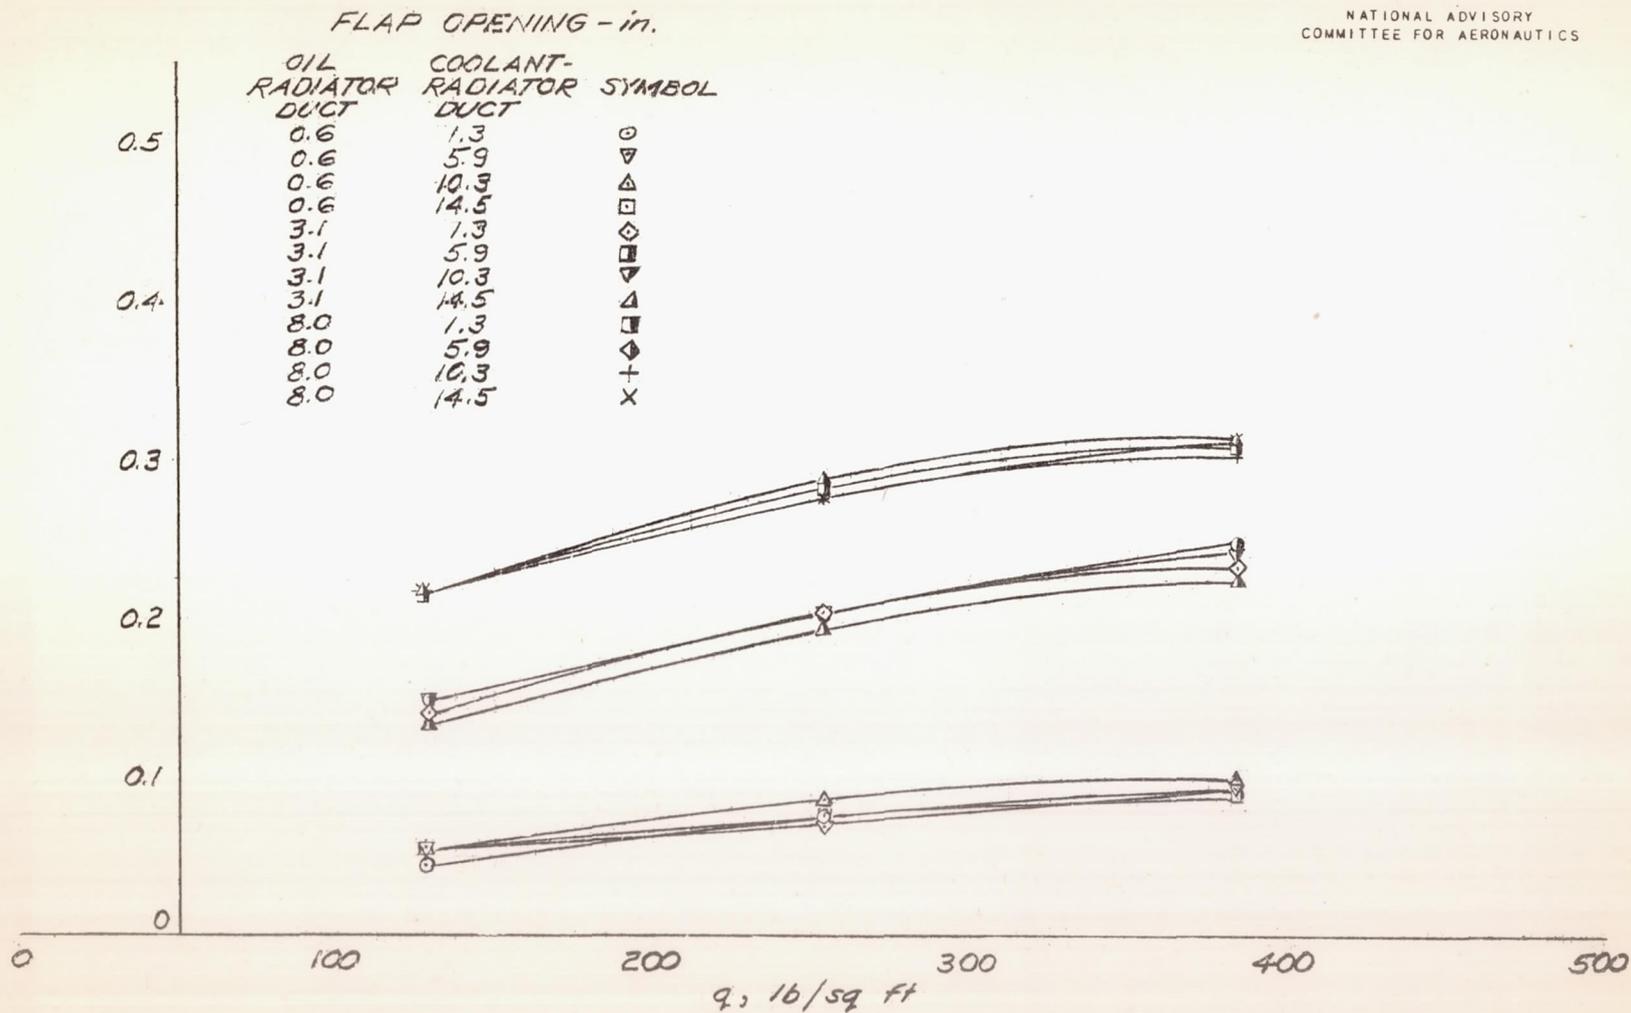
FIGURE 14.- MASS FLOW THROUGH OIL-RADIATOR DUCT FOR MODIFIED DIVIDED DUCT.  $\alpha = 0.56^\circ$

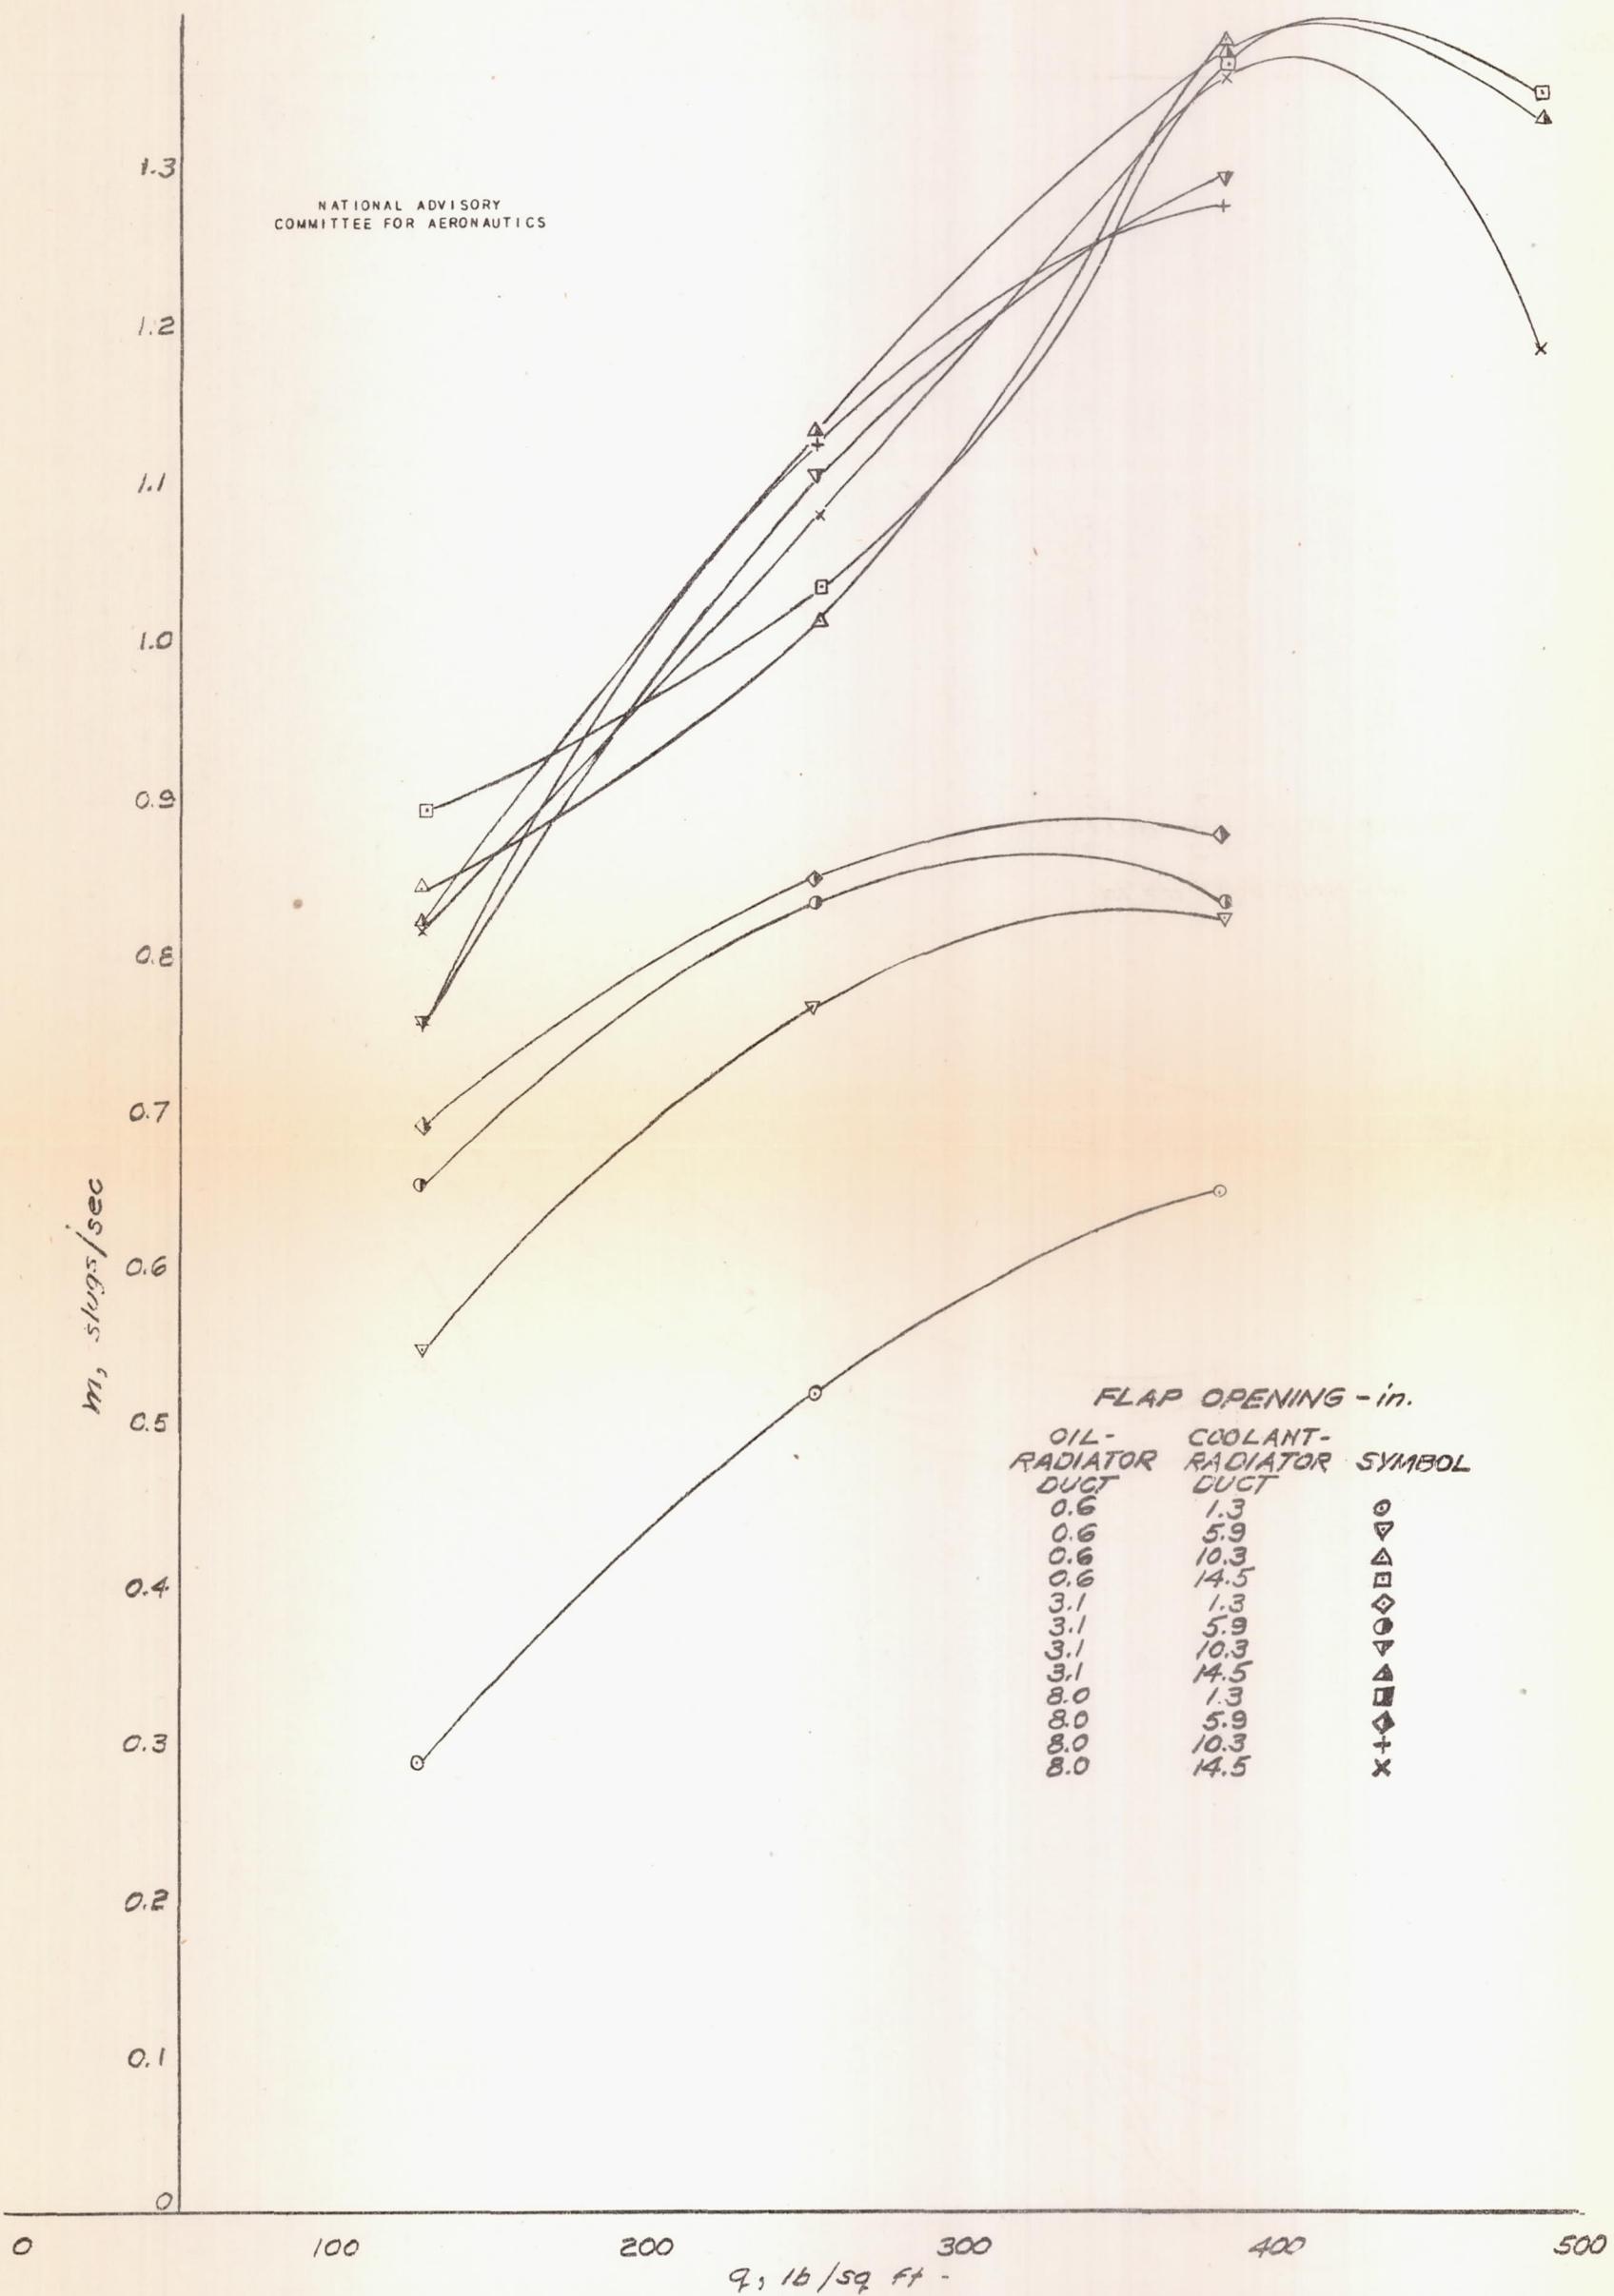
Likewise, figures 15 to 19 show the mass flow through the coolant-radiator duct for these three designs. In general, the flow for the original design was slightly greater than for the other two. The curves for the divided duct with the upper-lip extension and for the modified divided duct are much alike, with the exception that at the fully closed position of the coolant-duct-exit flap, those for the modified form show a definitely smaller mass flow.

FIGURE 15.- MASS FLOW THROUGH COOLANT-RADIATOR DUCT FOR ORIGINAL DESIGN.  $\alpha = -2^\circ$
