ELIMINATION OF RUMBLE FROM THE COOLING DUCTS OF A  
SINGLE-ENGINE PURSUIT AIRPLANE

By Howard F. Matthews

MEMORANDUM REPORT

Air Materiel Command, U.S. Army Air Forces

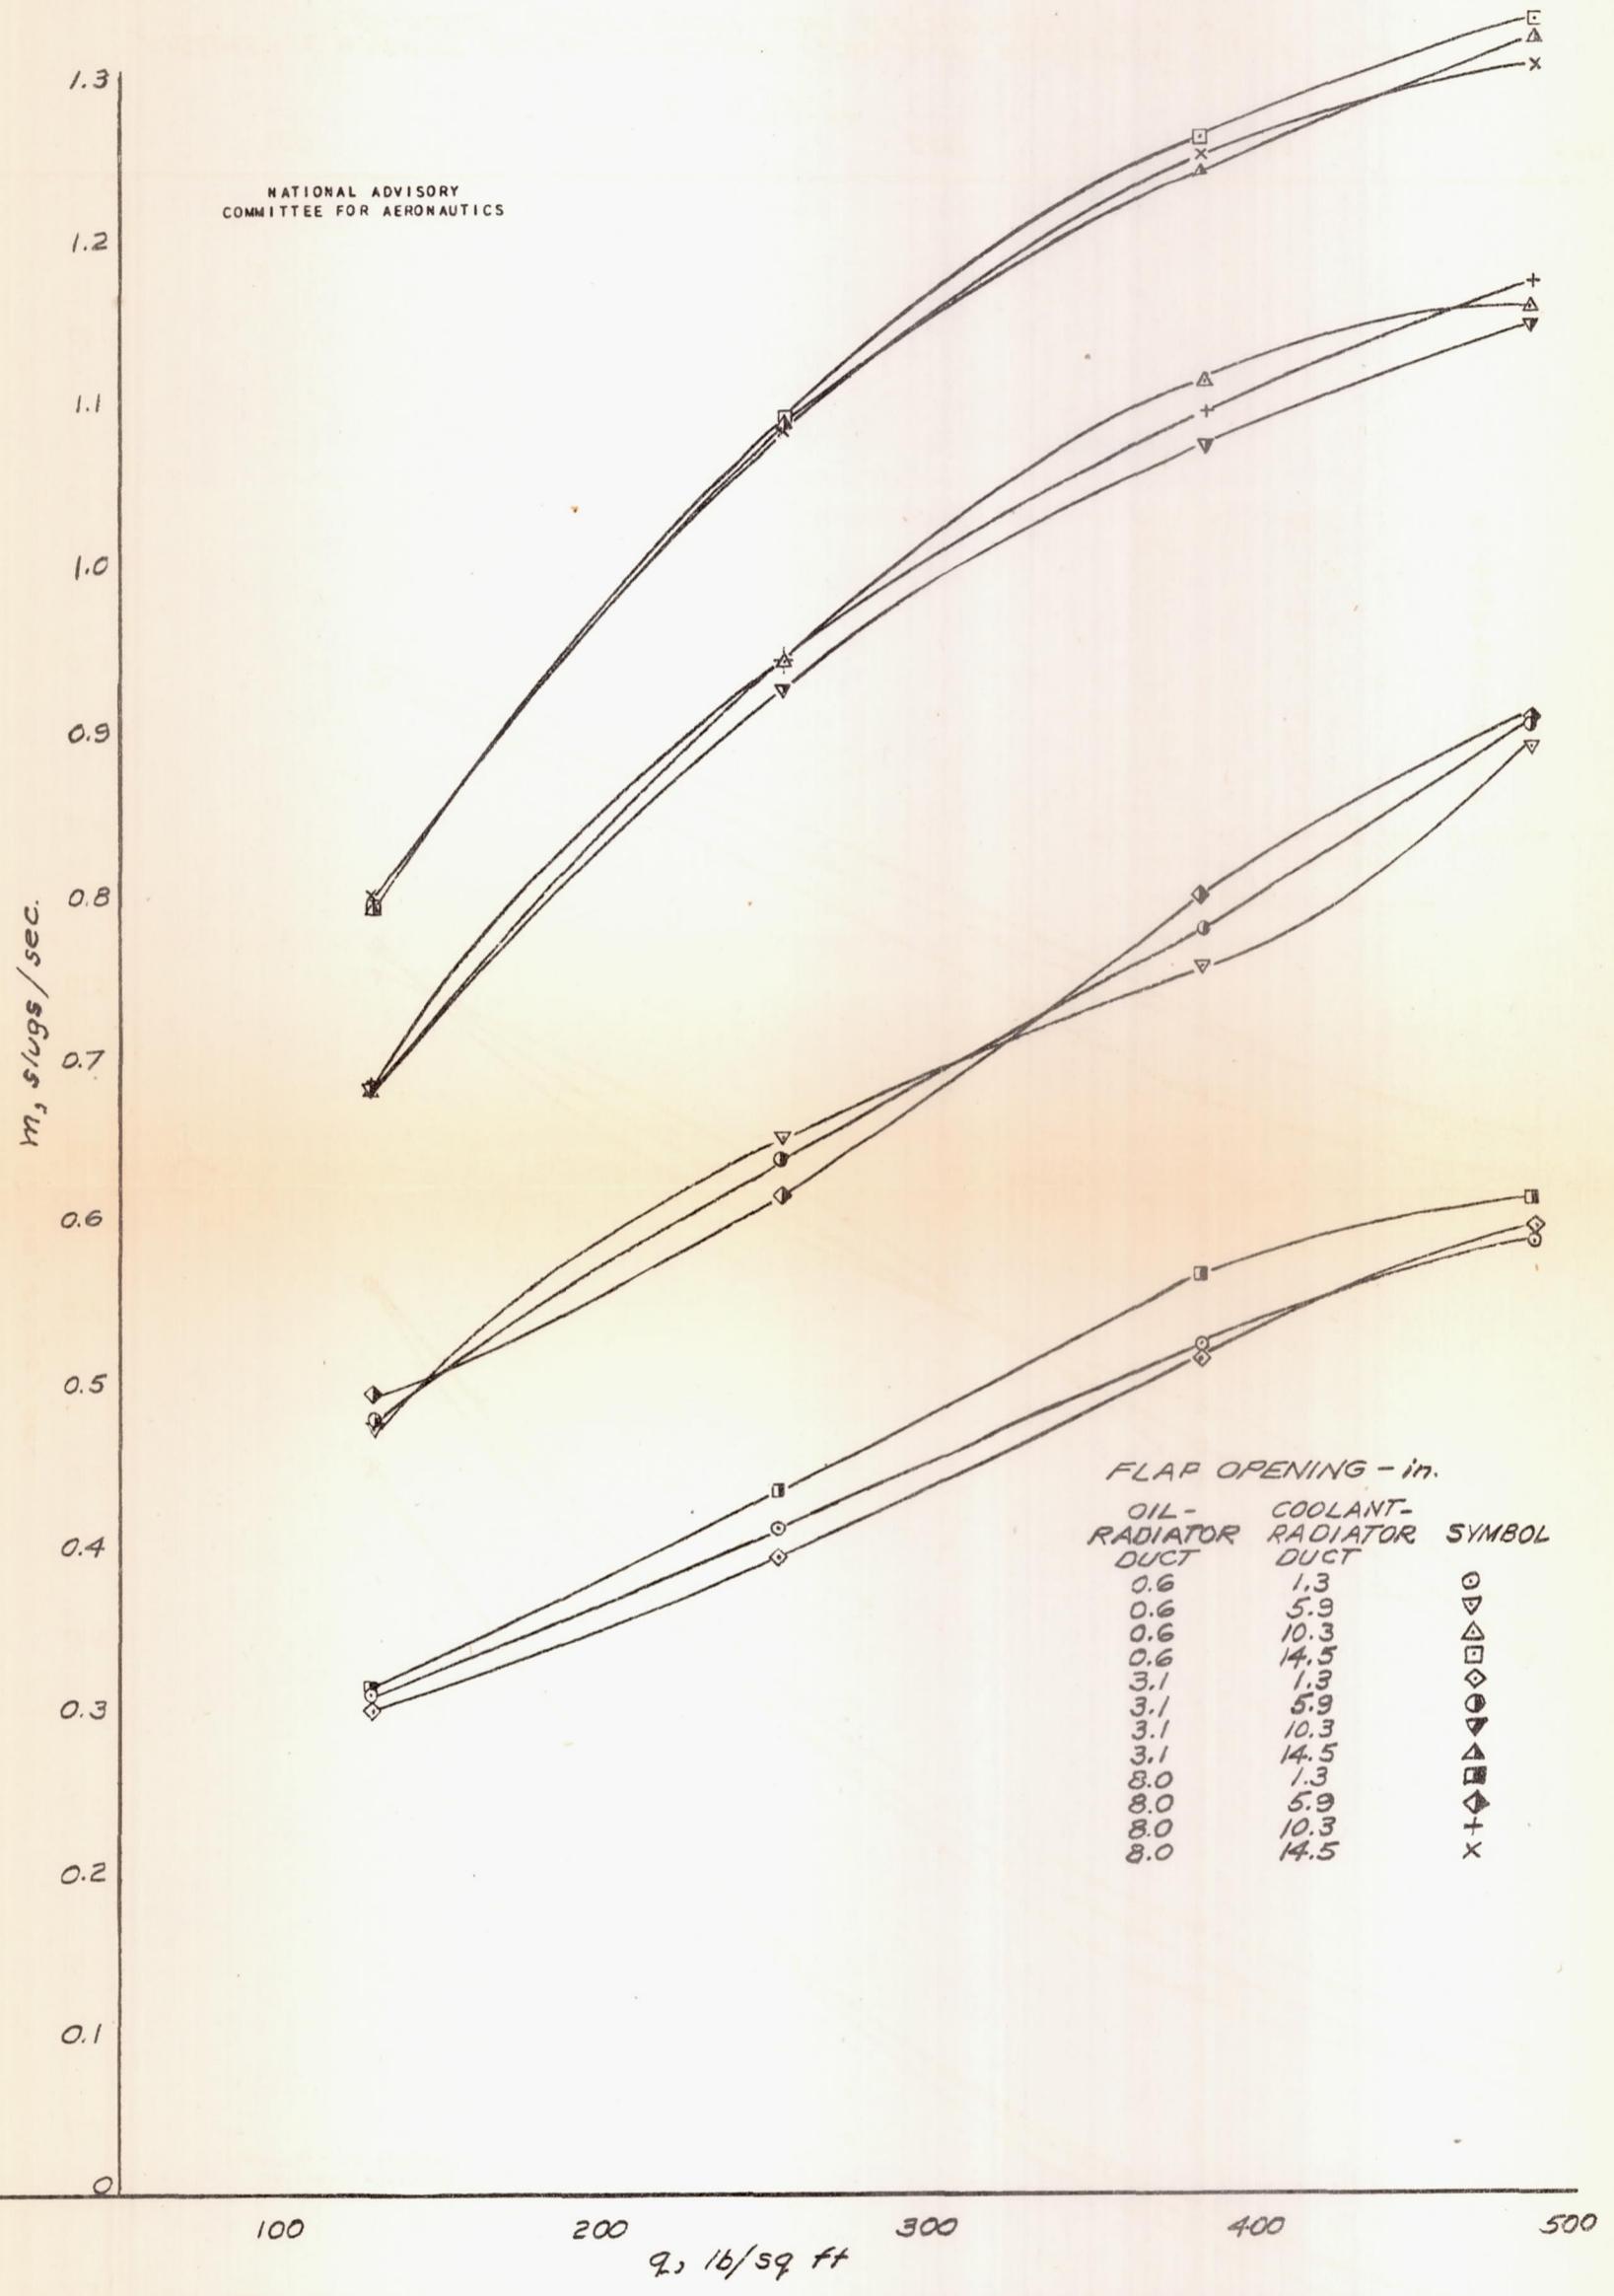
Likewise, figures 15 to 19 show the mass flow through the coolant-radiator duct for these three designs. In general, the flow for the original design was slightly greater than for the other two. The curves for the divided duct with the upper-lip extension and for the modified divided duct are much alike, with the exception that at the fully closed position of the coolant-duct-exit flap, those for the modified form show a definitely smaller mass flow.

FIGURE 16.-MASS FLOW THROUGH COOLANT-RADIATOR DUCT FOR DIVIDED DUCT WITH LIP EXTENSION.  $\alpha = -2^\circ$

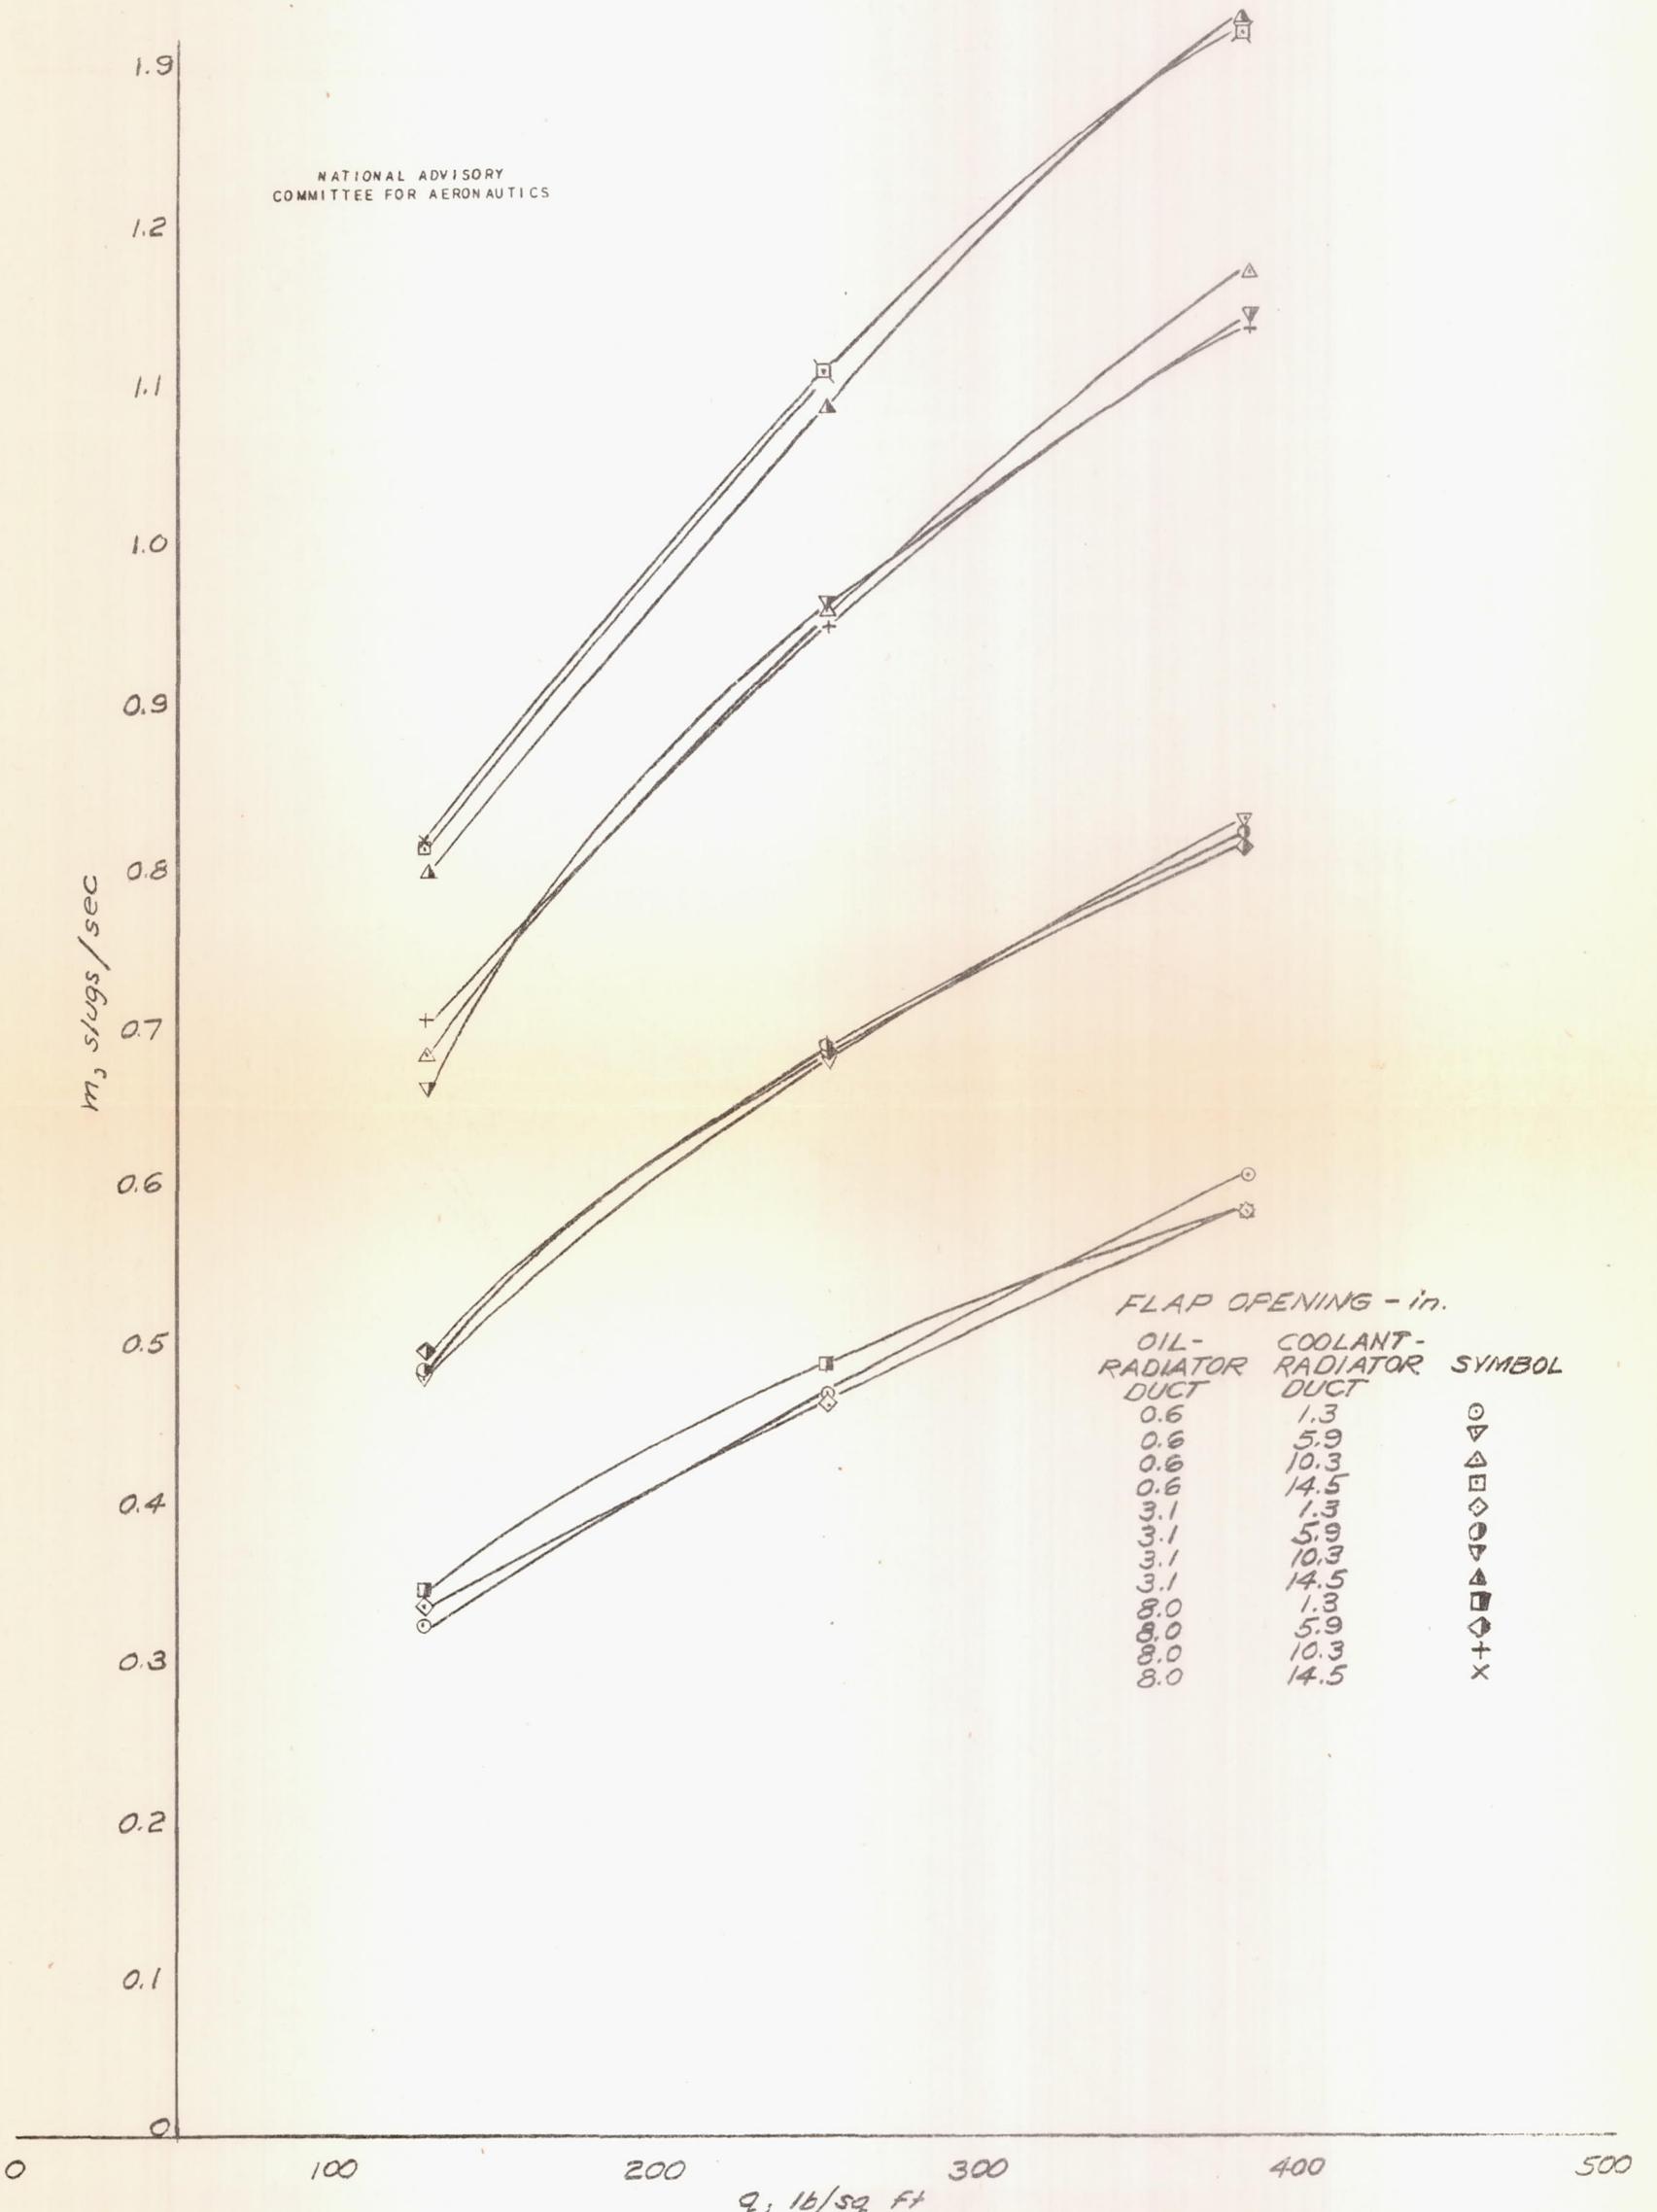
FIGURE 17.- MASS FLOW THROUGH COOLANT-RADIATOR DUCT FOR DIVIDED DUCT WITH LIP EXTENSION.  $\alpha = 0.56^\circ$

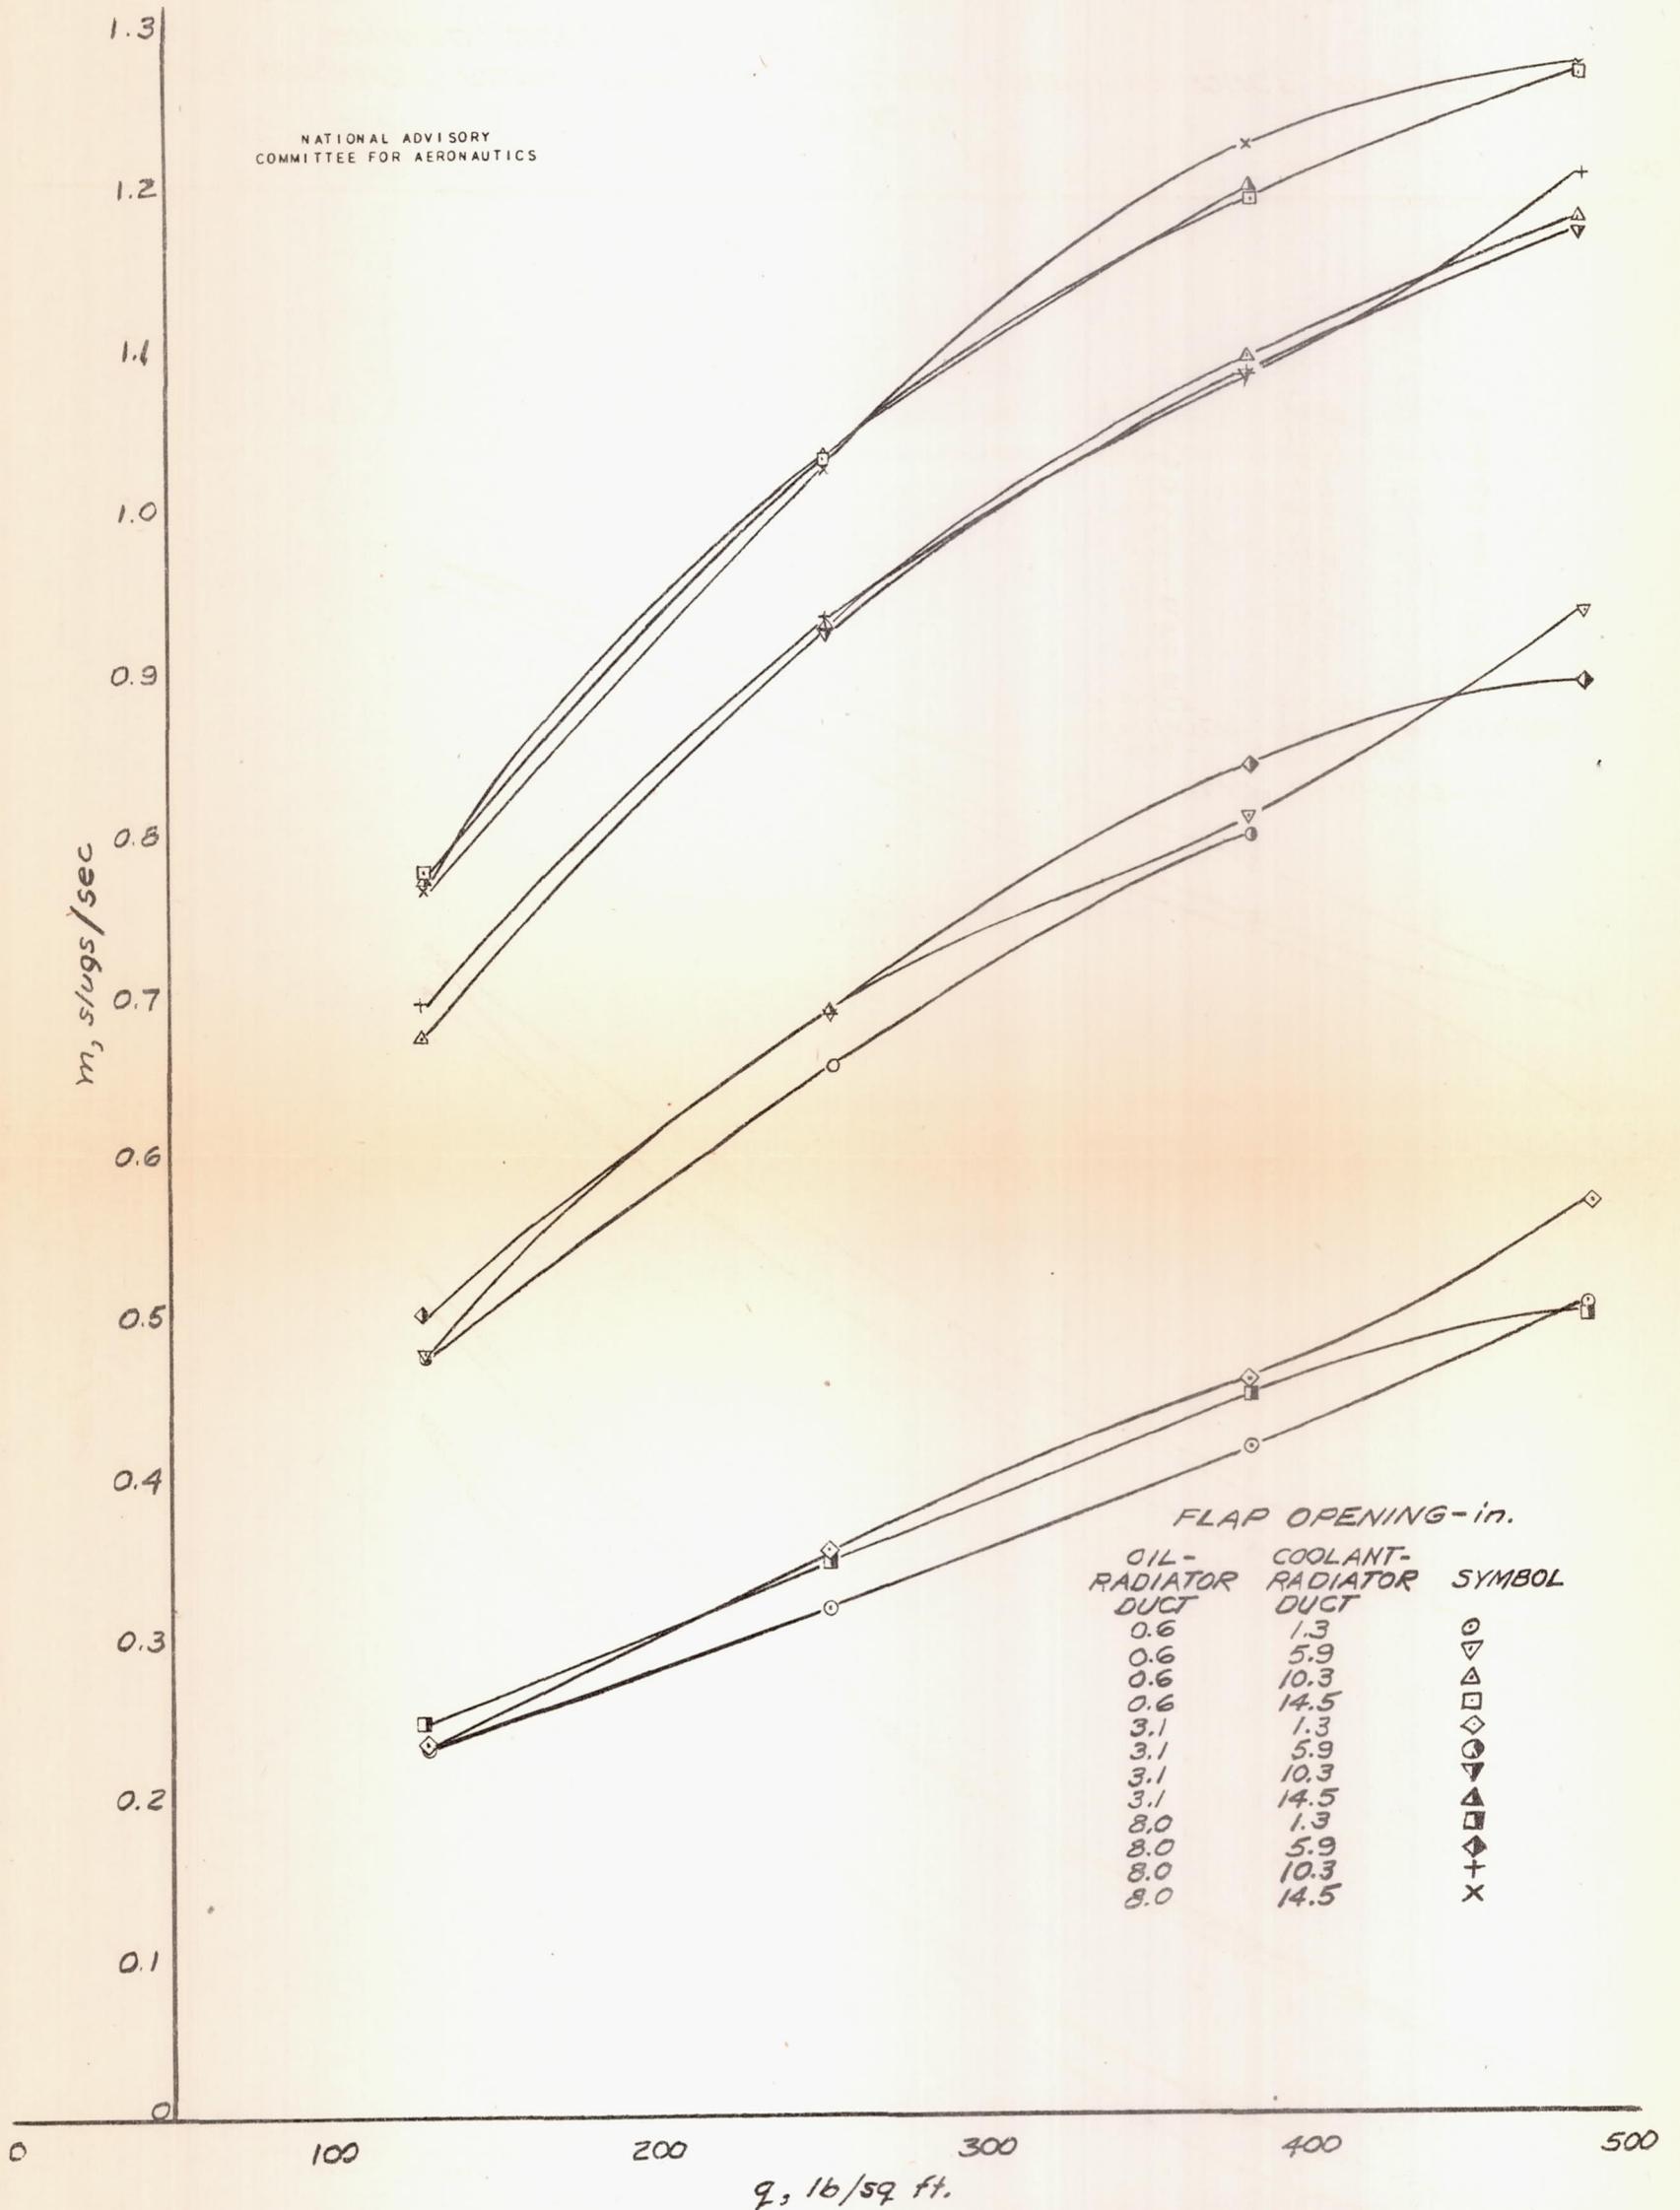
FIGURE 18.-MASS FLOW THROUGH COOLANT-RADIATOR DUCT FOR MODIFIED DIVIDED DUCT.  $\alpha = -2^\circ$

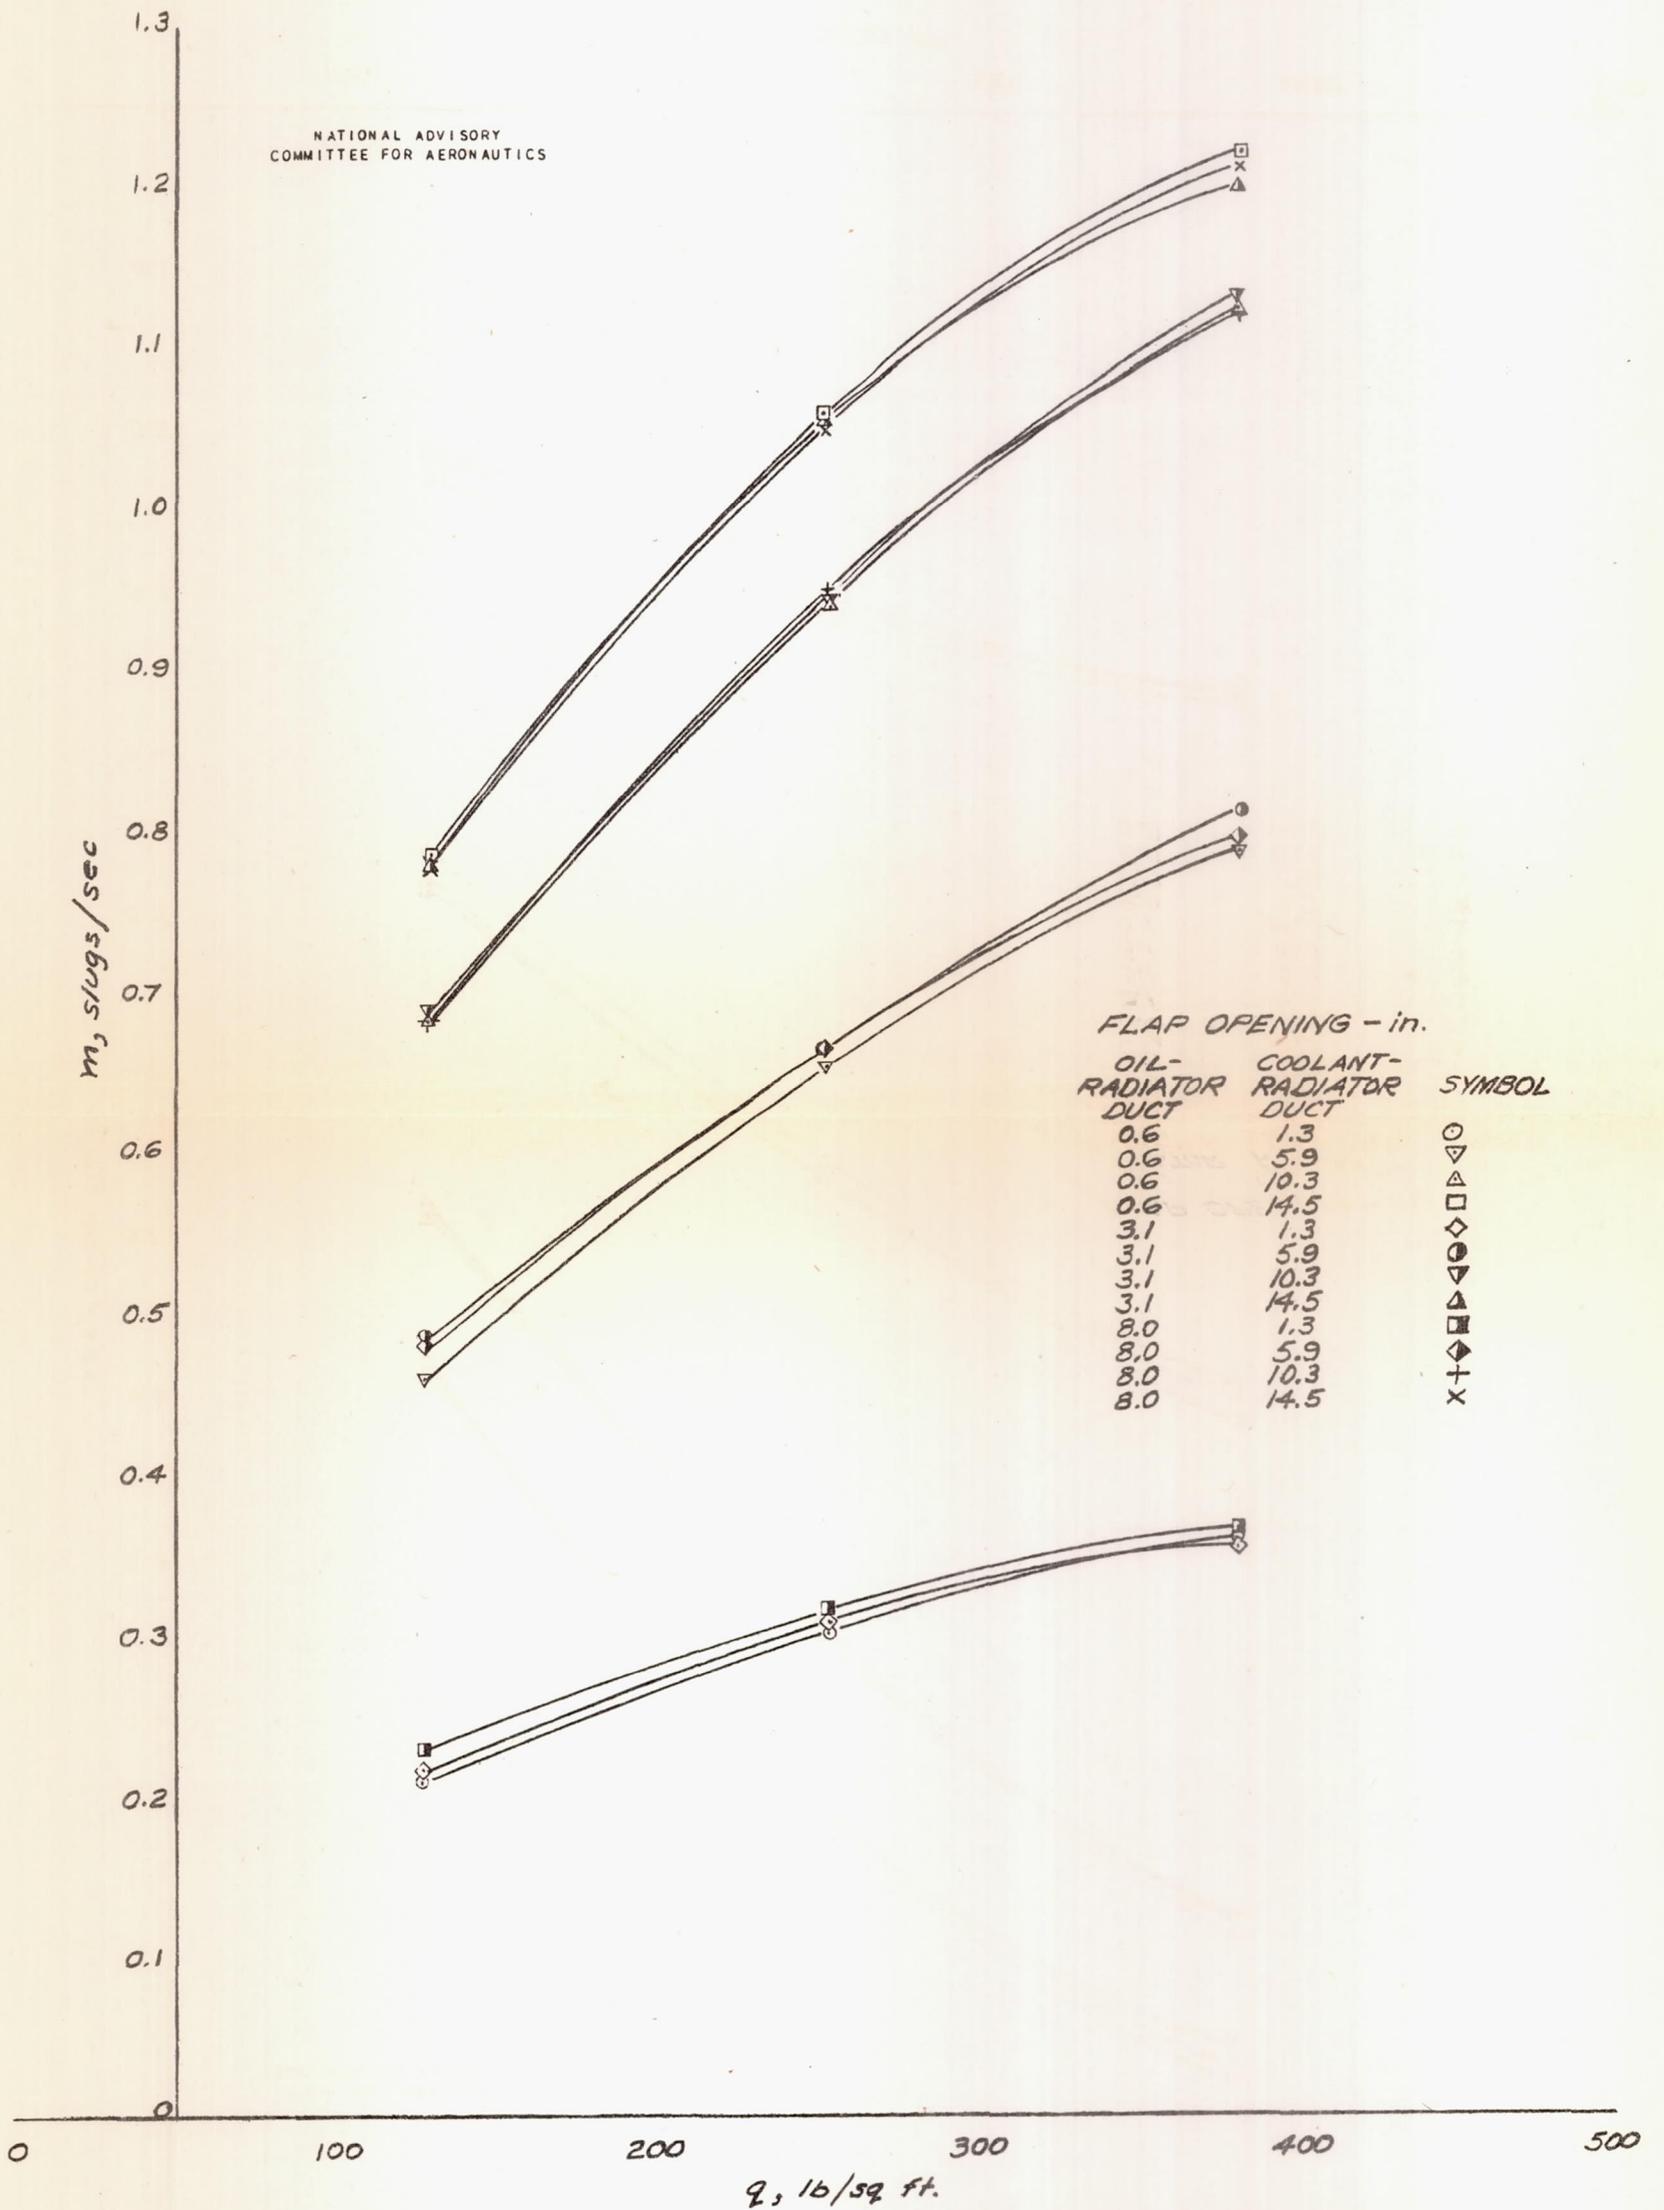
FIGURE 19-MASS FLOW THROUGH COOLANT-RADIATOR DUCT FOR MODIFIED DIVIDED DUCT  $\alpha = 0.56^\circ$

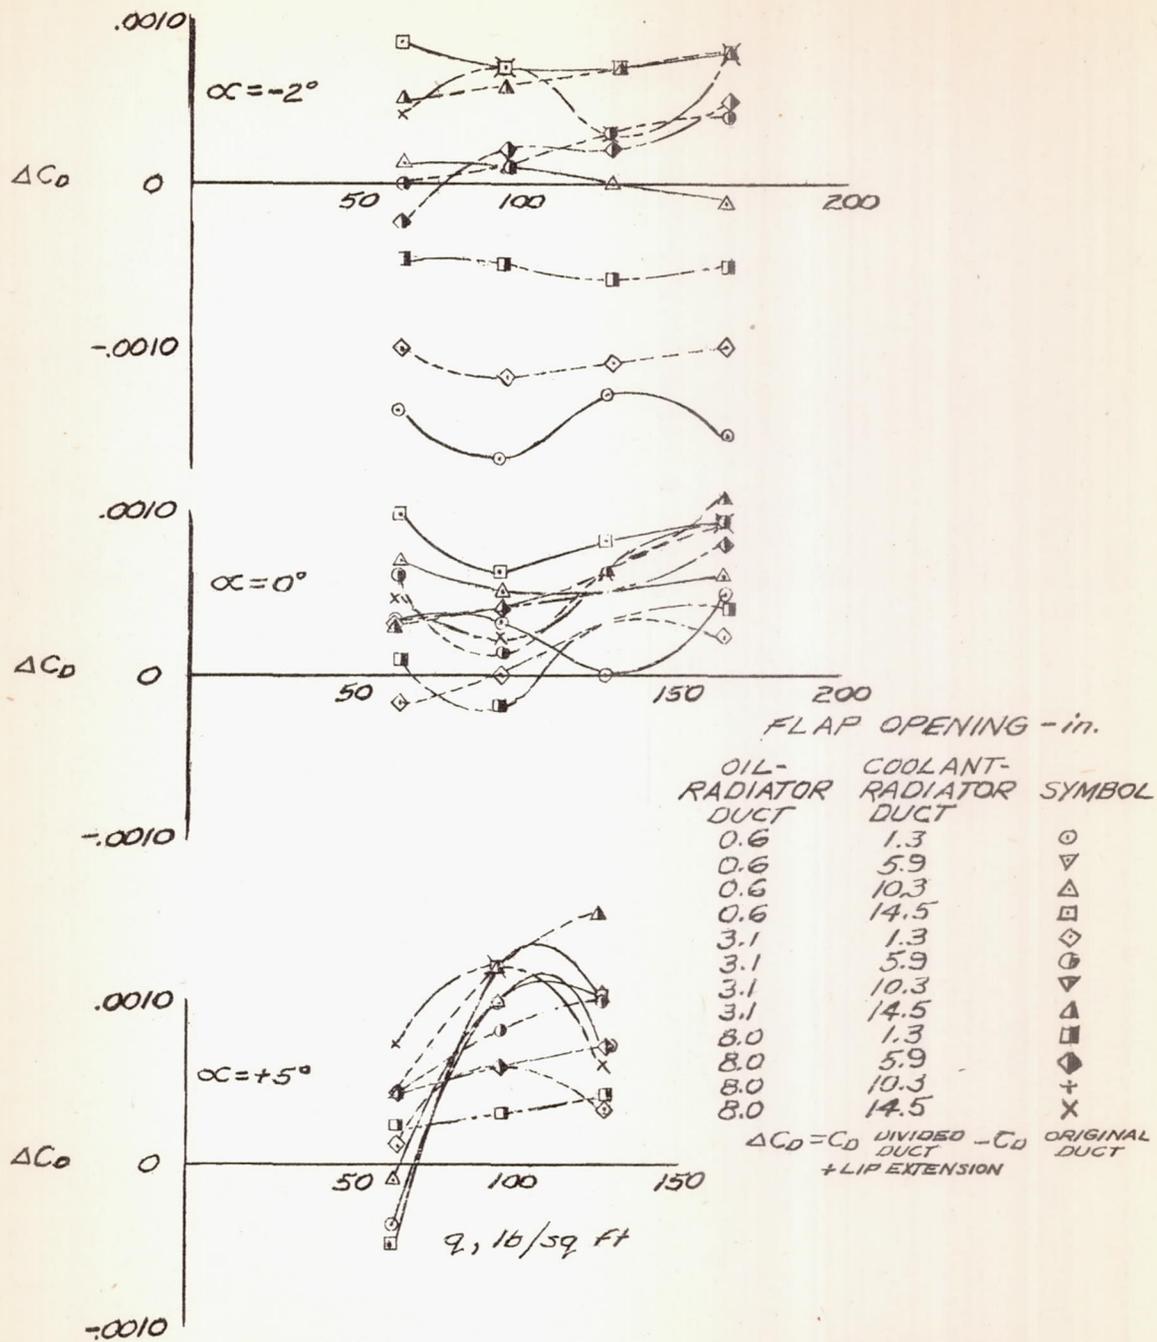
Drag.— The drag increment, due to substitution of the divided duct for the original duct with lip extension, is shown in figures 20 and 21. In the dive attitude (approximate angle of attack of  $-2^{\circ}$ ), either divided duct produced a decrease in the drag coefficient with the coolant-duct flap closed, and only a slight increase (about 0.0002) with the flap flush. At the high-speed level-flight attitude (angle of attack  $0^{\circ}$ ), the drag coefficient was increased an average of about 0.0004. For an angle of attack of  $5^{\circ}$ , the drag increment was slightly higher.

FIGURE 20.- DRAG INCREMENT FOR DIVIDED DUCT WITH LIP EXTENSION.

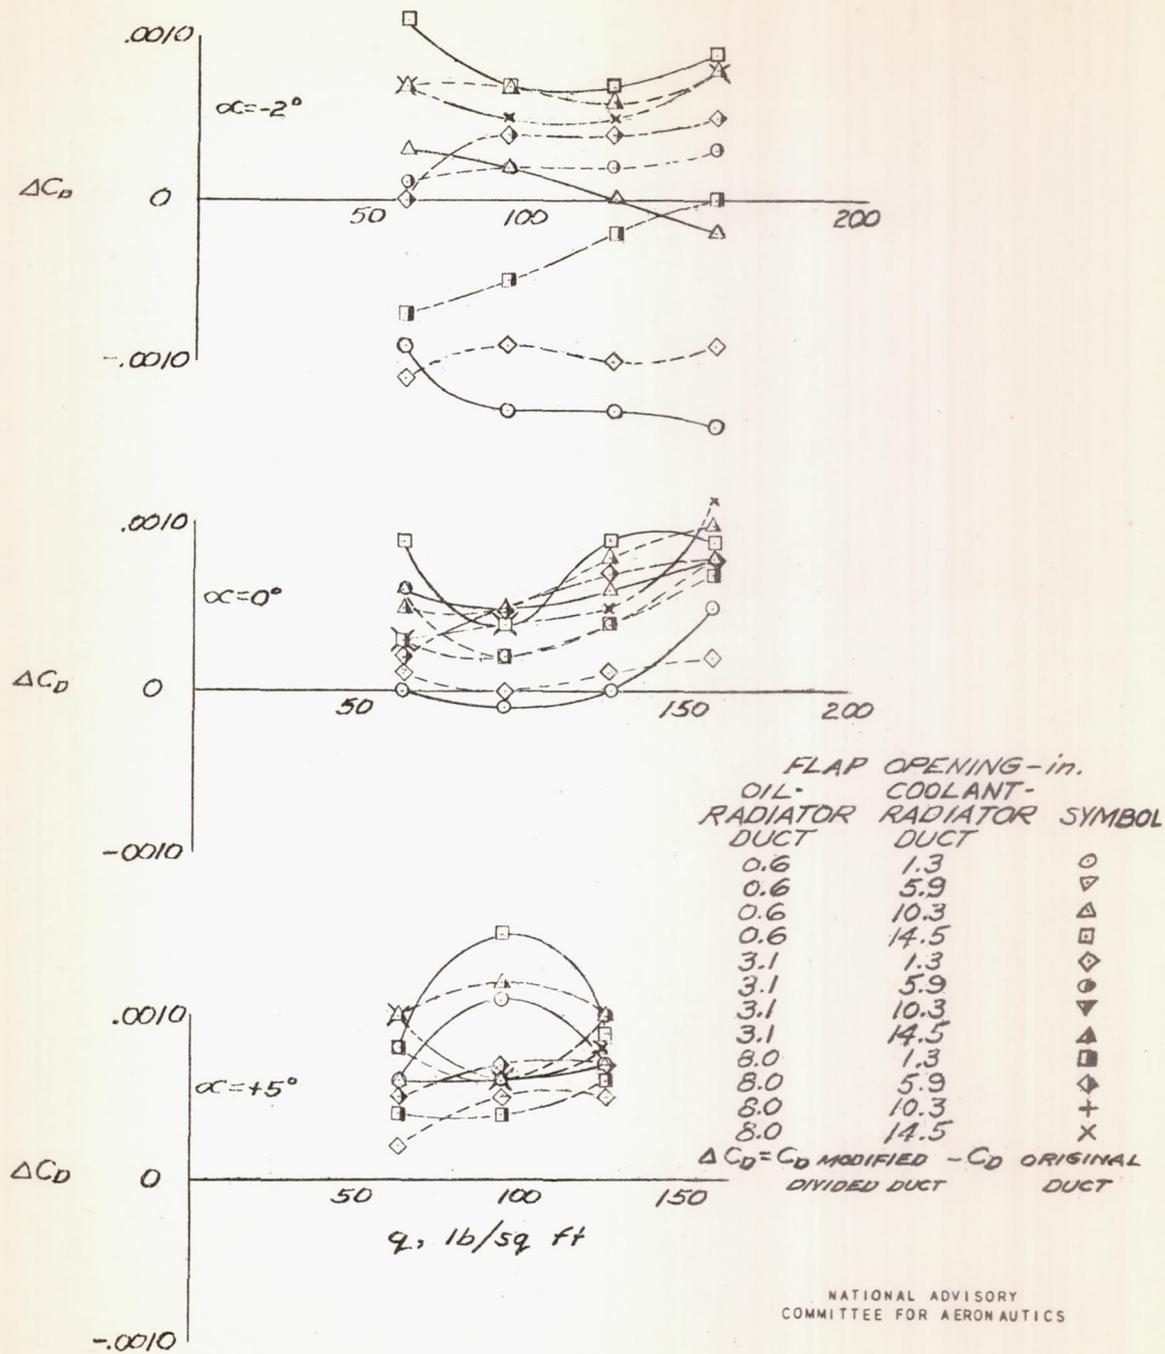
FIGURE 21.- DRAG INCREMENT FOR MODIFIED DIVIDED DUCT

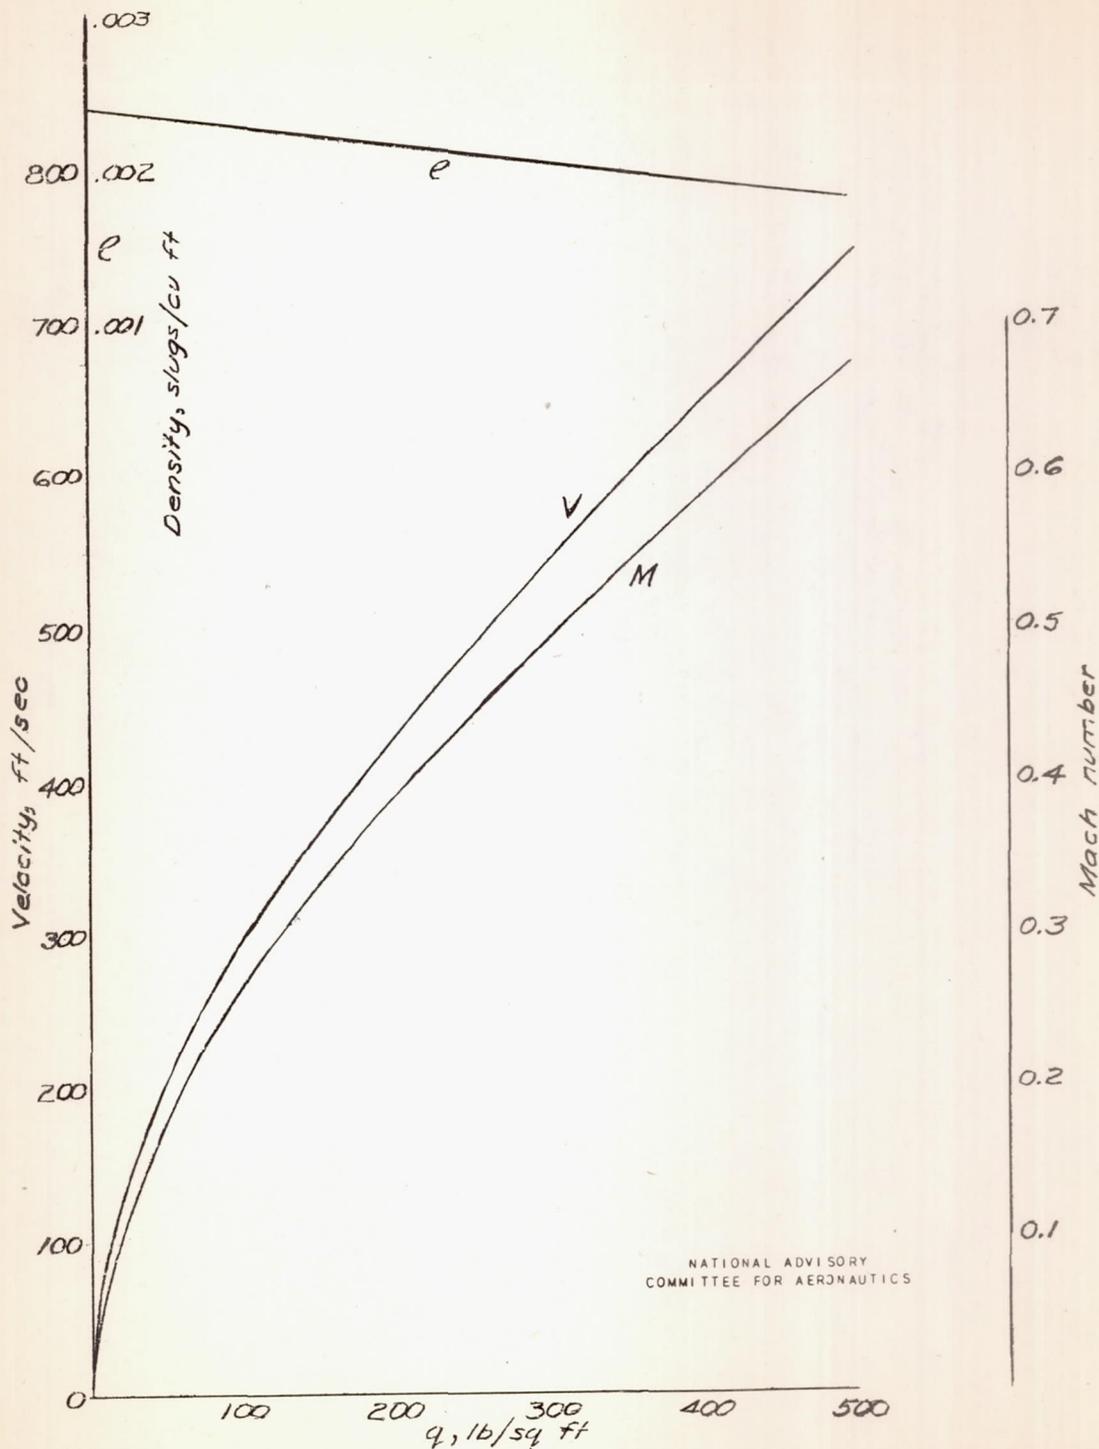
Figure 22 shows the density, velocity, and Mach number at the position of the airplane and as corrected for constriction effects, as functions of dynamic pressure.

FIGURE 22.-RELATION OF DENSITY, VELOCITY, AND MACH NUMBER TO DYNAMIC PRESSURE IN 16-FOOT WIND TUNNEL DURING TESTS OF A SINGLE-ENGINE PURSUIT AIRPLANE.

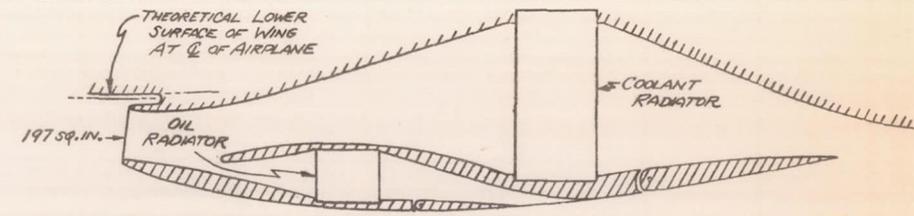
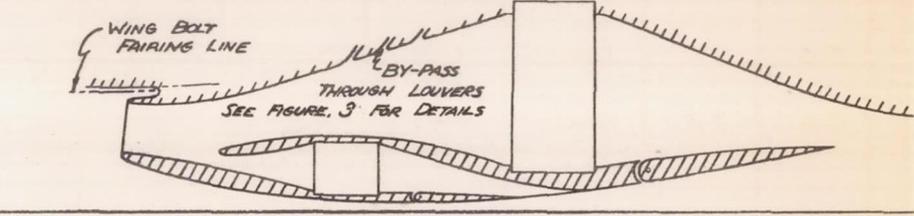
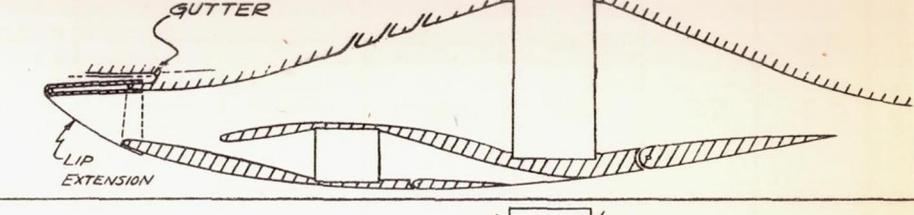
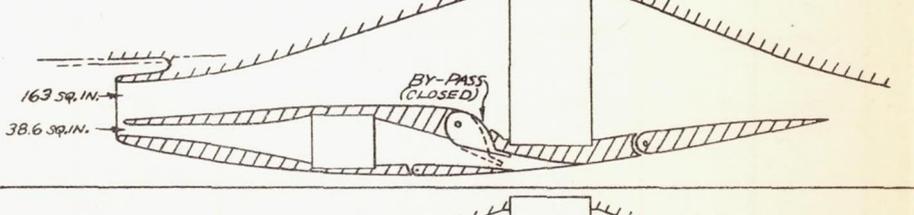
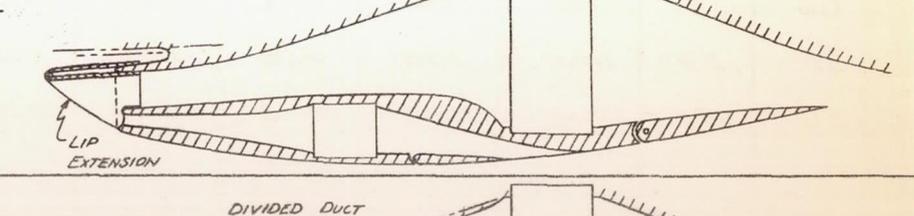
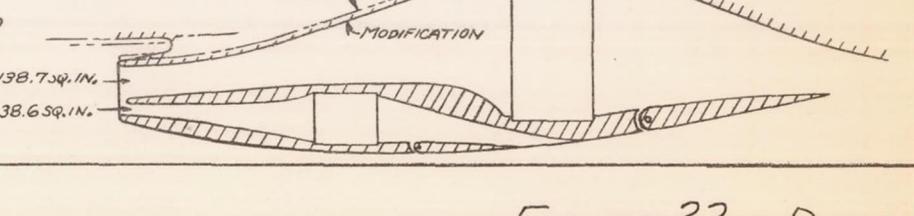
FIGURE 23.- DUCT DESIGNS AND SUMMARY OF THEIR PERFORMANCES

Figure 23 shows the principal forms of duct investigated and gives a summary of the performance, where determined, for the various conditions of the tests.

DUCT	FLAP OPENING - INCHES		RUMBLE $\alpha = -2^\circ$		$\Delta C_D$ ( $C_D - C_D$ WITH ORIGINAL DUCT) WING AREA = 233.19 SQ. FT. $\alpha = 0^\circ$		MASS FLOW SLUGS PER SECOND $Q = 385 \text{ LB./SQ. FT.}$ $V = 430 \text{ MPH.}$ MACH NO. = .570 $\alpha = -2^\circ$	
	OIL	COOLANT	SEVERE	MEDIUM	$Q = 254 \frac{\text{LB.}}{\text{SQ. FT.}}$	$Q = 487 \frac{\text{LB.}}{\text{SQ. FT.}}$	$Q = 63 \frac{\text{LB.}}{\text{SQ. FT.}}$	$Q = 127 \frac{\text{LB.}}{\text{SQ. FT.}}$
					$V = 337 \text{ MPH.}$	$V = 500 \text{ MPH.}$	$V = 161.5 \text{ MPH.}$	$V = 230.5 \text{ MPH.}$
		MACH NO. = .946	MACH NO. = .665	MACH NO. = .208	MACH NO. = .305	OIL RADIATOR DUCT	COOLANT RADIATOR DUCT	
ORIGINAL DUCT
