DESIGN, ANALYSIS, AND TESTING OF A METAL MATRIX COMPOSITE WEB/FLANGE INTERSECTION

S. B. Biggers and N. F. Knight, Jr.
Department of Mechanical Engineering
Clemson University, Clemson, SC

SUMMARY

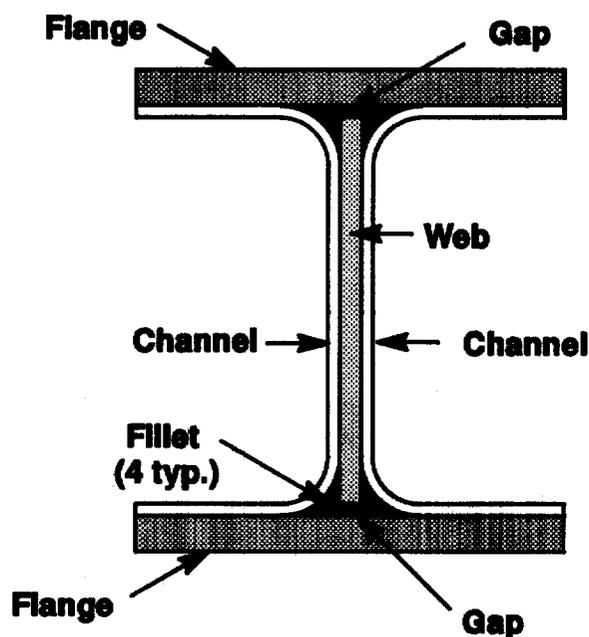
As shown in Figure 2, each SiCf/Al spar consists of nine individual components — two preconsolidated flange plates, a preconsolidated centerline web element, two preconsolidated channel sections which serve to tie the flanges to the webs, and four fillet radius fillers. In addition, a small gap exists between the web and flange that becomes filled with the filler material used in the fillets upon hot molding. The basic design configuration and tooling concept for these SiCf/Al spars were developed and evaluated in the SiCf/Al hot molding process development program conducted by Textron Specialty Materials Division during the initial stages of the AFWL contract.

Figure 2. Individual components of a SiCf/Al spar.

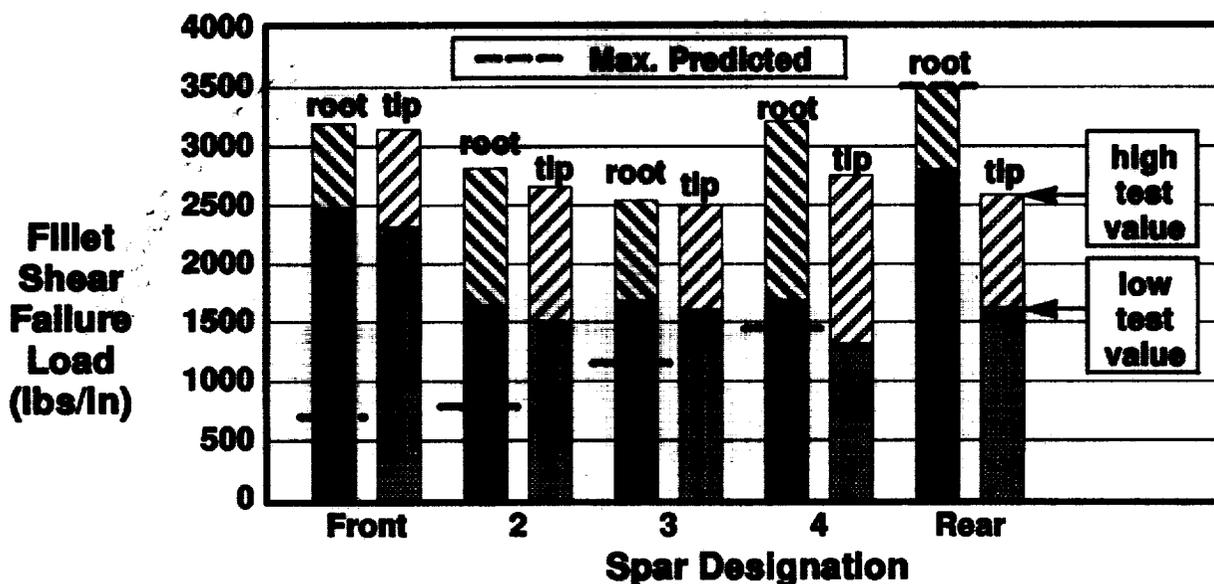
Based on lessons learned in the hot molding process development program, a qualification test was designed to measure the fillet shear strength of every SiCf/Al spar used in the full-scale test article fabrication. Samples were removed from the root and tip of each incoming spar and subjected to a special LASC-developed shear strength test. The results of these tests are shown in Figure 3 as high and low values from four tests for the root and tip segments of each spar. Also shown are finite element analysis predictions of the maximum shear loads for each spar. These maximum values usually occurred near the root.

Figure 3. Measured and predicted fillet shear strength in each spar.

Although the range between the high and low strength values is significant, indicating a wide variation in fillet shear strength from spar to spar and possibly within individual spars, all of the strengths were above the predicted strength requirement except for the rear spar (minimum of 2807 lbs/in. at the root versus 3524 lbs/in. required). Based on the spar qualification test results, the full-scale test article designs were modified by bonding titanium doublers in the fillet radii of the rear spars near the root.

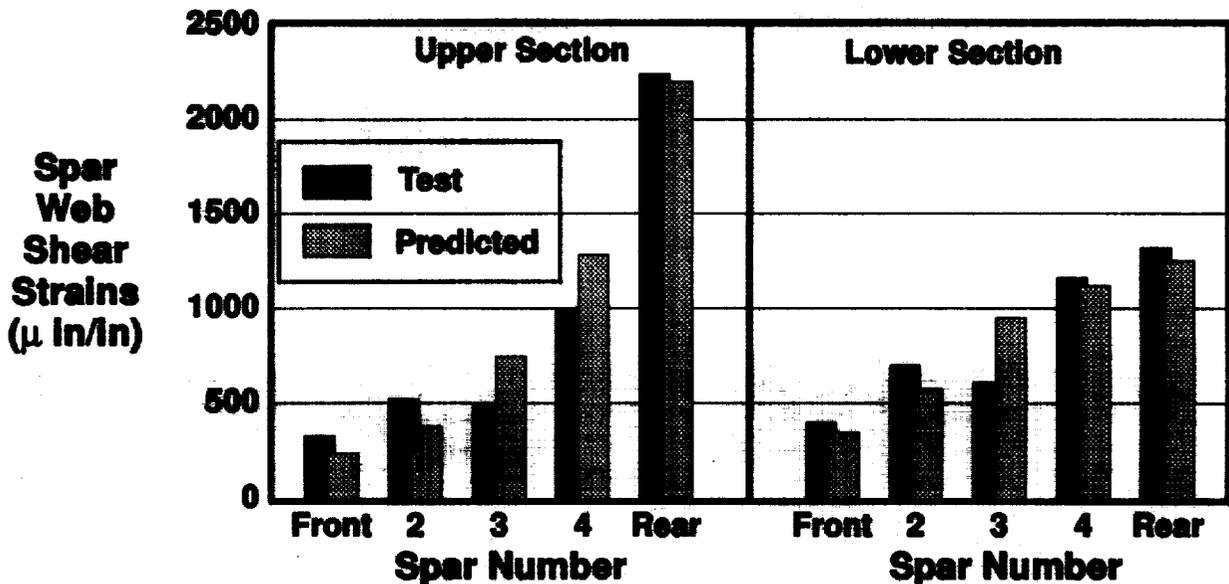
Since there was no adhesive bond in the skin of the SiCf/Al test article, the full-scale SiCf/Al ultimate load test was conducted in the environmental chamber at 250°F. The limit load applications at room and elevated temperatures were accomplished without problem. Correlation of analytically predicted (finite element method) and measured strains at limit load are shown in Figure 5.

Figure 5. Predicted and measured spar web strains at limit load.

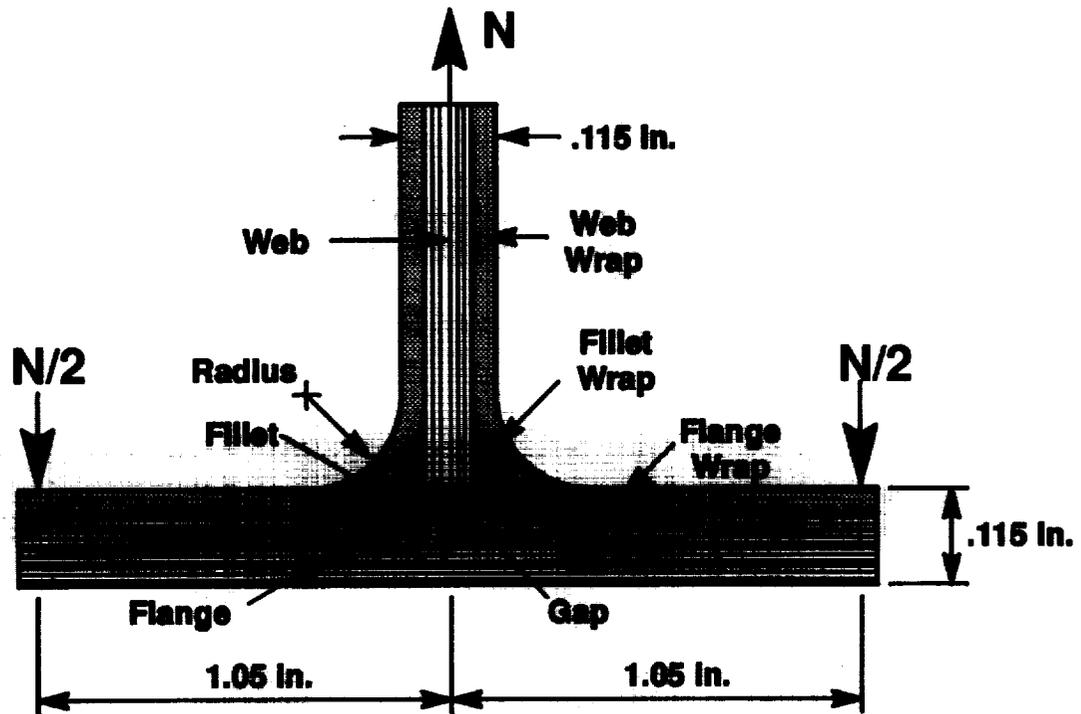
To examine the effects of the web/flange intersection design, T-shaped specimens were fabricated using two fillet radii (1/4 in. and 1/2 in.) and different filler materials for the fillet region. A schematic that shows the basic construction of the T-sections is presented in Figure 8. Filler materials with four fiber-volume-content percentages (0%, 17%, 33%, and 50%) were used for this purpose. It was conjectured that the more compliant low fiber-volume filler material might perform better in helping transfer flange bending stresses across the intersection. Preliminary analytical results predicted that the larger fillet radius configuration would delay failures originating in the intersection region due to high interlaminar stresses.

Figure 8. Schematic of T-section test geometry and nomenclature.

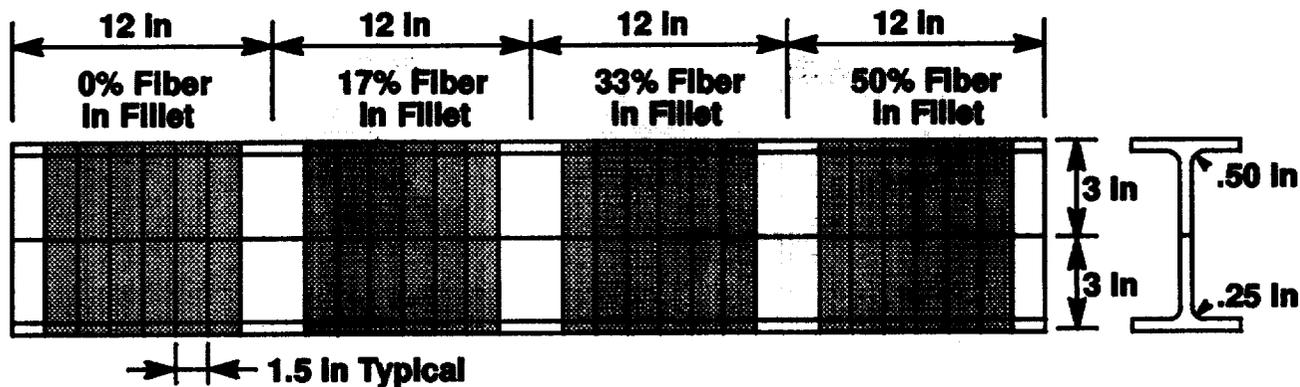
Specimens were cut from a single I-beam which was fabricated from SiCf/Al and incorporated three specimens of eight different design variations. A schematic of the beam and locations from which 48 T-specimens were taken is shown in Figure 9. Of this total, 46 specimens were tested to failure by symmetrically loading the web in tension and the flanges in downward bending as shown in Figure 8. In 23 of the tests the loads were applied to the flanges through rollers to simulate a simply supported condition. In the remaining tests, the flange loads were applied while clamping the flange ends to prevent rotation. Assembly conditions encountered in actual applications would fall somewhere between these two extreme boundary conditions. Each specimen was statically loaded to failure in a 60-kip Tinius Olsen Universal Test Machine used at a 2400 lb. range with an accuracy of ± 0.5 percent of the indicated load.

Figure 9. Fabricated I-beam from which T-specimens were taken.

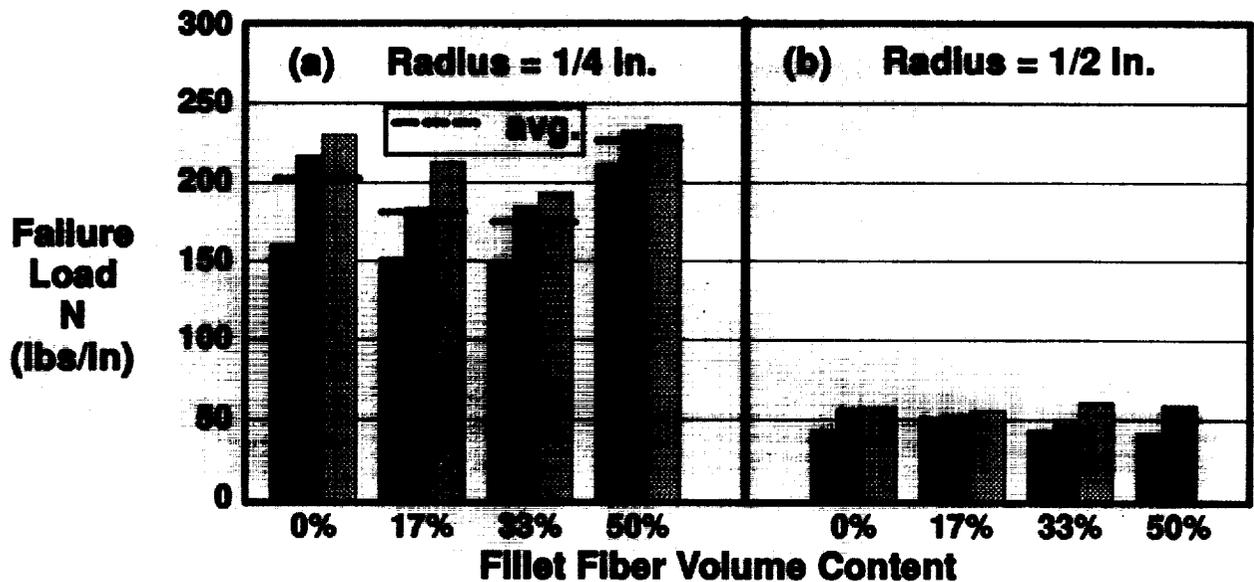
A summary of all experimentally obtained failure loads is presented in Figures 12 and 13. Consider first the results from the tests on the 1/4 inch radius specimens. Based on the average failure load of the three tests for each configuration, indicated by the dashed lines, there is some evidence that the 50 percent fiber-volume content material in the fillet produces a slightly higher failure load than the other fillet materials in both the simply supported case (Figure 12(a)) and the clamped edge case (Figure 13(a)). In addition, the test results for the 50 percent material are more consistent than with any of the others tested. It should be noted that the 50 percent, 1/4 inch radius configuration was used in the full-scale test article spars.

Figure 12. Test results for simply supported specimens.

Contrary to the analytical predictions to be discussed subsequently, the larger radius specimens all failed at much lower loads (see Figures 12(b) and 13(b)) than did the smaller radius specimens. Examination of the specimens prior to testing showed that the material in the critical intersection region of the 1/2 inch radius specimens was not well consolidated, making the results of these tests of questionable validity. This lack of consolidation is indicated in the post-failure photograph in Figure 11, where distinct bundles of MMC wires used to fill the fillet region can be seen. It should be noted that the hot molding process development was carried out for the 1/4 inch radius only.

Comparison of the average failure loads in Figures 12 and 13 shows that the clamped specimens fail at loads that are 1.6 to 2.2 times higher than the failure loads of the simply supported specimens. This increase is consistent with an elementary beam analysis of the flange which shows a reduction in the maximum bending moment by a factor of 2.0 for the clamped case compared to the simply supported case.

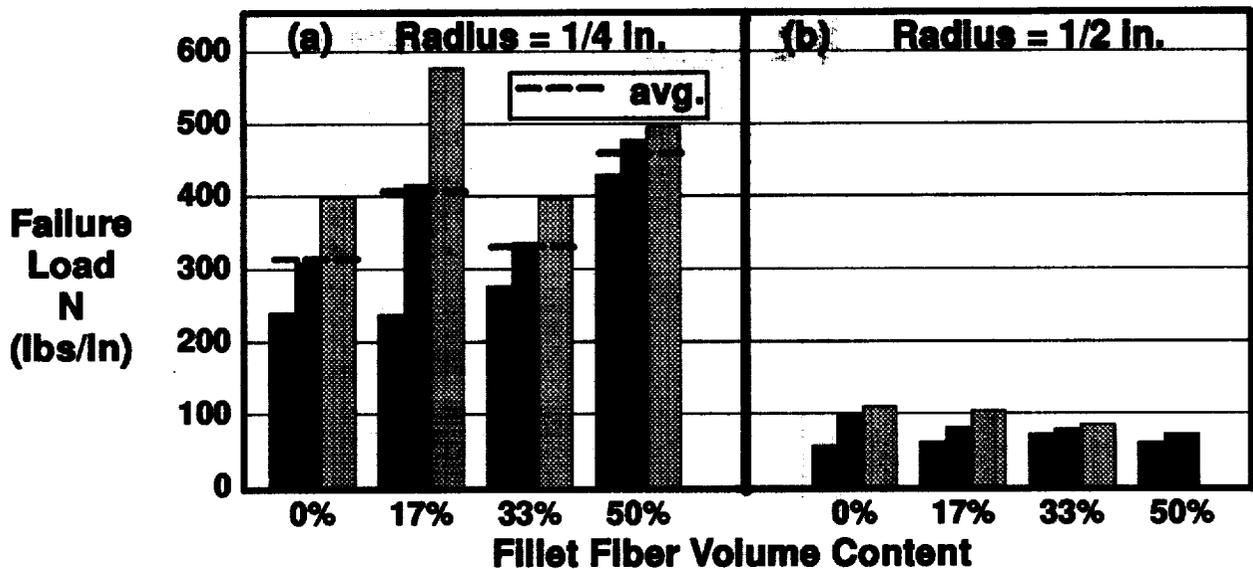
Figure 13. Test results for clamped edge specimens.

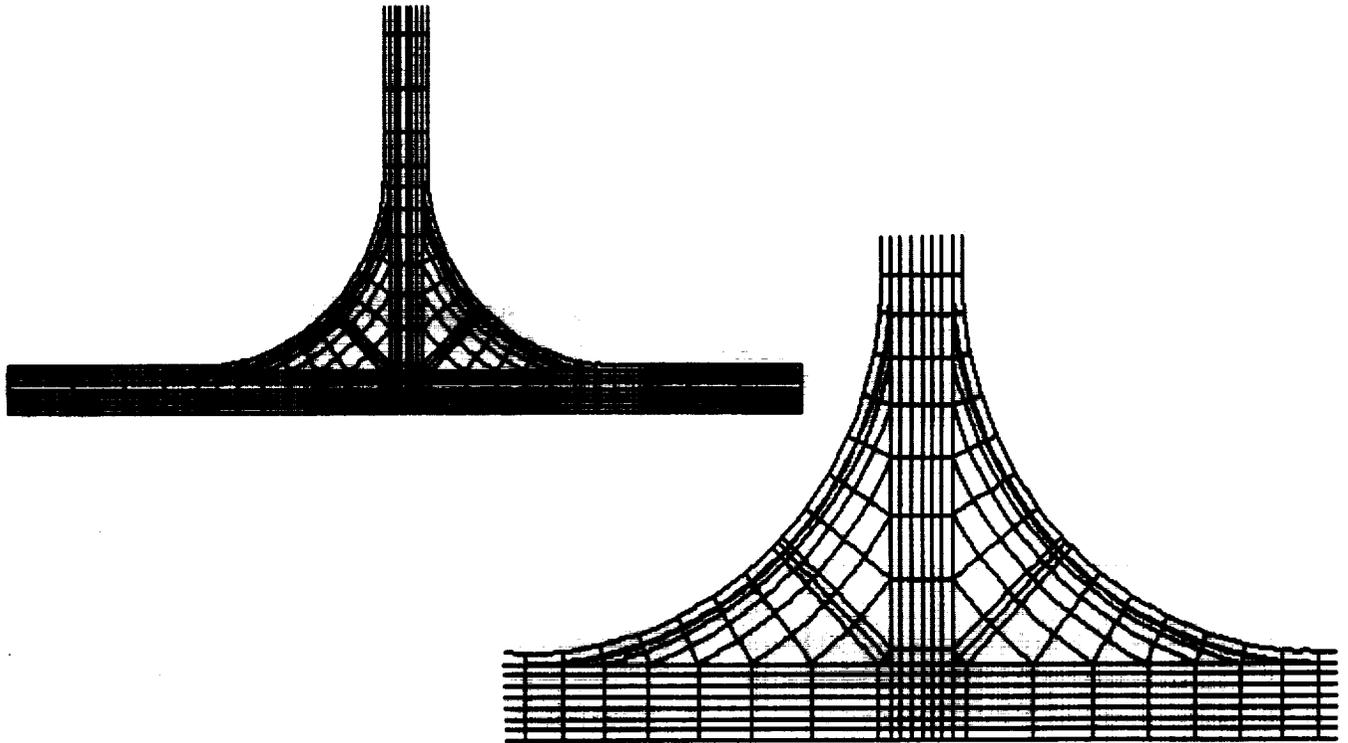
A model of a typical cross-sectional slice of the T-section is illustrated in Figure 14. Second-order, isoparametric, generalized plane-strain elements with a capability to represent fully

anisotropic material properties have been used. These elements allow most of the important laminar and interlaminar stresses to be evaluated. The wrapped plies in the critical fillet region are modeled appropriately as curved elements. The generalized plane-strain condition allows stresses perpendicular to the cross-section to be evaluated in conjunction with the laminar and interlaminar stresses in the plane of the model. Each lamina may be modeled through its thickness by one or more elements. The material properties associated with various fiber orientations of each layer in the model may be specified so that any laminate layup and stacking sequence may be considered. The number of plies in each of these laminates may be easily changed.

Figure 14. Finite element model mesh pattern for a typical isotropic T-specimen with a 1/2 inch fillet radius and a close-up view of the intersection region.

It may be noted from Figure 14 that the lengths of elements in the plies may vary except in the region of the flange directly under the web. This gradation of element lengths allows smaller elements to be defined in the critical regions where the wrap plies become tangent to the web and flange. In addition, very thin and similarly short elements are used in the fillet radius region near the wrap plies. As will be shown in some sample results, these regions develop relatively large stresses both in the lamina directions and in the interlaminar directions. This result bears out the assumption that local flange bending may be a major contributor to the observed failure near the fillet radius region in the box tests and in the T-element tests.

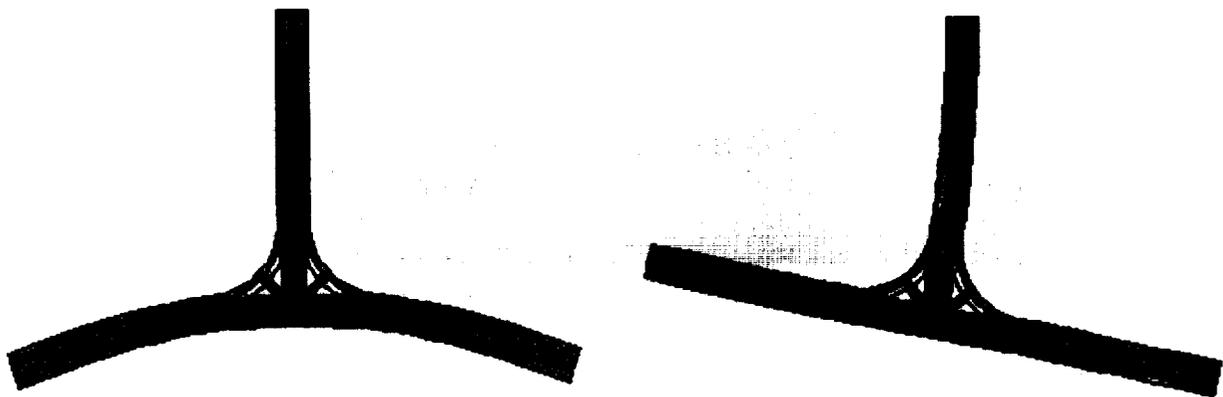
As initial checks on the model, two models with isotropic properties were created. Analysis of the results for even these simple cases indicates to some extent the important effects of the fillet-radius region geometric parameters on the stresses in this region. For example, consider an aluminum T-section with the dimensions shown in Figure 8. These dimensions are representative of the MMC specimens tested as previously described. Concentrated loads are applied at the ends of the flanges. No restriction of rotation is imposed at the load locations. The distribution and relative magnitudes of the stresses are of primary interest. However, to put a scale on these results, vertical loads of 200 lbs/inch were applied at each flange end in the case of a symmetrically loaded model. With a 1/4 inch fillet radius, the resulting vertical deflection of the tips of the flanges is 0.036 inches and the maximum tensile principal stress found in the model is 78 ksi. The antisymmetric load case was chosen to create the same moment (based on centerline dimensions) on the web as was created on the flanges in the symmetric case. That is, equal and opposite vertical loads of 100 lbs/inch each were applied at the flange ends. The horizontal deflection of the flange is 0.091 inches, the vertical deflection of the tips of the flanges is 0.155 inches, and the maximum tensile principle stress is 104 ksi in this antisymmetric case. Typical deformed shapes, with the deformations magnified for clarity, are shown in Figure 15.

Figure 15. Symmetric and antisymmetric deformations of an isotropic T-specimen.

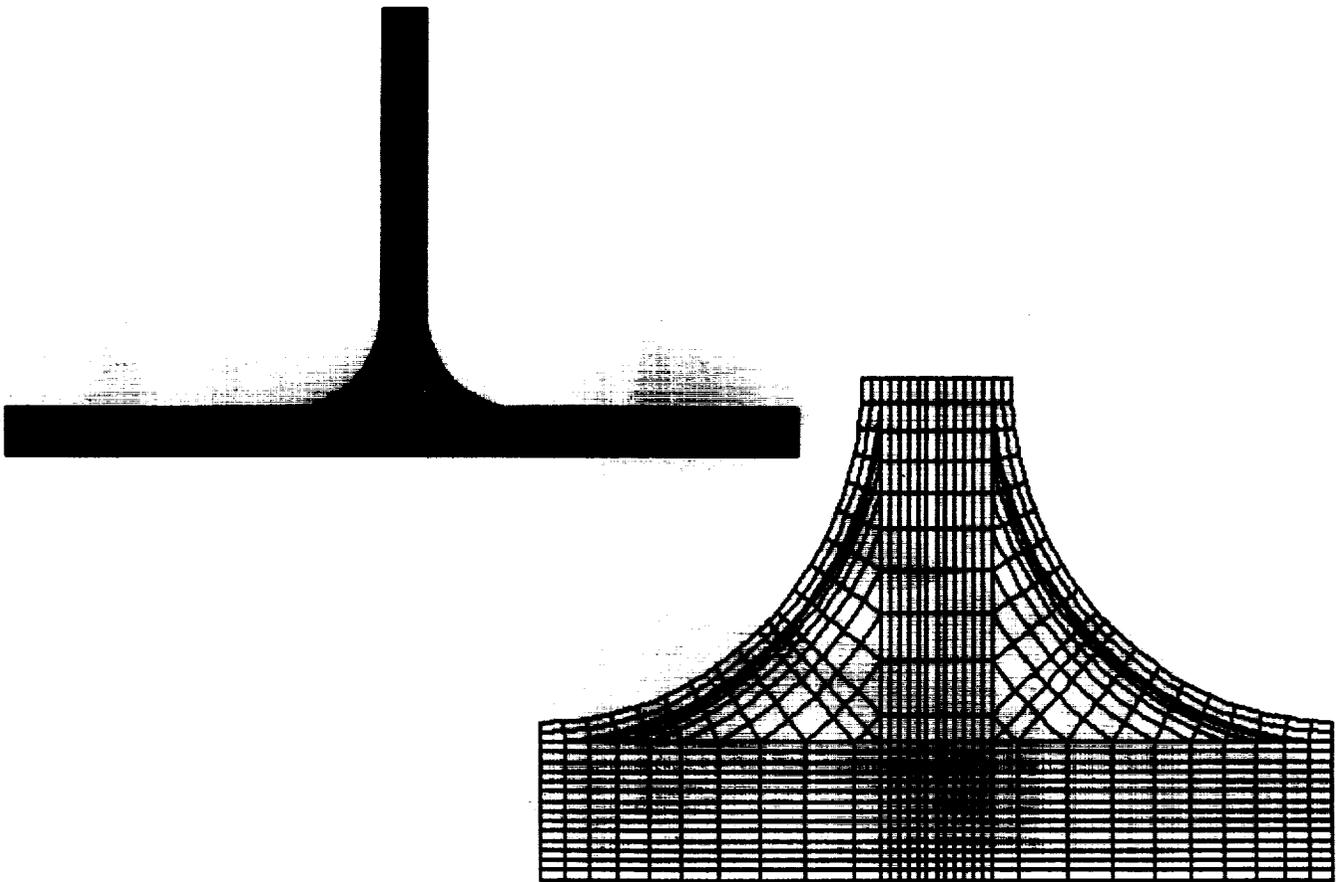
Models were also created for two T-shaped SiCf/Al sections representative of the specimens tested as discussed earlier. The level of detail, as shown by the 1/4 inch radius model in Figure 22, is greater than in the isotropic models. Here each ply was modeled by a separate second order element in the thickness direction. Three-dimensional anisotropic stiffness coefficients were computed for plies with 0, 90, +45, and -45 degree orientations. The following unidirectional lamina properties were used for this purpose:

The web and flange stacking sequences are the same as used in the fabricated sections. The gap between the preconsolidated portion of the web and flange laminates is assumed to be filled with the same 0-degree material as used in the fillet and for the results to be presented the gap is assumed to be 0.02 inches in the vertical direction. The 0-degree fiber direction is perpendicular to the plane of the model.

Figure 22. Finite element model mesh pattern for a typical MMC T-specimen with a 1/4 inch fillet radius and a close-up view of the intersection region.

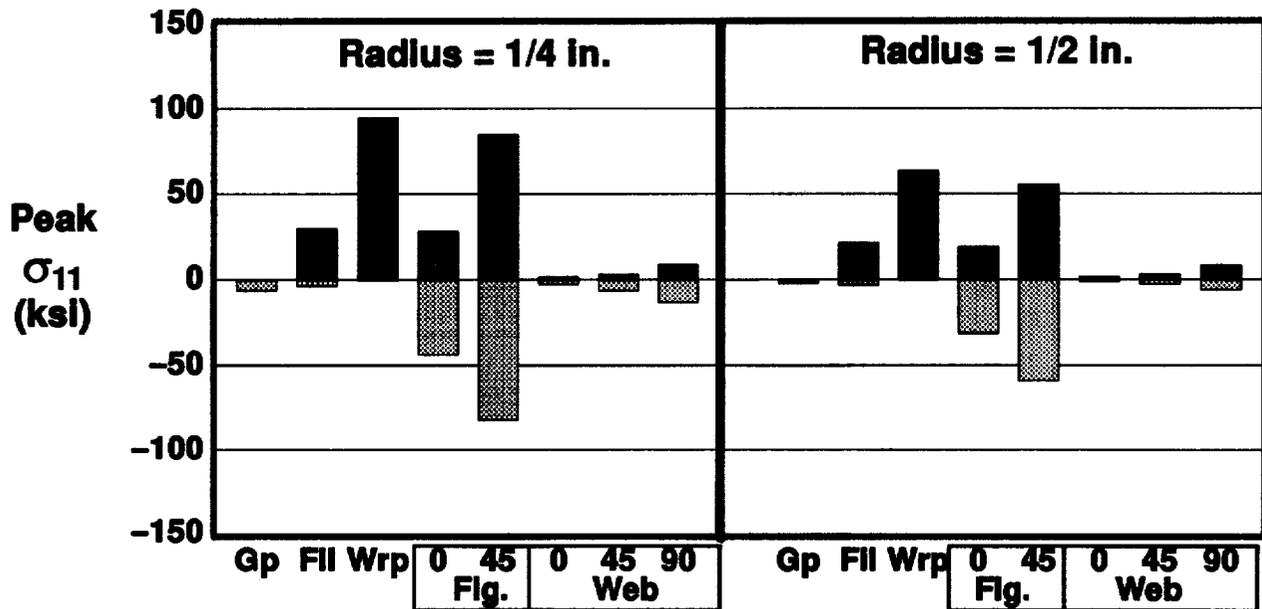
The largest laminar and circumferential transverse normal stresses, shown in Figure 26, indicate that the stiff ± 45 -degree plies in the wrap and flange carry the bulk of the bending load. However the tensile stresses perpendicular to the 0-degree material in the fillet and the flange are also very high. Using a maximum stress failure criterion and ultimate stresses of 200 ksi in the fiber direction and 15 ksi transverse to the fiber direction, the fillet material would be the critical part of the specimen. If the sense of the bending were reversed, the tensile stresses in the 0-degree direction in the flange would become the critical stresses.

Figure 26. Peak laminar and circumferential transverse normal stresses for symmetric loading.

The largest interlaminar normal stresses are plotted in Figure 27. As seen from the contour plot, the portion of the web that extends into the fillet carries the highest interlaminar tensile stresses. However, these stresses are not nearly as severe compared to the 15 ksi ultimate transverse stress as are the circumferential transverse normal stresses in the fillet material (Figure 26) and would not govern part failure.

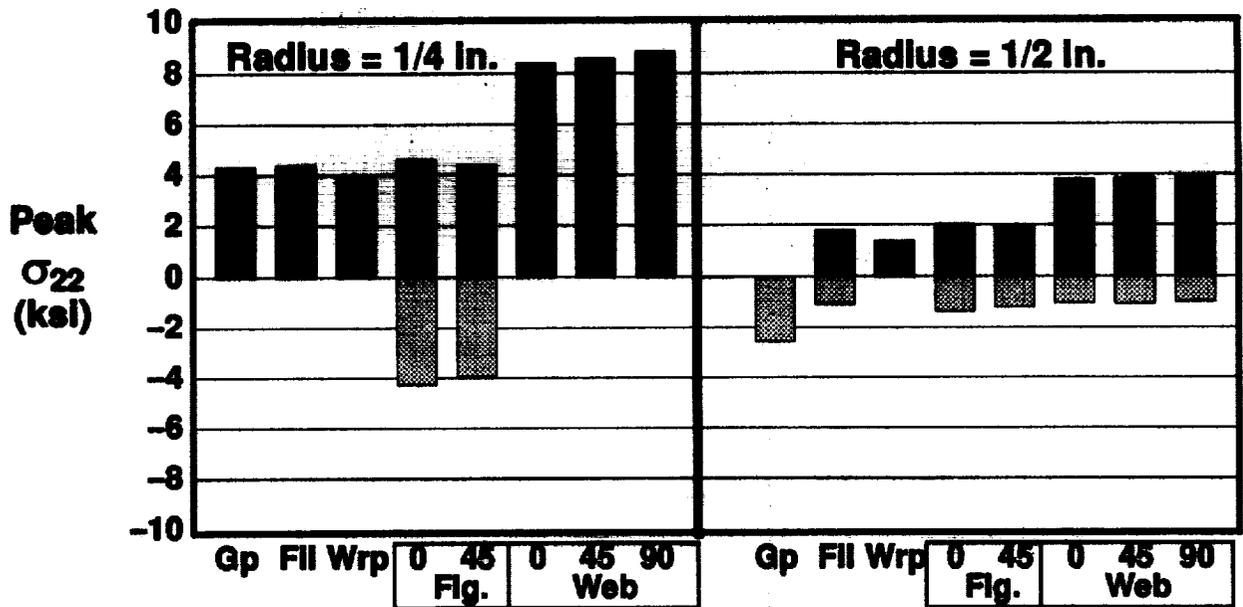
Figure 27. Peak interlaminar and radial normal stresses for symmetric loading.

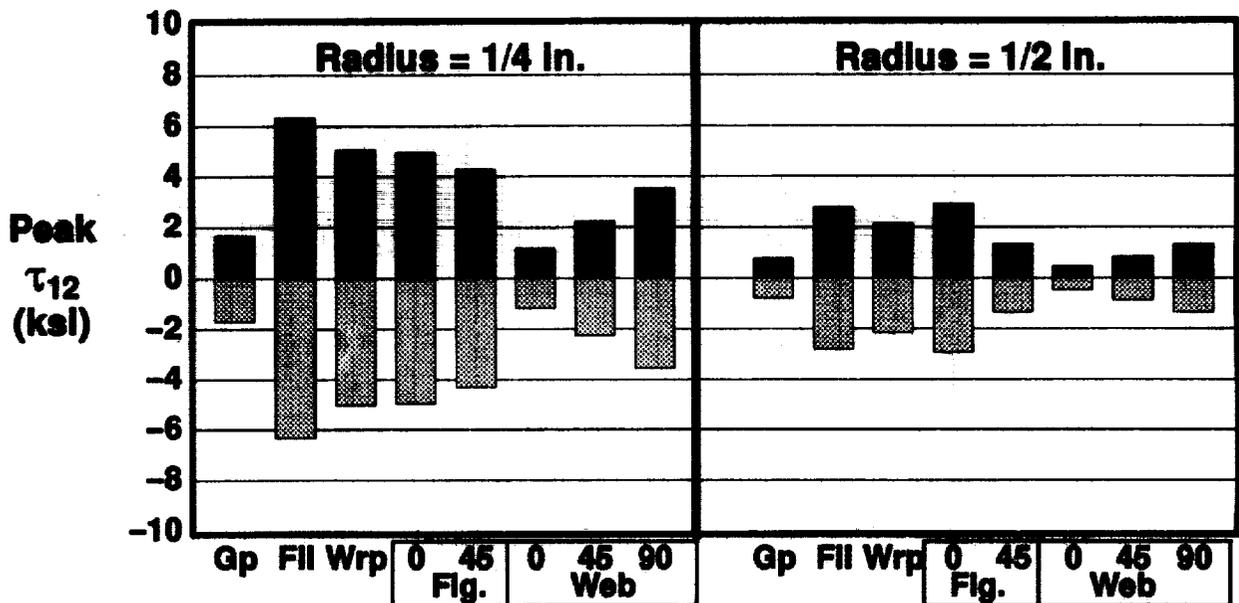
The largest interlaminar and transverse shear stresses are shown in Figure 28. The largest shear stress occurs within the fillet material, but based on an ultimate stress of 15 ksi and a maximum stress criterion, it would not govern part failure.

Figure 28. Peak interlaminar and transverse shear stresses for symmetric loading.

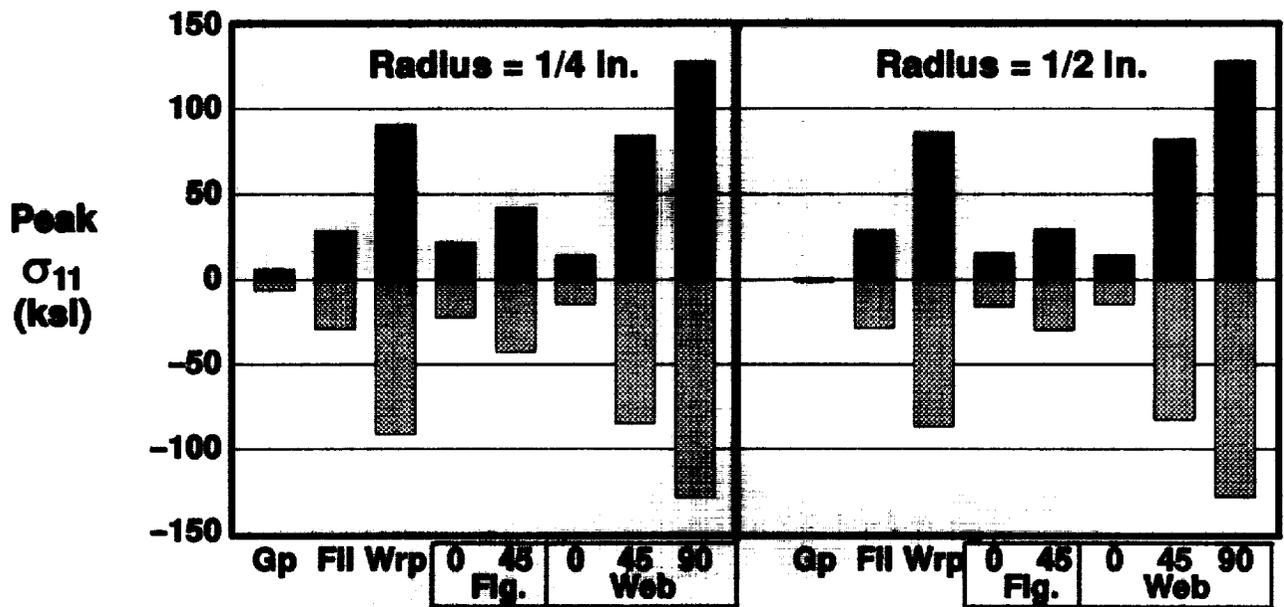
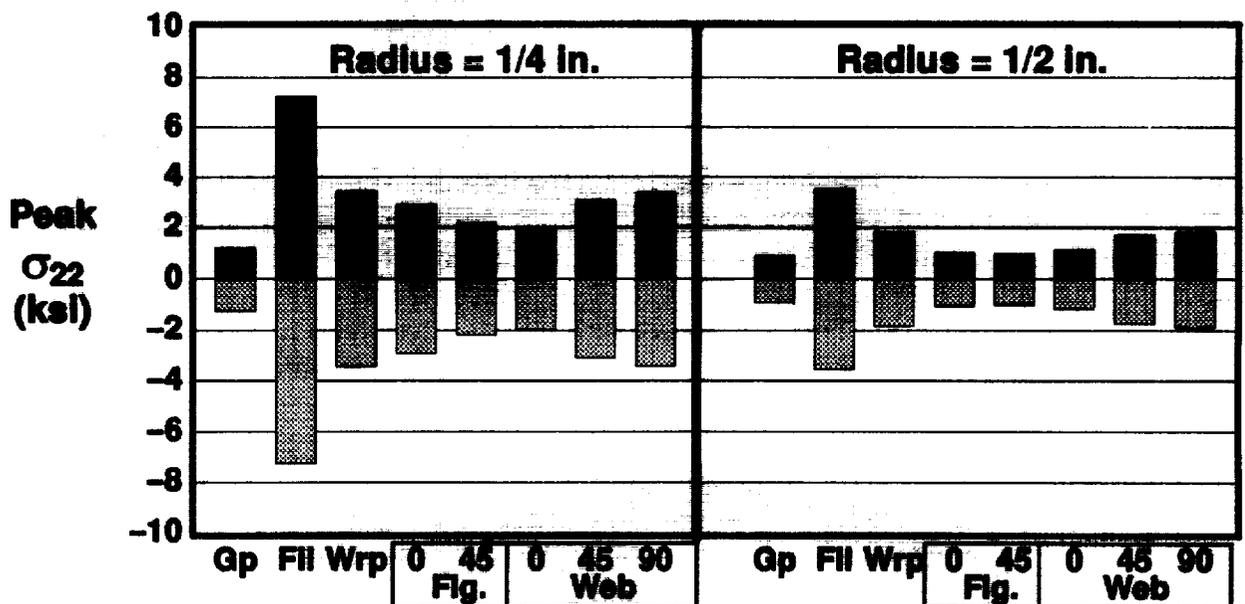
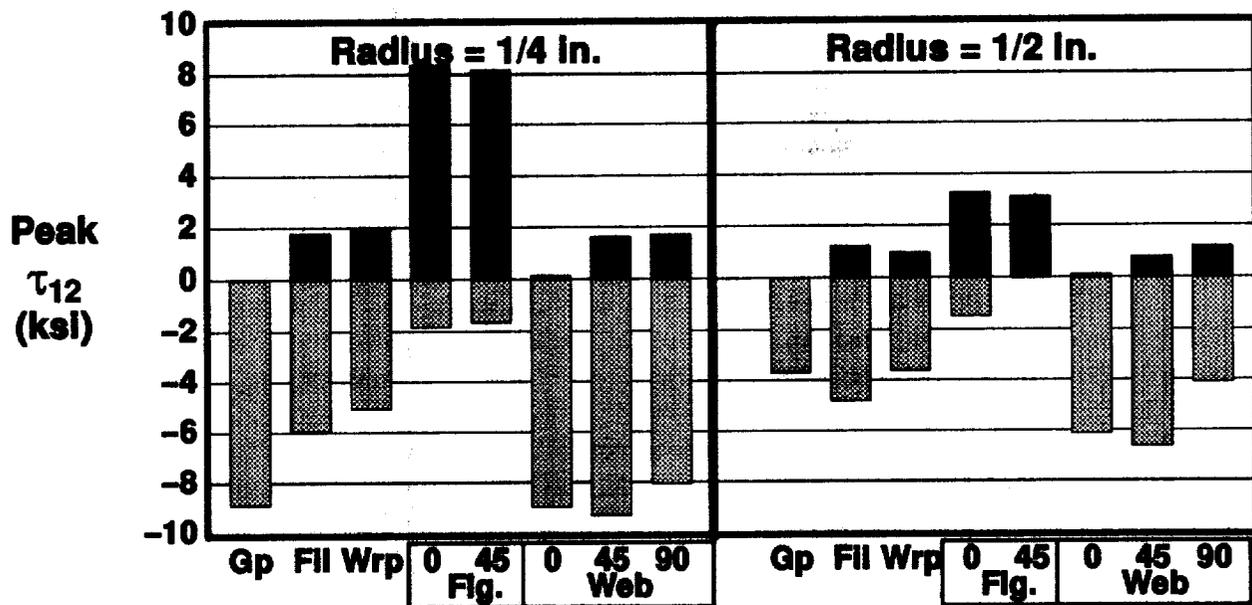
A summary of the largest positive and negative stresses σ_{11} , σ_{22} , and τ_{12} developed in various regions of the model is presented in Figures 32–34. The peak circumferential normal stress in the fillet material is nearly identical to that in the symmetrically loaded case, the difference being in its location near the web/fillet tangent point. The normal stresses in the web are predictably higher than in the symmetrically loaded case.

Figure 32. Peak laminar and circumferential transverse normal stresses for antisymmetric loading.

Figure 33. Peak interlaminar and radial normal stresses for antisymmetric loading.

Figure 34. Peak interlaminar and radial shear stresses for antisymmetric loading.
