RESEARCH MEMORANDUM

TUFT STUDIES OF THE FLOW OVER A WING AT
FOUR ANGLES OF SWEEP

Gerald Hieser

July 10, 1947

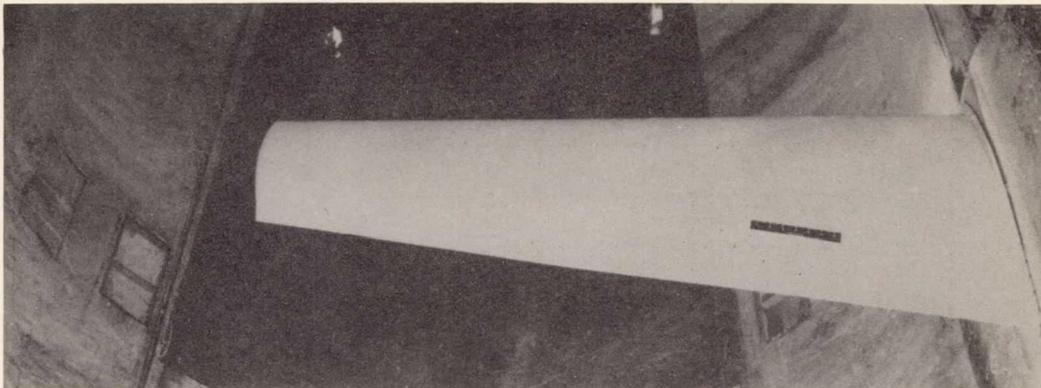
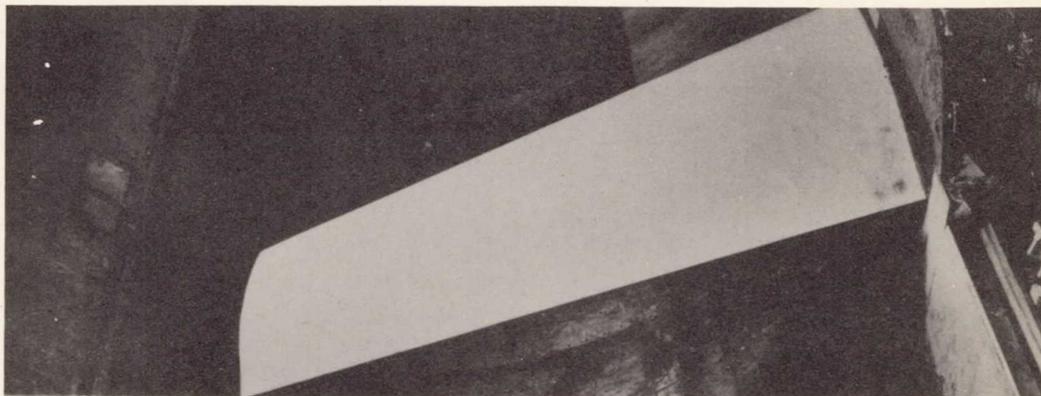
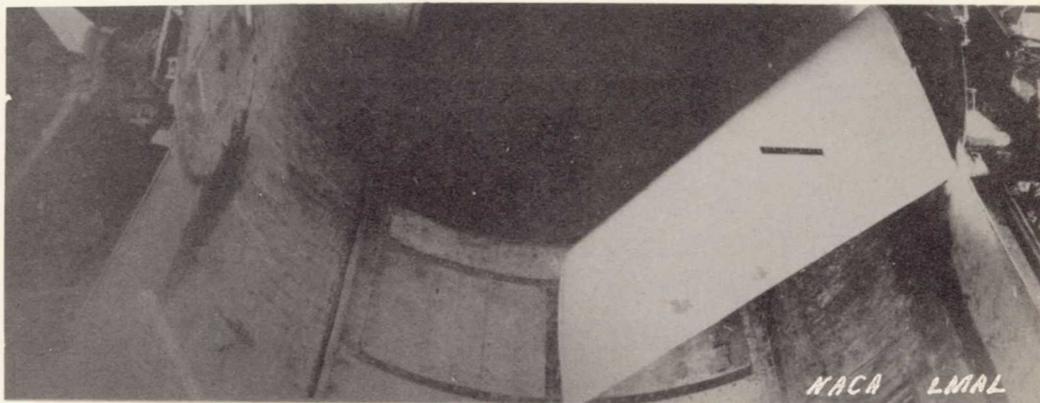
Figure 1.- 65_2 -215 wing mounted in 16-foot tunnel.

A 10-foot semispan NACA 65₂-215 wing which had a mean chord of 3.333 feet and tapered linearly from a root chord of 4.44 feet to 2.222 feet at the tip in the unswept configuration was used for the present study in the Langley 16-foot high-speed tunnel. The wing had no dihedral or twist and the airfoil sections were normal to the 1/4-chord line and parallel to the tunnel longitudinal axis at 0° sweep. The wing was mounted with the root at the tunnel wall and was pivoted at the 50-percent chord station of the root to obtain sweep. A different wing tip for each sweep angle was used so that the tip was parallel to the tunnel longitudinal axis. The over-all dimensions of the wing are given in table I for each sweep configuration. The model is shown mounted in the tunnel at sweep angles of 0° , 30° , and 45° in figure 1.

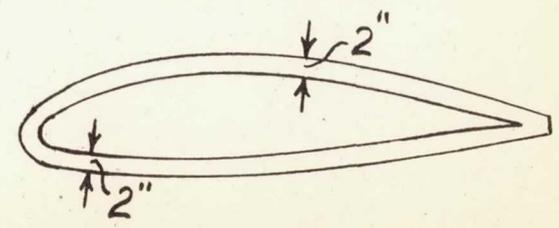
Figure 2.- Sketch showing location of leakage deflector plates.

Since there was considerable leakage of air between the tunnel test section and the test chamber, leakage deflector plates were installed to reduce the effect of air leakage on the flow about the wing surface. Figure 2 shows the details of the plates which were located $1/2$ inch from the tunnel wall and extended 2 inches from the upper and lower surfaces of the wing.

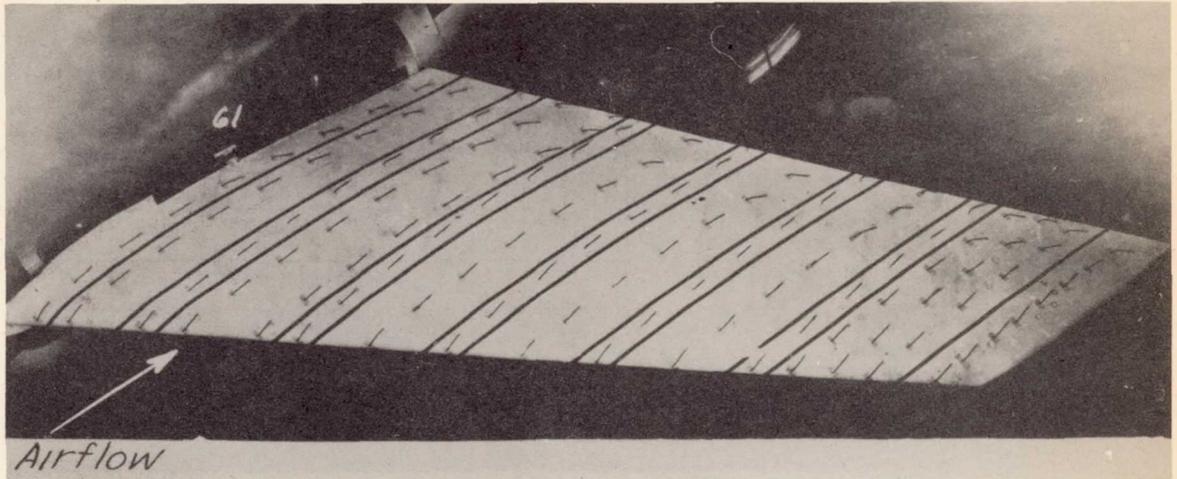
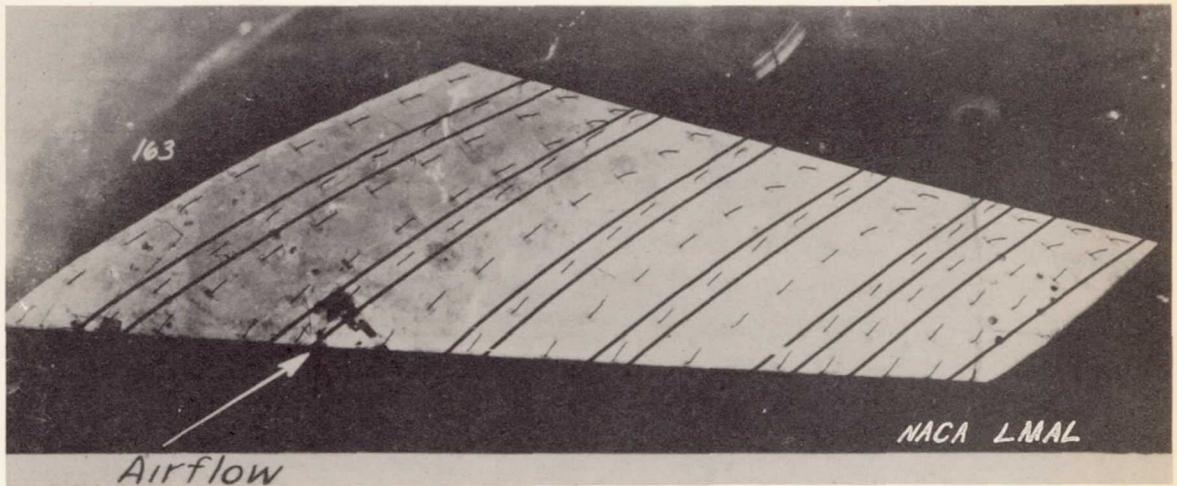
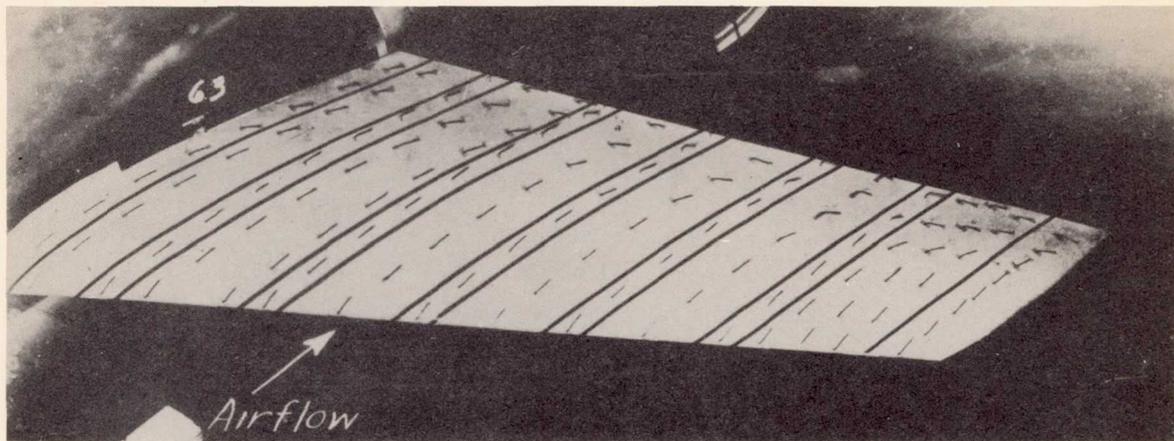
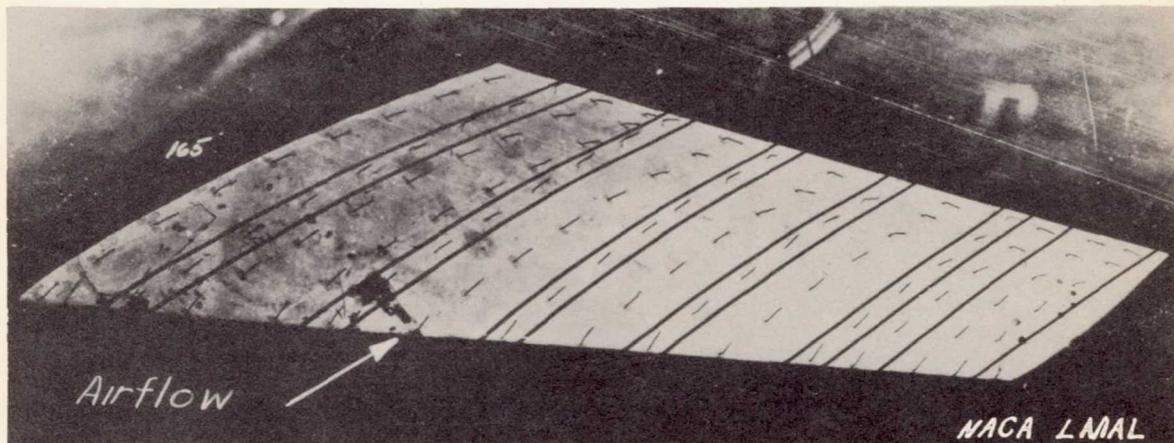
Figure 3.- Tuft patterns on a 65_2 -215 wing with and without boundary-layer plate installed, $\Lambda = 45^\circ$, $M = 0.13$.

Tuft photographs were obtained at the same test conditions both with and without the tunnel boundary-layer plate installed on the wing at a sweep of 45° . The pictures (fig. 3) were obtained at a Mach number of 0.13 and at angles of attack of 10° and 14° . As can be seen, no significant change in the flow characteristics, with and without the plate, is indicated by the tufts. Hence, all ensuing photographs were attained without the plate installed.

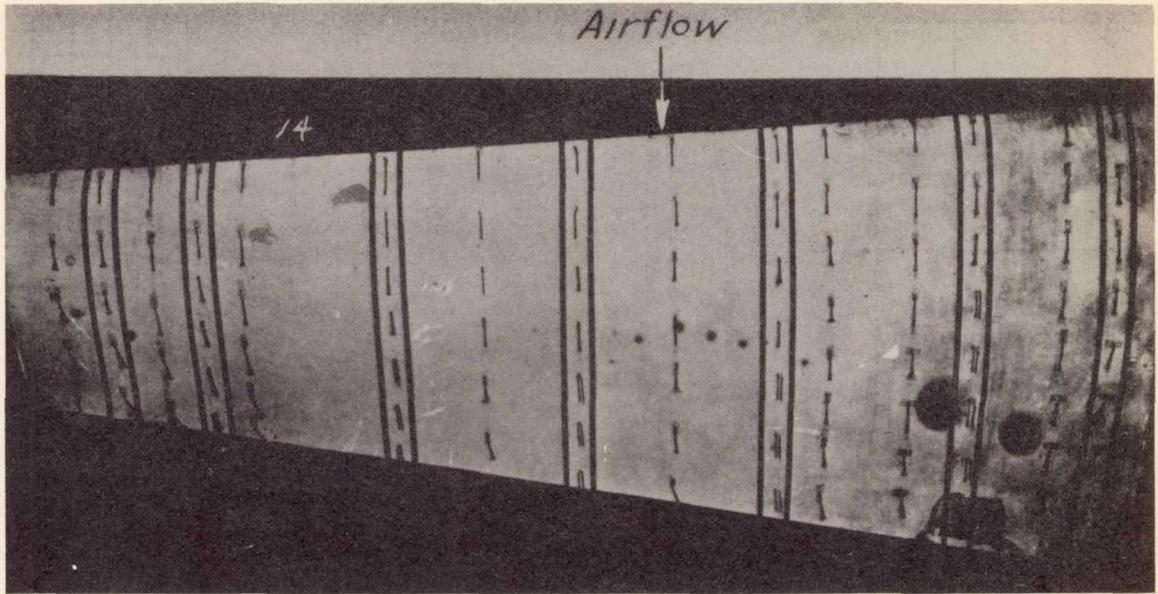
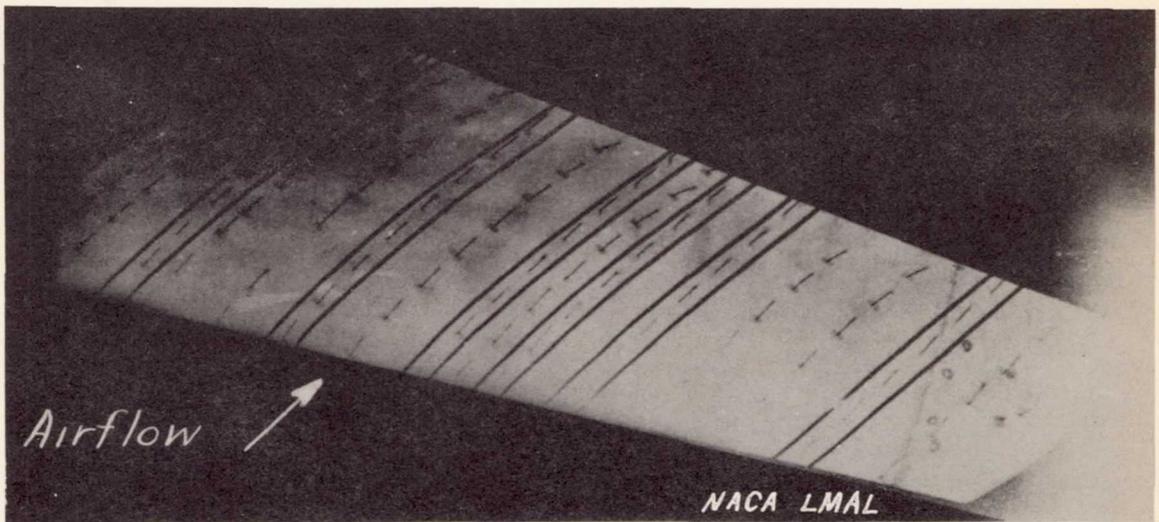
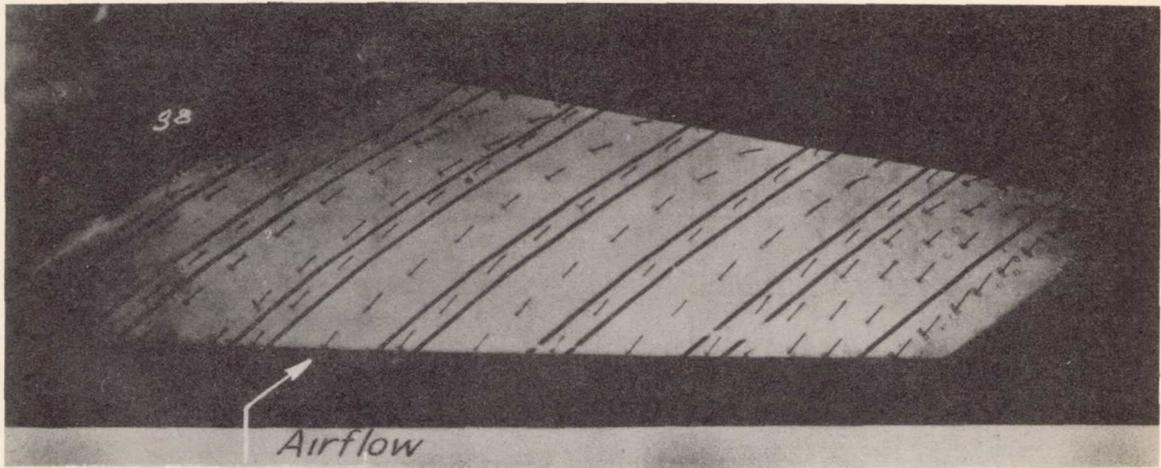
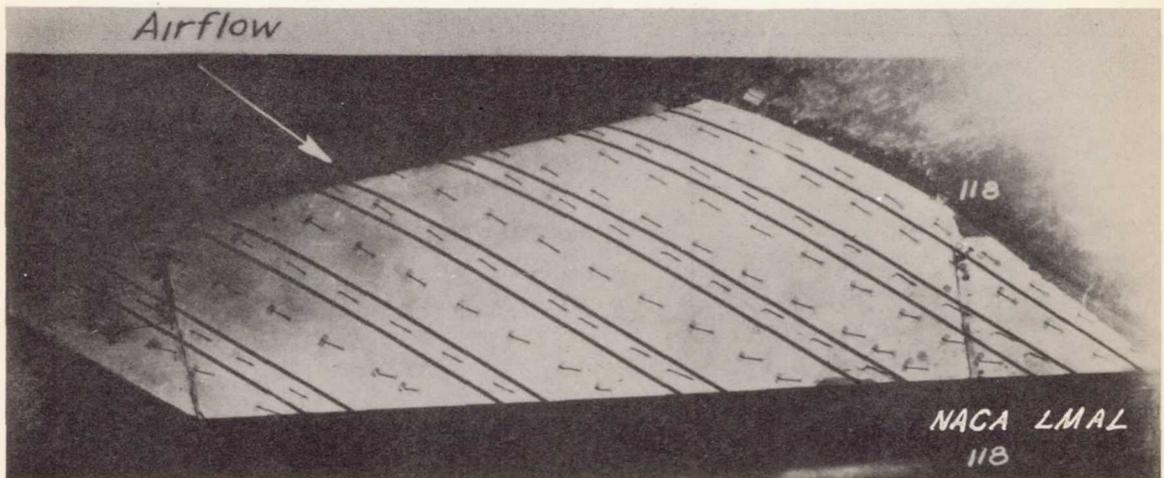
Figure 4.- Tuft pattern on 65₂-215 wing, $\alpha = 6^\circ$, $M = 0.55$.

The tuft patterns over the wing at each sweep angle for a geometric angle of attack of 6° and a Mach number of 0.55 are shown

in figure 4. A sketch of the wing at each configuration of figure 4 showing the streamlines is presented in figure 5. The solid lines on the sketches represent streamlines indicated by surface tufts and the dashed lines show streamlines indicated by rows of elevated tufts. With the wing unswept (figs. 4(a) and 5) the tufts show that the direction of flow over the surface was parallel to the free stream except at the rear portion of the tip and in the boundary layer along the trailing edge where the flow was inward. The inflow resulted from the spanwise pressure gradient which is present on all finite span wings. The tufts indicate that the flow outside the boundary layer at the trailing edge remained parallel to the free stream. In the boundary layer the component of inflow is large relative to the velocity in the free-stream direction; however, above the boundary layer the inflow is small in relation to the free-stream component. Hence, the effect of inflow is noted only by the tufts in the boundary layer. The deviation of flow from the free-stream direction which existed beyond the 50-percent chord station near the wing root was due to the wake of the small pivot pin bracket. This influence extended over only a small portion of the wing surface. At sweep angles of 30° and 45° (figs. 4 and 5), the air experienced an inward flow over the forward portion of the wing. This flow was caused by the increase in the velocity component normal to the leading edge. As the air progressed further across the surface, the decrease in the induced velocity of the normal component resolved the resultant flow in a direction parallel to the free stream. In the boundary layer near the trailing edge a spanwise flow toward the tip existed which resulted from the pronounced spanwise pressure gradient (normal to the free stream) due to sweep. As in the case of the unswept wing, the spanwise flow is large as compared to the boundary-layer flow in the free-stream direction, but is small in relation to the stream vector above the boundary layer. Hence, the outward flow is shown by the surface tufts but does not affect the elevated tufts. In the case of $\Lambda = -45^\circ$ (sweepforward) shown in figures 4(b) and 5, the spanwise flow over the front portion of the wing, due to changes imparted to the effective velocity, was outward. The spanwise flow near the trailing edge, which is inward at sweepforward, was more pronounced than the outward flow for the 45° swept-back configuration. The inward flow at sweepforward was indicated by both the surface tufts and the elevated tufts.

A similarity of the patterns of streamlines outside the boundary layer shown in figures 4 and 5 and the calculated patterns of figure 7 can be noted. The spanwise flow in the boundary layer near the trailing edge due to the spanwise pressure gradients were not included in the calculations of figure 7.

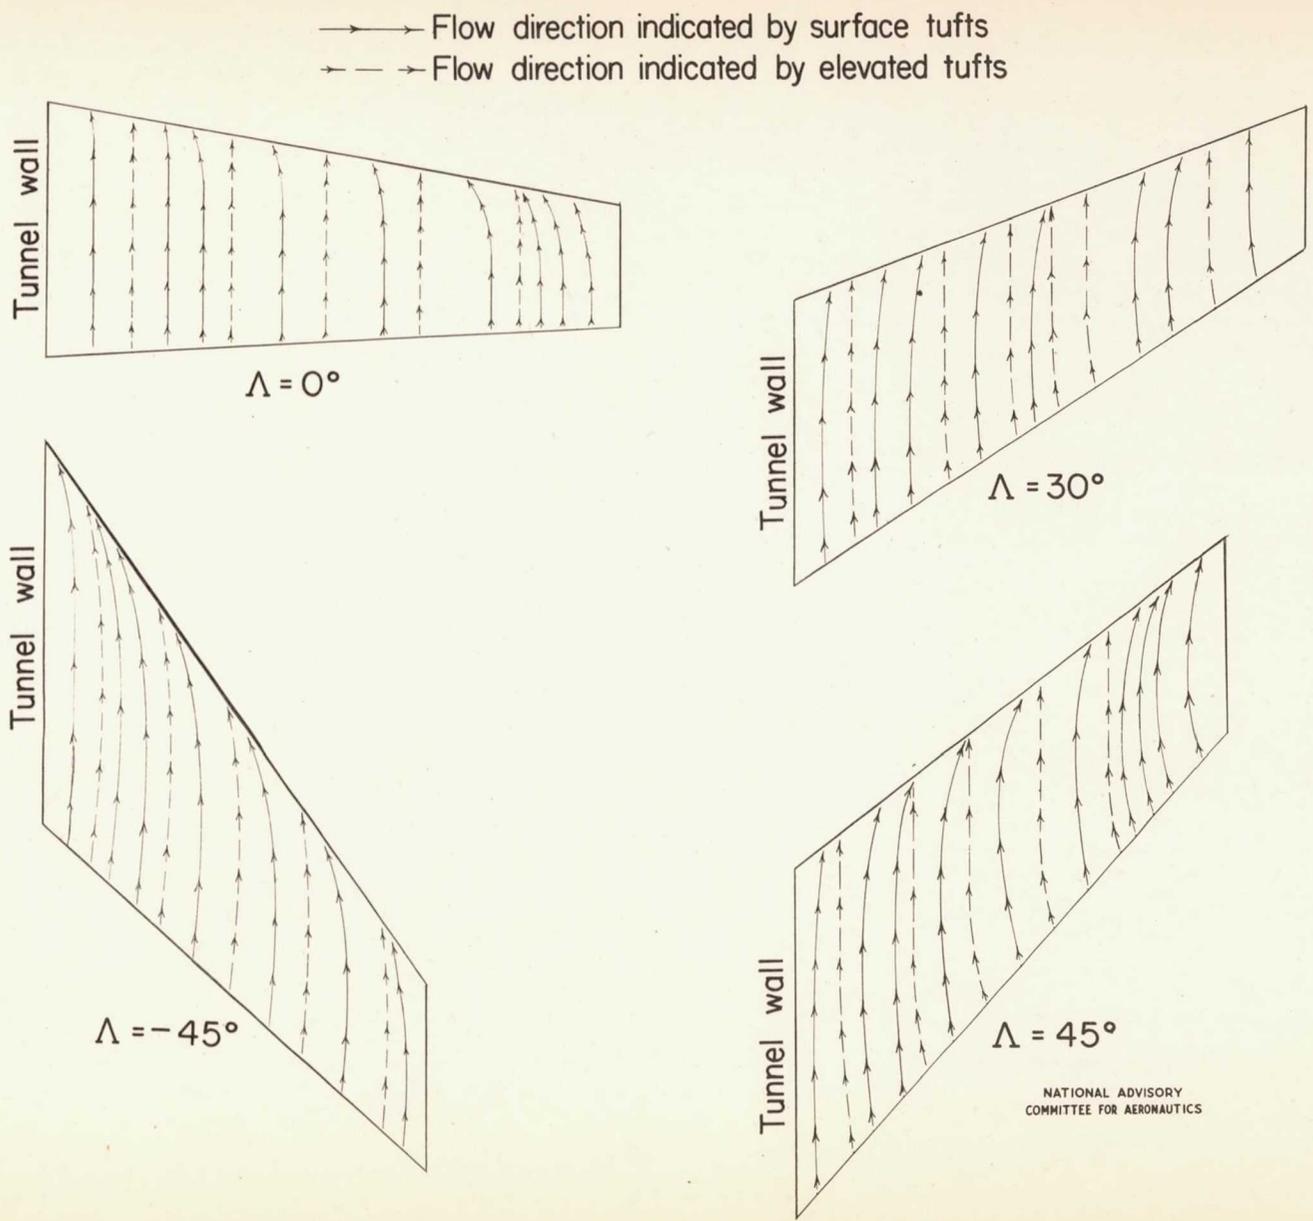
Figure 5.—Flow pattern indicated by tufts on a 65₂-215 wing at four sweep angles. $\alpha = 6^\circ$, $M = .55$.

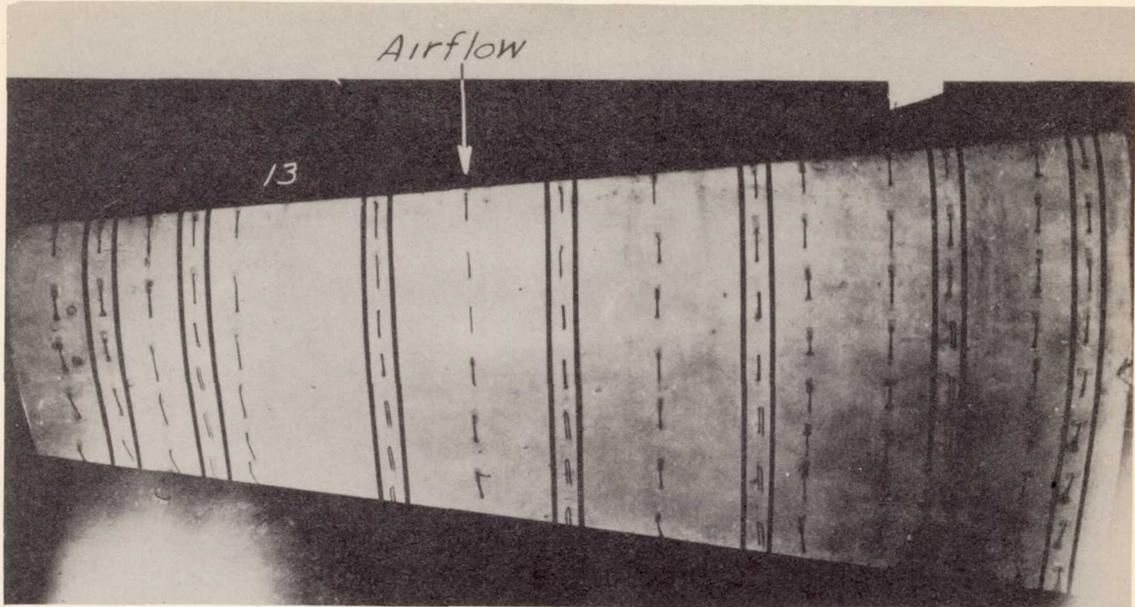
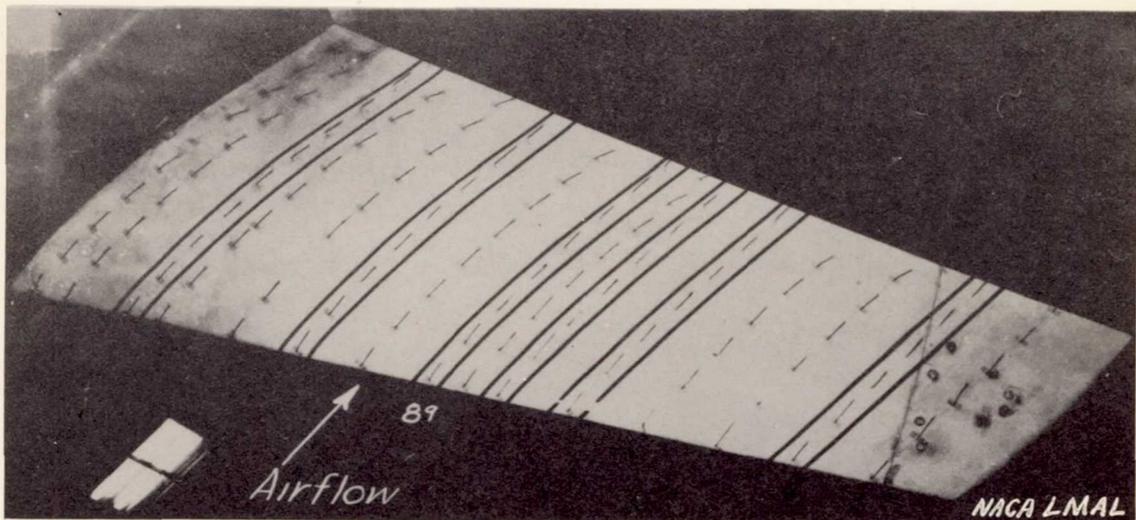
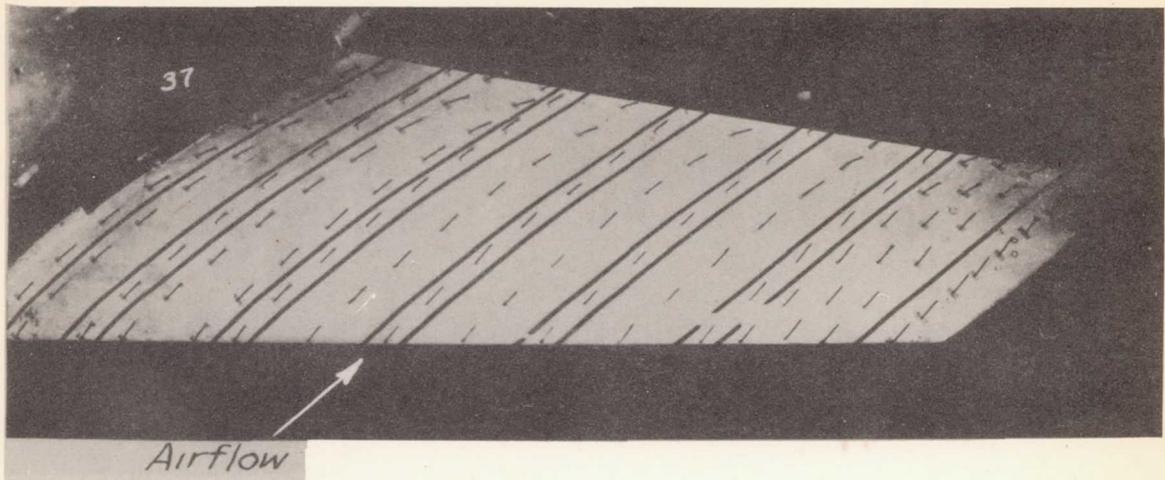
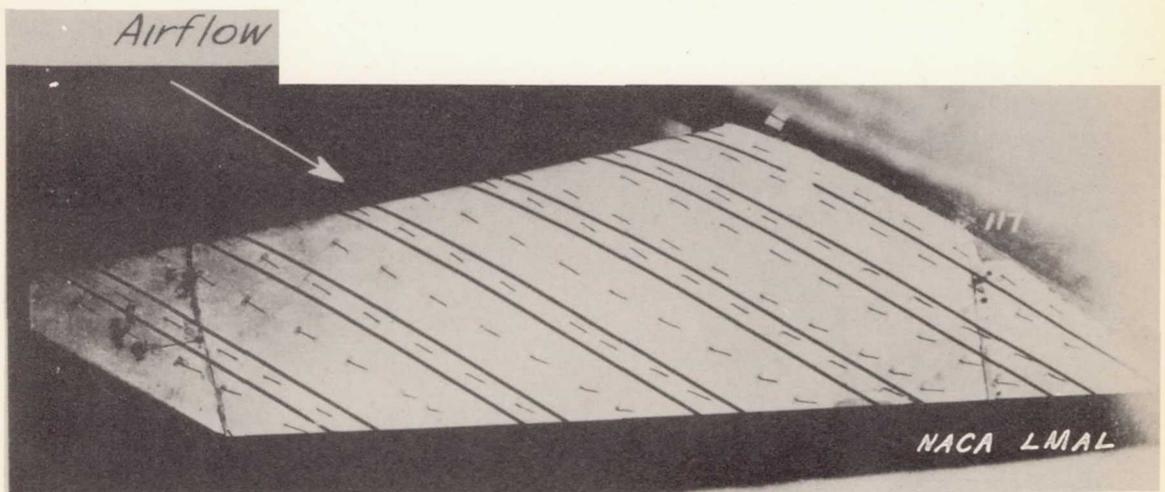
Figure 6.- Tuft patterns on a 65₂-215 wing, $\alpha = 6^\circ$, $M = 0.2$.

Tuft photographs of the wing at the various sweep angles for a geometric angle of attack of 6° and a Mach number of 0.2 are presented in figure 6. A comparison of the tufts in this figure with those in figure 4 shows that no effect of Mach number on the flow pattern existed in the range from $M = 0.2$ to $M = 0.55$.

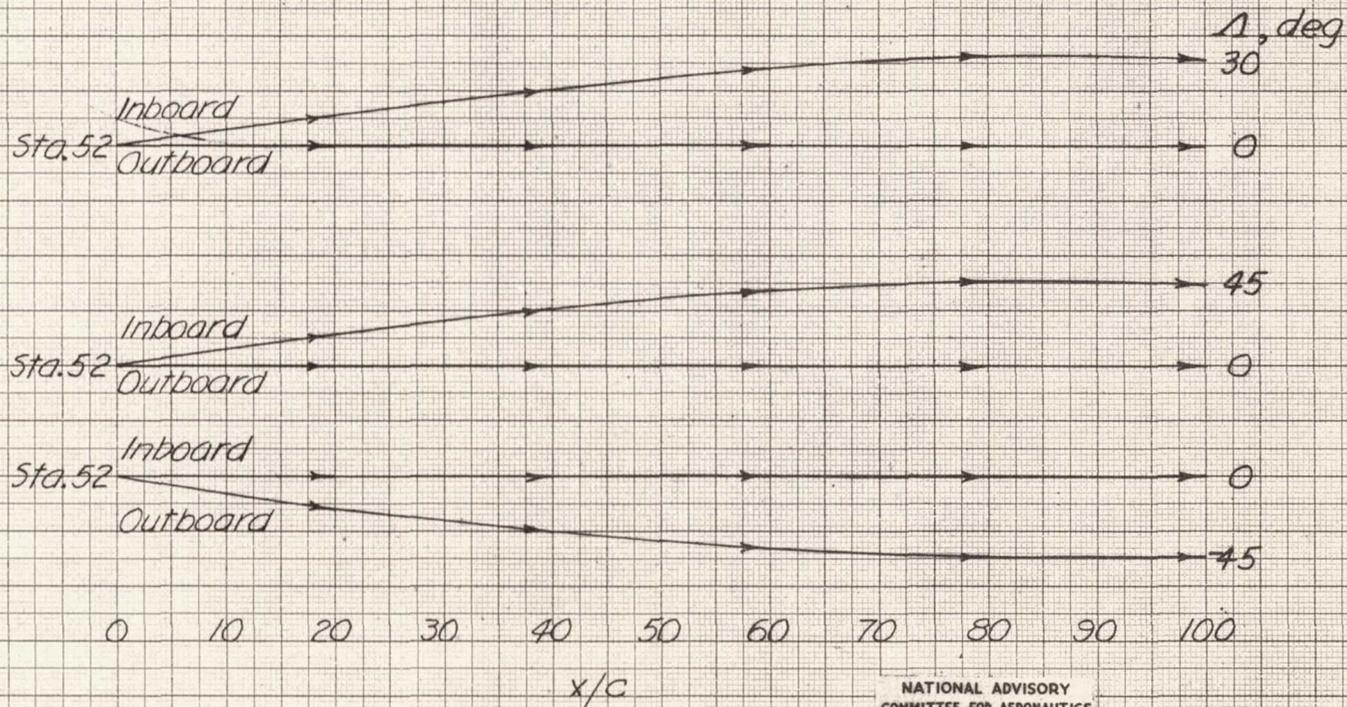
Figure 7.- Calculated streamlines over 65₂-215 wing at spanwise station 52 for the various sweep angles. $\alpha = 6^\circ$

Figure 7 presents calculated streamlines over the wing at each sweep angle for a geometric angle of attack of 6° . The calculations were based on pressure distributions measured at the spanwise station 52 inches from the root ($52 \cos \Lambda$). The distributions were measured when no tufts were on the wing and were cross-faired so that the pressures were determined along chord lines parallel to the free stream. The direction of the flow at any chordwise station was calculated assuming that the induced velocity corresponding to the pressure coefficient was imparted to the velocity vector normal to the leading edge. The resultants of the components normal to the leading edge and parallel to the leading edge were determined and the tangents of the angles between the free-stream direction and the resultant components were plotted against corresponding chordwise stations. The streamlines were then derived by integration of the resulting curve from the leading edge to various chordwise stations.

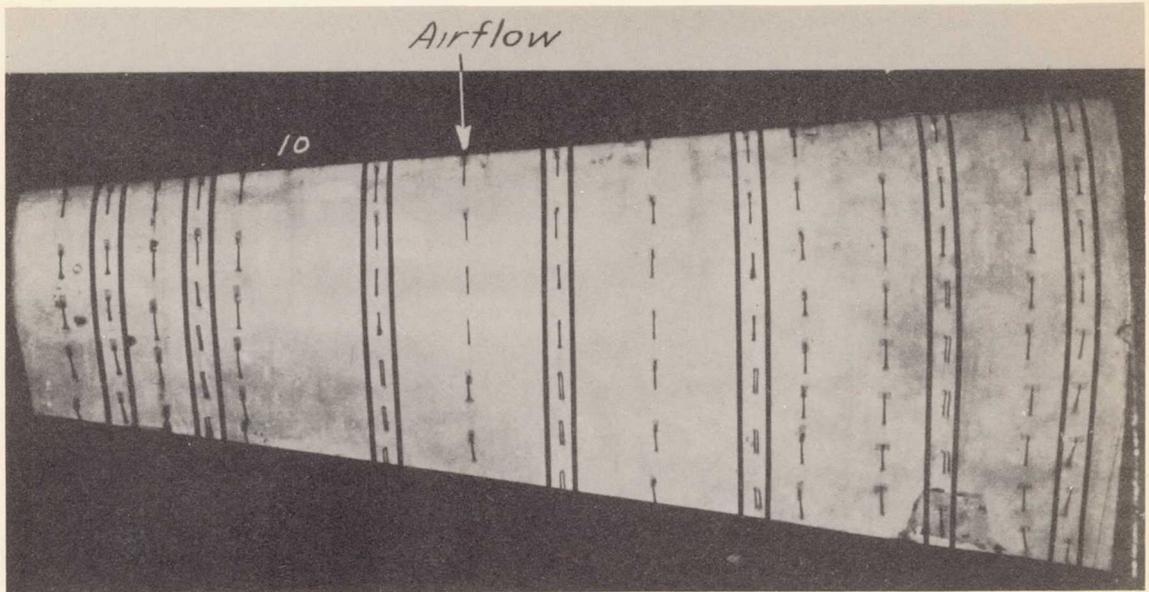
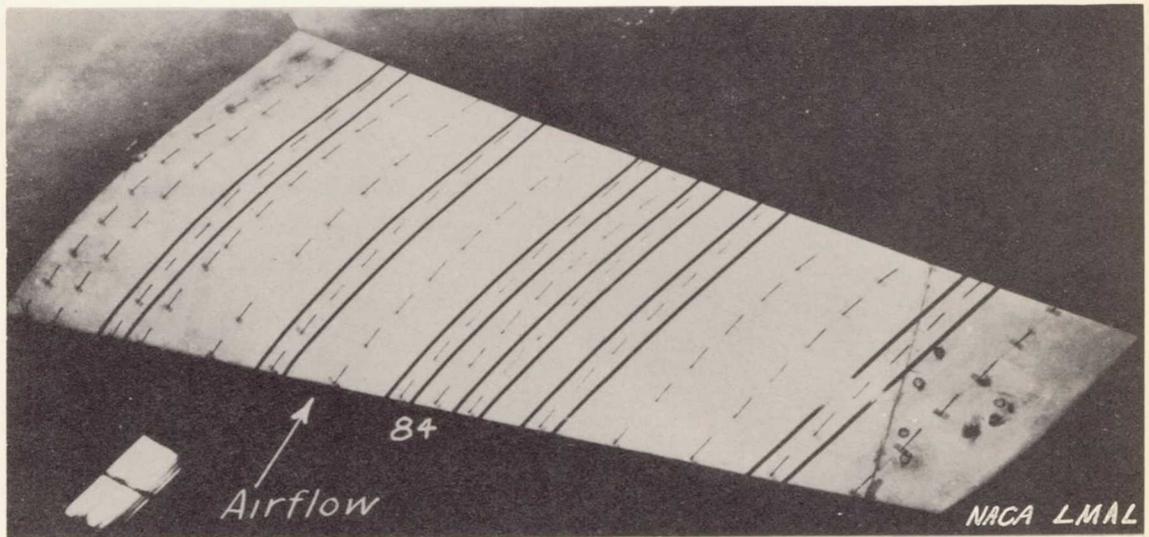
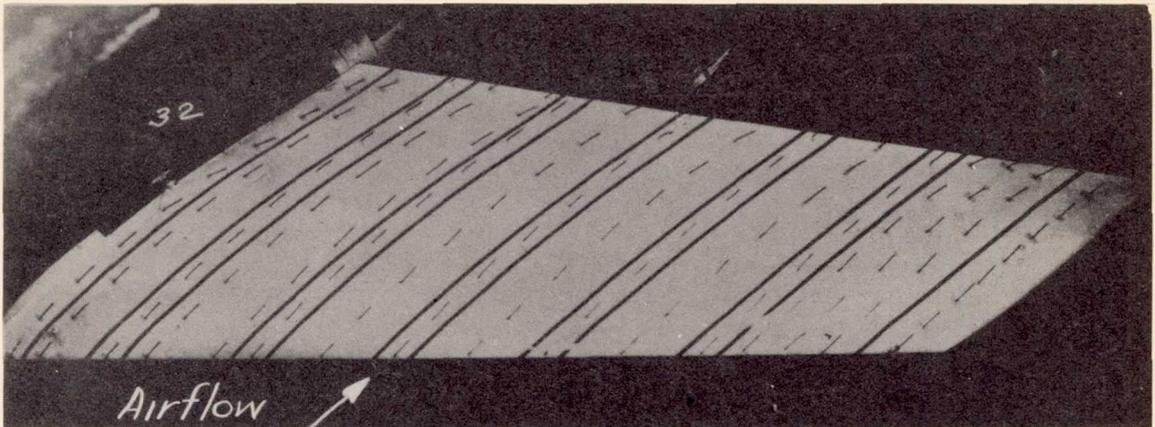
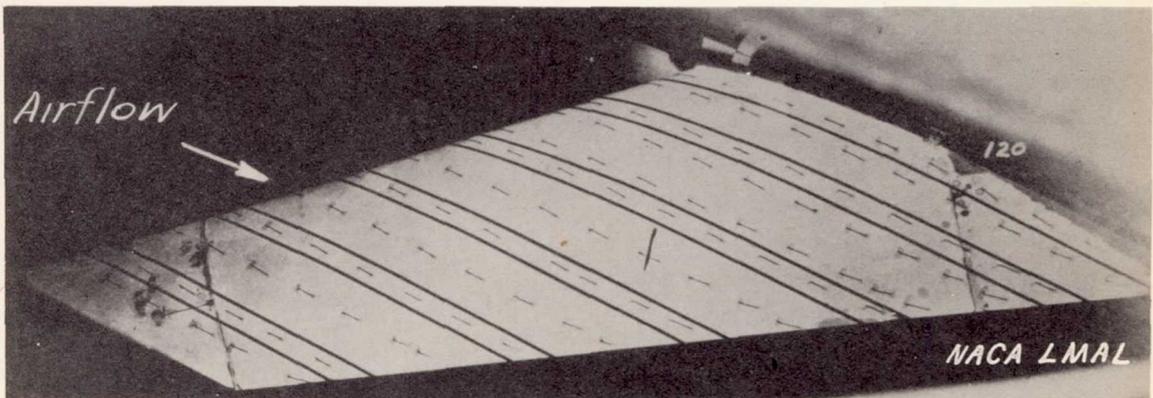
Figure 8.- Tuft patterns on a 65₂-215 wing, $\alpha = 0^\circ$, $M = 0.55$.

Figure 8 shows the tuft patterns over the wing at an angle of attack of 0° , Mach number of 0.55, and sweep angles of 0° , 30° , 45° , and -45° . Due to low induced velocities and small spanwise pressure gradients, the flow was, in general, parallel to the free stream at all sweep angles.

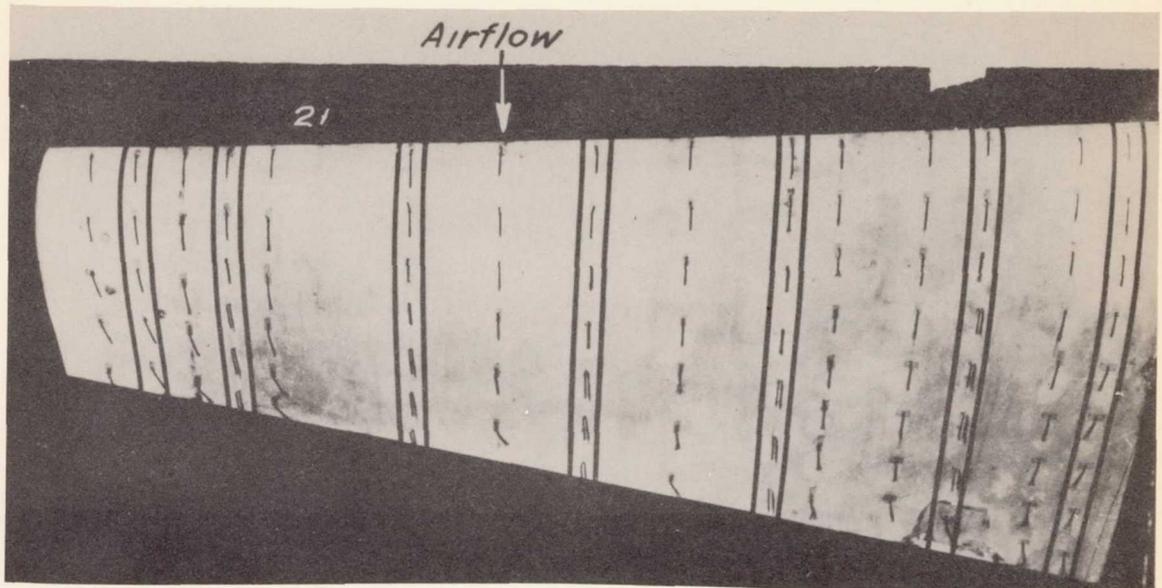
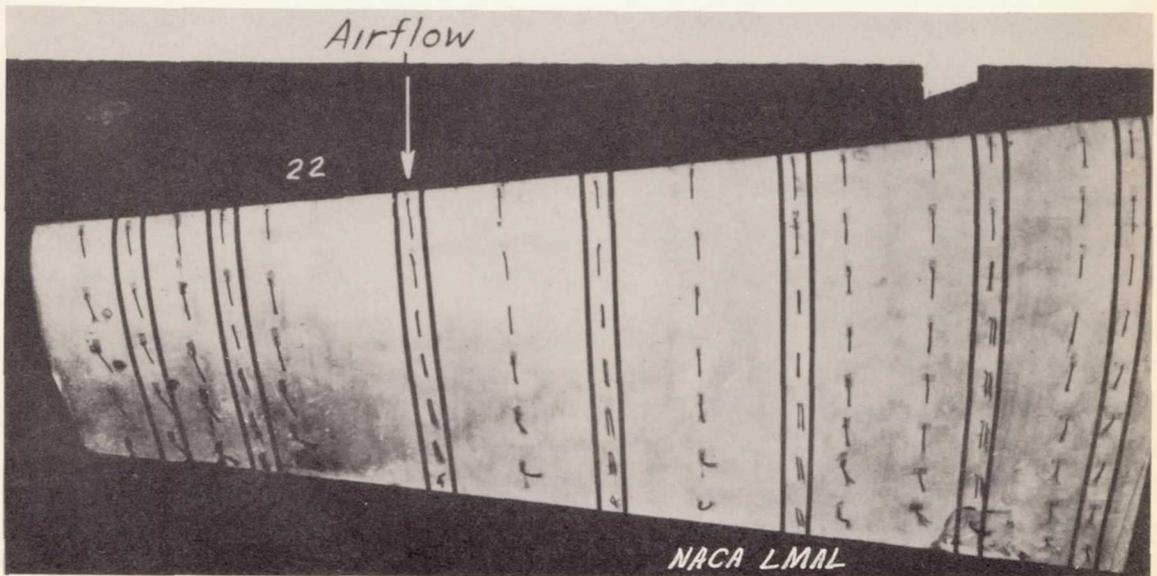
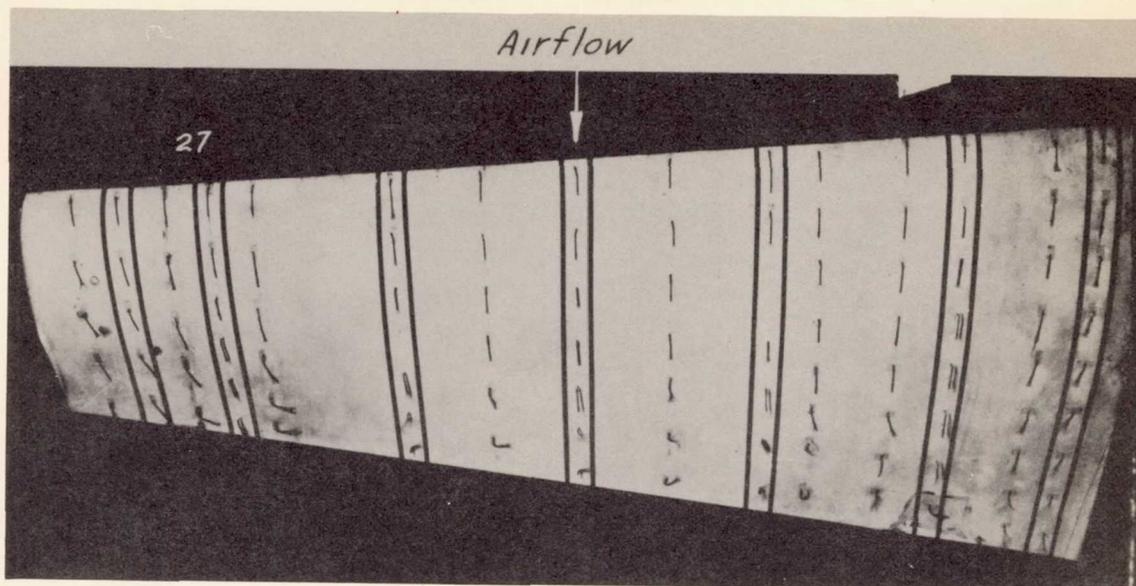
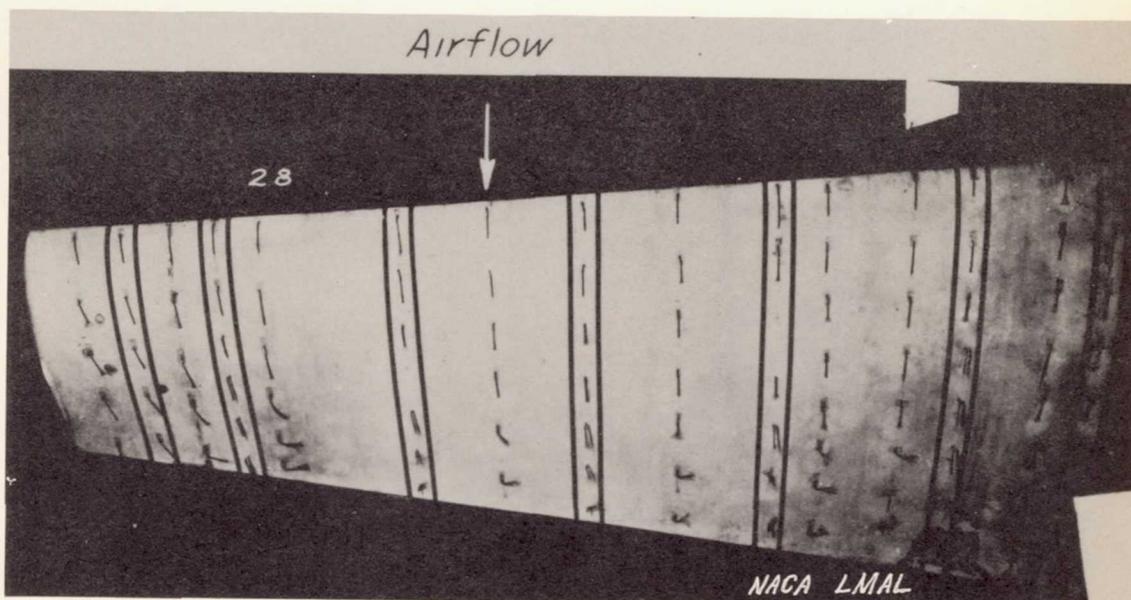
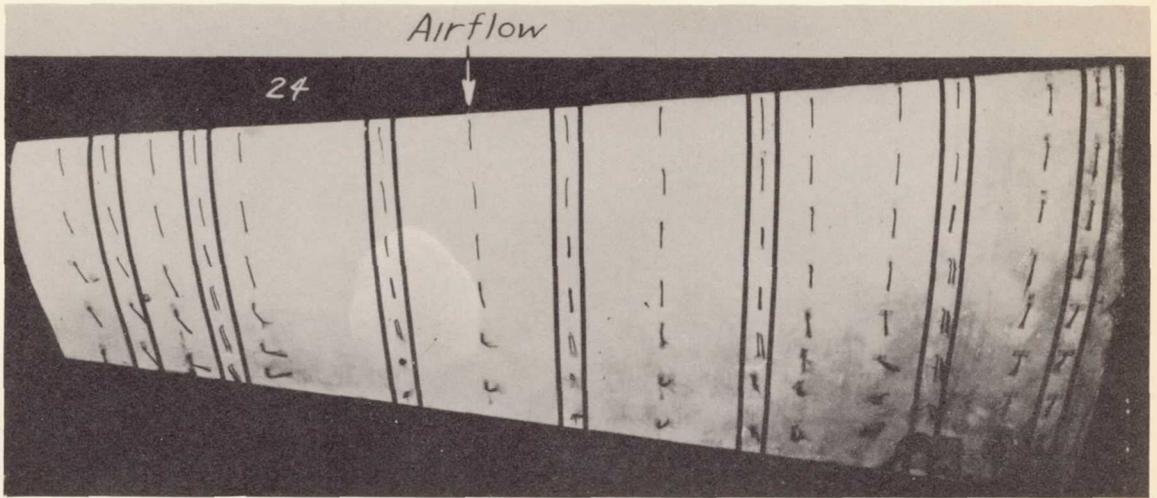
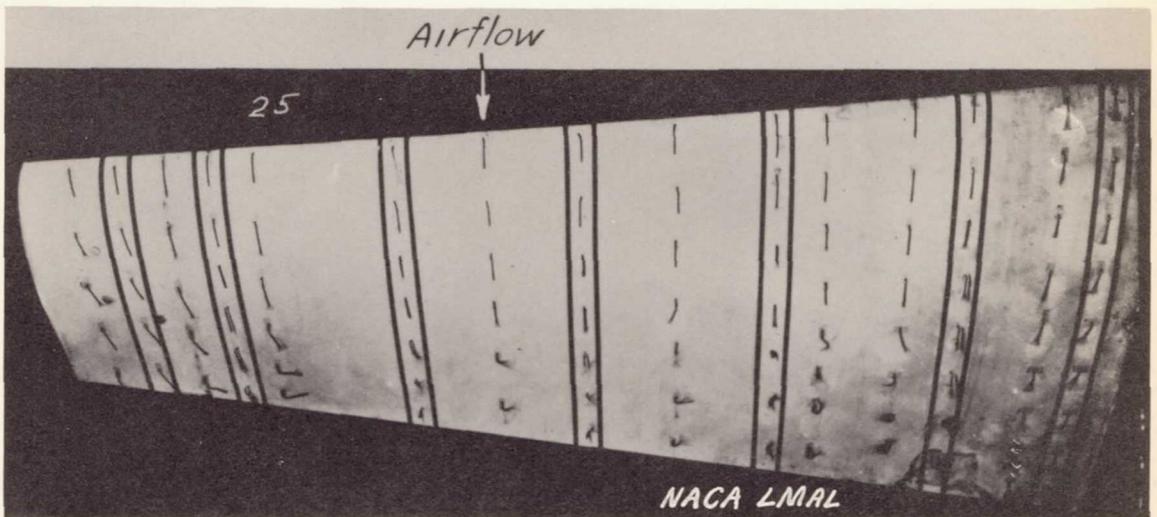
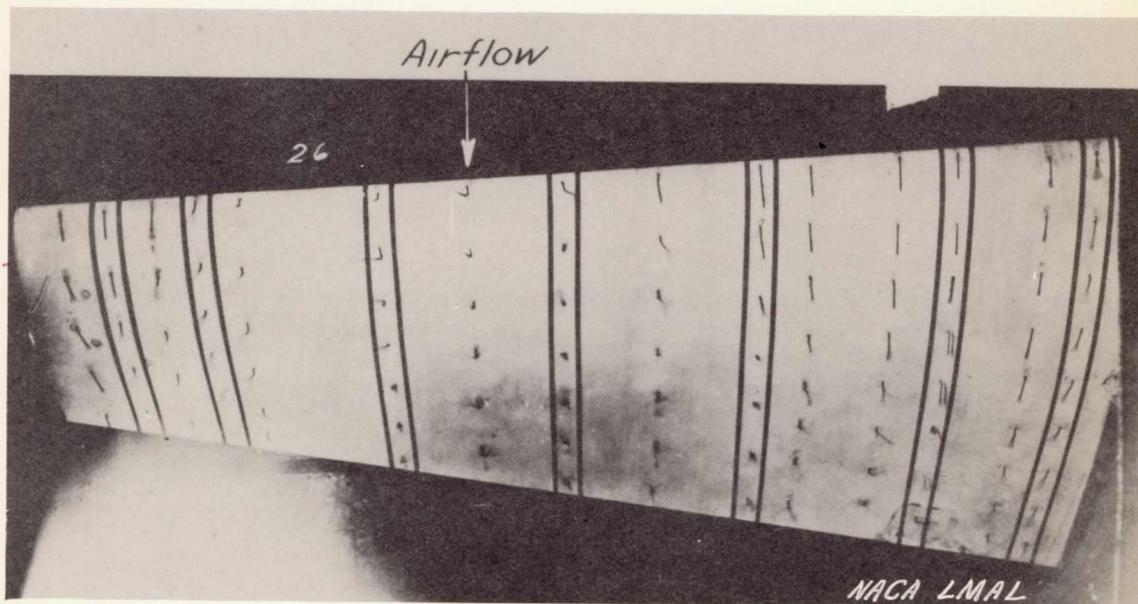
Figure 9.- Tuft patterns on a 65₂-215 wing, $\Lambda = 0^\circ$, $M = 0.13$.

The tuft patterns over the wing at geometric angles of attack from 8° through the stalling angles at a Mach number of 0.13 for sweep angles of 0° , 30° , 45° , and -45° are presented in figures 9, 11, 13, and 15, respectively. These figures are supplemented by sketches of the wing showing streamlines interpreted from the tuft photographs. The sketches are presented in figures 10, 12, 14, and 16, and the streamlines are shown for several angles of attack at each sweep angle. They also include shaded areas where the flow is unsteady and thereby aid in showing the progress of stall over the wing.

Tuft surveys on the wing with no sweep (figs. 9 and 10) show that separation began at about 14° near the trailing edge and progressed toward the leading edge as the angle was increased. The stall progressed forward more rapidly near the center of the wing than at the root and tip. No tuft photographs were obtained beyond 20° angle of attack, however, force data indicated that a sharp stall occurred at 22° .
